Manila-Quezon City A Safety Analysis

Safetipin, in collaboration with the ADB Youth for Asia, conducted safety audits in Metro Manila with a focus on Quezon City. The audits by the ADB team were conducted during from July-November 2016.

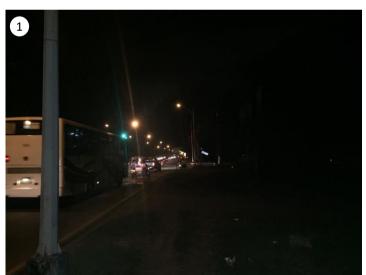
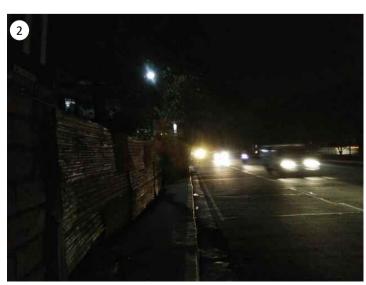
Shown below are examples from the University of the Philippines Diliman where the safety score has been rated as low. Here the lighting is poor and the footpath is broken and obstructed. There are no eyes-on-the-street and the access to public transport mode is limited. People are not seeing using these stretches at night. Overall the auditors rated these areas as unsafe.
