# ENHANCING LAST MILE CONNECTIVITY

a safety analysis of the AIIMS Metro Station

This Report has been prepared as part of the Project being undertaken with NDMC to Enhance the Last Mile Connectivity along the metro stations within it's jurisdiction. The safety audits were conducted by Smt. Saroj Sethi and Smt. Renu Wasandi, architects from NDMC, in collaboration with Jagori and the National Association of Blind.

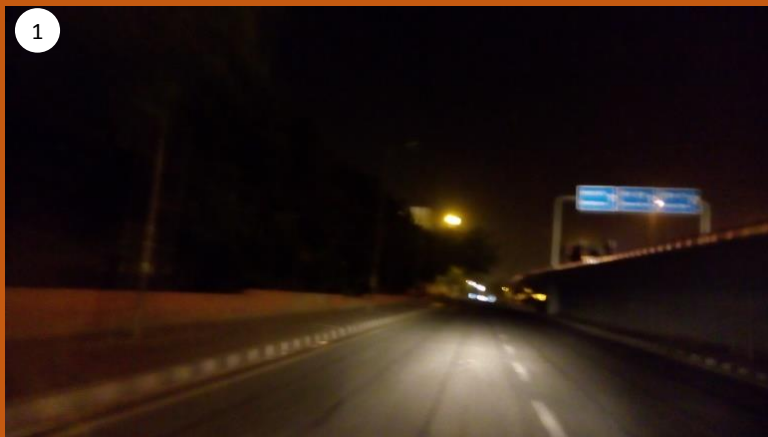
The areas outside the entry/ exit of both AllMS and Safdarjung Hospital are well lit. However, along the Ring Road near AllMS flyover, some streetlights are not operational. As a result, the lighting along the footpath is low while the flyover is brightly lit. Streetlights need to be made operational so that the area used for walking is well lit.

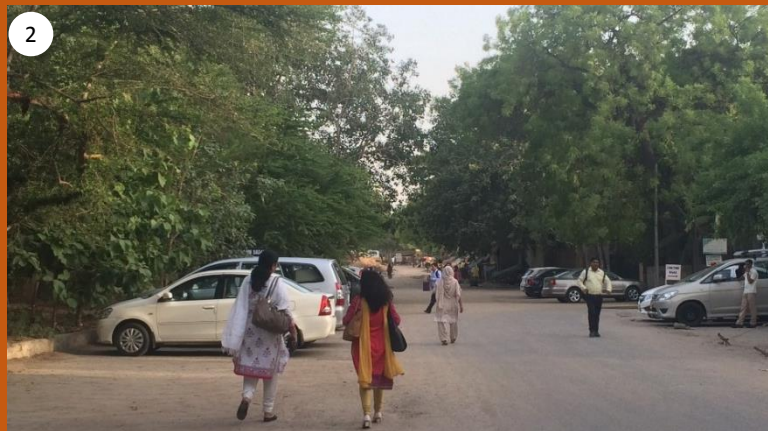
Dark spots are created in lanes adjacent to Safdarjung Hospital. At present, there are light poles on one side of the road that are hidden in trees. Installing additional light poles alternatively on the other side of the road will ensure uniform illumination throughout the road.

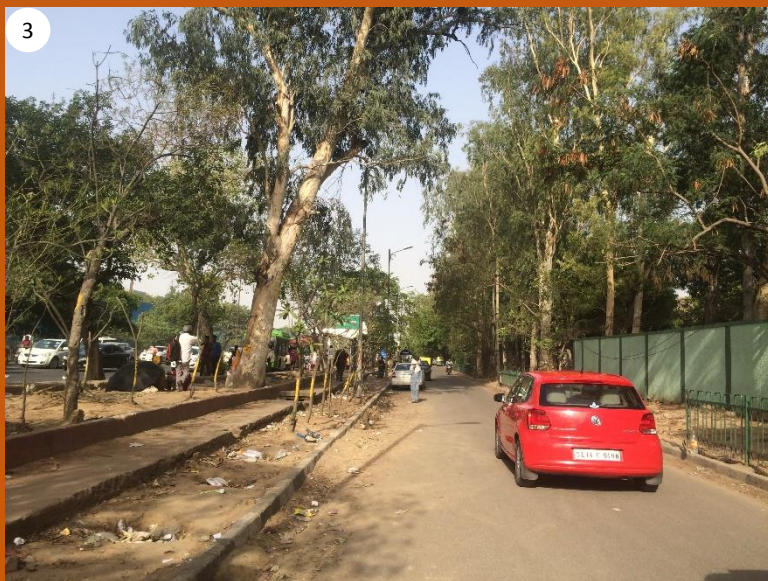
Currently, the streetlights have been provided focusing on the vehicular carriage way of the road. Seen here in Pic 3, near AllMS Gate no. 2 streetlights are focused on service lane resulting in poorly lit footpath. Additional lights should be installed alternatively on both sides i.e. one on the edge of the footpath and other on boundary side, facing the service lane.

Also, the foliage along the streetlights needs to be pruned regularly as the overgrown leaves shield the light fixture resulting in poor illumination

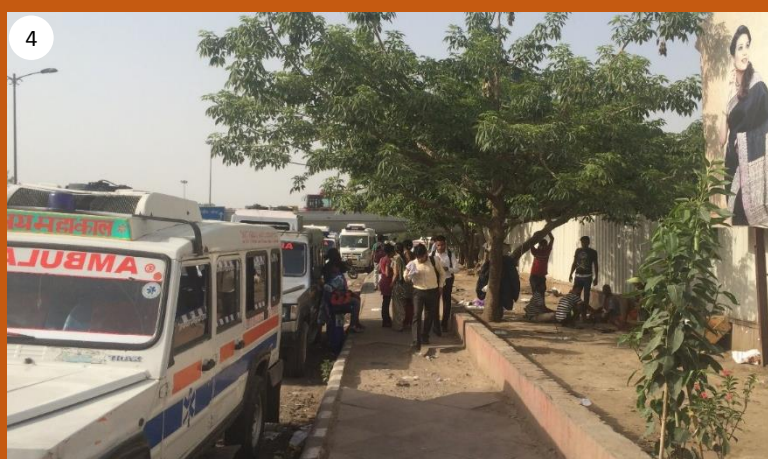
On Aurobindo Road, streetlights are installed only on central median, resulting in low illumination on the walkpath. Seen here in Pic 4, at the junction of the Ring Road and Aurobindo Marg, pedestrian scale streetlights need to be located along the footpath. These should be provided on the edge of the footpath so as not to obstruct the pedestrian movement.

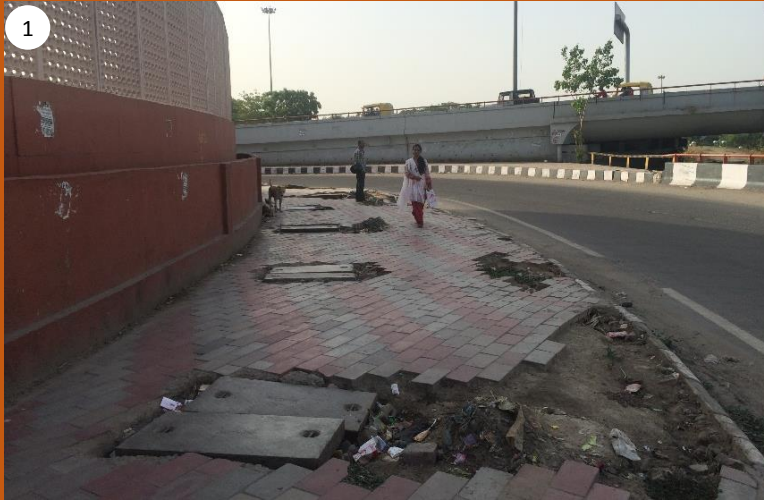
Though the footpath exists throughout the audit path, the condition is poor in most of the areas. As seen in the Pic 1, broken footpath and open drains can prove risky for the pedestrians. This footpath should be repaired and the manholes' cover should be flushed with the level of the footpath to ensure smooth movement of the pedestrians.

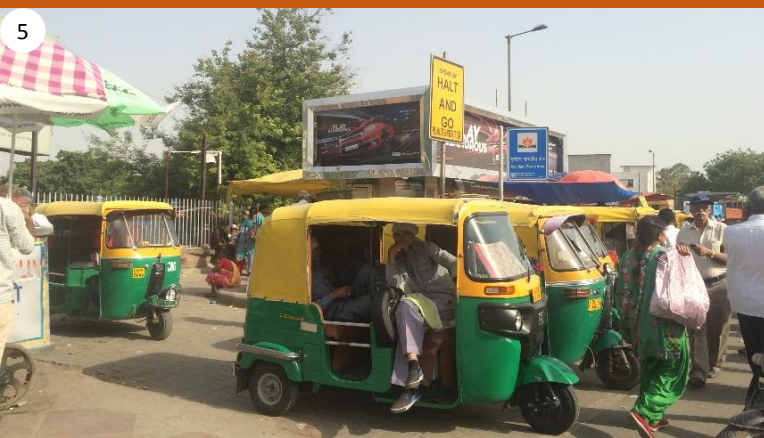
Seen here in Pic 5, footpath is obstructed by the autos in front of Gate no. 1 of AIIMS. With existing kiosk for prepaid auto, an auto stand should be provided clear of the footpath. Bollards need to be provided to ensure that the autos don't obstruct the pedestrians' movement.

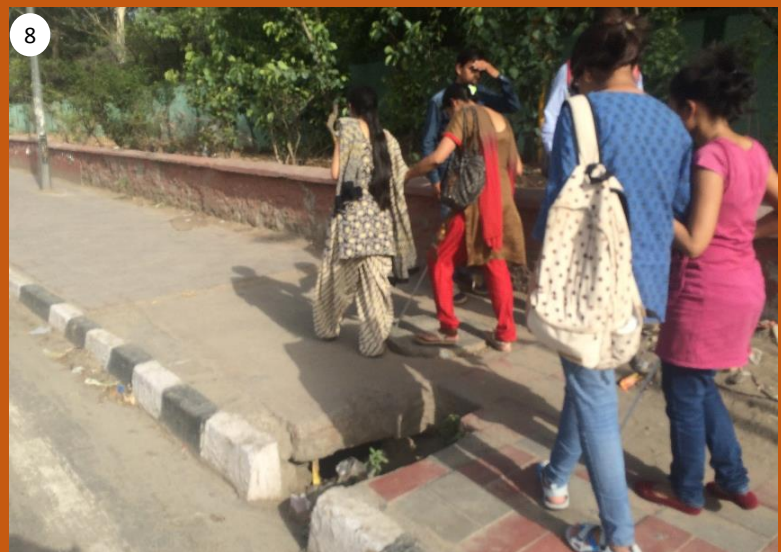
As seen in the Pic 8, open drains are risky for the pedestrians. These drains should be covered and the cover should be flushed with the level of the footpath to ensure smooth movement of the pedestrians.

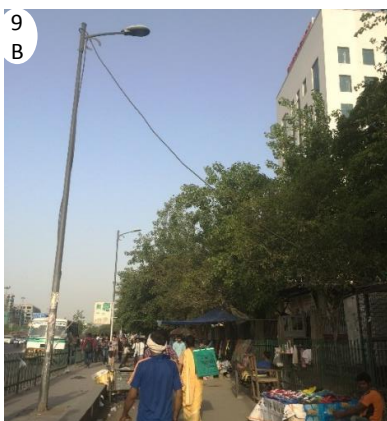
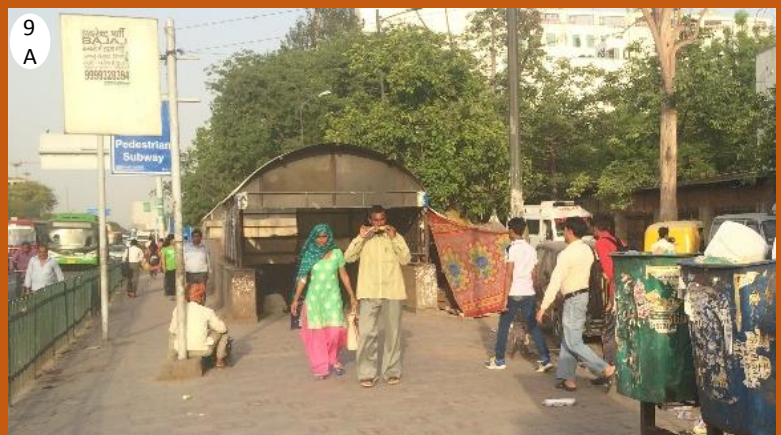
Seen here, inappropriate placement of signboards and the streetlight (Pic 9A and 9B) on a narrow stretch of the footpath proves to be nuisance rather than beneficial. These obstructions to be removed and placed at the edge of the footpath to provide a clear passage.

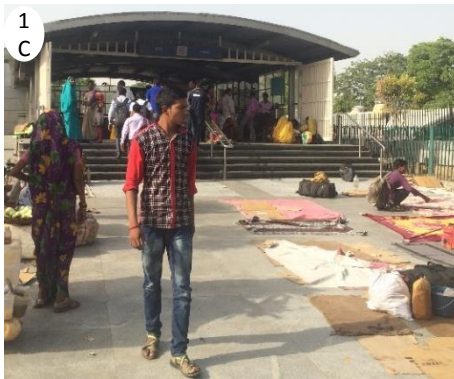
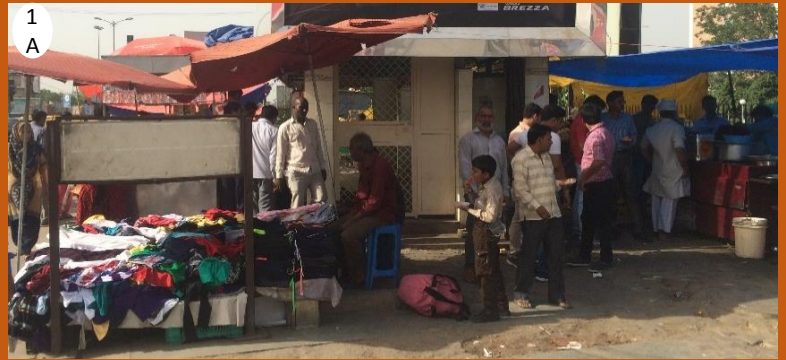
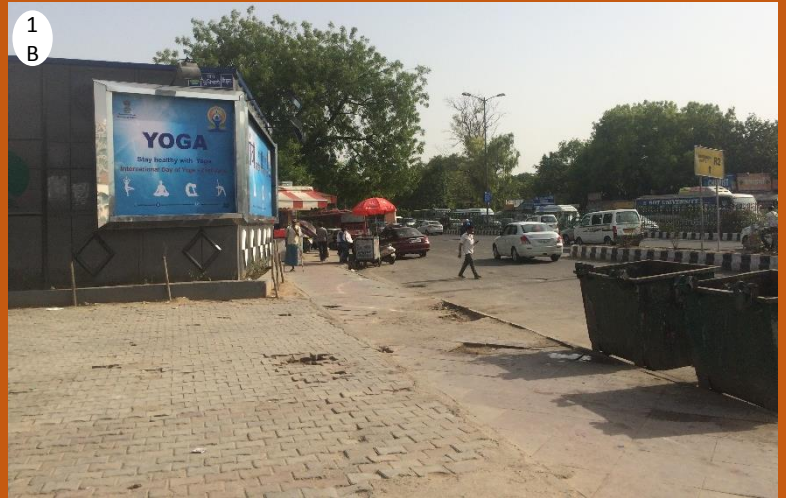
In absence of a designated space, hawkers present near AIIMS gate no. 1. end up crowding the footpath (Pic 1A). Seen here in Pic 1B, there is unused space near public convenience where a hawker zone should be set up clear of the footpath. The dustbins should be relocated within the hawker zone. Also as seen below, to avoid blocking of entry/exit of the metro station, street furniture should be installed for people.

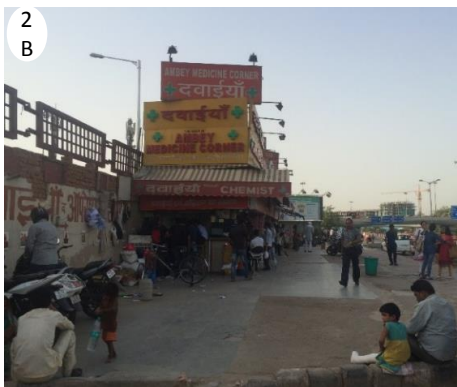
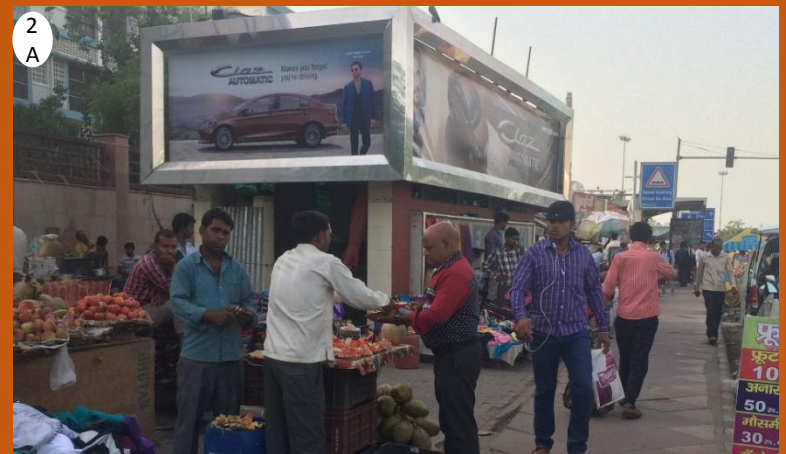
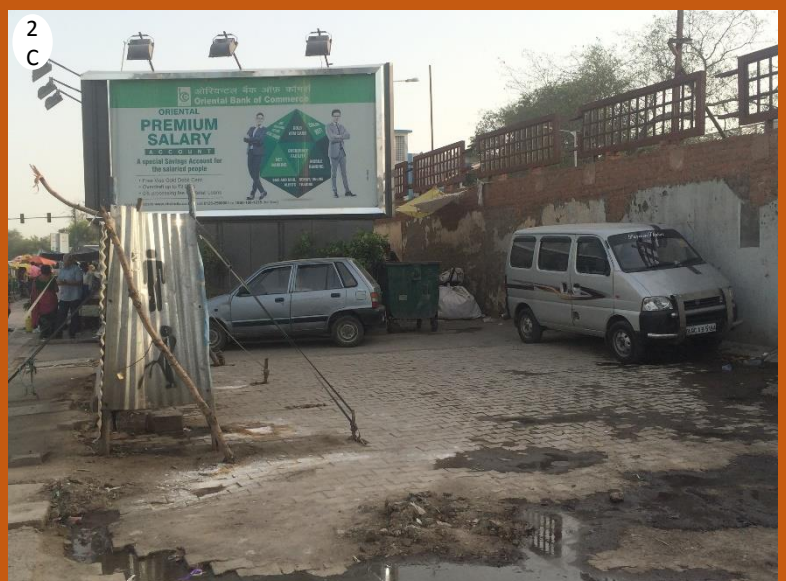
On the same road (Aurobindo Marg) near Safdarjung hospital, space has been provided for public convenience (2A) and medical shops (2B) clear of the footpath. The similar provision should be made for the hawkers. Seen in Pic 2C, there is an open toilet and a dump yard. This should be cleared to make a way for a hawker zone. Also, parking on footpath should be disallowed.

Another issue seen here in Pic 2B , is the lack of street furniture that forces people to squat and obstruct pedestrian movement.

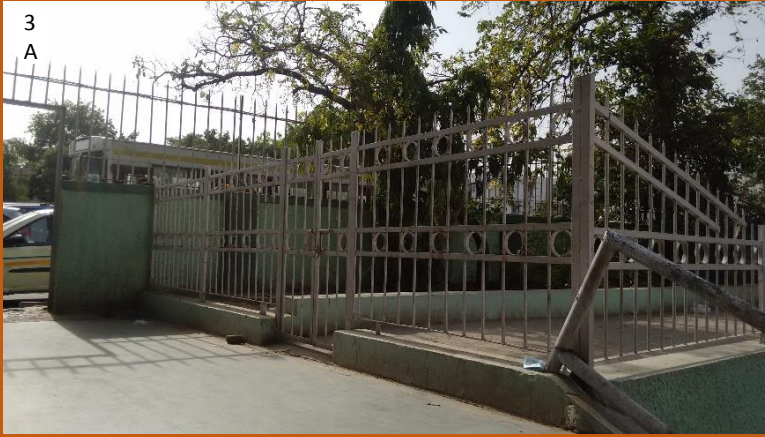
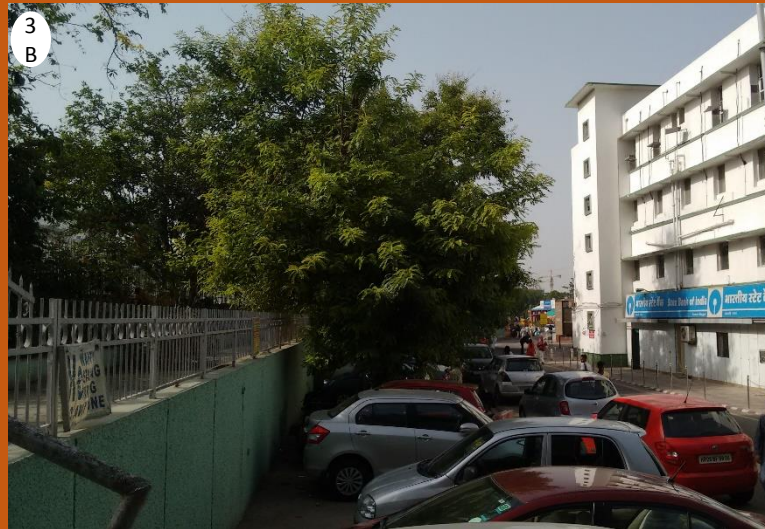
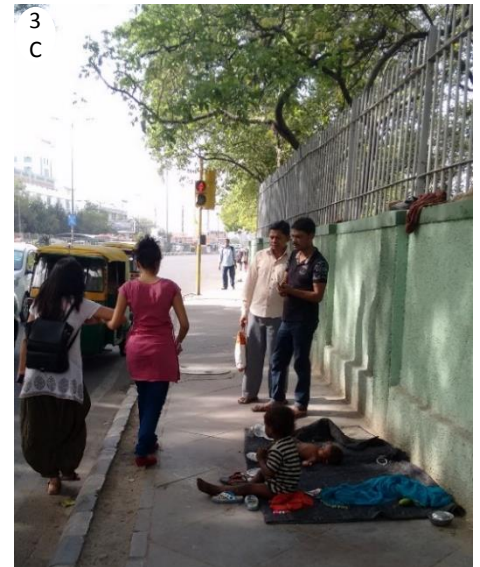
Seen here in Pic 3A, a locked walkpath inside AIIMS premises overlooking parking bay and SBI bank (Pic 3B). Since external footpath is narrow and occupied by people (Pic 3C), this edge needs to be redesigned to cater to the needs of both pedestrians and people visiting the hospital.

This walkpath should be opened up for the people and can be developed as interactive edge equipped with street furniture. This way the external footpath would be clear of any obstruction and provide some eyes on this stretch of the road.

Also, the boundary wall design of these areas needs to be modified. The solid surface of the boundary wall needs to be reduced to at least 1m and the remaining height be achieved using a grill.

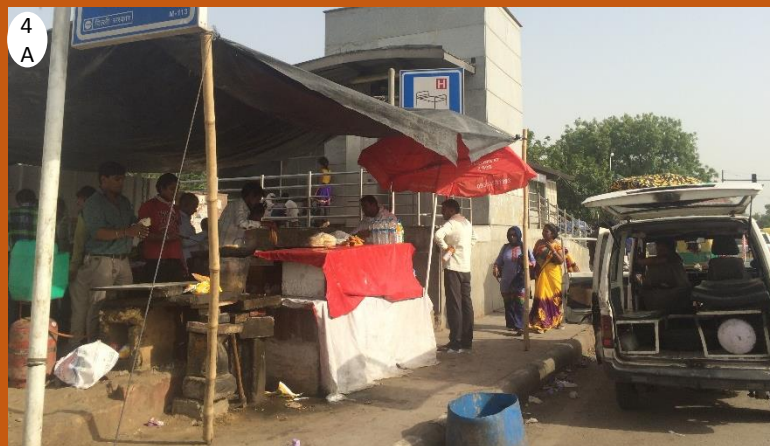
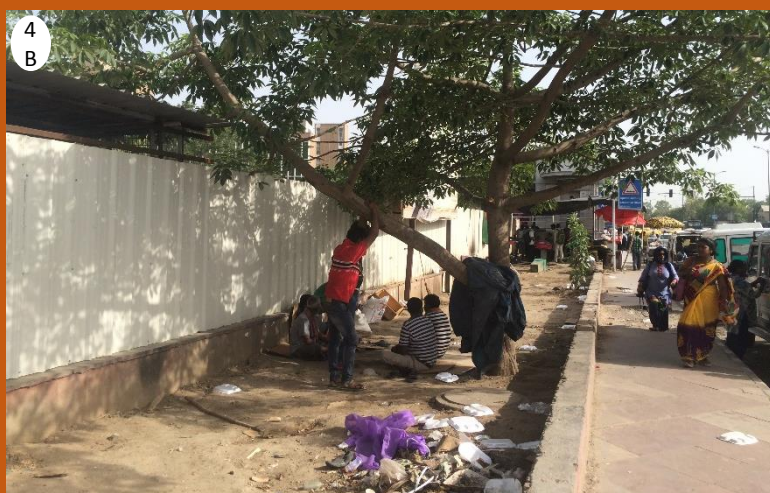
At present, the footpath near the metro station is obstructed by the temporary stalls, which need to be shifted. Further down this stretch, there is a buffer space between the boundary wall and the footpath (Pic 4B). This stretch should be redesigned to accommodate the temporary stalls, thus clearing up the footpath. Also, proper provisions should be made for garbage collection.

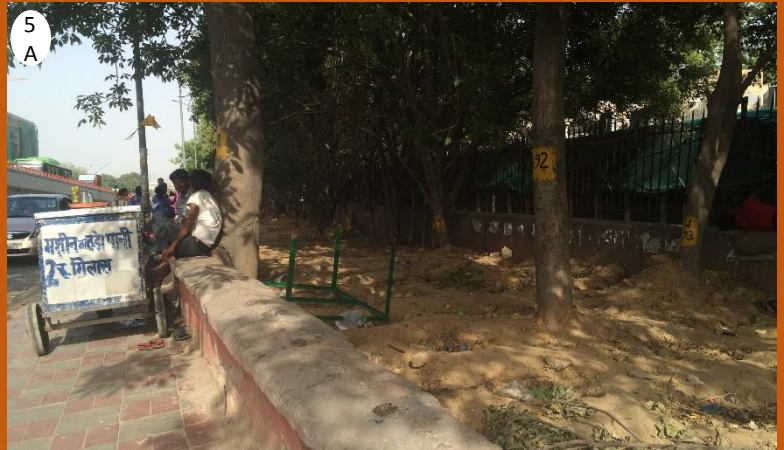
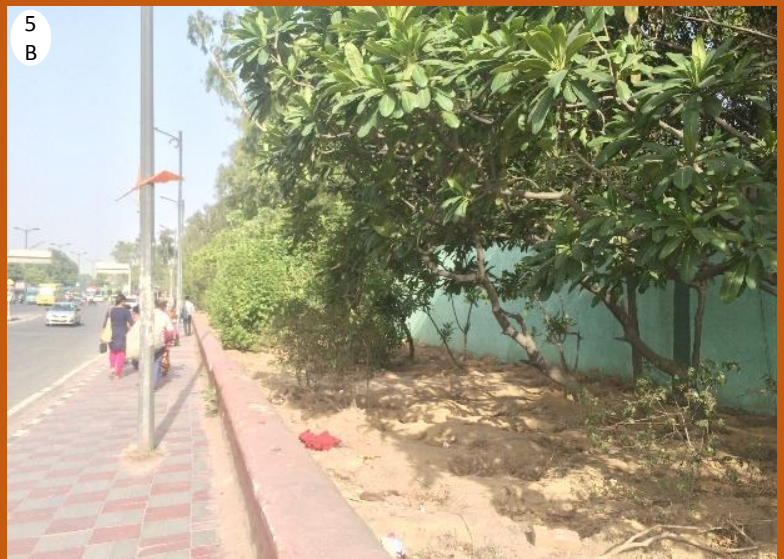
*There is a level difference between the walkpath and AIIMS building premises. Additionally, the buffer space along the boundary results in low visibility towards the walkpath. (Pic5A)*

*To activate this stretch, the buffer space should be redesigned to integrate it with the footpath. A shaded space equipped with street furniture should be provided for the pedestrians, which would accommodate the street vendors as well.*

*Further down this stretch (Pic 5B), the solid surface of the boundary wall needs to be reduced to atleast 1m and the remaining height be achieved using a grill.*

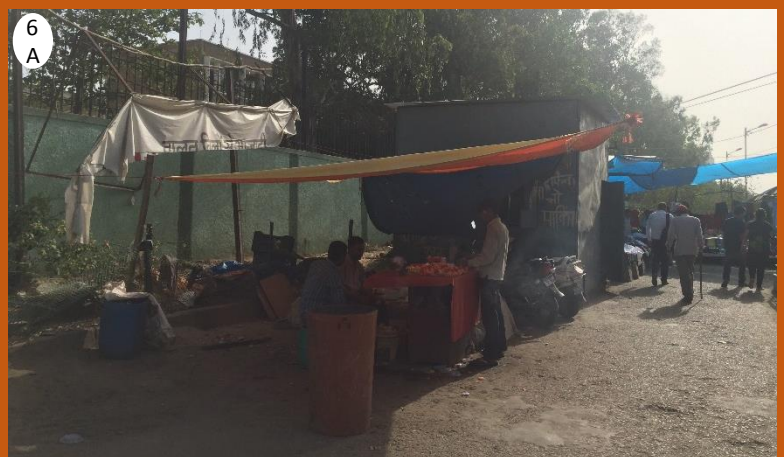
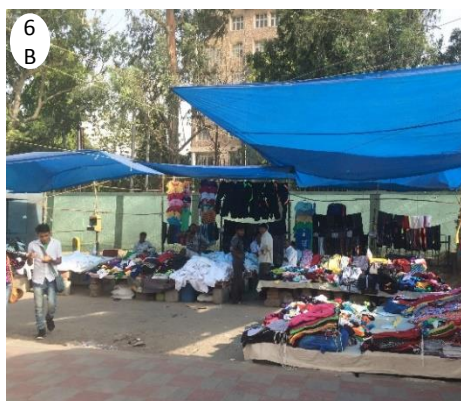
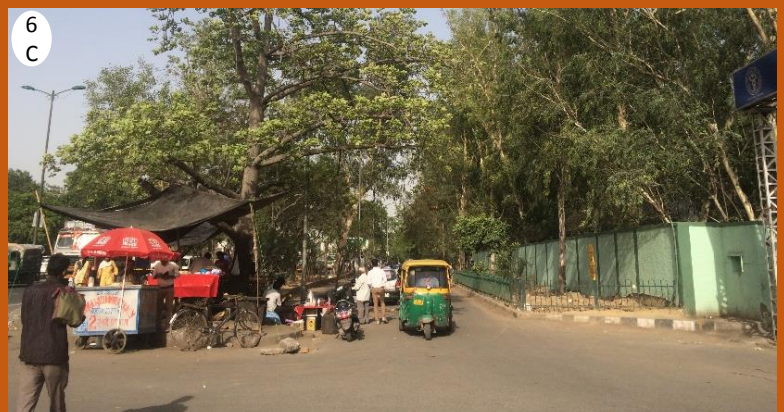
*Seen here in Pic 6A and 6B, the area outside Gate no. 2 of AIIMS (Ring Road) is occupied by street vendors. Public convenience facility is present but not operational. This space can be further enhanced by making it a para transit hub. A designated auto stand should be set up with proper parking space for the autos, clear of the footpath and service lane (Pic 6C). A hawkker zone should be created along the boundary wall of the hospital, thus ensuring activity in this stretch.*

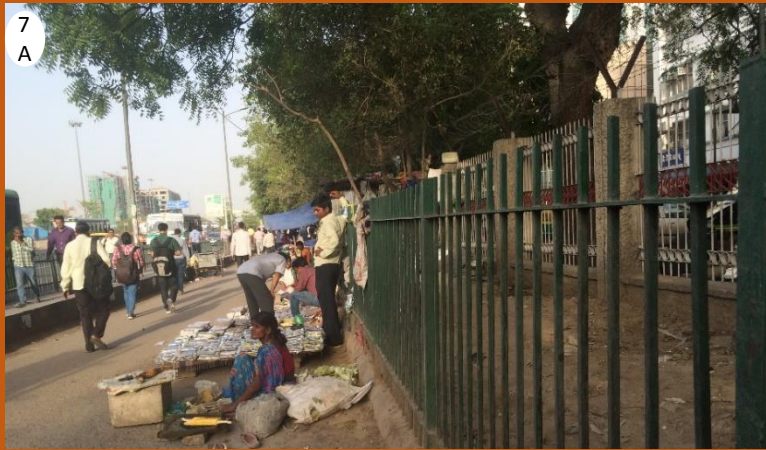
Seen here in Pic 7A, the boundary of Safdarjung Hospital is marked by double grills creating a buffer space. The, outer railing can be removed and the edge can be used to accommodate the hawkers, thus not obstructing pedestrians / vehicles in the service lane.

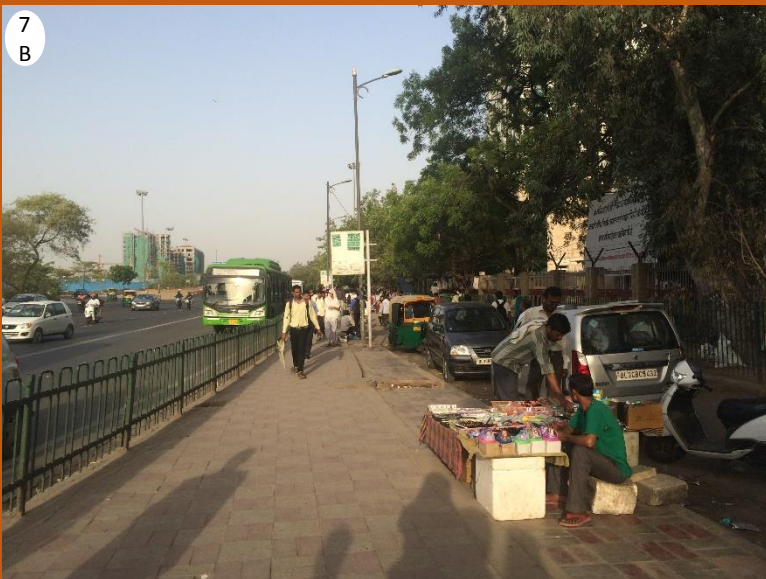
Alternatively, in stretches where footpath is wide enough (Pic 7B), hawkers can be placed along the footpath clear of service lane.

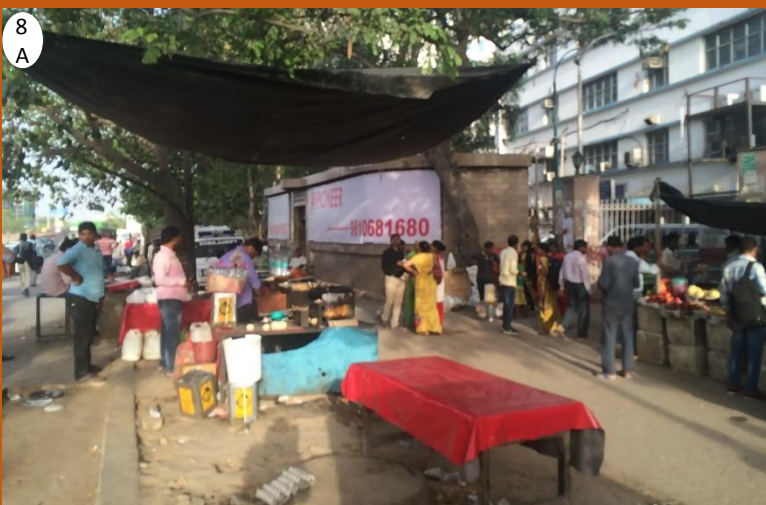
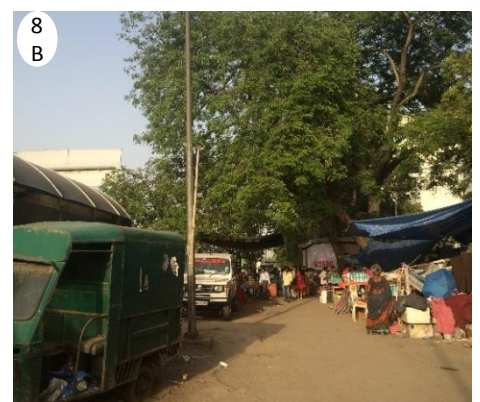
Seen in Pic 8A at entry/ exit gate of Safdarjung Hospital, in absence of a designated space, they have occupied the service lane. A hawker zone should be created along the boundary wall of the hospital. This would ensure smooth movement of the pedestrians and vehicles in the service lane .

Unauthorized parking should be disallowed in the service lane. Vehicles parked behind the subway / bus stop obstruct the service lane. (Pic 8B)

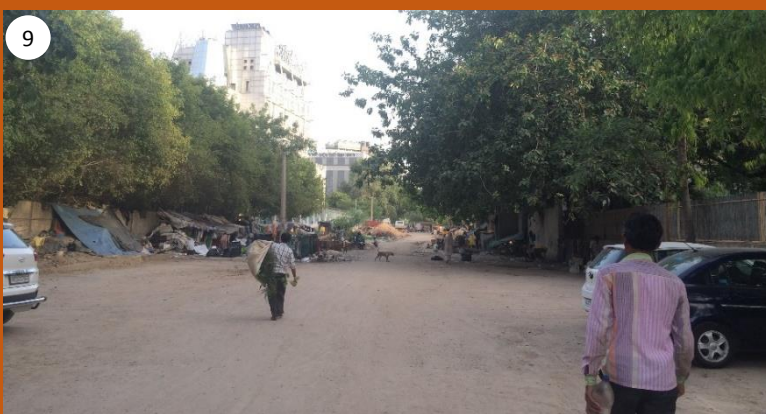
There is a squatter settlement in the lane adjoining the boundary wall of Vardhman Mahavir Medical College. With high boundary walls on one side and offices on other, the visibility is very poor in this area (Pic 9). An entry/ exit gate for pedestrians/ vehicles to the Medical college can be opened towards this lane so as to activate this area.

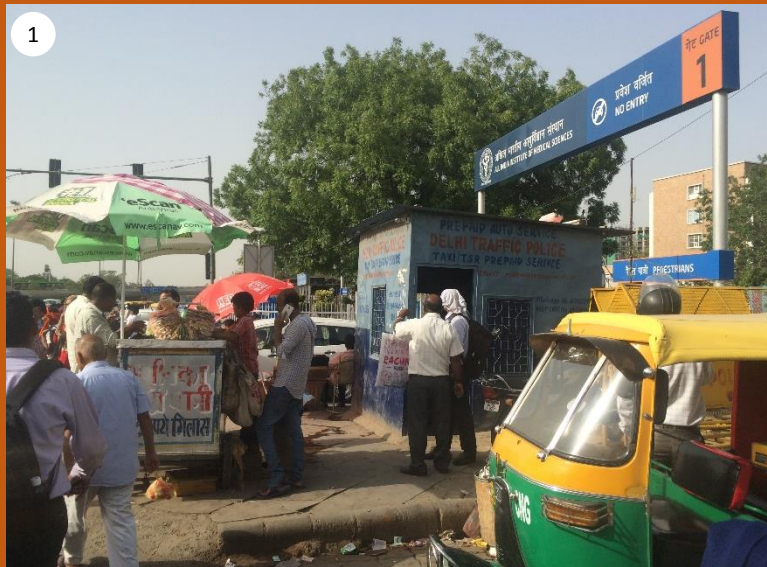
At AIIMS Gate no. 1, there is a designated kiosk of Prepaid Auto. However, in absence of proper parking space, autos and hawkers obstruct the pedestrian movement. A para - transit hub should be designed which has an auto stand and segregated space for hawkers clear of the footpath. This can be provided along the boundary wall of the building.

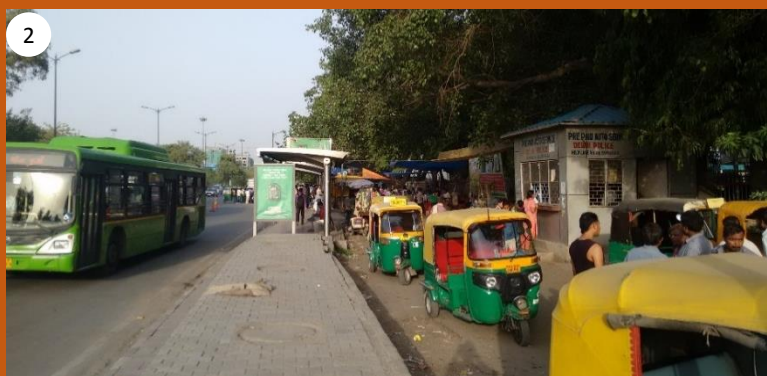
Seen here in Pc 2, there is a designated kiosk of Prepaid Auto near the Safdarjung Hospital's entry/exit gate. Autos have occupied the service lane. An Auto Stand can be provided along the boundary wall of the hospital so as not to disturb the movement of pedestrians.

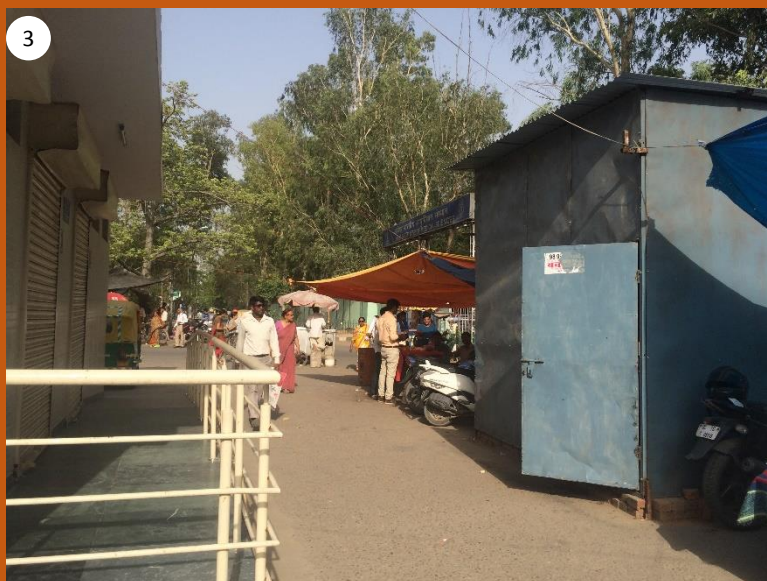
With the large number of people visiting AIIMS, a Para-transit hub should be developed near AIIMS Gate no. 2 as well. As seen here, at present there is no auto stand, and existing public convenience facility is non operational. A para transit hub should be developed along the boundary wall in the service lane. This would improve the visibility as well as provide convenient access to the para-transit facility.

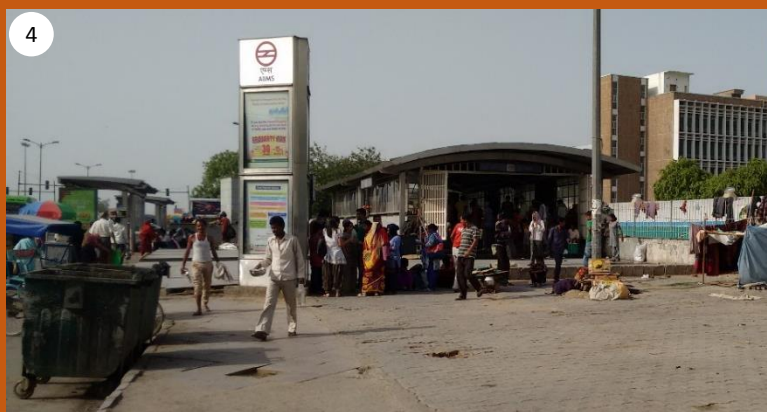
The area around the metro station and the bus stop is inhabited by people. Seen here in Pic 4, the large area outside the entry/exit of the metro station is obstructed by hawkers and inappropriately placed dustbins. Segregated space should be provided for the hawkers, which is equipped with the street furniture.
