ENHANCING LAST MILE CONNECTIVITY

a safety analysis of the Barakhamba Road Metro Station

This Report has been prepared as part of the Project being undertaken with NDMC to Enhance the Last Mile Connectivity along the metro stations within it's jurisdiction. The safety audits were conducted by Smt. Nutan, architect from NDMC along with Safetipin team.

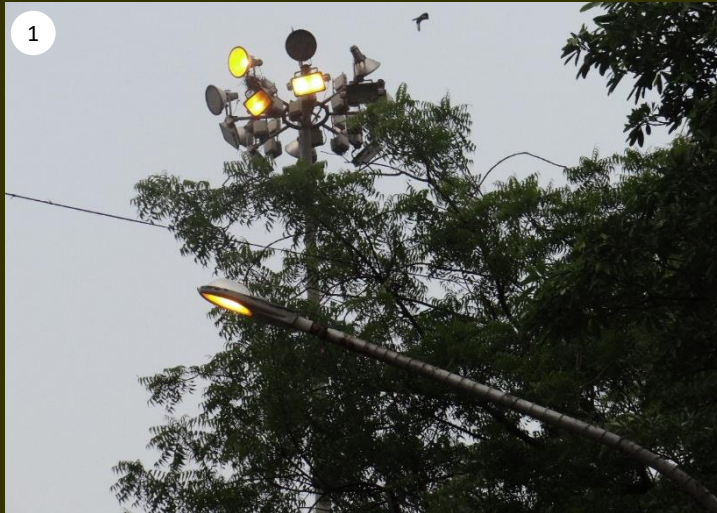
A few light fixtures were found to be un-operational. Regular maintenance checks are needed to ensure that all streetlights are operational at all times. Also, the lights need to be well spaced to ensure the entire area is well lit.

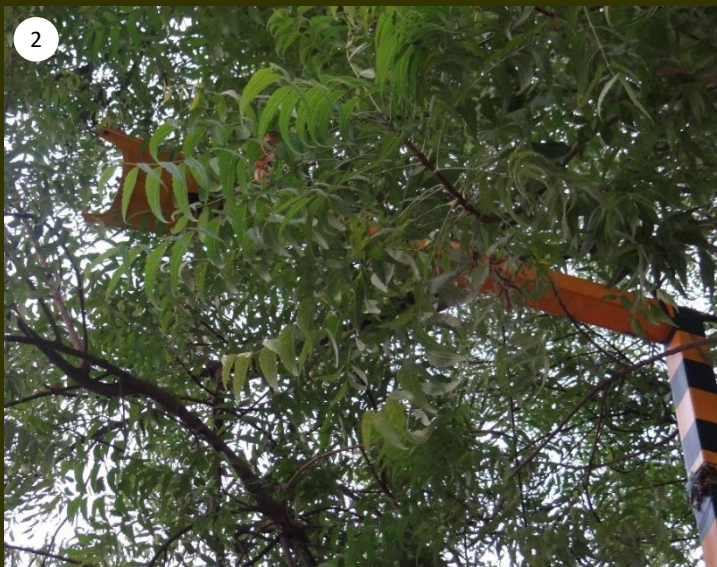
A few street poles do not have any light fixture installed on them. Light fixtures should be fixed and energized to sure illumination. Also tree leaves need to be pruned.

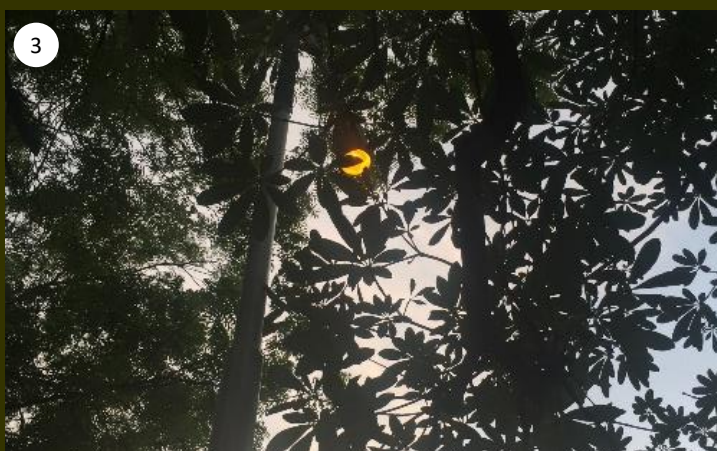
Some streetlights are covered by tree leaves resulting in dimmed illumination. Regular pruning of tree leaves is essential to prevent this.

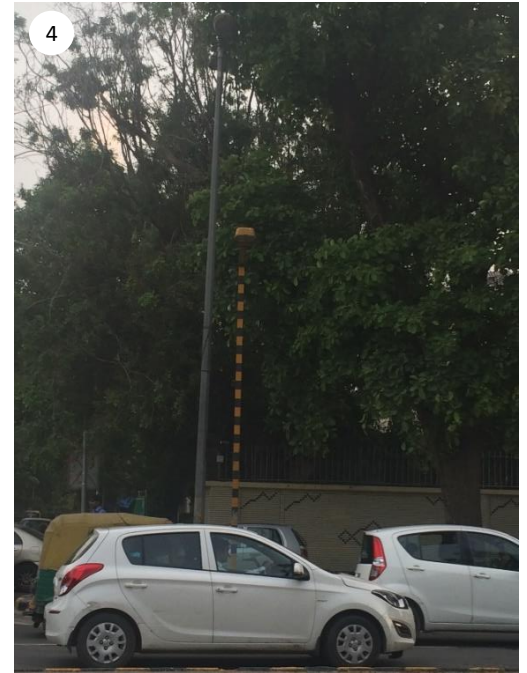
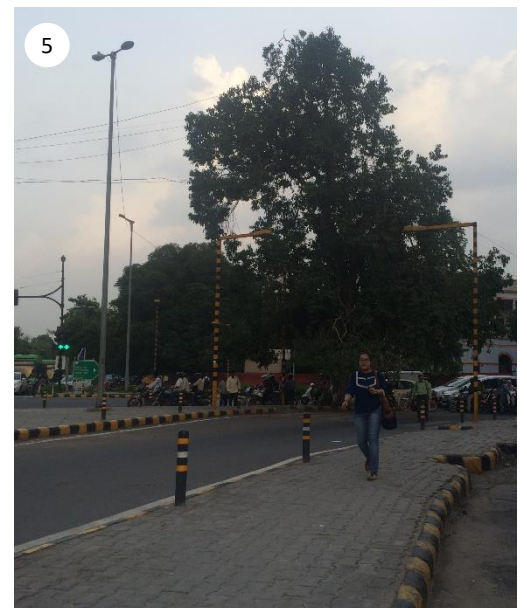
At few points , multiple streetlights have been located in close proximity. While installing new lights care should be taken to evenly space them such that the entire road stretch is uniformly illuminated. Currently while few spots are very brightly lit, other are not well lit. This also causes glare and should be avoided. Such poles should be re-located at a certain distance.

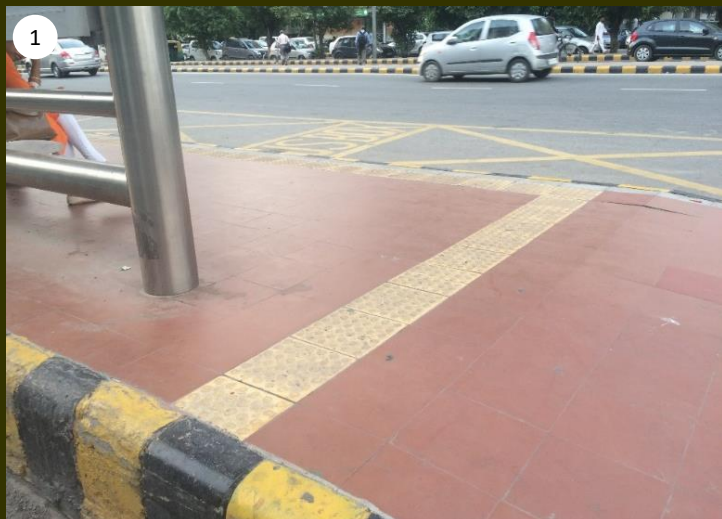
The tactile paving on the bus stop ends abruptly at the kerb. The kerb height is more than one foot which further makes it risky for the visually impaired. Tactile paving needs to be provided along the entire length of footpath and connected with the paving at the bus stops and metro stations.

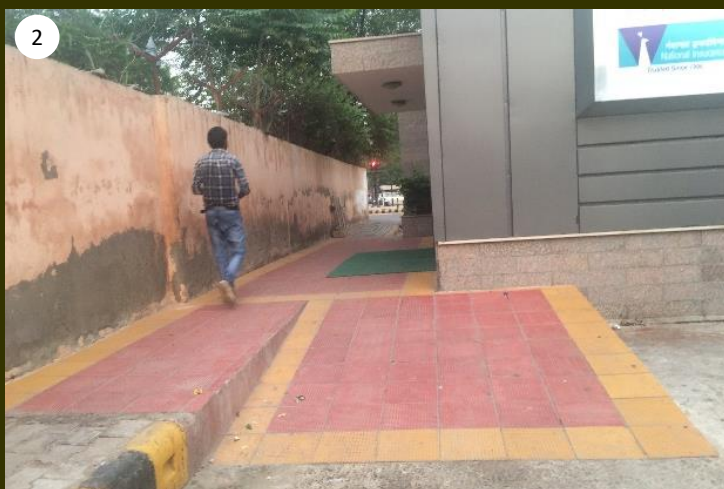
The ramp to the Public Convenience does not have any tactile paving. Though it has a rough surface for easier movement of wheelchair, tactile paving too needs to be incorporated.

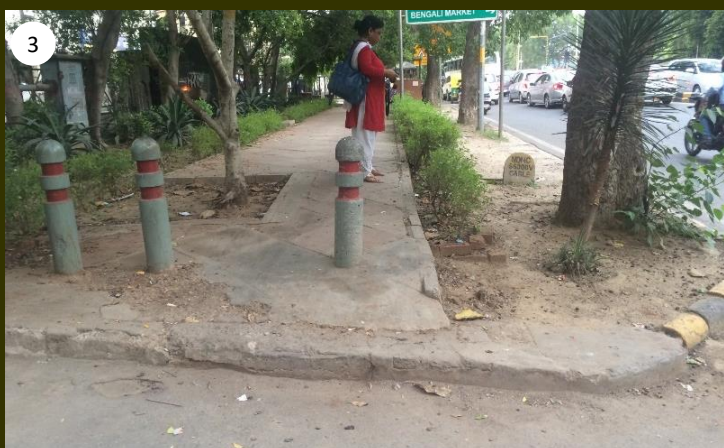
Bollards have been located randomly such that they not only prevent wheelchair movement but also obstruct pedestrian movement. Bollards should be spaced such that wheelchair can pass. A ramped edge also needs to be created.

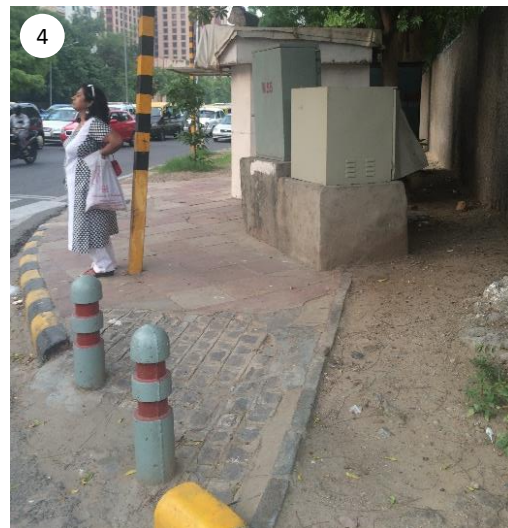
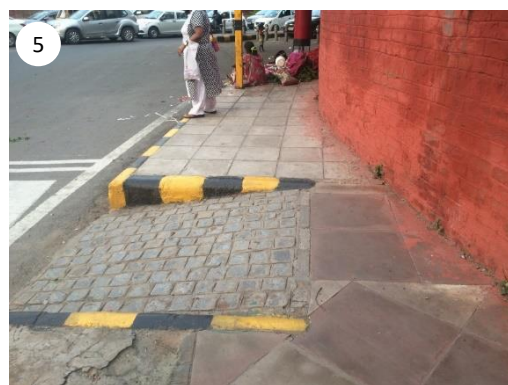
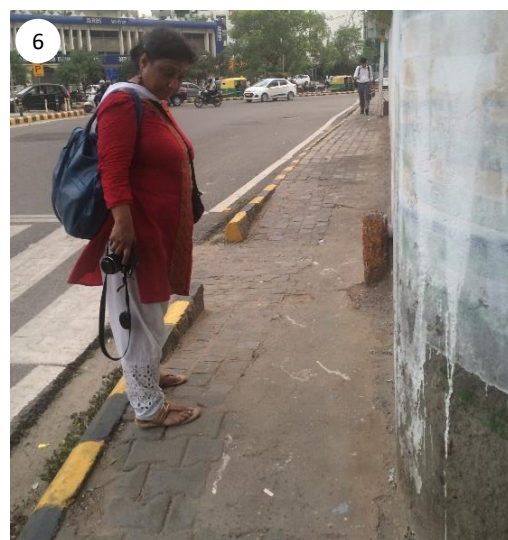
Ramps have been provided for egress/ingress but these are too steep and without proper turning radius. Also, as seen here in pic4, bollards have been located blocking the ramp. These need to be removed and a proper ramp be created. In pics 5&6, the ramp ends into the boundary wall and there is no space for a wheelchair. Even for pedestrians it is difficult to move. Also the ramp should be clear of the footpath such that pedestrian movement is not disrupted.

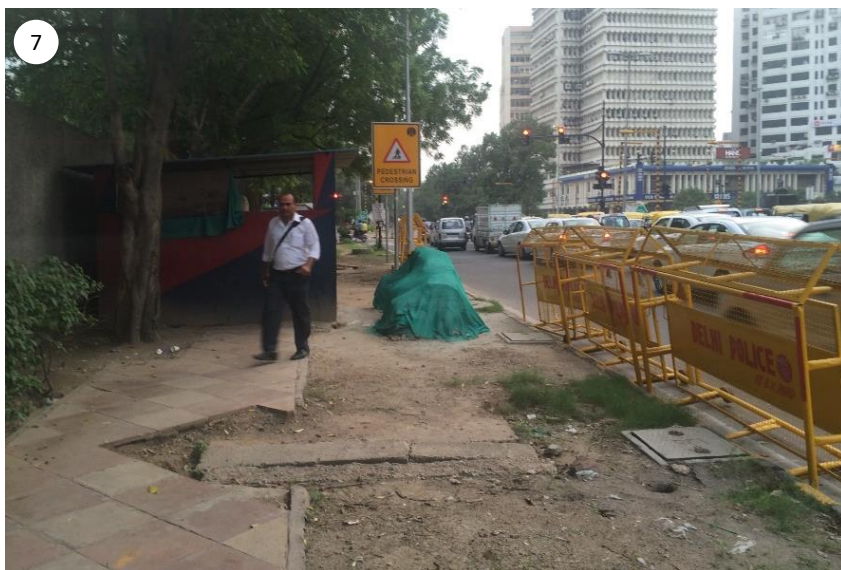
Police Booth on Maharaja Ranjit Singh Marg

The paving along most of the stretch is in fair condition. However due to obstructions it is difficult to walk on. Manholes and drain covers are seen protruding and obstructing the footpath. Either it is left broken after repair works or it is reducing the effective width of the footpath. Seen in pic7 along Maharaja Ranjit Singh Marg, the footpath is completely obstructed due to the Police Booth. People are forced to walk on the yet-to-be-developed green belt which too is blocked by sand bags and signage. Either the Police Booth should be relocated or the paving be extended and made continuous and obstruction free so people can walk comfortably. Also seen here is the drain reducing it's effective width.

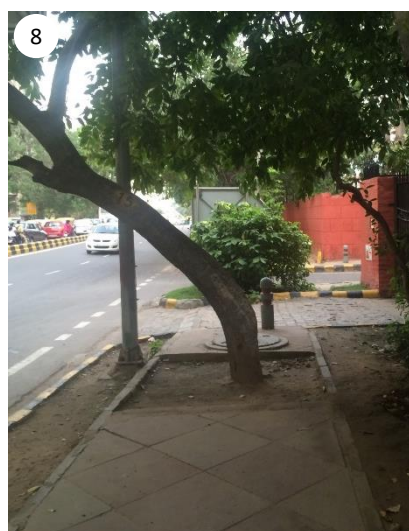
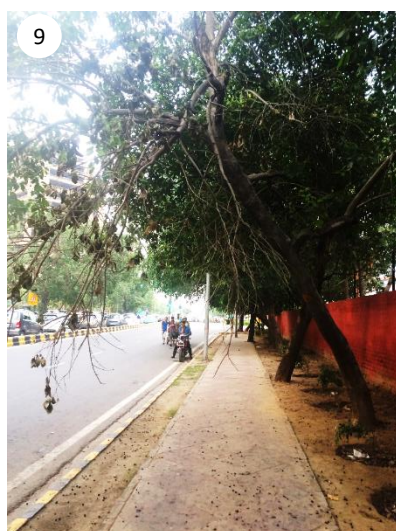
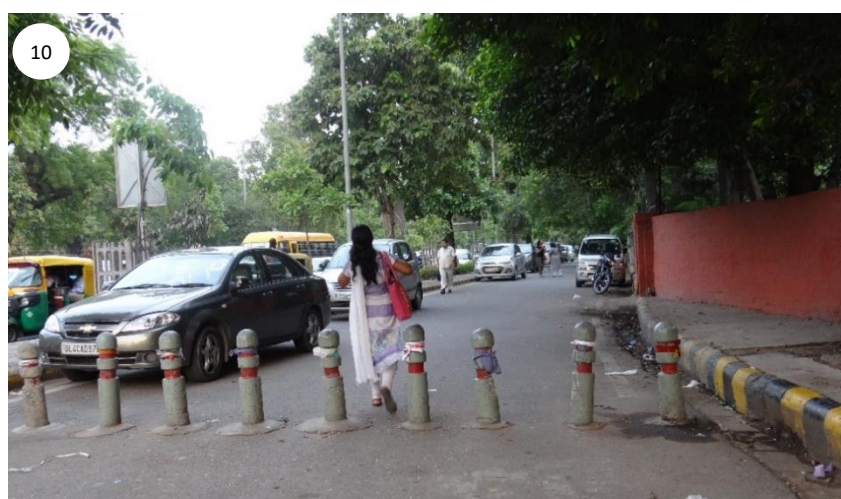
Tolstoy Road

Seen above is the footpath ending abruptly in the boundary wall. Also at many points one is walking over the drain covers which are unstable. As a result people are forced to walk on the road. Though bollards have been located on one side, vehicles access the service lane from the other side resulting in pedestrian-vehicle conflict. The footpath needs to be made continuous while ensuring constant width.

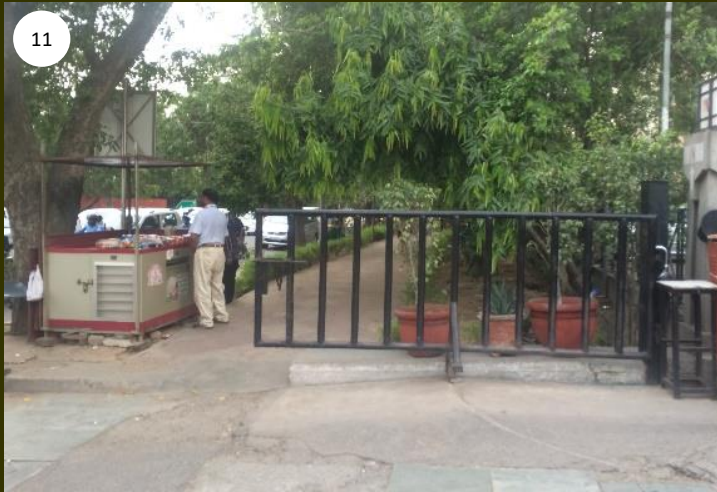
11

The footpath is not provided outside the entry to Hans Hotel. In order to cater to both pedestrians and the vehicles entering/exiting from the hotel, the footpath should be made continuous with ramped egress/ingress i.e. designed as a table top. Private driveways should not be allowed to encroach upon the public right-of-way.

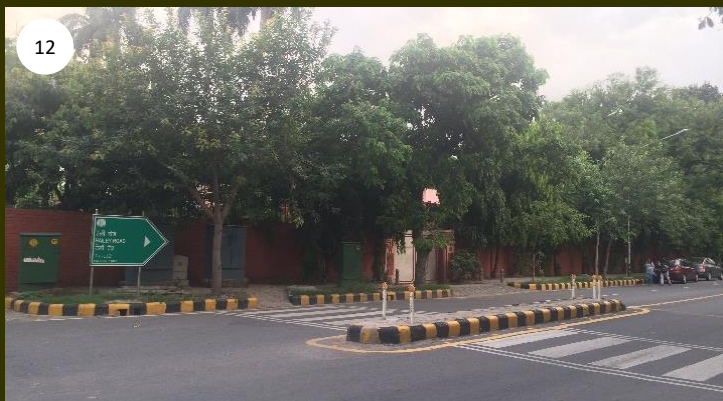
12

The zebra crossings too need to be continuous throughout the entire width of the road. The median should be broken at the zebra crossings.

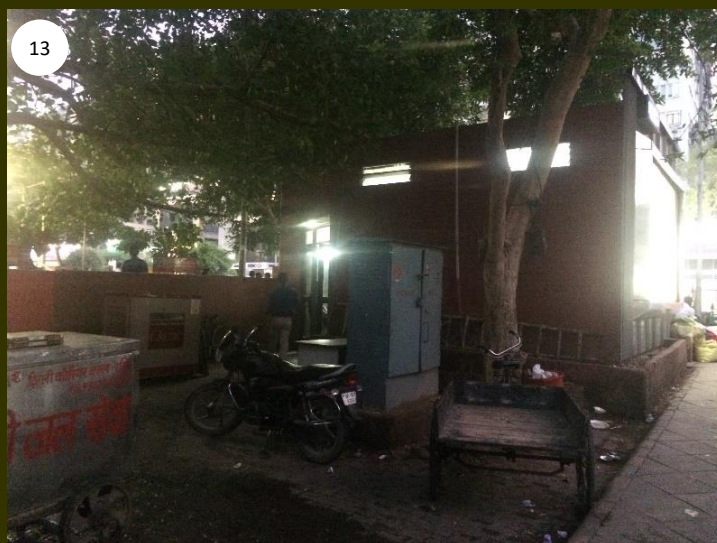
13

The Public Convenience facilities need to have proper access to them. As seen in pic13, the footpath is not connecting to the Toilet and there are many obstructions in between. The space abutting the Toilet should be cleared and properly paved including provision of tactile paving.

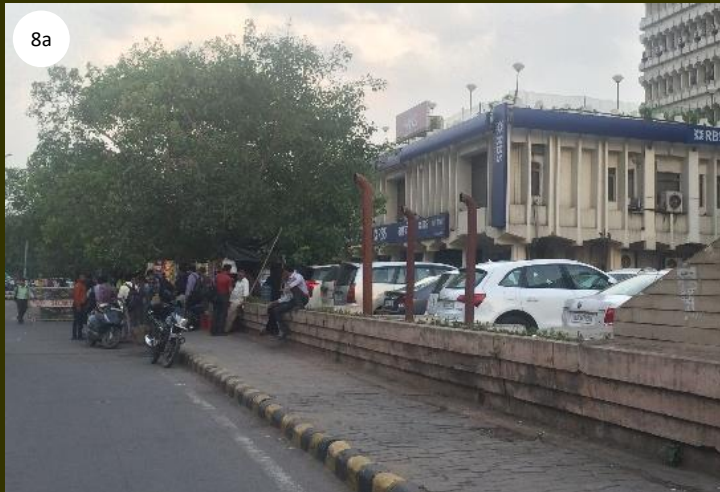
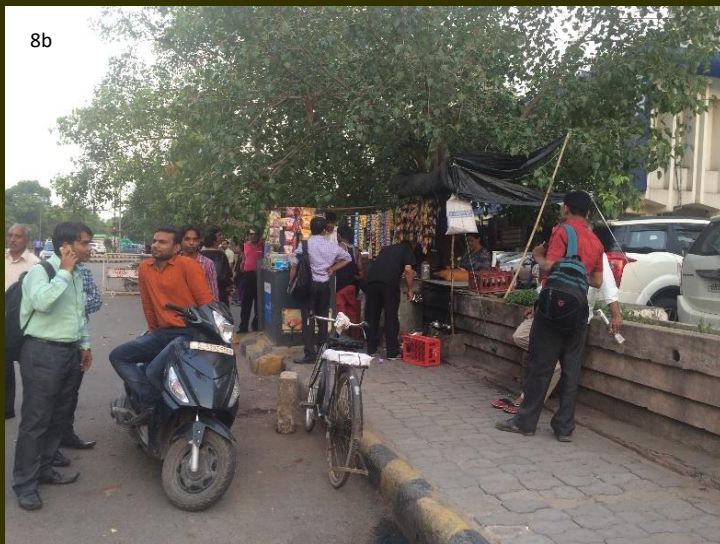
The boundary wall along Parsvanath building is low in height and has a planter. It allows for a visual connection hence enhancing visibility. Hawkers are present along it and people use the boundary wall as a seater. This should be adopted along the remaining area as well.

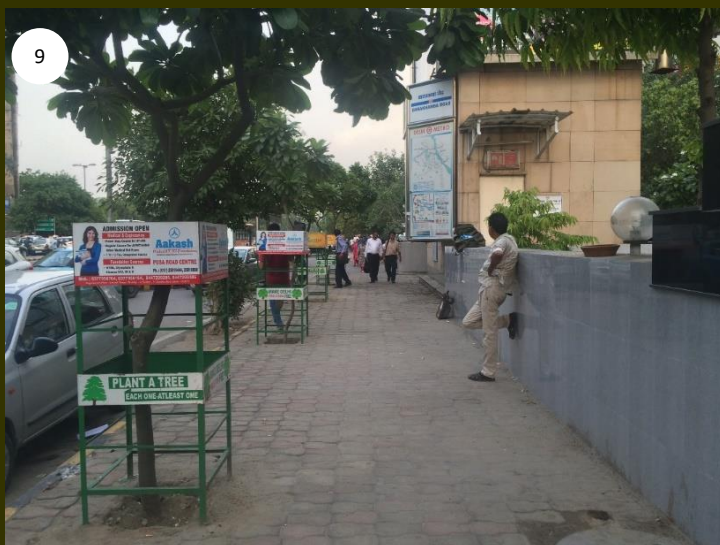
Seen above the boundary wall is not very high and allows some connection. It even has light fittings which add to the illumination. Street furniture can be incorporated in between the planters along with space for small kiosks. Alternately the wall height can be further reduced.

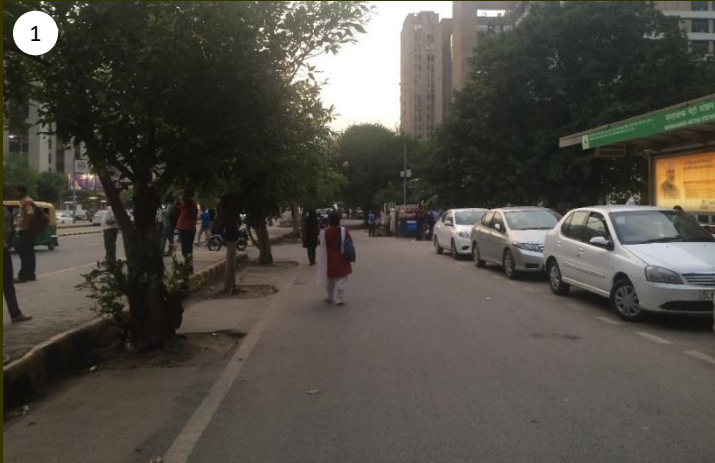
Shown here is the bus stop in front of Kanchenjunga building. It is located along the service lane. Proper turning radius hasn't been provided for the movement of buses. Furthermore, cars are parked in front of the shelter blocking bus movement completely. As a result while a few people wait in the shelter most people prefer to stand on the footpath along the main road. Proper turning radius should be incorporated at the junction and any obstruction should be prohibited.

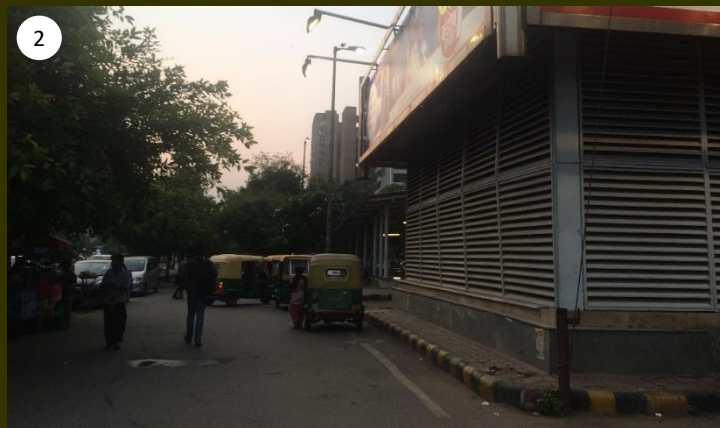
Autos queued up outside metro station exit.

Para transit stands need to be created along the metro station entry/exits. Currently autos queue outside crowding the service lanes. Also since the road is very wide, certain parts of the service lane can easily be designated as a vehicular free zone with space for hawkers and people. the para-transit hub can also be incorporated here.

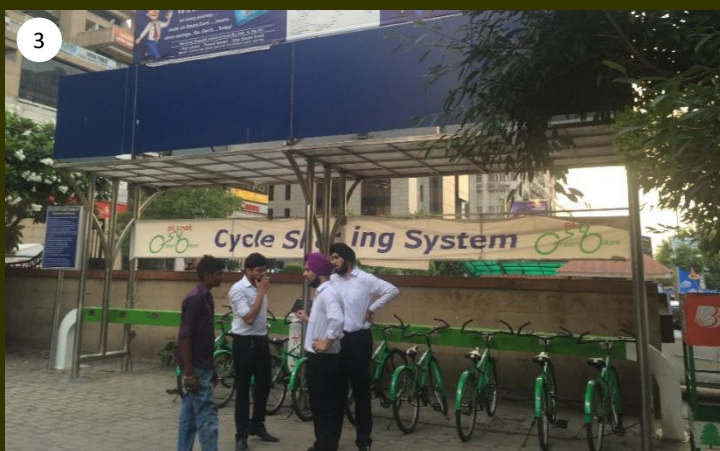
A Cycle Sharing System has been started along this metro station. However, the number of Cycle Stations is limited. These not to be provided at regular distances in the entire area for people to be able to avail this facility.

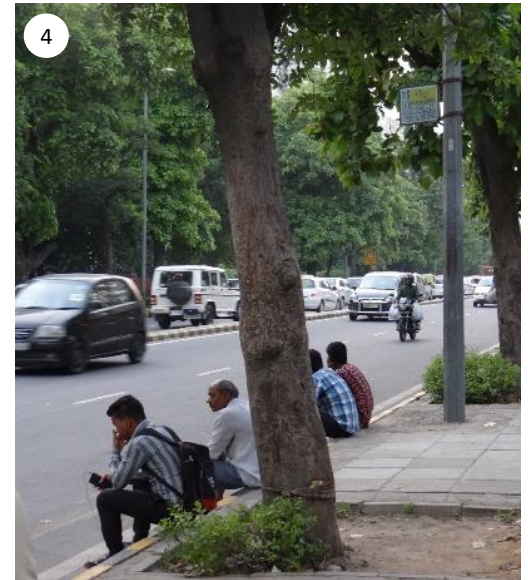
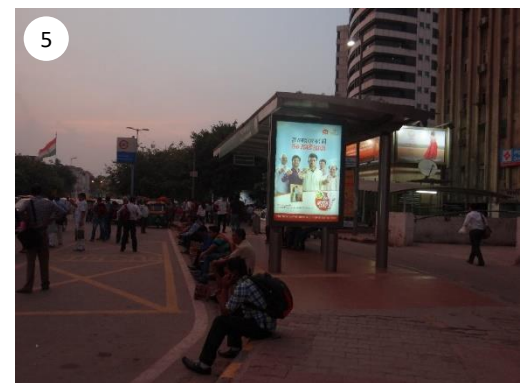
Seen above in pics 4 & 5 are people sitting on the footpath in the absence of adequate provision of street furniture. In pic 4, there is no bus shelter. A bus shelter needs to be provided clear of the footpath with adequate seating facility. In pic5, the bus shelter has been provided but the seating falls short of the footfall witnessed. Additional bus shelter should be provided.
