ENHANCING LAST MILE CONNECTIVITY

a safety analysis of the Central Secretariat Metro Station

Central Secretariat

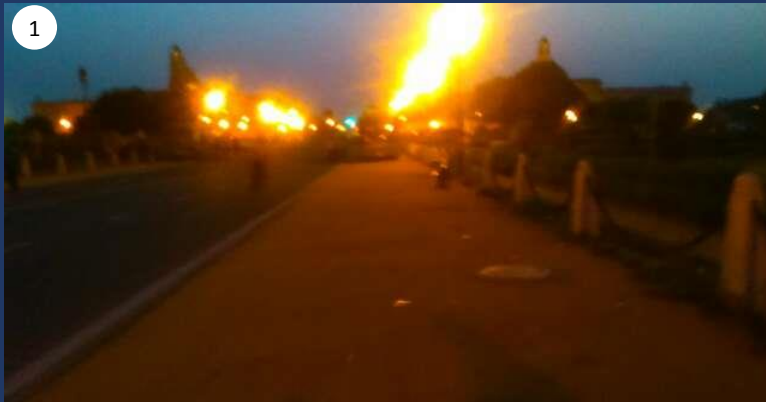
Most of the area around the Central Secretariat Metro Station is well lit. However, some streetlights were found to be non-operational on Rajpath leading to the Rastrapati Bhawan. As a result, the lighting along this path is low. Streetlights need to be made operational so that the area is well lit.

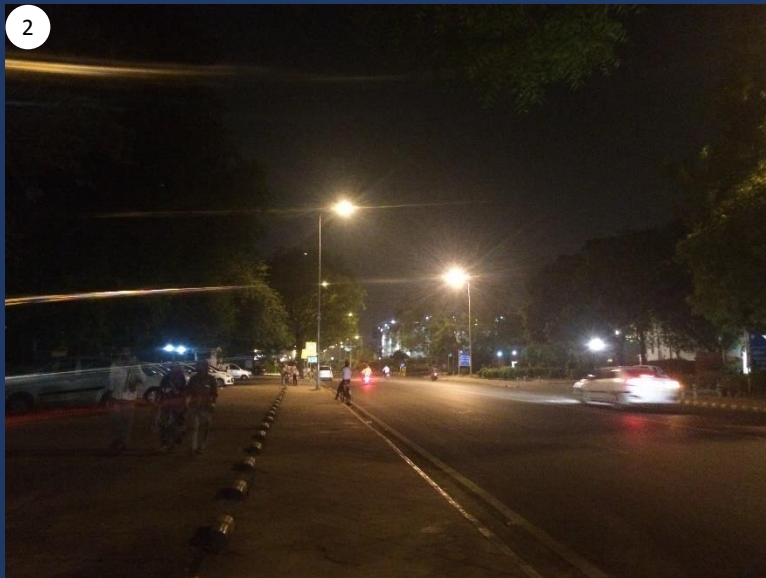
Currently, the streetlights have been provided focusing on the vehicular carriage way of the road. Seen here in Pic 2, streetlights are focused on carriageway resulting in poorly lit footpath. Additional lights should be installed on the edge of the footpath or along the boundary wall, facing the footpath.

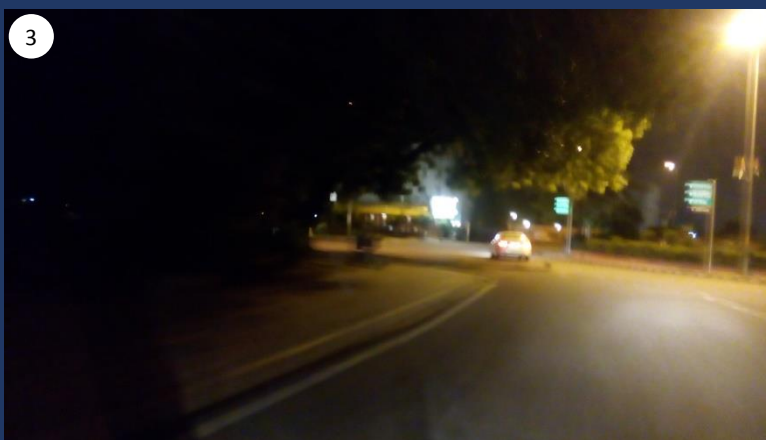
Dark spots are created owing to absence of light on the footpath. Installing pedestrian scale light poles along the walkpath will ensure uniform illumination.

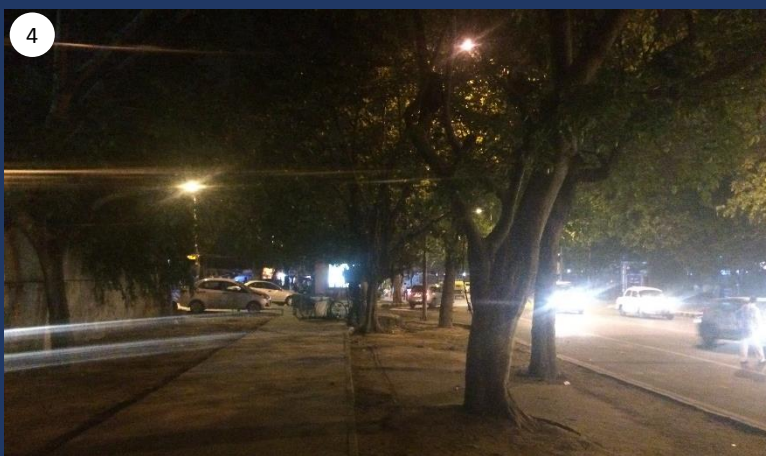
Also, the foliage along the streetlights needs to be pruned regularly as the overgrown leaves shield the light fixture resulting in poor illumination

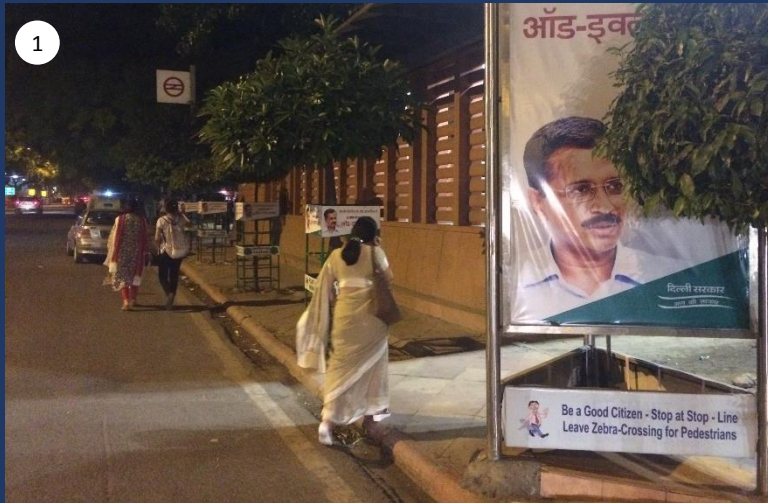
Though the footpath exists in good condition throughout the audit path, they are obstructed at some points. As seen in the Pic 1, planters and advertisement board in middle of the footpath can prove nuisance for pedestrians. These obstructions should be removed and placed at the edge of the footpath to provide a clear passage to ensure smooth movement of the pedestrians.

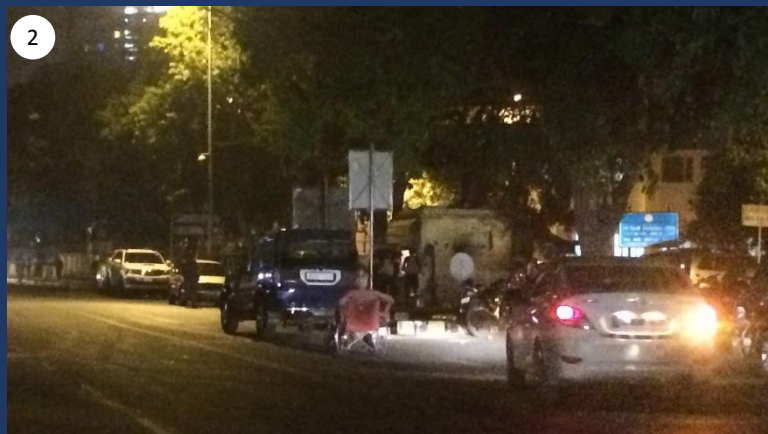
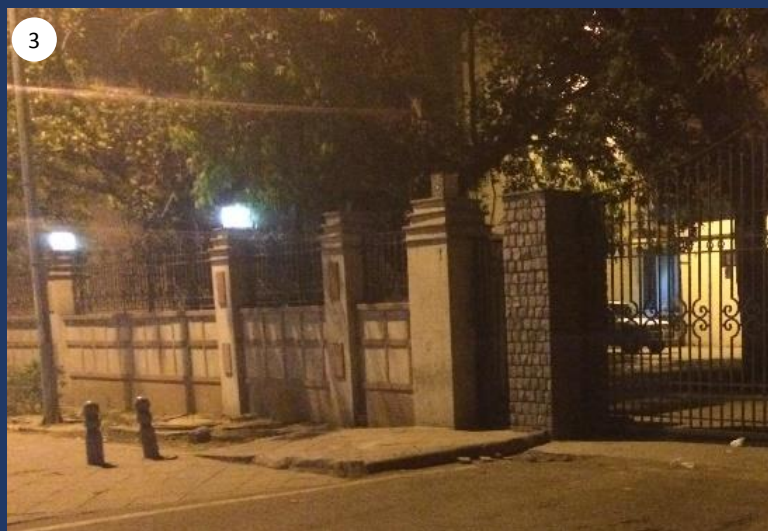
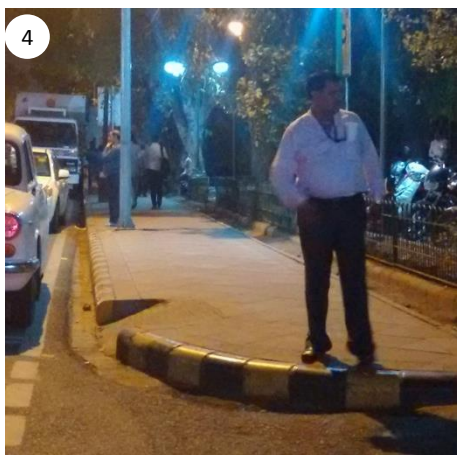
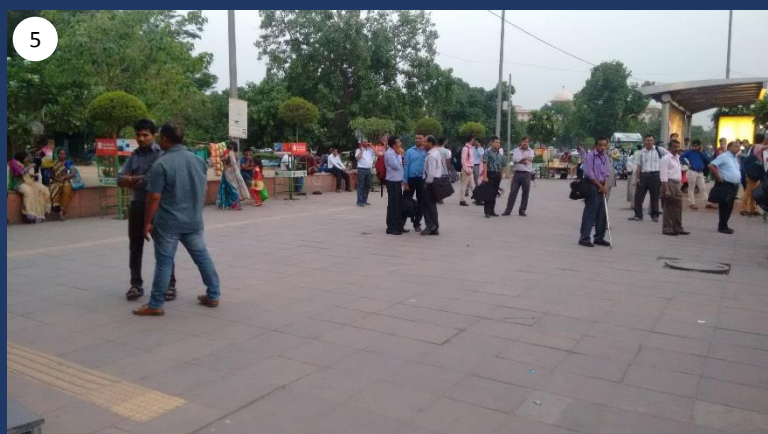
Seen here in Pic 2, a man in wheelchair is using main road in midst of oncoming vehicles. Also seen in Pic 3, the pedestrian access to the building isn't flushed with the footpath outside the building through ramp, which makes commuting difficult for disabled people. Also, improper slope (Pic 4) can prove risky for them. A continuous paved pathway should be provided which is accessible through ramp connecting them to the pedestrian entry/exit of a building.

Tactile paving outside the metro station ends abruptly, making it difficult for the visually impaired person to walk alone. As a result, they always need assistance right from the metro entry/exit to the bus stop/ surrounding government's offices. In order to make Public Transport easily accessible, proper tactile paving should be provided from the metro station to the nearest bus stop (Pic 5), clear of any obstruction.

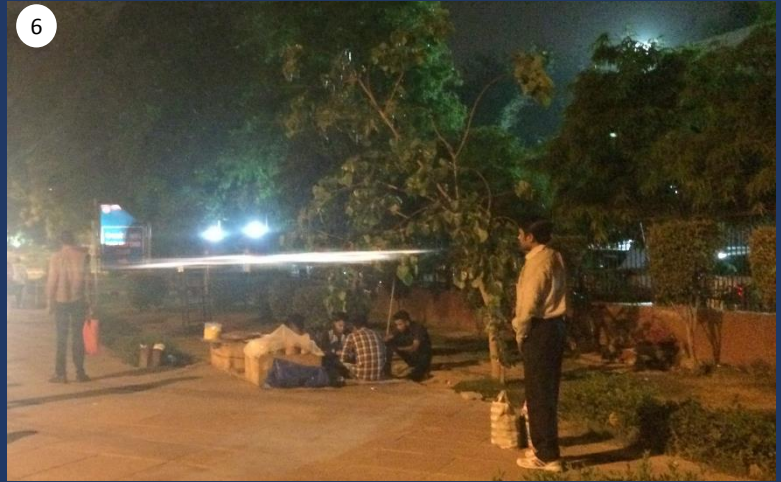
The street vendors should be located in a way that doesn't obstruct the pedestrian movement. As seen in Pic 6, there is a wide footpath that experience high footfall, a hawker zone should be set up clear of the footpath.

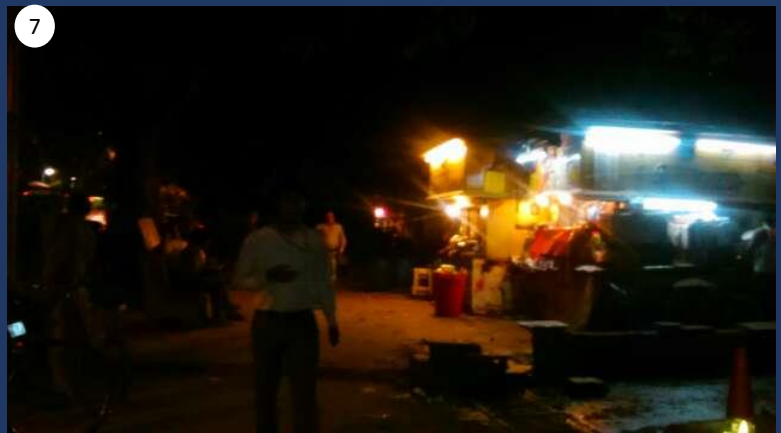
Seen here in Pic 7 are vendors provided with designated kiosks. In addition to that, proper lighting on walkpath and street furniture should also be provided for the people.

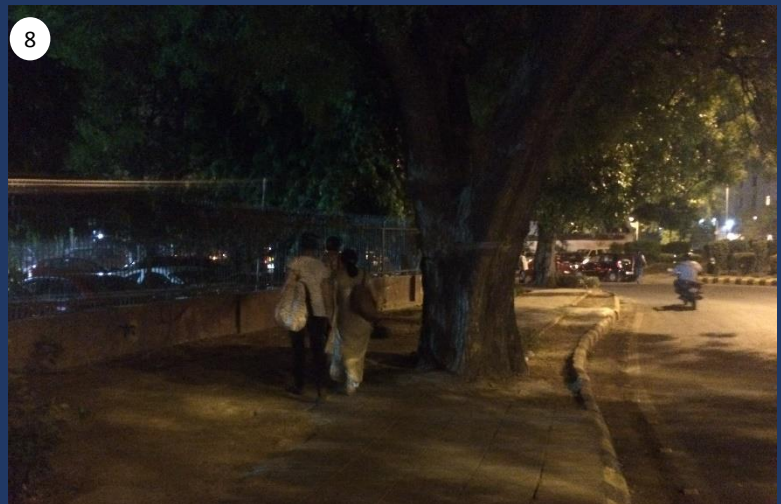
Footpath should be continuous and clear of any obstruction. As seen in the Pic 8, footpath is obstructed by a tree forcing people to walk on unpaved buffer area. This buffer area should be properly paved, thus widening the footpath to ensure smooth movement of the pedestrians.

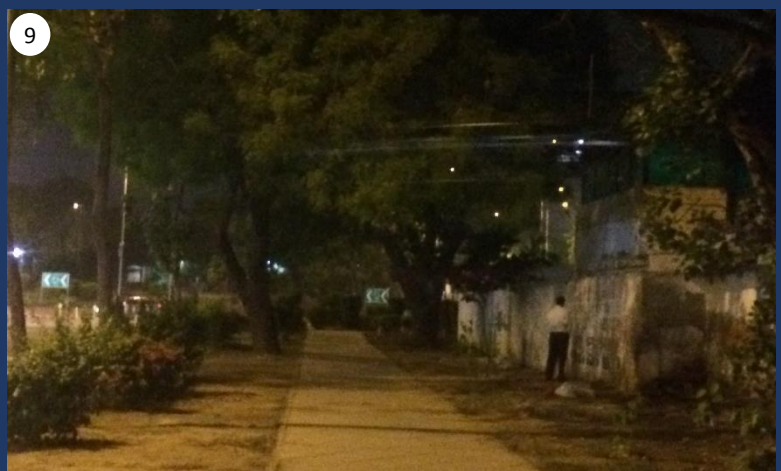
This footpath as seen in Pic 9 is flanked by shrubs and trees from both the sides, thus making it shady and unsafe at night. In such cases, height of shrubs should be maintained less than 1m, thereby providing a clear sightline to the pedestrians.

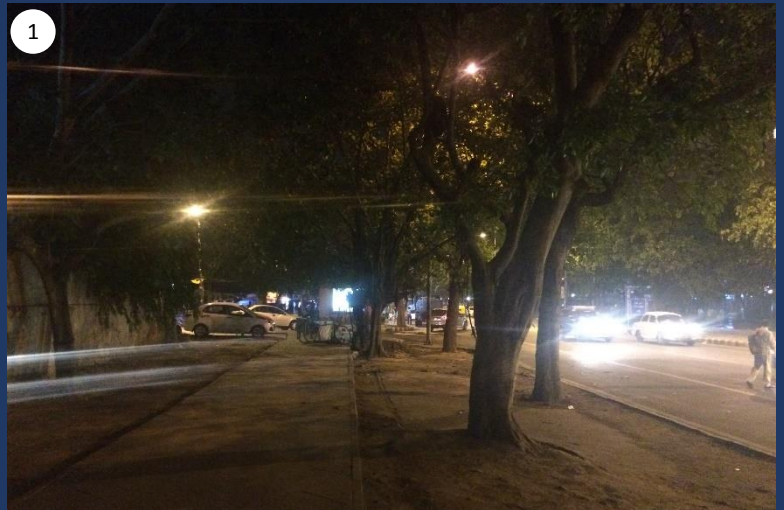
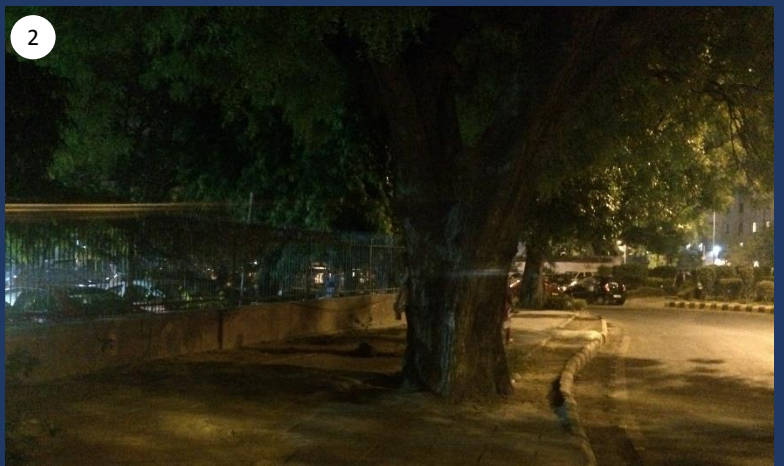
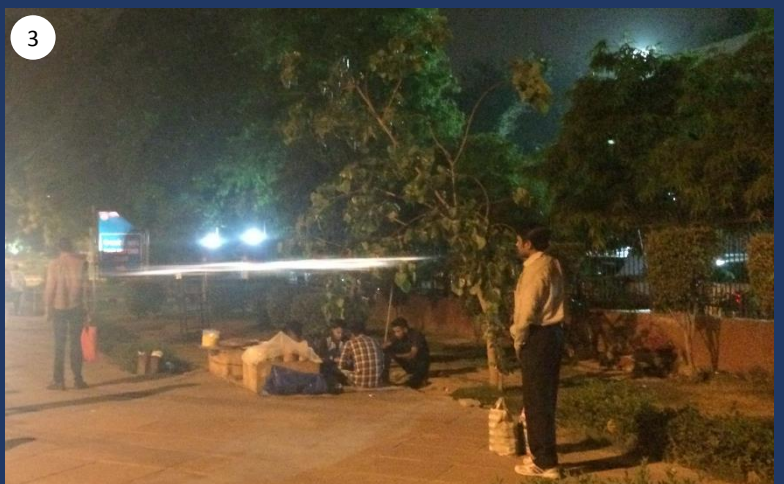
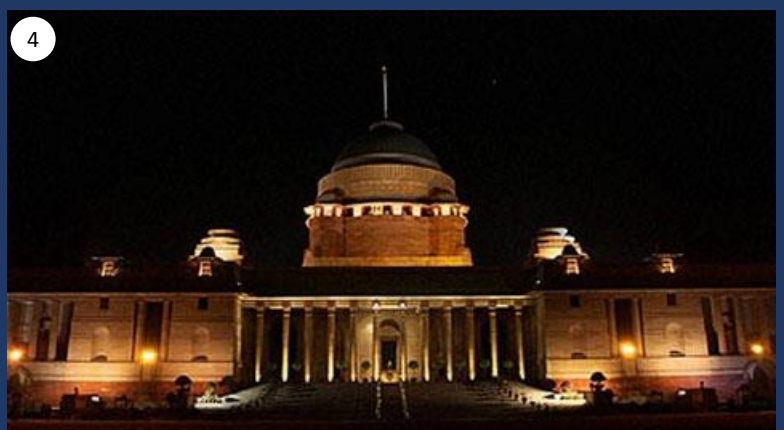
Seen here in Pic 1, the footpath is flanked by trees from both sides, making it unsafe at night. The boundary wall design of these areas should be modified. The solid surface of the boundary wall needs to be reduced to atleast 1m and the remaining height be achieved using a grill. (as seen in Pic 2)

Dead spots are created due to absence of activity and light. To activate this stretch, the space should be redesigned in a way that a shaded space equipped with street furniture is provided for the pedestrians, which can also accommodate the street vendors.

In absence of a designated space, hawkers end up crowding the footpath (Pic 2). At places where footpath is wide enough, a hawker zone should be set up clear of the footpath. Also, lack of street furniture forces people to squat on the pavement. Street furniture should be provided for them.

The area has government offices which all close in the evening. The area becomes extremely secluded in the post-office hours. Since this area forms a part of our Built Heritage, promoting Tourism through Heritage Walks and Night Photo-walks can help bring in more people in the area.

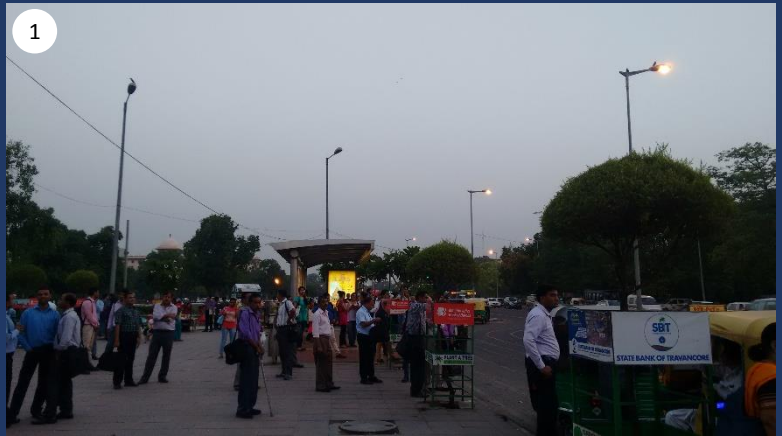
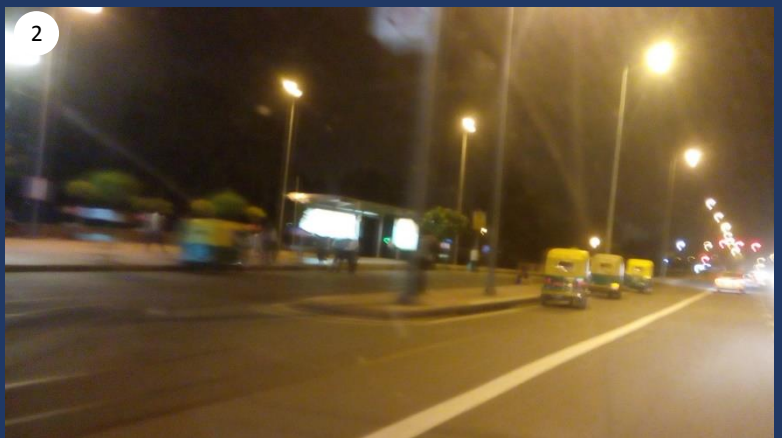
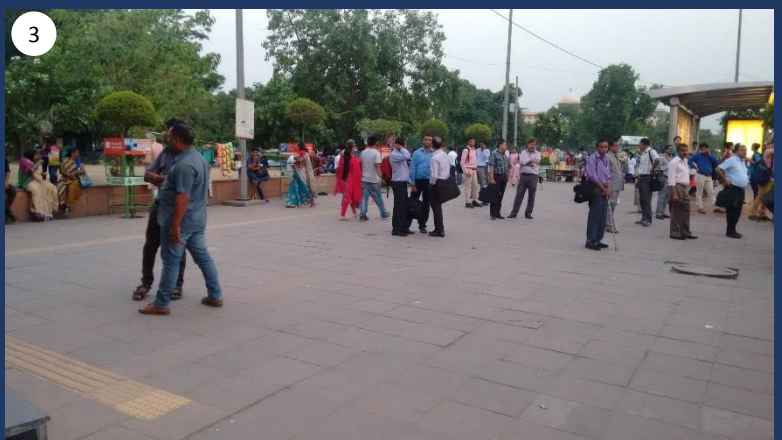
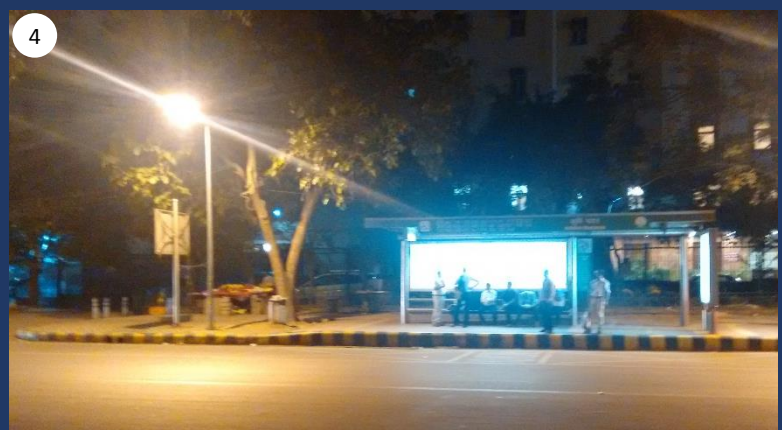
With the large number of people visiting India Gate and Rashtrapati Bhawan, autos are parked at every entry/exit of Central Secretariat Metro Station.

However, in absence of proper parking space, autos occupy main carriageway. This can be clearly seen in Pic 2, near Metro Station Gate no.3, there is a separate lane for the bus stop but no proper auto stand. This results in autos occupying both the main and bus lane.

The area around the metro station and the bus stop is inhabited by hawkers. As seen in Pic 3, outside the entry/exit of the metro station has many hawkers occupying an edge of the large pavement. This area should be redesigned to have segregated space for the hawkers equipped with the street furniture for people, clear of the footpath. Also, an Auto Stand should be provided along the bus stop clear of the footpath.

Seen here in Pic 4 at the bus stop, footpath is obstructed by inappropriately placed advertisement board, dustbins and signage. While designing a bus stop, street furniture should be provided clear of the footpath.
