# ENHANCING LAST MILE CONNECTIVITY

## a safety analysis of the I.N.A. Metro Station

# I.N.A.

**SAFETY SCORE: 3.2/5**

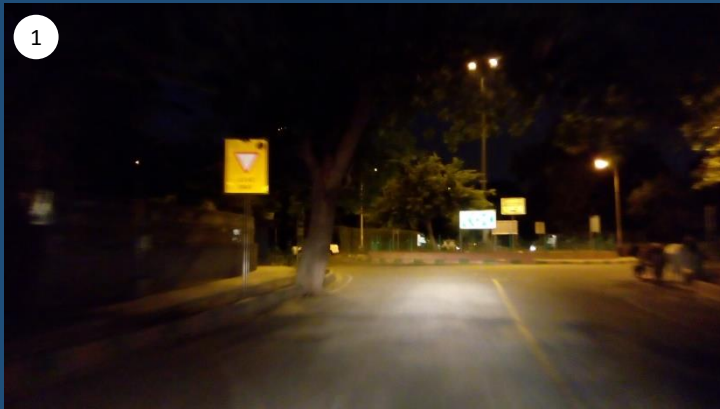
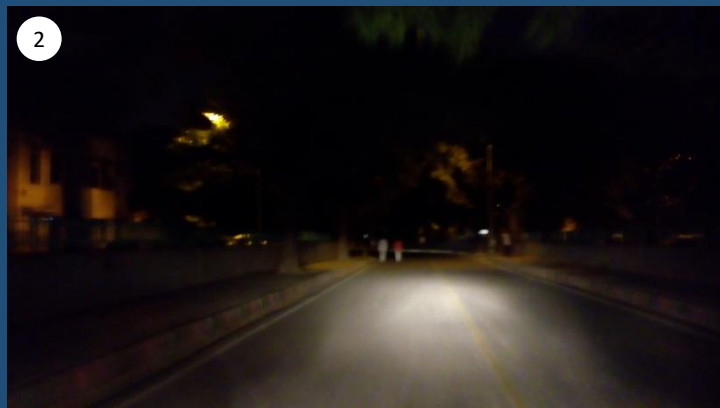
*Lighting in Laxmi Bai Nagar.*

*Dark spots are created between adjacent light poles. Installing additional light poles alternatively on the other side of the road will ensure uniform illumination throughout the road. The streetlights should be of pedestrian scale. Also, regular pruning of trees along the existing higher light poles is necessary.*

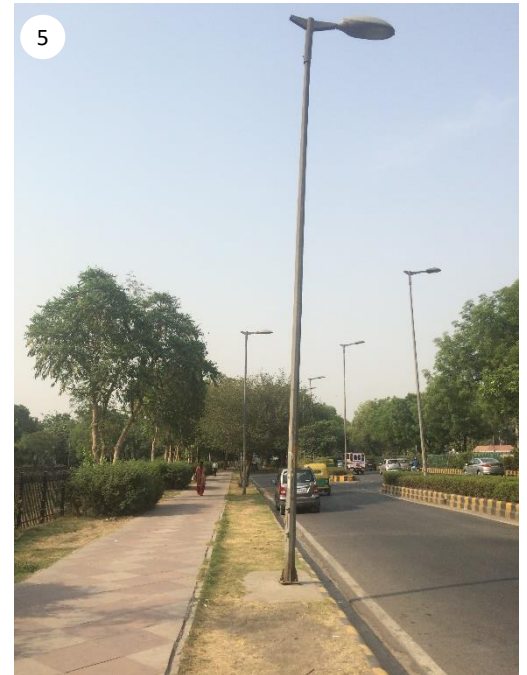
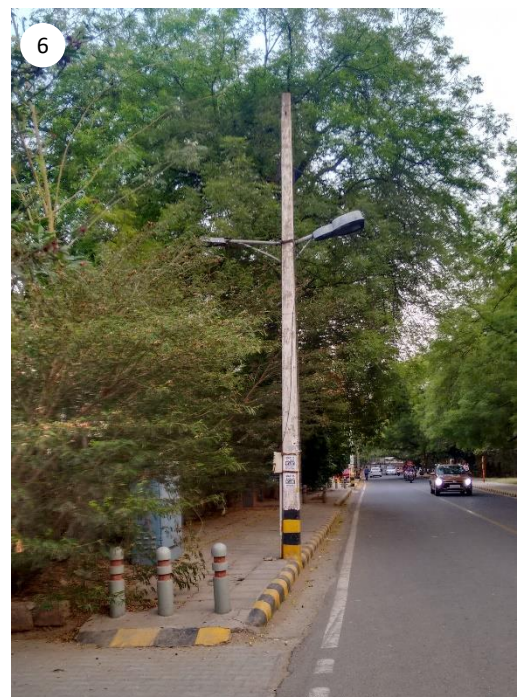
*Currently, the streetlights have been provided focusing on the vehicular carriage way of the road. The streetlights are higher for the same reason. Pedestrian scale streetlights need to be located along the footpath. These should be provided so as not to obstruct the pedestrian movement and clear off the tactile paving to be provided for the movement of visually impaired people. The foliage along the streetlights needs to be pruned regularly as the overgrown leaves shield the light fixture resulting in poor illumination along the pavement.*

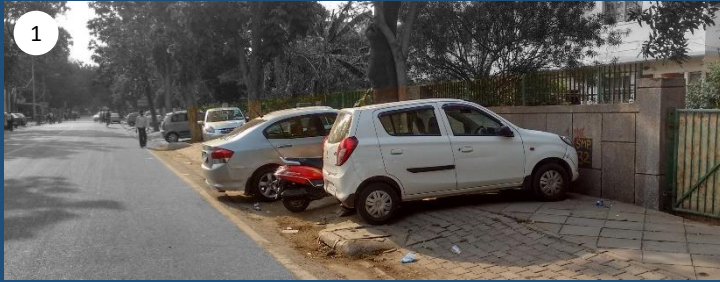
Vehicles parked on the pavement in Laxmi Bai Nagar.

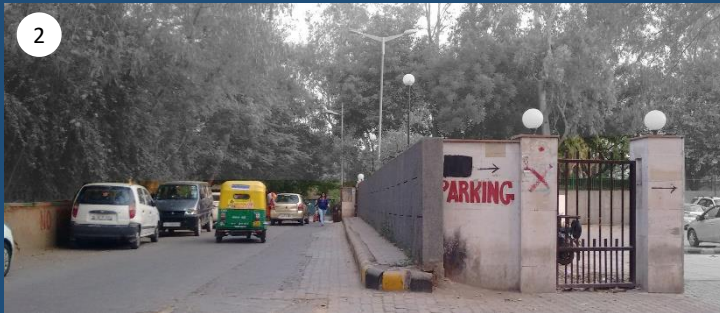
The rear entry of Dilli Haat has a Parking Area. The edge of Dilli Haat does not have a footpath and the one along the Parking is too narrow and too high. The vehicles should not be allowed to park on-street in this area. A proper footpath with tactile paving and ramps needs to be constructed. The boundary wall too should be demolished and be replaced by a Grill to ensure visual connectivity. The gate and piers serve no purpose and should be demolished as well.

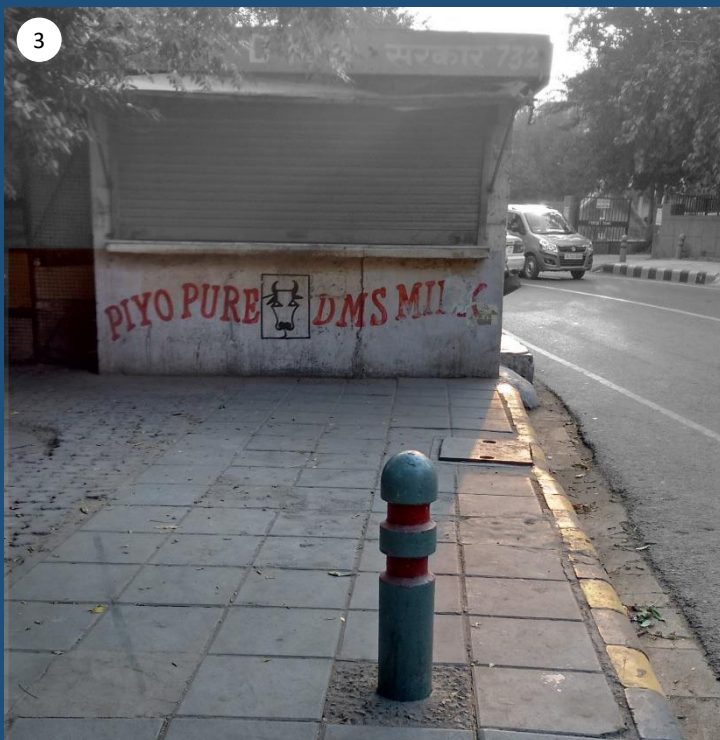
The Public Facilities need to be provided clear off the pavement so as not to hinder movement. There are many government offices in the area and the same can be easily incorporated within their premises. Also seen is a lone bollard that doesn't serve any purpose but disrupts smooth pedestrian movement. Such elements too need to be removed from all locations.

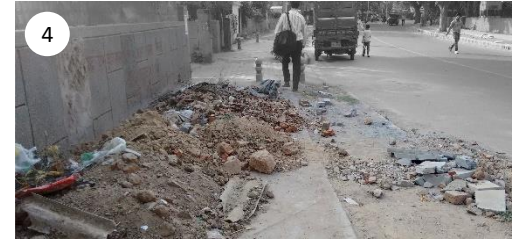
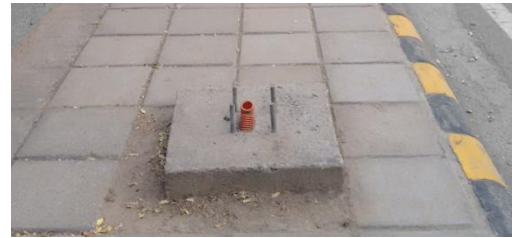
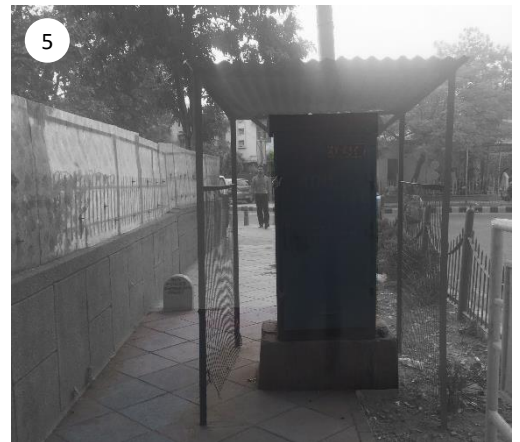
Construction Debris and other obstructions observed on the pavements in the area.

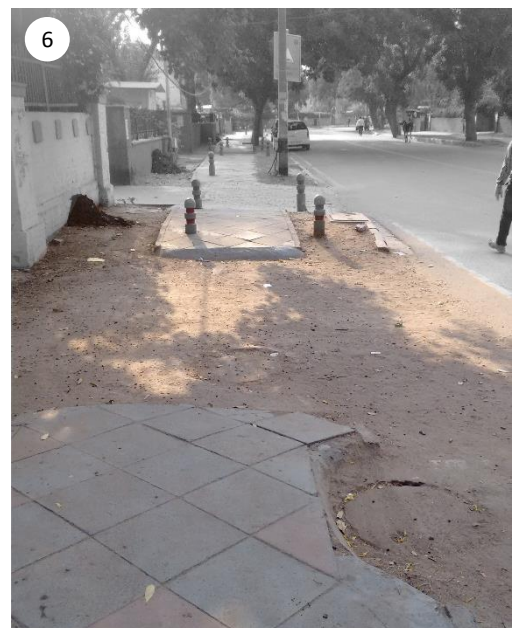
The pavements need to be constructed with proper ramped edges. The entry to the various buildings needs to be properly paved such that the tactile paving from the pavement is uninterrupted. Also, seen here are bollards placed randomly.

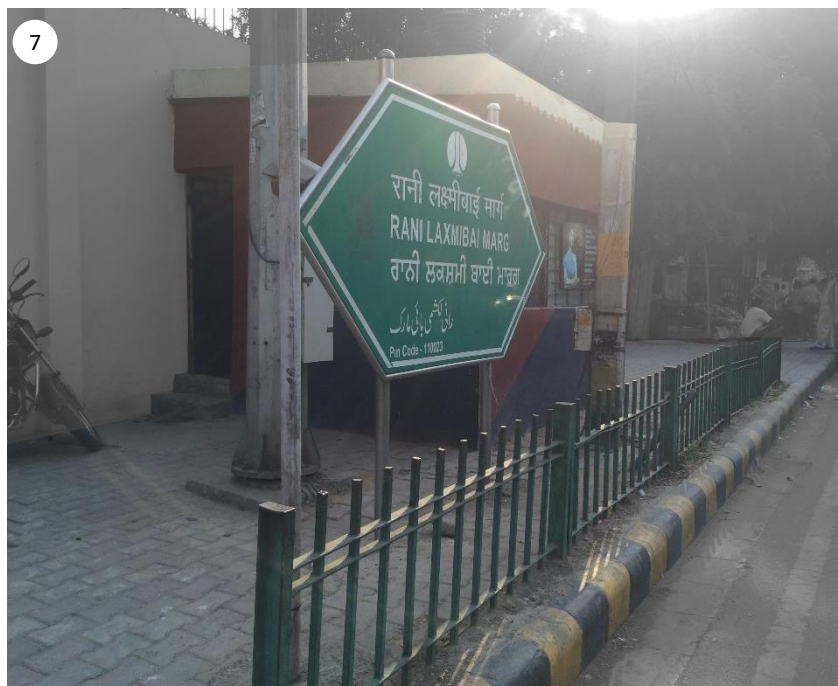
*Top Left: Seen here is a Police Booth built on the pavement. The space left between the booth's edge and the railing has a streetlight as well. The space left is too narrow as per Street Design guidelines. Also in the absence of tactile paving the visually impaired people find it difficult to maneuver. The height, design and the location of the Signage is not pedestrian friendly. The Police Booth needs to be shifted to clear the pavement. Tactile paving to be introduced free from obstruction from the Signages and Light poles.*

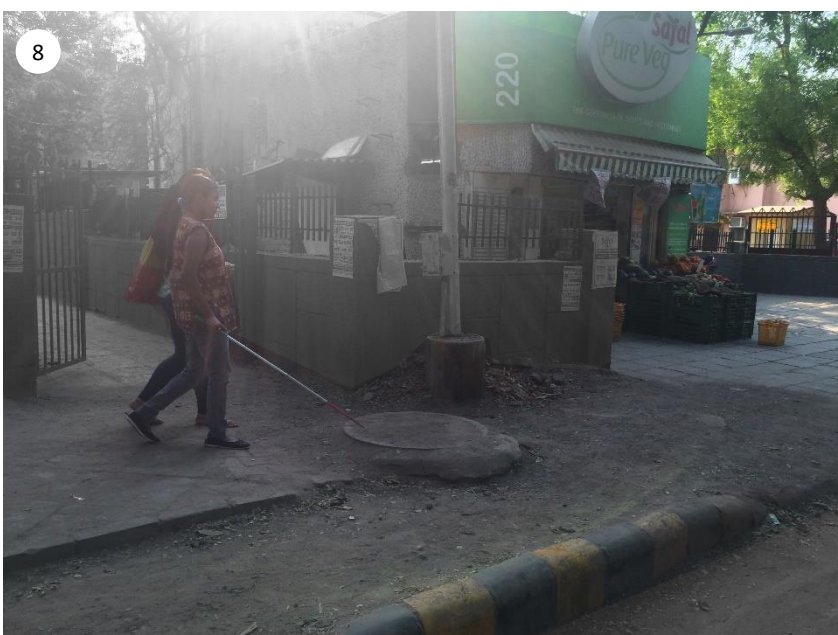
*Left Centre: The Safal Booth has been located clear of the pavement and do not hinder pedestrian movement. However, at their interface the pavement is broken and hasn't been constructed properly. Also the manhole covers protruding are a potential hazard. The pavement needs to be Continuous and Levelled throughout.*

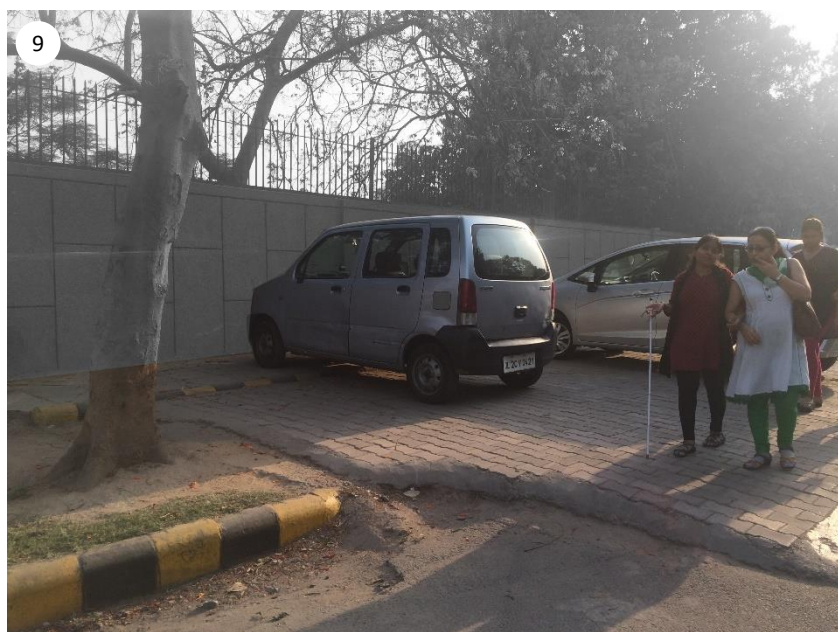
*Below Left: Despite dedicated parking space for vehicles they are seen obstructing the pavement. A proper level difference needs to be created between the pavement and the parking surface. The pavement to be widened and only the parking bay required for vehicles should be provided. The excess space seen here for parking should instead be used for pedestrian movement. Also, the pedestrian space needs to be constant throughout such that if a tree exists then the pavement should be widened and the tactile paving should be continuous and free from such obstructions.*

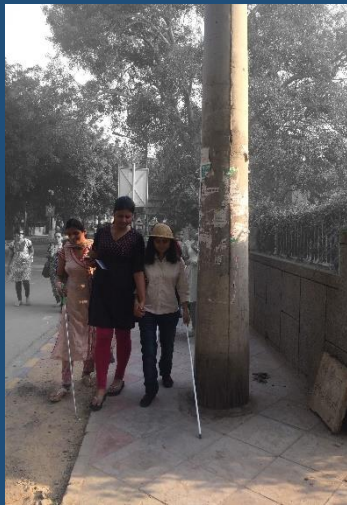
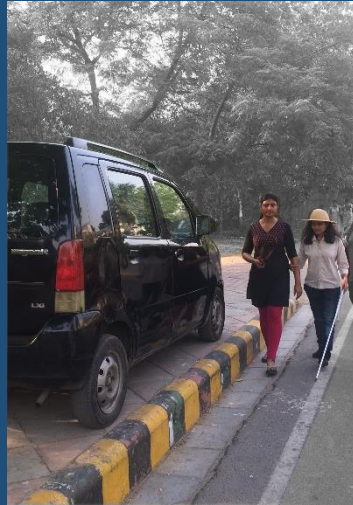
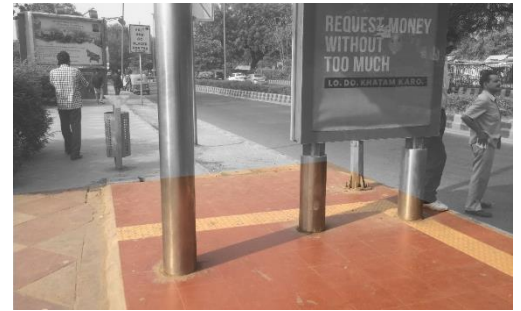
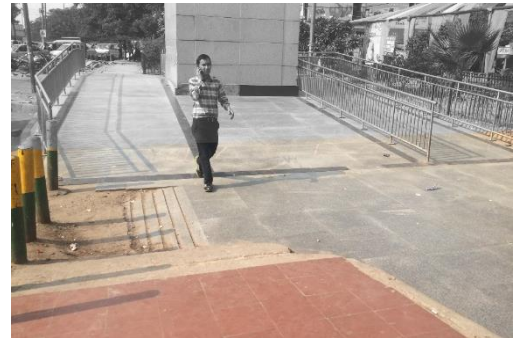
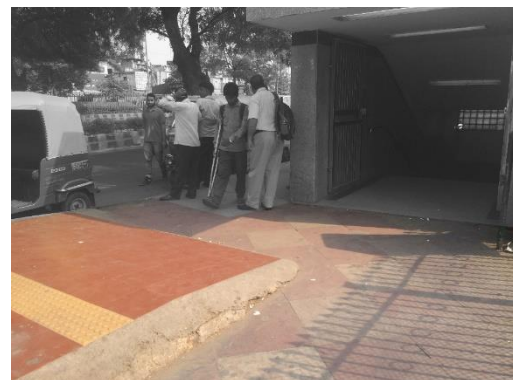
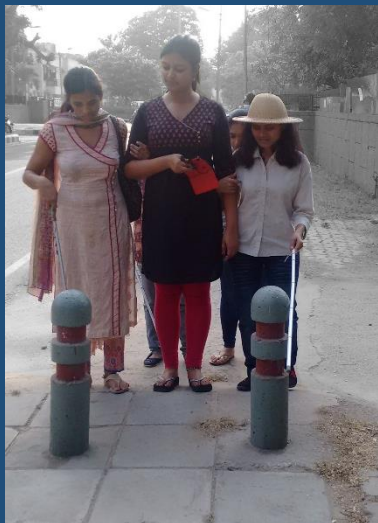
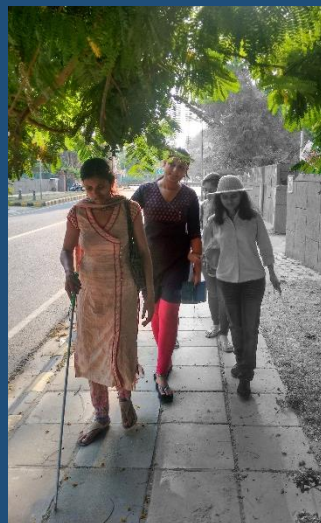
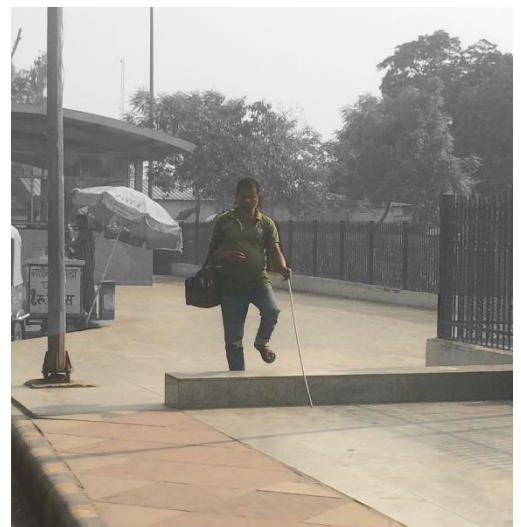
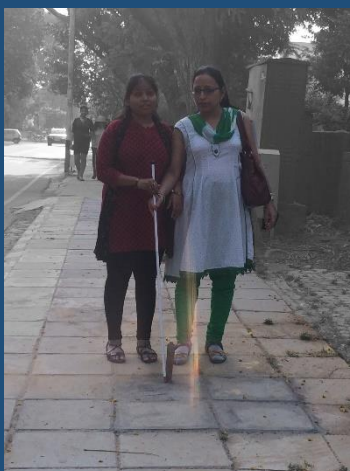
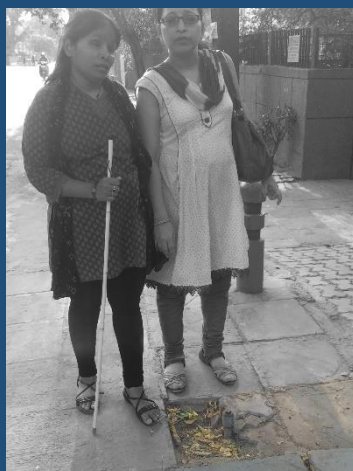
*Shown Below: Various obstructions along the pavement which make it difficult for people to walk comfortably. For the visually impaired however, these obstructions which may go unnoticed by others, are causes of potential accidents. The vehicles parked on the pavement force one to walk along the vehicular carriageway. All obstructions no matter how small like the protruding pipe, need to be removed and the pavement needs to be levelled with continuous tactile paving. Also, regular pruning of tree leaves is a must to ensure a clear height of at least 7' for the visually impaired. Also, the signages should be beyond this clear height.*

*The entry/exits of the metro station and the lift needs to be well connected with the bus stop and subway through continuous levelled tactile paving. This should be clear of all obstructions. Currently the paving has been provided only at the bus stop which however, ends abruptly and is intersected by the signage. Also some other unnecessary obstructions were observed which can cause serious injury to the people.*

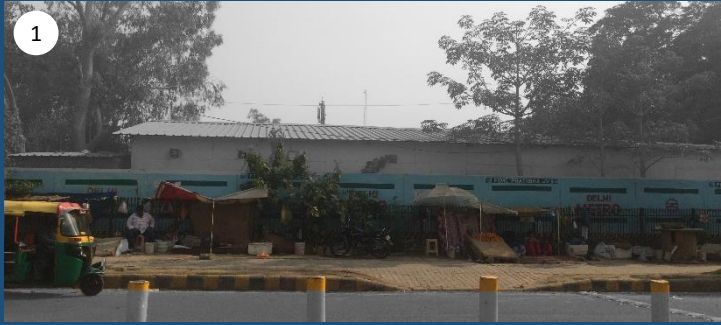
Hawkers are present outside the metro station. However, they do not have a designated space and end up crowding the footpath. Either the pavement should be widened or proper zone be created for them along the metro station entry/exit itself.

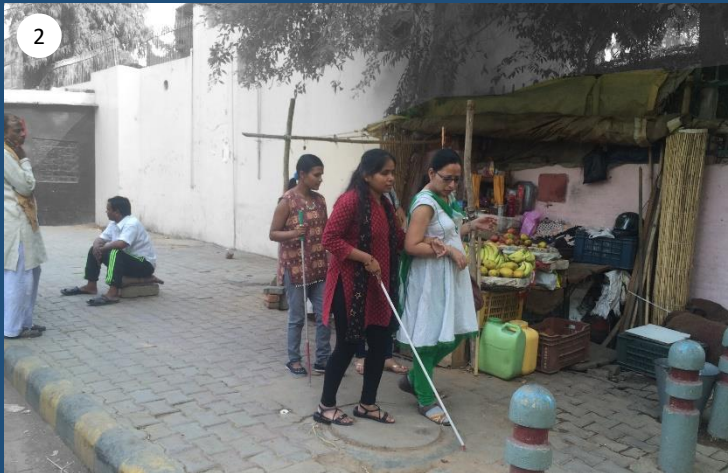
The hawkers catering to the domestic needs of the residents do not have any dedicated space. As a result they are forced to occupy the footpath. The lack of street furniture further forces people to squat and obstruct pedestrian movement.

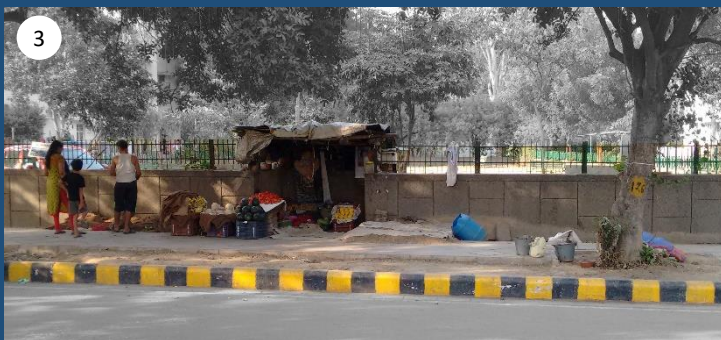
In the same area however, Niches for hawkers have been created in the boundary walls of public spaces like Parks. The same should be done along the boundary walls of residences and also the various Public Buildings and Government Offices in this area. These buildings have a huge setback from the front boundary. As a result the visibility is very low and also these are vacant at night. Niches for vendors can be created in their boundary walls along with incorporating functions like ATM's, DMS Milk Booth and Police Booth which are currently obstructing the footpath. These Hawker Zones should also be provided with street furniture and Public Conveniences like Toilets. The Public Toilets must be provided for Gents, Ladies and a Handicap Toilet must be provided as well. (Currently, the Public Toilet outside Metro Station Exit No.3 only has a Gents Toilet).

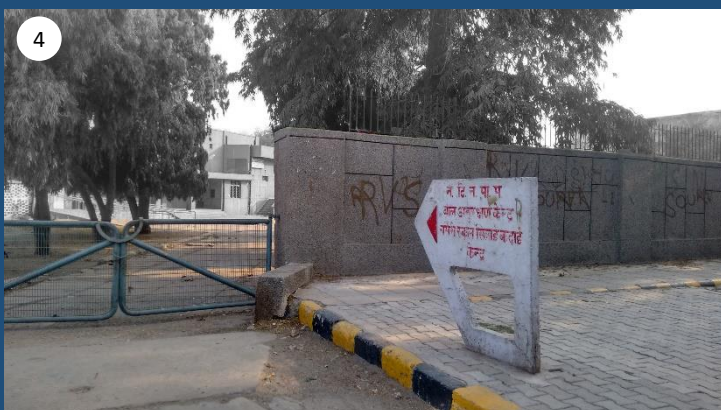
The boundary wall design of these areas needs to be modified. The solid surface of the boundary wall needs to be reduced to atleast 1m and the remaining height be achieved using a grill. It needs to be ensured that the grill is kept open at all times and not covered even for residential complexes.

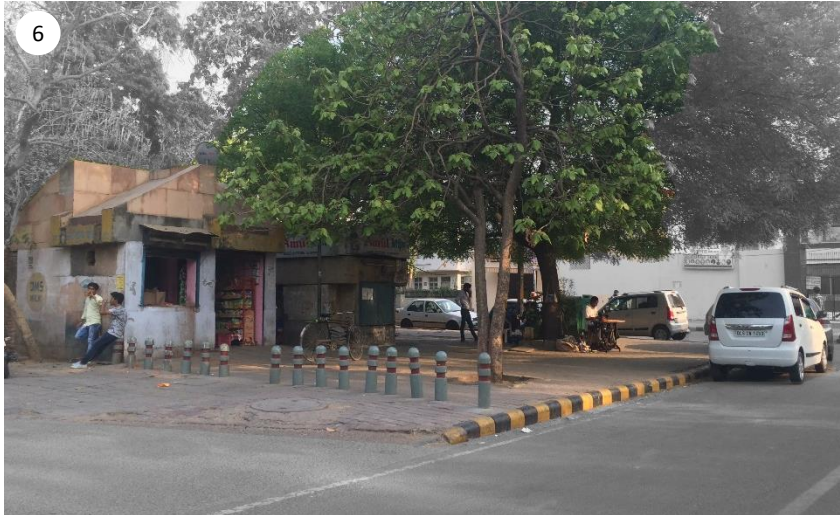
The local markets in the area are active at night and offer good visibility. However, proper street furniture and lighting is needed here. Also separate parking zone needs to be created to prevent vehicles obstructing the road. The rear sides of these complexes are often neglected and are used for Public Urination and other undesired activities. These too need to be well-lit and have functions which ensure regular footfall making the edge safe.

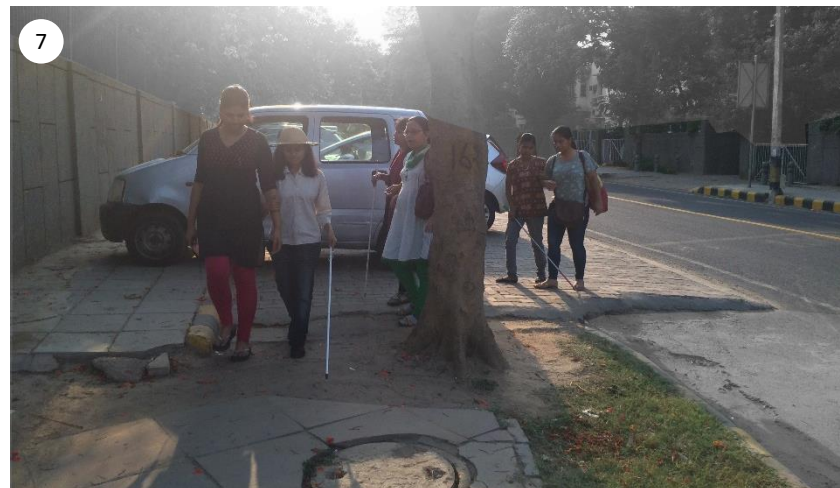
Parking bays have been created for the residents to park their vehicles. These are wider than the footpath and without a sufficient level difference. As a result the cars encroach upon the footpath. This parking bay needs to be regulated both in terms of its width as well as continuity. Breaks need to be created having grass cover provided with street furniture and hawker zones. This will make the edge active which is currently dead.

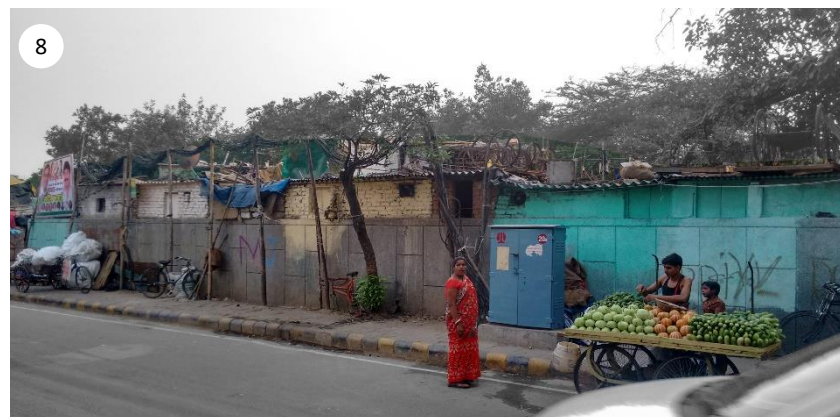
There is a squatter settlement towards the south of Laxmi Bai Nagar along the storm water drain. The visibility is good in this area. However, here too there is no designated space for vendors who end up occupying the walkpath. Proper zones need to be created in this area itself as re-locating them would reduce visibility in this area.

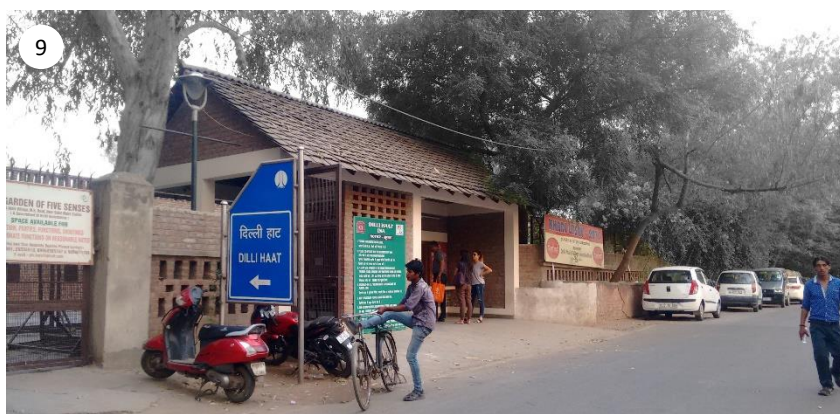
The rear entry of Dilli haat offers no visibility. The boundary wall is mostly opaque providing no connect with the internal activities. There is some visibility due to the ticket counter but largely the edge remains dead. This western edge of Dilli Haat has the stage for events. Opening up the read edge and making it transparent will improve visibility. It will also encourage people to use the adjacent Parking.

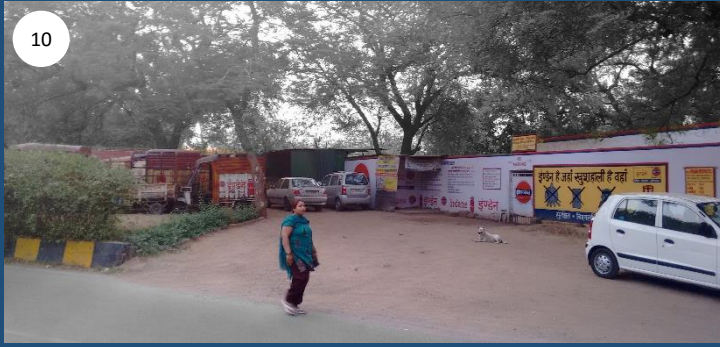
There is a tempo parking in Kidwai Nagar West. This area is completely dead except for the drivers loitering. This makes it unsafe for women. The area needs to be brightly lit. Also turning it into a Autorickshaw/taxi stand will ensure regular footfall making it active. Some space for vendors can also be earmarked. There should be a Public Toilet as well.

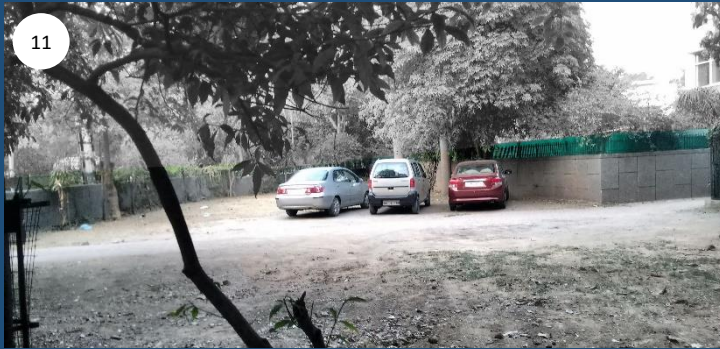
A huge space has been left for vehicular parking of the residents. This area sees a double layer of boundary walls, one for the residences and second for the vehicles. As a result the visibility here is very poor. The boundary wall along the parking needs to be removed completely and the design of the first to be changed as specified earlier. This area should be turned into a park for small kids and elderly.

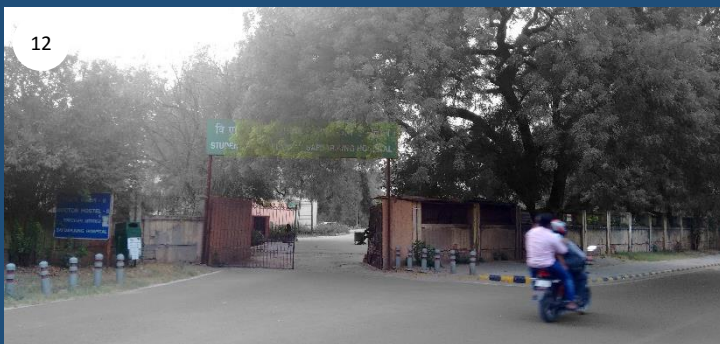
The Vardhman Mahavir Medical College & Hostel defines one edge on Kidwai Nagar West. Currently the edge is defined by a boundary wall. This can be replaced by either a small Park. Alternatively, shops (like bread & butter, stationary, photocopy) and cafes and food stalls catering to the needs of the students, faculty and the residents can be provided along the edge of the institute. Both sides of the road have a wide footpath sufficient to cater to the increase in pedestrian footfall. These activities will well connect with the small park on the residential side of the road. Adding street furniture would further ensure activity and presence of people and women.

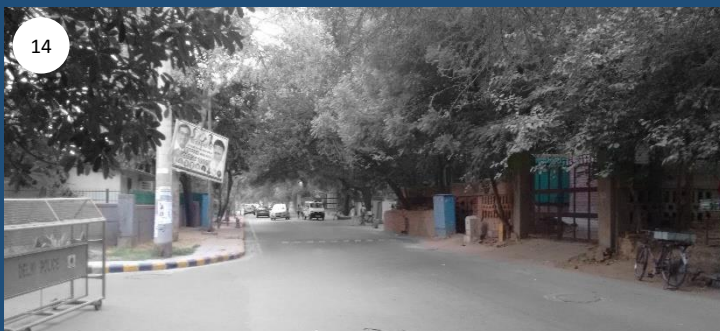
The southern side edge of Dilli Haat houses all its services making it dead and inactive. The other side of this road is defined by boundary walls. However, there is a small undeveloped land at a raised level currently having vendors and public facilities. This should be developed into a proper local market catering to the residents.

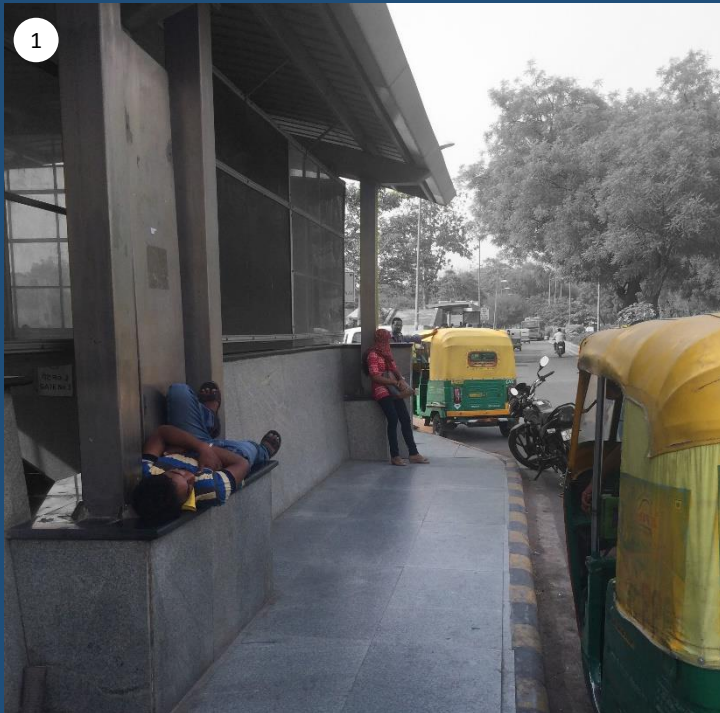
*There is no designated stand for autos/e-rickshaws outside the metro vomitories. As a result they crowd onto the street. There is no space for metro users to wait for their cabs. Designated stands for para transit facilities needs to be incorporated within the metro area. This should be well integrated with the bus stop location as well.*

*Also a Bicycle Rental System should be introduced. The bicycle stands can be integrated with the Para-transit nodes being created throughout the area. This will not only give more flexibility to the commuters but also encourage more people to use metro.*

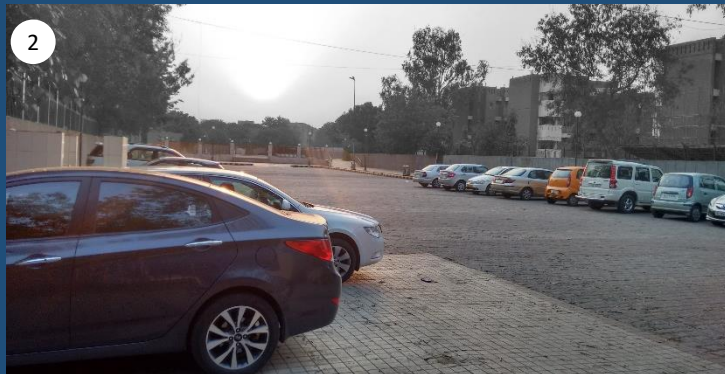
*There huge parking area towards the rear entry of Dilli Haat should be developed as a Para-transit hub. It is flanked by residences and the Ullas park. This area can be used to stitch together the various areas. Once the area becomes active the commute would not only be safer but shorter as well.*

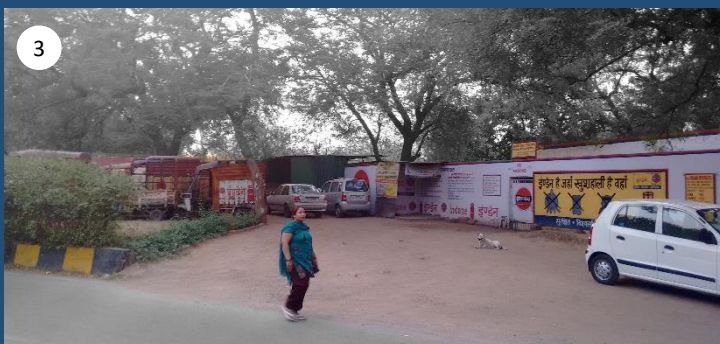
*The tempo parking area in Kidwai Nagar West should have a para-transit hub integrated into it. This should be well lit with proper Public Conveniences.*

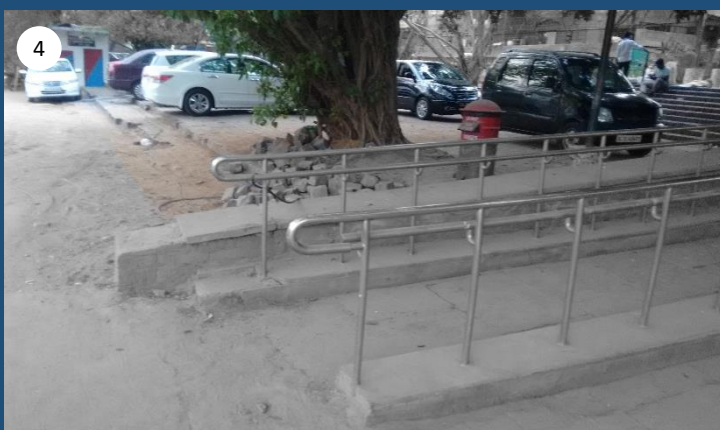
*The southern edge along the main entry of Dilli Haat has a small vehicular parking zone. This side also has provision for access for people on wheelchair. This parking area should have a para-transit stand incorporated. The space for parking of private vehicles and public transport should be segregated and both should be segregated from the pedestrian movement. Proper tactile paving should also be provided in this area.*
