ENHANCING LAST MILE CONNECTIVITY

a safety analysis of the Janpath Metro Station

Janpath

SAFETY SCORE: 3.9/5

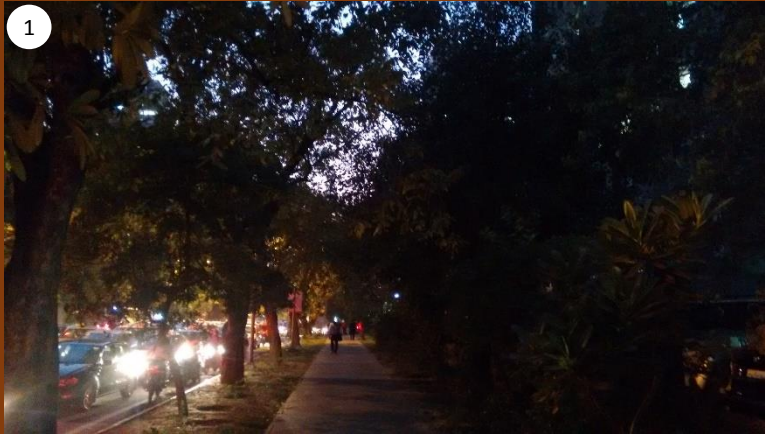
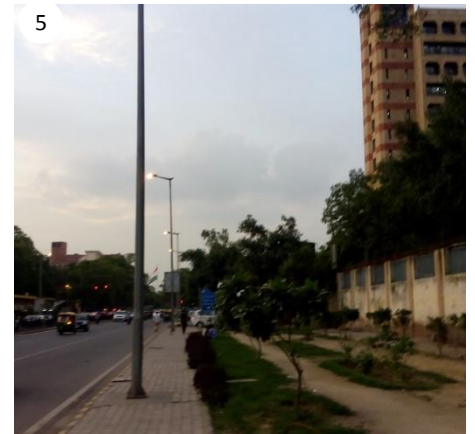
The walkpath provided for the pedestrians is wide throughout the audit area as seen in Pic 1, 2 and 5. Currently, the streetlights have been provided focusing on the vehicular carriage way of the road resulting in poorly lit footpath. Additional pedestrian scale lights should be installed on both sides of the road along the edge of the footpath or along the boundary wall, facing the footpath.

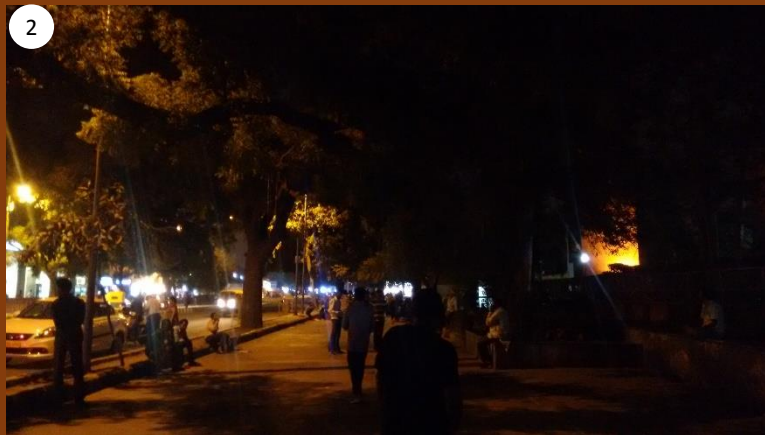
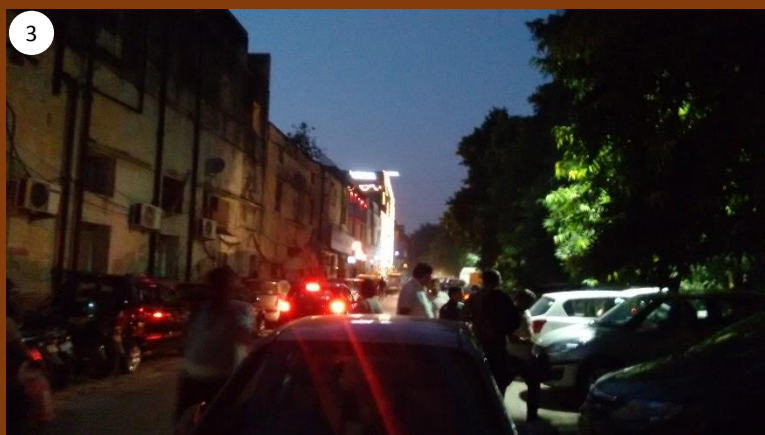
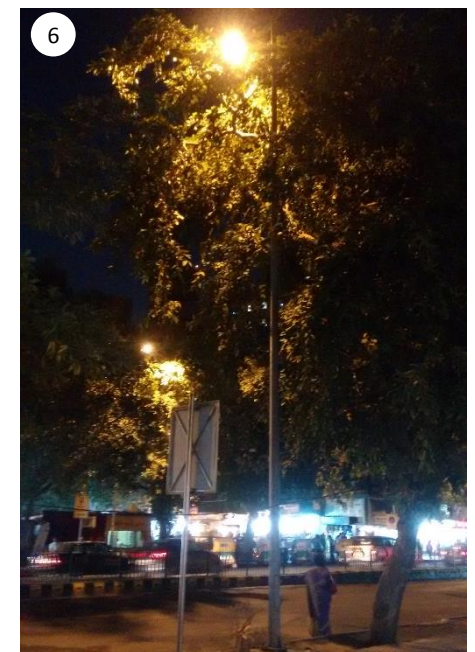
Also, the foliage around some streetlights needs to be pruned regularly as the overgrown leaves shield the light fixture resulting in poor illumination.

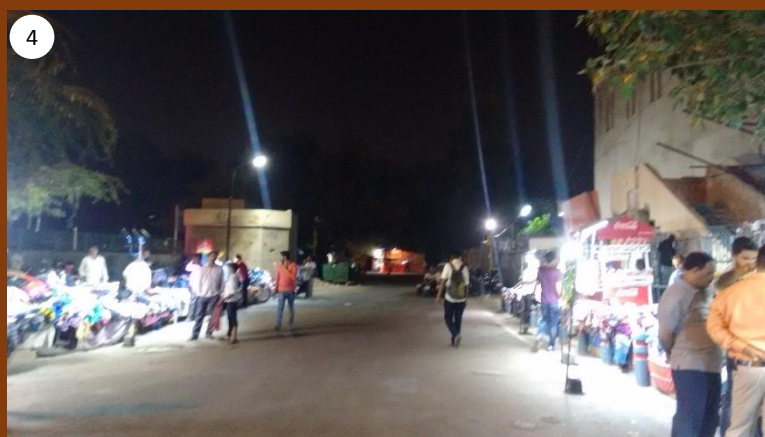
In absence of streetlights, dark spots are created in India Connaught lane (Pic 3). As seen in Pic 3 and 4, the inner lanes are illuminated by lights from vendors, and lights installed on boundary walls of adjoining building complex. However, these are not a permanent source of lighting. Therefore, streetlights should be installed to ensure uniform illumination.

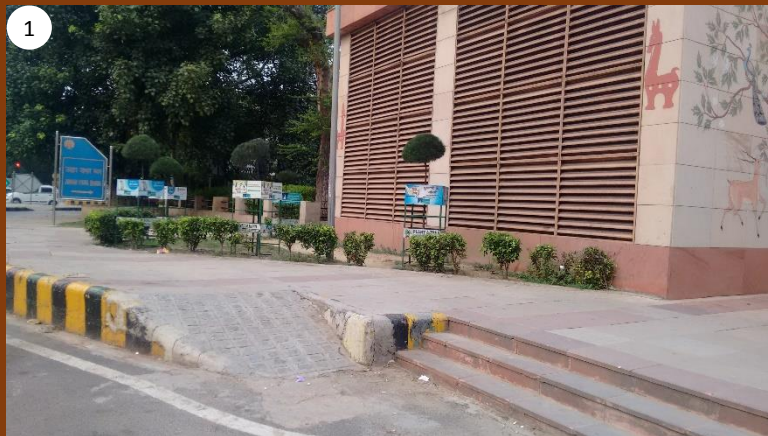
Though the footpath exists in good condition throughout the audit path, they are not easily accessible by physically disabled due to multiple issues. Seen in image 1, the ramp with steep slope is difficult to use for a person using wheelchair. On the other hand in absence of bollards on a wide and gradual slope, vehicles are parked on the footpath (Pic 2). At another audit point as seen in pic 3, designated parking for disabled is provided but there is no ramp provided to reach the footpath. Also, the footpath is obstructed by the signage board.

To offer unobstructed and comfortable movement for the disabled, a ramp having a gradual slope, clear of any obstruction should be provided. Bollards should be placed to avoid vehicular entry.

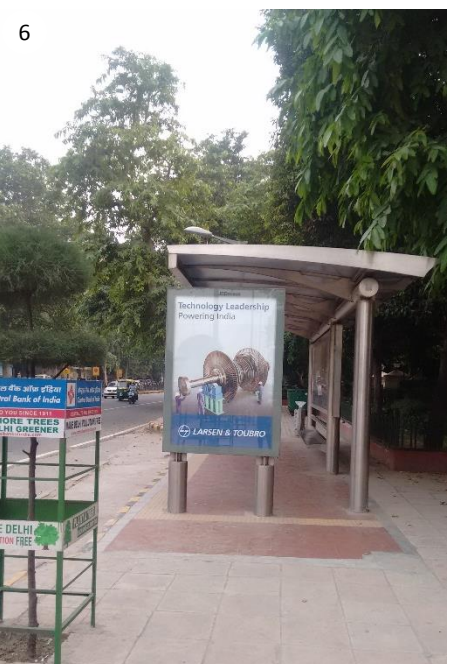
Tactile paving at the bus stop is obstructed by the advertisement board, and ends abruptly. In order to make Public Transport easily accessible for visually challenged, proper tactile paving should be provided from the metro station to the nearest bus stop (Pic 6), clear of any obstruction.

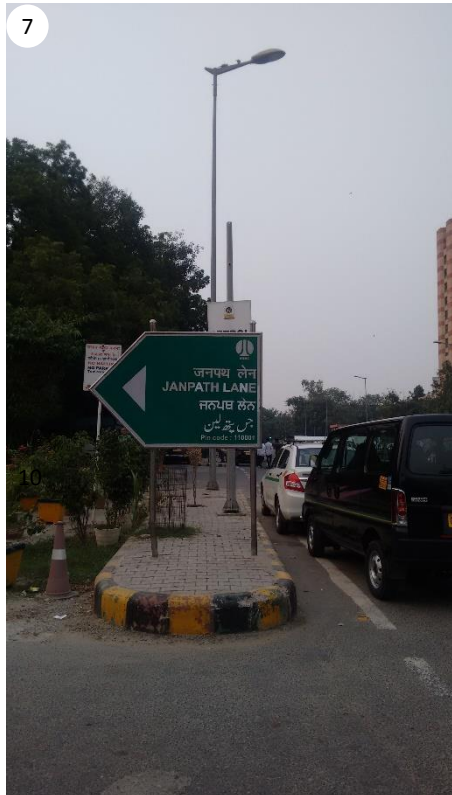
Footpath should be continuous and clear of any obstruction. As seen in the Pic 7, footpath is obstructed by signage board, planter and streetlights. These should be placed at the edge of the footpath, thereby providing unobstructed movement for the pedestrians.

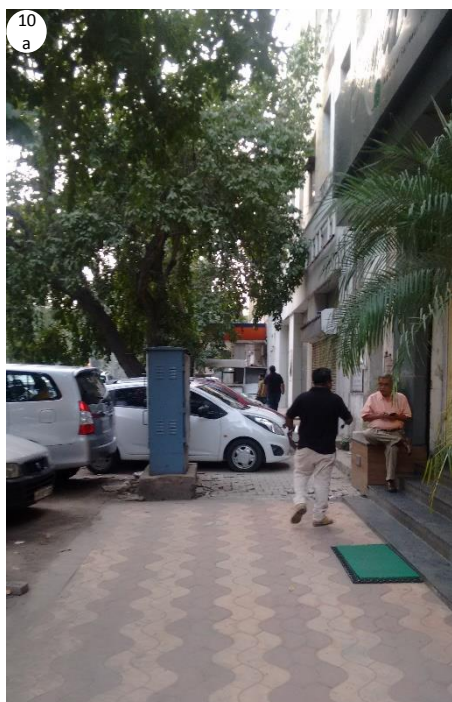
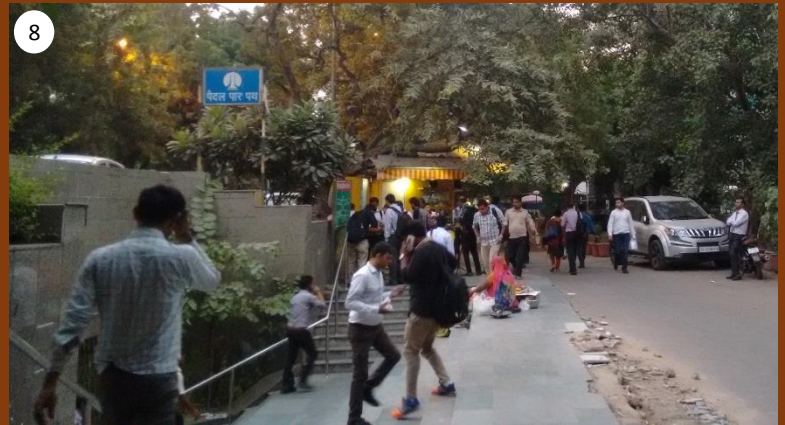
The stretch on KG Marg has street vendors occupying the footpath at regular distance. Seen here in Pic 8, the pavement near the subway is broken and the footpath is occupied by the temporary stall. This footpath should be repaired, and a designated space should be provided for the temporary stalls, clear of the footpath.

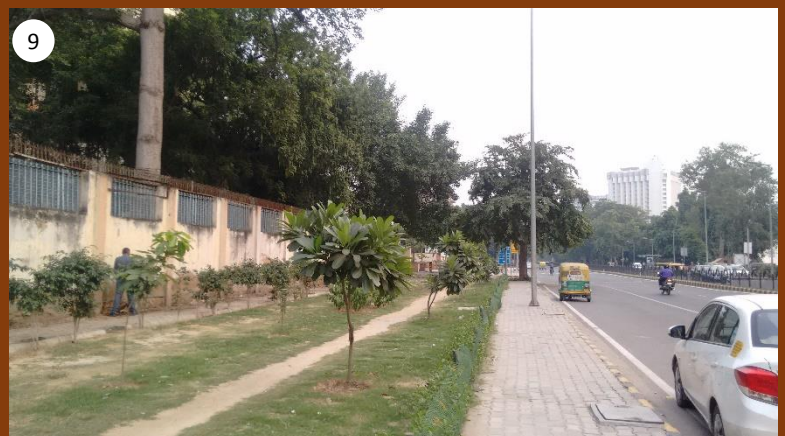
Wherever obstructed by a tree (Pic 9), the footpath should be widened to provide smooth movement for the pedestrians.

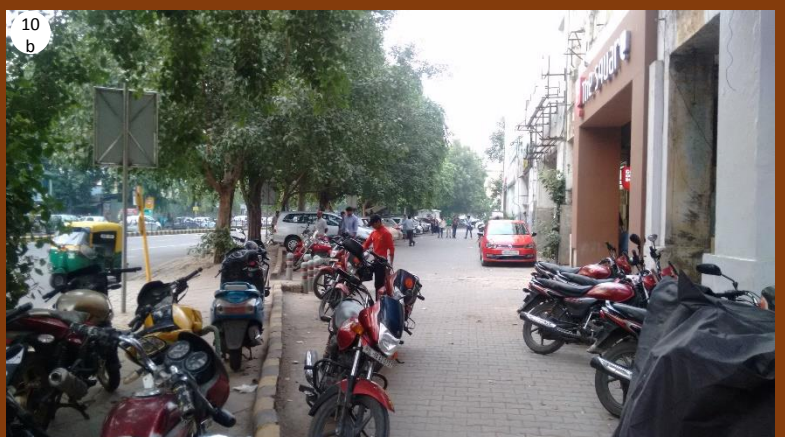
Vehicular parking on the pavement is seen at multiple audit points. Despite providing a designated space for parking, few bikes are parked on the footpath (Pic 10b). This should be disallowed. Also, seen in pic 10a space left for walkpath is used as parking space. The footpath should be raised at a level from the road, to avoid vehicles being parked on it.

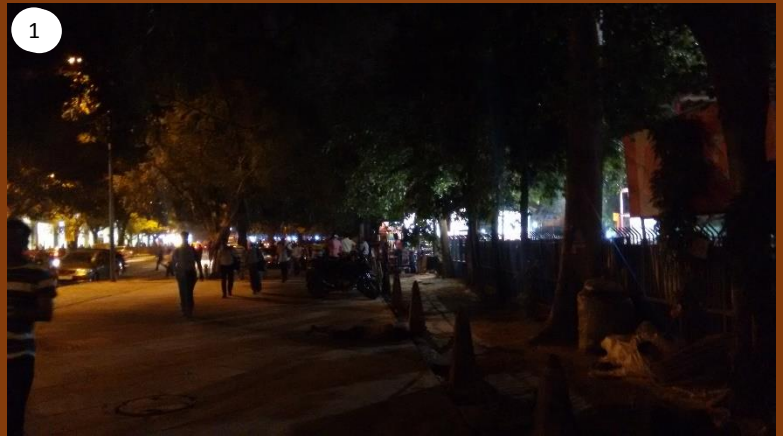
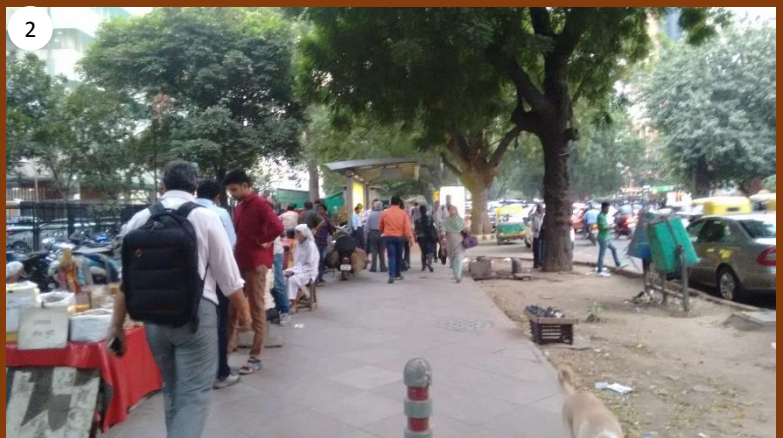
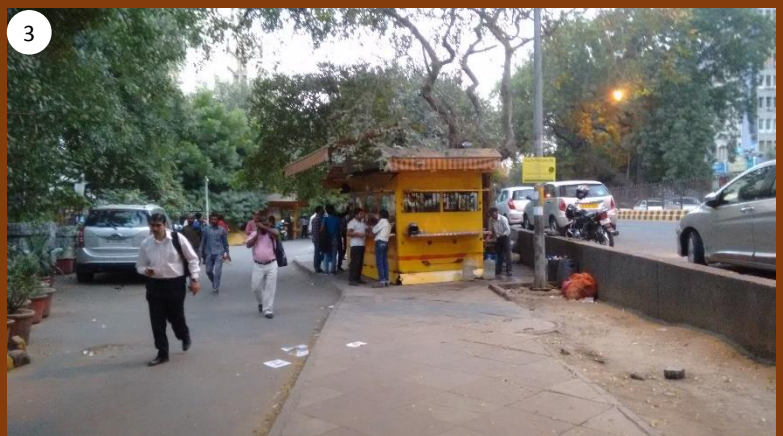
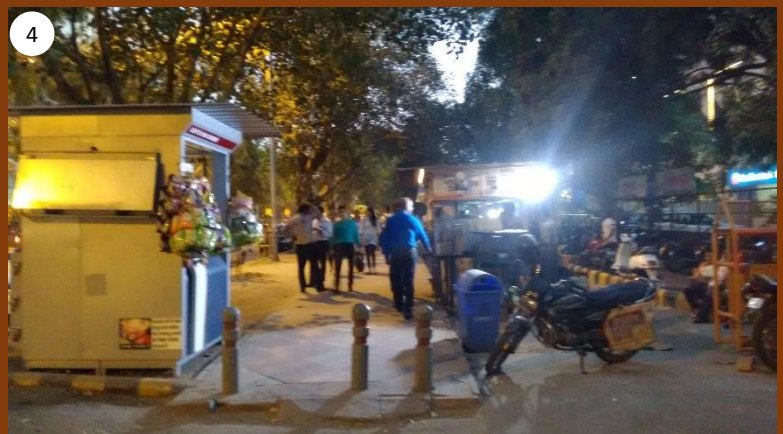
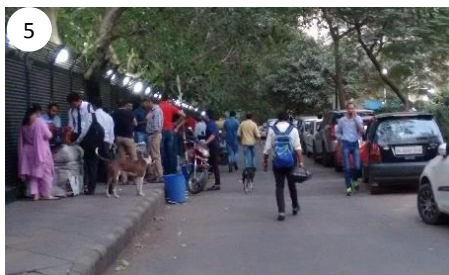
On Sansad Marg (Pic 1), there are few hawkers present near the entry/exit of building complex. However due to absence of light, this stretch is perceived inactive and unsafe. To make this stretch active, the space should have a designated space for hawkers equipped with pedestrian scale lighting and street furniture. Also, separate space for vehicular parking should be provided, clear of the footpath.

As seen in Pic 2, 3, 4 and 5 on KG Marg, temporary stalls and hawkers are present at regular distance catering to people from neighboring offices. But in absence of a designated space, hawkers end up crowding the footpath, forcing pedestrians to walk in service lane (Pic 3). At points as seen in Pic 2 and 3, the hawkers can be shifted to the space left for planters. Equipped with streetlights and street furniture, a hawker zone should be set up, clear of the footpath.

Seen in Pic 4 while a kiosk is set up clear of the footpath, another street vendor is occupying the service lane. There is a designated two – wheeler parking towards the edge of the road. Since, this service lane is not used for vehicular movement, the pavement should be widened to set up a designated hawker zone. The widened pavement would then have space for street furniture and a public toilet, clear of the footpath.

Along inner lane as seen in Pic 5, the footpath should be widened to accommodate the street vendors.

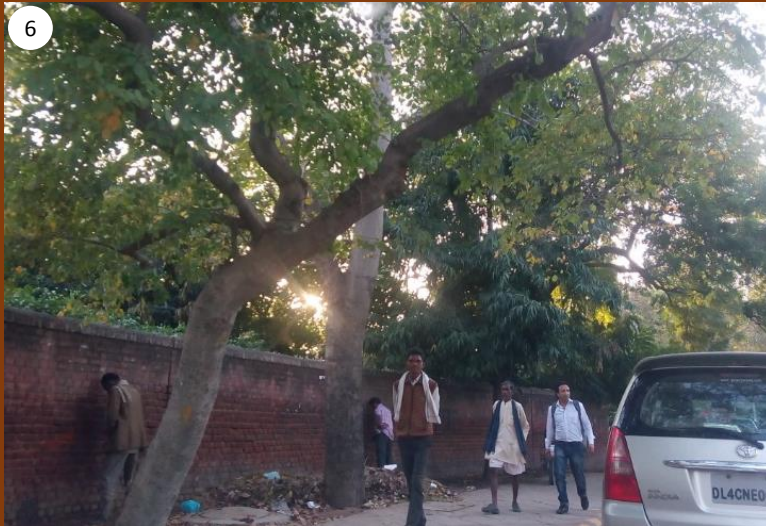
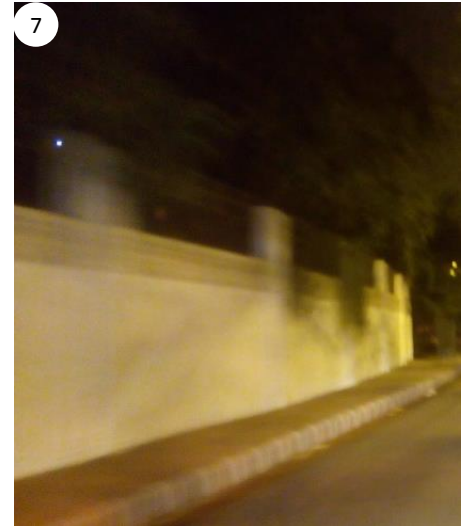
The stretch on Tolstoy Marg towards Sansad Marg, is characterized by high boundary walls. These are inconvenient and unsafe for a pedestrian, be it a day or night as seen in Pic 6 and 7. To improve visibility, the height of the solid part of boundary wall should be limited to 1 m and rest of the height should be achieved using grills. Also, a Public Convenience facility is needed along this stretch.

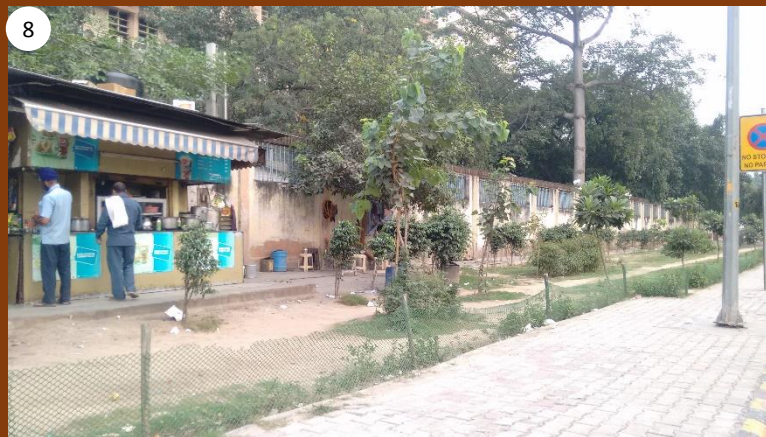
Seen in Pic 8 is a stretch on Janpath near the metro station. This stretch can be redesigned to set up a designated hawkker zone equipped with the street furniture and public convenience. Also, space for a para – transit stand should be provided.

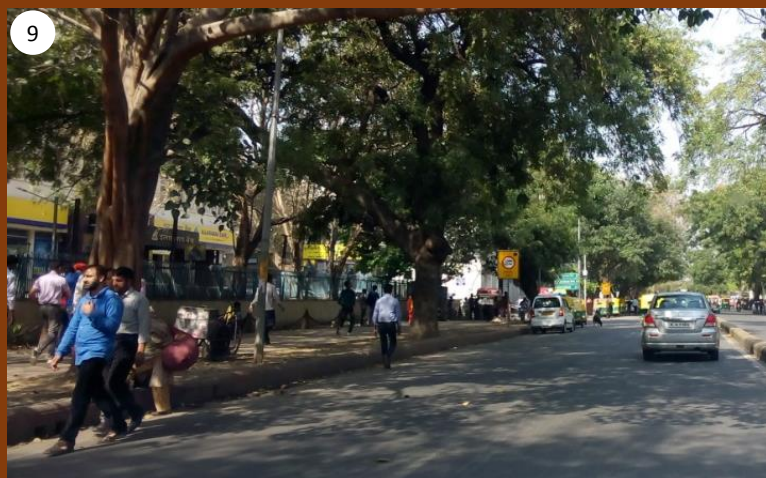
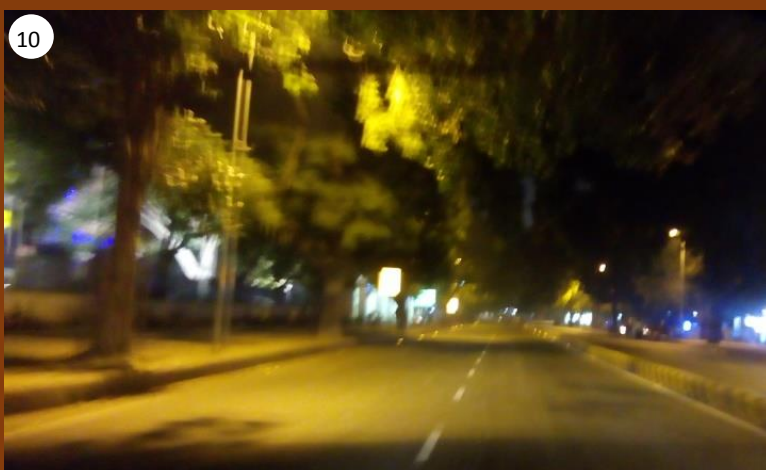
On Sansad Marg, as seen in Pic 9 and 10, the environment of same stretch changes from day to night. While it is quite active during the day, it becomes secluded during the night. Since, this area is a part of built heritage, night tourism can be promoted here through heritage walks, photo walks, food walks, etc. This would ensure activity in these areas and could contribute to the feeling of safety.

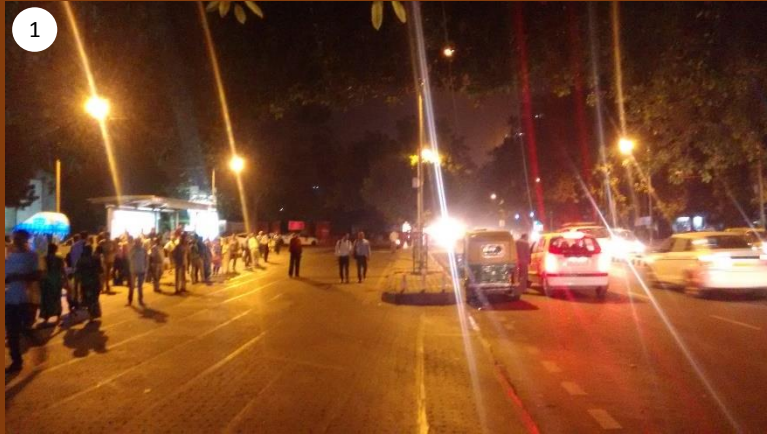
At most of the bus stops in this audit area, one can see autos waiting. But in absence of proper parking space, autos occupy main carriageway. On Sansad Marg as seen in Pic 1, there is a separate lane for the bus stop but no proper auto stand. An auto stand should be set up here with proper parking space for them.

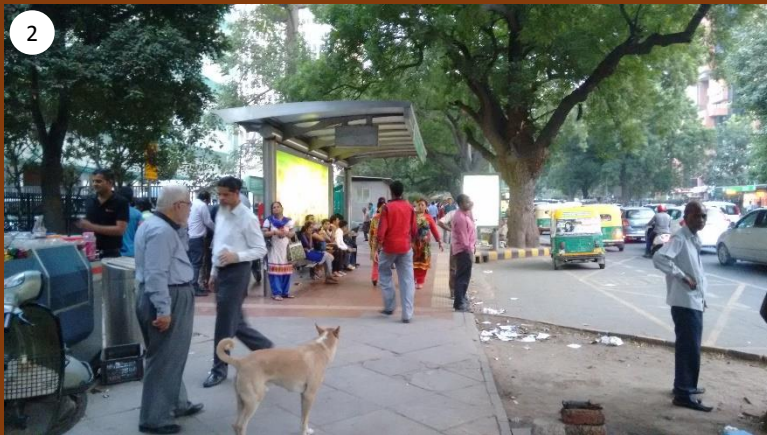
On KG Marg, the area around the bus stop has autos waiting and few hawkers along the footpath. A Para – transit hub should be set up here catering to neighboring offices, pedestrians and commuters. The hub should have parking space for autos, public convenience and street furniture.

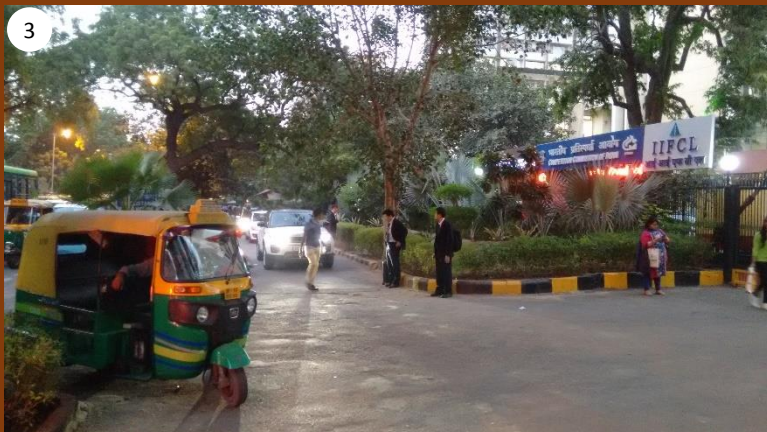
Further down the stretch on KG Marg, few autos can be seen waiting in front of HT media house and adjoining office complex. Parking space should be provided for the autos and taxi at places with high footfall.

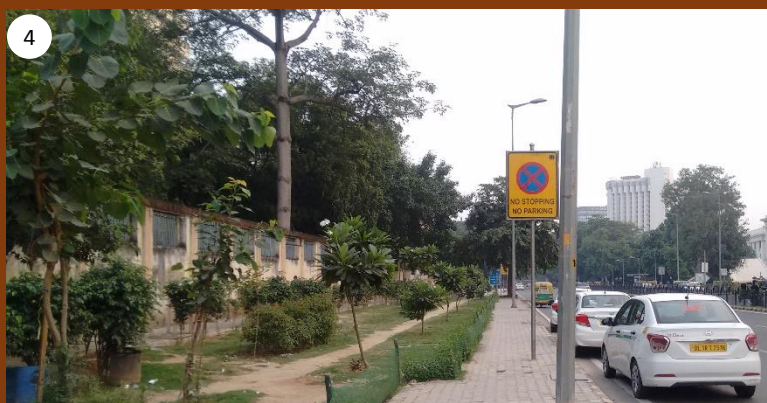
On Janpath, as seen in Pic 4, with no designated para transit stand, taxi and autos can be seen waiting in No Parking zone. This space should be redesigned to set up a Para – Transit stand with proper parking space for the autos and taxi, equipped with Public convenience and street furniture.
