ENHANCING LAST MILE CONNECTIVITY

a safety analysis of the Jhandewalan Metro Station

This Report has been prepared as part of the Project being undertaken with NDMC to Enhance the Last Mile Connectivity along the metro stations within its jurisdiction. The safety audits were conducted by Safetipin team.

Jhandewalan

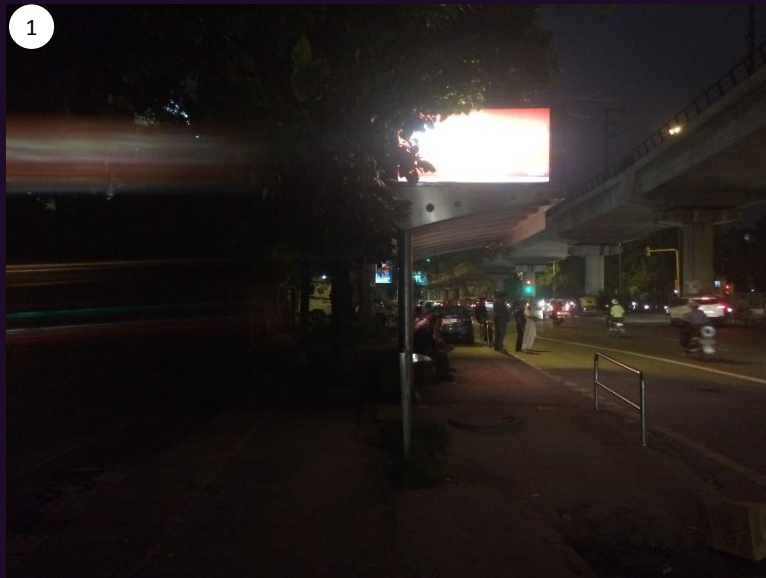
Though there is illumination on the main road, the pedestrian path as seen in Pic 1 is not lit properly. Additional streetlights should be installed along the edge of the boundary wall to illuminate the footpath.

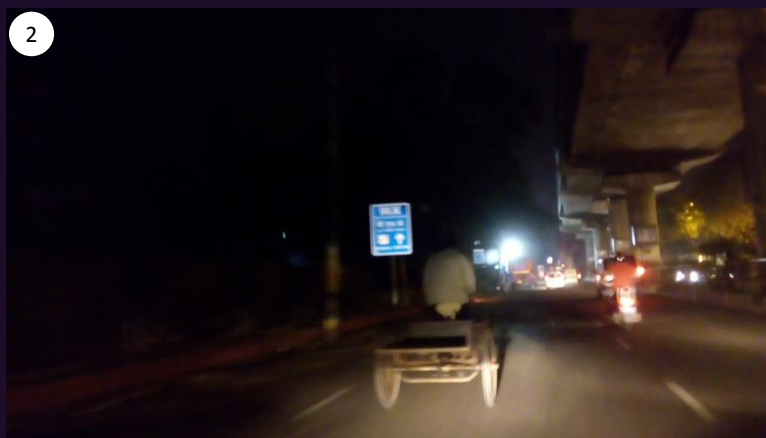
Some streetlights as seen in Pic 2 were found non – operational. Regular maintenance checks should be carried out and these streetlights should be made operational.

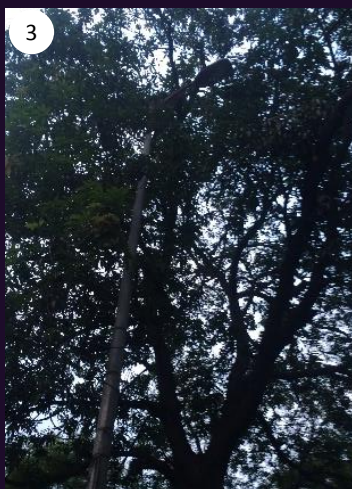
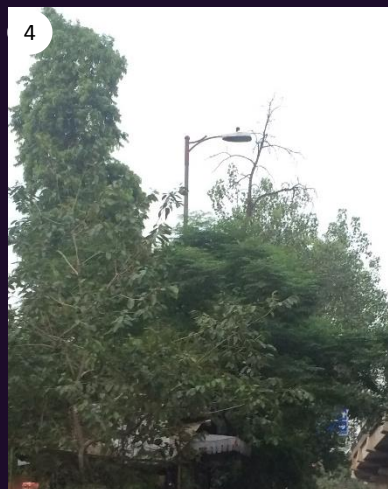
Some streetlights were found to be hidden behind trees' foliage as seen in Pic 3. As a result, shadows are cast by trees' foliage. Regular pruning of tree leaves should be done. At some points as seen in Pic 4, the height of the streetlights should be reduced so that it isn't obstructed by trees' foliage.

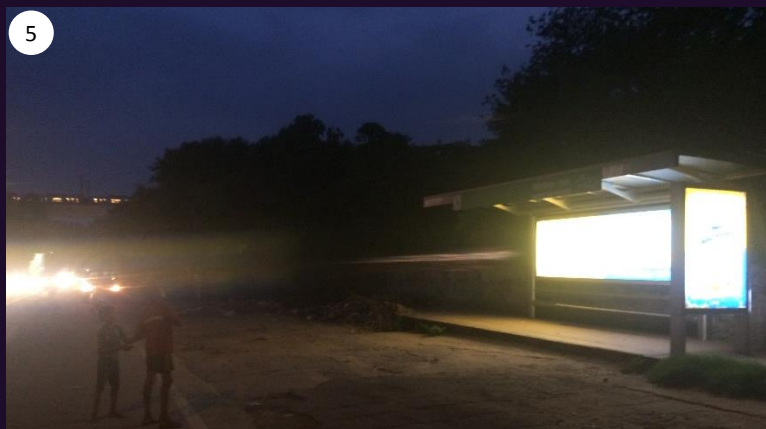
On Rani Jhansi Road as seen in Pic 5, the stretch is illuminated by light from the bus stop. Additional streetlights should be installed along the edge of the boundary wall to ensure uniform illumination.

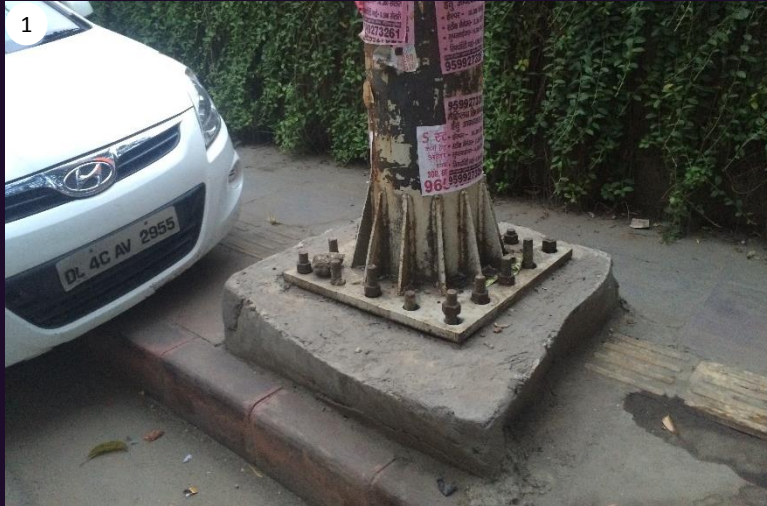
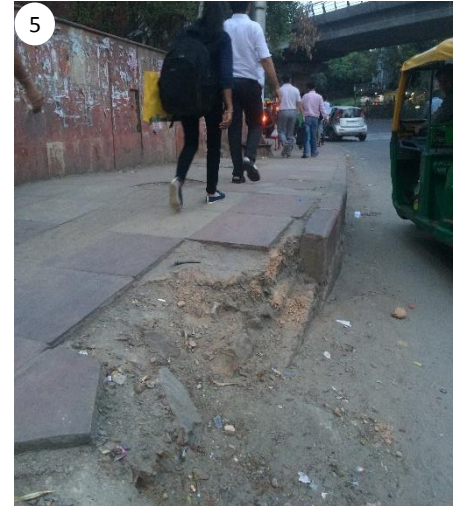
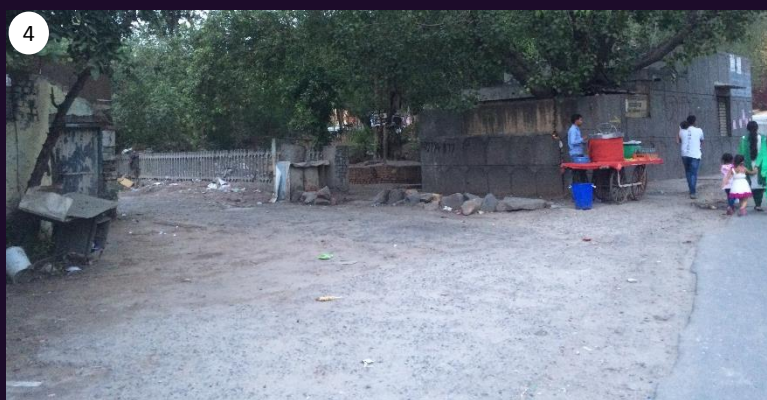
The footpath was found to be damaged at many audit points. The broken and obstructed footpath as seen in Pic 1, 2 and 5 can prove risky for pedestrians. There are no ramps provided for the people on wheelchair. Tactile paving is provided, but it is broken and non-continuous at multiple audit points. Cars are seen parked on the footpath, despite a defined edge (Pic 1). The footpath should be repaired and the tactile paving should be laid again, clear of any obstruction. Also, ramps should be provided for the physically challenged. To avoid vehicular parking on the footpath, designated space should be provided for them.

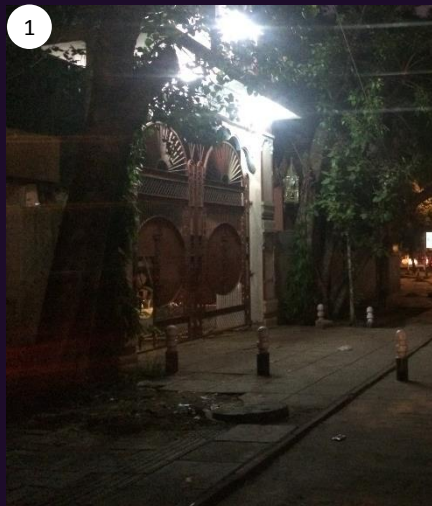
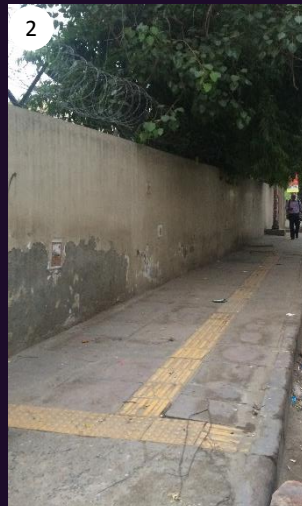
High boundary wall as seen in Pic 1 and 2, results in low visibility on the streets. The boundary wall of public buildings such as temple complex, spiritual centre, offices should be of low height so as to maintain visual contact with the public realm. The opaque part of the boundary wall should be maintained at 1m and the rest of the height can be achieved using grills.

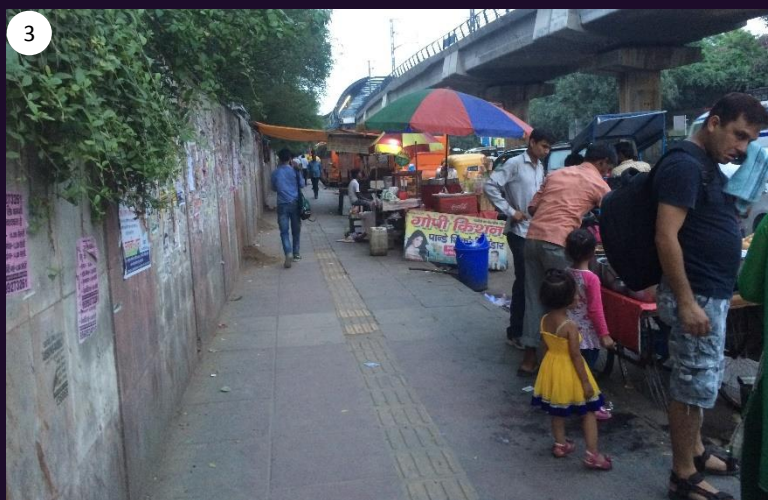
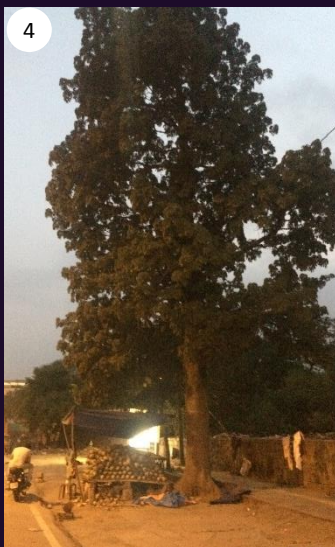
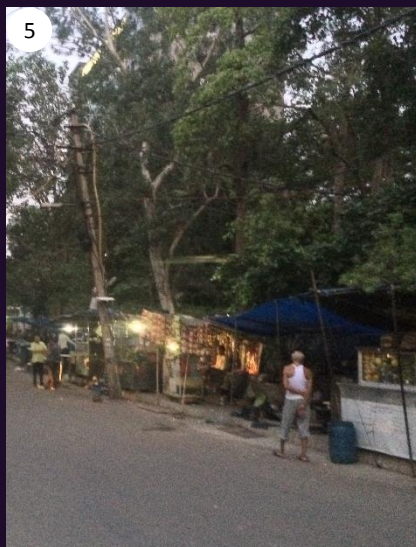
Street vendors contribute in maintaining some visibility as seen in Pic 3, 4 and 5. In absence of a designated zone, hawkers are seen occupying the road (Pic3) and pavement (Pic5). The pavement should be extended to accommodate vendors and provide them space along the built edge. Street furniture and a public convenience should also be provided, clear of the pedestrian path. The footpath seen in Pic 4 isn't utilized properly. A proper pavement should be constructed in space of existing kaccha walkpath, and should be flushed with the level of existing footpath. Streetlights should also be provided along this stretch.

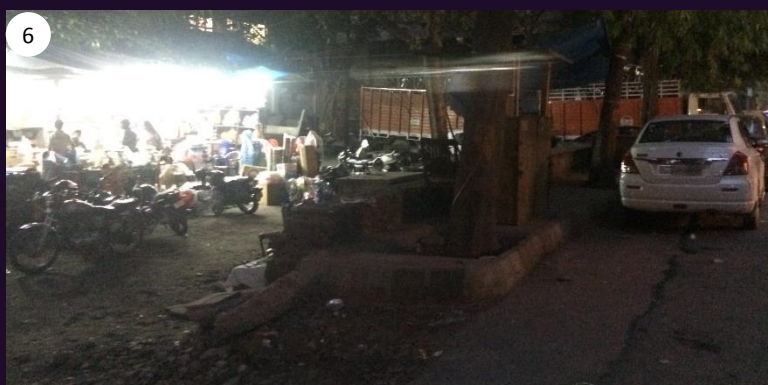
The vegetable market seen in Pic6 isn't well maintained and the access path has been damaged. The access path should be repaired, and the market area should be equipped with streetlights, proper vehicular parking space and a public convenience.

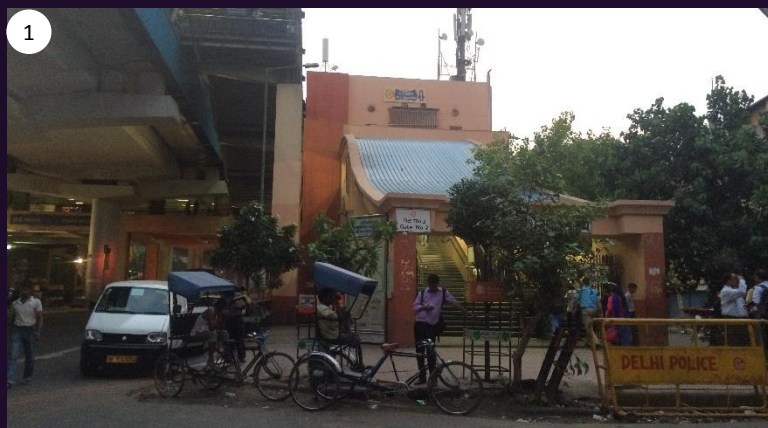
At the entry/exit of the metro station, one can see cycle rickshaws waiting (Pic 1). At present, there is no designated space for them. There should be a para transit stand at each entry/ exit of the metro station. The stand should have proper parking space and a public convenience.

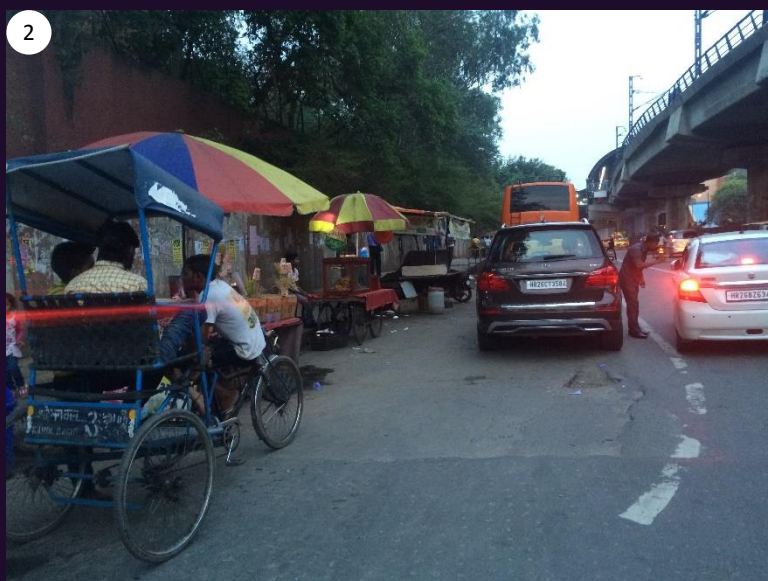
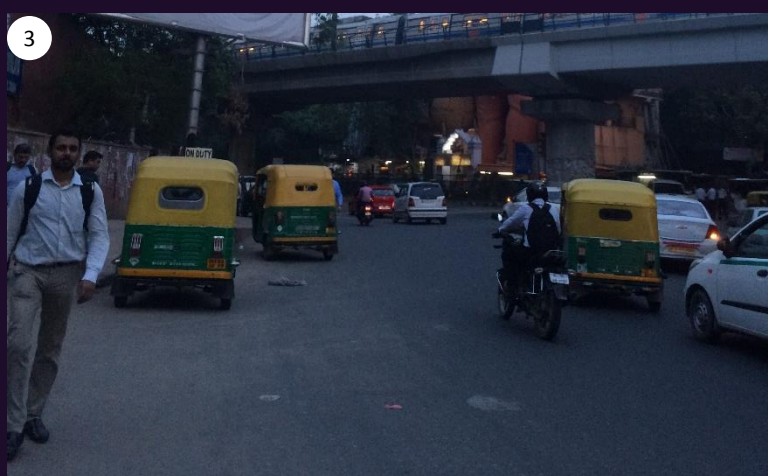
As seen in Pic 2 and 3, cycle rickshaws and auto rickshaws are parked at various audit points. These points can be set up as para transit stand. Along with designated parking space for rickshaw/auto/taxi, separate space should be provided for the street vendors. A public convenience should also be set up, clear of the footpath for drivers and commuters. To improve last mile connectivity to the neighbourhood level, such para transit stands should be set up along all the bus stops, and at regular distance within residential neighbourhoods.

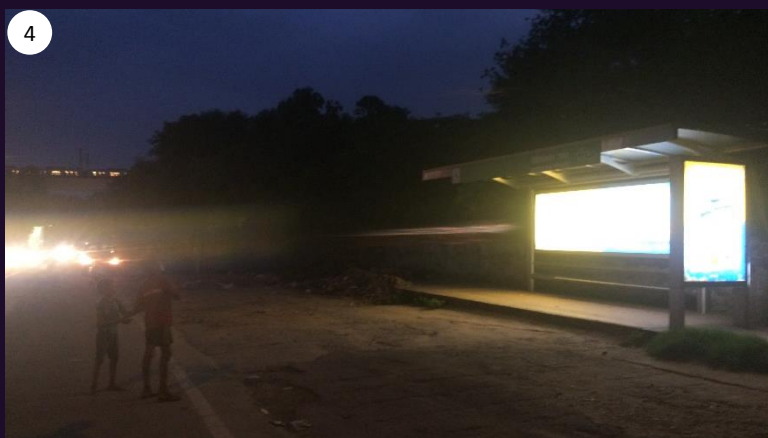
The bus shelter as seen in Pic 4 is set up away from the main road along the boundary wall. The area surrounding the bus stop is poorly lit, and used for dumping garbage. Currently, commuters avoid using this bus shelter and prefer to stand on the main road. This area should be cleared and streetlights should be installed. In place of the kaccha walkpath, a proper footpath should be constructed that is flushed with the level of existing bus shelter. Separate space can be created for a para transit stand, and hawkers.
