ENHANCING LAST MILE CONNECTIVITY

a safety analysis of the Jor Bagh Metro Station

Jor Bagh

SAFETY SCORE: 3.5/5

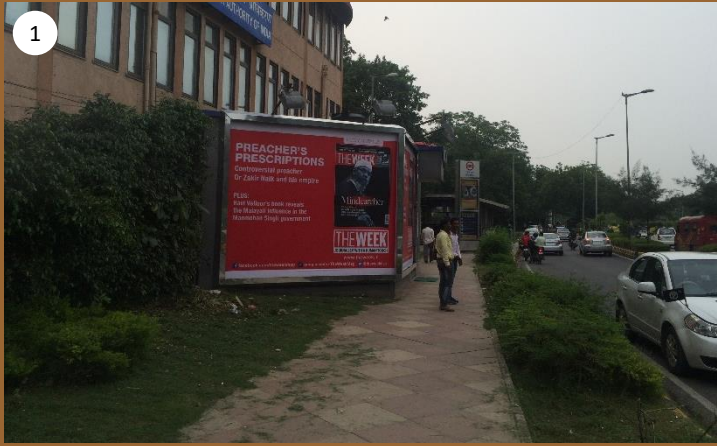
1
Outside Jor Bagh Metro Station. No streetlights are located along the footpath here. Illumination is from the metro station exit and the streetlights along the main road. Pedestrian scale streetlights should be installed along the length of the footpath.

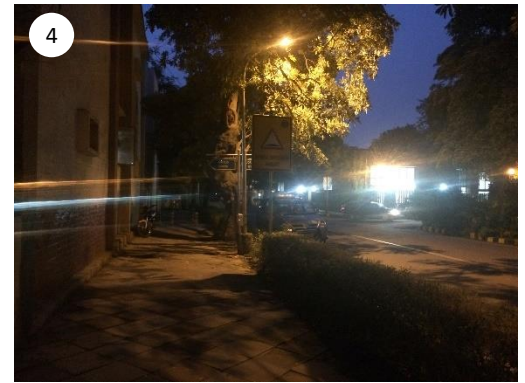
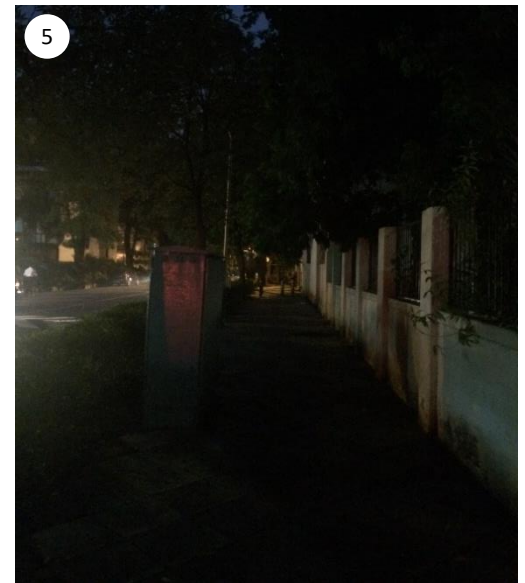
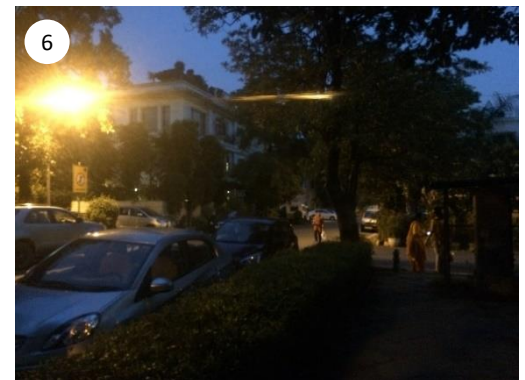
4
5
6
The above photographs show the Lighting levels in Jor Bagh residential area. The high height of the light fixture results it in being obstructed by the foliage. As a result, dark shadows are cast on the footpath making the area poorly lit. Trees should be regularly pruned to prevent this from happening. Also since the lights are installed only on one side of the road, the other side remains poorly lit. Streetlights should be installed on both sides with their position being staggered such that both sides of the road are brightly lit.

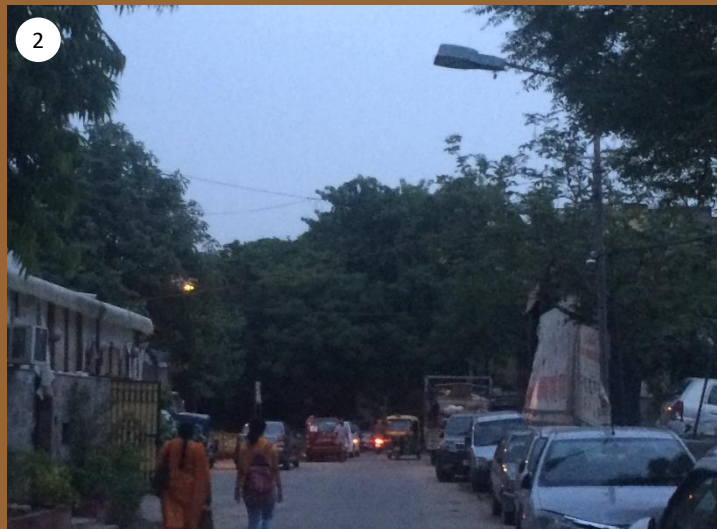
2
B.K. Dutt Colony. Some streetlights were found to be un-operational at the time of the audit.

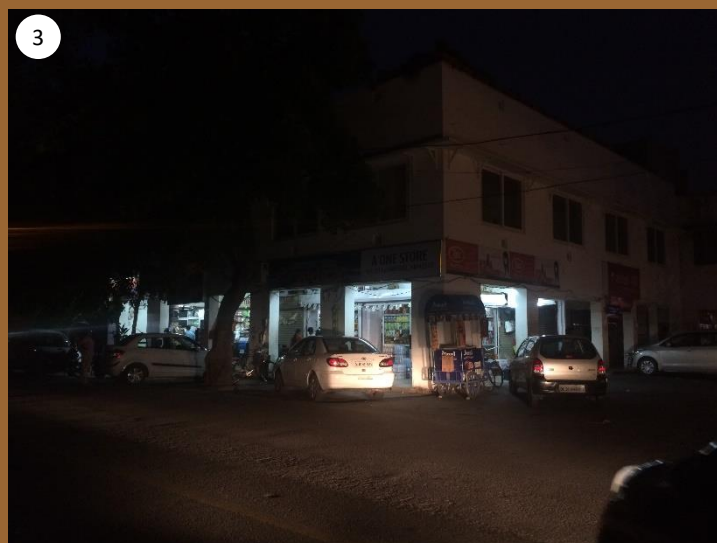
3
Jor Bagh Colony Market. The lighting around the market in the parking area was found to be inadequate with the illumination being primarily from the shops. Streetlights should be installed all around the market such that the abutting area is also brightly lit.

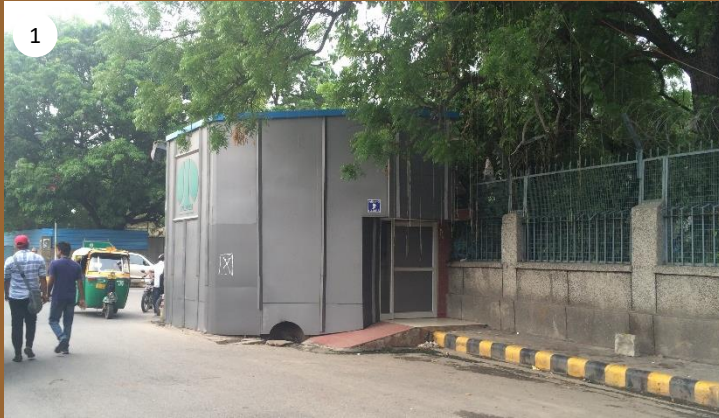
1
Along Aurobindo Marg, the footpath ends abruptly at the Public Toilet. The footpath should be continuous throughout the perimeter of the Public Toilet. The ramp should connect the road with this footpath.

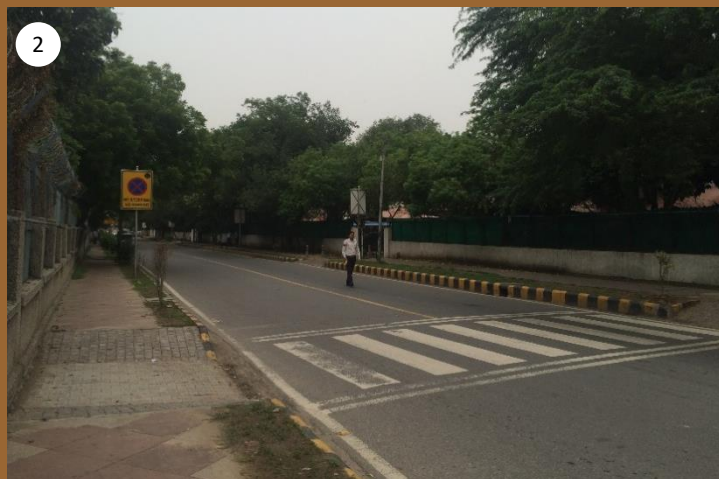
2
Data Ram Bhutani Marg. As seen here in pic2, there is a ramped ingress/egress along the zebra crossing. However, the two ramps should be exactly aligned with the crossing. Currently, this is only on one side of the road and on the other side the zebra crossing meets the kerb stone.

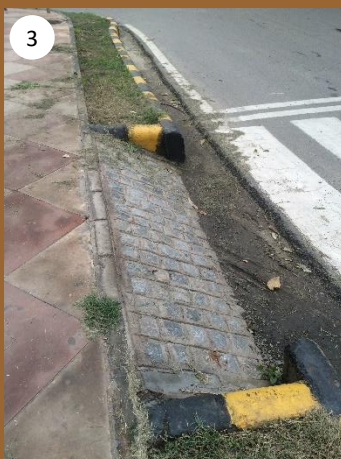
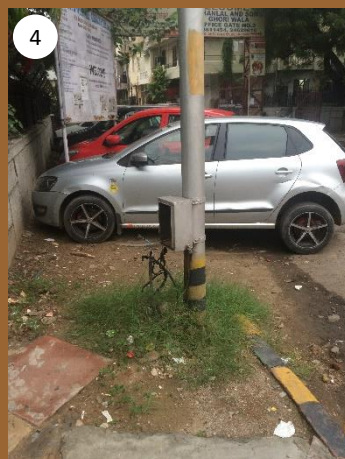
3
4
Seen here in pics3 and 4 are the edge conditions of the footpath with the road. The ramp needs to be built at a slope of 1:15 to ensure comfortable movement of people on wheelchair and women with prams. The footpath needs to have a kerb height of 150mm such that vehicles cannot be parked on it.

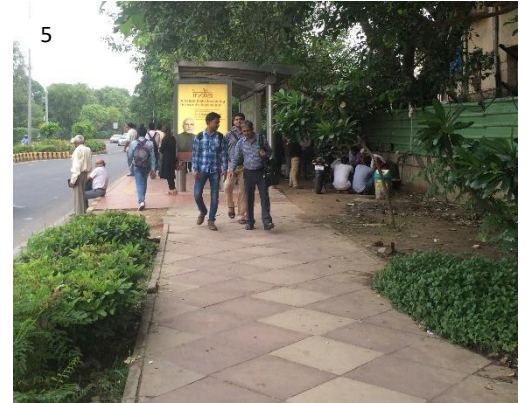
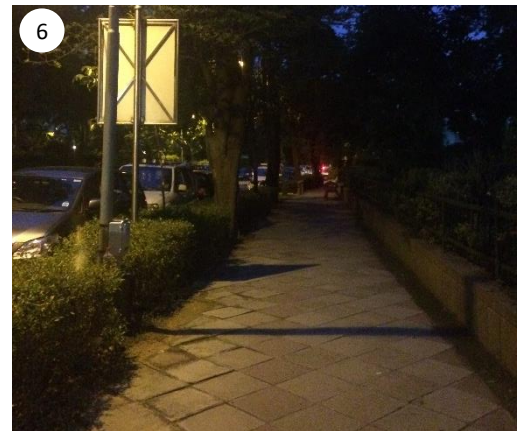
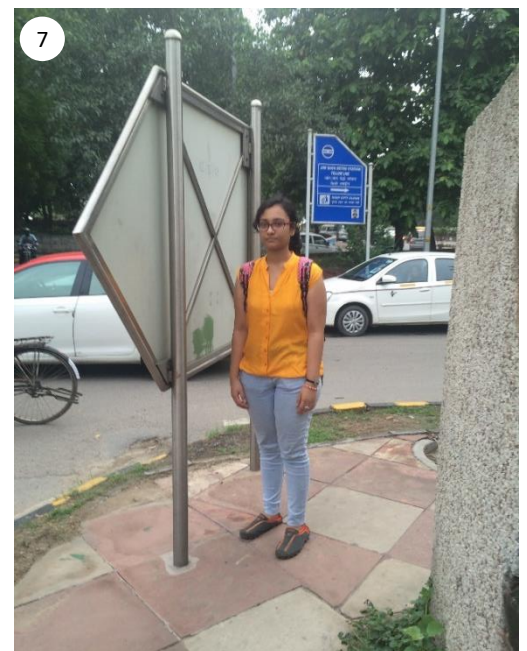
5
6
7
In the study area, except at the metro station and bus stop, the footpaths do not have tactile paving. While the footpaths are paved and in fair condition, there were obstructions like signages and manholes which make walking difficult especially for the visually impaired. The entire length of footpaths should have tactile paving and this should be integrated with that at the transportation nodes and Public Convenience facilities as well as market areas.

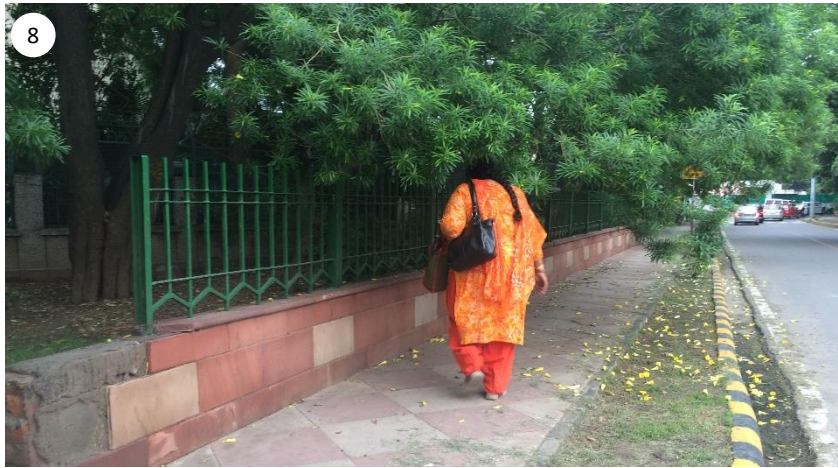
In many areas while the footpath exists, it either cannot be used or is difficult to use. Seen in pic8, the foliage in the green belts abutting the footpath is hanging too low for comfortable movement of people. The leaves need to be pruned regularly.

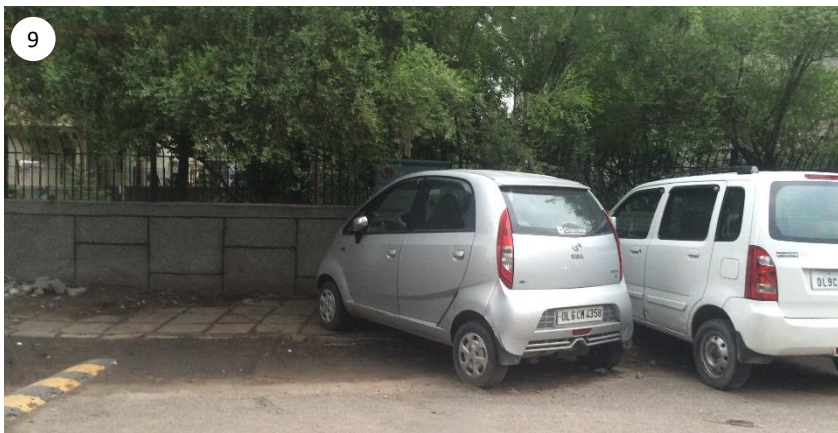
As seen in pic9, vehicles were parked over the footpath. This was mostly in the residential areas where the paving is almost flushed with the road surface. A proper edge needs to be constructed such that the kerb height is atleast 150mm from the road level. Regular checks and patrolling should be done to prevent vehicles being parked on the footpath.

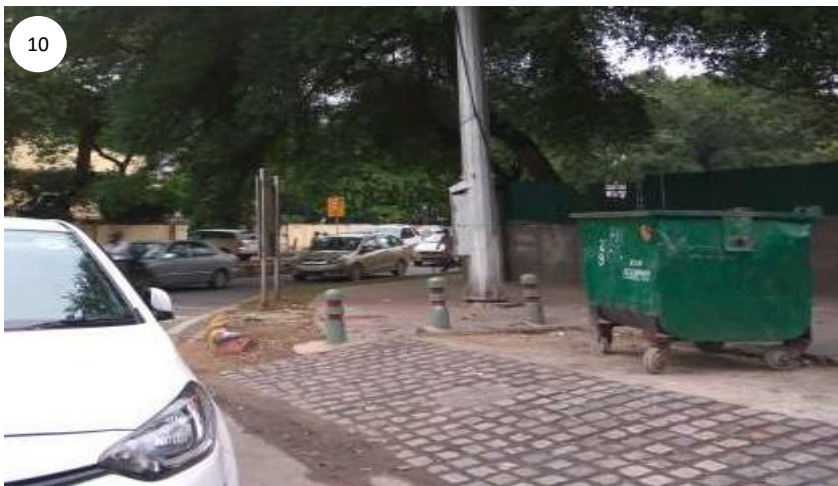
In pic10 we can see a well constructed, wide footpath with a ramped egress to the road. However the garbage dump has been located in the middle of the footpath hindering pedestrian movement. Also the location of bollards is important. They should be located to prevent vehicles from coming on the footpath. The current location of these bollards does not prevent vehicular movement on the footpath.

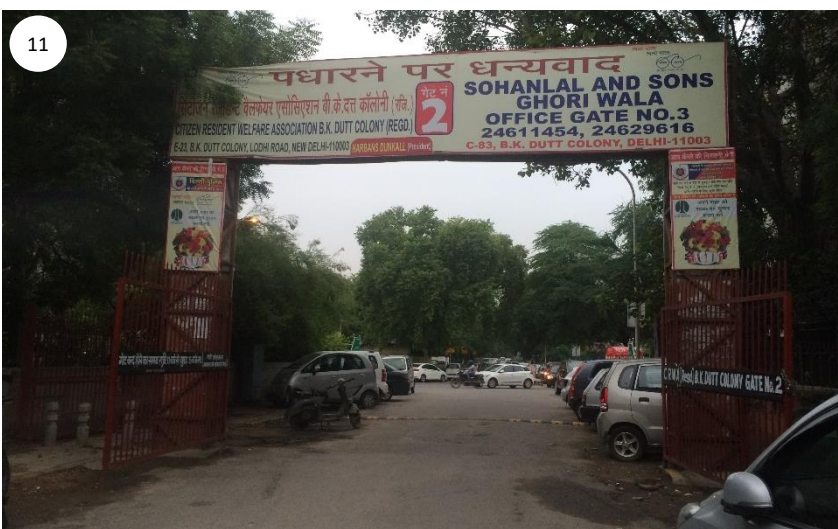
Pic11 shows a footpath being obstructed by the entry gate to the B.K. Dutt colony. The gate has fixed grill at the side along the boundary wall which obstructs the footpath completely. While the gate maybe necessary for the security of the residential area, it needs to be designed and constructed so as not to obstruct the footpath. Currently the design of the gate forces people to walk on the road. This also encourages people to park vehicles along the footpath as people are walking on the road.

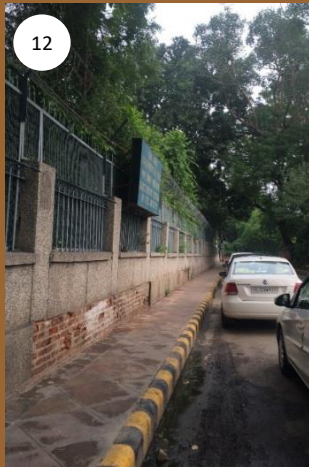
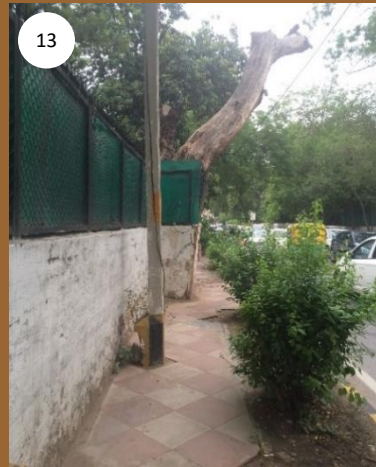
Along few roads while a proper pavement exists, it is too narrow for people to comfortably walk on. As seen in pic12 & 13 electric poles and protrusions in the boundary wall further reduce the effective width of the footpath. Pic12 shows the footpath along a wide service lane. There is space for the footpath to be widened to ensure comfortable movement of pedestrians and people on wheelchair. Also the shrubs in the green strip along the footpath need to be regularly trimmed.

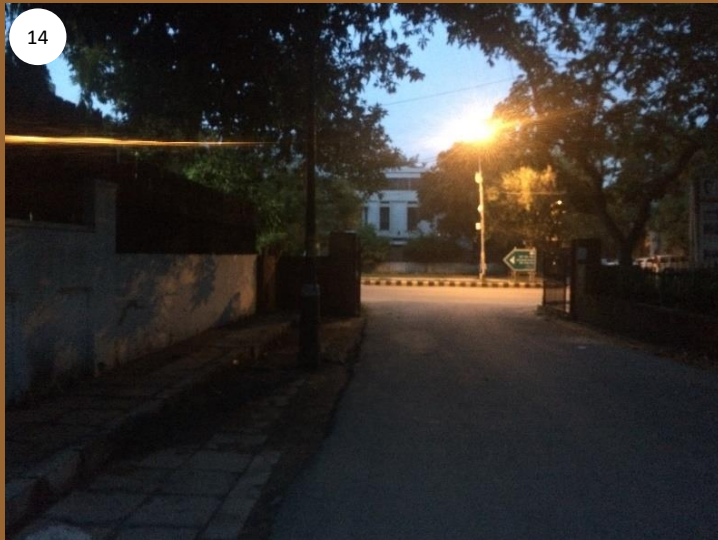
Pic14 shows the situation inside the residential area. Here a wide pavement was reduced to half its original width. This forces people to walk on the vehicular carriageway. Also the footpath ends abruptly at the gate. The wall/grill should be removed such that the footpath is uninterrupted.

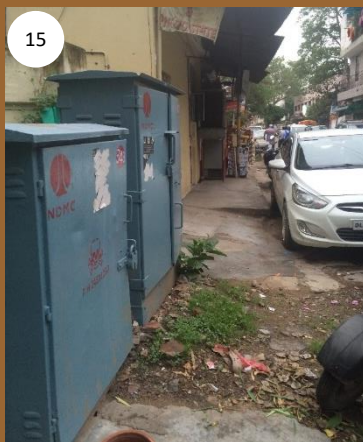
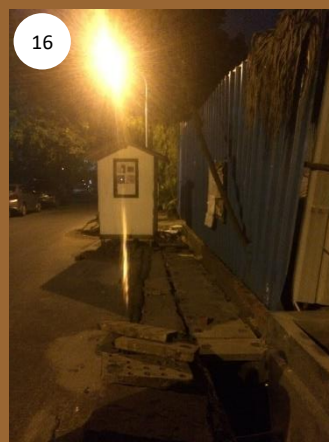
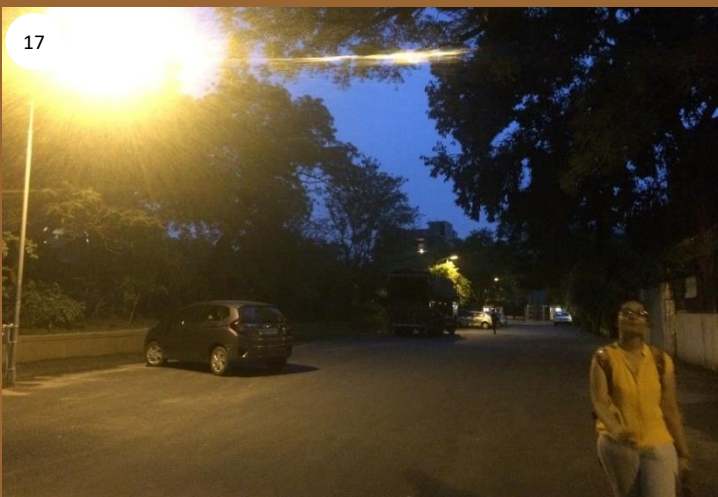
The footpaths in the residential areas are mostly broken or non-existent. Along shops, they are being used for display of products. At certain points they are obstructed by infrastructural elements as seen in pic15. In pics16 & 17, we see lanes in Jor Bagh residential area not having a footpath. At places the footpath was built over the drain but along many points there is no footpath. Even during a construction activity, the drains should be covered at all times and no private structures should be allowed to occupy the footpath or the vehicular carriageway. In pic17 we see a wide lane which does not have a footpath on either side. A footpath should be built atleast on one side on the lane to ensure safe and comfortable pedestrian movement.

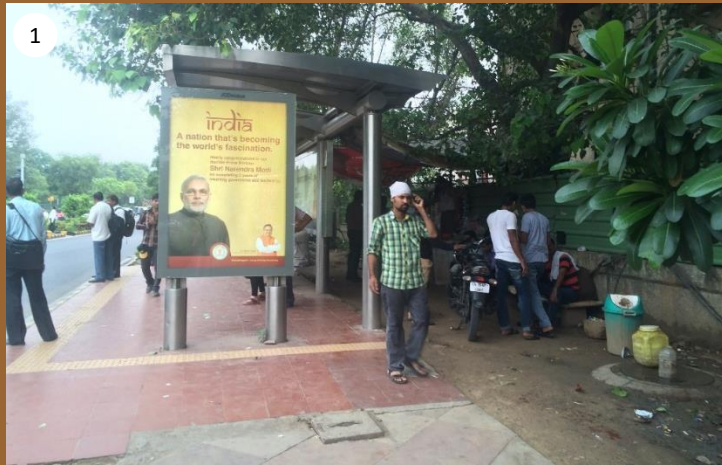
Bus Stop outside Jor Bagh Metro Station.

Seen in pic1 is the bus stop outside the Jor Bagh metro station. Few hawkers can be seen here. In the absence of a proper designated zone for them, they end up squatting along the footpath. In the absence of any street furniture people tend to bring their vehicles onto the footpath for sitting. Proper street furniture and lighting needs to be introduced and a proper Hawker Zone be created to formalize these activities. Similarly street furniture should be installed in locations shown in pics2, 3 and 4. There is a wide green belt along these roads. Installing street furniture, ensuring proper illumination and space for hawkers would help activate these currently dead edges. Currently even the municipal staff was seen squatting on the edge of the road. Such loitering is an added inconvenience to vehicular movement.

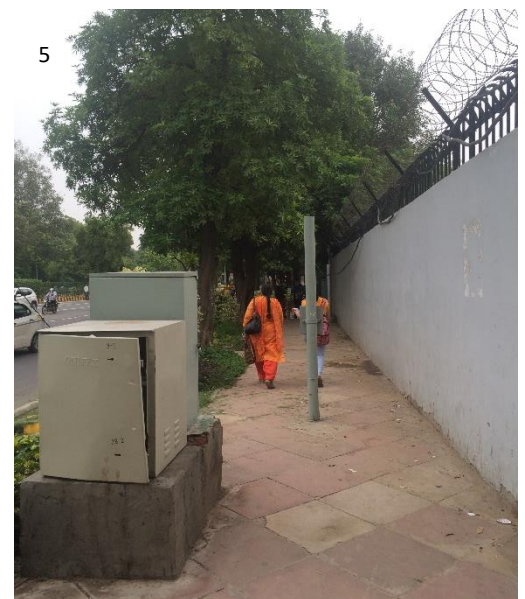
High Boundary wall along Aurobindo Marg. The opaque surface needs to be limited to 1m height. The remaining needed height can be achieved by a grill with barbed wire on the top. Another option is puncturing the wall to make it porous. Currently it creates an extremely blank edge to walk on. Reducing the opacity by either method would result in better visual connectivity between the private and public realm.

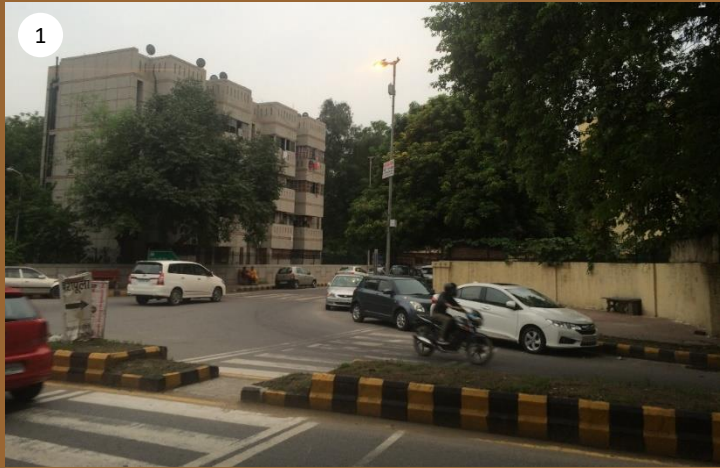
Pic1 shows the junction of Data Ram Bhutani Marg and Najaf Khan Road. This junction has residential area on one side and public functions on the other. A para-transit stand should be established here. The facilities shall then be easily accessible by the residents as well as visitors.

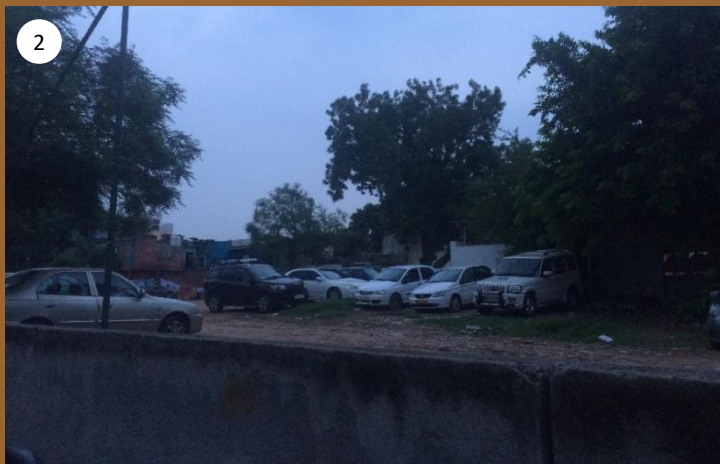
In the residential area certain vacant land was seen. This is currently being used for the parking of private vehicles. Some part of government land can be used for creating a para-transit stand. This also has religious functions like Lal Masjid near it.

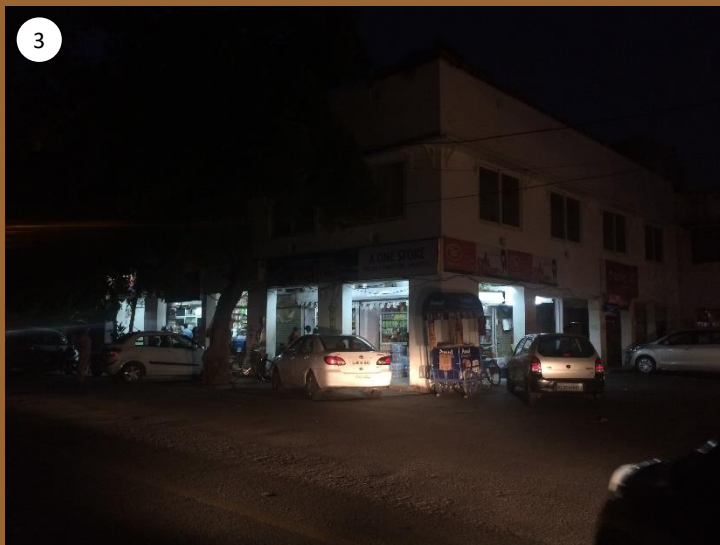
The Jor Bagh market has a lot of vacant space around it which is used for vehicular parking. This land around the market needs to be developed to have proper demarcation for vehicular parking, para-transit stand, Public Convenience and pedestrian zone. This would help in streamlining the movement and activities outside the market complex. Currently while the market is active, it still does not have an active and porous edge with the lane.

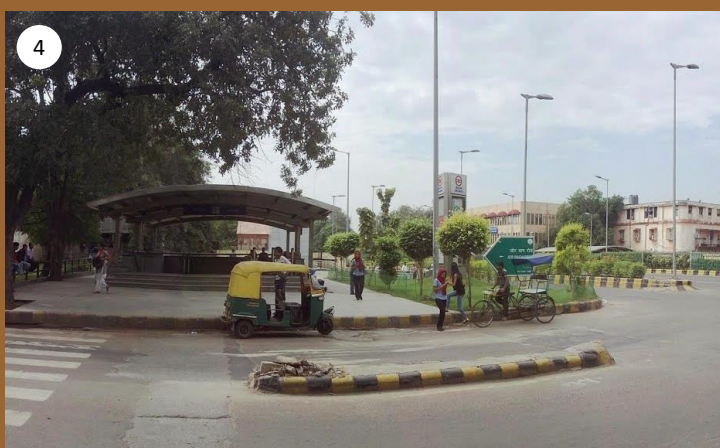
The metro station entry/exits have auto rickshaws and cycle-rickshaws waiting on the road for passengers. This causes congestion disrupting the movement of vehicles. Creating a para-transit stand with lanes for autos would help ease the flow of traffic. The para-transit stand can be integrated with space for hawkers seen outside the station as well as Public Convenience facilities.
