# ENHANCING LAST MILE CONNECTIVITY

a safety analysis of the Mandi House Metro Station

# Mandi House

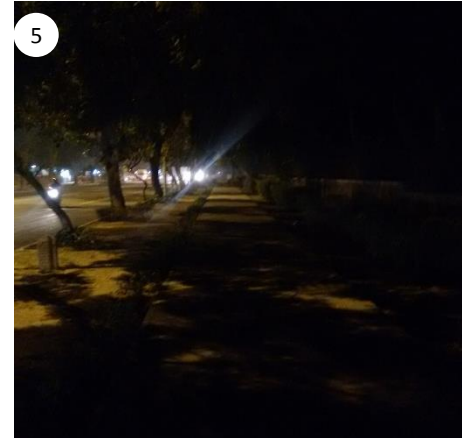
*As seen in Pic 1 and 5, the footpath in this area, flanked by trees is poorly lit. Seen in pic 2, pavement is lit by kiosk's light, i.e. a temporary source. Pedestrian scale streetlights should be installed along the boundary wall focusing on the footpath.*

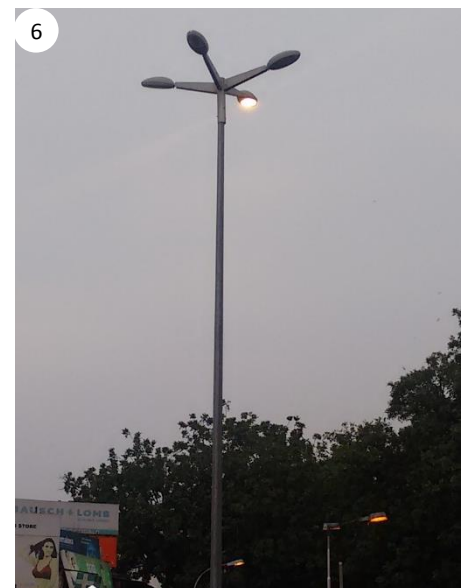
*Seen in pic 6, some streetlights were found to be non - operational. Regular maintenance checks should be carried out to ensure uniform illumination.*

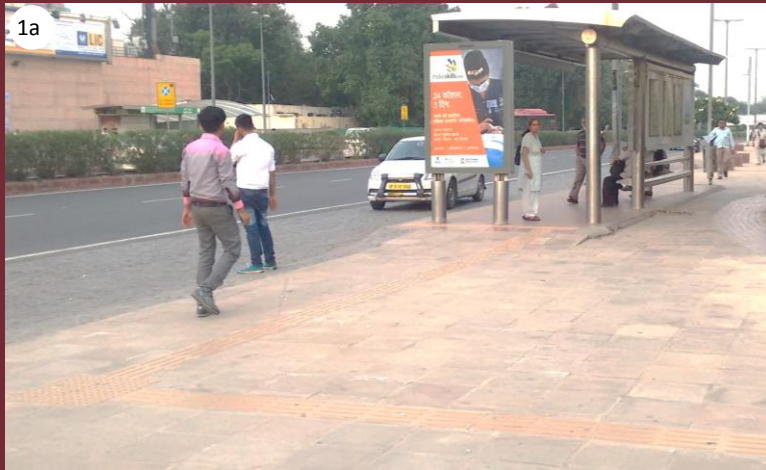
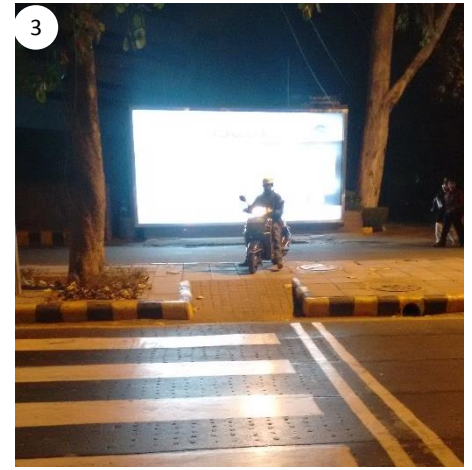
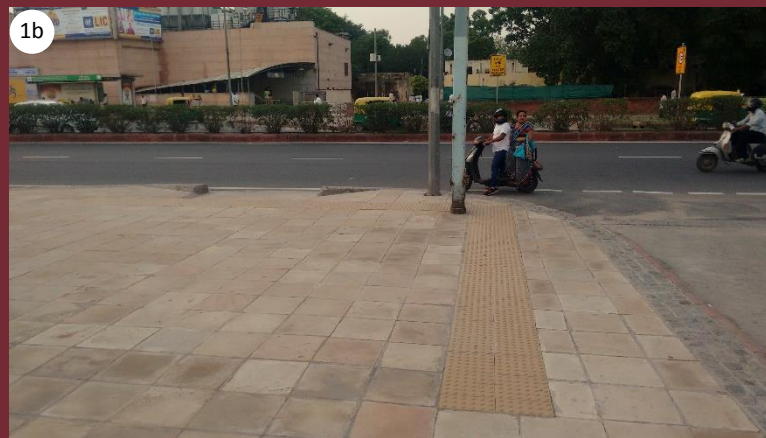
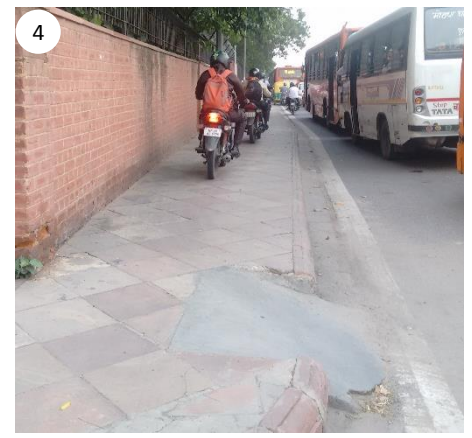
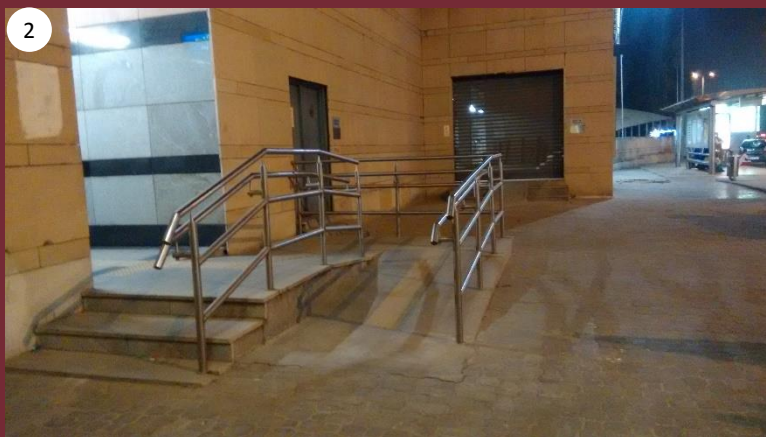
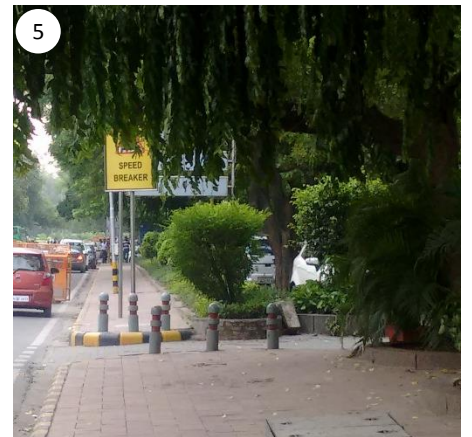
The footpath exists in good condition throughout the audit path. However, they are not easily accessible by the physically disabled. While there is tactile paving from metro station's lift to the bus stop on one side of the road (Pic 1a), the tactile paving provided on the other side of the road ends abruptly outside the lift (Pic 2). Seen in pic 1b at a little distance from the bus stop, a random L shaped tactile paving is provided i.e. not connected to any utility / building. Also, as seen in pic 1a, the placement of advertisement board is risky for the visually challenged. In order to provide smooth movement for them, proper tactile paving should be provided throughout on the footpath, clear of any obstruction.

As seen in pic 3 and 4, the ramp provided is not convenient for people on wheelchair, and two – wheelers can access the pavement as well. Also, bollards are placed where there is no ramp (Pic 5). To make commuting comfortable for the disabled, the ramp should have a gradual slope. The bollards should be placed such that it provides smooth movement for the physically challenged and prevent the vehicles from accessing the footpath.

Footpath should be continuous and clear of any obstruction. Various obstructions found in the audit area include streetlights, banners, vehicles etc. As seen in pic 6, the streetlights and cooling appliances are obstructing the pedestrian path. These appliances should be removed, and streetlights should be installed along the edge of the boundary wall facing towards the road. Also, mother dairy booth seen in Pic 7 should be set up clear of the footpath.

Seen in Pic 8, the kiosk set up on the footpath has reduced the pedestrian path. Also, people squatting on the footpath and the placement of dustbins hinder pedestrian movement. Niches can be created along this boundary wall to house this kiosk. Benches and dustbins should be placed at the edge of the boundary wall.

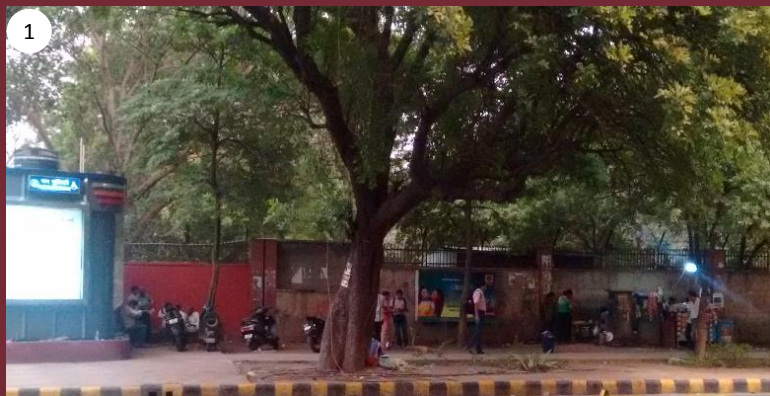
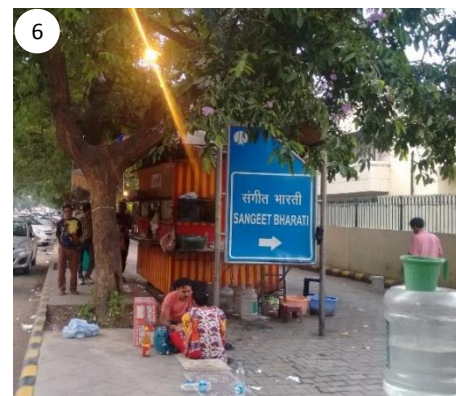
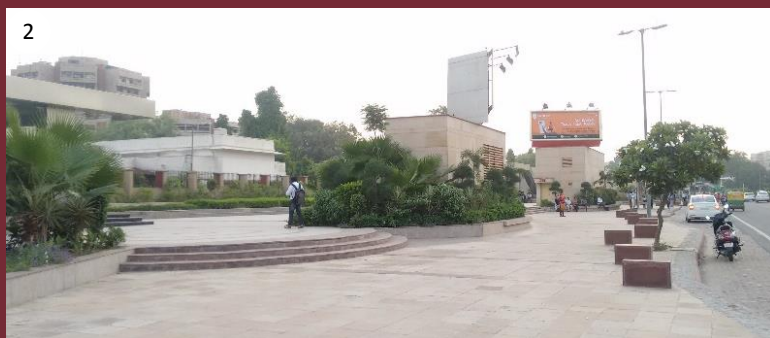
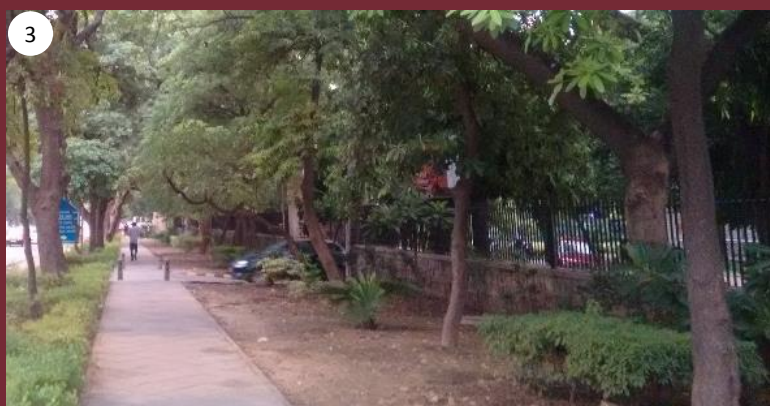
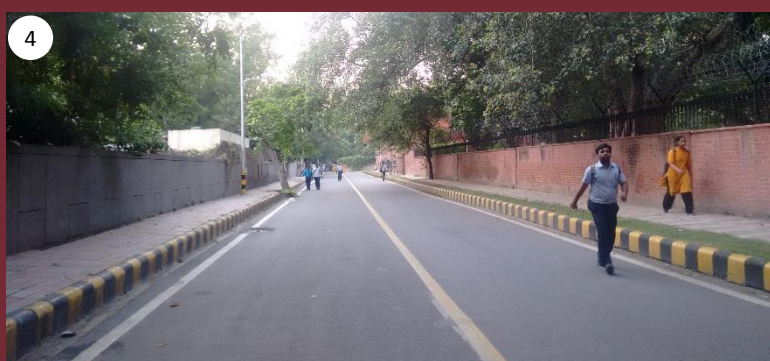
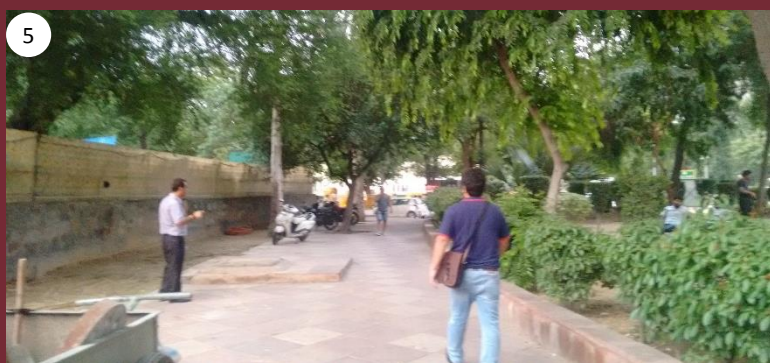
Street vendors present along the boundary wall contribute to visibility at various audit points as seen in Pic 1 and 6. These spaces should be redesigned to improve the experience. Vehicular parking on the pavement should be disallowed (Pic 1). Green belt along the built edge should be equipped with street furniture and designated for the hawkers. In case of Pic 6, the service lane is not used for vehicular movement. A hawker zone can be set up here, equipped with street furniture and a public convenience. The footpath should be widened wherever tree obstructs. The area outside the metro station (Pic 2) can also be developed as a hawker zone.

While cultural institutions maintain some transparency through their boundary walls (Pic 3), the government offices and housing societies have high boundary walls (Pic 4). The boundary wall of public buildings should also be of low height as seen in Pic 3. The solid part of the boundary wall should be maintained at 1 m and the rest of the height can be attained using grills. However, in some places the grills were found covered using plastic sheet (Pic 5). The grills should not be covered with any opaque material. Additionally, to improve visibility along the pavement, designated hawker zone should be set up, clear of the footpath. Street furniture can be added within the green belt.

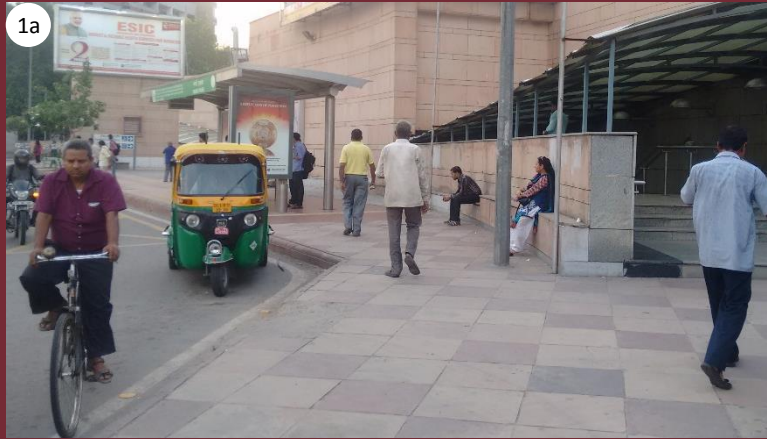
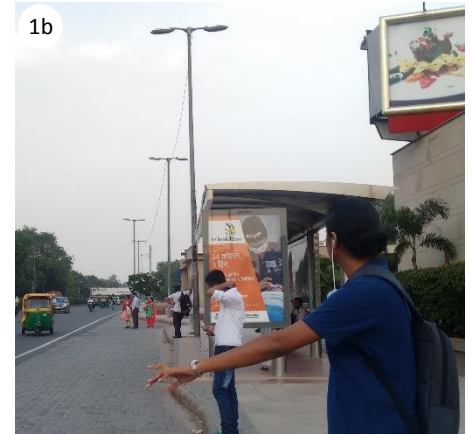
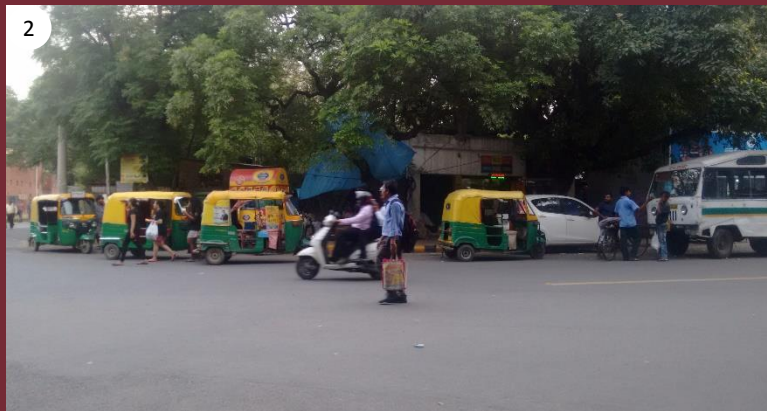
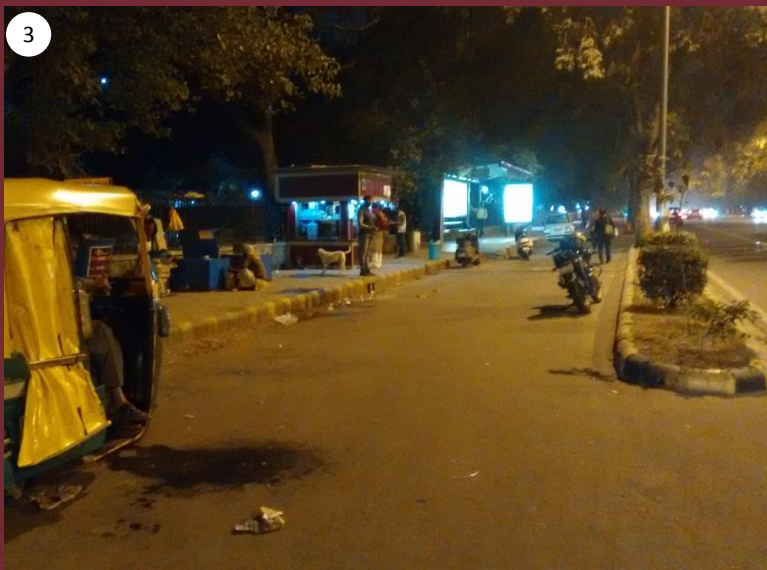
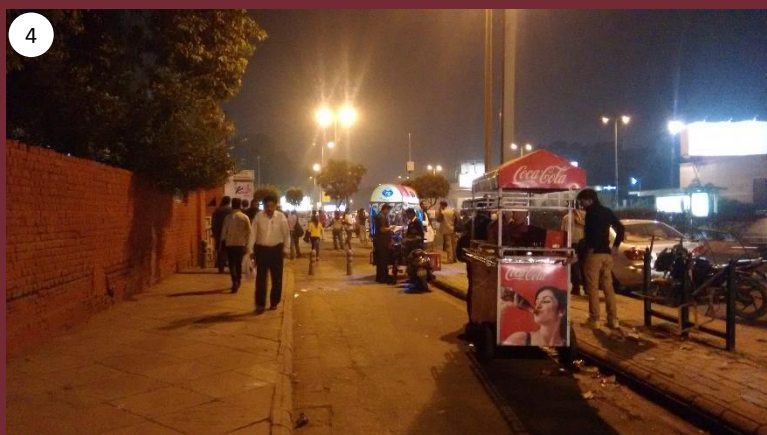
As seen in pic 1a and 1b, the bus stop is right outside the metro station. In the absence of proper parking space, autos occupy bus lane (Pic 1a). Auto stands should be set up near the bus stop on both sides of the road. The stand should have parking space for the autos and a public convenience for the drivers. Similarly, auto stands should be provided at all the bus stops. Autos were seen waiting near Lady Irwin College (Pic 2) and Bangla Market. To improve last mile connectivity to neighbourhood level, auto stands should be set up within the residential area as well.

As seen in pic 3, the bus lane is occupied by two wheeler and autos. As a result, buses stop on main road. The bus lane should be kept clear of any obstruction, and a para transit stand should be set up for auto/taxi. Vehicular parking should be disallowed in the bus lane.

Street vendors are seen occupying the cycle lane near the metro station (Pic 4). Designated space should be provided on the pavement along the main road for the hawkers. Street furniture can be added to enhance the area.
