ENHANCING LAST MILE CONNECTIVITY

a safety analysis of the Patel Chowk Metro Station

Patel Chowk

SAFETY SCORE: 3.9/5

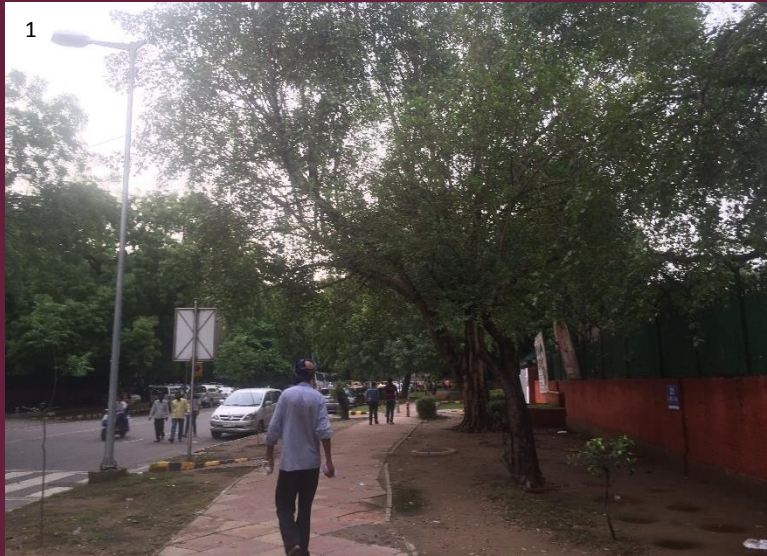
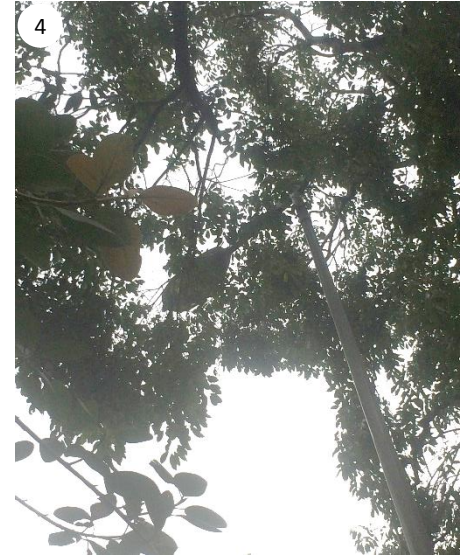
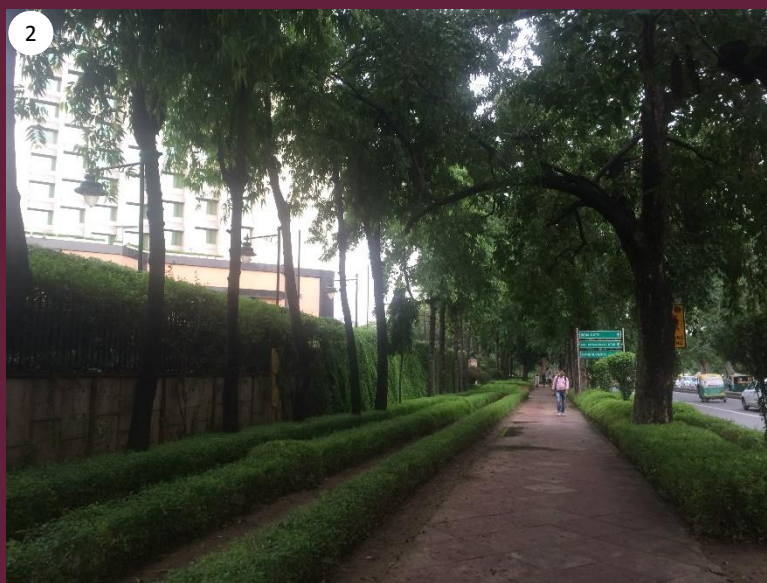
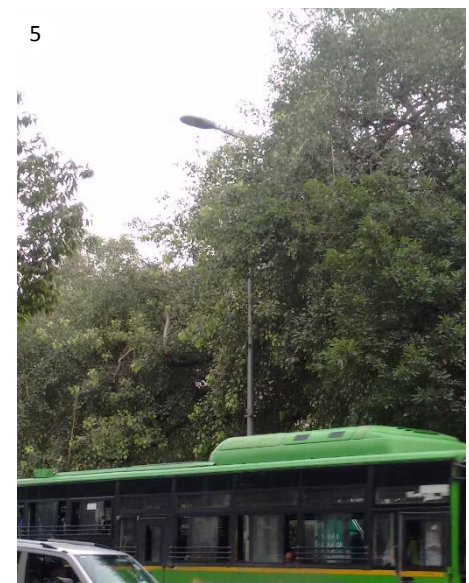
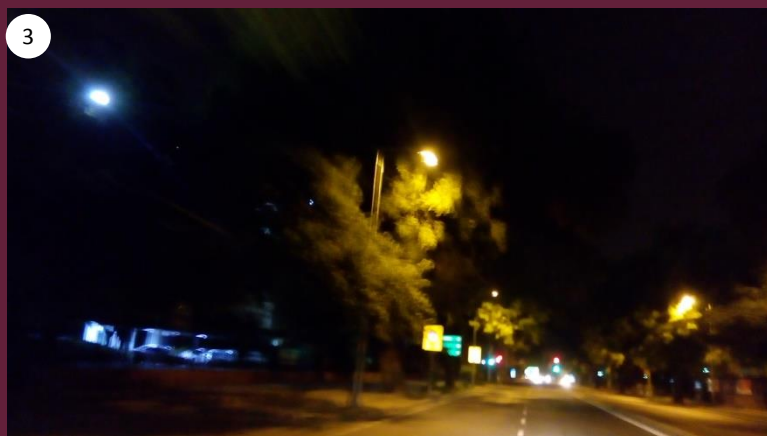
At various points, streetlights were found to be hidden behind trees' foliage (Pic 4). To avoid this, regular pruning of trees should be carried out. Also, shadows are cast by trees wherever height of the streetlight is higher than the trees (Pic 5). To ensure uniform illumination, the height of streetlights should be reduced.

In this area, the streetlights are installed along the footpath facing the main road (Pic 1). As a result, only vehicular carriageway is lit as seen in Pic 3. The footpath in this area is flanked by trees on both sides, often forming a colonnade shading the whole path (Pic 2). Pedestrian scale lighting should be provided facing pedestrian path either along the edge of footpath or boundary wall.

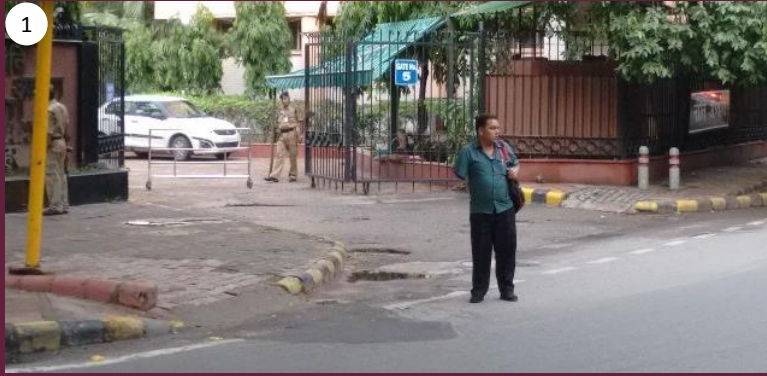
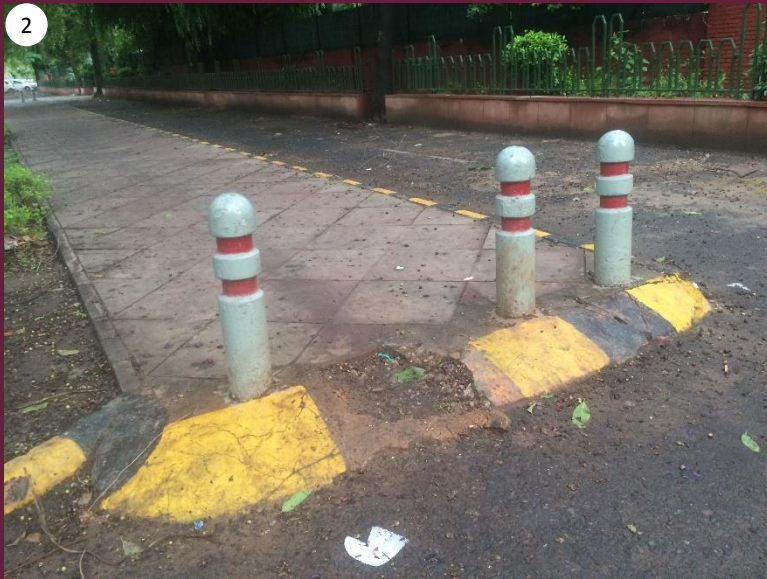
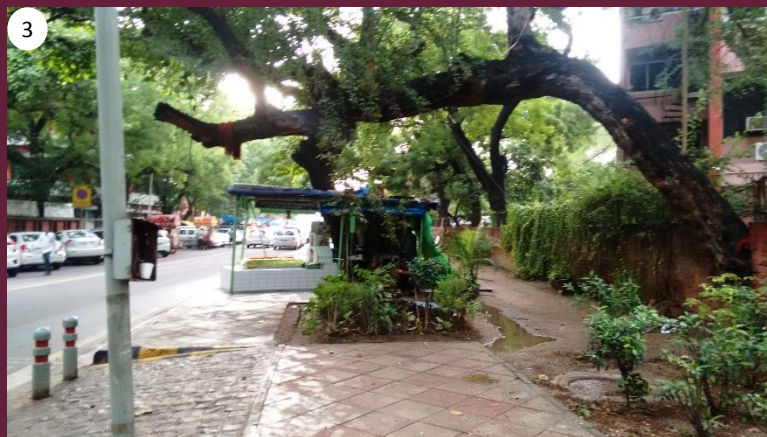
Though well maintained footpath exists throughout the audit path, it is not user friendly for physically challenged people. As seen in Pic 1 and 2, the slope of ramp and the placement of bollards is inconsistent and inconvenient to use. In Pic 1, there should be table top crossing and should have a gradual slope. The spacing between the bollards should be such that it is accessible by a person on wheelchair(Pic 2). Seen in Pic 3, while there is a ramp provided, the footpath is obstructed by a planter and a religious structure. With defined edges and obstructions, it is difficult for people on wheelchair to commute around. Existing unused green belt should be paved to provide a footpath, clear of any obstruction. Additionally, tactile paving should be provided throughout on the footpath for the visually challenged.

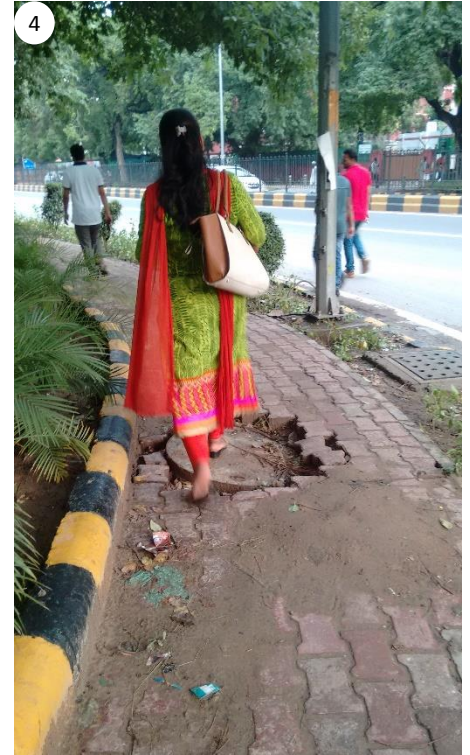
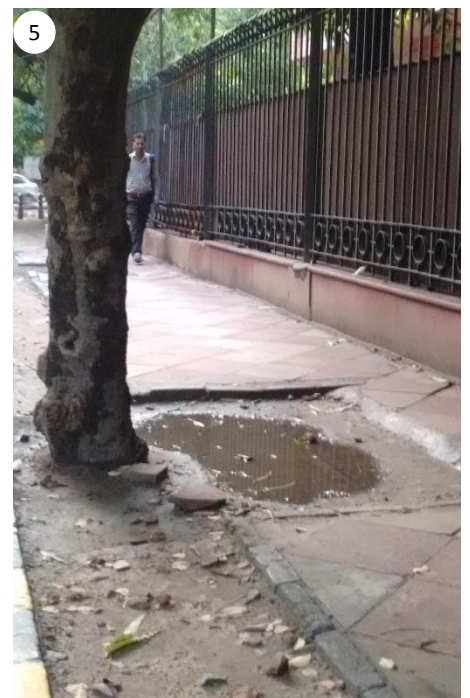
At some points, paving on the footpath were found to be broken as seen in Pic 4. The paving around manholes should be repaired and the manhole's cover should be flushed with the level of the footpath.

The footpath should be widened wherever tree obstructs. If the case is as seen in Pic 5, paving around trees should be done with perforated pavers, thus providing an even footpath for the pedestrians.

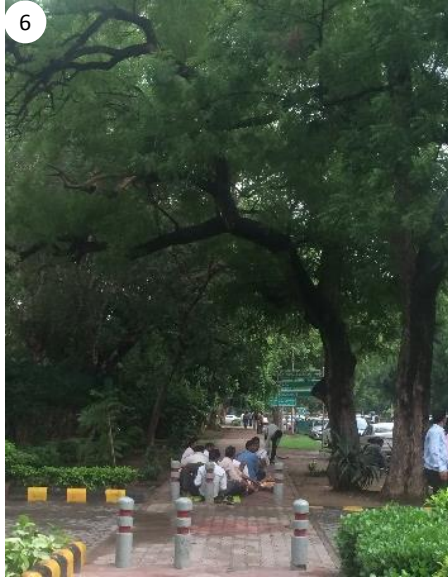
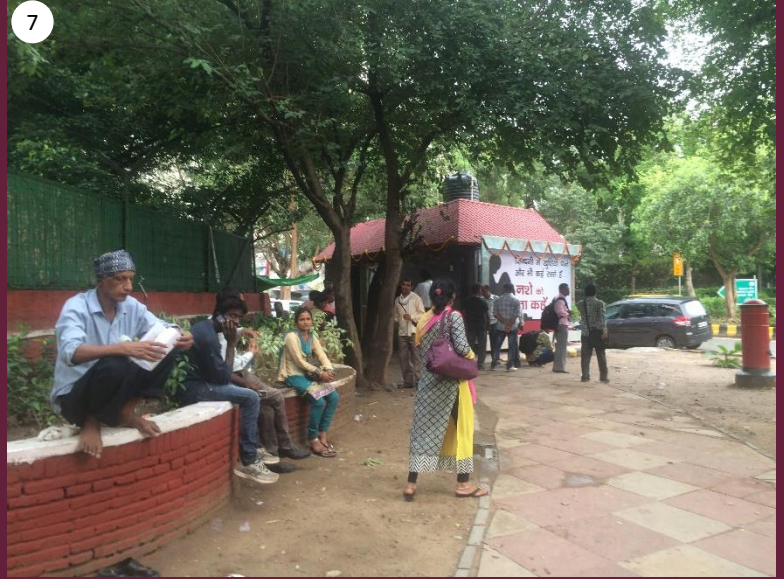
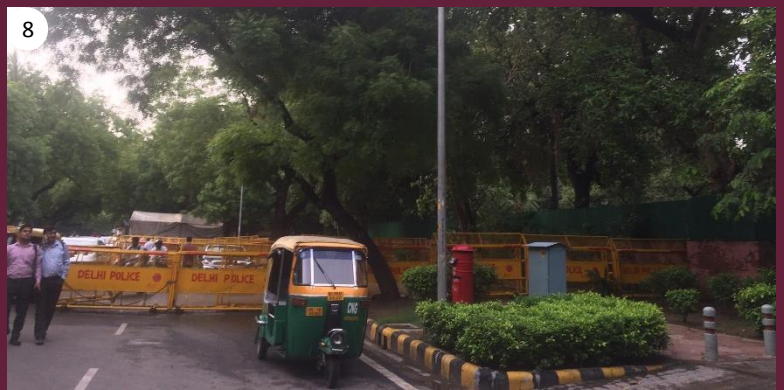
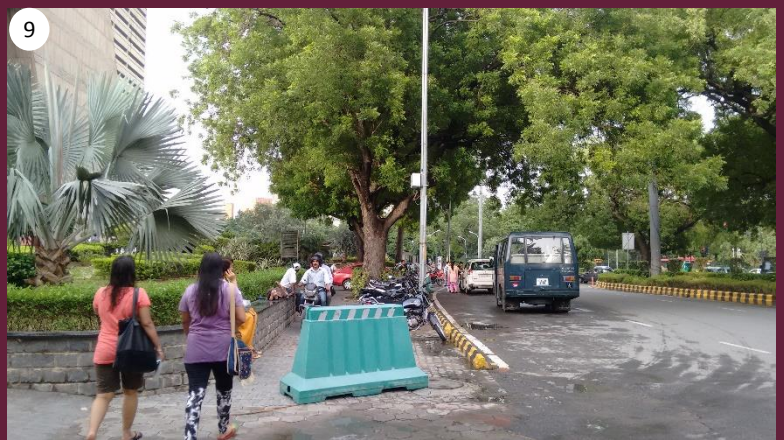
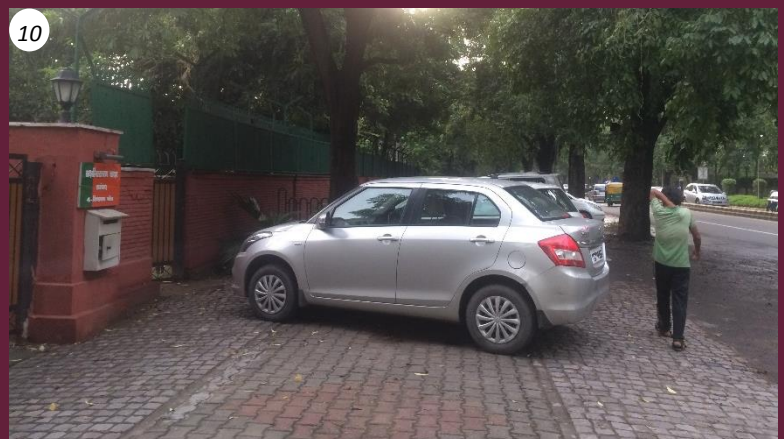
Area around Jantar Mantar Road is known for public meetings, protest march etc. One can see people waiting on the footpath outside officials' residence as seen in Pic 6 and 7. Also, at some points the footpath is blocked using barricades (Pic 8). Pedestrians are forced to walk on main road. There should be street furniture provided in the green belt, clear of the footpath for the people, and space should be provided to keep the barricades, when not in use.

The footpath should be kept clear of any obstruction. As seen in Pic 9 and 10, vehicles obstruct the pedestrian path at some audit points. Separate space should be provided for vehicular parking. To reclaim the footpath seen in Pic 9, a footpath should be constructed, raised at a level, clear of any obstruction.

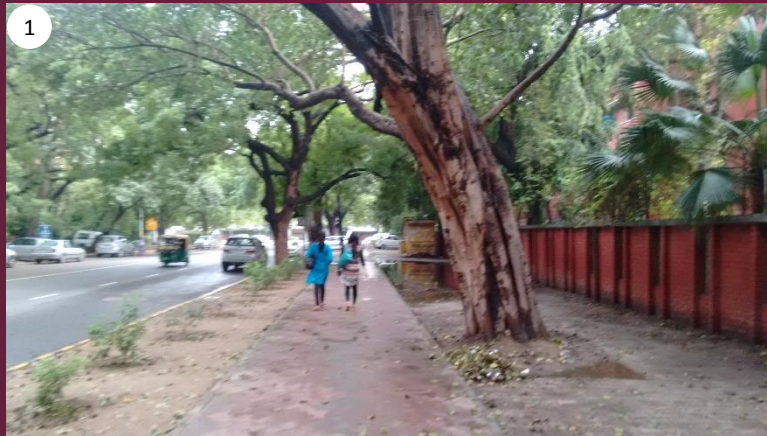
Seen in Pic 1 and 2, high boundary walls and shrubs limit visibility on the streets. The opaque part of boundary wall should be maintained low just like other public buildings in this area. The height can be achieved using grills. Alternatively, a hawker zone can be set up in the green belt outside institutions like Youth Hostel as seen in Pic 1. Seen in Pic 2, the shrubs along road side should be pruned and their height should be maintained at 1 m.

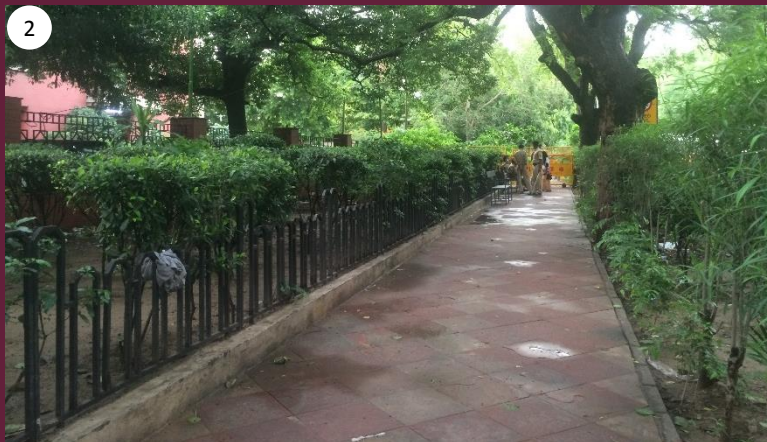
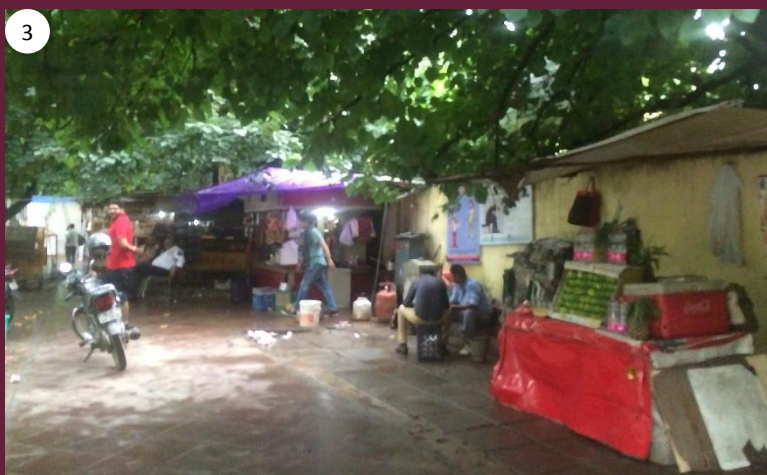
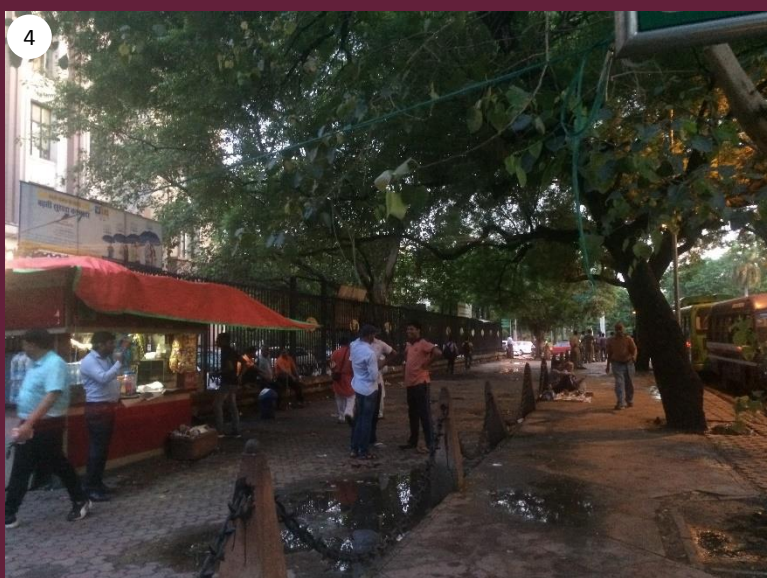
As mentioned before, Jantar Mantar Road is frequented by people for public gatherings. Several hawkers and kiosks can be seen along this road (Pic 3). Similarly, vending kiosks can be seen in front of government offices as seen in Pic 4. These spaces need to be developed as designated hawker zones. With proper lighting and street furniture for people and vendors alike, these spaces can be enhanced. Public convenience should also be provided. Separate space should be provided for vehicular parking (Pic 3).

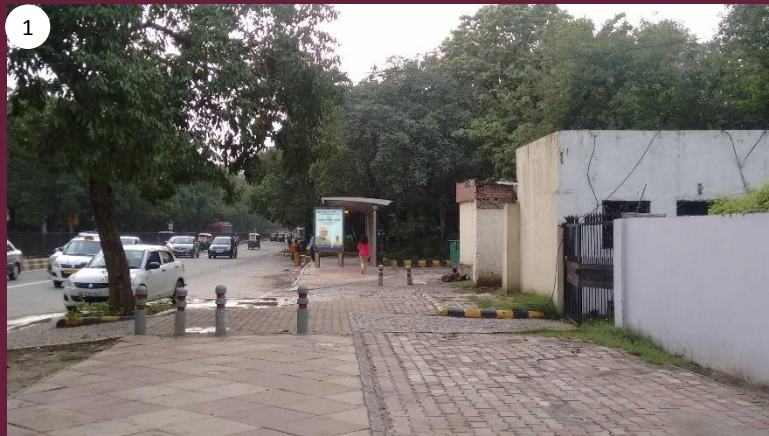
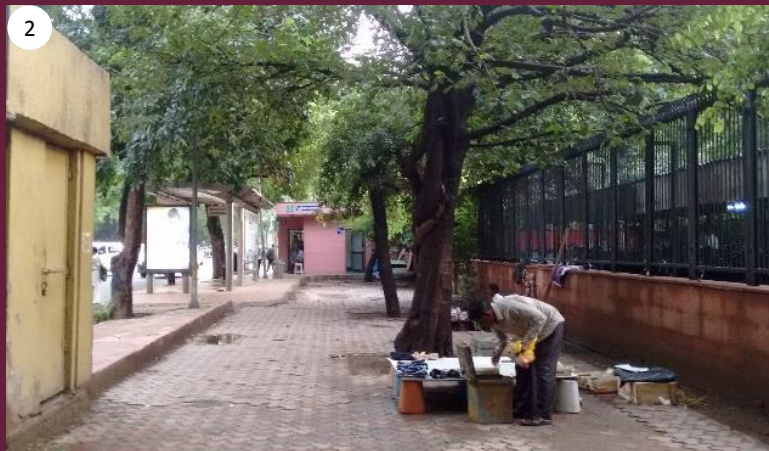
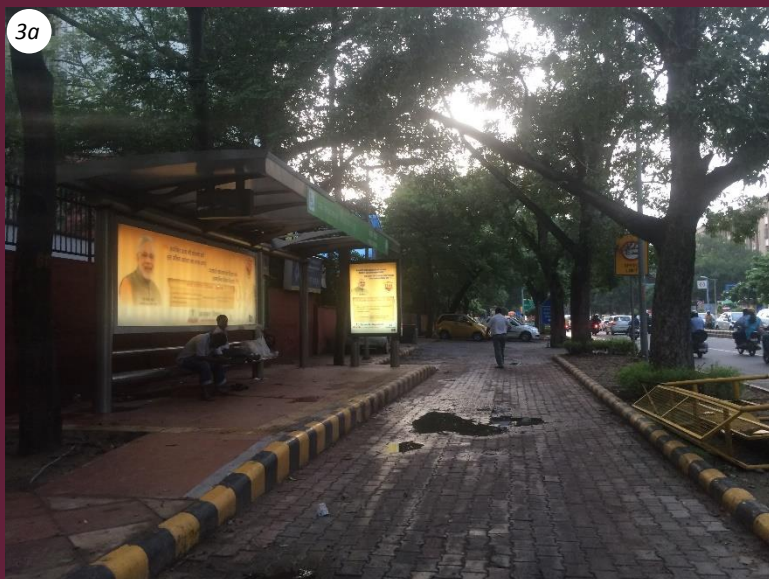
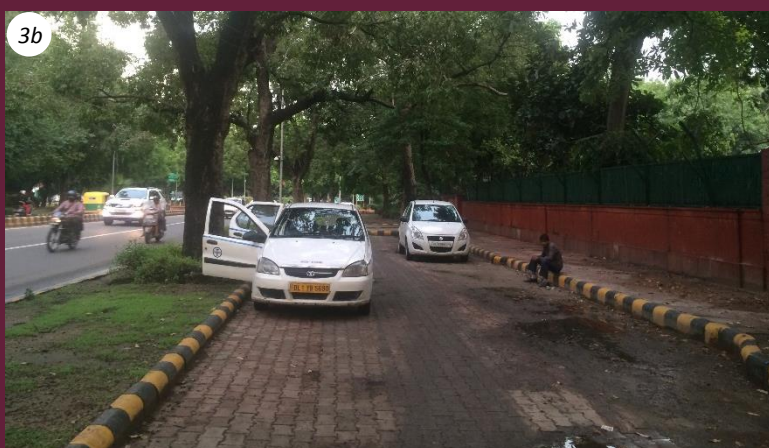
In addition to metro station, bus stops should also have designated parking space for auto rickshaw and taxi. As seen in Pic 1 and 2, the space near the bus stop can be used to set up a para transit stand. The unused service lane seen in Pic 2 can be set up as a hawker zone. The vending kiosks should be set up along the boundary wall, clear of the footpath. Further along this stretch, there is a functional public toilet. Adding streetlights and street furniture for the vendors and commuters would enhance this space.

Seen in Pic 3a and 3b, entry/exit to this bus lane on Ashoka Road is occupied by taxis. As a result, buses are not able to enter their designated lane, instead stop on main road. Vehicular parking should be disallowed in the bus lane and a para transit stand should be set up for auto/taxi. Also, the advertisement board at the bus shelter hinders pedestrian movement on the footpath. The board should be removed and a ramp should be constructed ensuring smooth transition to the footpath.
