# **ENHANCING LAST MILE CONNECTIVITY**

a safety analysis of the Rajiv Chowk Metro Station

This Report has been prepared as part of the Project being undertaken with NDMC to Enhance the Last Mile Connectivity along the metro stations within it's jurisdiction. The safety audits were conducted by Smt. Anshu Gupta and Smt. Veena, architects from NDMC along with Safetipin team.

# Rajiv Chowk

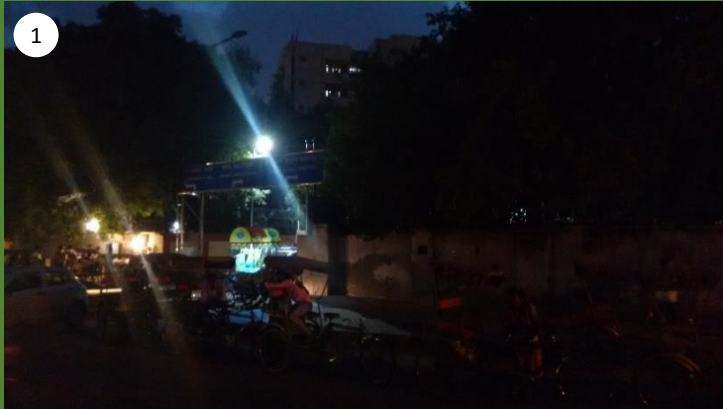
Chelmsford Road intersection

The shown photographs indicate the reasons for poor lighting in certain areas. Entry points of buildings and hawkers ensure proper illumination around them but adjacent areas continue to be poorly lit. The existing streetlights need to be made operational and at places additional streetlights are needed. These should be low-height pedestrian scale lights to ensure no obstruction from foliage. The lighting along the Middle Circle was comparatively poor at certain points. Also all Public Conveniences need to be well lit on all sides. Along some the entry was lit only by light coming from inside.

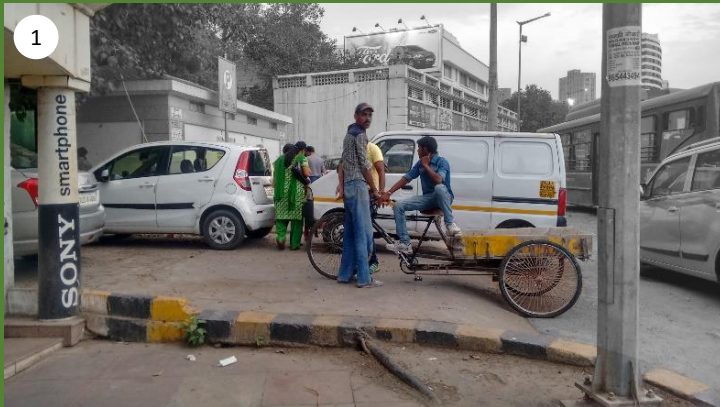
*The pavement and table top need to be properly flushed with a ramp to mitigate the level difference and ensure smooth pedestrian movement. All wires and drain pipes need to be underground and not be protruding onto the pavement as is seen here.*

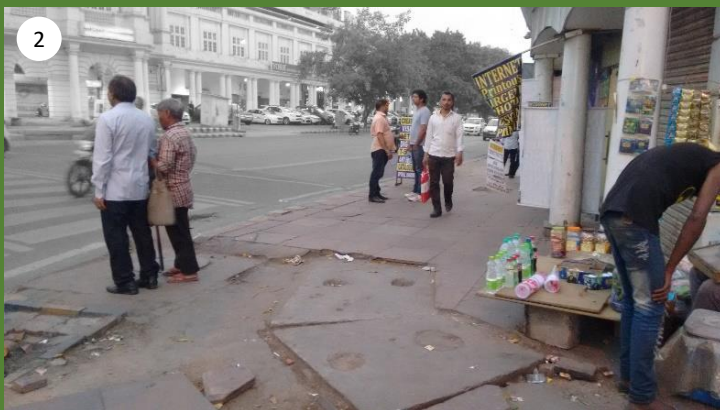
*The manhole covers need to be properly flushed with the pavement surface. Tactile paving also needs to be provided throughout the length of the pavement. This too should be unobstructed and continuous. The junctions (of the pavement and zebra crossing) need to have ramps.*

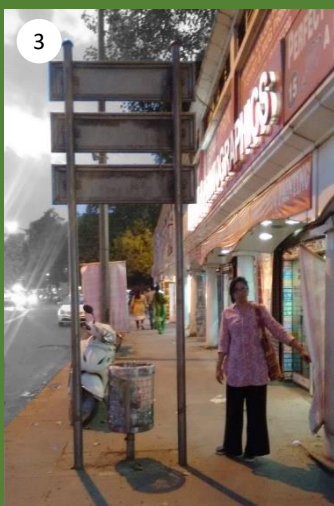
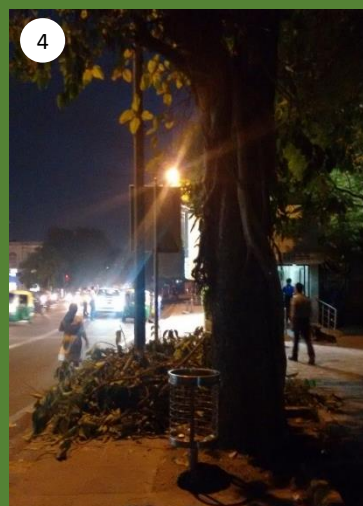
*The dust bins and signages need to be located clear of the walking space. Their current location hinders movement especially for people on wheelchair. Regular pruning of trees is essential to ensure there are no low hanging branches. Garbage and other such waste should not be left on the pavement and be cleared immediately.*

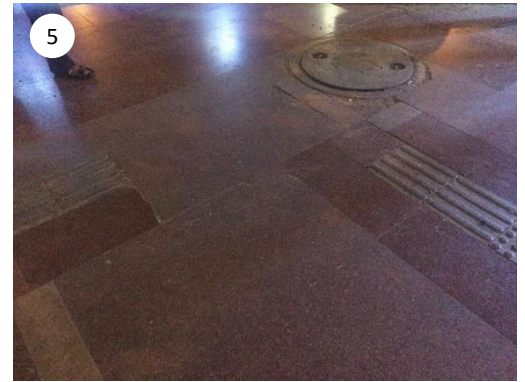
*Tactile paving has been provided in certain areas in the Inner Circle. Currently this is only at some places and is also discontinuous. This needs to be continuous with proper detailing at intersections.*

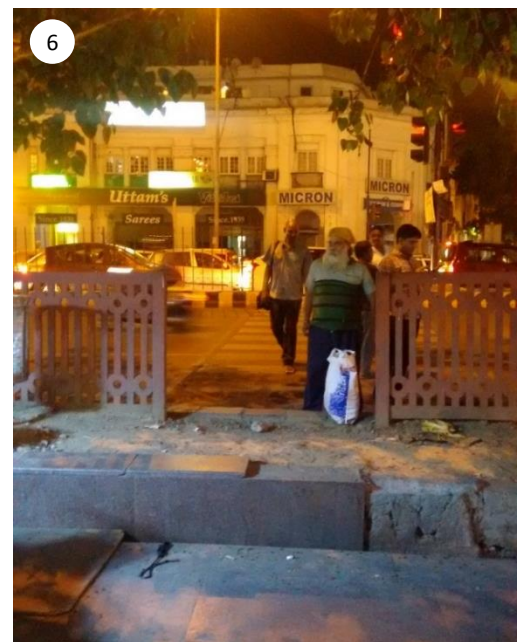
*The footpath needs to be at level with the zebra crossing and the plaza paving to which it connects. The pavement need not be at a higher grade but at the same level connected via a ramp.*

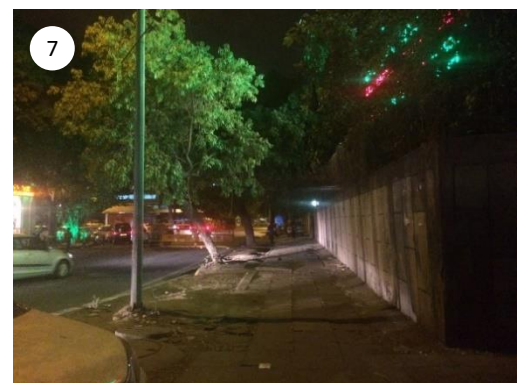
*The pavements are broken in many areas making walking uncomfortable. These need to be repaired.*

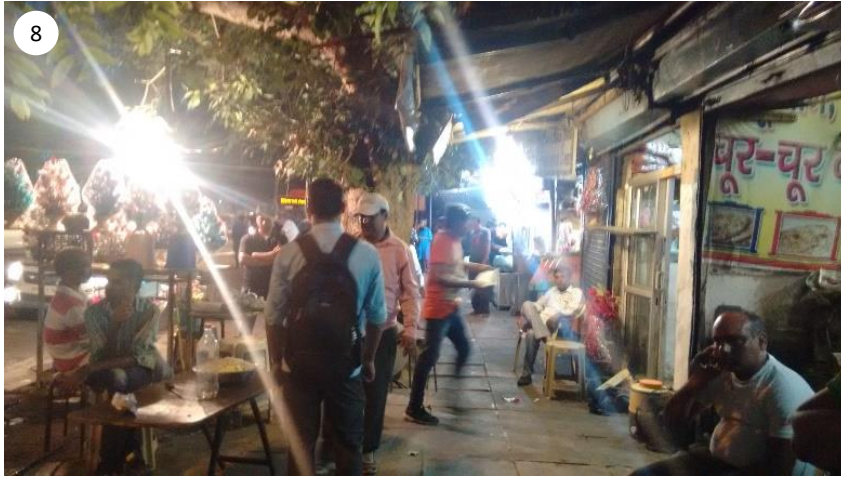
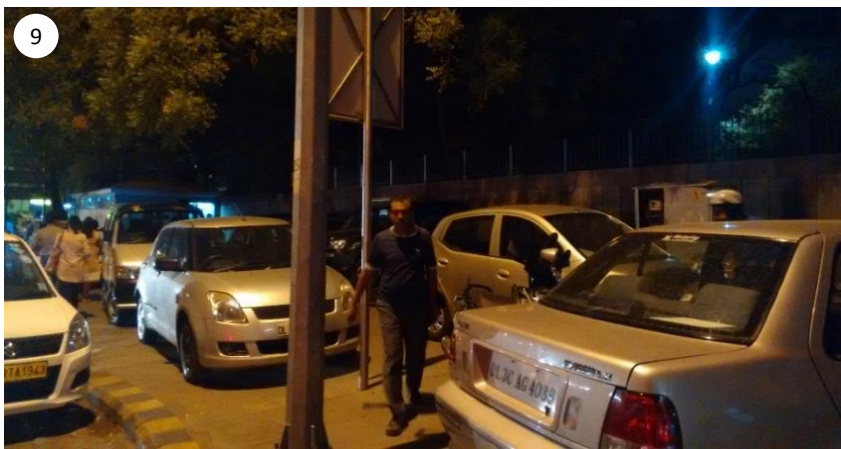
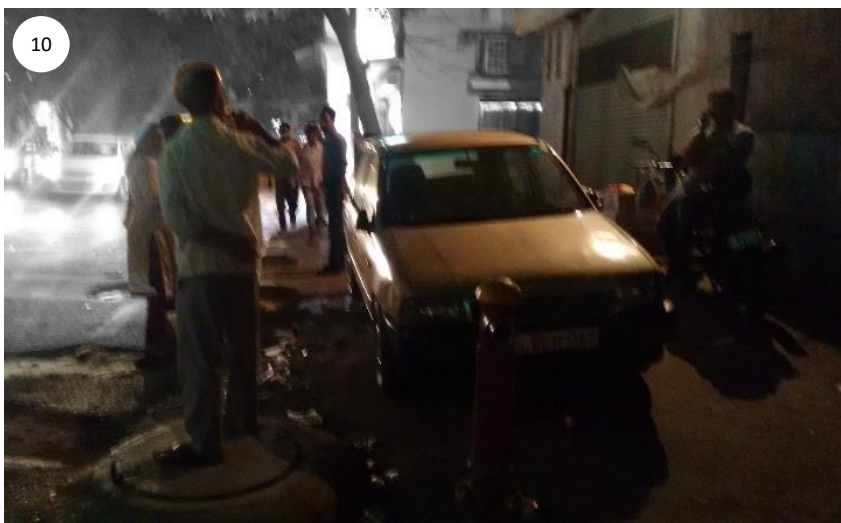
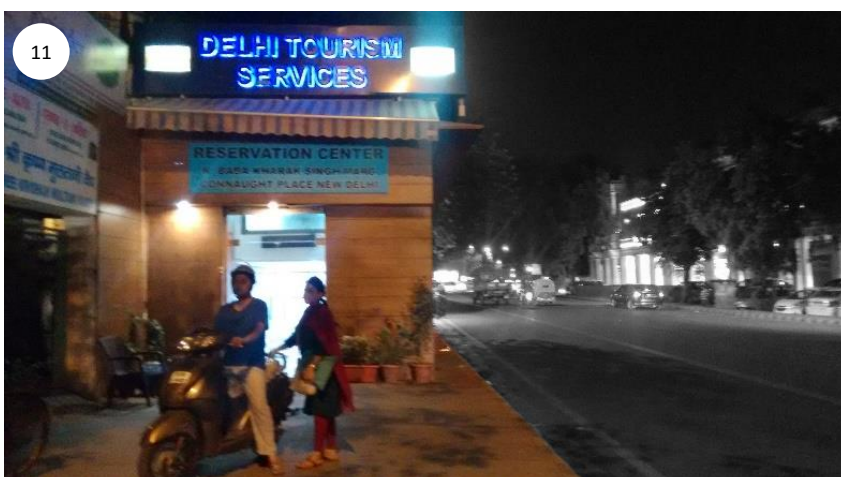
Many vendors are seen at some locations along the Circles as well as the radials offering the much needed eyes-on-the-street. However, due to the absence of a proper designated zone, they are currently occupying the pavement. While this introduces the much needed activity along the stretch, for pedestrians they are an obstruction. The pavement needs to be widened. Proper space needs to be designated for vendors along the built edge such that the pedestrian walkpath is unobstructed.

At many locations vehicles are seen parked on the pavement forcing people to walk along the vehicle carriageway. This also damages the pavement in the long run making it difficult to use when vehicles are not parked on it. The area has designated vehicular parking and vehicles must not be allowed to park on the pavement. The parking zones should be well lit and have public convenience and street furniture especially for the use of drivers.

At many points small structures, like the Delhi Tourism Office seen in pic 11, are located on the pavement leaving no space for pedestrians. No such structures should be constructed in the future. In the locations that they currently exist, these should either be removed or the pavement be widened to ensure there is continuous walking space for the pedestrians. Infrastructural elements like electrical units should also be re-located so as to leave clear walking space.

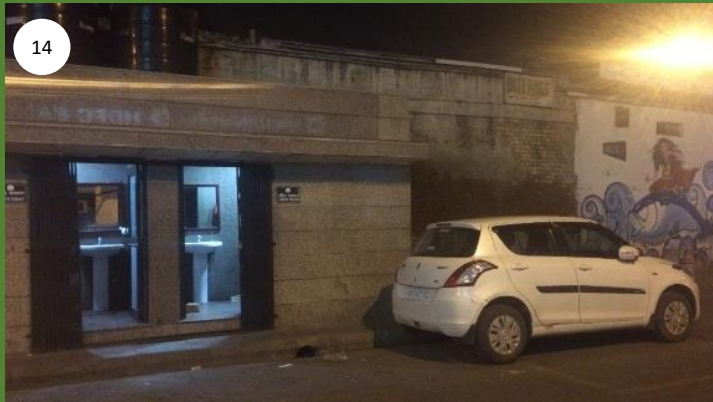
*The Public Conveniences provided along the Middle Circle currently sit facing the road making it difficult for women to both use and cross them. Also, along these toilets the pavement either doesn't exist or is too narrow. A wide pavement needs to be built. The design of these toilets should be changed such that the entry is from the sides. This would not disrupt the pedestrian movement or cause discomfort to the female users. Also, a handicap toilet needs to be added to these.*

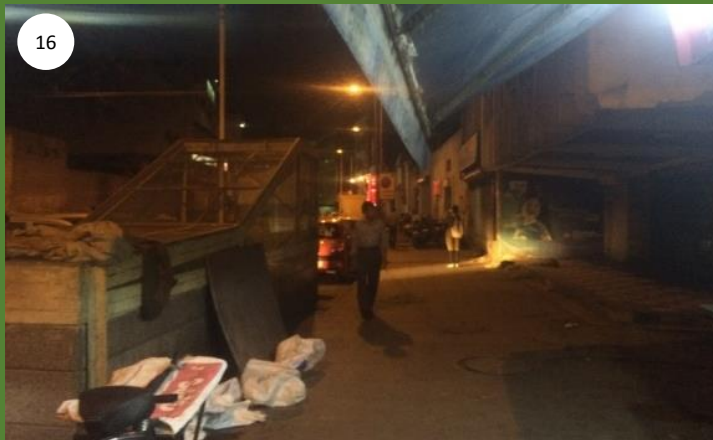
*Seen in the pic above is a footpath which ends at the built façade. A pavement needs to be built along the building edge such that it is continuous and free from any obstruction. Encroachment needs to be removed and the public right-of-way should be reclaimed. Also seen is the staircase for the Utility Tunnel of the Middle Circle. These service elements result in the creation of a negative space along its edges. Such areas can be used to provide street furniture and other amenities especially for the staff, drivers and for the floating population. It can also be landscaped (as seen below) to create a positive space.*

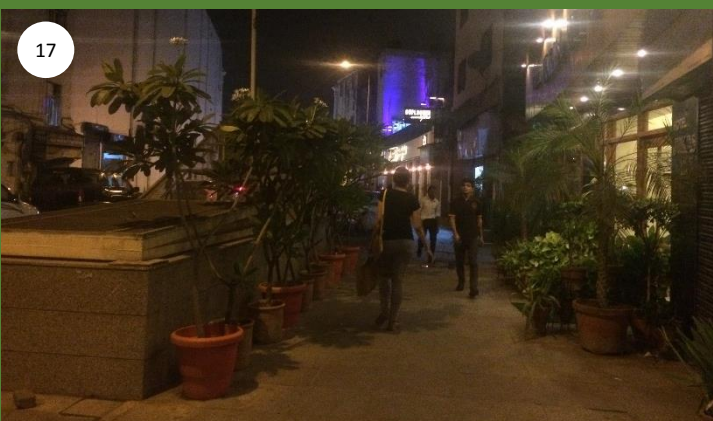
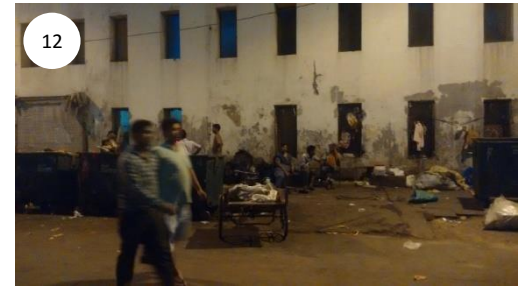
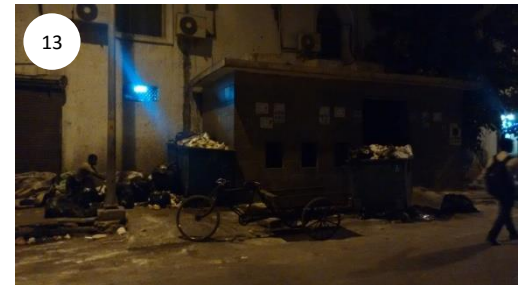
*Seen above is the absence of any pavement along the Middle Circle. The lane has many public toilets and garbage collection points. However, in the absence of regular garbage collection, the garbage is strewn all over the area. Hand-drawn carts are also used which are parked along the road due to lack of proper designated space. The garbage collection needs to be streamlined so as not to cause inconvenience to the people. A proper pavement needs to be built, free from any obstruction and disabled-friendly. Also, street furniture needs to be provided clear off the walking space. Currently the maintenance staff and drivers are forced to squat on the garbage itself.*

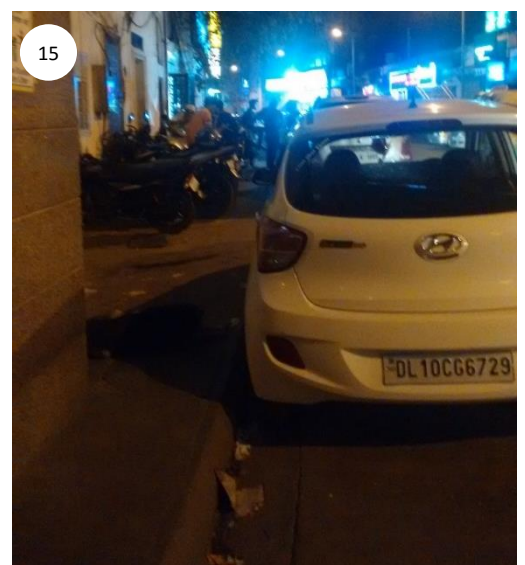
*At locations where the pavement exists, it is too narrow for people to comfortably walk on. Vehicles parked on the pavement further add to the woes of the pedestrians.*

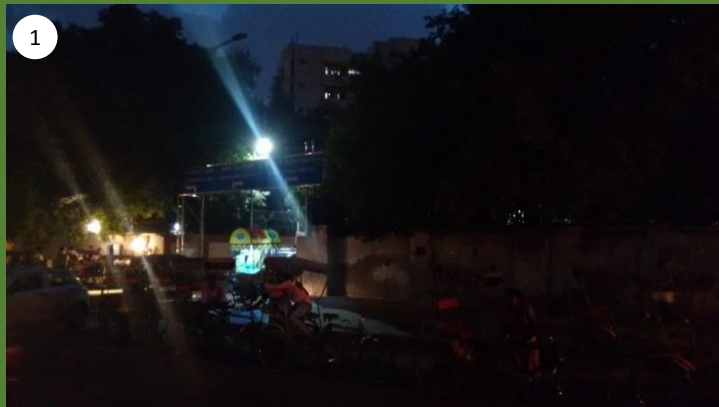
Chelmsford Road intersection

Many stretches of the Outer Circle are defined by huge boundary walls which offer no eyes-on-the-street. At the entry gates of a building, there are a few hawkers along with cycle-rickshaws and auto-wallahs. But largely the periphery offers low visibility. Hawker Zones should be created at the entry gates along with para-transit stands. These should have Public Convenience and street furniture.

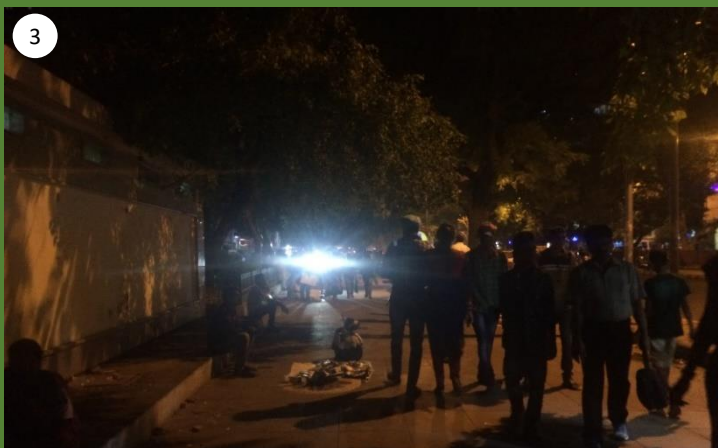
Sansad Marg

Also seen in some parts of the Outer Circle, are hawkers squatting on the pavement in the absence of a designated space. The Outer Circle has wide pavements which can easily accommodate a Hawker Zone leaving comfortable walking space for pedestrians. These should have a Public Convenience along with adequate street furniture. Seen below is a Public Convenience along which a proper hawking zone can be created.

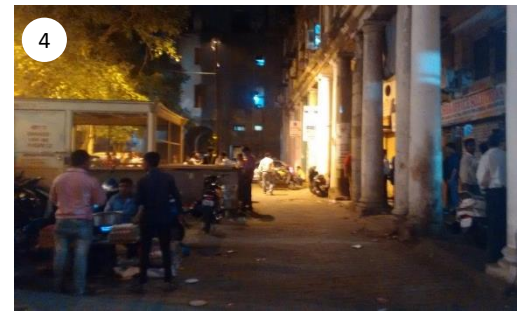
Plaza connecting Middle and Outer Circle

Certain parts like the plaza connecting the Middle and Outer Circle should be pedestrianized with space for hawkers. No vehicle should be allowed to enter or park in this space. Separate parking zones exist already.

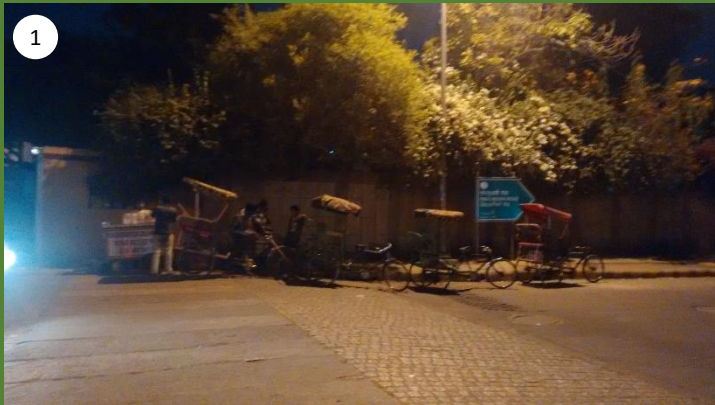
Cycle rickshaws are seen parked along the radial intersections. No proper stand exists for them currently. A para-transit stand should be created at intersections for all the various modes – autos/taxis/cycle-rickshaws. This should be well lit and designed with space for hawkers catering to the needs of the drivers and other floating population.

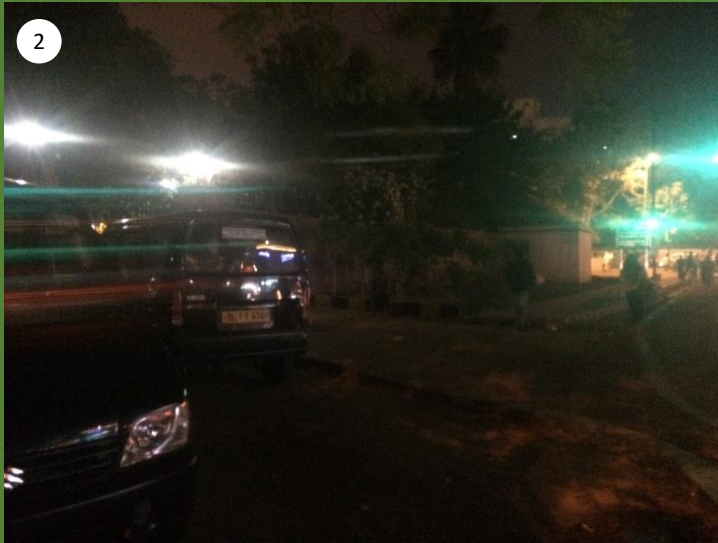
Para-transit facilities are available outside the entry gates of many building complexes. However, in the absence of proper space, the pavement is used for parking. As a result, the pedestrians are forced to walk on the vehicular carriageway. Proper stands should be created with the vehicular movement defined in a manner least disruptive to pedestrian movement and safety.

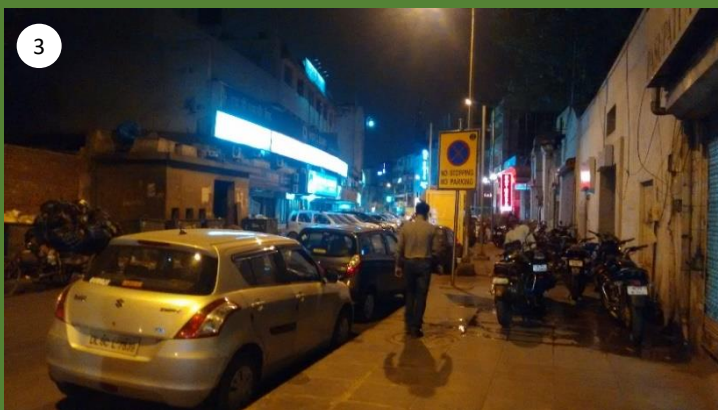
The Middle Circle has been designated as a 'No Stopping, No Parking' zone. However, vehicles are parked not only on the road but also the pavement. Strict enforcement of laws is needed. The public right of way needs to be reclaimed. The parking spaces available in the Inner Circle and Palika Parking should only be used.

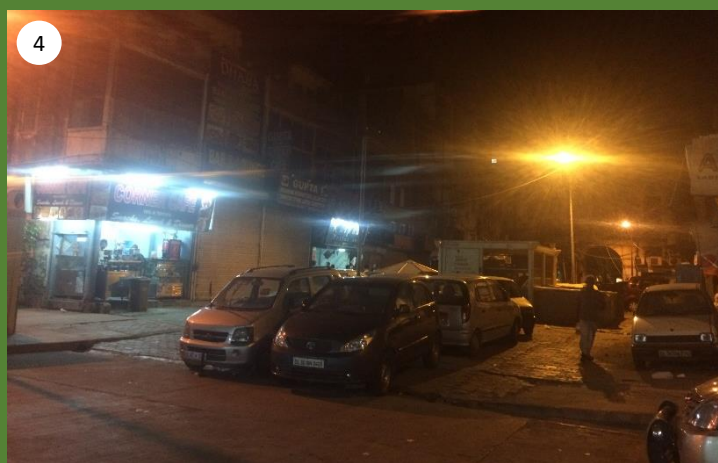
The plazas connecting the Outer and Middle Circle together is being used for vehicular parking in some areas. While there are food stalls and restaurants abutting this plaza, it is still being used for vehicular parking instead of a public space. The parking, if needed, should be restricted to a few locations such that the vehicular movement is towards the Outer Circle and does not interfere with the pedestrian/NMV zone of the Middle Circle. These should also include a para-transit stand and public facilities.
