ENHANCING LAST MILE CONNECTIVITY

a safety analysis of the Udyog Bhawan Metro Station

This Report has been prepared as part of the Project being undertaken with NDMC to Enhance the Last Mile Connectivity along the metro stations within it's jurisdiction. The safety audits were conducted by Smt. Nutan, architect from NDMC along with Safetipin team.

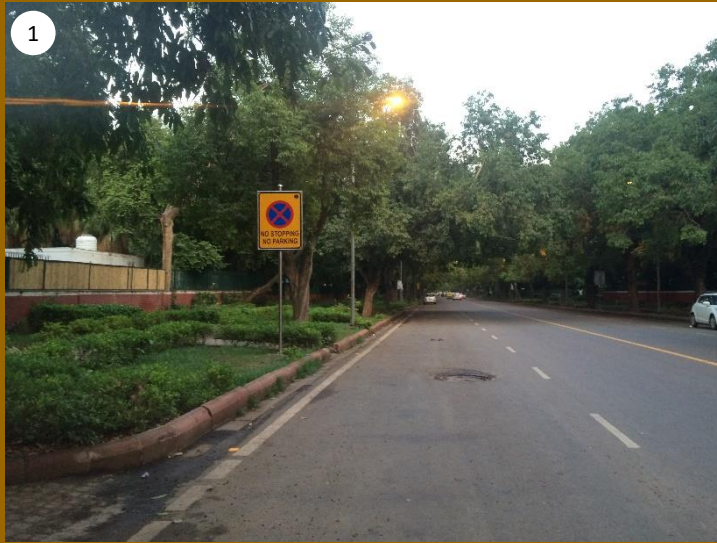
Motilal Nehru Marg towards Akhbar Road. Streetlights have been located only towards the vehicular carriageway and not along the footpath.

The streetlights have been provided along the road edge focused towards the vehicular carriageway. Also the dense foliage along these stretches casts dark shadows along the footpath. Reducing the height of the streetlight to a pedestrian scale and regular pruning of tree leaves will help ensure that the

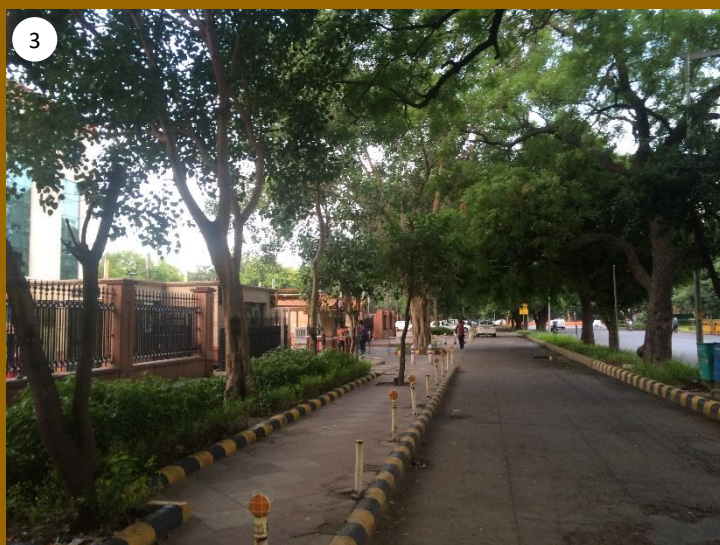
Maulana Azad Road. The footpath along the bus lane does not have any streetlights along it. The light from the building/entry gate or the streetlight towards the road is the only source of some illumination.

At locations having a bus lane, no streetlights have been provided along the footpath resulting in poor illumination. Streetlights should be added along this stretch. Also additional streetlights are needed in the parking areas outside the offices.

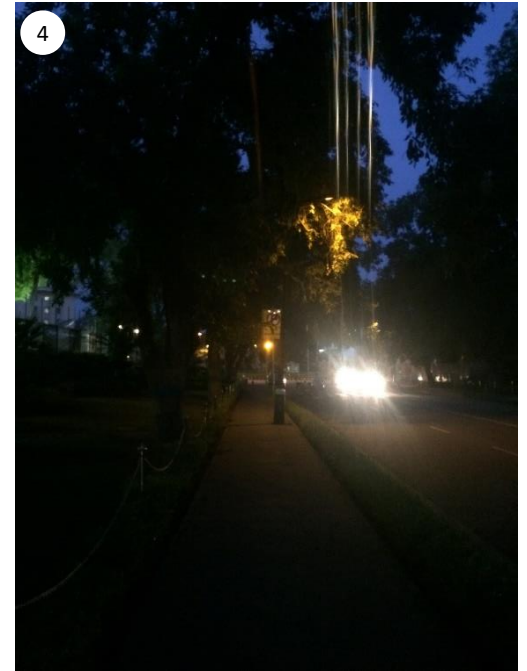
Along the points where there is a streetlight, the illumination was found to be high. However, as one moves away the brightness reduces. Strong shadows are cast by the foliage obstructing the luminaire. Regular pruning of tree leaves is essential. At points where there can be no further pruning, the height of the streetlight needs to be reduced such that it isn't obstructed by the foliage.

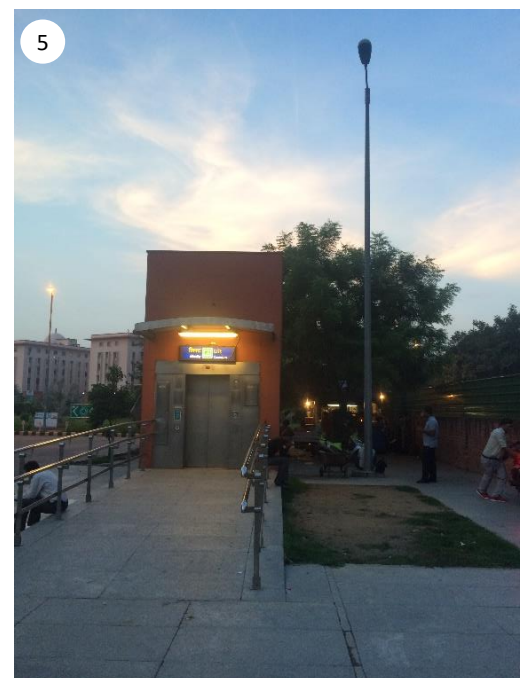
Some streetlights were found to be un-operational. Regular maintenance checks are essential to ensure that all streetlights are operational at all times.

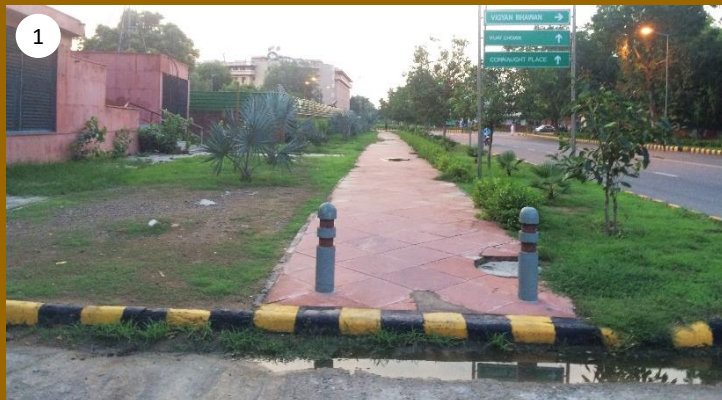
Motilal Nehru Marg towards Akhbar Road. The footpath should have a ramped interface with the road.

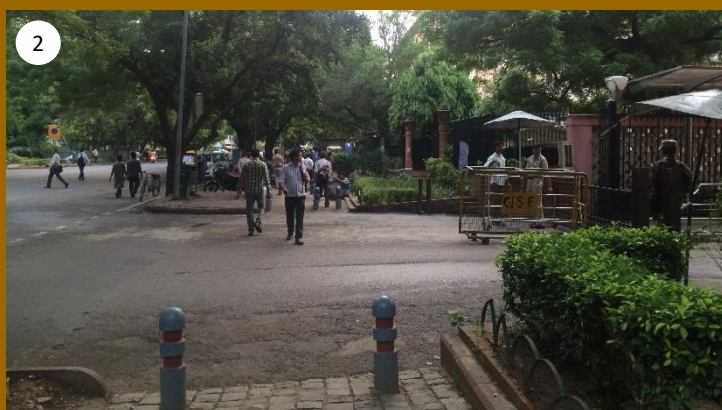
Maulana Azad Road. A table top should be created especially along the entry gates of all buildings, such that pedestrians are able to cross comfortably.

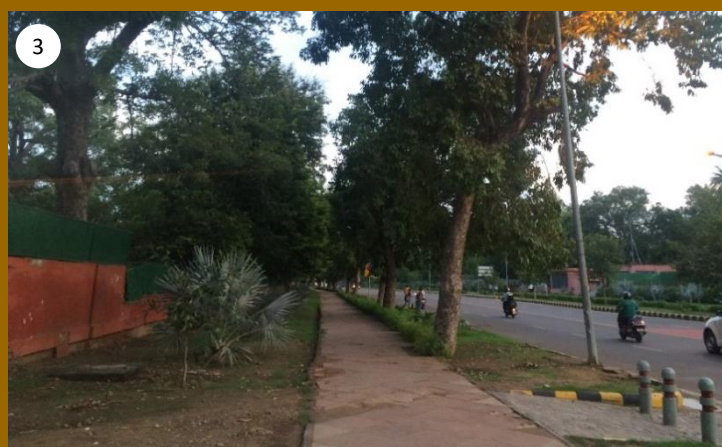
Motilal Nehru Marg. The road has a footpath and a ramped egress. But the bollards at the edge prohibit movement of wheelchair. While the bollards are necessary to prevent entry of vehicles, they should be placed so as to allow smooth movement of pedestrians and people on wheelchair. Also tactile paving needs to be incorporated along the entire length of the footpath including the ramps.

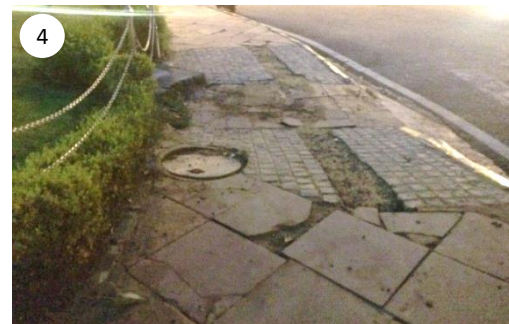
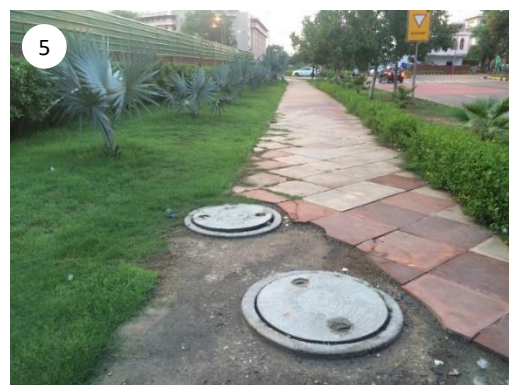
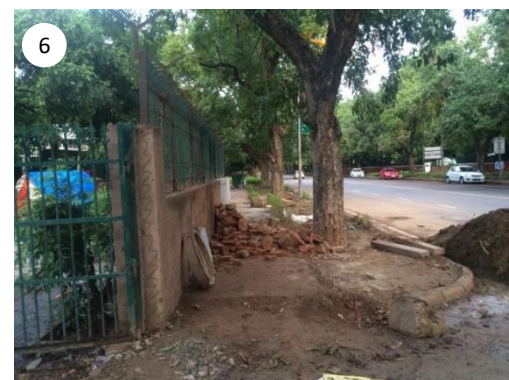
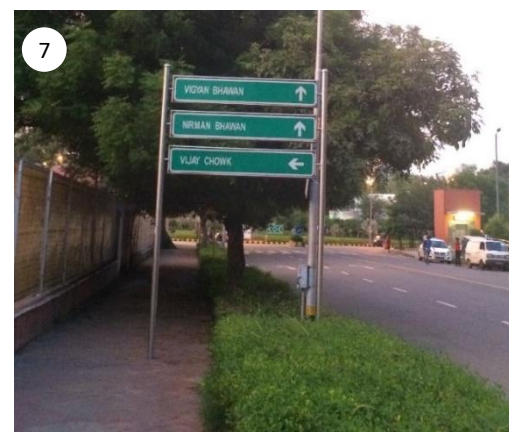
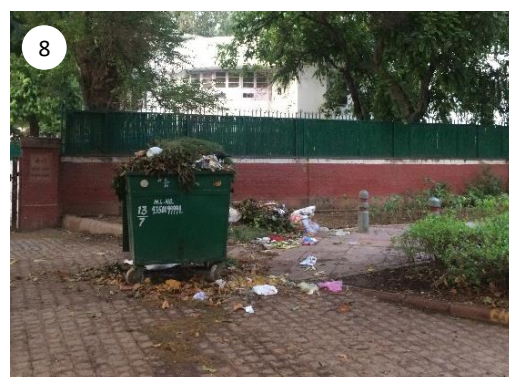
Shown on the right are different types of obstructions that were observed in the study area. The footpath should be continuous with no obstructions throughout its length. At places where it is broken it should be repaired and maintained thereafter.

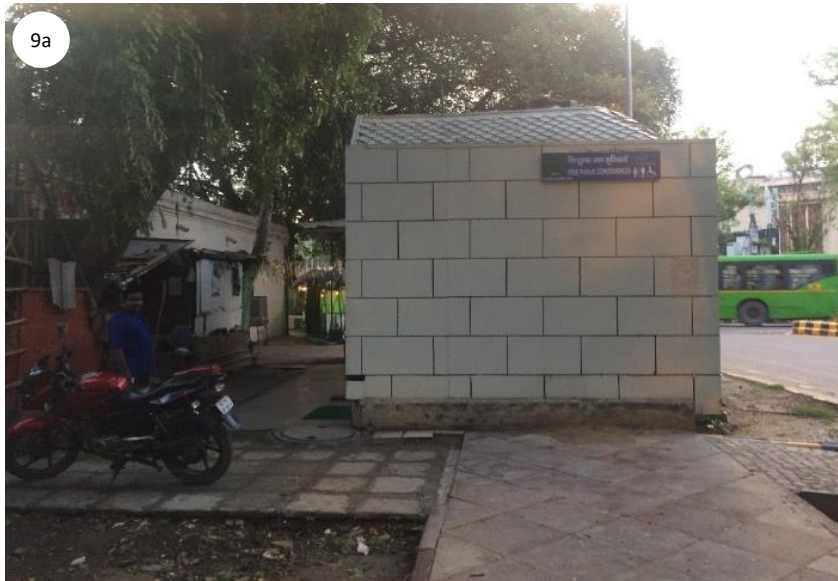
Shown on the left is the situation along the Dargah Sharief Sunahri Baba road turning. A Public Convenience is located adjacent to it. While both the functions are important, it is necessary that they be well integrated spatially so as not to disrupt the pedestrian movement.

The Public Toilet has been located completely obstructing the footpath. A ramped egress is provided on one side and the entry to the toilet is from the other side where the path merges with the Dargah. Also vehicles were seen parked along the footpath.

The Dargah and its activities occupy the entire footpath. As a result people are forced to walk on the vehicular carriageway. While proper street furniture has been provided for the devotees, it is equally important to ensure that these activities do not affect the pedestrians who are currently at risk especially since the road takes an acute turn at this point.

Therefore, along such areas the footpath has to be widened. This will result in modifying the traffic movement and the traffic island along the median may have to be removed as well. This will not disturb the activities of the Dargah and the pedestrian movement can happen comfortable adjacent to it. The entry to the Public Toilet will remain as such. Also, tactile paving needs to be incorporated throughout the stretch even along the path leading to the Public Toilet.

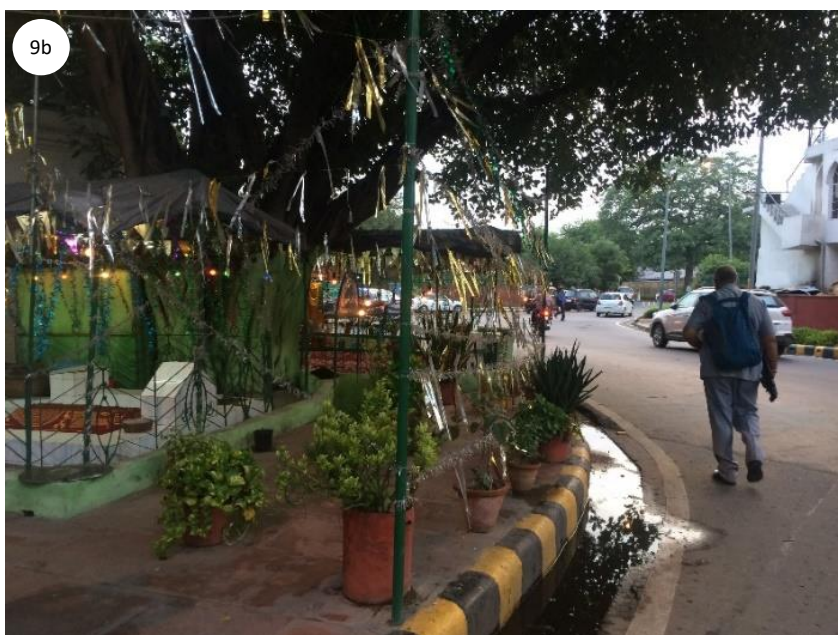
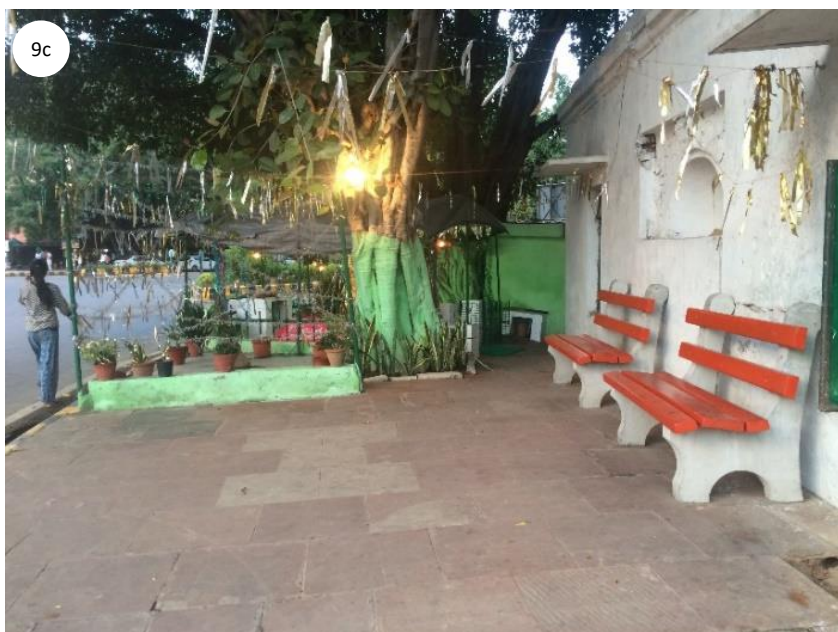
Along Sunheri Bagh Masjid round about

Also, it was observed in some locations that vehicles were parked along the footpath. At certain places like the unused entry gates to buildings, the area in front was being used for parking. This disturbs the pedestrian movement. At such points a table top needs to be created so that the people can walk comfortably and cars can be parked on the ramp if needed. Ideally Parking Zones, like the one across from the National Museum, should be created at regular intervals.

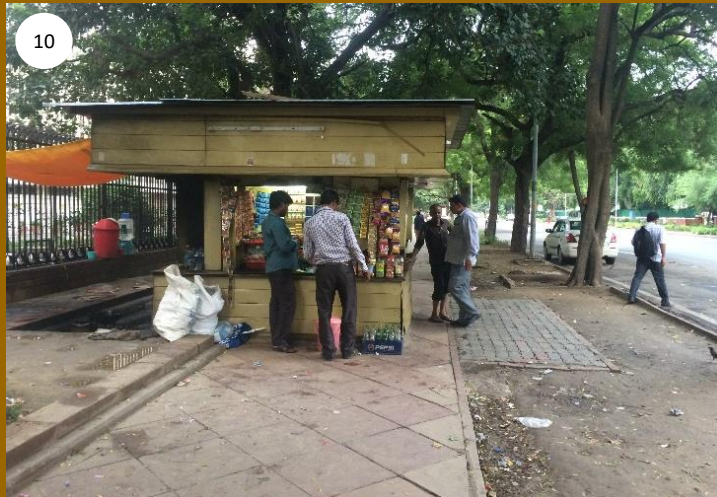
Many hawkers are seen outside Udyog Bhawan catering to the office-goers. At some places there is space for them clear of the footpath. However at few points (as shown above) the stalls occupy the footpath forcing the pedestrians to walk on the supposed-to-be green belt. At such places the footpath should be widened so as to ensure its continuity. The width of the green belt would be reduced in this case.

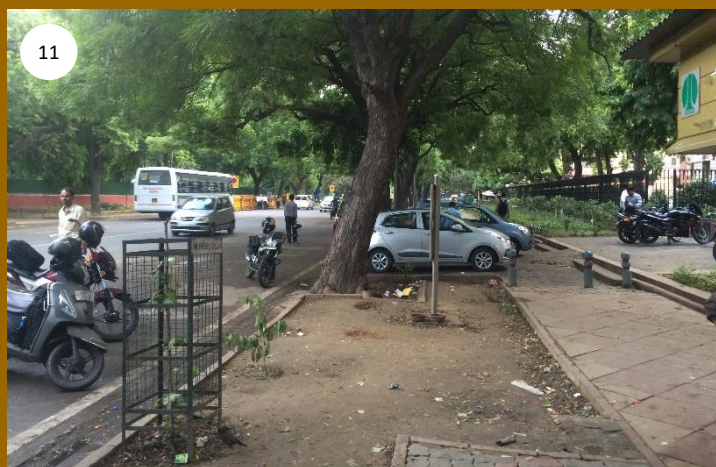
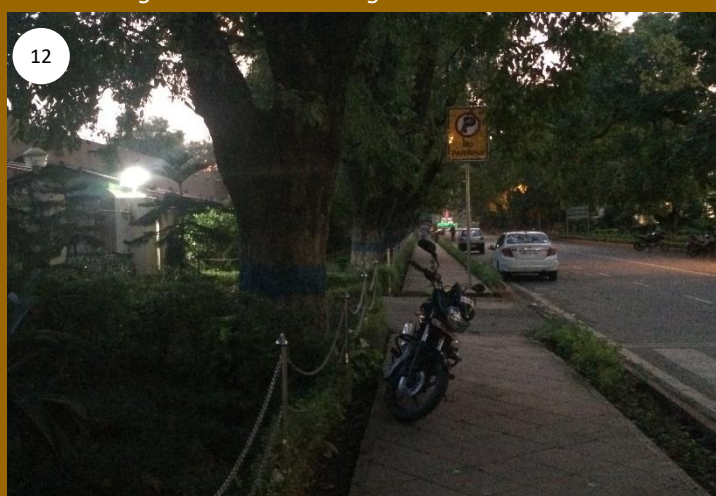
Seen above along Maulana Azad Road and below along Motilal Nehru Marg, vehicles have been parked either along the footpath itself or adjacent to it such that the pedestrian movement is affected. Vehicles were seen parked even in areas designated as No Parking zones.

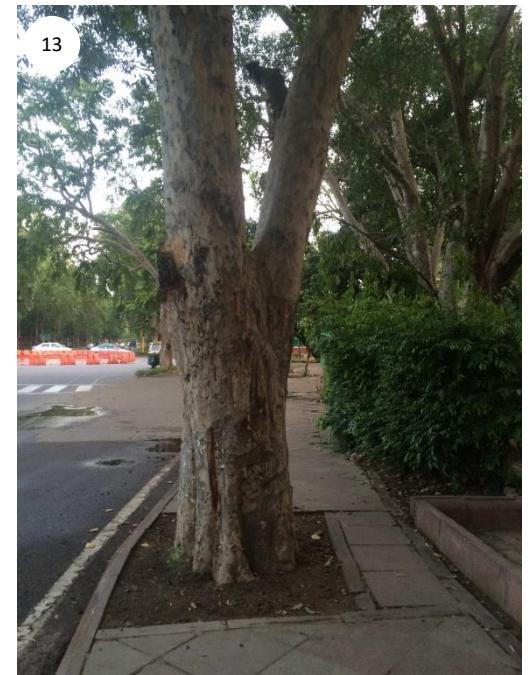
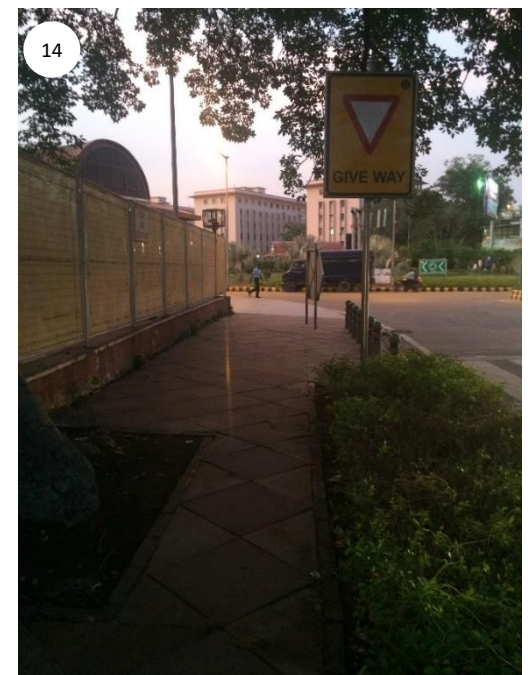
Shown in the pics above are locations where the footpath width is reduced owing to the present foliage. At such points where there is an existing tree the footpath has to be widened enough to ensure clear space for the movement of a person on a wheelchair. At points (as seen in pic 14) where there is a green belt as well, there the footpath can be widened by reducing the width of the green belt.

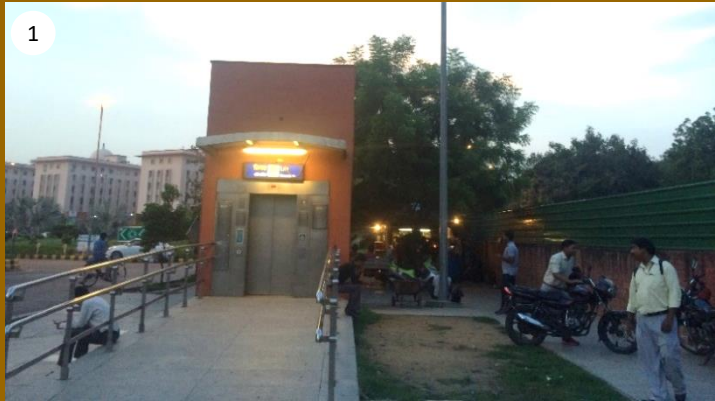
1
Entry/exit to the Metro Station. There is a food stall located along it clear of the footpath. However due to lack of street furniture people were seen squatting along the ramps and staircase. As seen above there is space along the boundary wall which is currently being used for vehicular parking. Developing this strip with seaters and stalls will increase the activity here. Provision for a Public Toilet also needs to be made and the entire stretch should be well lit. The green metal sheet on the boundary wall should be removed.

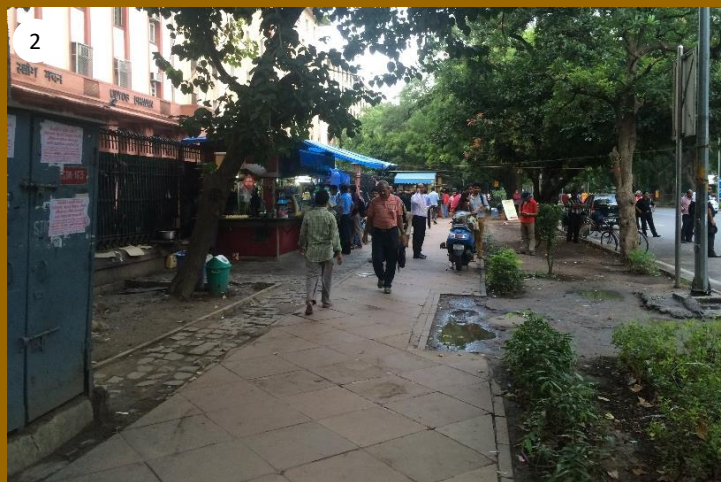
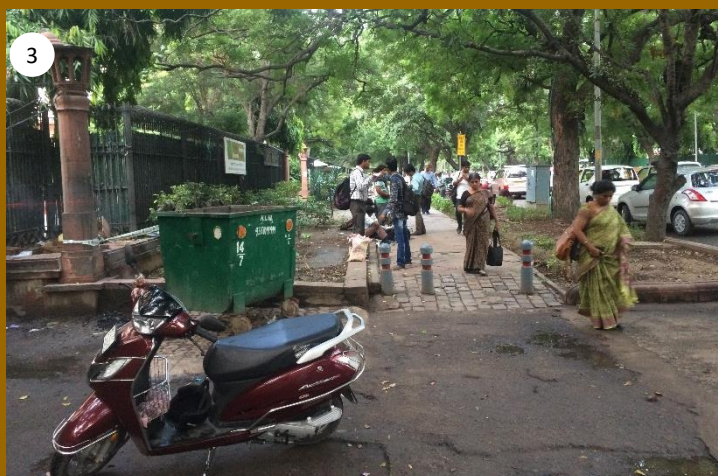
2
3
Food Stalls are located outside Udyog Bhawan but there is no provision for people to sit and enjoy. As a result people do not tend to linger around. The stalls are located clear of the footpath. Street furniture should be incorporated along these stalls. This will help keep the area active.

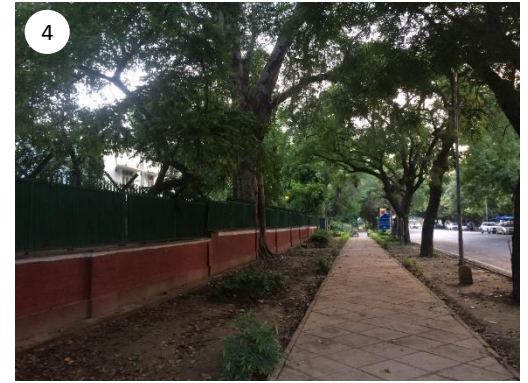
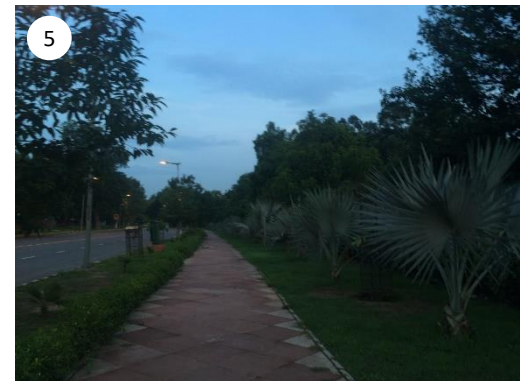
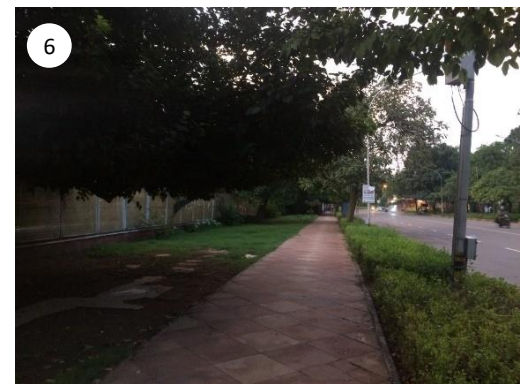
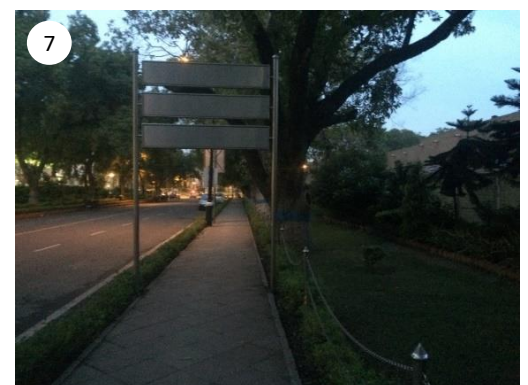
4
5
6
7
The radials in this area all have a inactive edge defined by a blank boundary wall and vegetation. The opaque part of these walls needs to be limited to a height of 1m and the remaining height should be achieved by a grill. The grill should not be covered by foliage or a screen and transparency must be maintained. Street furniture should be added along the green belt.

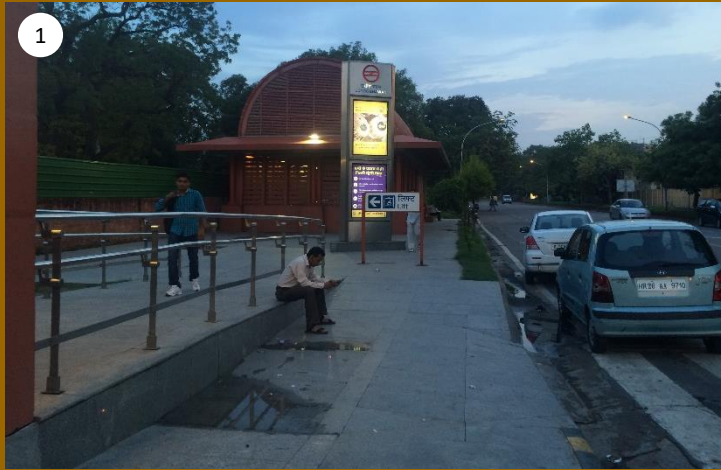
The ramps along the metro station entry/exits do not have any tactile paving for the movement of the visually impaired people. This needs to be incorporated and also provided along the entire length of the footpath. The same needs to be provided along the bus stops as well. The tactile paving should be unobstructed throughout.

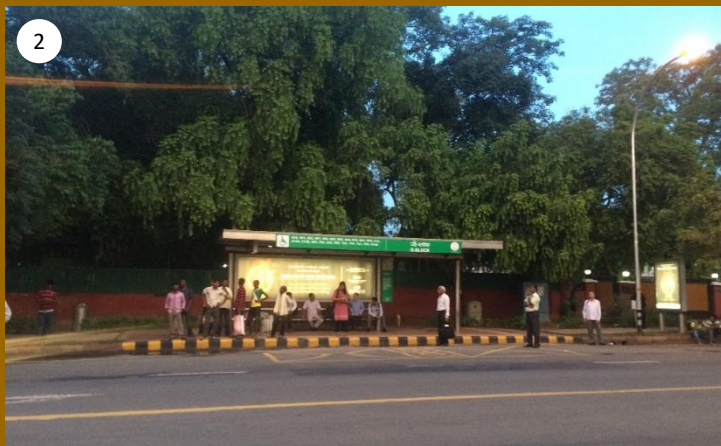
Seen in pics 2 & 3, bus stops have been provided throughout the study area. However, the seating capacity is inadequate forcing people to stand on the road. Street furniture needs to be provided along the bus stops. A para-transit stand also needs to be established along the bus stops. Currently very few para-transit facilities are available from the metro station and bus stops. The problem is more pronounced in the late evening hours. As a result it is difficult to hail these facilities.

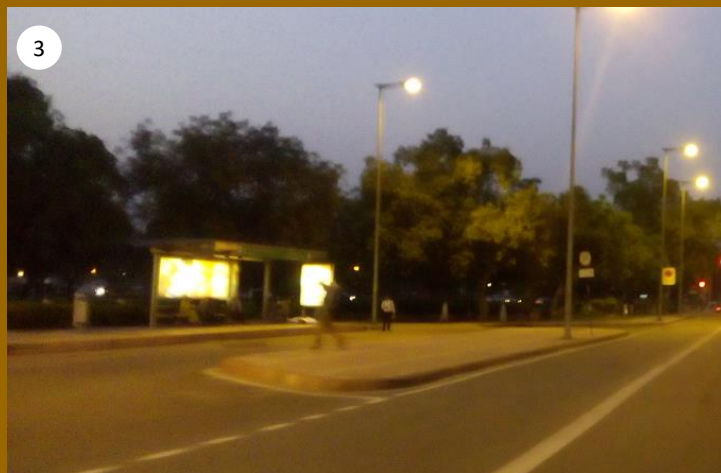
The para-transit stands would also have a Public Convenience facility for the commuters as well as the drivers.

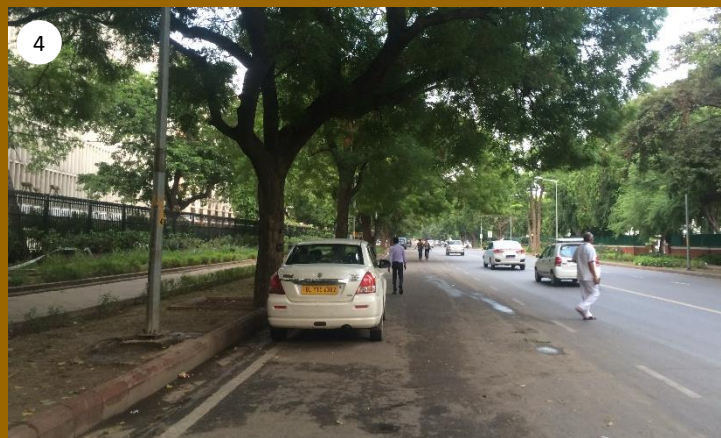
Taxis were spotted waiting on the road for passengers. Establishing dedicated para-transit stands will make hailing these services more convenient for the passengers as well as the drivers. These stands should be well lit with convenience facilities for the drivers and passengers.
