ENHANCING LAST MILE CONNECTIVITY

a safety analysis of the Lok Kalyan Metro Station

Lok Kalyan

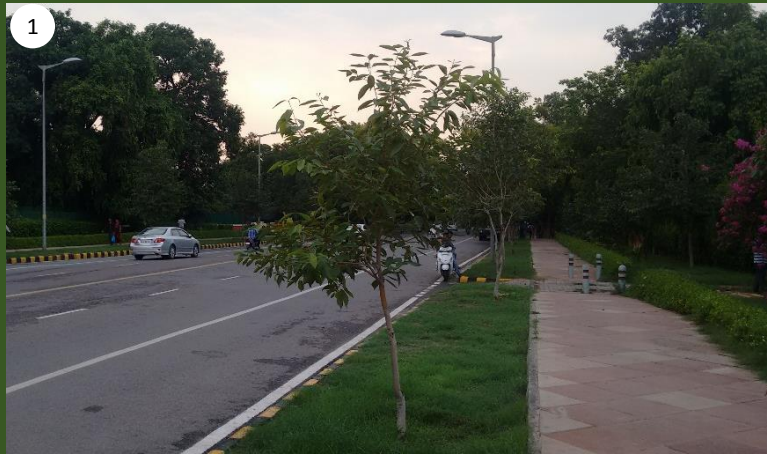
As seen in Pic 1, streetlights are installed on both sides of the main road throughout the audit area. These streetlights installed along the footpath are facing the vehicular carriageway. This results in brightly lit road, but dim lit footpath (Pic 2a and 2b). Additional streetlights need to be installed to provide pedestrian scale lighting on the footpath.

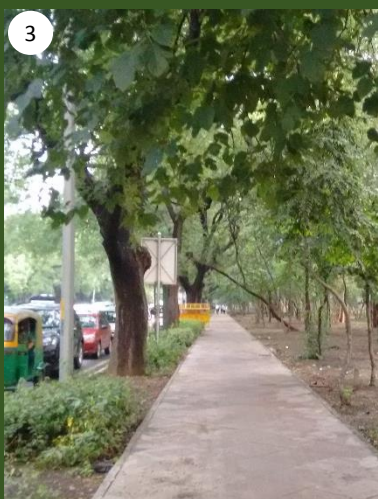
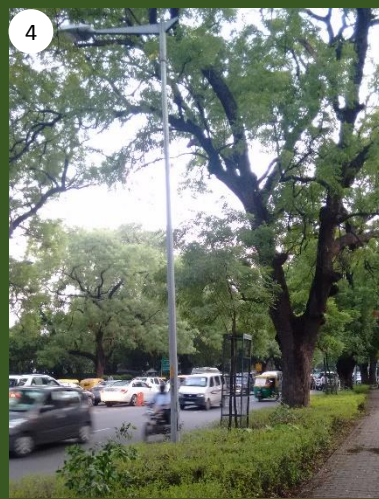
The footpath in this area is flanked by trees (Pic 3). Therefore, care has to be taken while installing streetlights between trees for lighting the footpath. Pedestrian scale lights should be installed along the edge wherever required. Also, the foliage needs to be pruned regularly as the overgrown leaves shield the light fixture resulting in poor illumination (Pic 4).

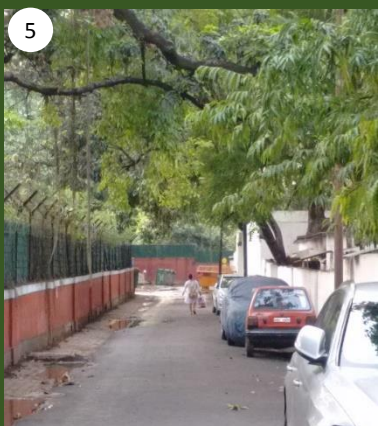
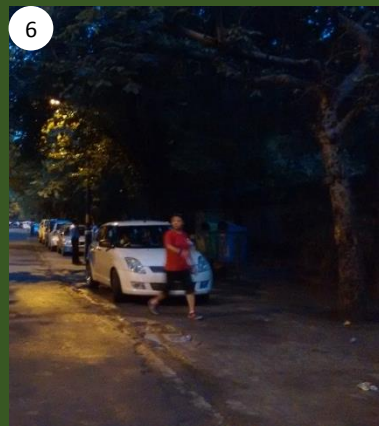
There are no streetlights installed in some inner lanes (Pic 5). In some lanes, though streetlights are present (Pic 6), there is low illumination along the boundary wall. With the vehicular parking, the pavement along the boundary lane is further shaded. In inner lanes, streetlights should be installed along the boundary wall, thus ensuring uniform illumination.

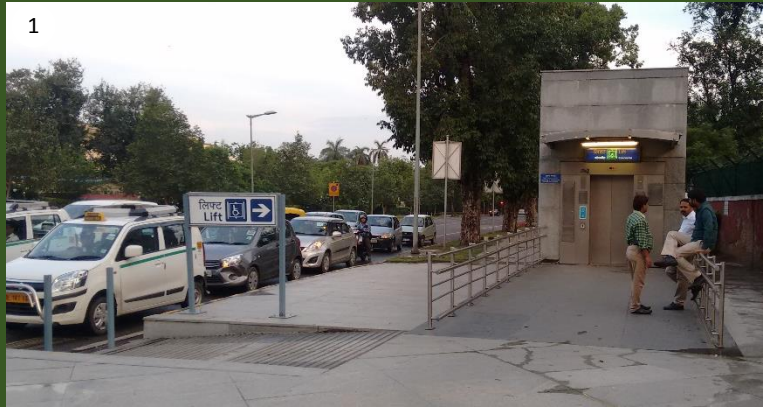
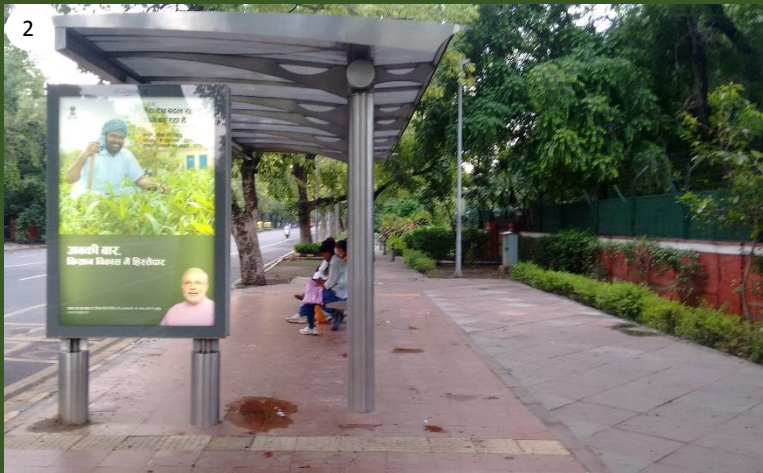
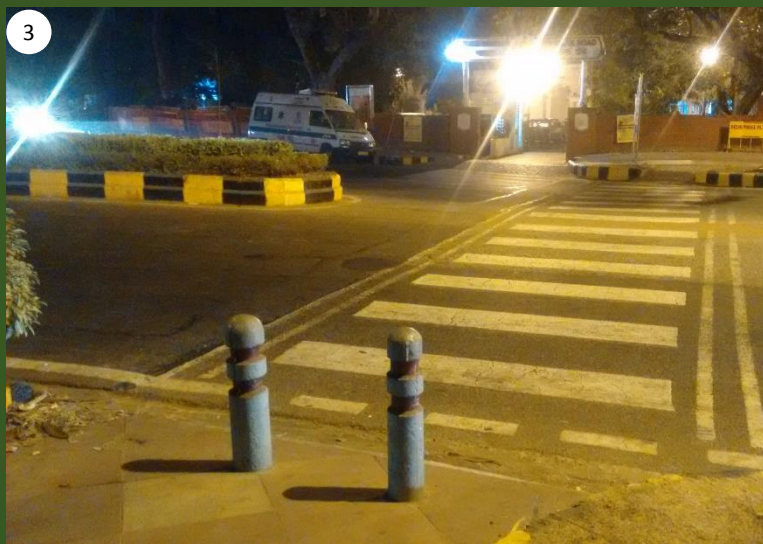
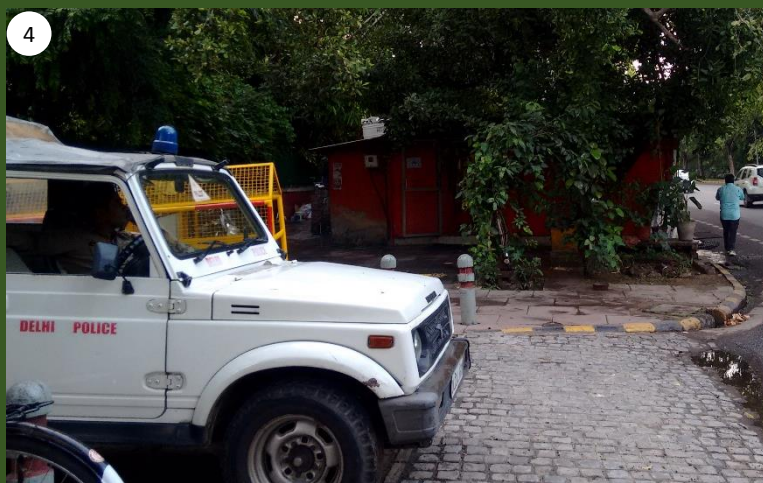
While metro station's premises have been equipped with tactile paving, there is no tactile paving once you move out of the lift to guide the visually challenged (Pic1). The ramp provided with bollards on its edge is not convenient for people on wheelchair. Also, seen in Pic 2 tactile paving at the bus stop is obstructed by the advertisement board, and ends abruptly. Proper tactile paving should be provided throughout on the footpath, clear of any obstruction. As seen in Pic 3, at many audit points bollards are placed in a way that is inconsistent and inconvenient. While one side of the road has bollards that are not comfortable for disabled, the other side doesn't have any. The bollards should be placed in a way that it is convenient for the physically challenged but prevent vehicles from accessing the footpath.

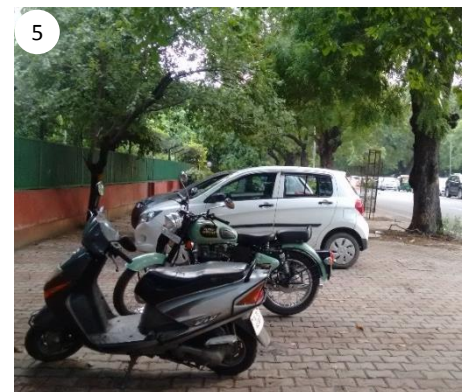
Seen in Pic 4, a Hanuman Temple built on the pavement hampers the smooth movement of the pedestrians. This has resulted in pedestrians walking on the vehicular carriageway. On few days, the activities of temple extend till the road. This pavement should be reclaimed for the pedestrians. The space currently occupied by vehicles and barricades should be cleared or the pedestrians. Vehicular parking on the pavement was seen at few other audit points (Pic 5). In such cases, a separate space should be provided for the parking and the footpath should be raised at a level.

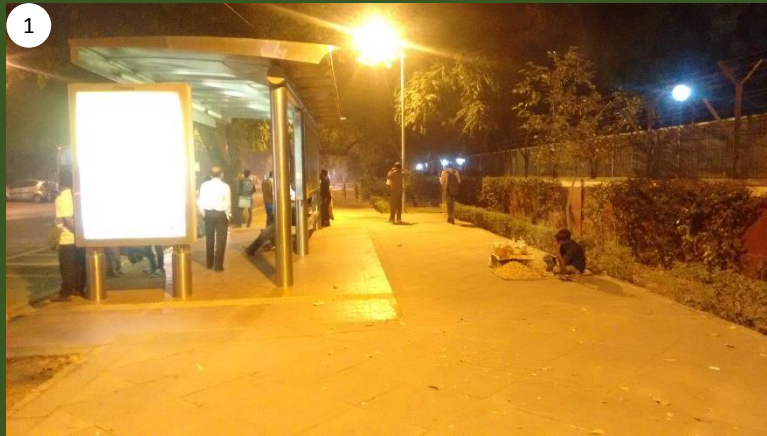
In a neighbourhood with high boundary walls, street vendors present at various audit points provide some visibility. As seen in Pic 1 and 5, hawkers are present near the bus stop and metro station respectively. But in the absence of a designated space, hawkers end up occupying the footpath. On the path leading to the metro station, there is some vacant space that can be put to use as a designated hawker zone. Similarly, at the bus stop, hawkers can be provided a designated space. The space should be equipped with street furniture for vendors and commuters.

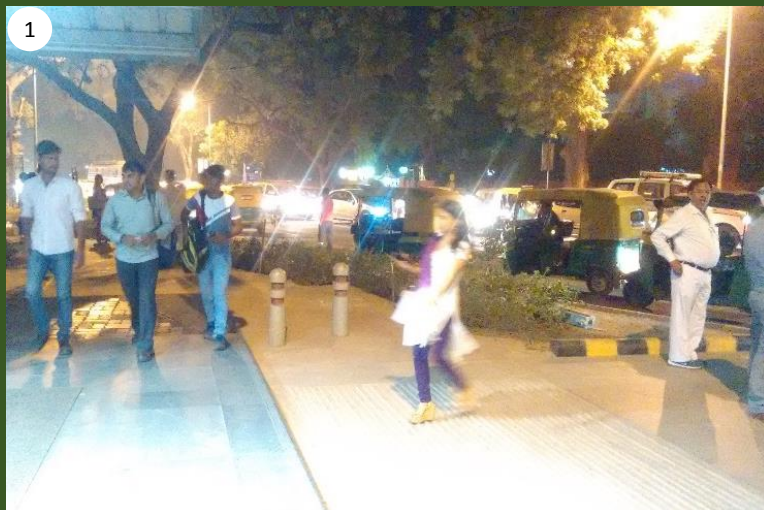
As seen in Pic 1, at the entry/ exit of metro station, one can see autos waiting. But in the absence of proper parking space, autos occupy main carriageway. Auto stand should be set up here with proper parking space for them.

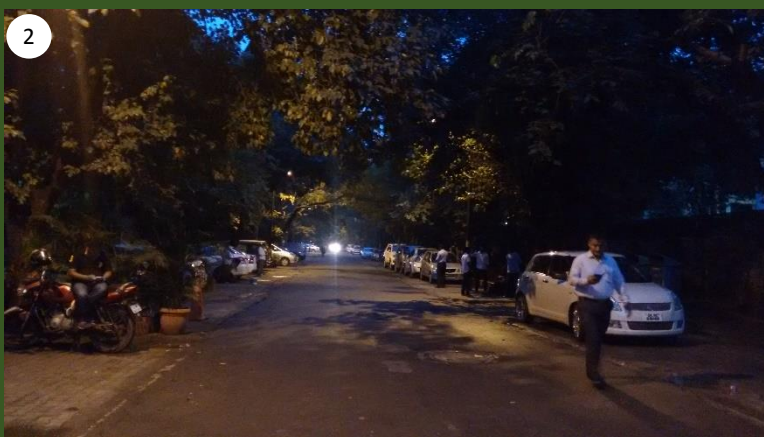
As we move away from the metro station, the rating of public transport decreases. To improve the public transport facility in this area, para-transit stands should be set up at the bus stops, and also within the residential neighbourhood (Pic 2).

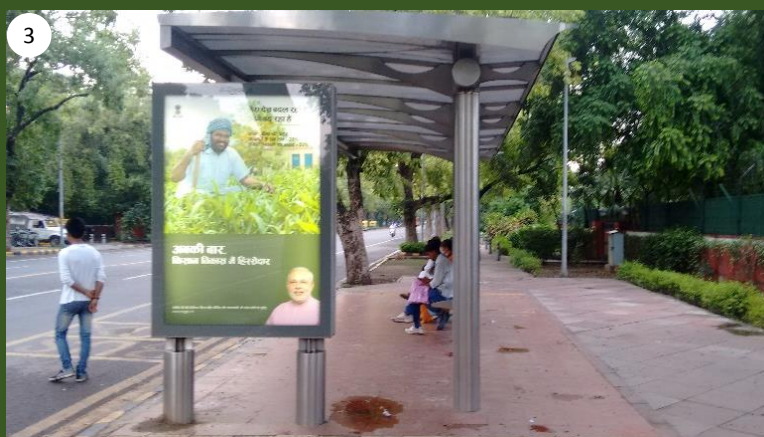
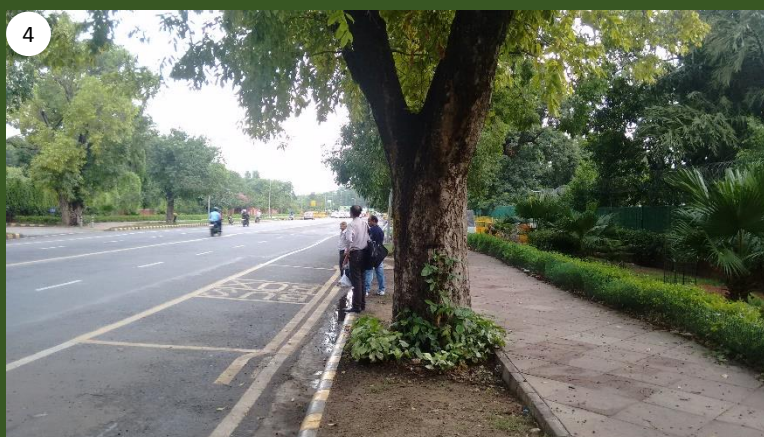
At some audit points, bus shelter was found only on one side of the road (Pic 3, 4). At such points, bus stop is identified through the marking on the road (Pic 4). The bus shelter should be provided for people on both sides of the road. Space should be provided for auto stand as well.
