SAFETY AUDIT DATA TO STRENGTHEN HANOI METRO LINE 3

Hanoi Metro Line 3

Safety Audits of Hanoi Metro Line 3

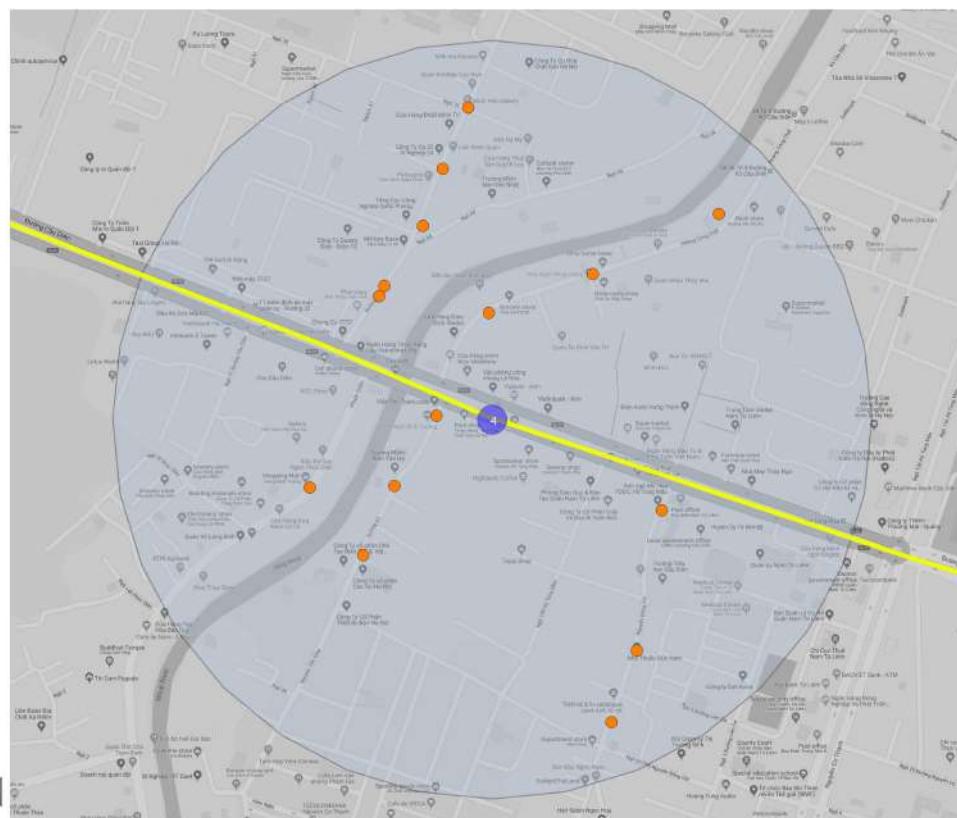
Map on the left above: showing points for pavements which are within the 500 meter radius of the metro station and are either missing, broken or blocked with/encroached upon currently.

Recommendation: Walkpaths as mapped within the zone to be fixed and consequently checked for blockages due to bikes and cars parked on them or for encroachments by small shops and informal businesses. Pedestrian walkpaths must be clear of any hindrances and the route ahead clearly visible. Well maintained walkpaths improve walkability and increase accessibility for pedestrians.

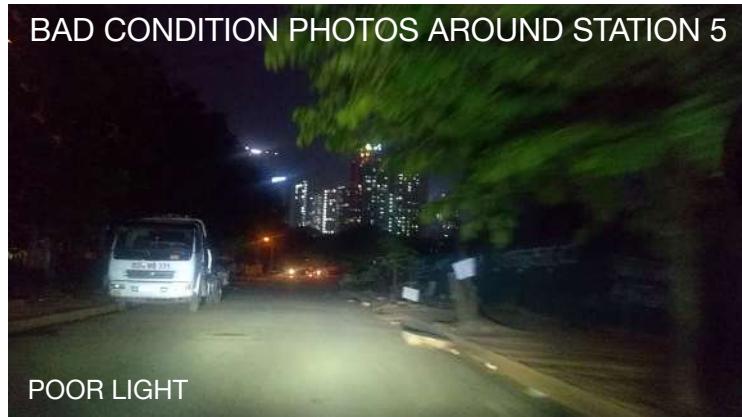
POOR LIGHT

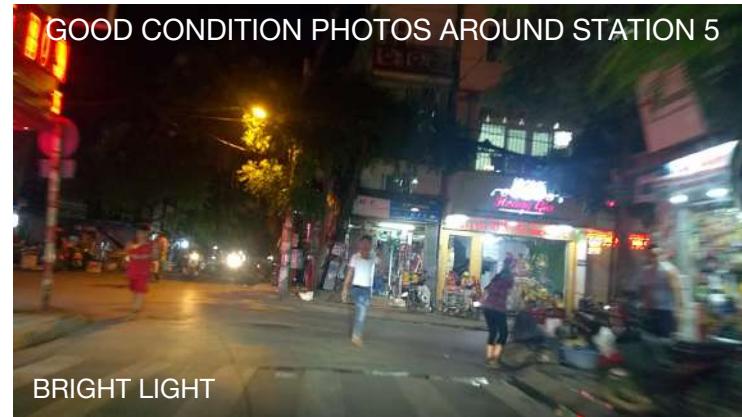
BRIGHT LIGHT

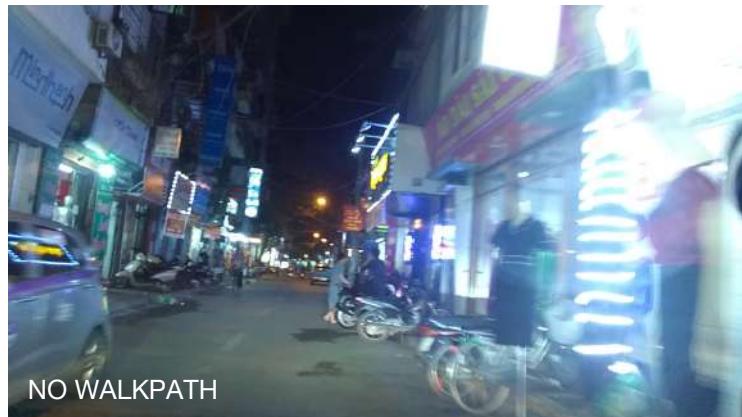
NO WALKPATH

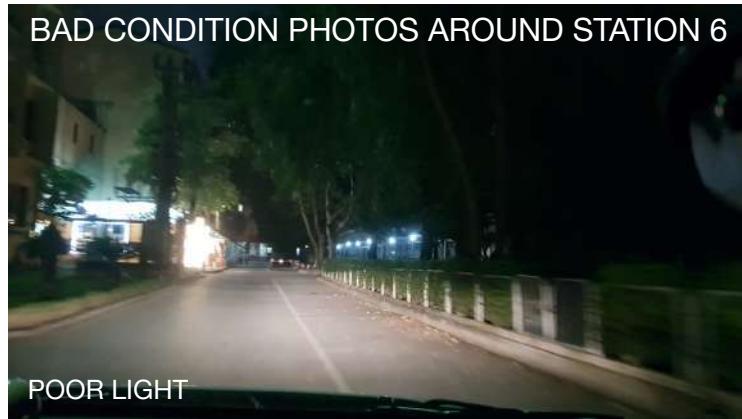
POOR LIGHT

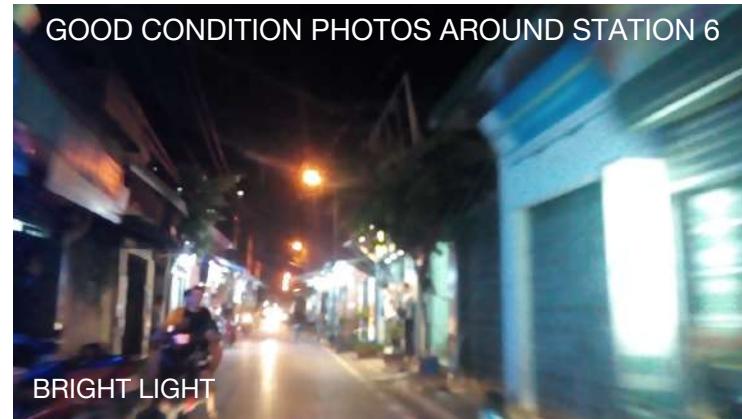
BRIGHT LIGHT

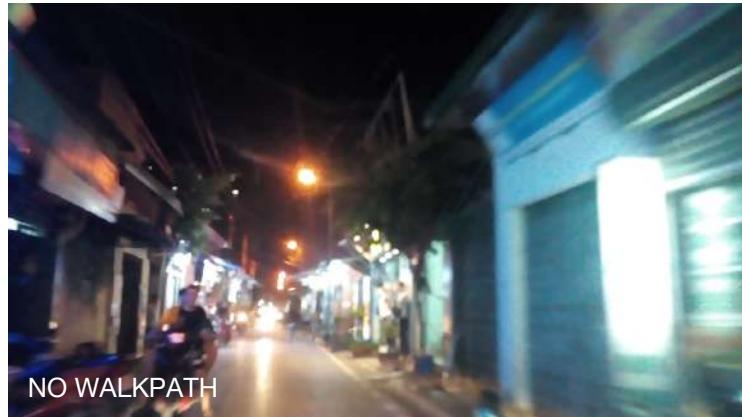
NO WALKPATH

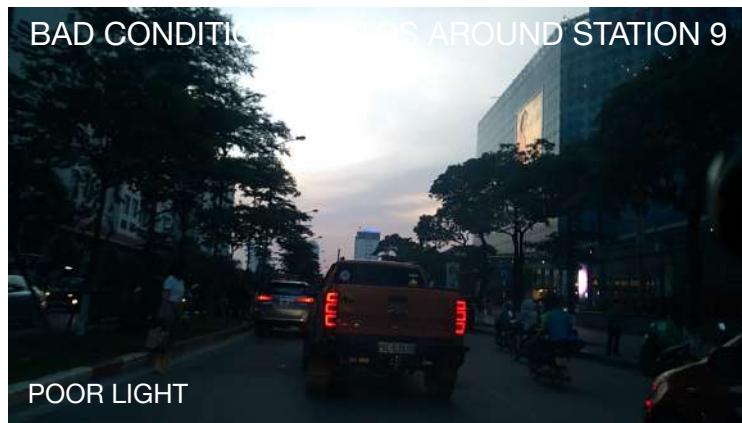
POOR LIGHT

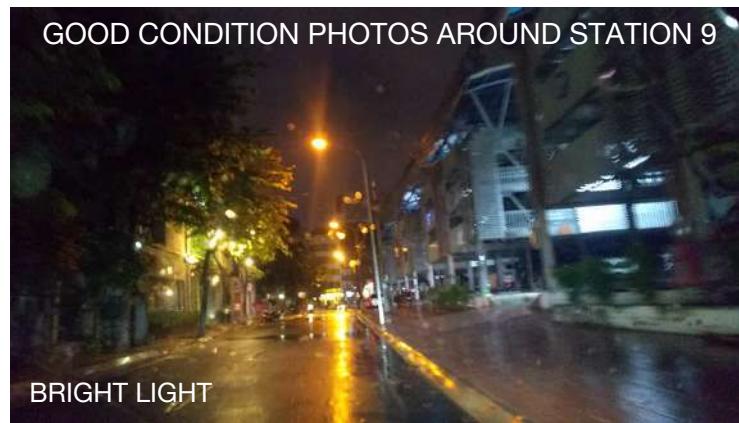
BRIGHT LIGHT

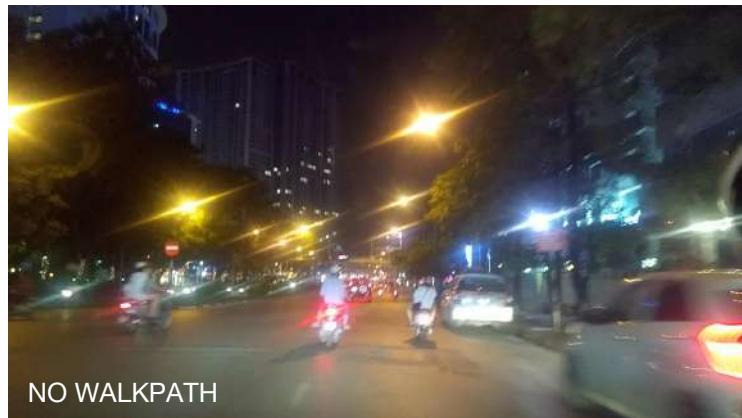
NO WALKPATH
