# SAFETY AUDIT REPORT COLOMBO

**SAFETIP**  
Supporting Safer Cities

As a part of the Safe and Inclusive Cities Initiative under The Metro Colombo Transformation Platform, the World Bank engaged [Safetipin](#) to evaluate the public spaces of Colombo city and suggest recommendations to make them safer. Safetipin uses apps and technology platform to collect data to measure safety and inclusivity of public spaces in cities. At the core of the Safetipin apps is the safety audit, based on 9 parameters Lighting, Openness, Visibility, People Security, Walkpath, Availability of Public Transport, Gender Usage and Feeling. For this study, Safetipin used two of its applications i.e. My Safetipin and Safetipin Nite, to map the city by conducting safety audits. The audits were conducted in the five council areas of Colombo District i.e. Colombo Municipal corporation area, Sri Jayewardenepura Kotte Municipal council area, Kolonnawa Urban Council area, Dehiwala-Mount Lavinia Municipal Council area, and Moratuwa Municipal Council area. In total 7,663 safety audits were generated, and the collected data was analyzed to highlight key issues related to safety and mobility in each of the council are

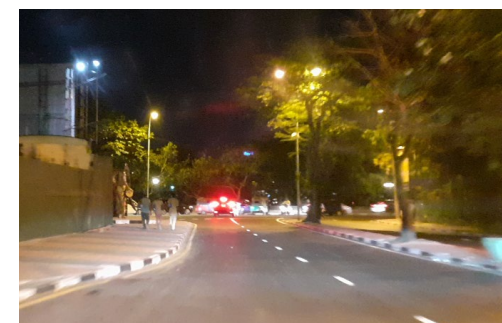
Image 6 showing well-lit Galle road

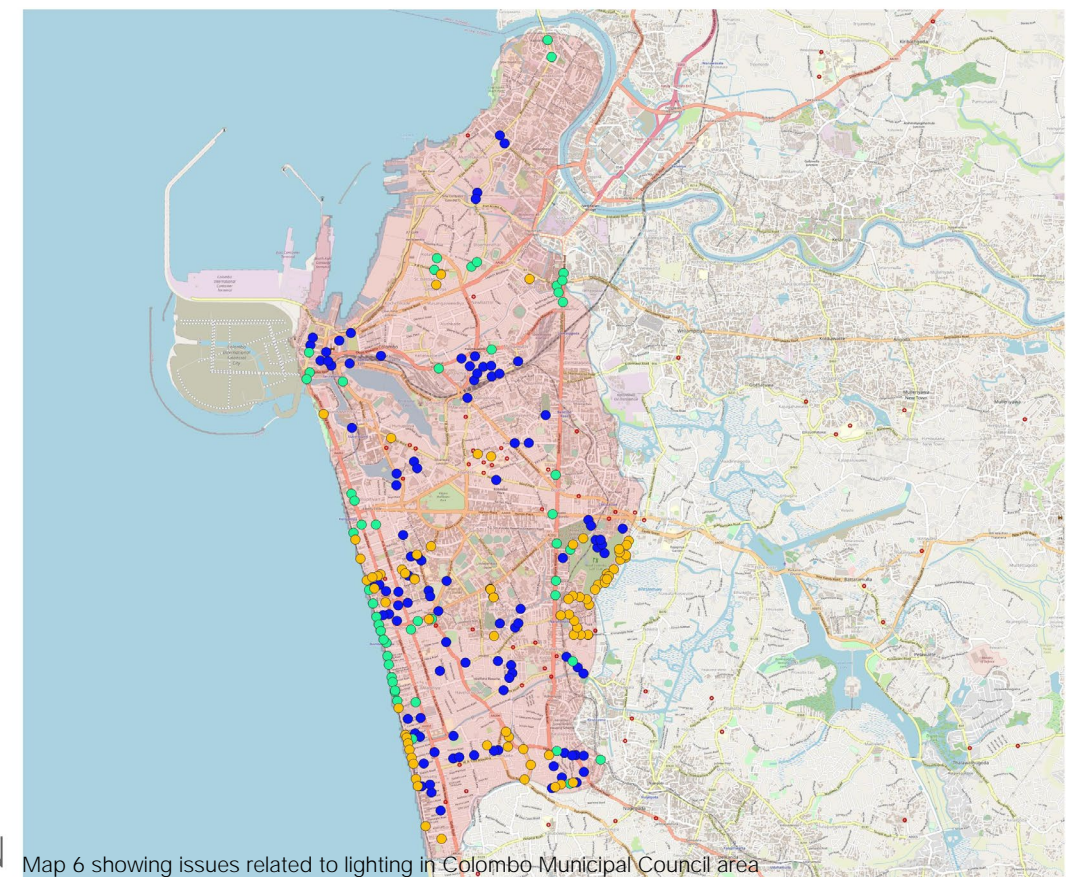
Map 6 showing issues related to lighting in Colombo Municipal Council area

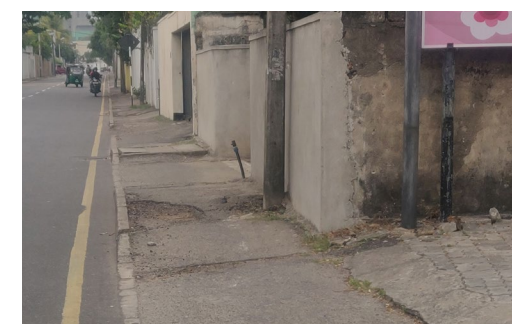
Image 13 showing the broken pavement

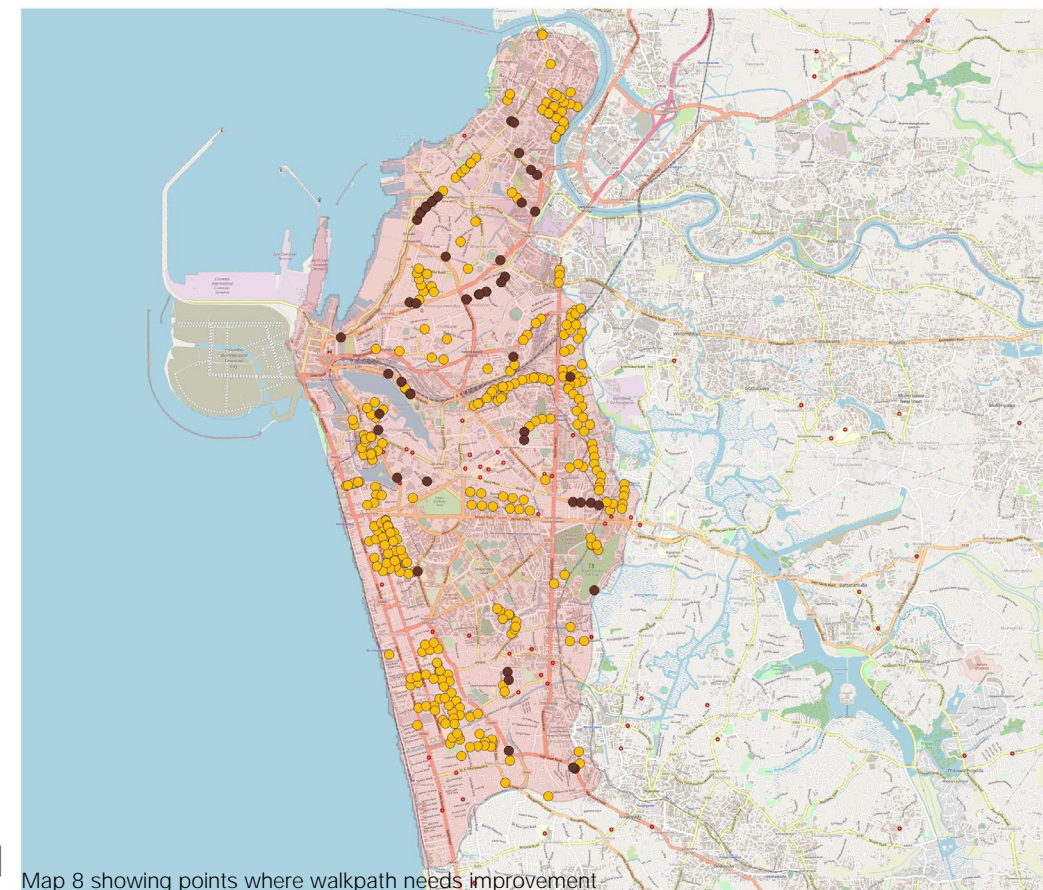
Map 8 showing points where walkpath needs improvement

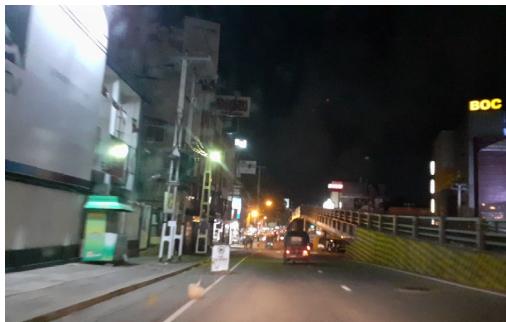
Image 26 showing well obstructed pavement on High level Road

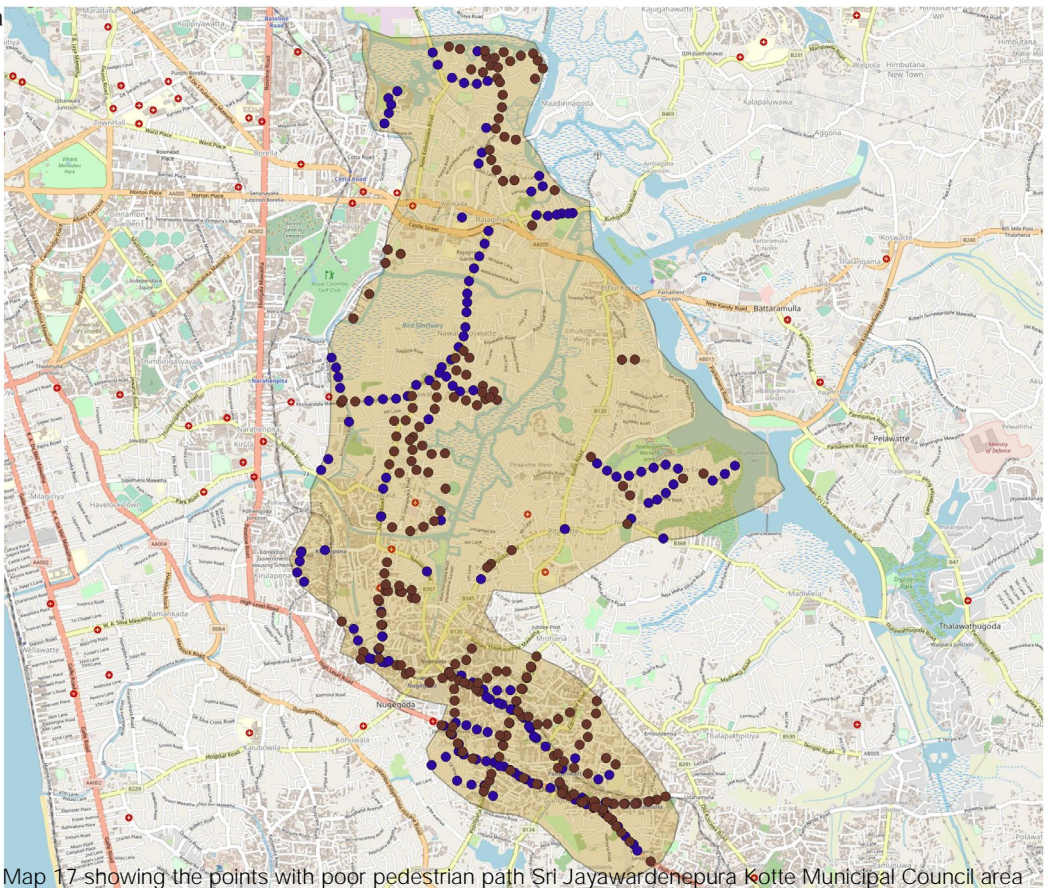
Map 17 showing the points with poor pedestrian path Sri Jayawardenepura Kotte Municipal Council area

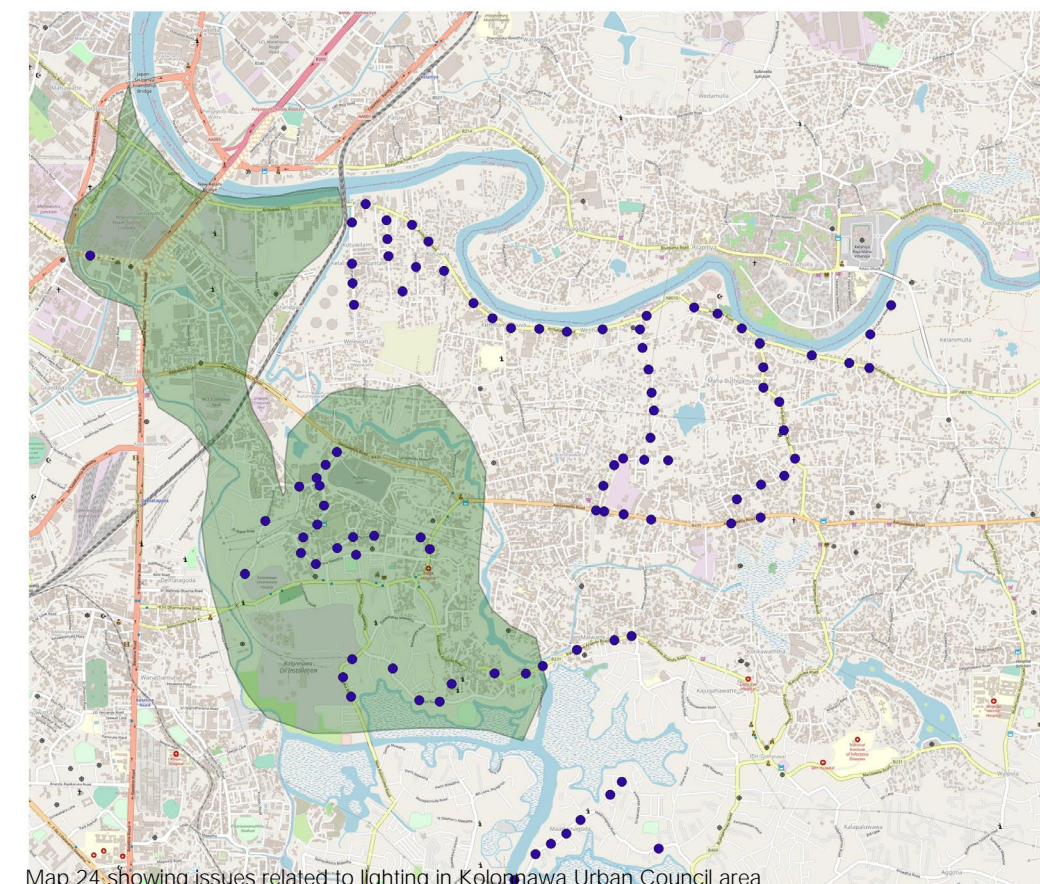
Map 24 showing issues related to lighting in Kolonnawa Urban Council area

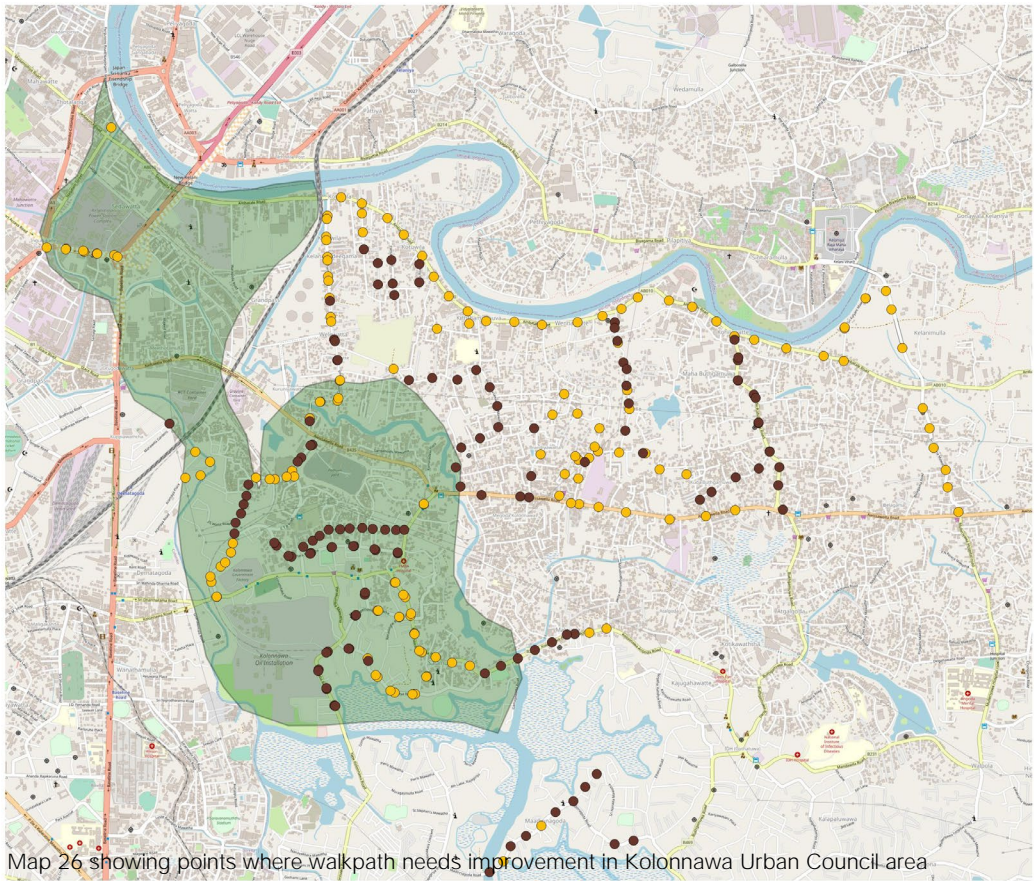
Map 26 showing points where walkpath needs improvement in Kolonnawa Urban Council area

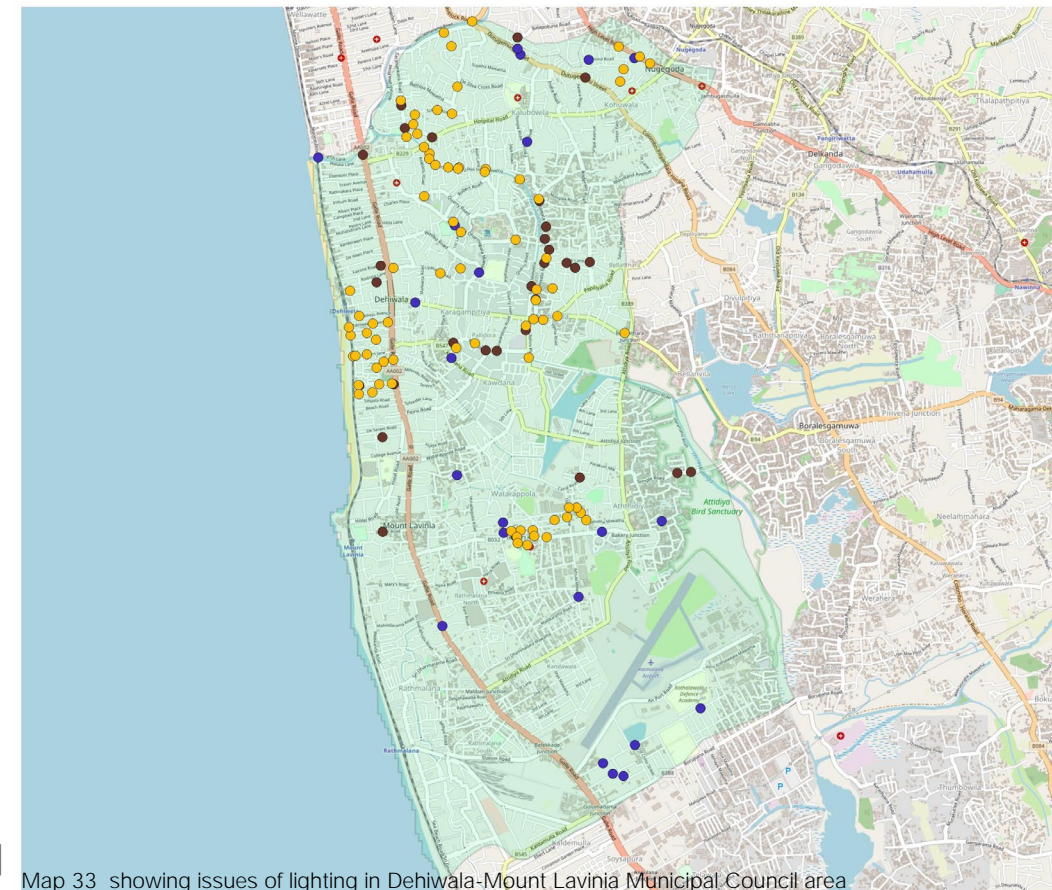
Map 33 showing issues of lighting in Dehiwala-Mount Lavinia Municipal Council area

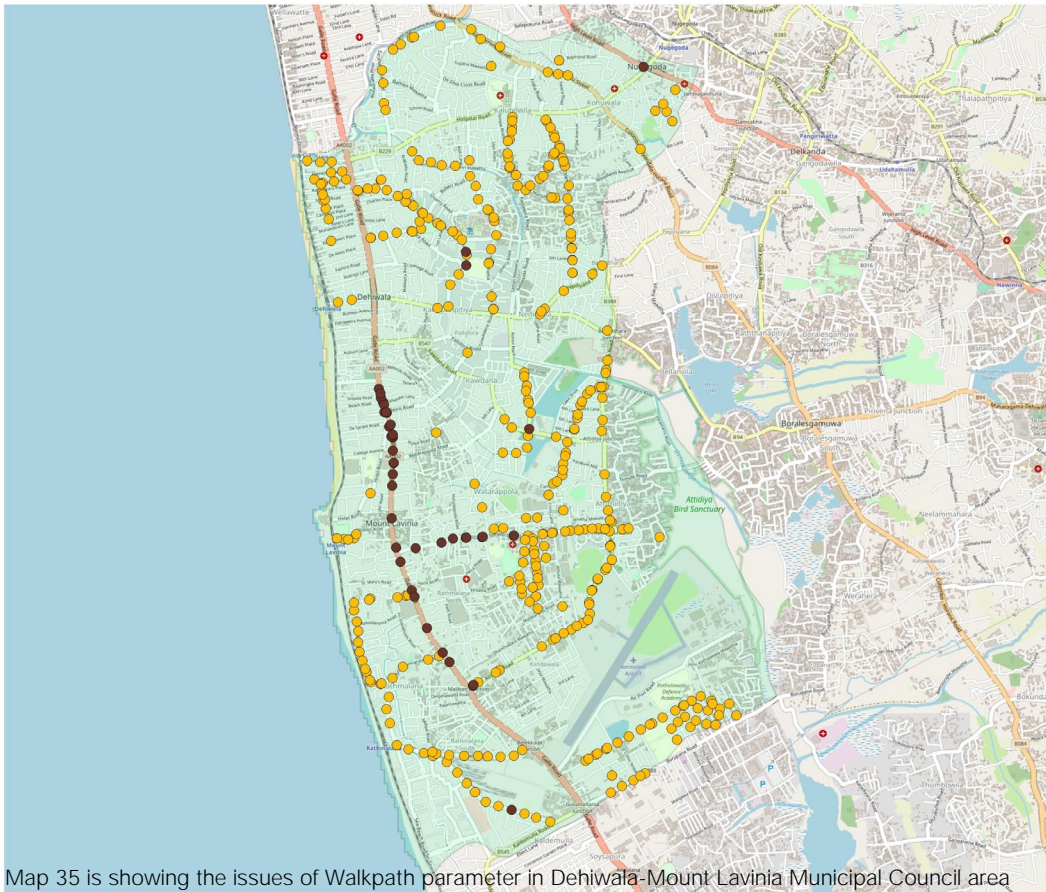
Map 35 is showing the issues of Walkpath parameter in Dehiwala-Mount Lavinia Municipal Council area

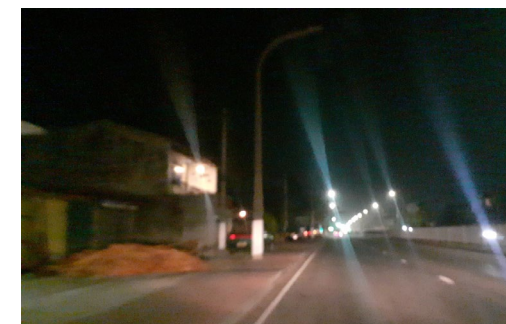
Image 72 showing off street lights on some points of Galle Road New Deviation

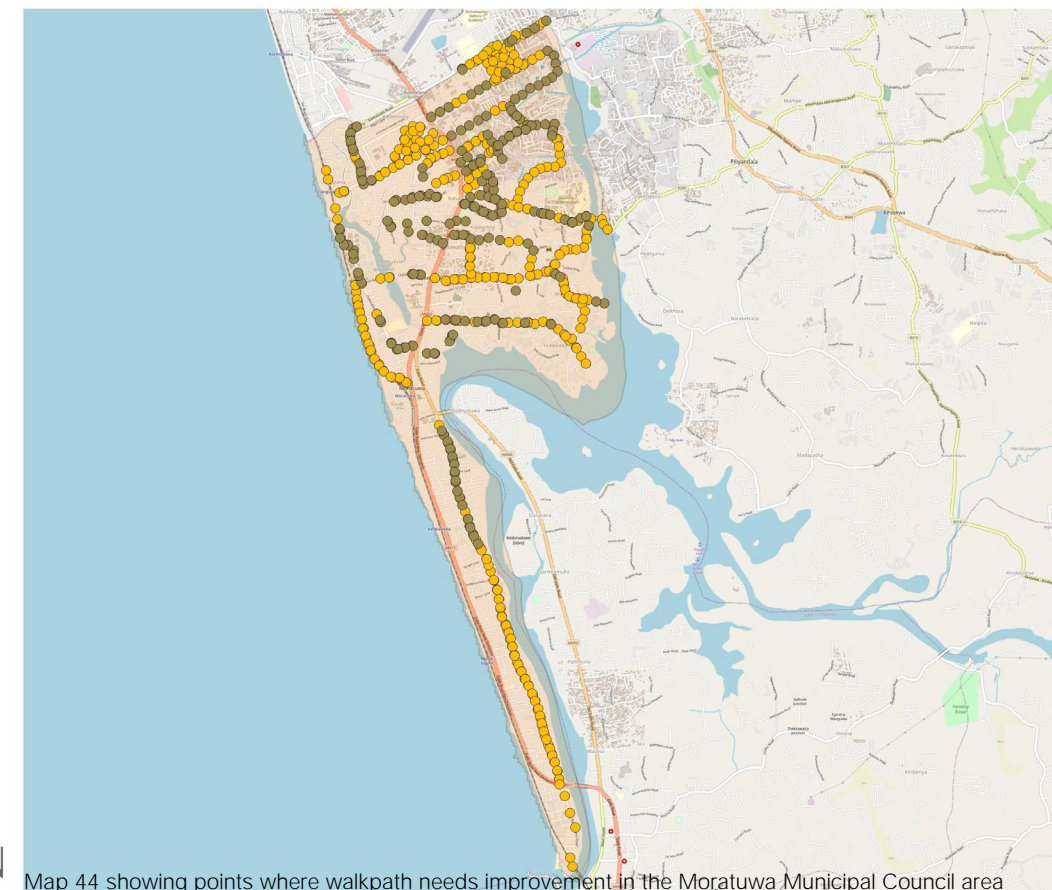
Map 44 showing points where walkpath needs improvement in the Moratuwa Municipal Council area

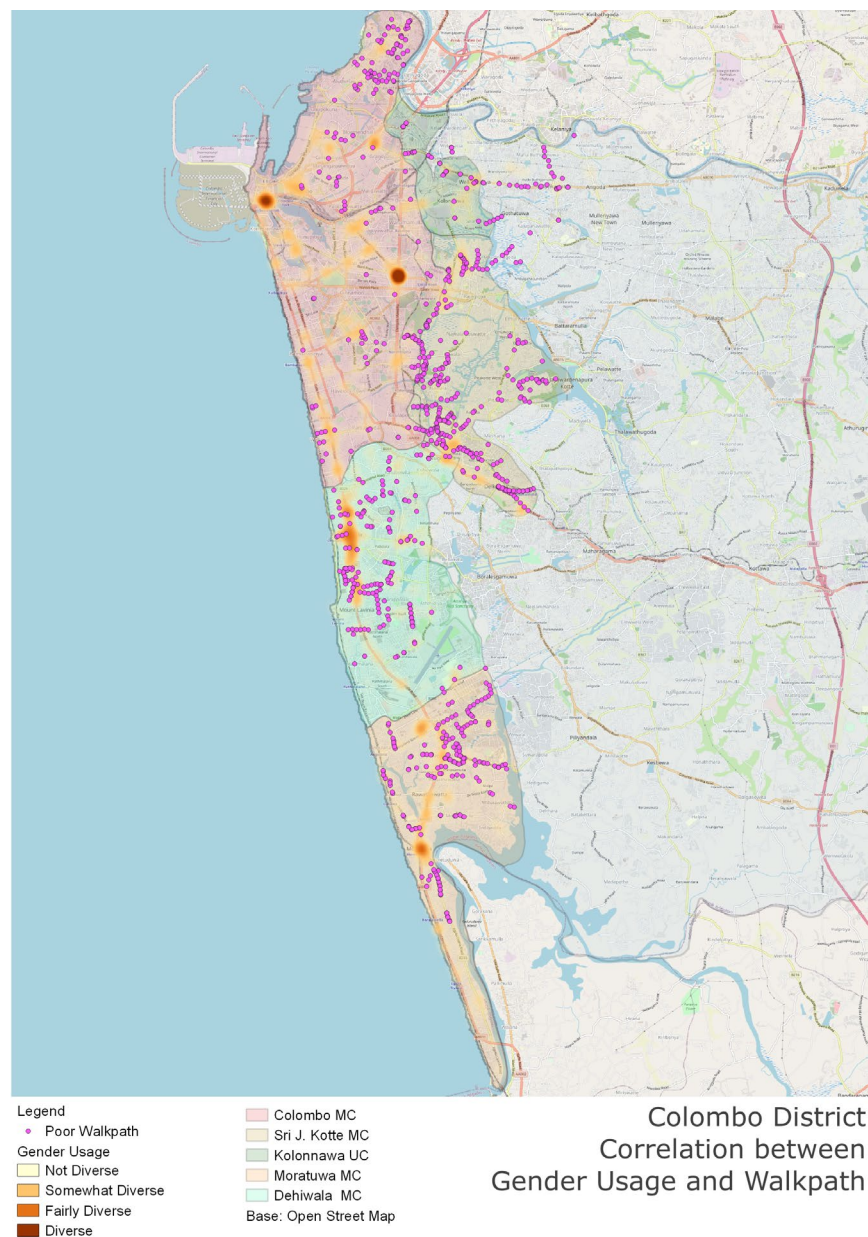
The map 49 shows audit points in the Colombo District where women are present but walkpath has been rated poor. There are all together 478 points identified that are frequently used by women but poor walking conditions. The walkpath is either unpaved or broken, thereby obstructing smooth pedestrian movement. Since this is visual mapping, every geo-tagged audit point is supported by two or more images. Such data would enable the authorities to investigate deeper into the city's walking infrastructure and plan better in order to improve its quality and accessibility. Women's mobility would certainly improve if there is an obstruction-free pavement with ramps, tactile paving and signage.

Map 49 on the right is showing the audit points with there is high gender usage but walk path is poor

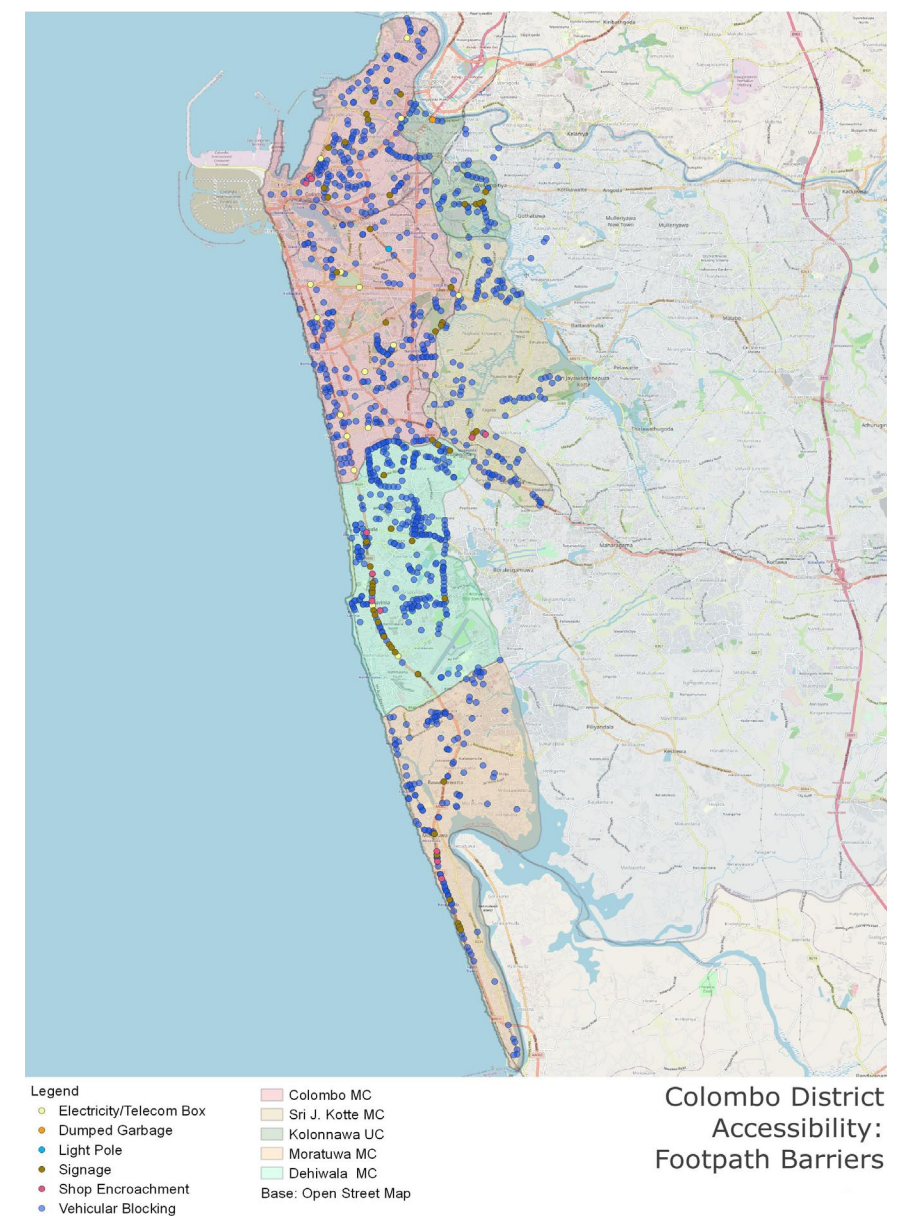
Safetipin identified five type of physical barriers which make walking uncomfortable for the pedestrians especially vulnerable groups like elderly, children, women and the differently abled.. These are parked vehicles, electricity/telecom box, light pole, dumped garbage and shop encroachment. We mapped all of these barriers present on the footpath during the image mapping and geo-tagged the information with their exact locations on GIS layers. The composite map 53 below represents all the kinds of barriers found on footpaths and highlights the intensity of the issue in all the five councils. The data could be integrated with the city's existing GIS platform for further analysis.

Map 53 on the right is showing the Footpath Barriers in Colombo district

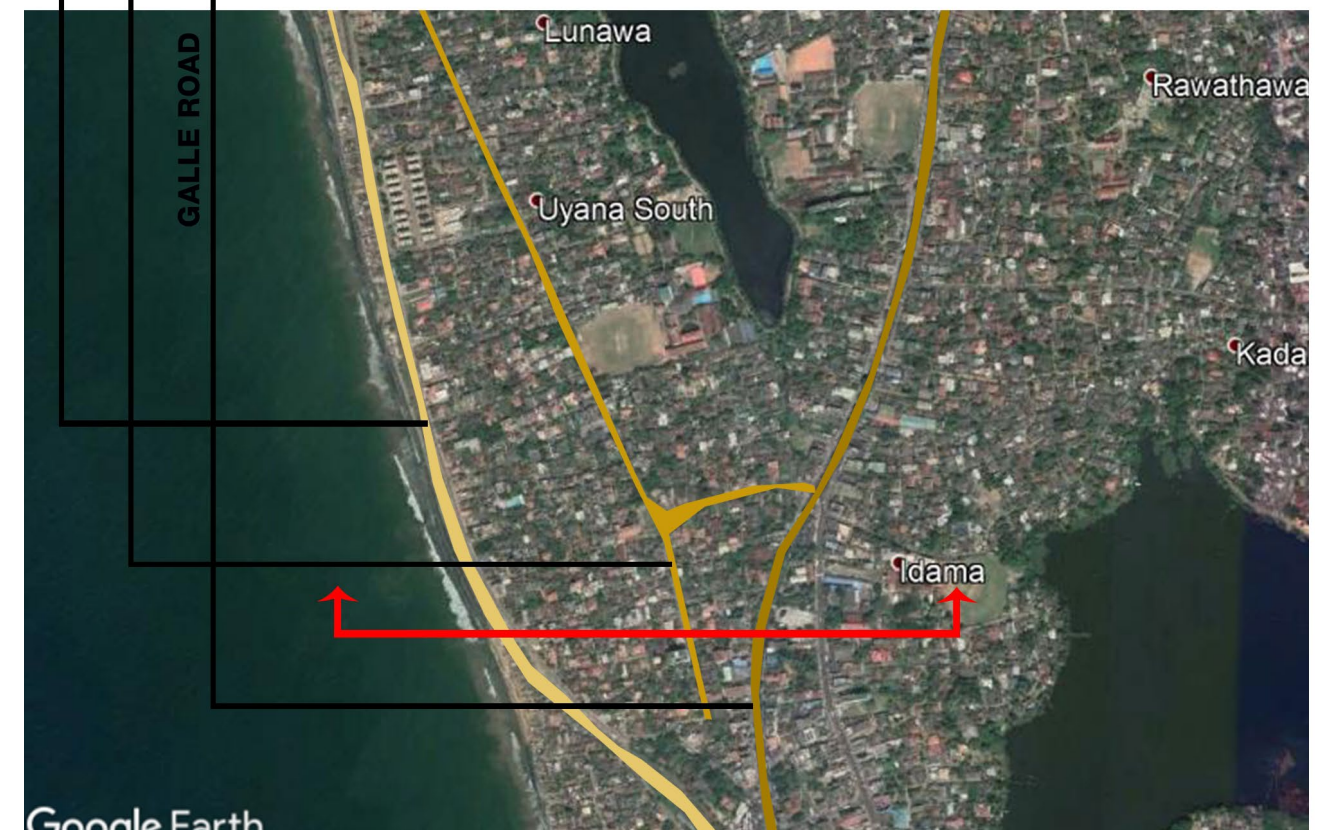
Map 56 showing three parallel roads with stark difference in infrastructure in Moratuwa Municipal Council area
