CHOLOMA

A Safety Analysis Report

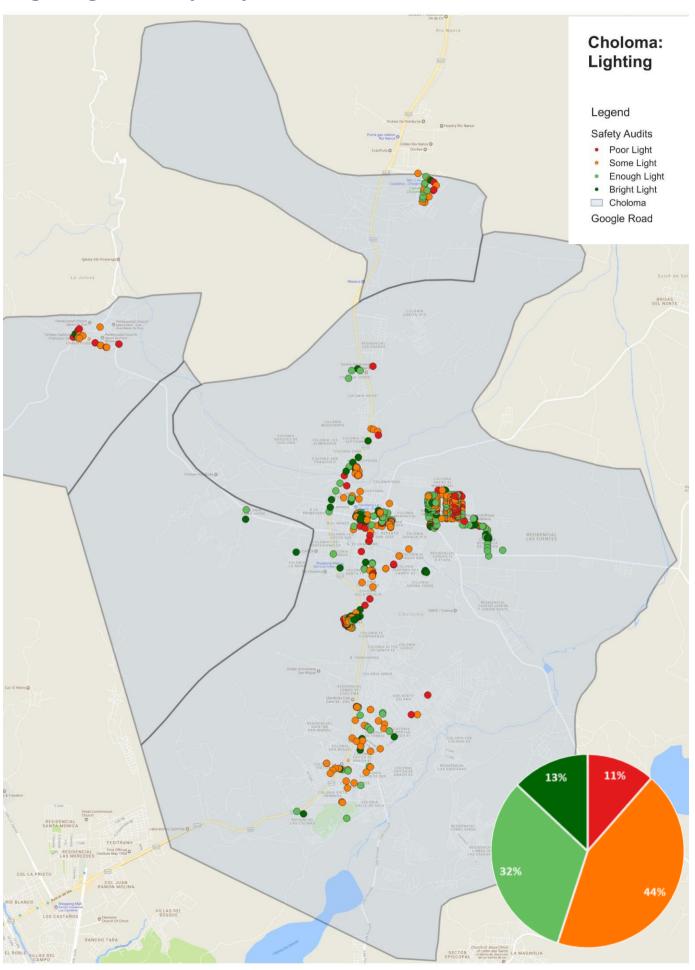
Map 5 Indicating Lighting Rating

Lighting has been rated 1.5/3 i.e. Average. While 44% of the audit points have been rated poor, 11% of the points have been identified as dark spots as seen in Pic 8. The dark spots indicate no source of lighting and no streetlights installed along the road. Streetlights need to be installed along this points immediately as most of them lie in residential areas with high pedestrian crowd.

At some places as seen in Pic 9, luminaire of the streetlights are dim and do not provide uniform illumination. Auditors also reported broken lamps as a cause at certain locations. These locations are considered unsafe after dark.

The existing streetlights that have been found non-operational or having faulty luminaire need to be checked. Also, regular checks are necessary to ensure uniform and unobstructed illumination. Streetlights need to be installed along areas, identified as dark spots i.e. at these locations there is no illumination at present. Along the residential streets, additional streetlights need to be installed alternately on both sides of the road to avoid dark blind spots.

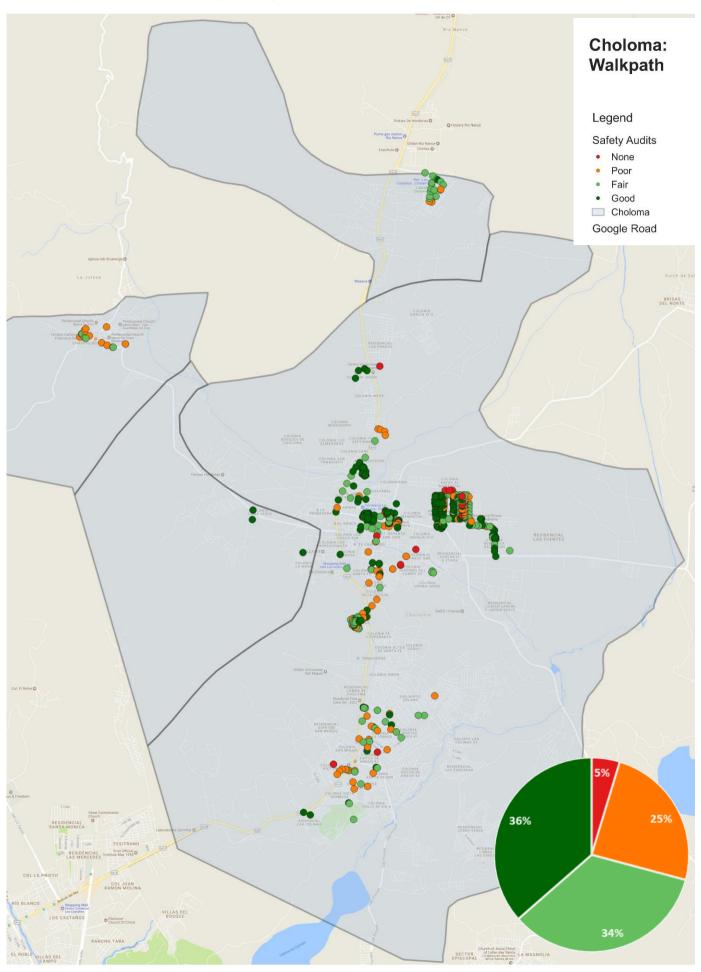
Walkpath: Municipality Level

Walkpath has been rated 2.0/3 i.e. Above Average. 70% of the audit points have been rated 2 and above indicating presence of paved path for pedestrians. . However at certain locations, there is a need for a raised sidewalk along the main roads.(Pic 10)

On analysing points with poorly rated walkpath, it was found to be due to unpaved streets thus posing a risk for the pedestrians. Most of these poorly rated points were found in the residential colonies (Pic 11). These streets need to be properly paved along with providing provisions to manage stormwater drainage.

The streets that were found unpaved and uneven needs to be paved along with providing provisions for stormwater drainage management. Along certain main roads, space has been left for the sidewalk but it hasn't been constructed. A sidewalk that has proper level difference from the road needs to be constructed, free of any obstruction.

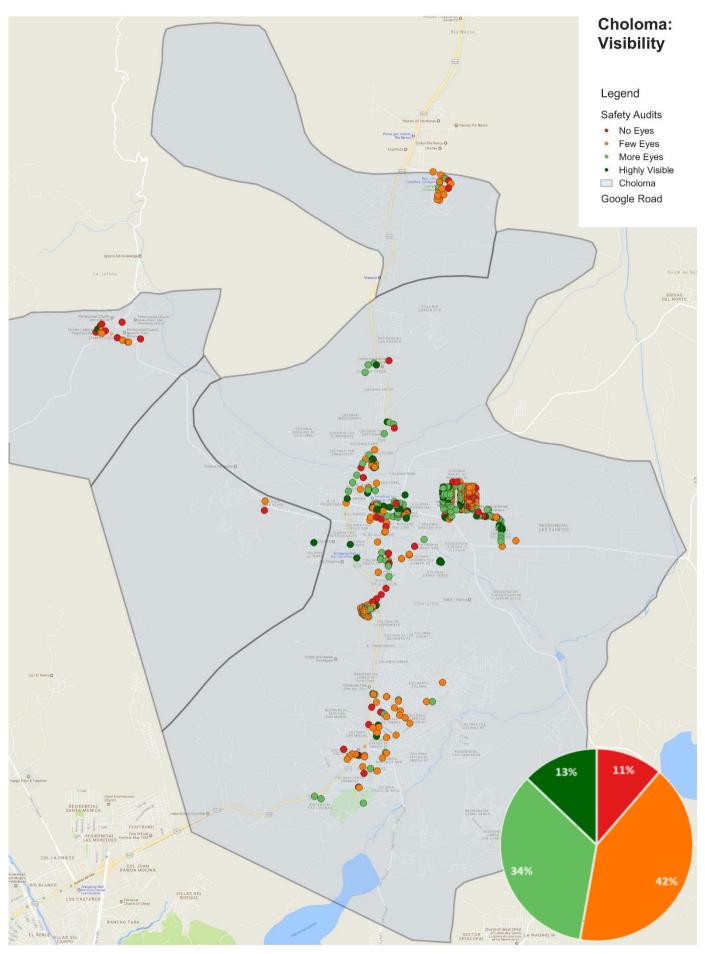
Map 7 Indicating Visibility Rating

Visibility has been rated 1.5/3 i.e. Average. 53% audit points have been rated poorly making it as the one of least rated parameter in terms of physical infrastructure. This can be attributed to geographical setting of the city which has large number of unused spaces and fields in between the localities. As seen in Pic 12, open areas provides no or limited visibility. hence people tend to avoid such areas after dark. The streets that have houses with no boundary walls or low/partial boundary walls (Pic 14) fared better as compared to streets as seen in Pic 13, that has no visual contact between built environment and the street.

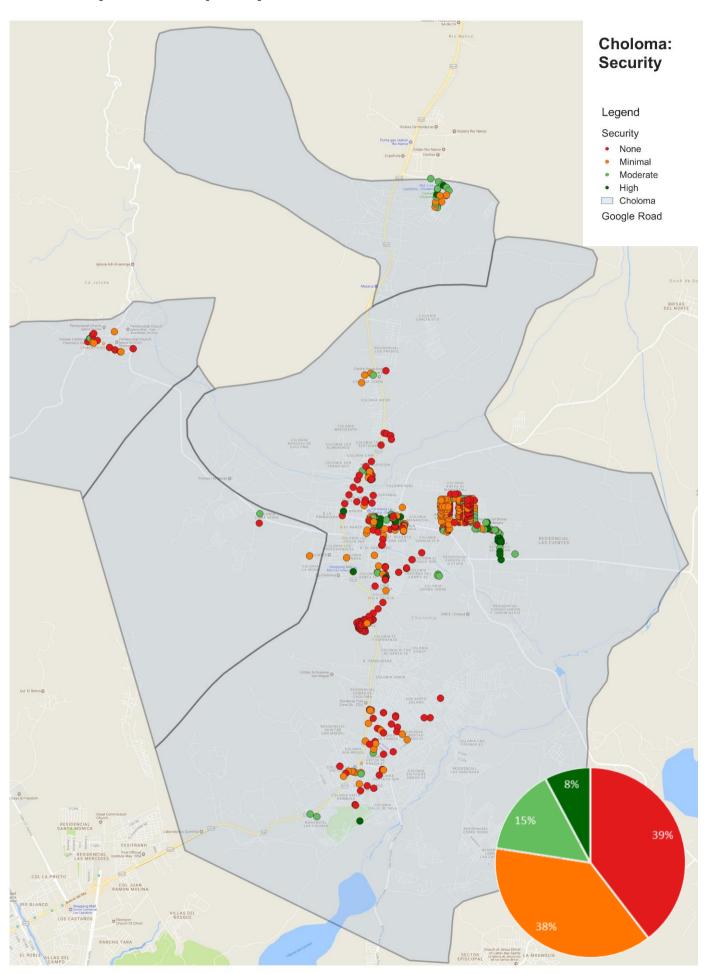
Map 8 indicating Security Rating

Security has been rated 0.9/3 i.e. Below Average. The auditors mentioned that security is of maximum concern as several cases of violence against women have been reported. Around the clock security should be provided at the locations that are least rated on security parameter. Pic 15 shows main roads that have been rated poor in terms of security and visibility. Regular Police Patrolling should be done along the major streets of the locality.

Additionally, auditors reported cases of harassment and mugging at the bus stops. This dissuade women to wait at the bus stop alone. Regular Police patrolling around the bus stops could prevent the cases of harassment and assault. Community Policing could help in preventing cases of assault, drug abuse and drinks.

Many areas do not have any form of security – private guards or Police. Regular police patrolling needs to be ensured in all areas, especially near public parks and schools. In the marketplaces and industrial areas, around the clock security should be provided..

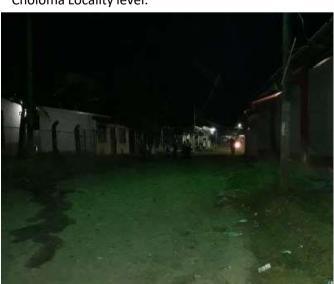
While only female auditors conducted audits in La Jutsa, only male auditors conducted audits in Quebrada Seca. Female Auditors feel highly unsafe in the streets of La Jutsa as seen in the Map 11 and Pic 16. They find the streets uncomfortable to walk and find it unsafe to walk after dark due to no streetlights.

Pic 16 La Jutsa's unpaved and poorly lit streets

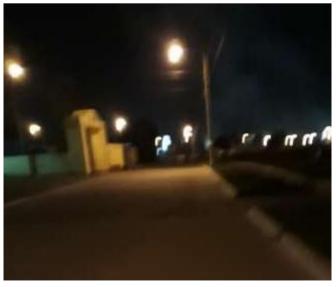
Quebrada Seca being a commercial place, male auditors have rated it comfortable to walk around even after dark (Pic 17). Map 12 shows the distribution of audits at Choloma Locality level.

Pic 17 Main road of Quebrada Seca

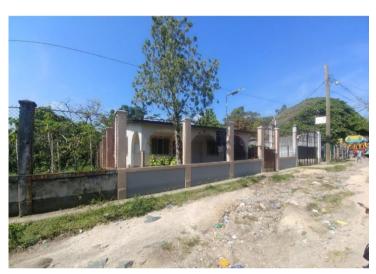
Public Spaces like Church, Park and Stadiums are frequented by all citizens of the city. The focus should be on providing proper walking and lighting infrastructure along the streets adjoining them. Existing streets along the major public spaces were found to be unpaved and uneven as seen in Pic 10 and 11. These streets should be paved to provide unobstructed movement for the pedestrians.

Pic 10 Street of Catholic Church, La Jutosa

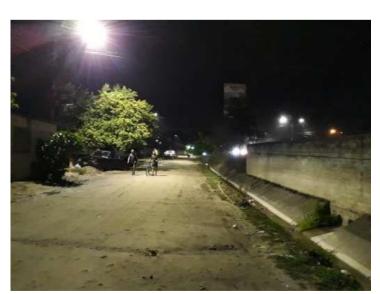
Pic 11 Street along Lopez Arellano Park

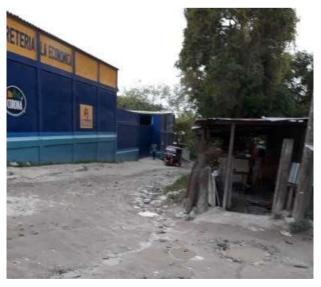
The most unsafe locations were reported in residential areas with poor lighting (Pic 12) and some industrial areas (Pic 13) where cases of assault and murder have been reported. Regular police patrolling needs to be carried out here. Streetlights should be installed alternately along the sides of the road to ensure uniform illumination.

Pic 13 Street along a mill, rated dangerous by auditors
