BHOPAL

SAFETY ANALYSIS REPORT

2019

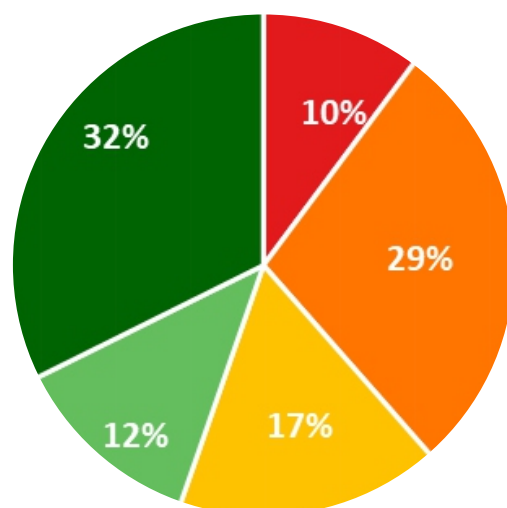
The Safety Score of a point is a reflection of the perception of safety at that particular location. For each audit point it is a number between 0 and 5, 0 being Poor i.e. Very Unsafe and 5 being Excellent in terms of overall safety.

Indicated in the pie chart is the percentage distribution of pins in each range. Over 39% of the audit points were rated poor i.e. safety score less than 2 out of 5, on the other hand 44% were rated excellent or good i.e. safety score above 3. As seen in the Safety Score map, points located around Ibrahimganj, Jahangirpura, Ibrampura, Arera Hills, Indra Press Complex and Kotra Sultanabad were highly rated whereas in BHEL, Govindpura, Gulmohar Colony and Lalghati road safety score was found to be poor.

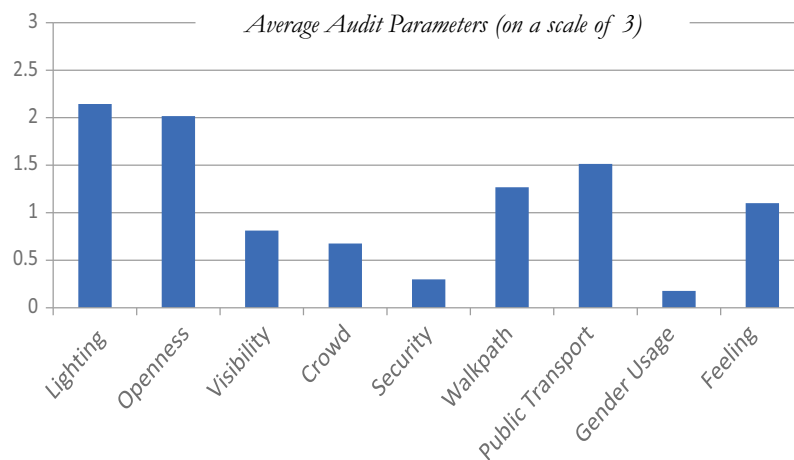
Each of the nine parameters is rated 0/1/2/3, 0 being the poorest and 3 is good. The average parameter ratings graph indicates the overall average rating for each parameter. As seen in the graph, the Lighting parameter has been rated the highest and is followed by Openness.

Crowd, Gender Usage, Security and Visibility parameters are the least rated parameters, indicating less number of pedestrians after sunset Women's participation in public spaces is very poor. Security parameter has not been assessed completely due to lack of information on police patrolling routes, hence it's rated low. The overall feeling of safety for Bhopal city is rated Below Average.

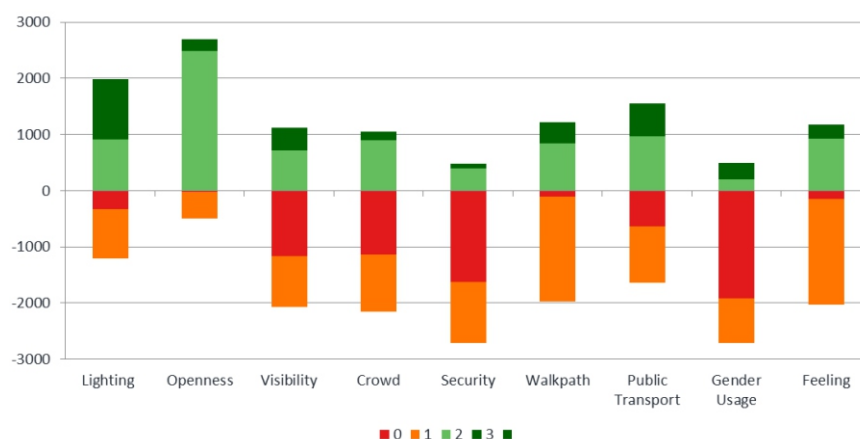
The Parameter wise pin distribution graph indicates the number of points rated 0/1/2/3 i.e. 2 & 3 rated points as positive and 0 & 1 ratings as negative. The parameters of Gender Usage, Visibility and Crowd have been rated poorly for the most parts of the city. While parameters like Walkpath and Lighting can be improved by repairment or installation, increase in Crowd and Gender Usage is dependent on improvement of other parameters.

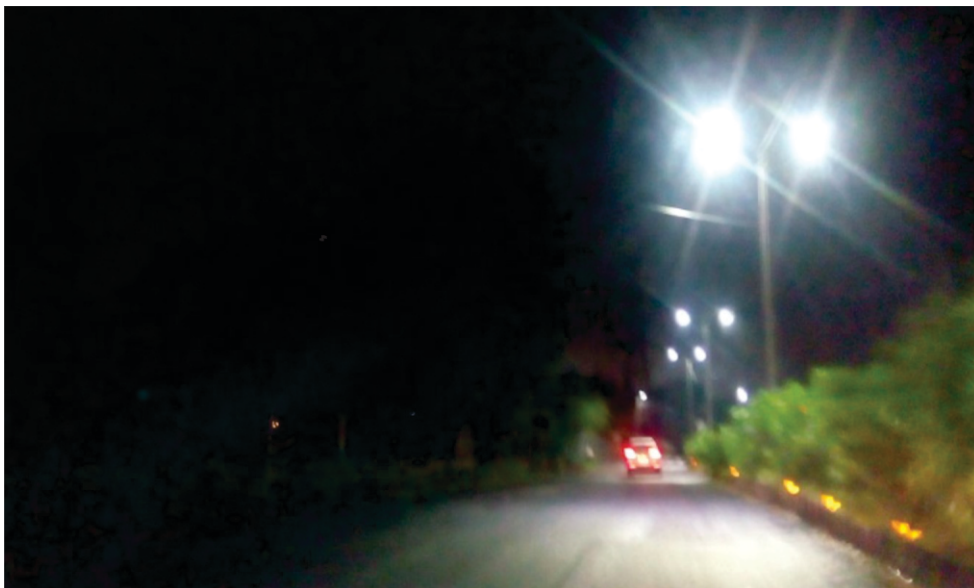
Lighting has been rated 1.9/3 i.e. Average. Streetlights are installed along the central median on most of the roads. While 63% of the audit points have been rated good, 10% of the points have been identified as dark spots. The dark spots indicate no source of lighting and no streetlights installed along the road. Streetlights need to be installed along this points immediately as most of them lie in residential areas including Gulmohar-3, Govindpura and Arera hills.

Image showing streetlights installed along median

Along the main roads having four lanes or more, streetlights are provided along the central median of the road. In such cases, additional streetlights need to be installed along the footpath. Pedestrian scale streetlights should be installed such that the footpaths are also well light.

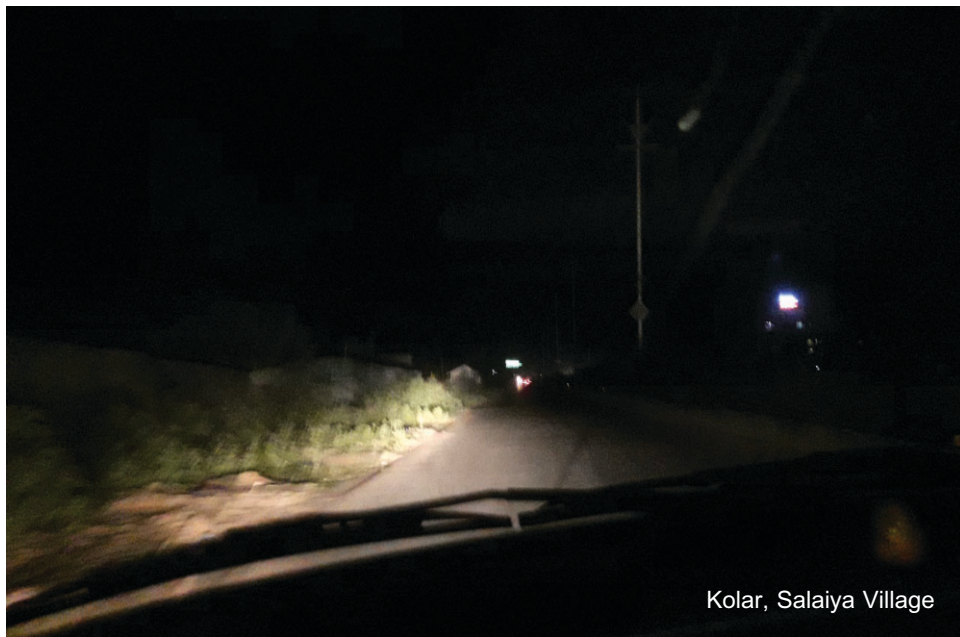
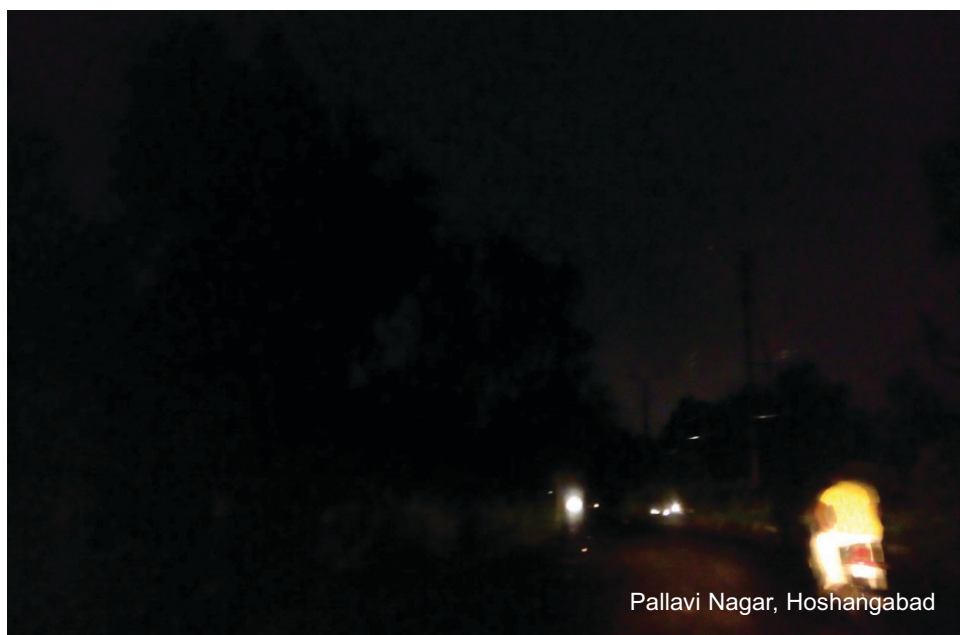
Images showing stretches with non-functional streetlights

The existing streetlights that have been found non-operational need to be checked. Regular checks should be carried out to ensure uniform and unobstructed illumination. Streetlights need to be installed along areas, identified as dark spots i.e. at these locations there is no illumination at present.

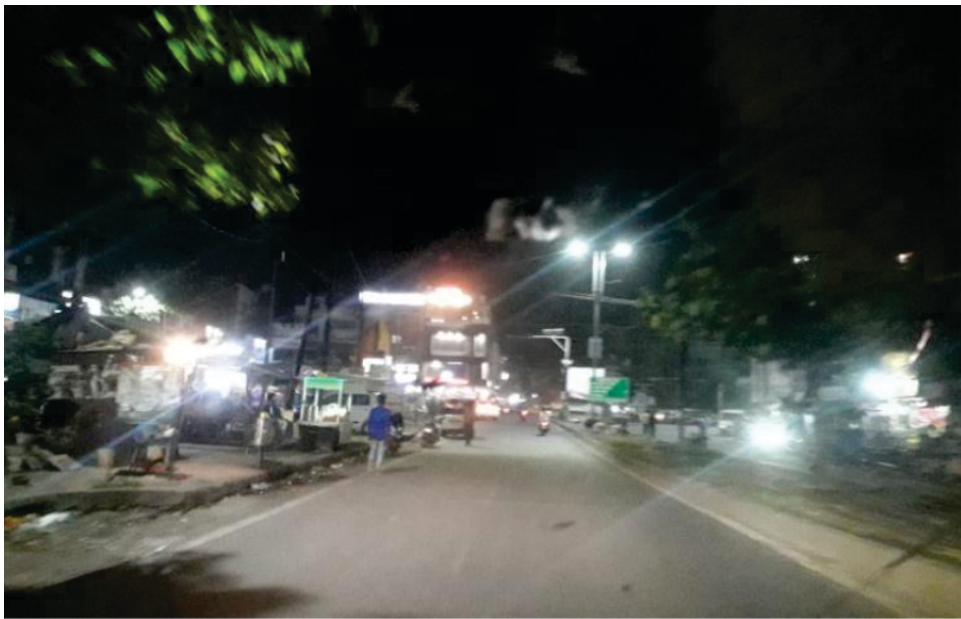
Image showing a stretch with vendors blocking the footpath

Footpath should be kept free from any obstructions. Obstructions due to vehicular parking, construction debris or extended shops should be removed. Designated space to be provided for on-street parking clear of pedestrian path. Space should also be provided for hawkers as they help in making streets active hence safer for women pedestrians.

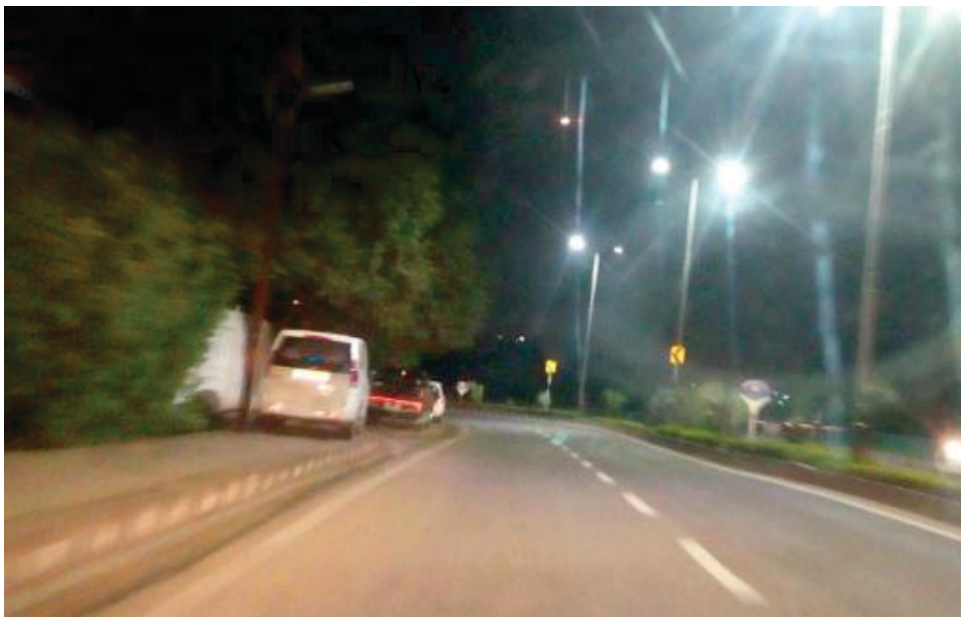
Image showing walkpath being blocked by the cars

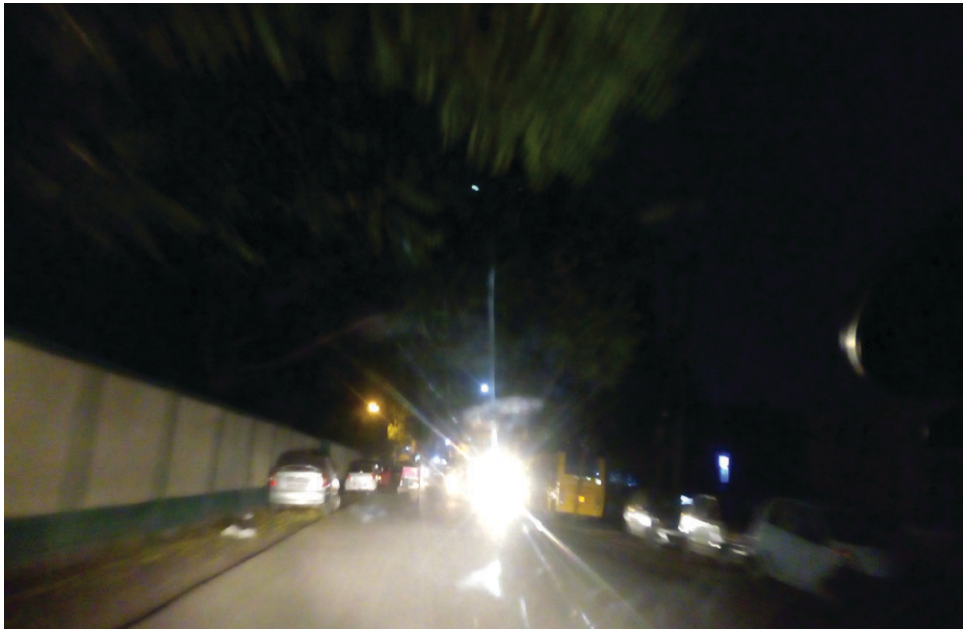
Visibility has been rated 1.1 out of 3 i.e. Average. It is the least rated parameter in terms of physical infrastructure. 65 percent of the audit point have been rated poor visibility. The residences and government institutions on major roads have high boundary walls. This results in poor visibility and pedestrians have no visual contact with the inhabitants. To improve visibility, the height of solid part of the boundary wall should be reduced to 1 m and the rest of the height can be attained through grills. This would increase level of transparency between the streets and the buildings.

Image showing a stretch with high boundary wall

High boundary walls result in poor visibility along the walkpath. Wherever possible, the height of the solid part of the boundary wall should be maintained at 1m. Above the solid part, grills can be used to achieve the remaining height. Inactive edges along the footpath instill a sense of fear in the pedestrians.

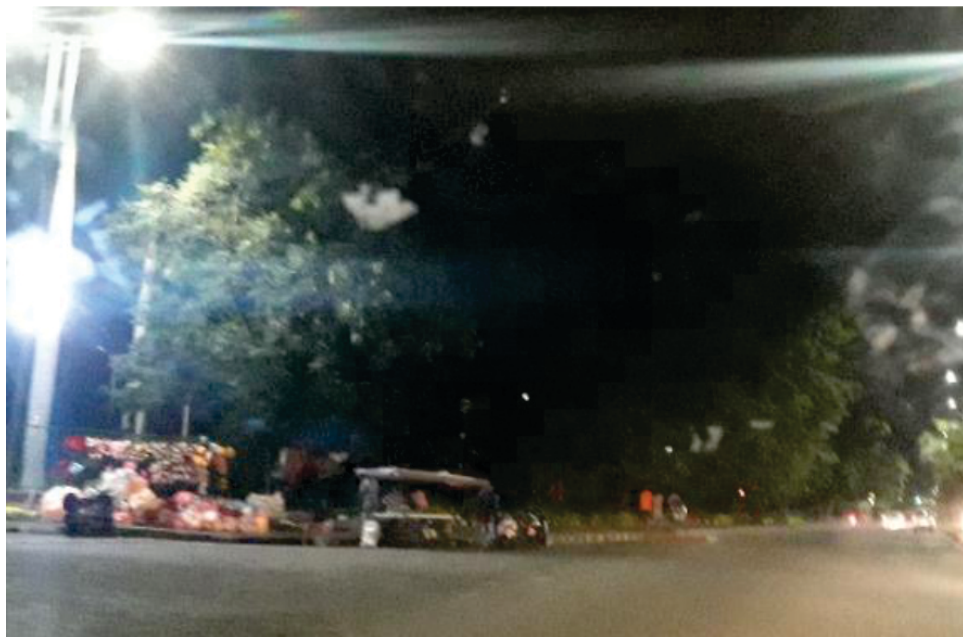
Vendors and hawkers at junctions and road sides were found to be contributing to 'eyes on the street' thus acting as a natural surveillance. Designated spaces i.e. 'hawker zones' should be provided for them along the footpath to clear of the pedestrian path.

Image showing street vendors along a stretch

Edges can be made active by providing space for street furniture and incorporating the street vendors. Hawkers and vendors act as natural surveillance system. Creating such zones throughout the city will help activate the public realm making one feel safer.

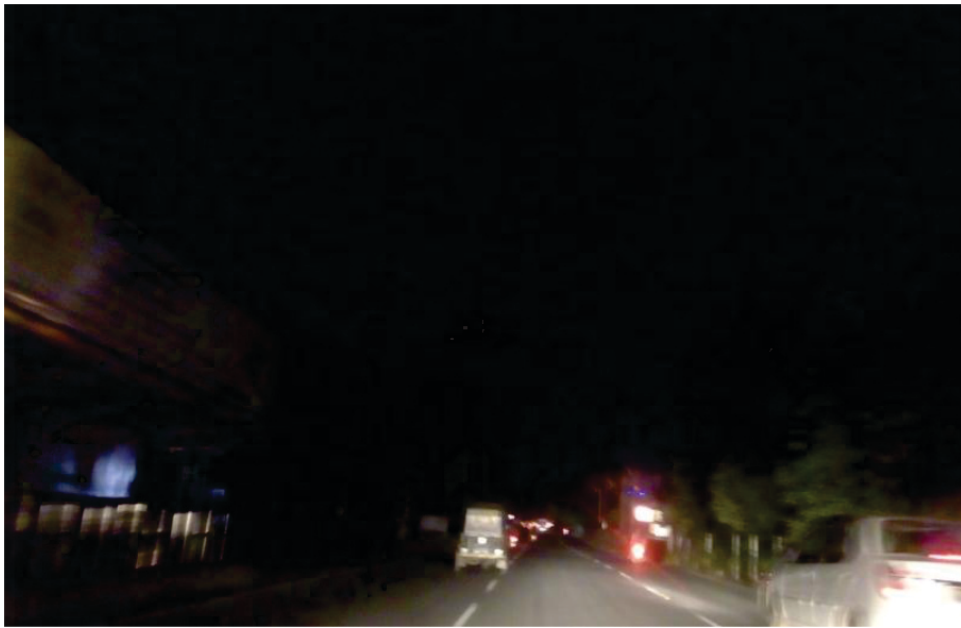
Image showing a deserted dim-lit bus stop

It is important to ensure that people find public transport in their city as safe and convenient. Existing bus shelters should be upgraded. They should be well lit and have adequate seating. Interactive panels indicating routes, emergency helpline numbers and an emergency button for help in distress should be provided at the bus stops.

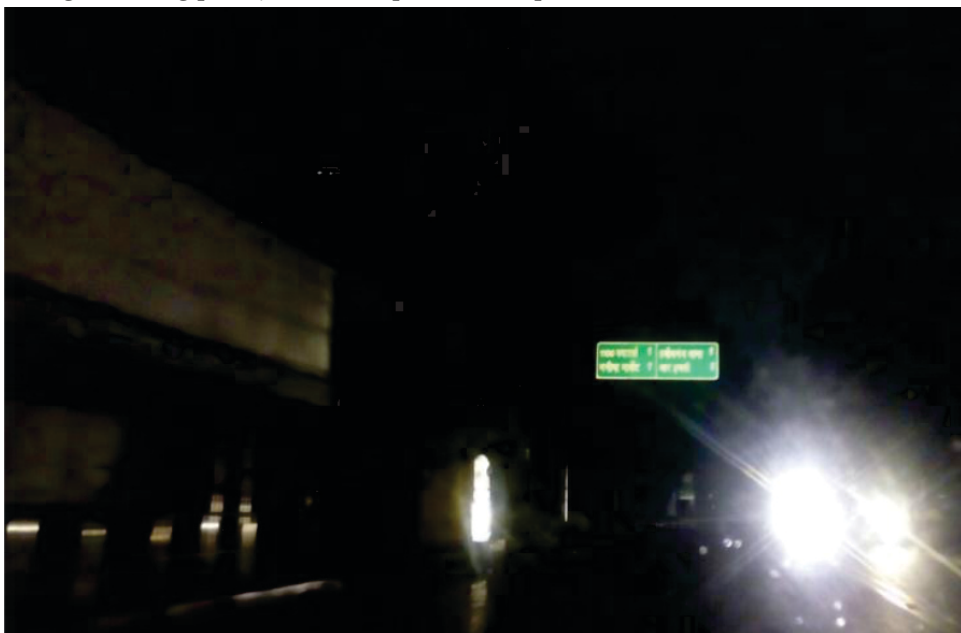
Image showing poorly lit Bus stop in Ibrahimpura
