BOGOTA

a Safety Analysis Report

Introduction:

Safetipin in partnership with District Secretary for Women, Bogota conducted safety audits in Bogota supported by UN Habitat and Cities Alliance.

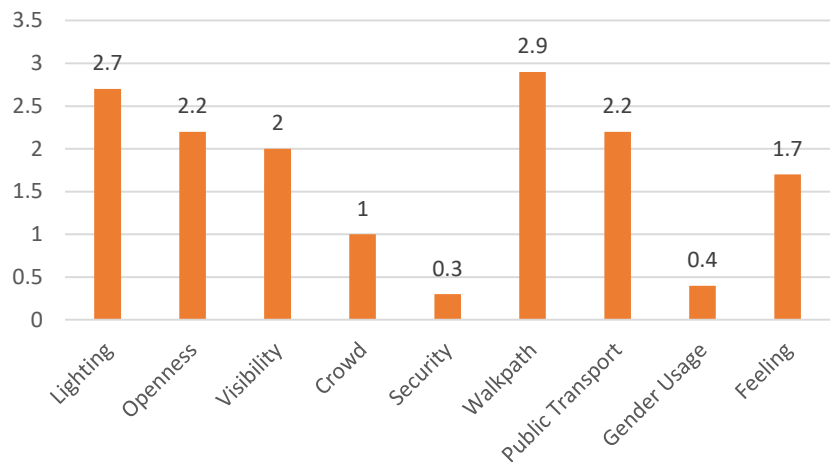
Average Parameter Rating

Each of the nine parameters is rated 0/1/2/3, 0 being the poorest and 3 good. The average parameter ratings graph indicates the overall average rating for each parameter. Walkpath and Lighting parameters have been rated the highest i.e. Good followed by Public Transport, Openness and Visibility. Security and Gender Usage are the least rated parameter i.e. Poor. The overall feeling of Safety for the city of Bogota is rated Average.

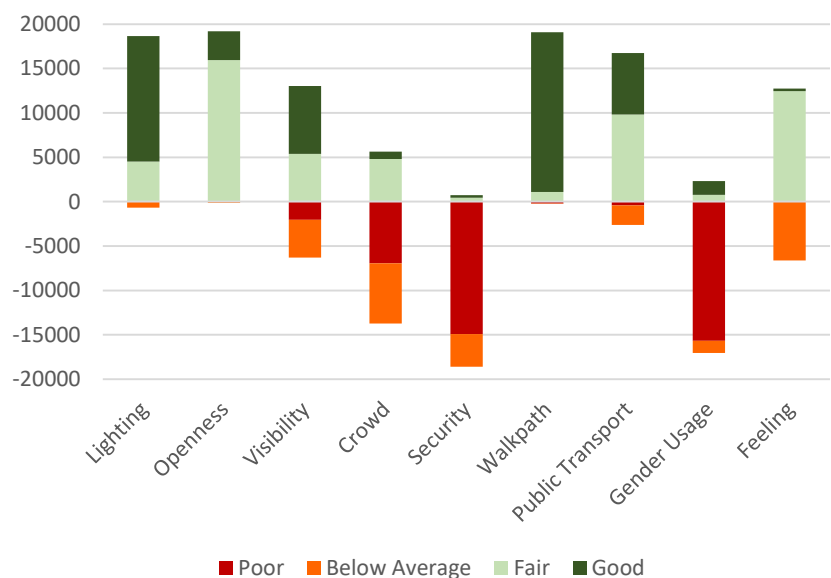
Pin Distribution Graph

The Parameter wise pin distribution graph indicates the number of points rated 0/1/2/3 i.e. the good points as positive and poor ratings as negative. The parameter of Crowd, Security and Gender Usage have been rated poorly for the most parts of the city. Visibility and Public Transport needs to be improved in some parts of the city.

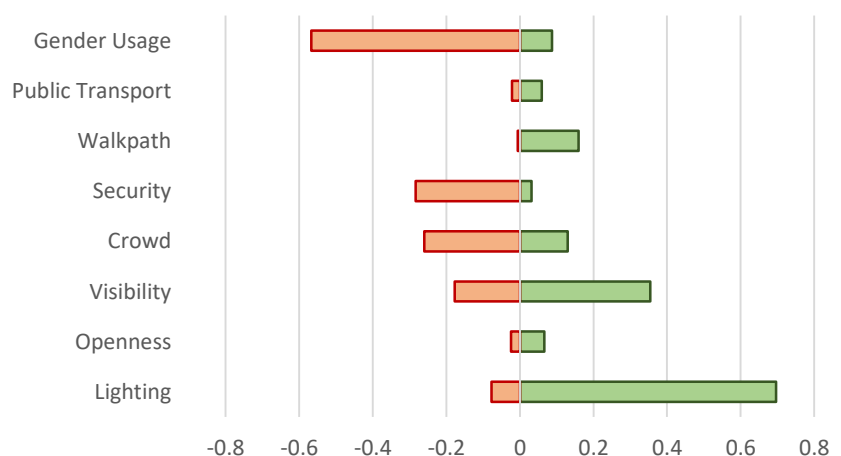
Gap Impact Graph

All parameters do not have an equal impact on the perception of safety. It is therefore useful to know how an improvement in each parameter will impact the Safety Score of the area. The Impact Bar shown indicates the extent of influence and the relative impact that each parameter has on the perception of safety. The combined length indicates the impact potential of the parameter. The parameters with the maximum combined length have the highest impact on the perception of safety and vice versa i.e. Lighting has the maximum impact and Transportation the least. The positive length (in green) indicates the extent of provision that has already been made on ground. The negative length (in red) indicates the (remaining) amount of improvement needed to increase the Safety Score. Since, increase in Crowd and Gender Usage is dependent on other parameters, improving Visibility and Security on the streets of Bogota will result in safer public spaces.

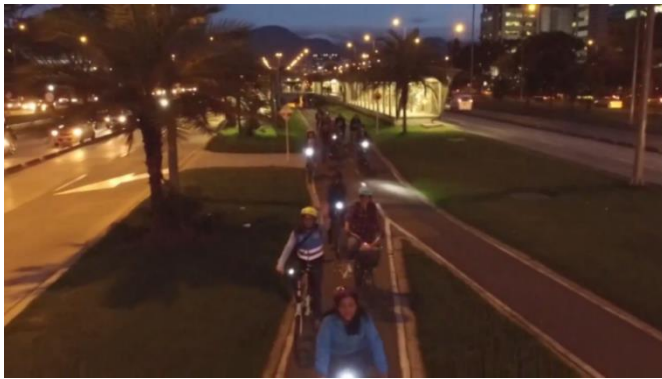
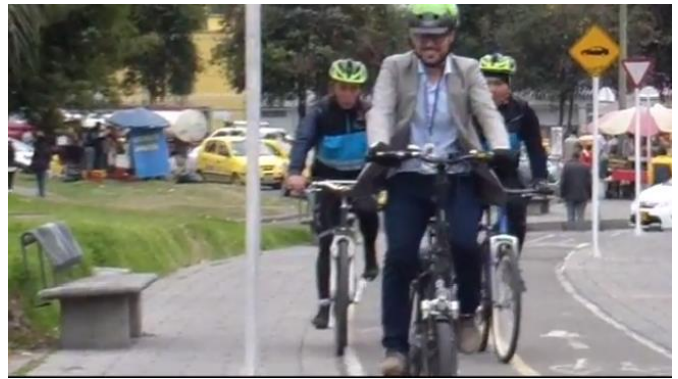
Map indicating Lighting rating along the Cycle track

Lighting Parameter has been rated 2.4/3 i.e. Above Average. As seen in the map, most of the area i.e. 49% is brightly lit with only 9% of audit locations have inadequate illumination.

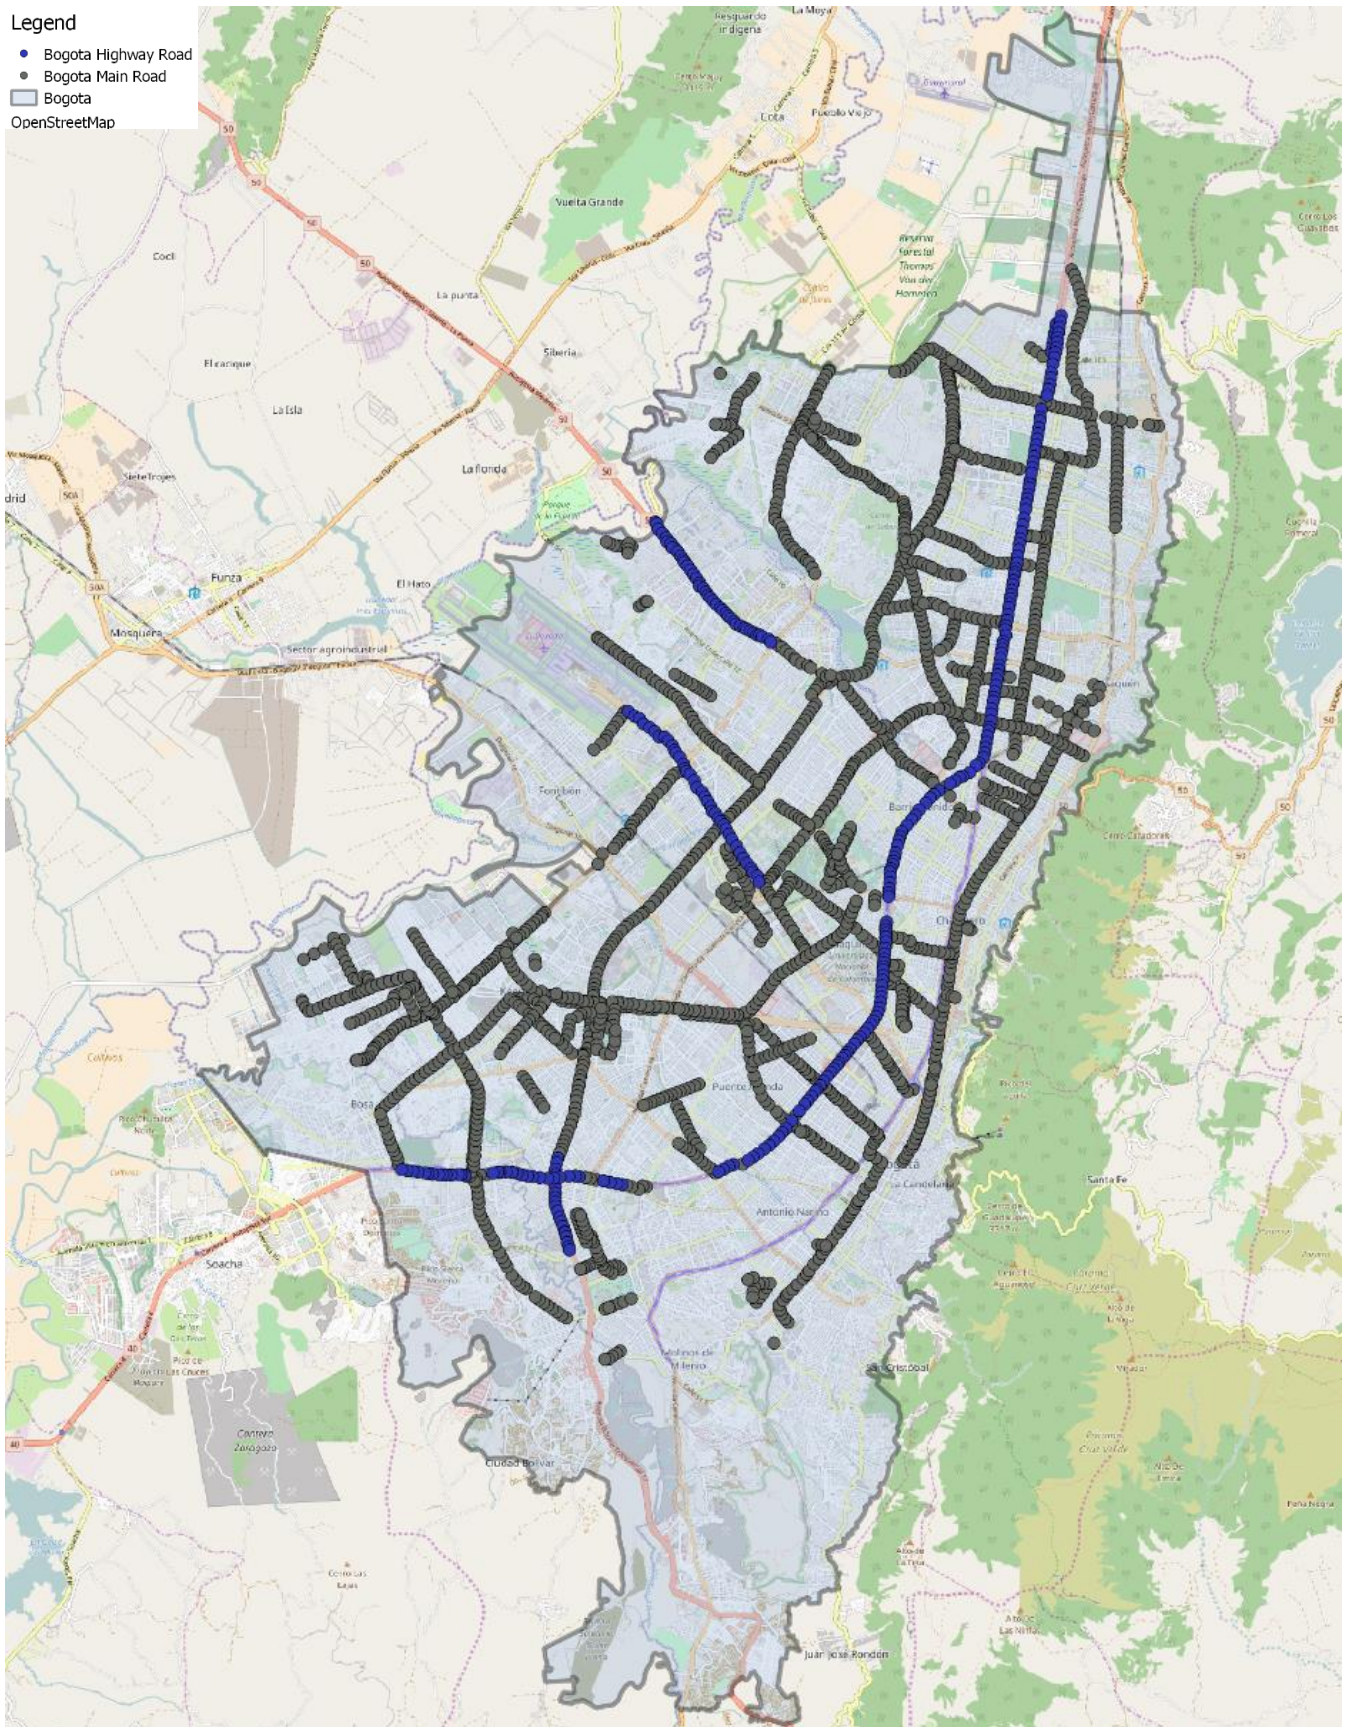
Map indicating distribution of Cycle track

This map shows the distribution of the existing cycle track along the highways having more than 6 lanes and the main road having 4 or 6 lanes. Using this data, a smooth and unobstructed cycle trails could be planned around the city.

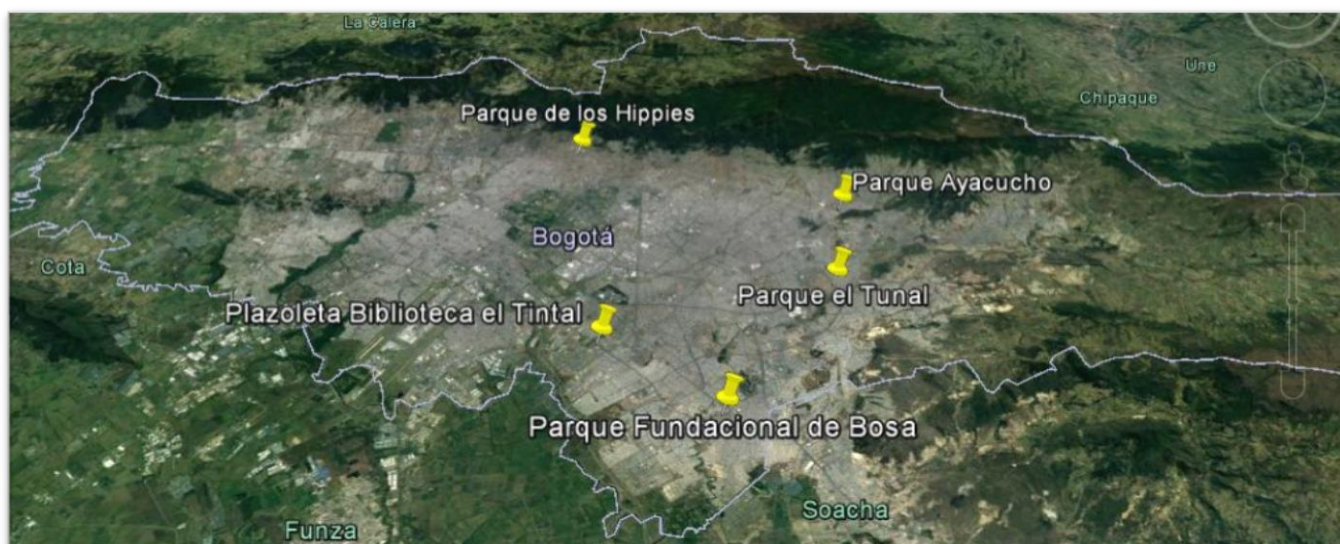
Map indicating the five identified locations for the campaign

Through the analysis of this georeferenced information, and with the support of the territorial team of the SOFIA strategy, that belongs to the Elimination of Violence and Access to Justice Department of the Secretary for Women, five points of the city were identified to prioritize and intervene. These localities are Tunjuelito-Ciudad Bolívar, San Cristóbal-Usme, Chapinero, Kennedy and Bosa.

Women's District Secretariat under the slogan "Women taking the night" carried out five night sessions at sites (as shown in the map) that are closest to the areas identified as unsafe for women in the use of public night spaces. These included the participation of citizens and Local Operative Councils for Women and Gender, and local women's organizations.
