ENHANCING LAST MILE CONNECTIVITY

A SAFETY ANALYSIS OF THE YELLOW LINE, DELHI METRO

SafetiPin has been conducting audits to assess the safety of the city of Delhi since August 2013. This report is based on the safety audits done from June 2015 for 17 metro stations of the Yellow Line of the Delhi Metro. These stations were selected on the basis of their footfall and further connectivity options.. The study reveals the shortfalls in the public transportation system of Delhi and suggests recommendations to better integrate the Metro with other modes of travel.

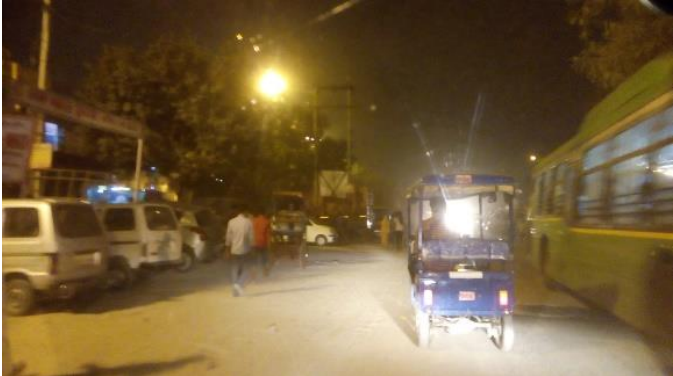
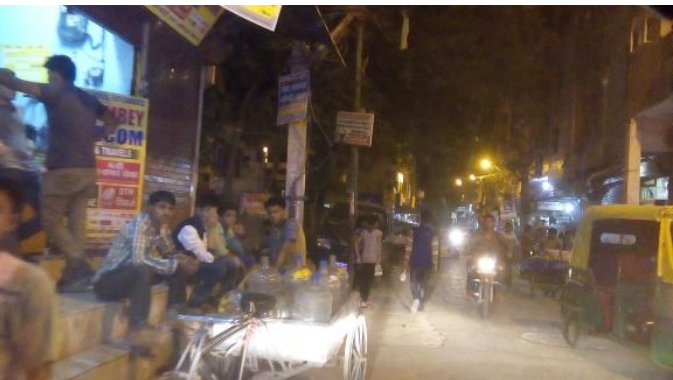
The Mall Road Extension has buildings set back from the road. The setback is used for vehicular parking. There are no vendors visible.

The Colony Roads have some crowd on the street but they are mostly men in the evening hours. Also, the shop goods spill out onto the pedestrian right-of-way. In other areas, the vehicles are parked along the walk path forcing people to walk on the road.

- **Proper Footpaths.** The residential areas have walkpaths but they are being used for vehicular parking in many places. The footpaths need to be reclaimed. Parking zones need to be created outside market areas. Along the neighbourhood roads with shops, it has to be ensured that the goods do not spill out on to the street and there is space for people to walk comfortably.

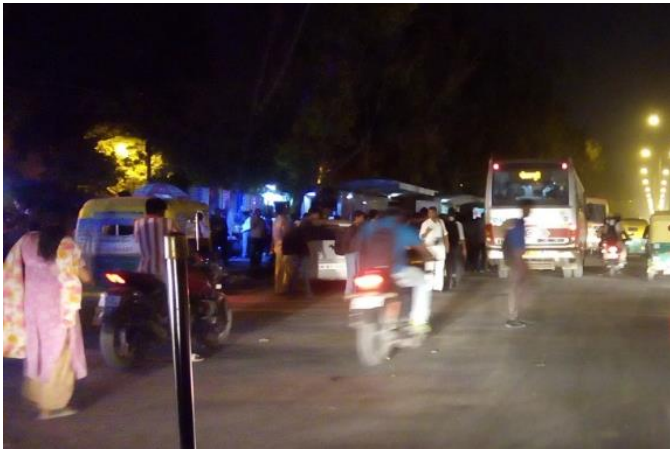
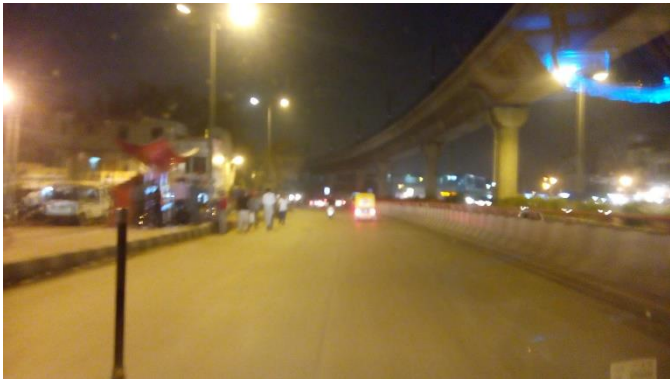
Edge conditions along the Ring Road

The visibility is poor in this area both along the Ring Road and the residential areas. The industrial areas offer no visibility due to blank walls flanking the roads.

- **Re-develop Industrial Edge.** The industries and warehouses do not have a porous edge. Also in certain places the activities and goods tend to spill out on the road. Both of these affect the pedestrian movement. The encroachment on the roads needs to be checked. The built façades need to be made porous by having more windows.

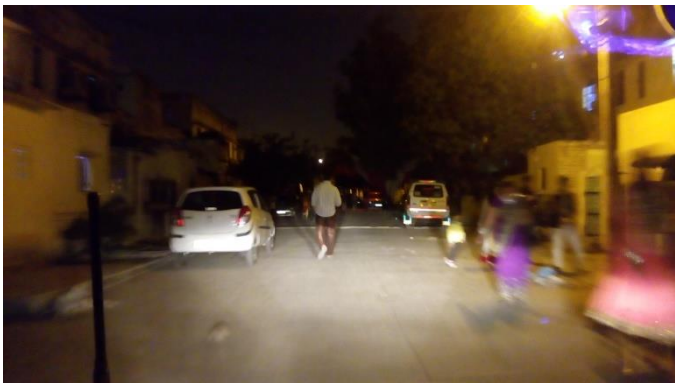
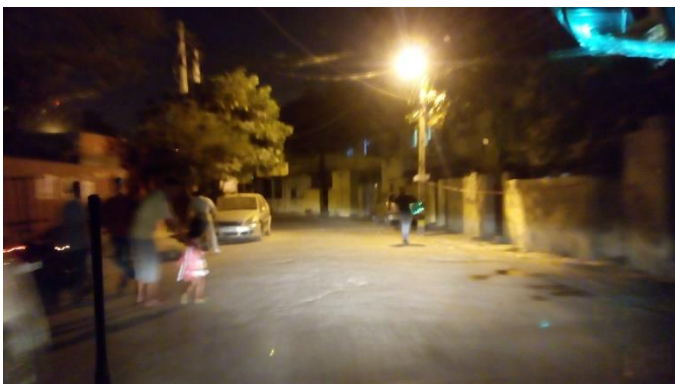
The Residential streets are well lit with few people on the street. The hawkers are seen in very few areas only.

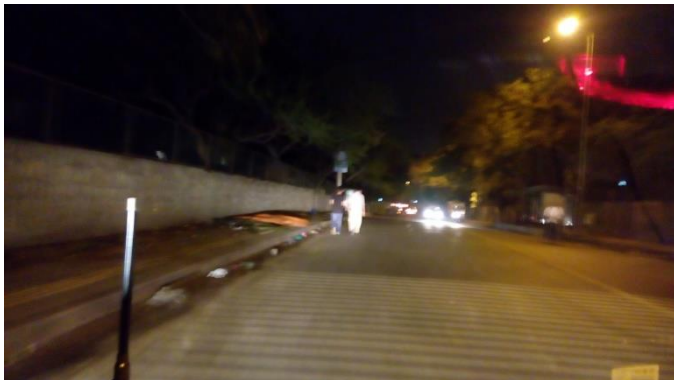
Edge condition along the Ring Road

Despite being a Campus zone, the visibility is poor in the evening hours. The buildings have wide setbacks.

- **Establish Public Edges.** Currently the boundary walls create a dead interface between the institutional buildings and the public realm. Taking down the boundary walls will create a spatial connect enhancing one's visibility. As the campus has hostel facilities as well, public functions like small kiosks, book shops, eateries and cafes can be located along the road edge to make it active even after it gets dark. Currently, functions like Sports Complex also has high boundary walls.
