# GURGAON

A SAFETY ANALYSIS

Safetipin has been conducting safety audits of Gurgaon since August 2013 and a total of 7195 audits have been done.

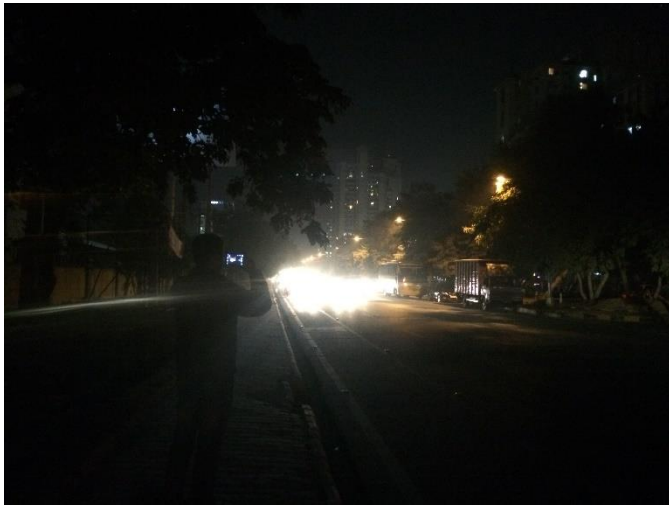
## Lighting Rating – 1.2/3

Lighting was found to be poor along most parts of the city. Increasing the illumination level at a place has the maximum impact in increasing the feeling of safety. New streetlights should be installed where there aren't any currently. Additional streetlights should be installed where they are too far or only on one side of the road. Regular pruning of trees is necessary to ensure the light isn't obstructed by foliage.

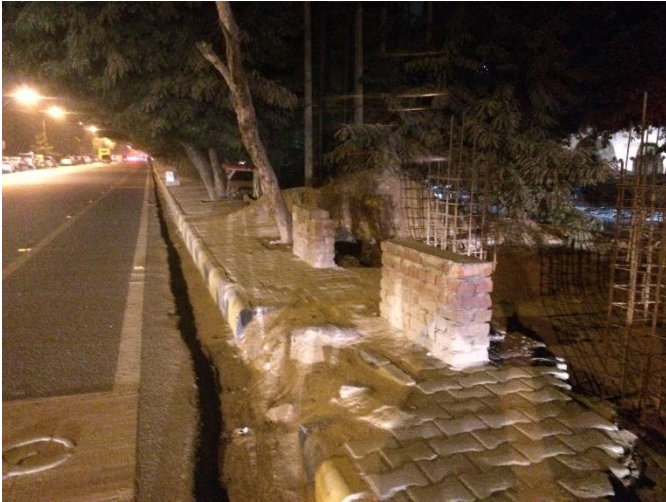
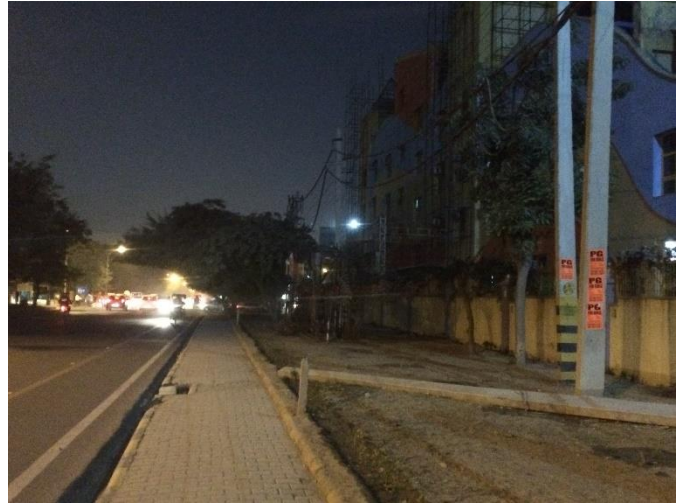
## Walkpath Rating – 1.7/3

Walkpath has been rated Average for the city. While it exists in many locations and in good condition, along many point it is either not properly paved or is broken. At many locations the footpath was observed to be obstructed by trees, streetlights, traffic lights, electrical poles and other built structures. These should either be removed or the footpath widened where it isn't possible to clear the footpath. Also tactile paving should be incorporated at all places.

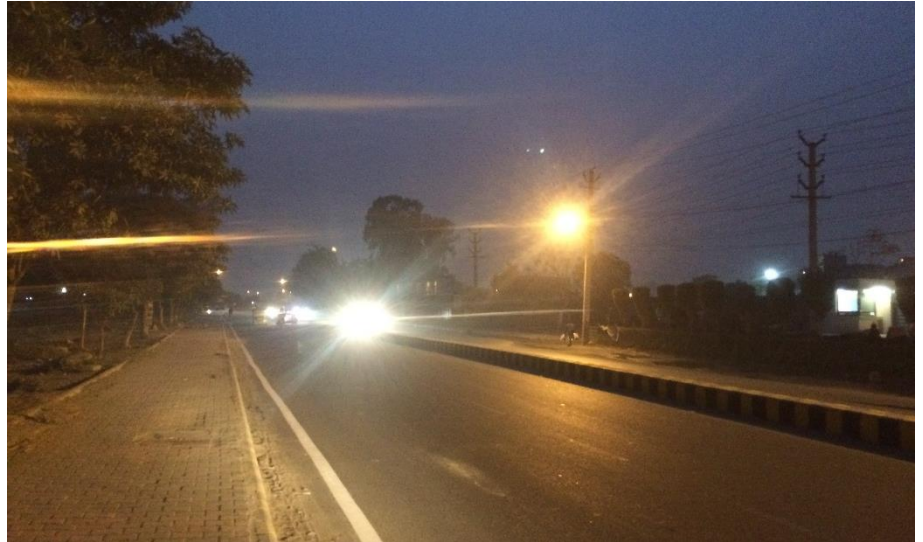
## Visibility Rating – 0.9/3

After Lighting and Gender Usage, the Visibility parameter was found to have the maximum impact on the feeling of safety. In Gurgaon most of the roads are flanked by dead edges making it unsafe. The height of the boundary walls should be reduced. At places with wide footpaths or green buffers or where a service lane exists, there is a possibility of using the road space more efficiently to make it active and safe. At such places creating hawker zones or even incorporating street furniture would make the space more usable and inclusive.

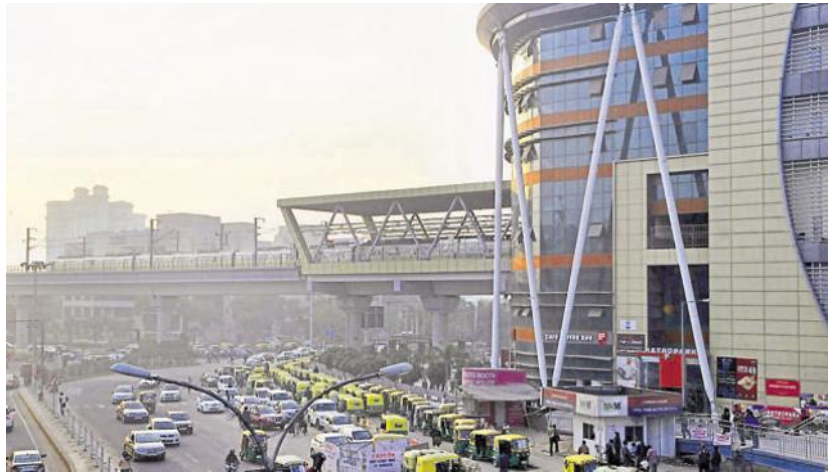
## Rating of Public Transport – 0.6/3

Public transportation network in Gurgaon is very limited catering to a few neighbourhoods. While the Rapid Metro line is being expanded, the city largely lacks proper public transportation facilities, both - mass (rapid) transit and para transit. A bus system for the city should be developed such that the bus movement is given priority on the city roads. Additionally the para-transit network and facilities need to be improved. A bicycle-rental scheme should be introduced with bicycle stands at regular intervals. Dedicated cycle tracks should also be built.
