How Safe are the Tourist Places in Delhi?

Safety Analysis Report

Tourist Places of Delhi

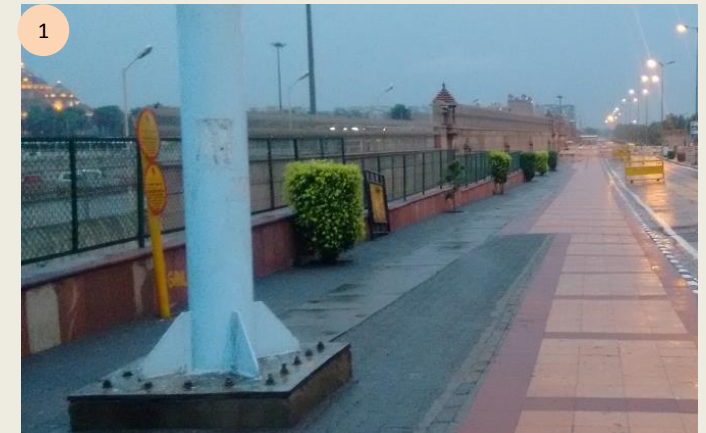
Safety Score is rated excellent at this audit point, owing to high rating in the Lighting, Walkpath, Security and Feeling parameters.

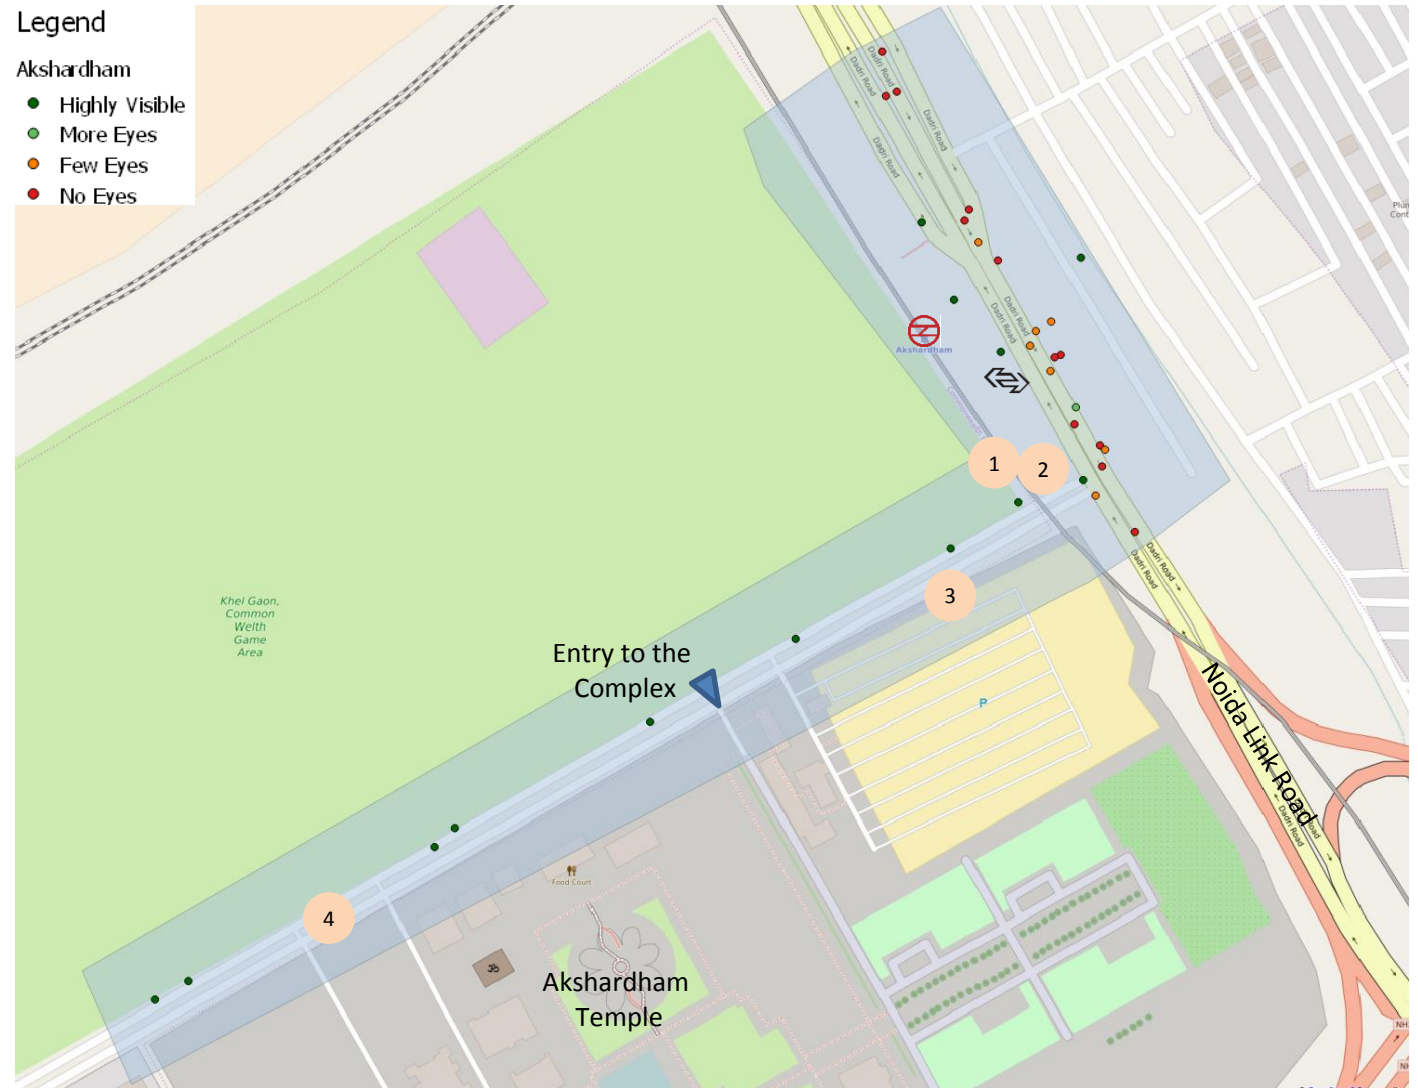
Visibility is rated 1.6/3 i.e. Average. Street vendors and temporary stalls are present near the metro station on Noida Link Road. However, they are active only till 8 PM., post which the audit stretch offers low visibility.

- 1 On the stretch from the metro station to the Akshardham Temple, various
- 2 temporary stalls and street vendors are present. In absence of any designated space, they end up obstructing pedestrian's movement on the footpath (image 2). A hawker zone should be created along the built edge, clear of the footpath.
- 3 With no street vendors (image 3) and
- 4 high boundary walls (image 4), this road to the temple offers poor visibility. As seen in image 3, the footpath on the left side is wide enough for setting up a hawker zone. A hawker zone equipped with street furniture should be set up here. Also, the solid surface of the boundary wall on the right side needs to be reduced to atleast 1m and the remaining height can be achieved using a grill.

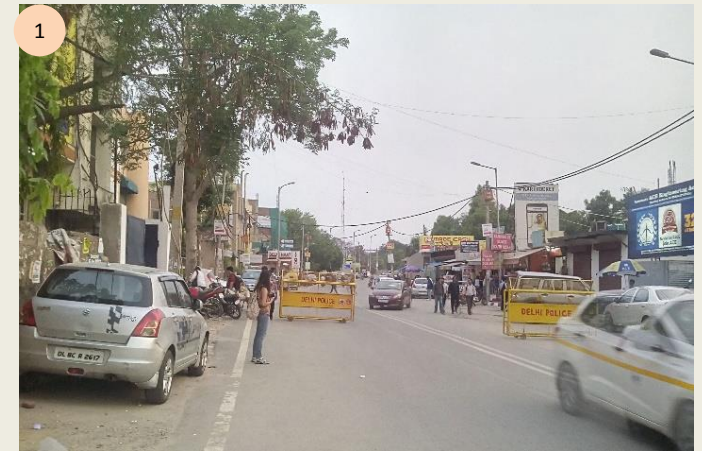
Safety Score is rated excellent at this point, owing to high rating in the Visibility, People, Security, Gender Usage and Feeling parameters.

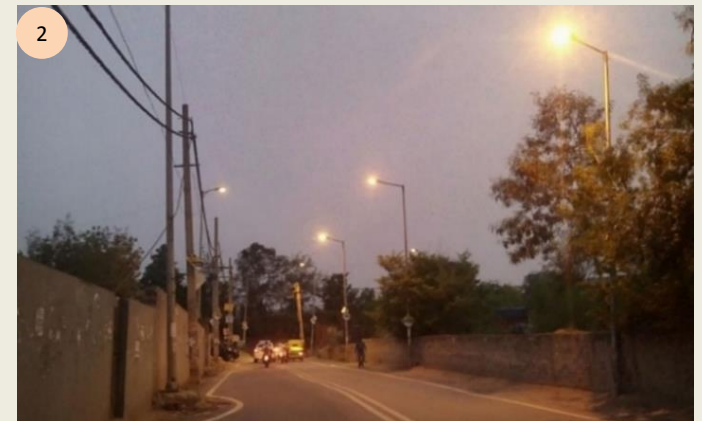
Safety Score is rated poor at this point, owing to low rating in the Visibility, People, Security, Public Transport, Gender Usage and Feeling parameters.

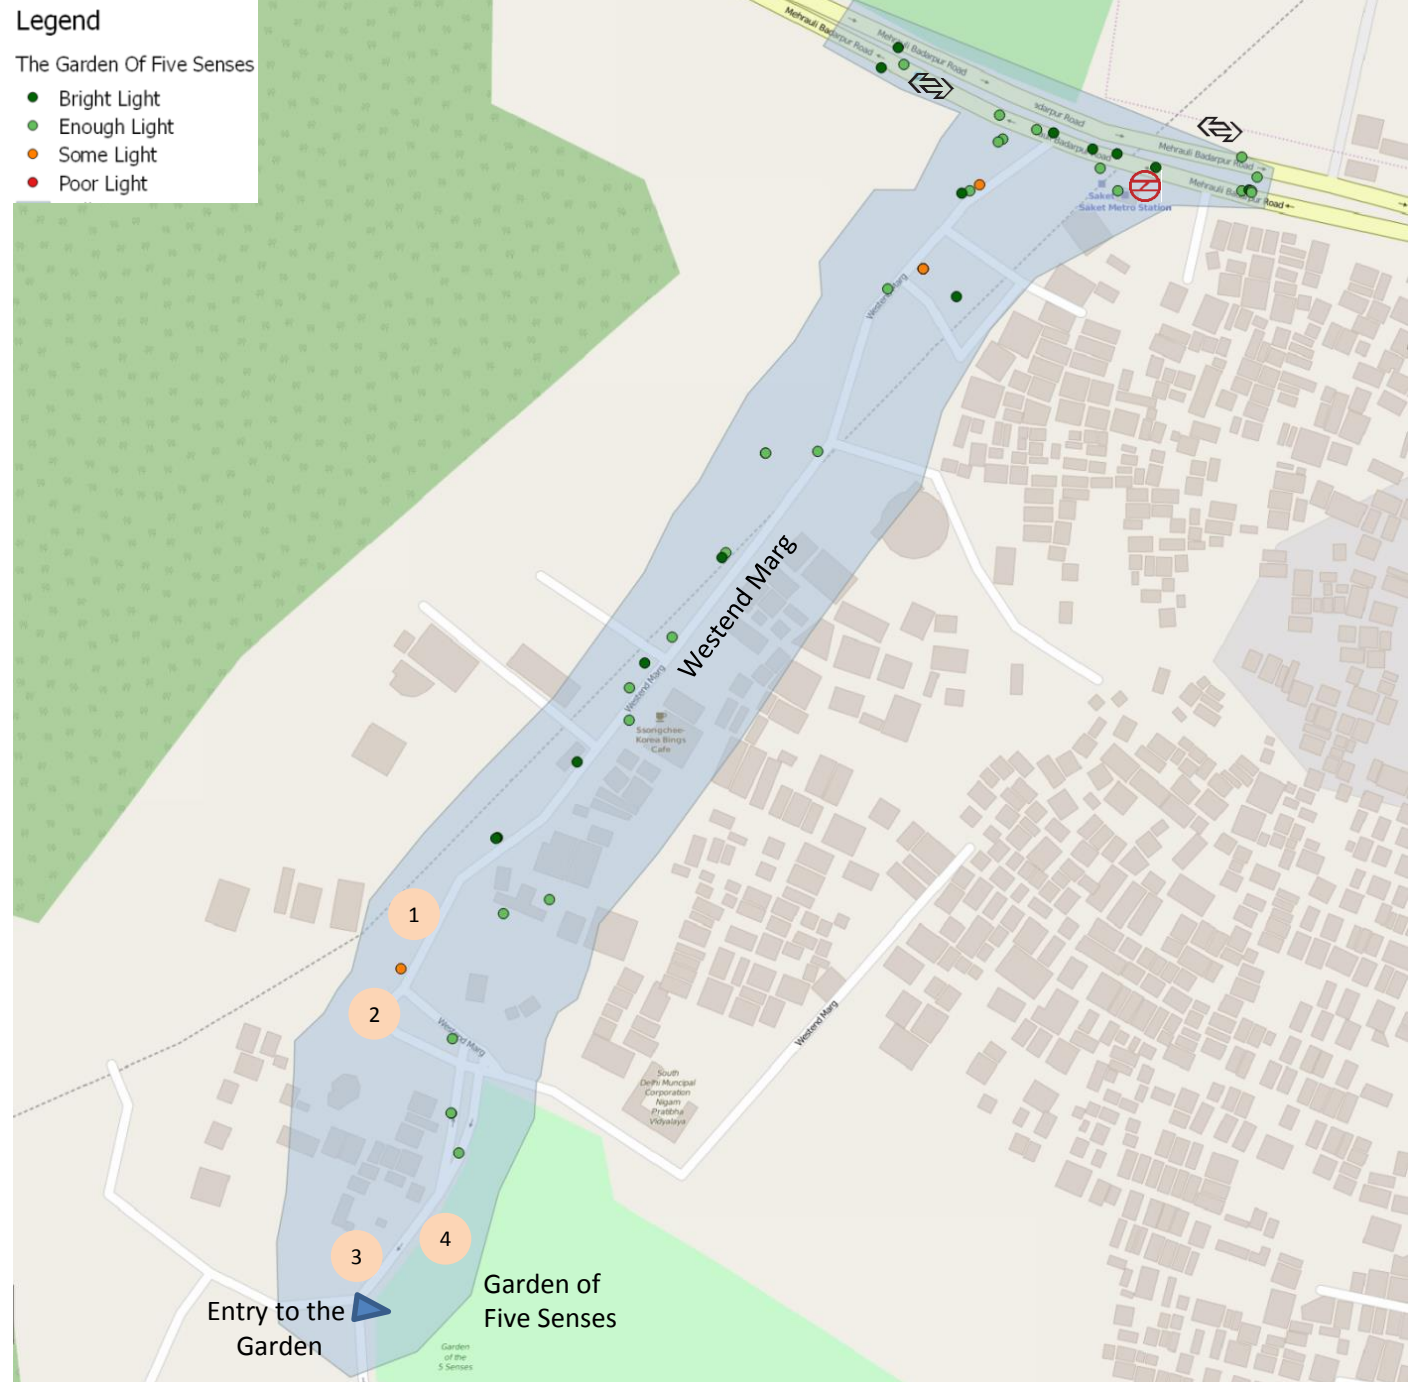
Lighting is rated 2.1/3 i.e. Above Average. Street lights are present only on one side of the road. As a result, few dark spots were observed on the other side of the road. Also, lighting in parking spaces near the garden and the market was found to be inadequate.

1 On the stretch from the metro station to the market on the Westend Marg, light poles are installed only one side of the road. Additional light poles should be installed alternately on the other side of the road, that will ensure uniform illumination throughout the road.

2 Some lights were found to be non-operational at the time of audits. They need to be checked and made operational.

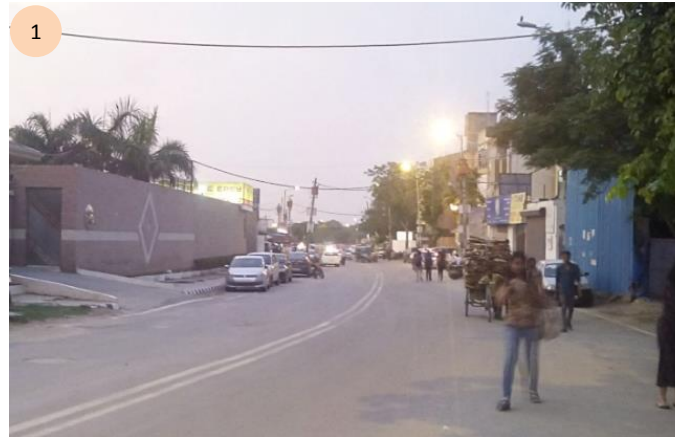
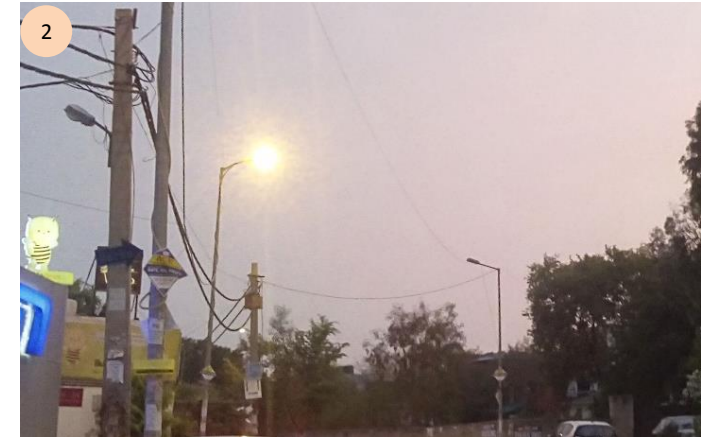
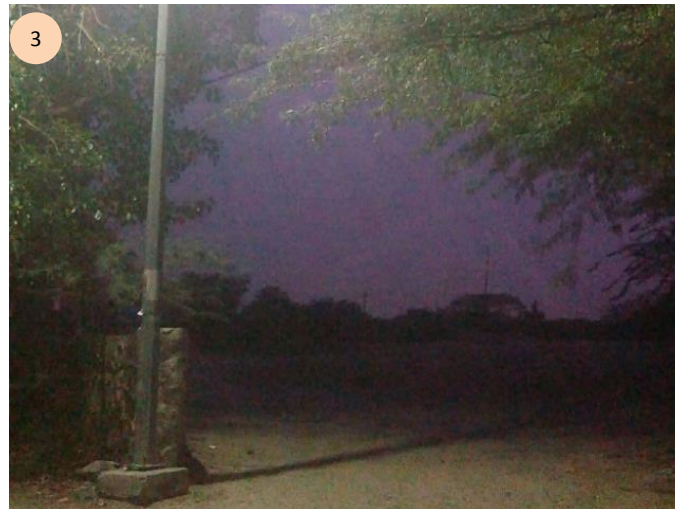
3 The parking space provided for tourist buses is not well lit. There is only one light installed at the entry. As a result rest of the area becomes completely dark at night. Additional lights should be installed to avoid dark spots.

4 Similarly, additional lights should be installed in the parking area provided for private vehicles. Also, the foliage along the streetlight needs to be pruned regularly as the overgrown leaves shield the light fixture resulting in poor illumination.

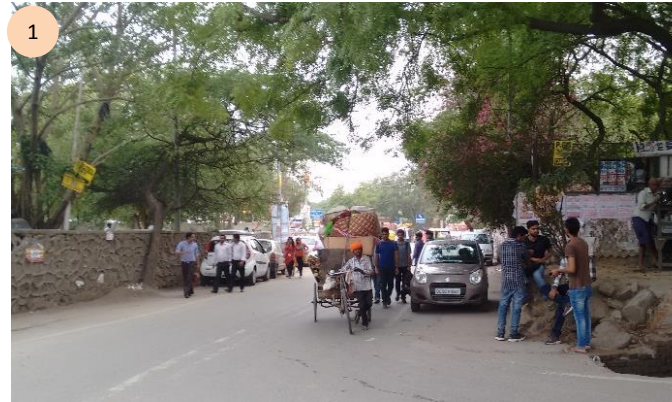
2 The footpath is completely blocked by Public Convenience and parked cars. The footpath should be built around the toilet to provide proper access. Parking on footpath should not be disallowed.

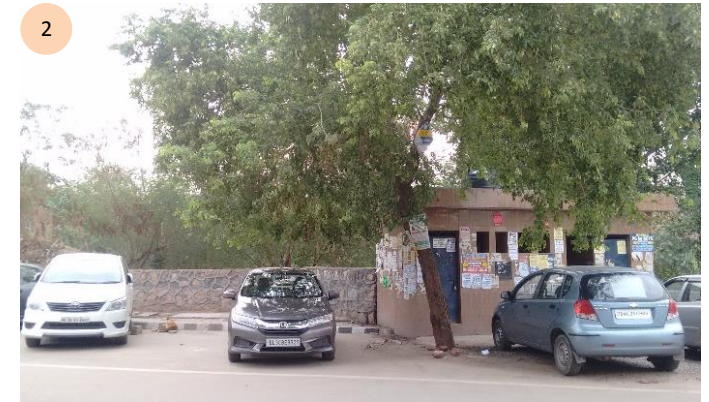
3 Footpath should be widened wherever it is obstructed by a tree. Also, vehicular parking should be disallowed on the footpath.

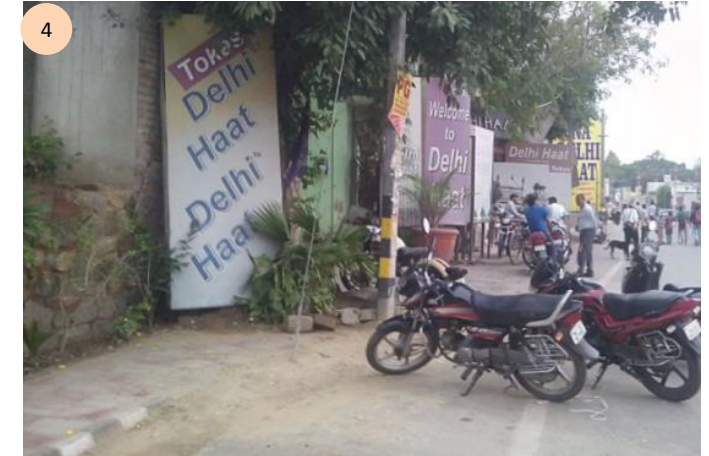
Walk path is rated 2.4/3 i.e. Above Average. Footpath exists in most of the audit path but is unusable at many spots. Along the Westend Marg, footpath is obstructed by vehicles, shops and roadside vendors, thus forcing pedestrians to walk on the road. A designated space should be created for the street vendors and temporary stalls, clear of the footpath. Also, vehicular parking on the footpath should be disallowed.

1 The footpath doesn't exist in some parts of the audit stretch, that forces pedestrians to walk on the road. In case of narrow road as seen in the image, a proper paved footpath should be constructed on one side, clear of any obstruction.

4 Shops and street vendors have occupied the footpath as seen in the image. The banners and other obstructions present in the front of the shops should be removed. At places where footpath is wide enough, a segregated space should be provided for street vendors in a way that doesn't obstruct the pedestrian movement.

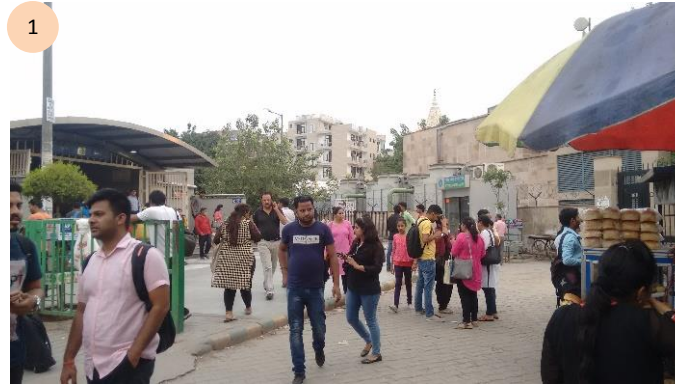
2 *The footpath leading to the market is largely inactive but occupied by street vendors at some distance. Public convenience facility is present but not operational. This space can be further enhanced by making it a hawker zone, clear of the footpath.*

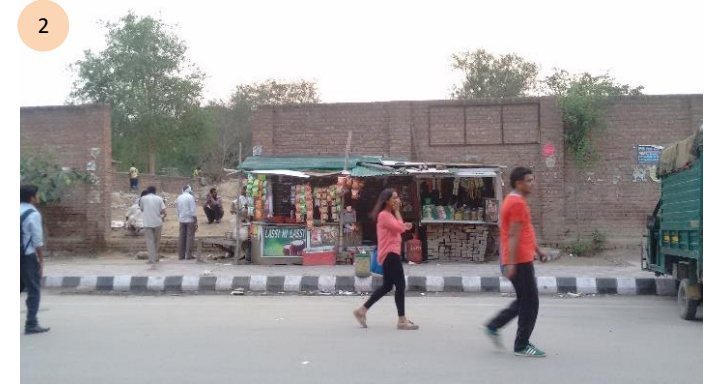
3 *The route from the market to the garden is flanked by high boundary walls as seen in image. The solid surface of the boundary wall needs to be reduced to at least 1m and the remaining height can be achieved using a grill. Also, a footpath should be constructed along one side on this stretch.*

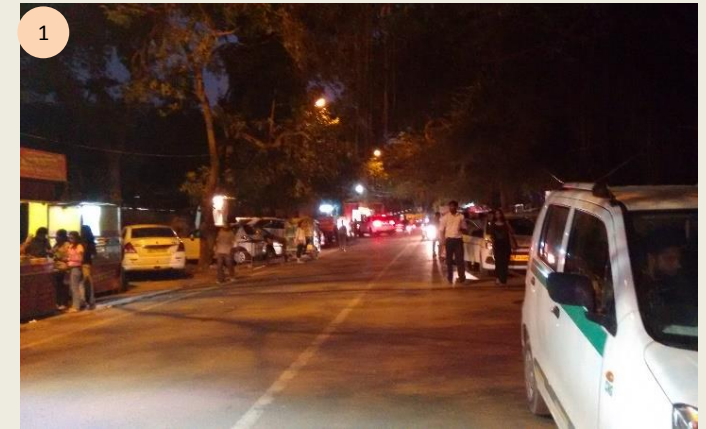
Safety Score is rated excellent at this point, owing to high rating in the Visibility, People, Gender Usage and Feeling parameters.

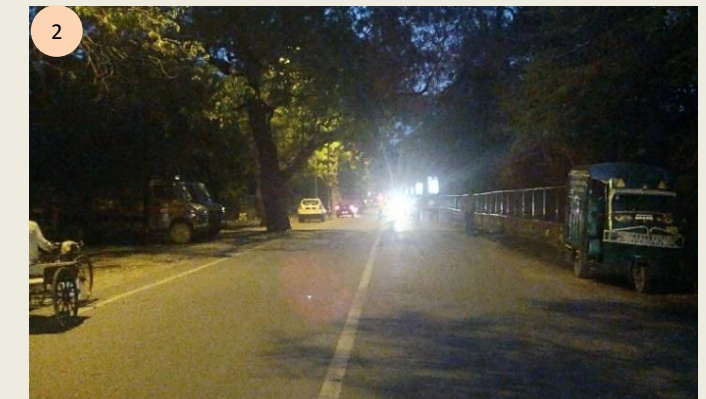
Safety Score is rated poor at this point, owing to low rating in the Visibility, People, Gender Usage and Feeling parameters.

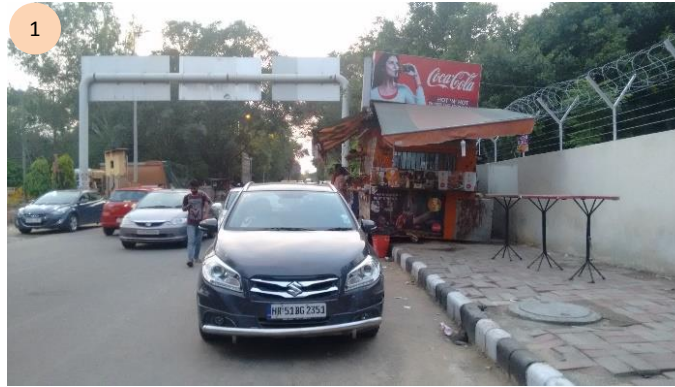
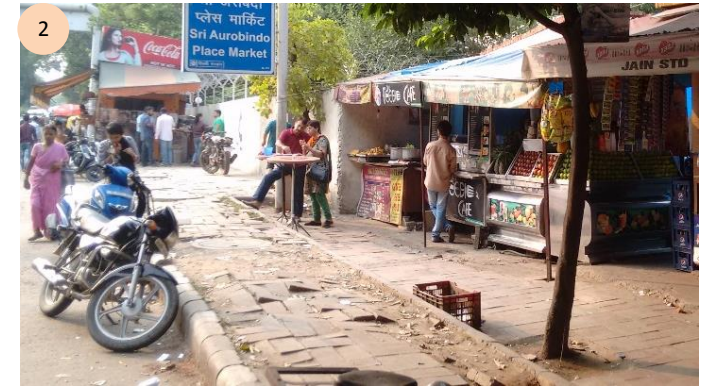
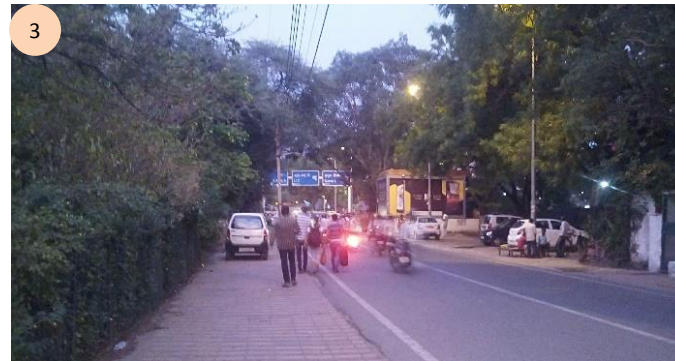
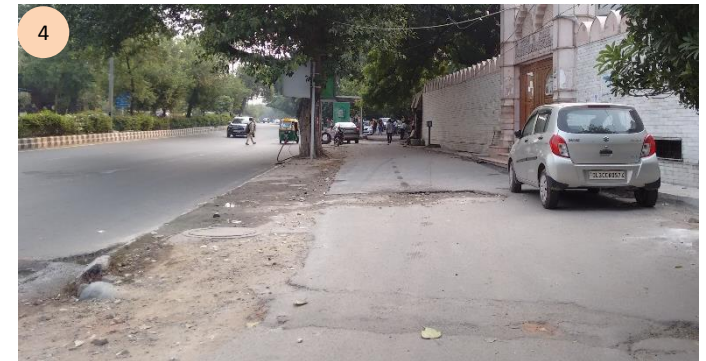
Walk path is rated 2.4/3 i.e. Above Average. However, existing walkpath on Hauz Khas Village road was not found to be user friendly. Also, the footpath on Aurobindo Marg is non- continuous and broken at some places. At some places, cars parked on the footpath obstructs the pedestrians' movement.

1 On the road to Hauz Khas Village, the footpath present is occupied by temporary stalls. They should be removed from here and shifted at the junction of Hauz Khas Village road and Aurobindo Marg (image 2) which has several other temporary stalls, clear of the walkpath.

3 Further down this road, there is no footpath. This is a two lane road which experiences heavy traffic. Currently, the walkpath for pedestrians is flushed with the road, therefore obstructed by parked cars. A footpath should be constructed and parking should be restricted to other side of the road.

4 In front of the Mosque on Aurobindo Marg, the footpath is broken. Also, there is no level difference between the footpath and the service road. To provide a continuous and smooth movement to pedestrians, this footpath should be repaired and a kerb should be constructed to segregate it from the service road. Also, wherever footpath is obstructed by a tree, it should be widened.

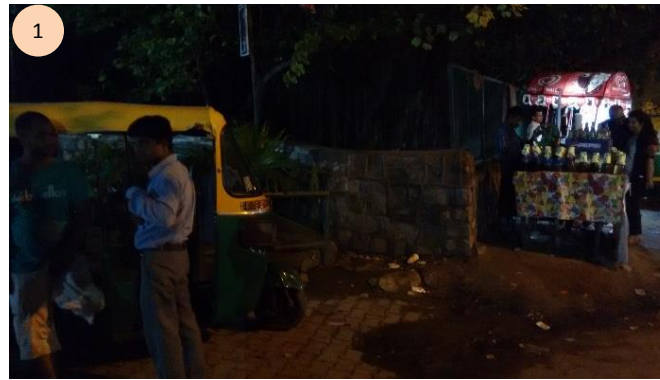
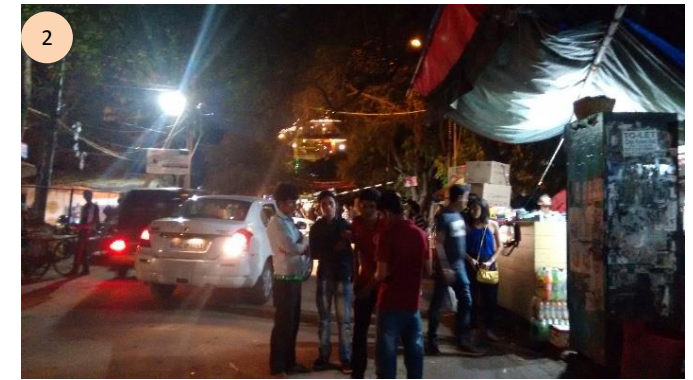
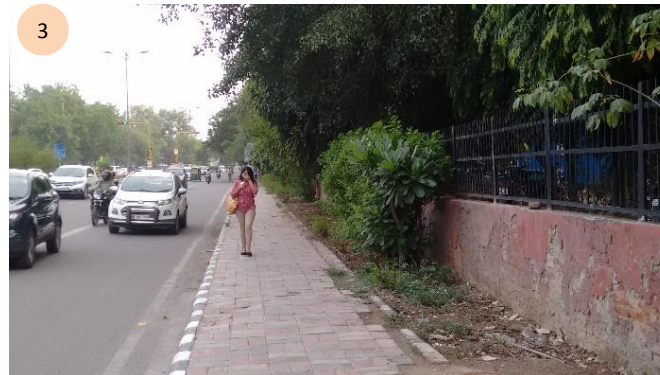
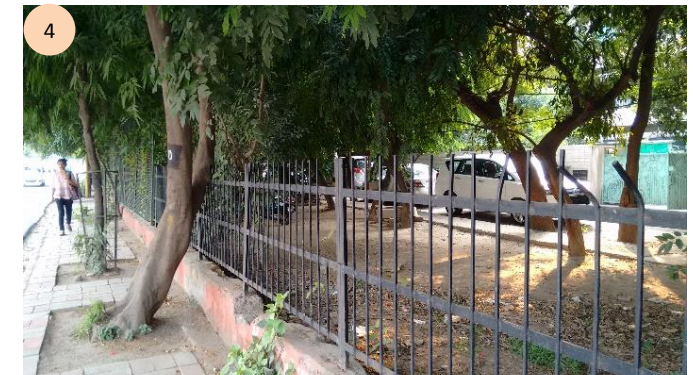
1 Near the entry of Hauz Khas Village, there are few hawkers present. A space should be designated for them by creating niches in the boundary wall of the park (image 2), clear of the walkpath. Also, a designated auto stand should be made where autos can be parked clear of the footpath and traffic.

3 Along the Aurobindo Marg, due to the planters between the service lane and the footpath, this stretch offers low visibility. To make this stretch active, this space should be redesigned to integrate it with the footpath. A shaded space equipped with street furniture should be provided for the pedestrians, which can accommodate the street vendors as well.

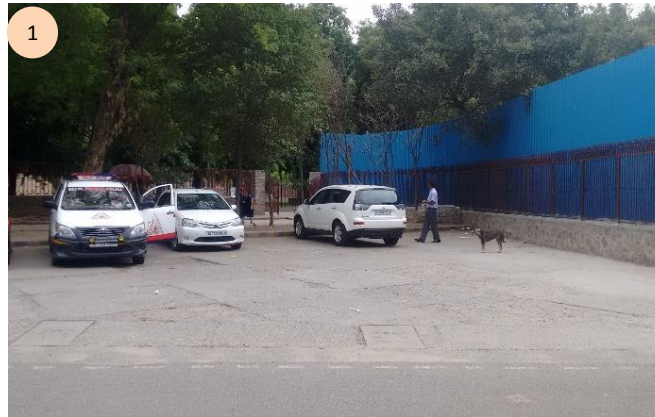
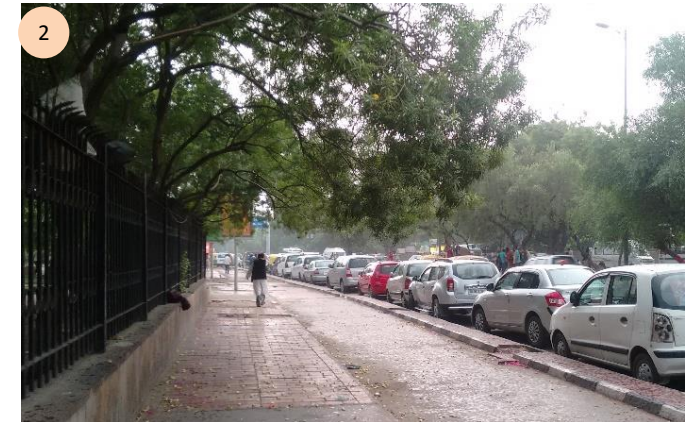
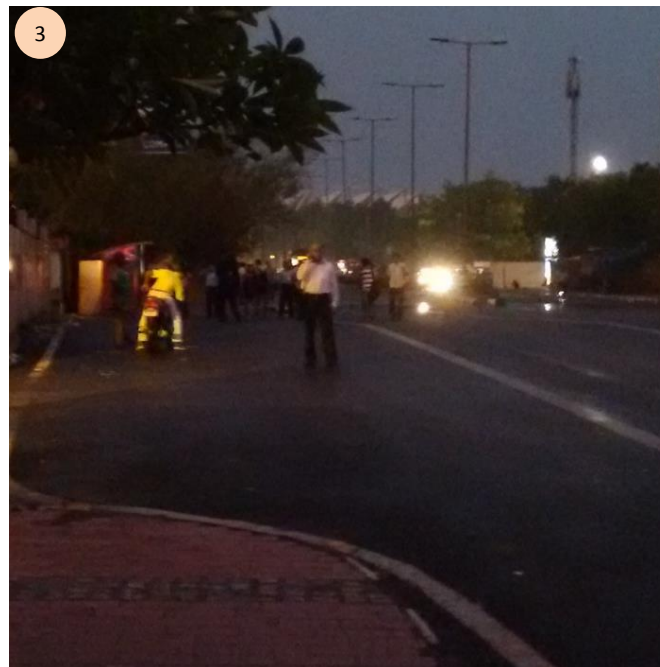
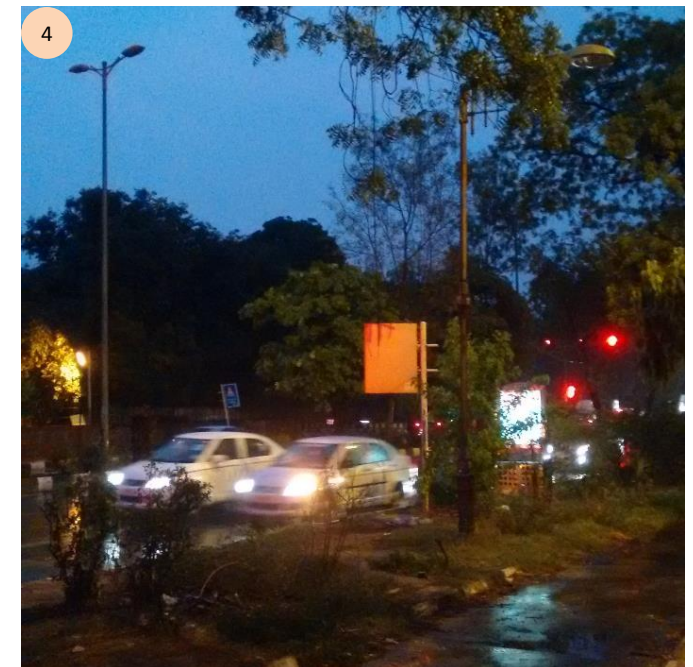
1 *There are no streetlights installed near the second entry to the tourist place. Also, lighting poles on this road i.e. Bharat Scouts and Guide Marg are installed too far from each other, resulting in low lighting. Therefore, additional light poles should be installed along this stretch.*

3 *Some streetlights near the bus stop (image 3) and on Lodhi Road (image 4) were found to be non- operational at the time of audits.*

4 *They should be made operational. Also, the foliage along the streetlights needs to be pruned regularly as the overgrown leaves shield the light fixture resulting in poor illumination*

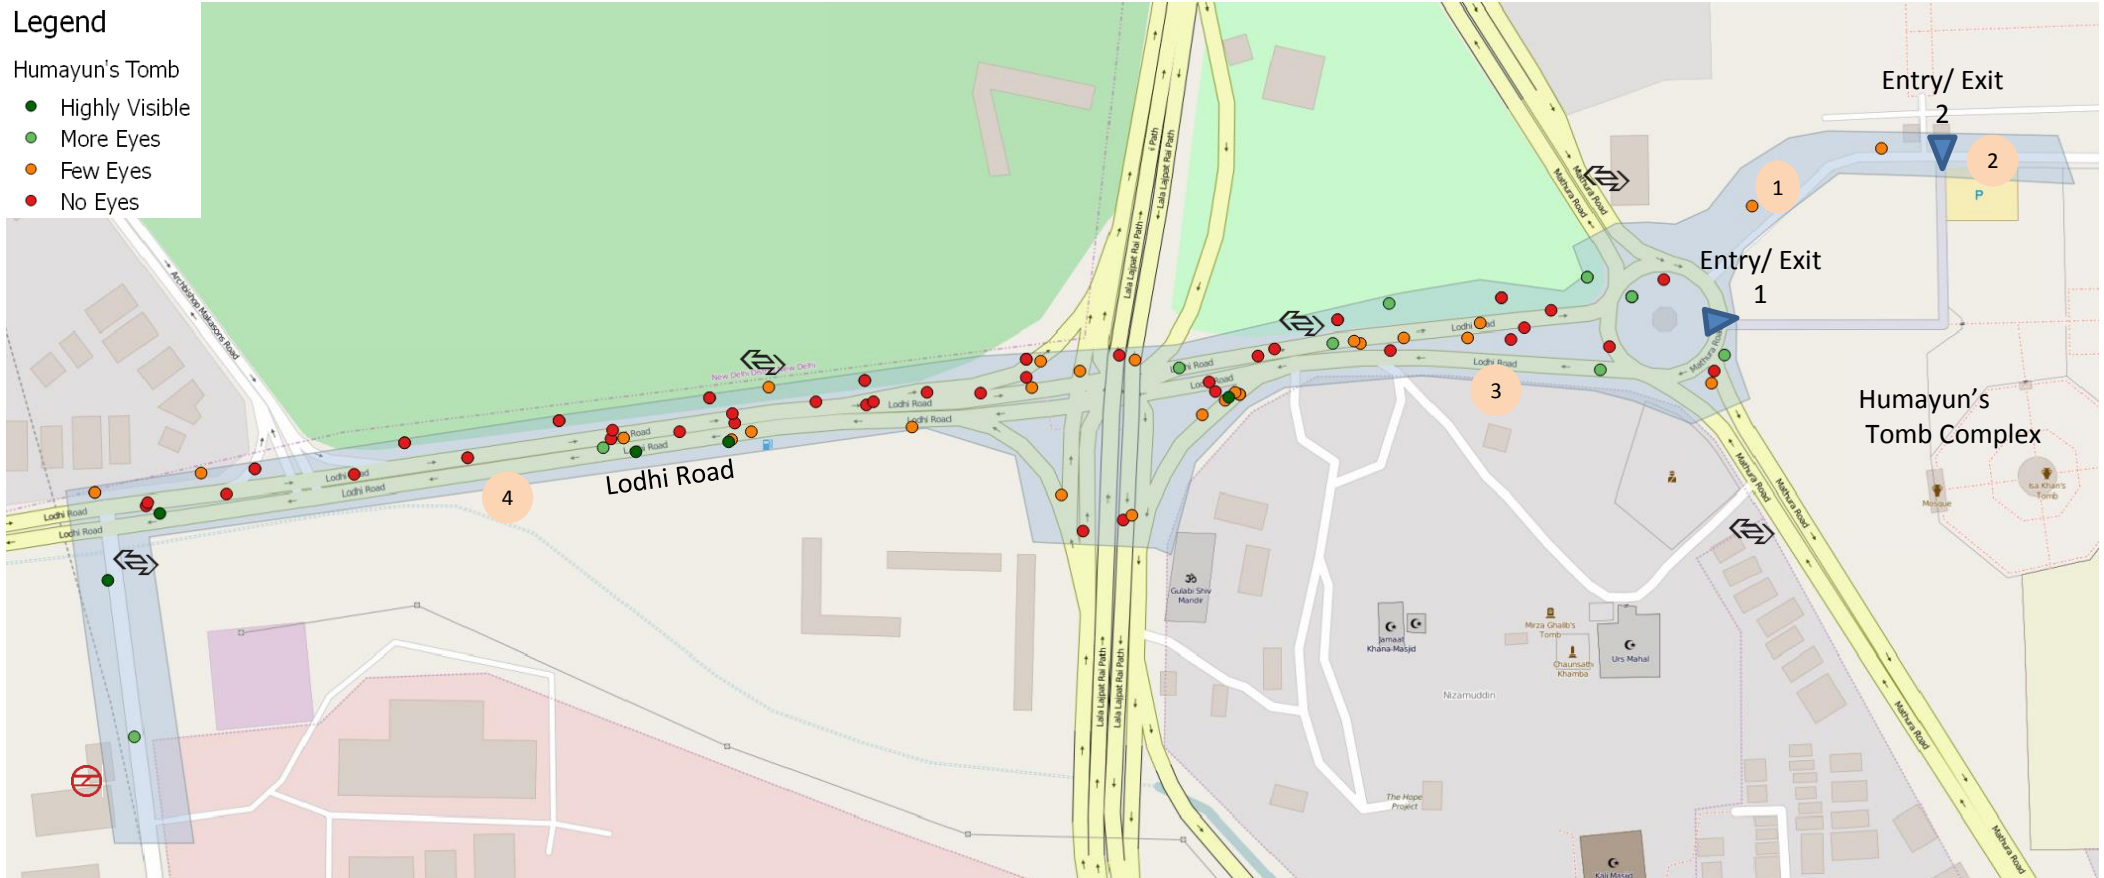
Map showing Visibility rating

Visibility is rated 0.7 i.e. Below Average. There are some vendors near the entry/exit gate of the Humayun's Tomb Complex but there is no designated space for them. The lane adjoining the complex is largely inactive due to no "eyes on the street". Additionally, with high boundary walls and large building setbacks, Lodhi Road offers minimal visibility for a pedestrian.

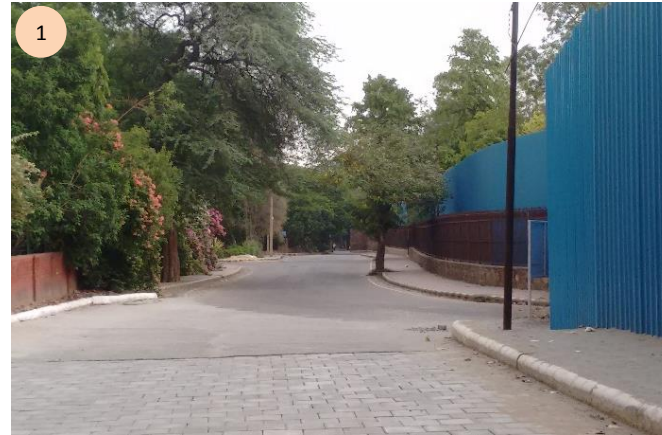
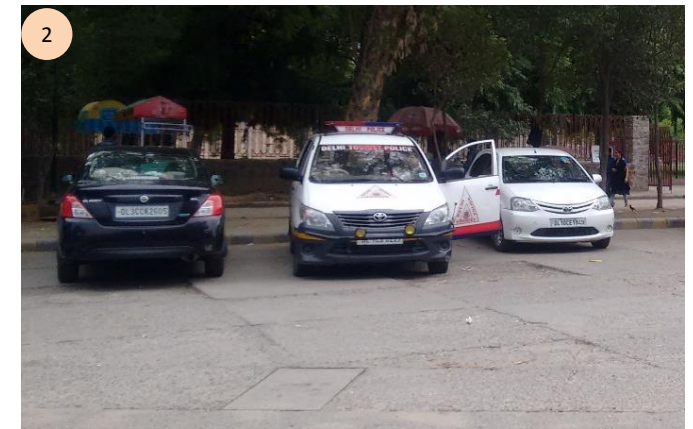
1 As seen in the image, the stretch near the complex's second entry, is largely inactive. There is a parking space for private vehicles, and a few vendors are seen behind the parked vehicles in image 2. To make this stretch active, a hawker zone should be set up here equipped with street furniture. Also, as discussed before, additional lighting is needed to avoid dark spots.

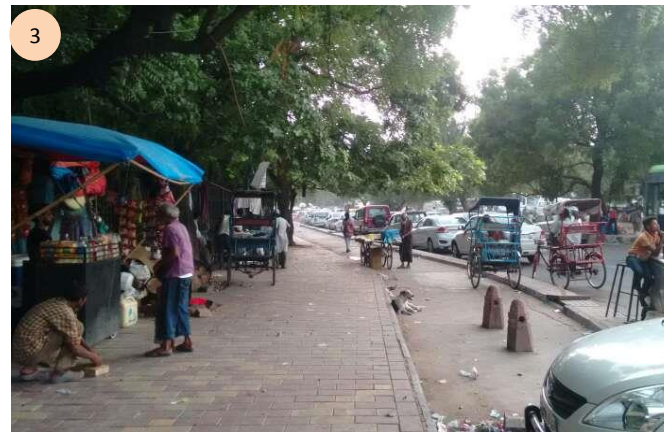
3 Lodhi Road offers poor visibility along most of its stretch, however there are few vendors near the roundabout. Apart from a wide footpath, it also has a cycling track but obstructed by parked cars. To enhance this space, a hawker zone should be created equipped with street furniture along the boundary wall, Also, parking should be disallowed in cycling track.

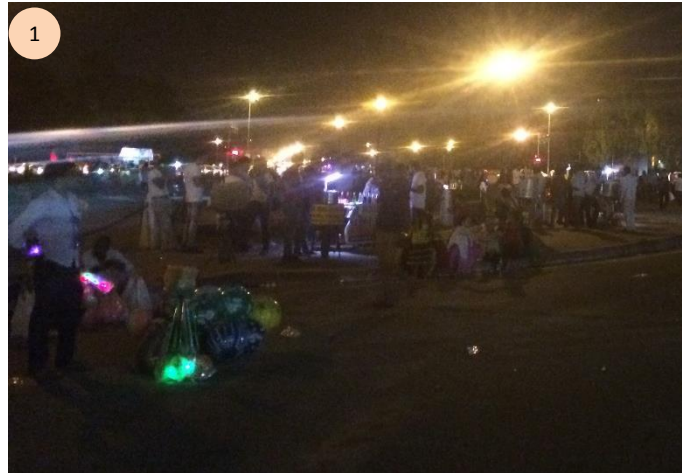
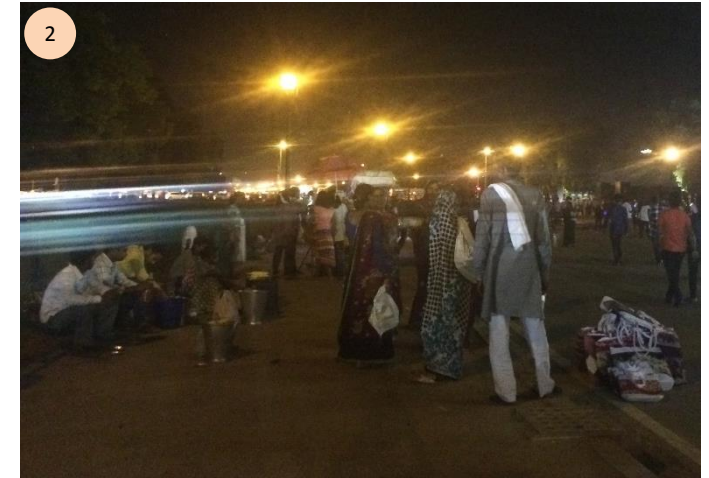
1 As seen in image 1 and 2, numerous street vendors can be seen near the India Gate on Rajpath. This space can be further enhanced by providing street furniture for people and the street vendors.

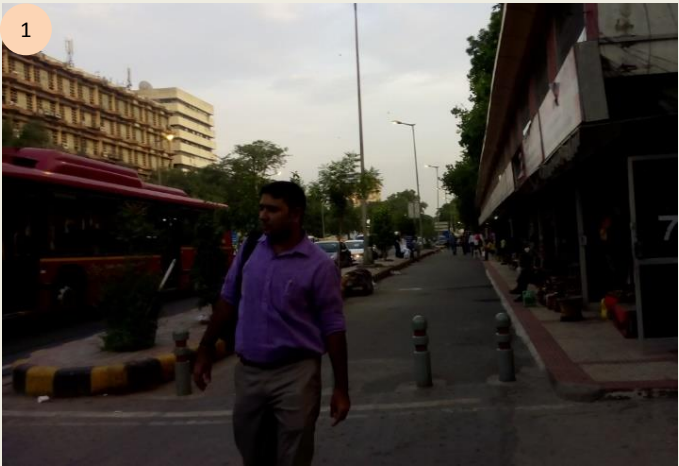
Janpath has been rated excellent in Safety score owing to high score in Visibility, People, Walkpath, Lighting, Public Transport and Feeling parameters.

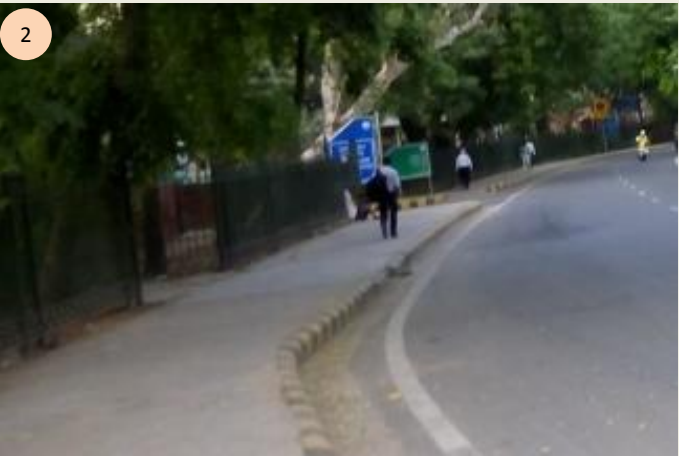
This spot on Tolstoy Marg has been rated fair in Safety score owing to low score in Visibility, Security, Gender Usage and Feeling parameters.

1 These stretch on Tolstoy Marg, with high boundary walls are inconvenient and unsafe for a pedestrian, be it a day or night. To improve visibility, the height of the solid part of boundary wall should be limited to 1 m and rest of the height should be achieved using grills. Also, a Public Convenience facility is needed along this stretch.

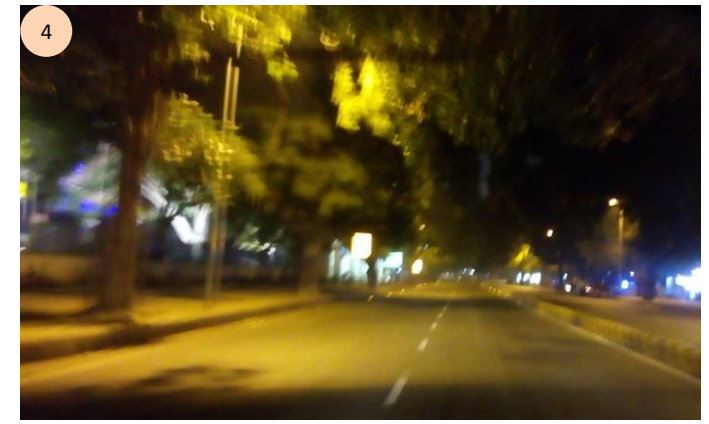
3 As seen in image 3 and 4, the environment of same stretch changes from day to night. While it is quite active during the day, it becomes secluded during the night. Since, this area is a part of built heritage, night tourism can be promoted here through heritage walks, photo walks, food walks, etc. This would ensure activity in these areas and could contribute to the feeling of safety.

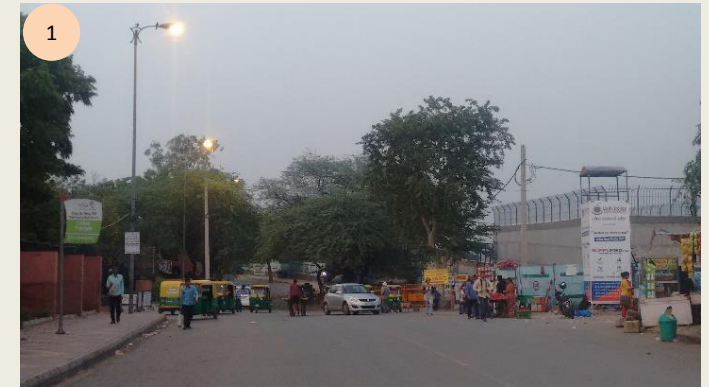
This audit point has high safety score based on high rating in Lighting, Visibility, People, Security, Gender Usage and Feeling parameters.

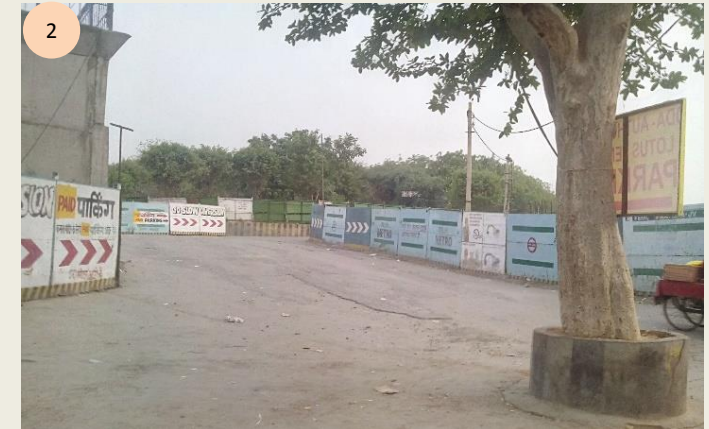
This spot near the parking lot has been rated poor in safety score owing to low rating in Lighting, Visibility, People, Security, Gender Usage and Feeling parameters.

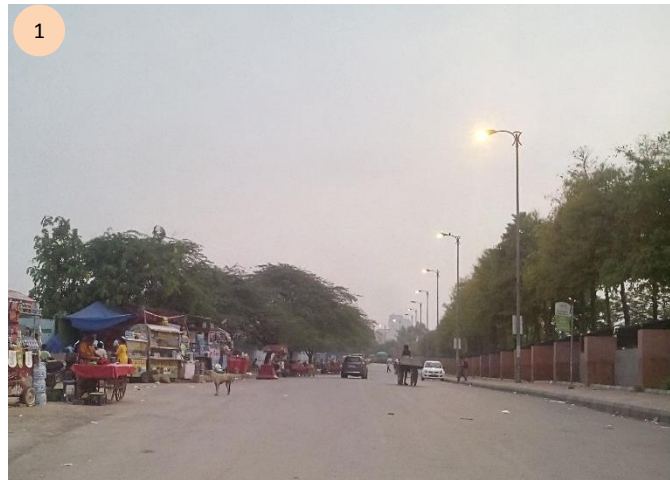
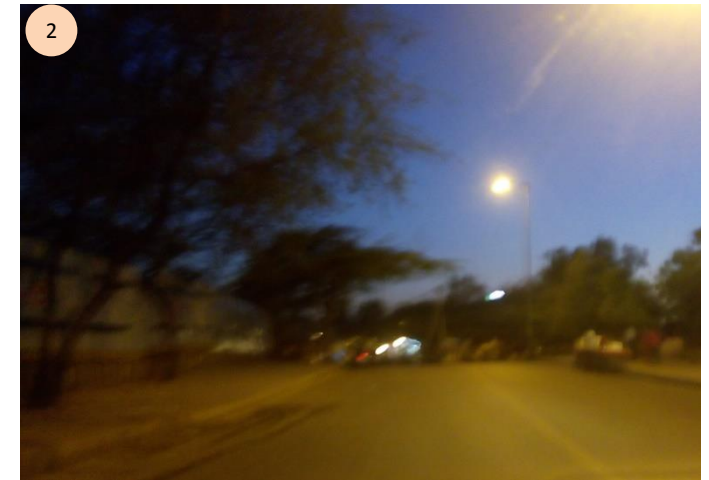
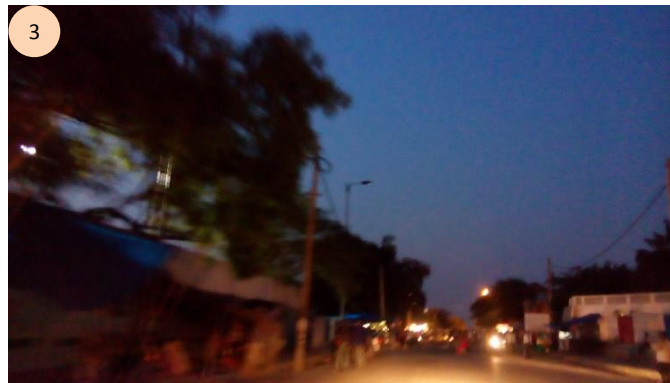
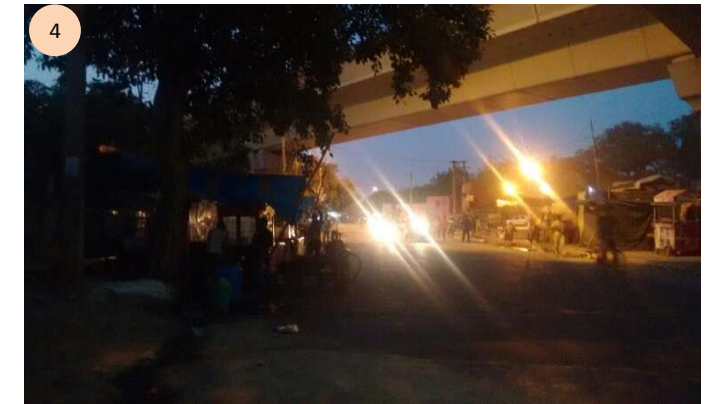
- 1 *The streetlights are installed only one side of the road. As a result, the footpath on the other side is poorly lit. To improve lighting on this stretch, additional streetlights should be installed on the other side, along the built edge facing the footpath and the road.*
- 2 *Some streetlights were found to be non – operational at the time of the audits. These need to be checked and repaired.*
- 3 *The space under the bridge (metro line) is poorly lit. Lighting from temporary stalls provide some illumination. However, it is inadequate, and not a permanent source of lighting. Therefore, additional streetlights should be installed to illuminate this space.*

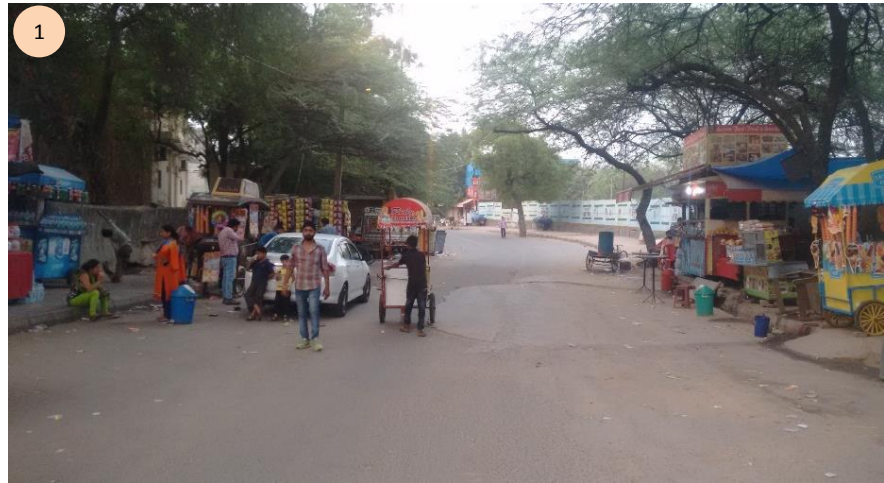
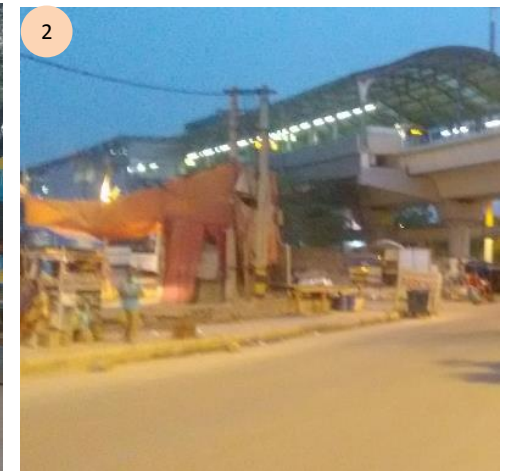
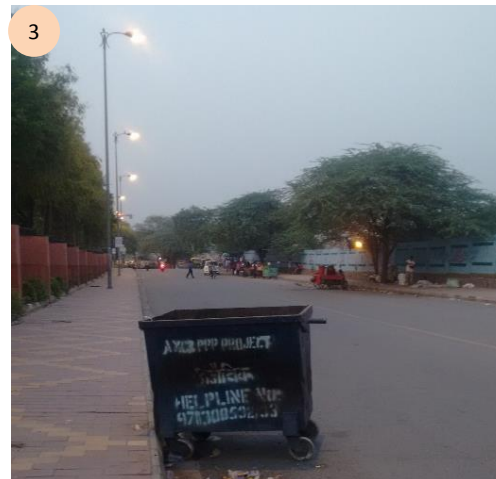
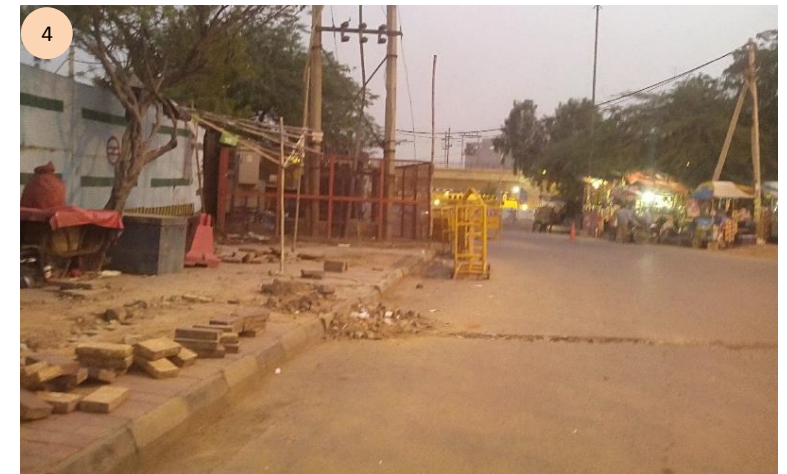
- 1 Footpath exists throughout the stretch but is obstructed by temporary stalls and street vendors near the temple (image 1) and the metro station (image 2). A designated space should be provided for these hawkers, clear of the footpath. Also, it should be equipped with the street furniture for pedestrians.
- 3 Improperly placed street furniture like streetlights, dustbins as seen in the image 3 isn't favourable for the pedestrians. The streetlights should be installed along the boundary wall clear of the footpath. Also, the dustbin should be placed in designated hawker zone or by creating niches in the boundary wall, clear of the footpath.
- 4 The stretch from Lotus Temple to the metro station has a broken footpath on one side. Moreover, it is obstructed by construction debris and a transformer. The footpath should be repaired and widened wherever it is obstructed by the electric pole.

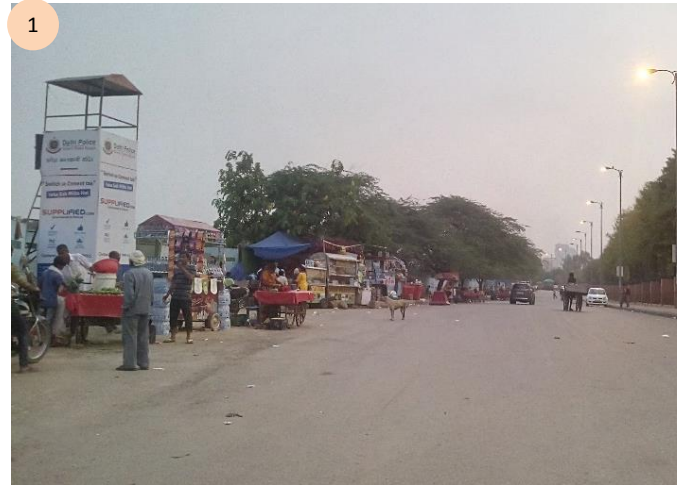
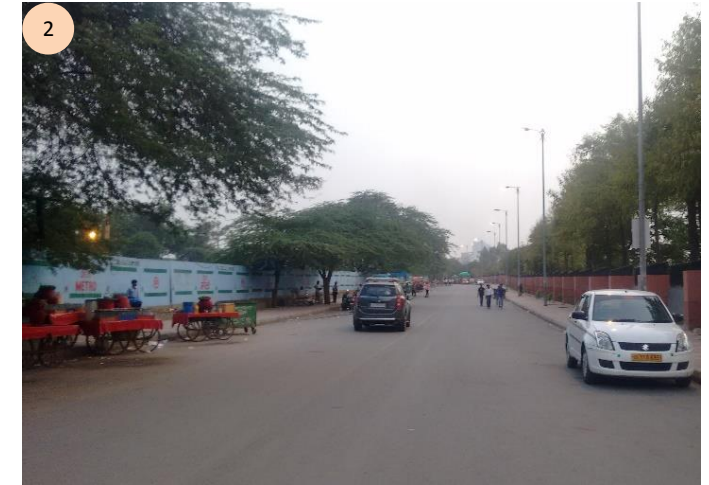
1 As mentioned earlier, there are street vendors present near the entry/exit of the Lotus Temple during the day. In absence of a designated hawker zone, they occupy the footpath and road. A hawker zone should be created, equipped with street furniture for people to sit and wait. Currently, the area gets secluded and inactive after sunset. To make this stretch active, some activities or festivals can be organized in the adjoining parks namely Astha Kunj Park and Kalkaji District Park.

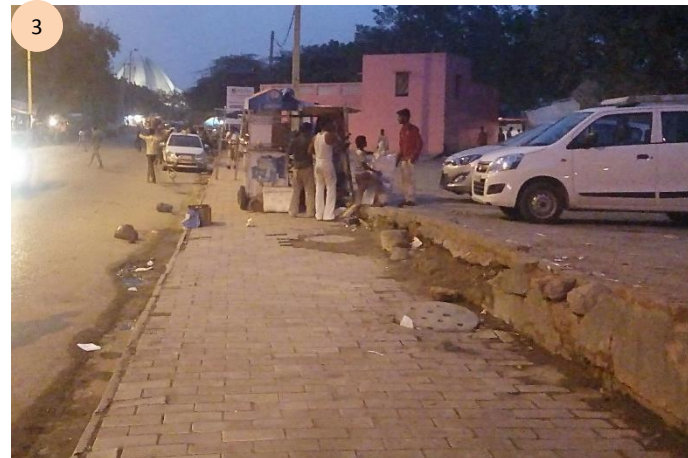
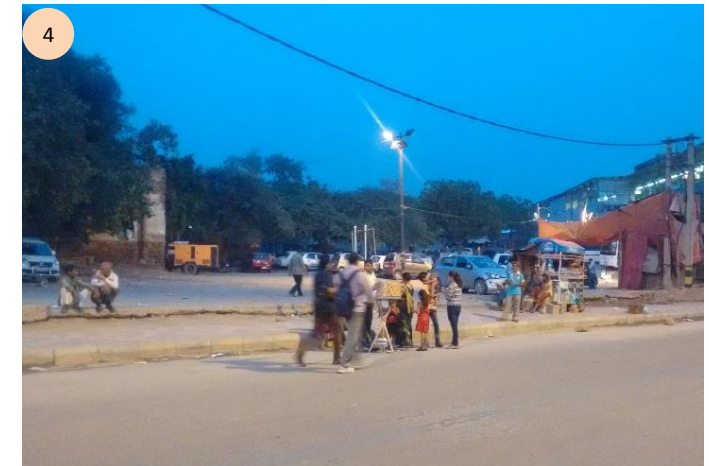
3 Outside Kalkaji Metro Station, there are street vendors catering to metro commuters as well as devotees visiting Kalkaji Mandir. A hawker zone should be set up, clear of the footpath. It should have a public convenience, and street furniture.
