How Safe are the Tourist Places in Delhi?

Safety Analysis Report

Tourist Places of Delhi

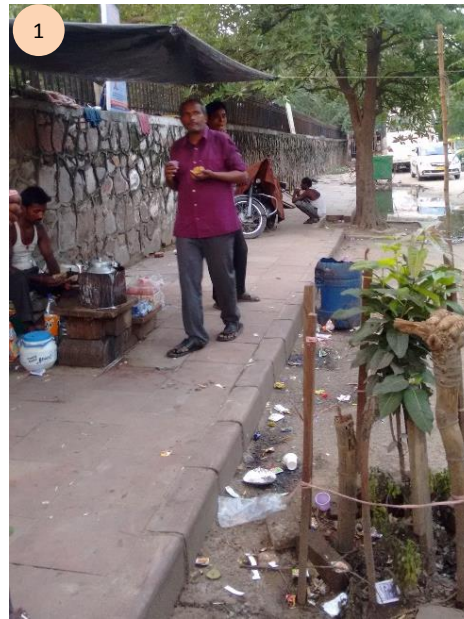
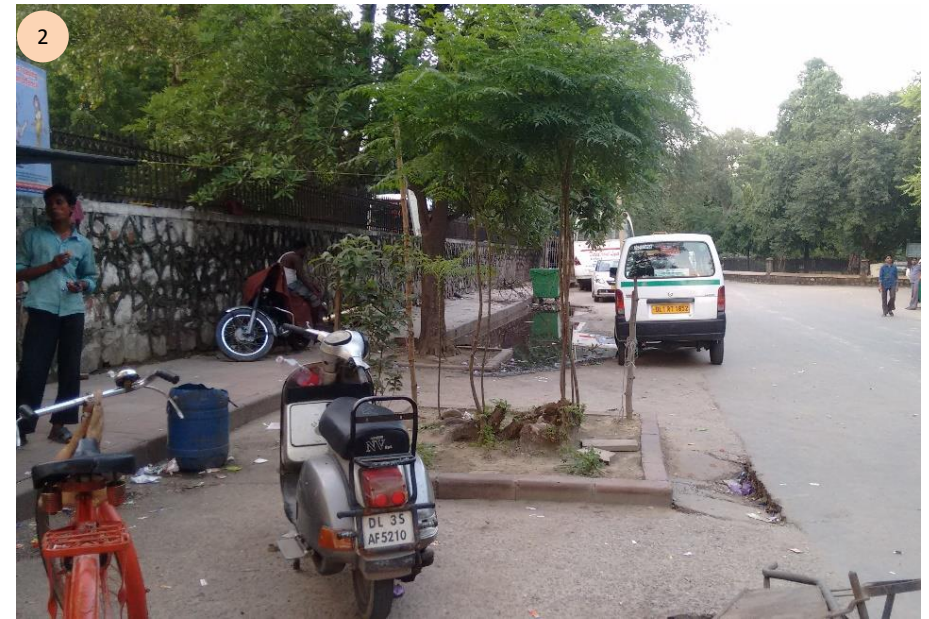
- 1 The footpath leading to Purana Qila complex is occupied by street vendors and vehicles are parked over it, forcing pedestrians to walk on vehicular carriageway. To ensure a smooth movement of the pedestrians, the footpath should be widened (till the planter in image 2) to accommodate one and all. Hawkers can be given space along the boundary wall, clear of the footpath. The vehicular parking should be restricted to the parking lot provided by Zoological Park and Qila complex authorities.

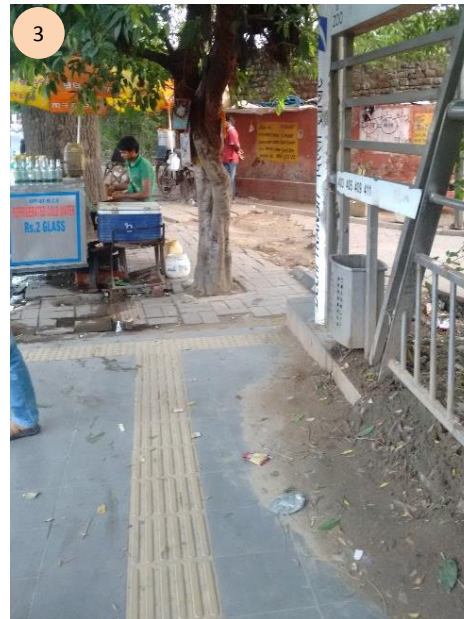
- 3 The tactile paving ends abruptly, which can prove risky for visually challenged people. The footpath level should be flushed with that of bus stop or provided a gradual slope. Also, a designated space for the hawkers should be provided, clear of the footpath.

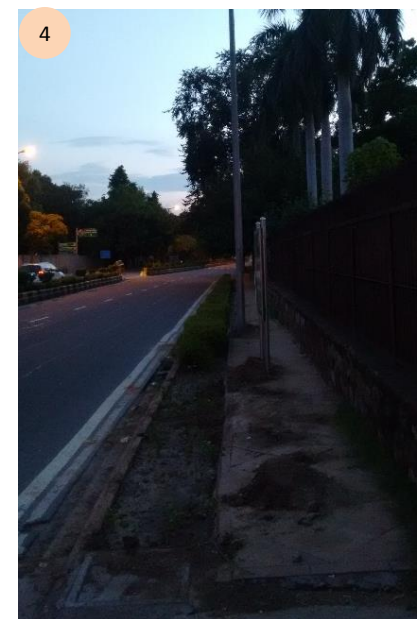
- 4 The footpath is broken and obstructed by light poles and signage board (image 4) as seen on Subramaniam Bharti Marg. This should be removed and installed at the edge of the footpath and the footpath should be repaired.

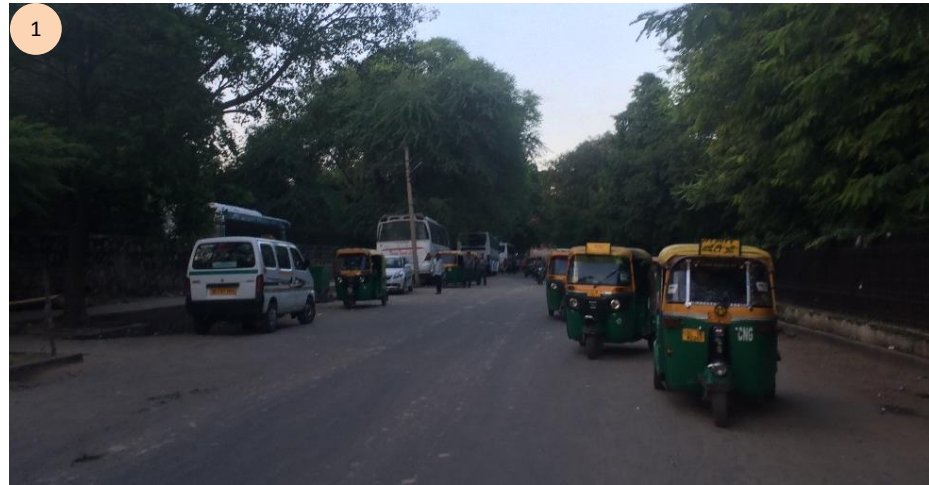
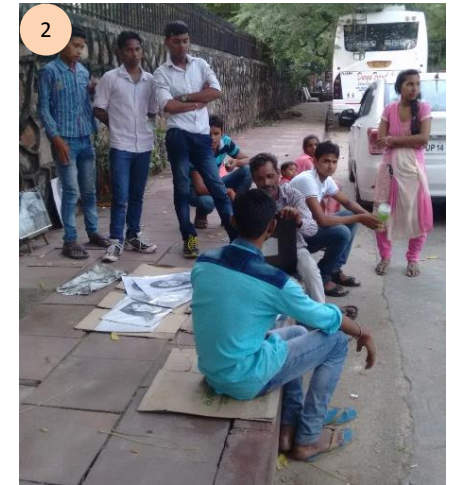
1 The stretch leading to Purana Qila Complex from Mathura Road gets inactive post sunset. This stretch is flanked by boundary walls of Qila complex on one side and Zoological Park on the other. Seen are few vendors occupying the footpath (image 2), and the autos lined up near the boundary wall (image 1). To enhance this area, a Para-Transit Hub should be created here. A designated auto stand should be set up with proper parking space for the autos on one side. As mentioned earlier, the footpath on the other side should be widened to create space for a hawker zone, equipped with street furniture for people to sit.

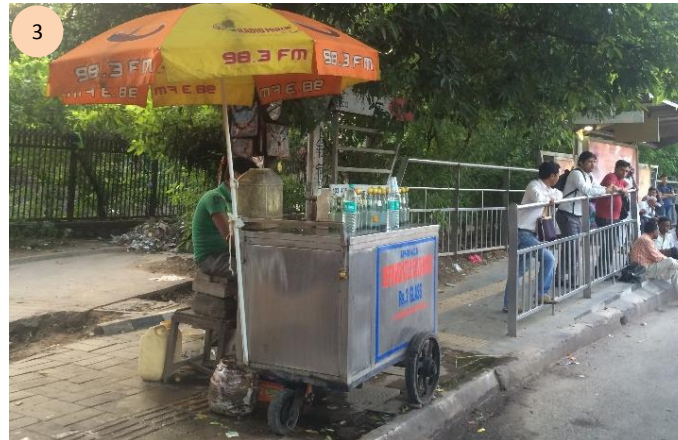
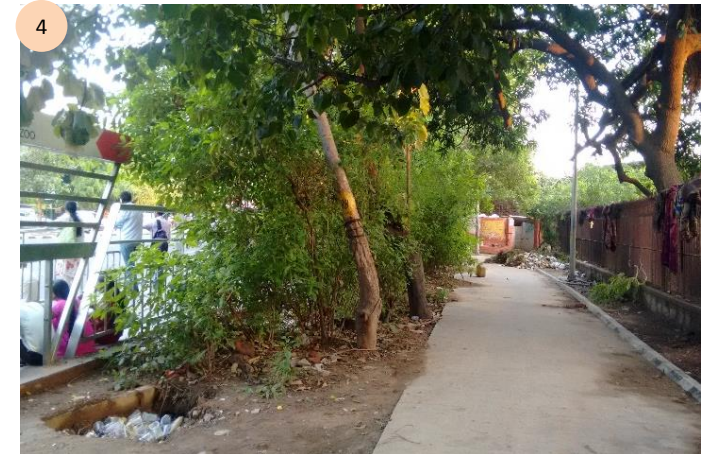
3 As seen in image 3 and 4, the path behind the bus stop is flanked by trees and shrubs on one side, and boundary wall on the other. To improve visibility, the tree leaves should be regularly pruned and height of the shrubs should be maintained at 1 m. Also, this space should be redesigned to provide a designated hawker zone for the existing hawkers present near the bus stop.

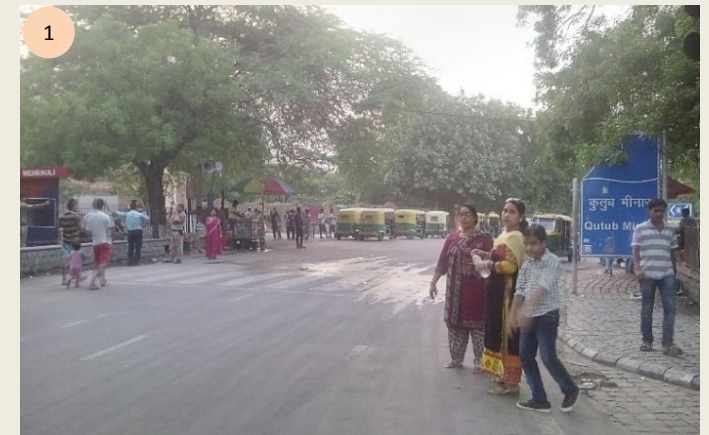
The entry/ exit to the Qutub Minar has high rating in Visibility, People, Security, Gender Usage and Feeling parameters.

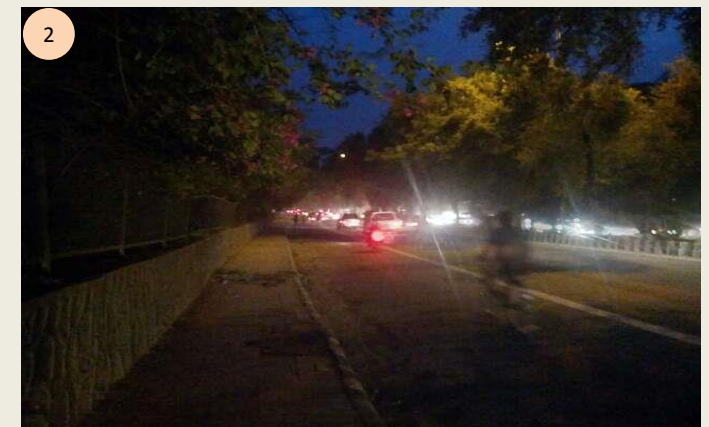
This audit point is given low rating in Lighting, Visibility, People, Security, Gender Usage and Feeling parameters.

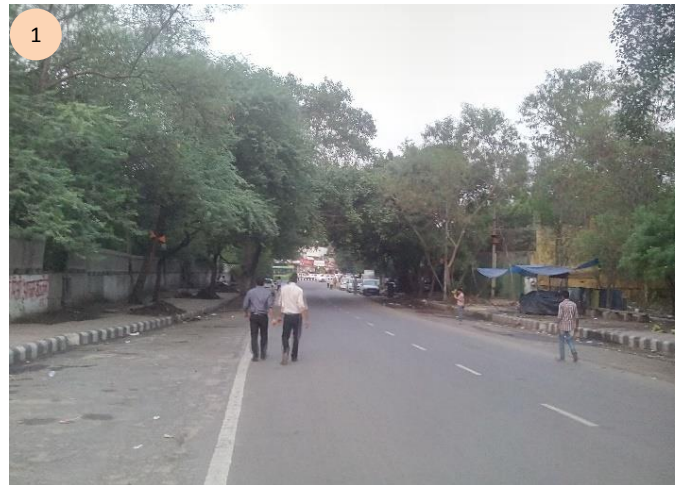
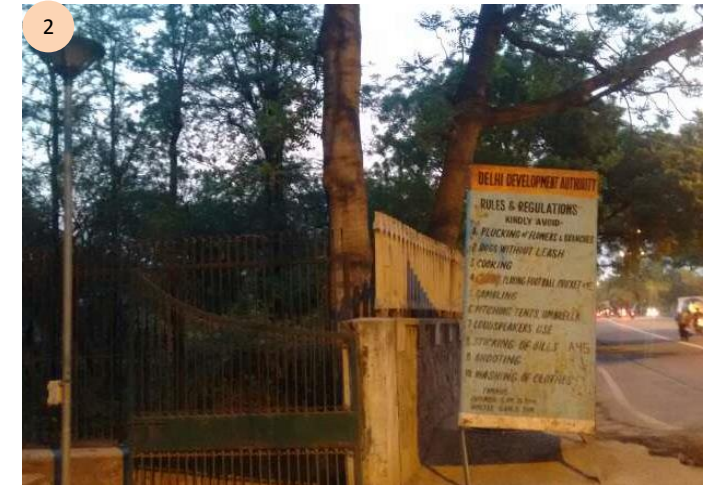
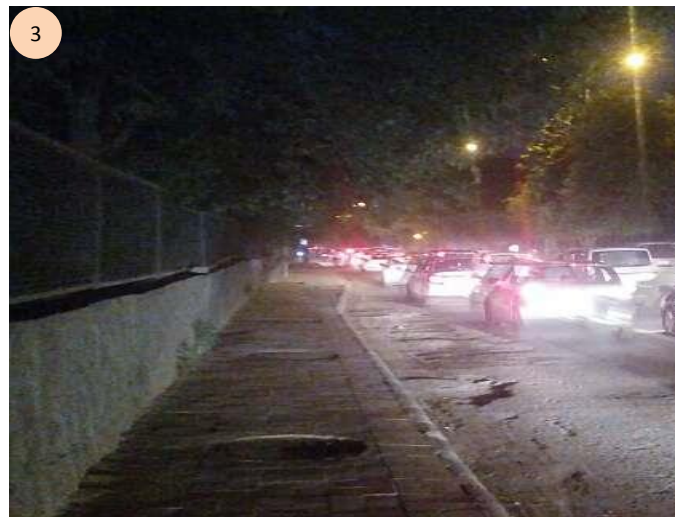
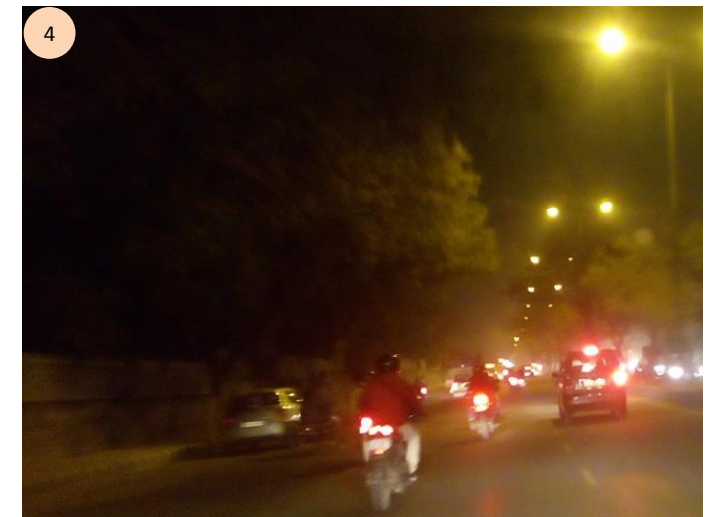
2 Lights installed at the entry/exit of a complex were found to be non-operational as seen in front of Mehrauli Archaeological Park (image 2). Similar cases were found in front of Delhi Jal Board's STP and Central Bharat Sevak Samaj. These lights should be made operational so as to illuminate the entry/exit of a complex.

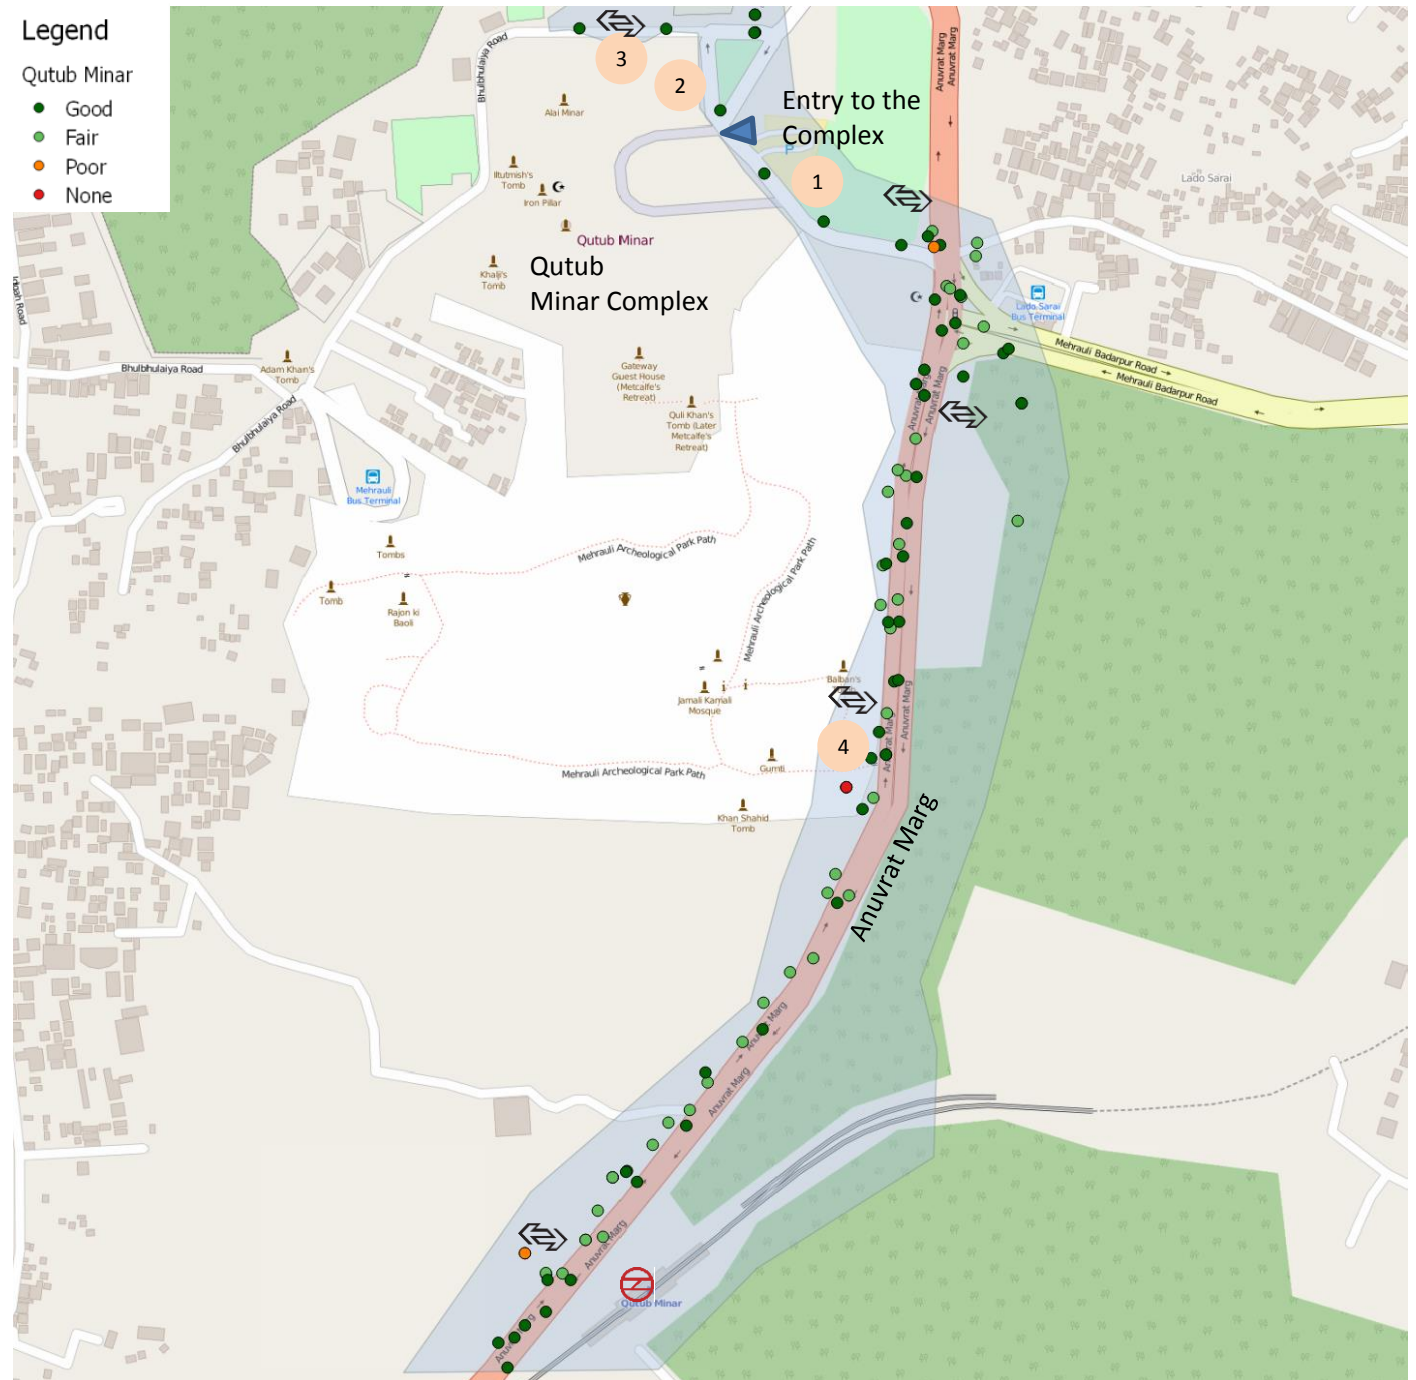
Map showing walkpath rating

Walk path is rated 2.4 i.e. Above Average. Walk path exists throughout the audit stretch but was found to be broken and obstructed by construction debris, open manholes, signage boards etc. Improperly placed signage boards can prove to be risky for the visually challenged. They should be removed to make way for smooth pedestrian movement. Also, the walkpath should have tactile paving, accessible through a gradual ramp.

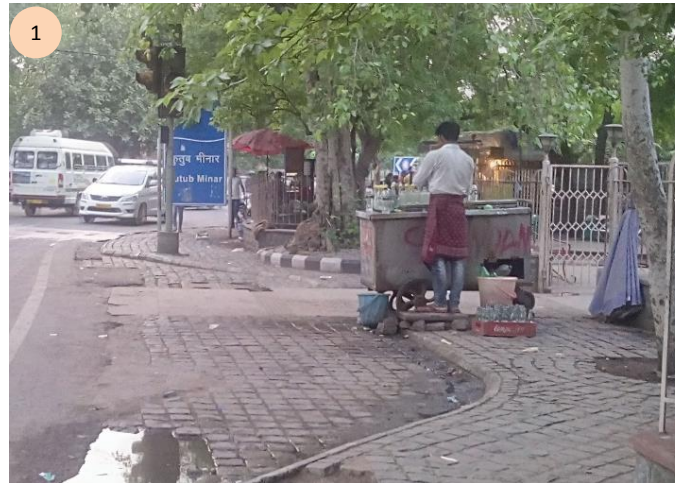
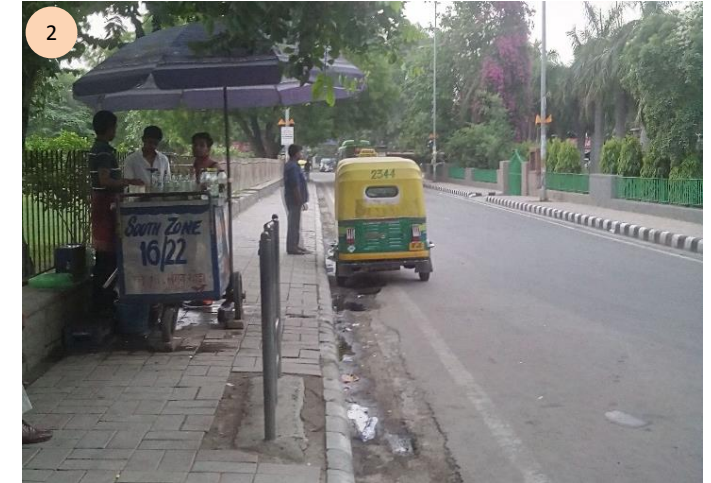
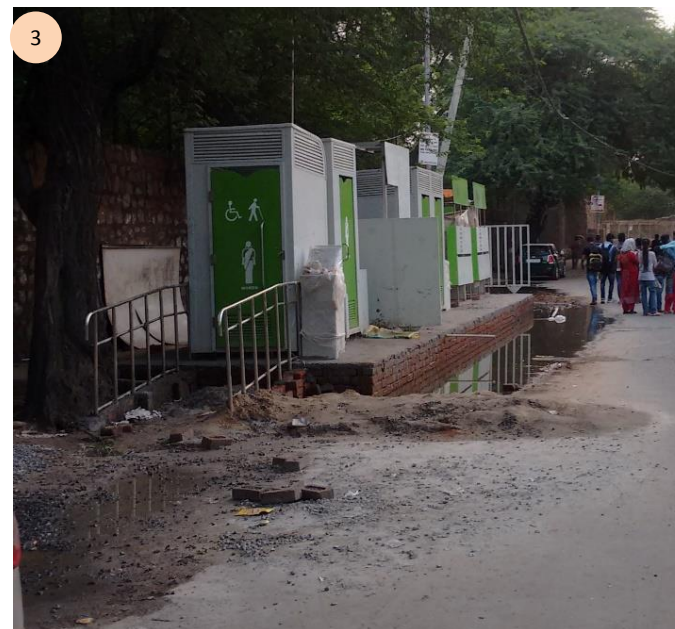
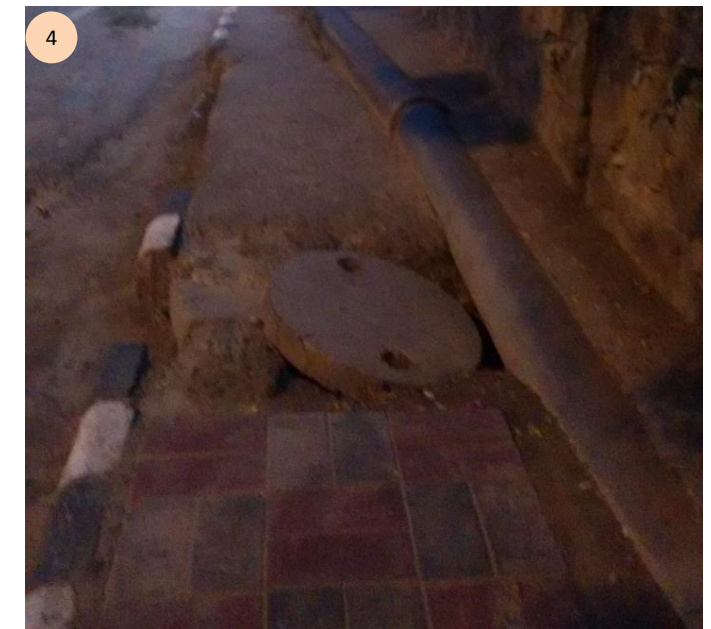
- 1 The footpath is provided throughout the audit stretch but as seen in image 1 and 2, it is obstructed by street vendors, signage boards, pole stand etc. at various spots. These obstructions should be removed to make way for uninterrupted paved footpath. Footpath should be widened to create space along the built edge for hawkers.
- 2
- 3 A continuous paved footpath should be constructed to connect it with the new Public Convenience facility being set up, as seen in this image.
- 4 On Anuvrat road, footpath was found to be broken at several spots. As seen in the image 4, improperly covered manhole and pipe can be risky for the pedestrians. These should be covered and the cover should be flushed with the level of the footpath to ensure smooth movement of the pedestrians.

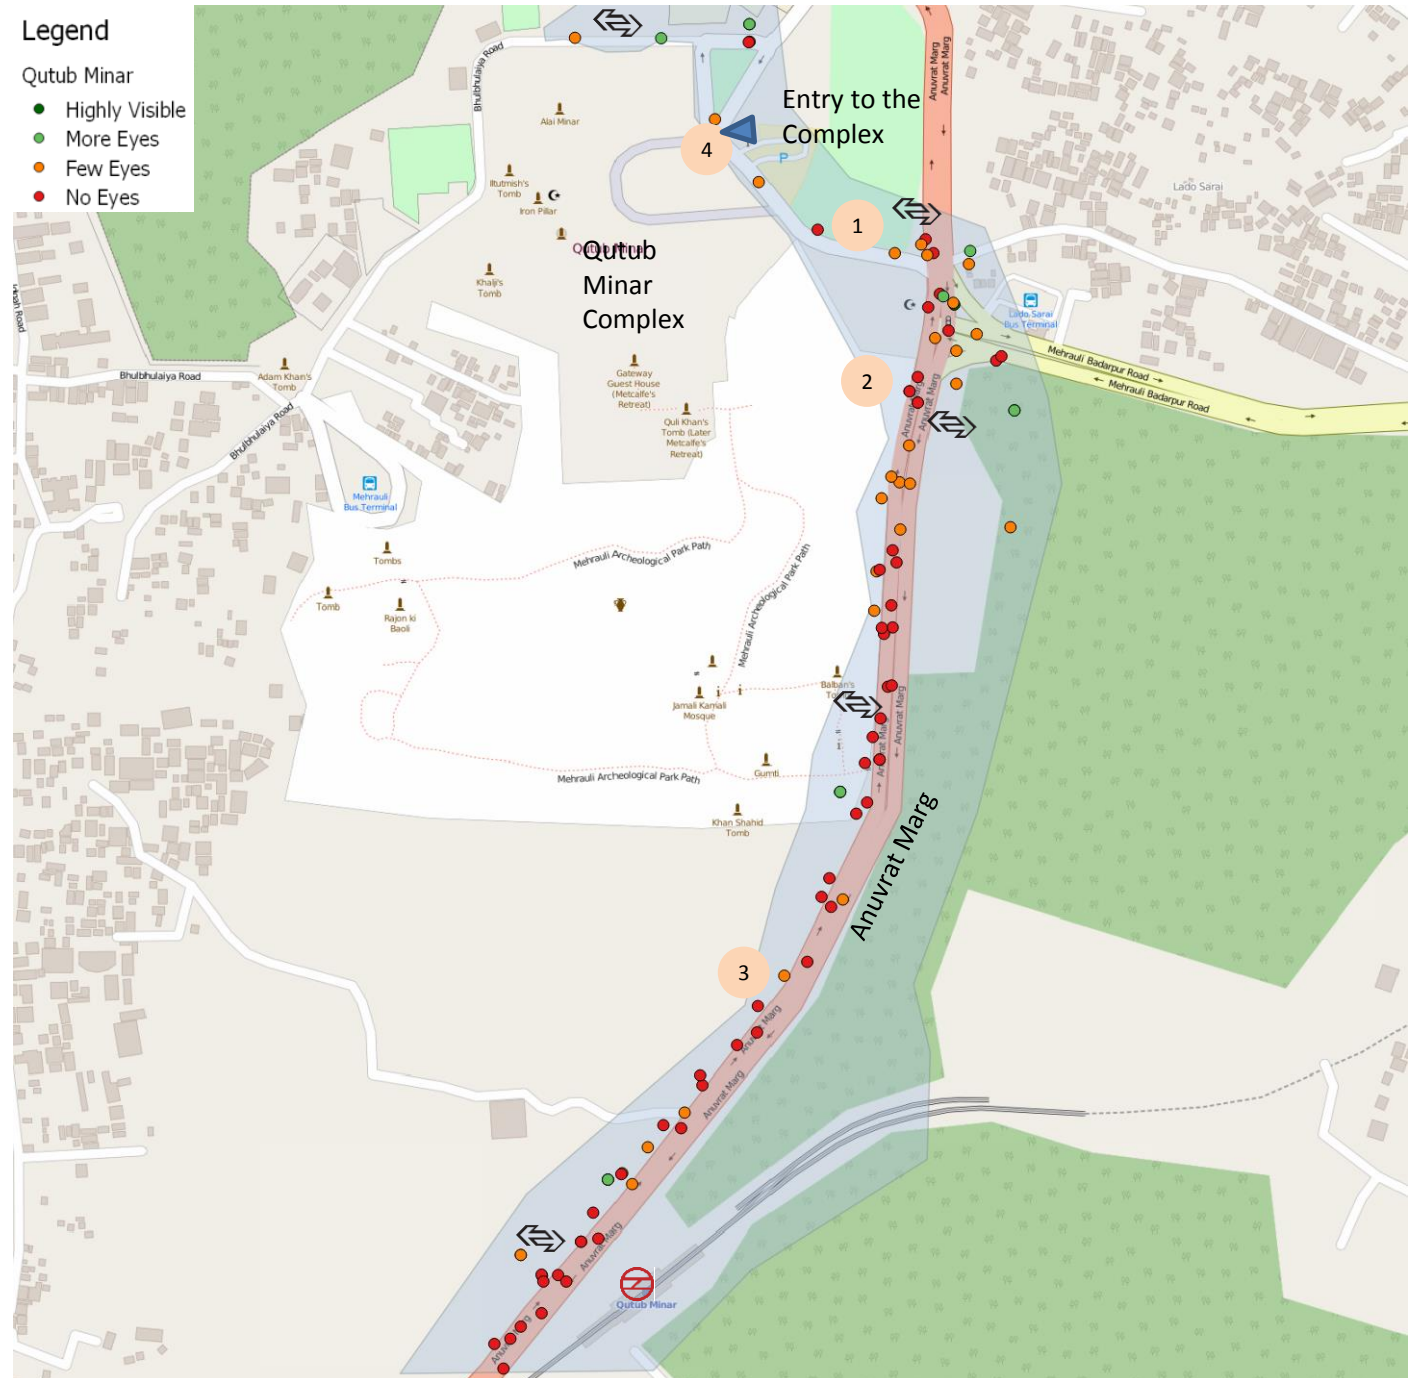
Map showing visibility rating

Visibility is rated 0.6 i.e. Poor. This stretch is characterized by continuous boundary walls of huge parks which houses various monuments of archaeological importance. Therefore, the audit stretch was largely found to be deserted with few hawkers in between.

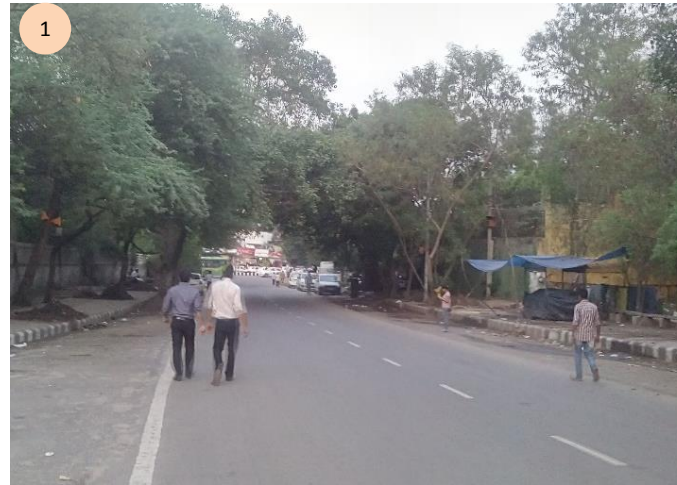
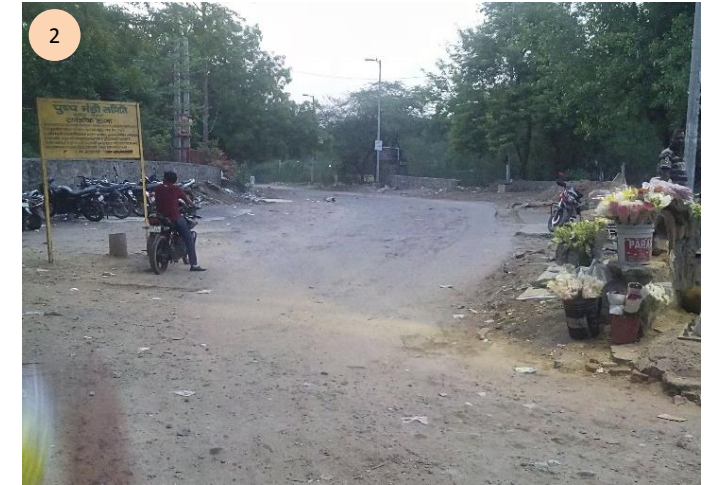
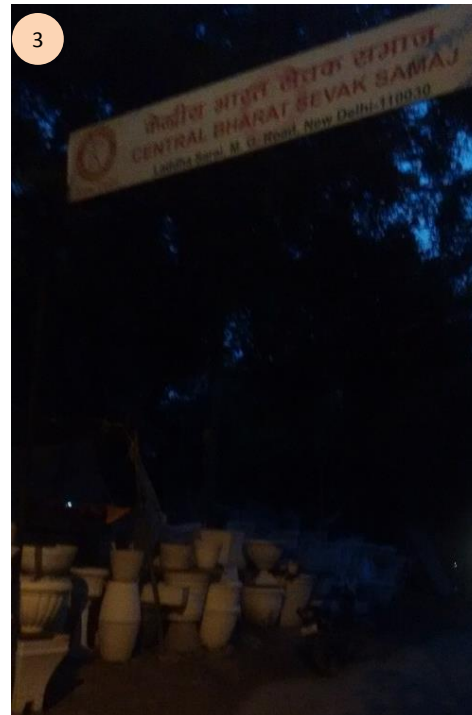
1 As mentioned earlier, the audit stretch has many dead spots that results in poor visibility. However, few vendors and temporary stalls are present at some distance on the audit stretch. The spots seen in image 1, 2 and 3, can be turned into a hawker zone. At spot seen in image 1, there are few temporary stalls.

2 At spots seen in image 2 and 3, there is an existing flower mart and nursery respectively. With proper lighting and equipped with street furniture, these spots can be designated as a hawker zone, thereby activating the area.

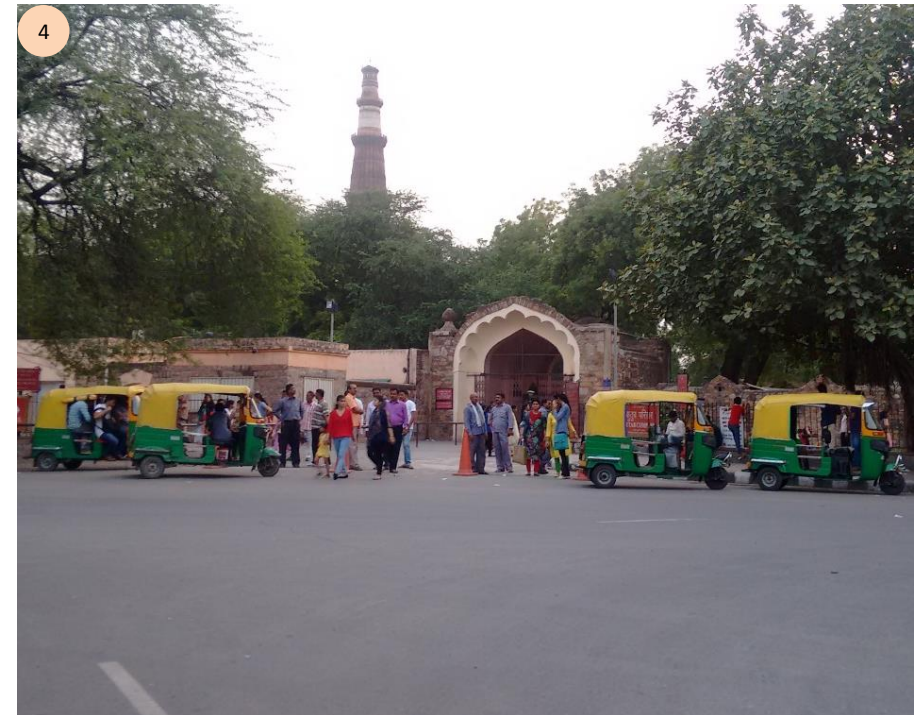
4 Near the ticket counter, there is a hawker zone with temporary stalls, public convenience and street furniture. However, many street vendors occupy the area outside the entry/exit of Qutub Minar. To accommodate these vendors, another hawker zone can be set up near the entry/ exit of Qutub Minar. Also, a designated auto stand should be set up with proper parking space for the autos, clear of the footpath.

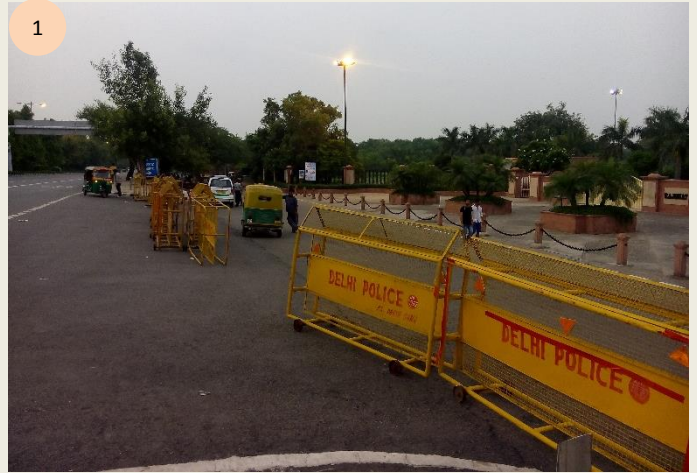
The entry/exit to Rajghat has been given high rating in Lighting, Openness, Security, Walk Path, Public Transport and Feeling.

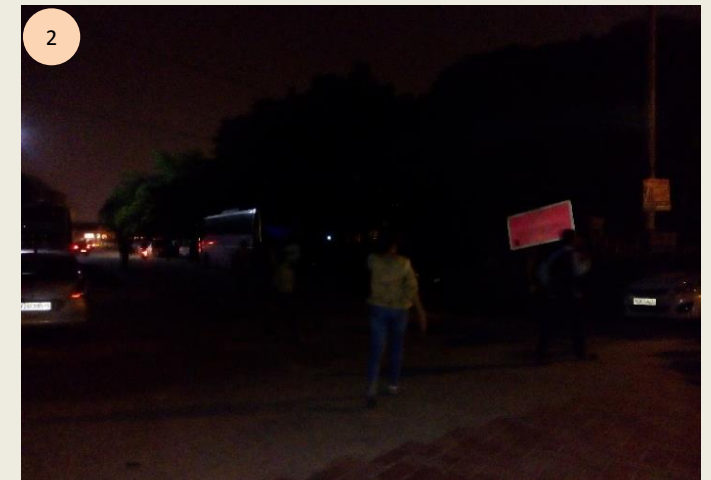
The audit point has been given low rating in Lighting, Visibility, Security and Feeling.

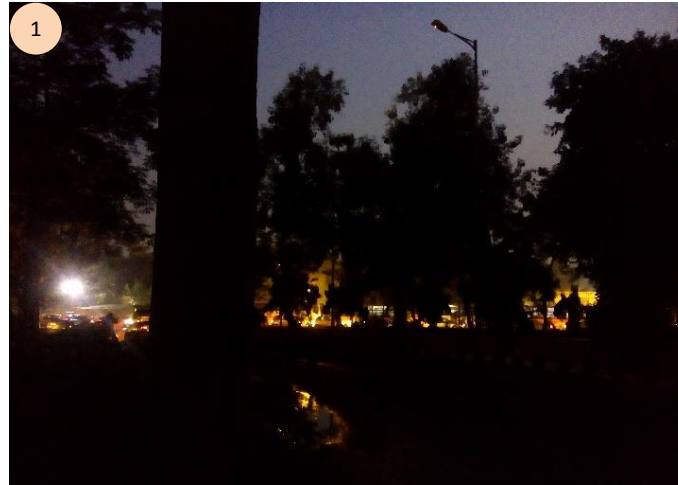
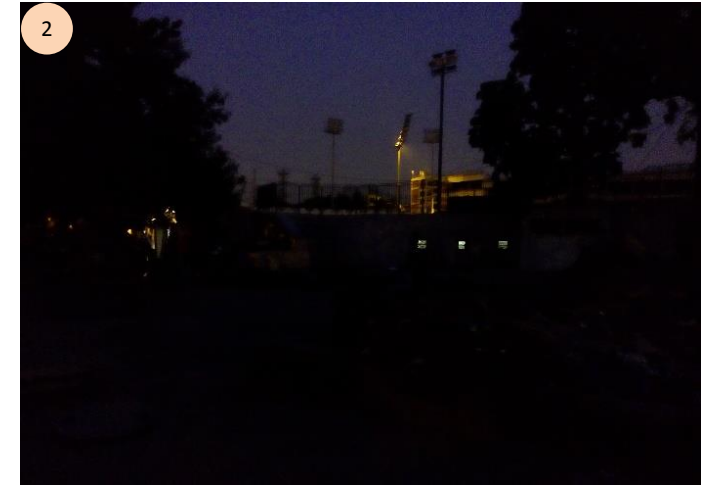
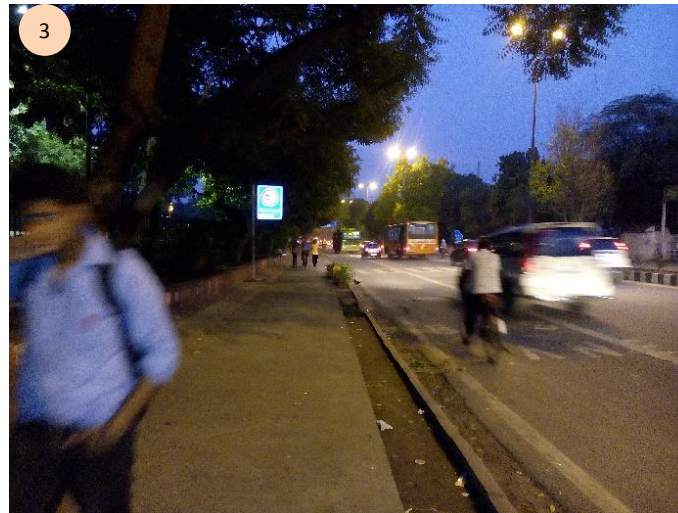
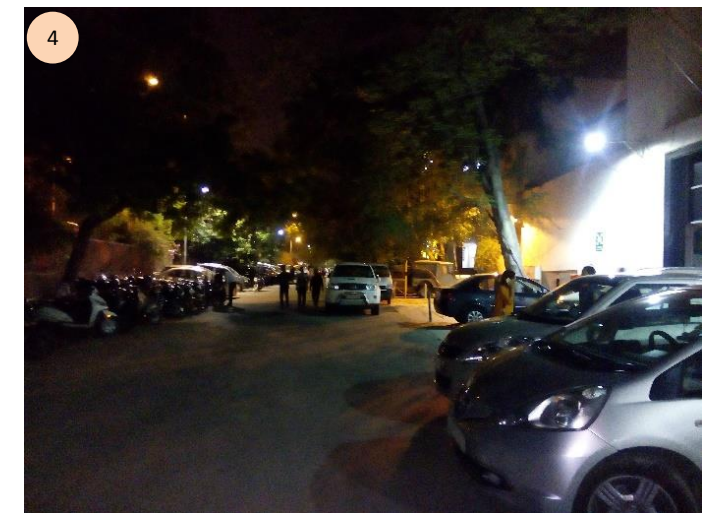
1 Though streetlights are present throughout the stretch, some of them were found to be non- operational. The stretch near Firoz Shah Kotla Stadium to Kotla Firoz Shah has many dark spots due to non – operational streetlights as seen in image 1 and 2. These streetlights should be checked and made operational.

4 At present, the service road is lit owing to building's lights. The foliage along the streetlight as seen in image 4, needs to be pruned regularly to provide uniform illumination.

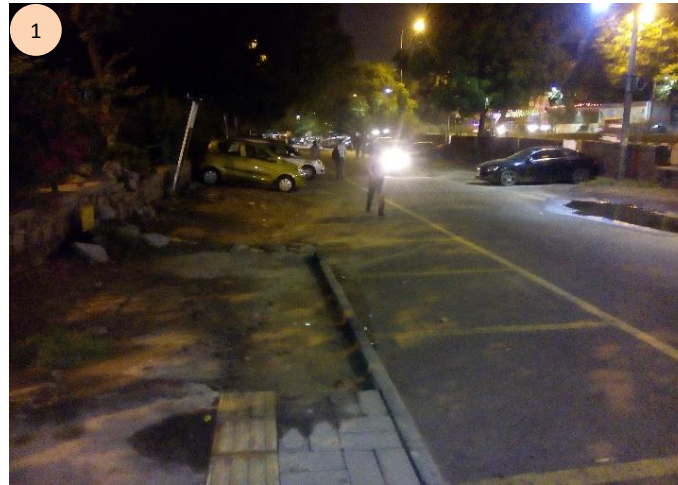
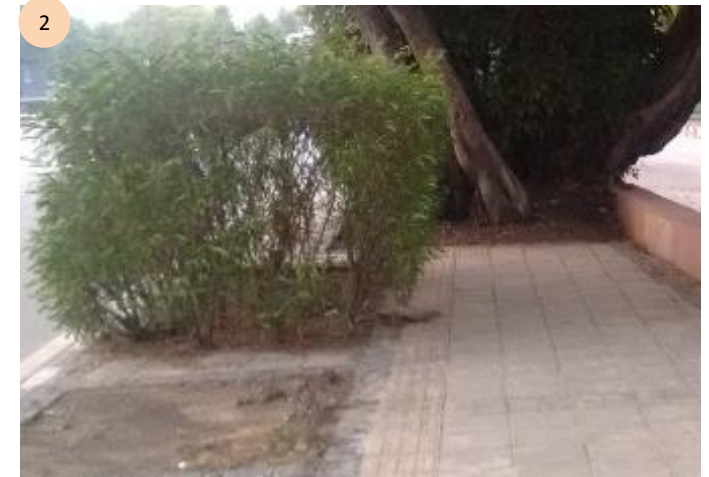
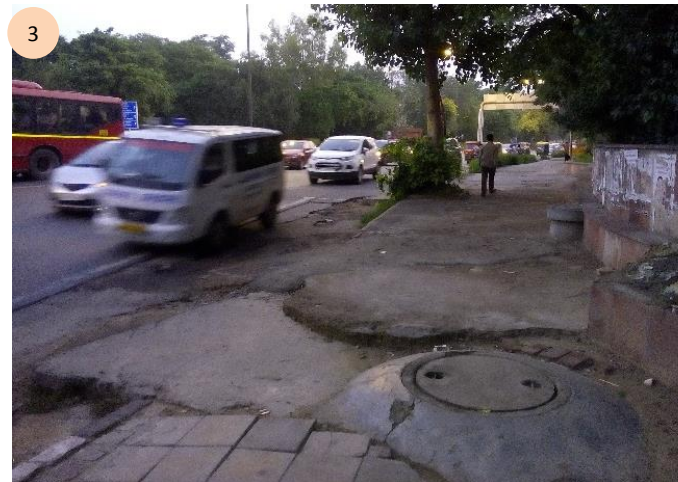
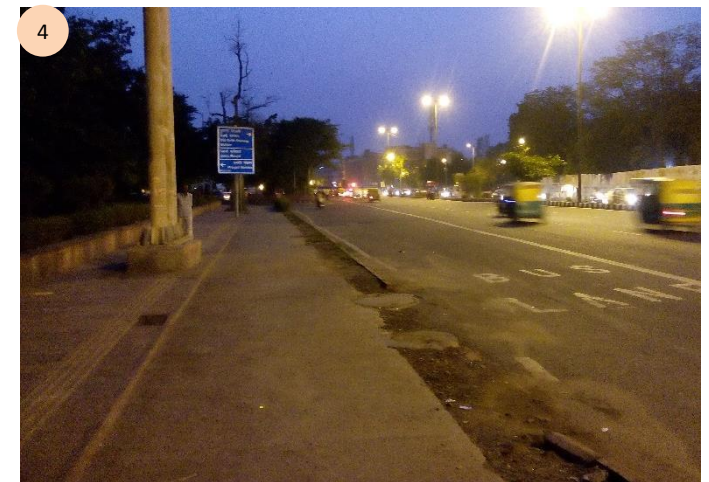
- 1 At some spots, the footpath is broken and non- continuous as seen in image 1.
- 2 The tactile paving ends abruptly which can prove extremely risky for visually challenged people. In image 2, the tactile paving is placed in non- linear pattern and too close to the planter, that can prove inconvenient for the visually challenged people. A continuous paved footpath with tactile paving should be constructed, clear of any obstructions. The footpath should be widened wherever it is obstructed by a tree. In case of image 2, the planter should be restricted to one side thereby providing a linear footpath.

- 3 Seen in image 3, the broken footpath with unflushed manhole cover can prove risky for the pedestrians. This needs to be repaired and the cover should be flushed with the level of the footpath.

- 4 On Jawaharlal Nehru Marg, the tactile paving on a wide footpath is obstructed by the signage board. This can prove risky for the visually challenged. This tactile paving should be removed, and a new one should be constructed, clear of any obstruction.

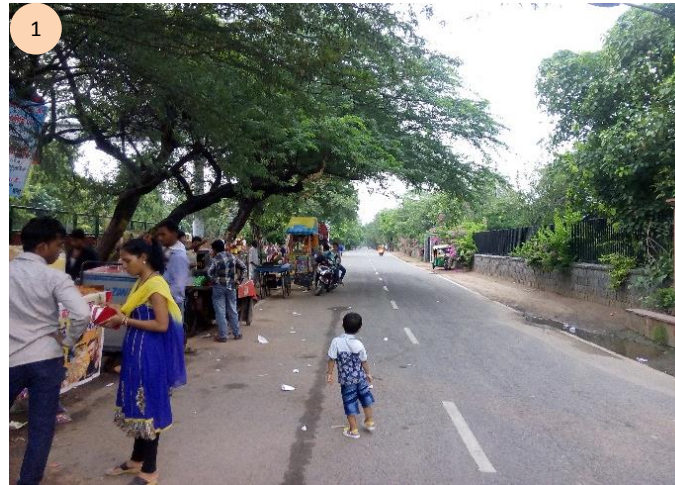
2 On Jawaharlal Nehru Marg, few vendors can be seen near the bus stop. The bus stop on one side of this road doesn't have a proper shelter for people. This space should be redesigned to create a bus shelter, and a designated space for these street vendors.

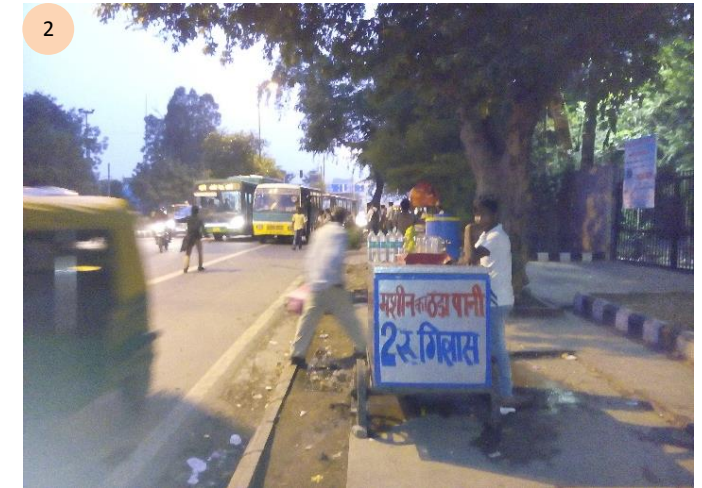
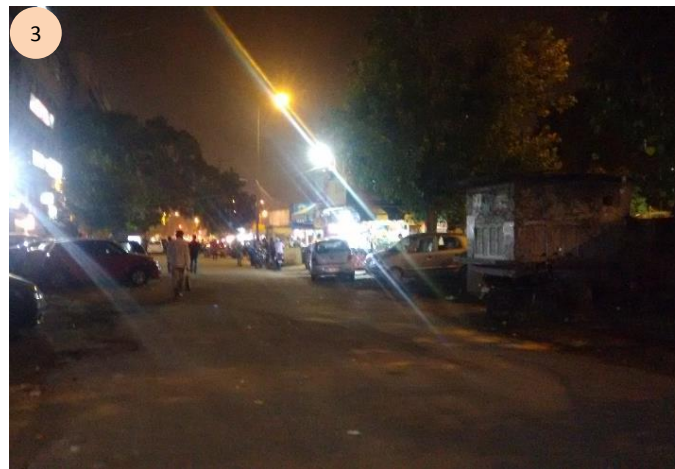
3 The service road in front of Times of India and Indian Express office, as seen in image 3 and 4 has many temporary stalls and street vendors, catering to the employees. This stretch should be redesigned to provide designated space for these stalls and vendors, equipped with street furniture.
