# Mapping Port Moresby using Safetipin Technology and Apps

**Port Moresby, June 2018**

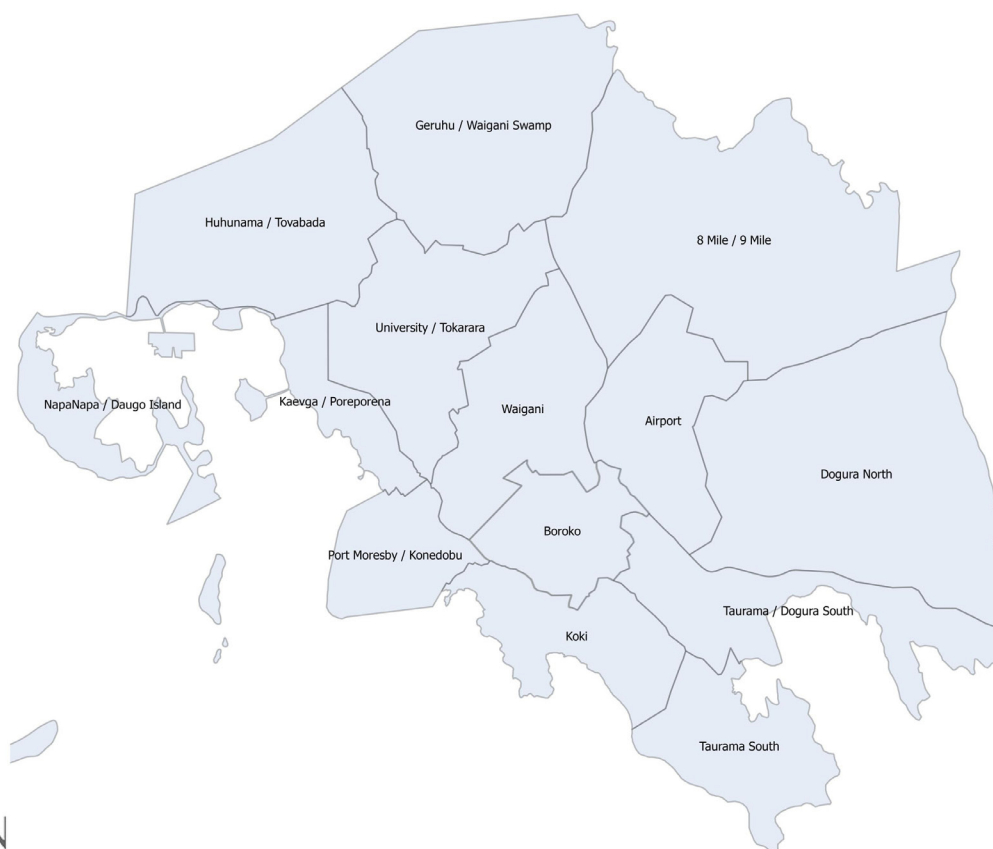
Map 1: Local Planning Areas (LPA) with number of safety audits done

Table 1: No. of audits conducted in Port Moresby

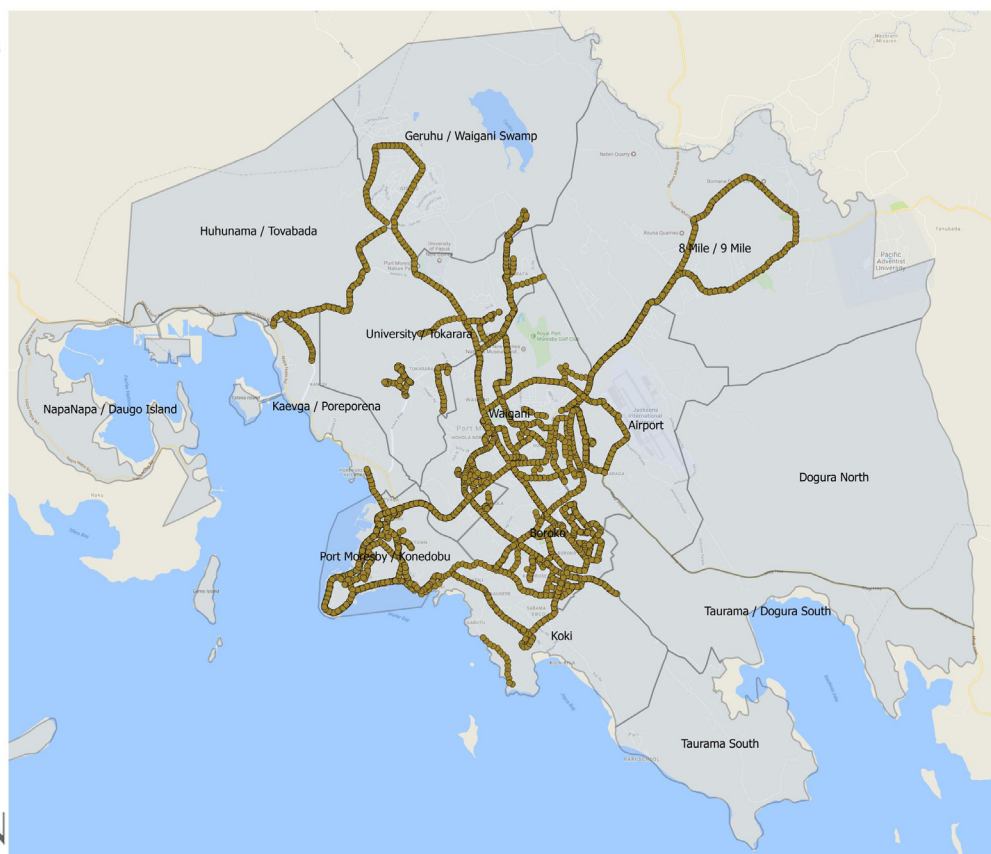
Map 3: Area covered by audits generated from Safetipin Nite data collection

Safetipin Nite app generates data by clicking pictures across the city via a camera phone mounted on a moving vehicle (shown in Figure 2). Data in the form of photographs is collected to capture pedestrian's safety conditions at regular intervals. The conditions that are examined are based on the 9 parameters of the safety audit with greater detail on the existing status of the infrastructure (see the list in Annex 1). The pictures are then uploaded on to a server, codified and eventually translated into audits that appears as pins on the Safetipin's map.

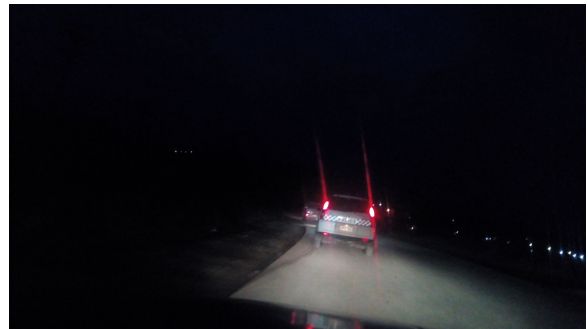
Figure 7: Dark spots i.e. points with no streetlights

The audit points with poor lighting are indicated in the Map 6 and 7. The corresponding list of streets with no streetlights (as seen in Figure 7) and non- functional streetlight (as seen in Figure 8) for each of the LPAs is shown in Table 1. The streets with no streetlights need to have new streetlights installed as there is no source of lighting for the pedestrians currently. Streets with non- functional streetlights need to be checked and repaired.

The existing streetlights that have been found non-operational need to be checked. Also, regular checks are necessary to ensure that all streetlights are operational at all times. Streetlights need to be installed along areas, identified as dark spots i.e. at these locations there is no illumination at present.

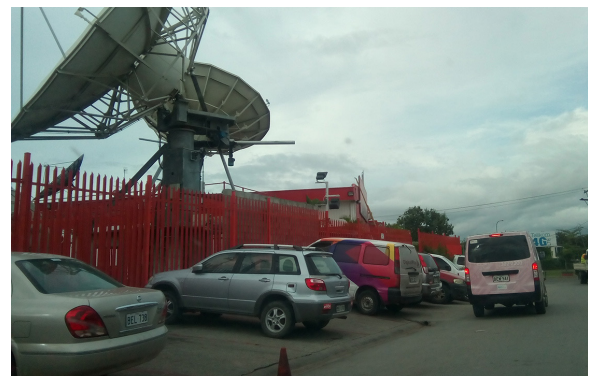
Figure 9: Parked cars blocking the footpath

Though most of the city has a fairly good availability of pavements, the condition needs to be improved. At points with a high rating for Walkpath, it was found to be obstructed due to car parking (Figure 9). Provision should be made for designated on-street parking, clear of the pedestrian path.

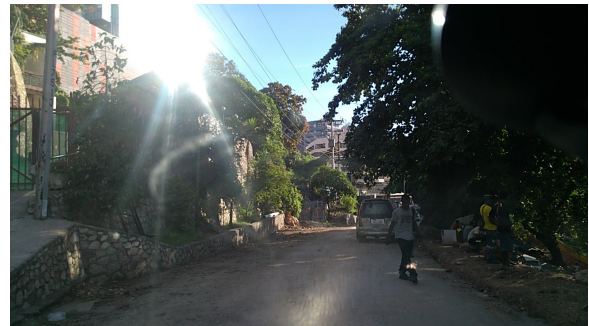
Figure 10: No Walkpath

In Port Moresby, walkpath has been rated the highest parameter among all the parameters owing to presence of pavement at 68% of the audit points. The balance 32% of the points were found to either having no pavement or unpaved pavement as seen in Figure 10 and 11 respectively.

The list of streets which needs improvement in terms of walkpath is shown in Table 2 for all the LPAs. Proper raised pavement to be constructed at points with no or unpaved walkpath. Points with broken walkpath needs to be checked for repairs. Regular maintenance checks to be carried out.

At certain locations, the pavement was found to be broken. This damage needs to be repaired and a proper paved surface needs to be created. Along certain roads either no footpath exists, or space has been left for one, but it hasn't been constructed. A proper footpath needs to be constructed, free of any obstruction.

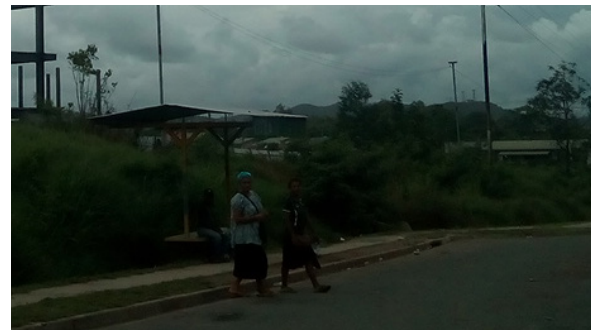
Figure 12: A typical Bus Stop in Port Moresby

57% of the audit points fared poorly in terms of accessibility to the bus stop, that goes to 68% during the night. This is due to absence of designated bus stops around the city. Few areas with designated bus stops have bus shelter as shown in Figure 12.

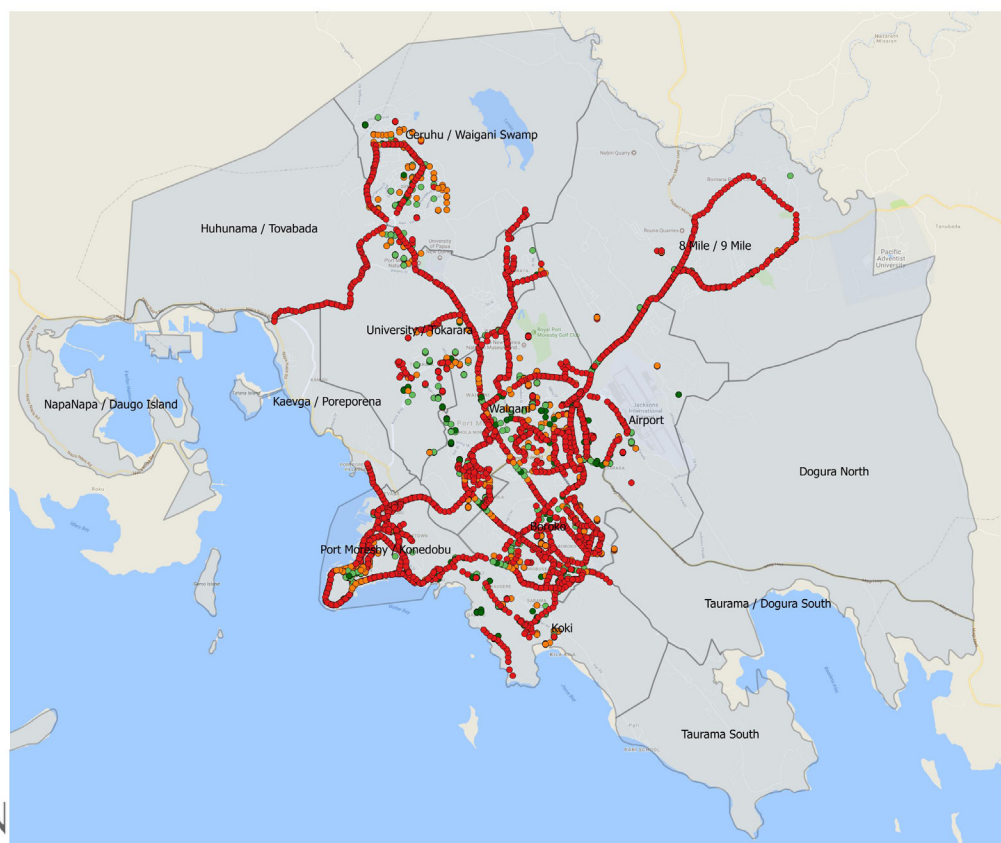
Map 11: Audits showing rating of the public transport during daytime

The areas of Central Business District (CBD), Waigani market, Airport and University area have been rated higher in Public Transport as these are high activity zone. Majority of the buses are run by private service providers and have

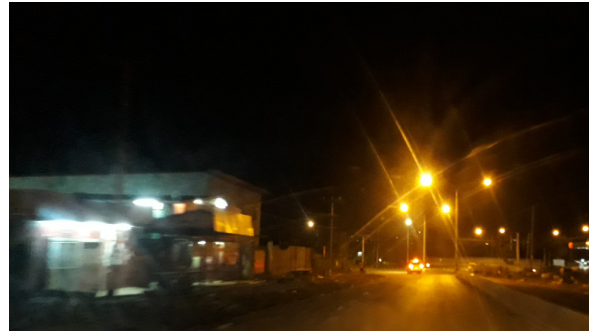
Figure 13: Deserted Bus Stop at night

fixed timings during morning and evening. Some of the existing bus stops were found to be deserted at night and only few of them had proper lighting in the night (Figure 13). Figure 14 shows a bus stop at a height along unpaved part of the road. There should be proper lighting and seating furniture at the bus stops in order to provide smooth and comfortable access to the travellers. Map showing lighting at the bus stops can be seen on Map 13.

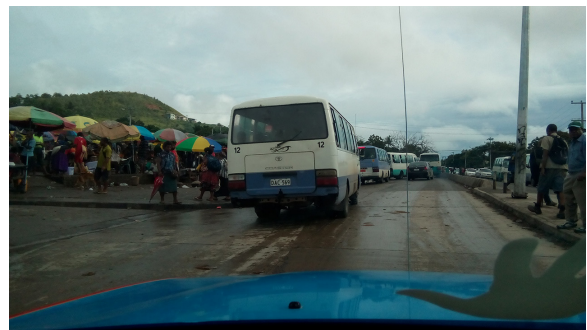
Figure 20: Street Market provides natural surveillance

In marketplaces with large number of street vendors and hawkers, while visibility was rated high, there was no Police or Private security. At some points, street side vendors and hawkers were found acting as natural surveillance (Figure 20). However, the auditors mentioned that security at these highly crowded areas are a concern. Audit points with high visibility in terms of road side vendors and temporary stalls indicate marketplaces. Around the clock security should be provided at these marketplaces as these are high activity zones.

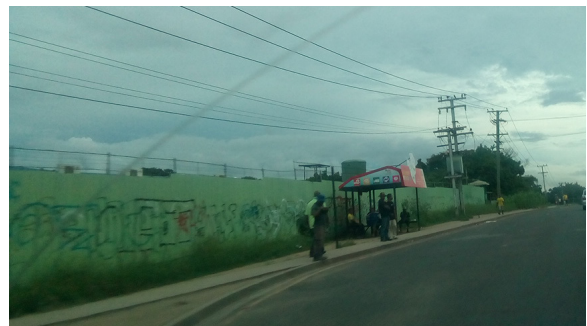
Figure 19: No Security at the bus stop

Additionally, auditors reported cases of harassment and mugging at the bus stops. This dissuade women to wait at the bus stop alone and instead wait on the road. High Boundary walls around the bus stops are added concern for female commuters. Regular Police patrolling around the bus stops could prevent the cases of harassment and theft.

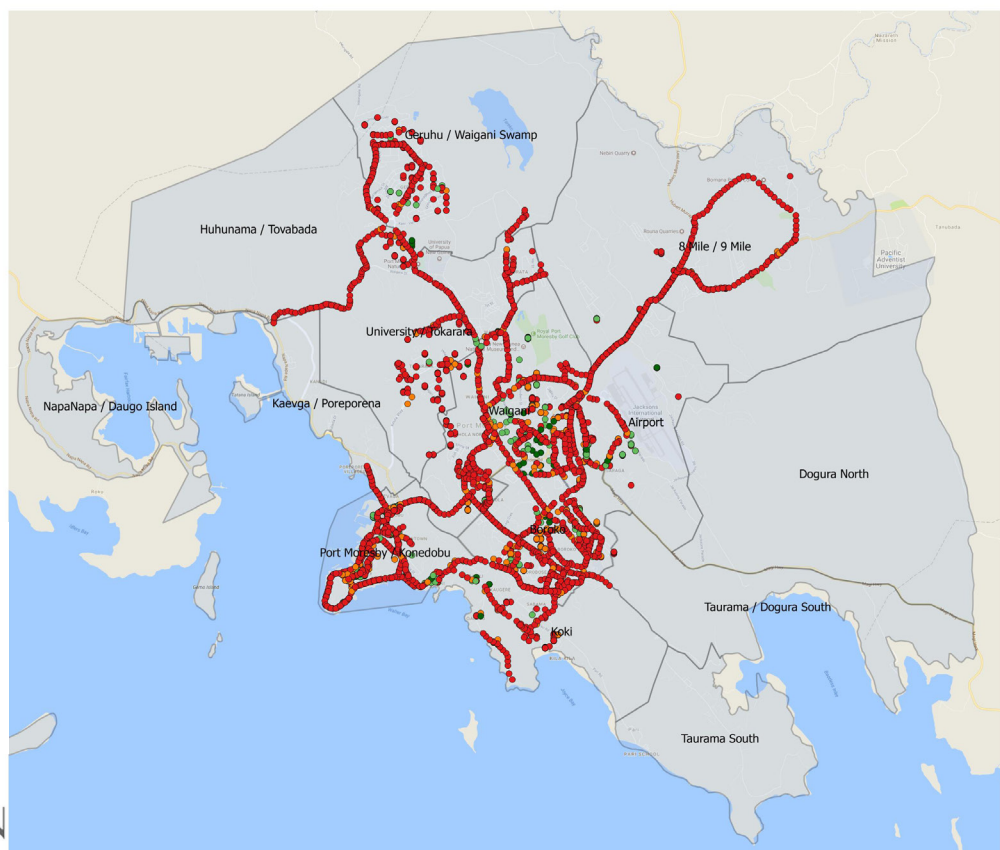
Map 17: Audits showing security rating during night

Local Planning Area (LPA)	Security	
	Low (0,1 rating)	High (2,3 rating)
<b>Port Moresby/ Konedobu</b>	Chalmers cres, Streetanley Esplanade, Airvos Ave, Ela Beach Road, Champion parade, Healy Road, Davara Road, Lawes Road, Elanese Road	Port Road, Dauglas Street, Musgrave Street, Koki Street, Lawes Road, Elanese Road, Stanley Esplanade
<b>Boroko</b>	Wards Rd, Taurama Rd, Moonbi St, Merrie England Rd, Gavamani Rd, Moisana St, Pipi Gari St, Korobosea Dr, Chinsurah St, Hubert Murray hwy, Lahara Ave, Stores Rd, Waigani Dr, Gabaka St, Angau Dr, Bisine Parade, Laurabada Ave, Okari St, Bava St, Leander St, Igua St, Karu St, Besese St, Bau Bau St, Boroko Dr, Tana-Tana St, Vaivai Ave, Ilimo Ave, Turua Ave, Lokua Ave, Budoa Ave	Nita St., Ororo Cres near St Martin's Church, Lokua Ave
<b>Gerehu</b>	NA	Goro-kaeaga Rd, Gerehu Dr, Tarurmana Ave, Nigibata Rd
<b>University/ Tokarara</b>	Waigani Dr, Baruni Road, Savari Road, Goro-Kaeaga Road, Gannet Road, Cassowary Road, Curlew Street, Pelican Street, Pipit Street, Matabudi Street, Kate Street, Giung Street, Talapai Street, Koura Way, Rakatani Road, Arere Street, Diara Street, Gevana Ave, Kenese Ave	Waigani Dr, Rakatani Road

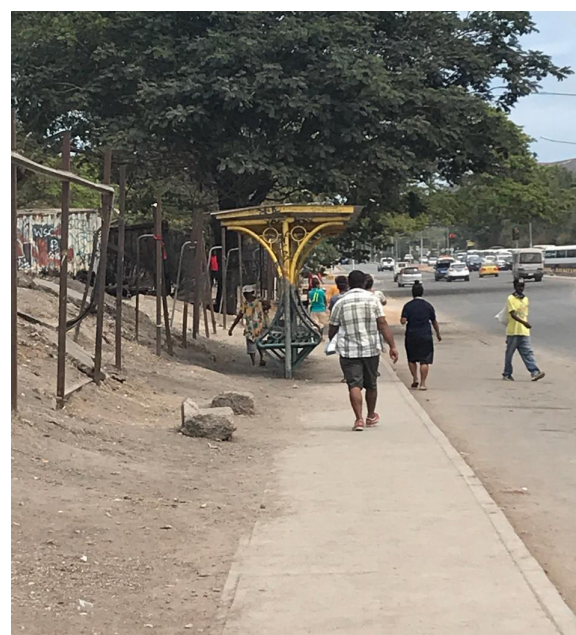
Figure 27: Bus Stop in Waigani (Intervention Site)

Also, the current bus stand is an old design with no proper seating or lighting. We have shared a design

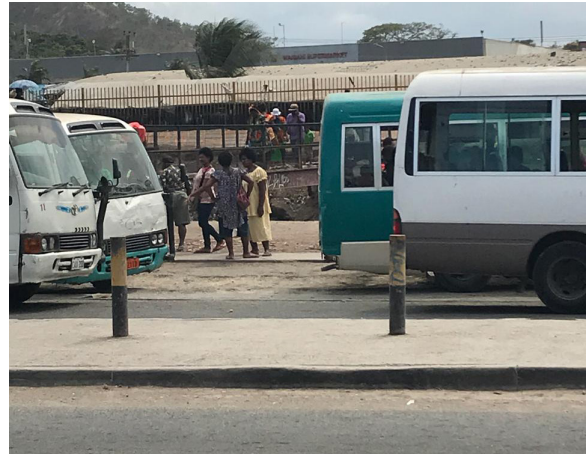
Figure 28: Bus Stand in Waigani (Intervention Site)

There is a need for a parking bay and a bus stand, designed in a way that it doesn't block pedestrians' path and view. Proper seating and lighting to be provided at the bus stand.

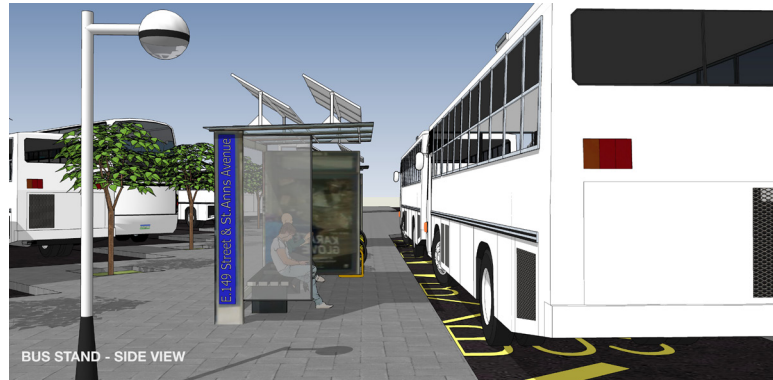
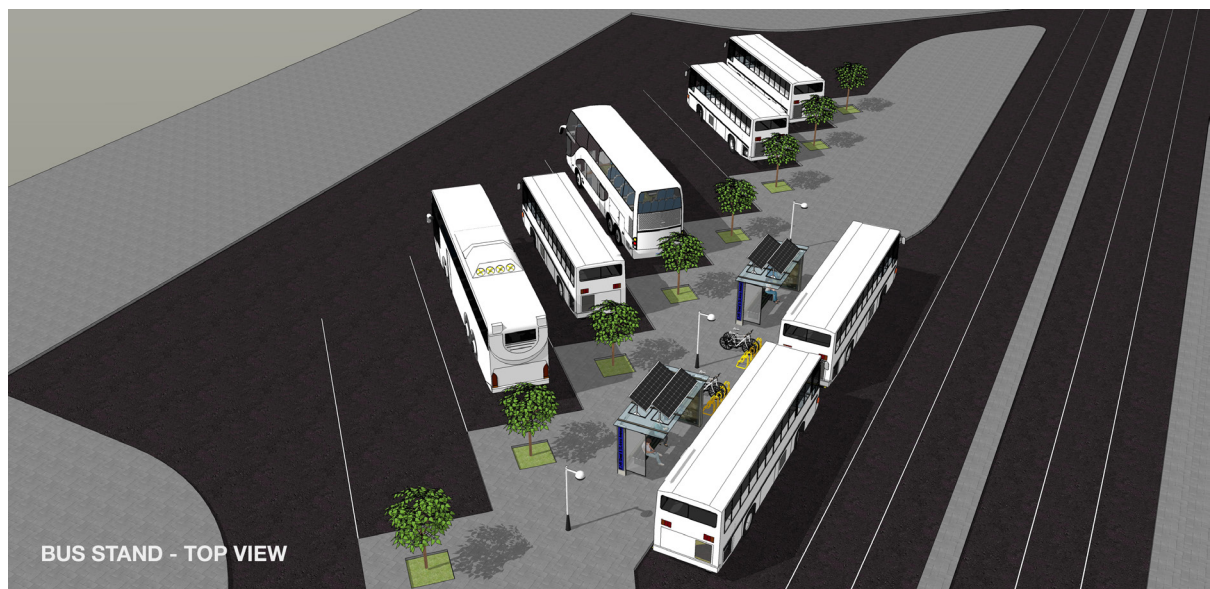
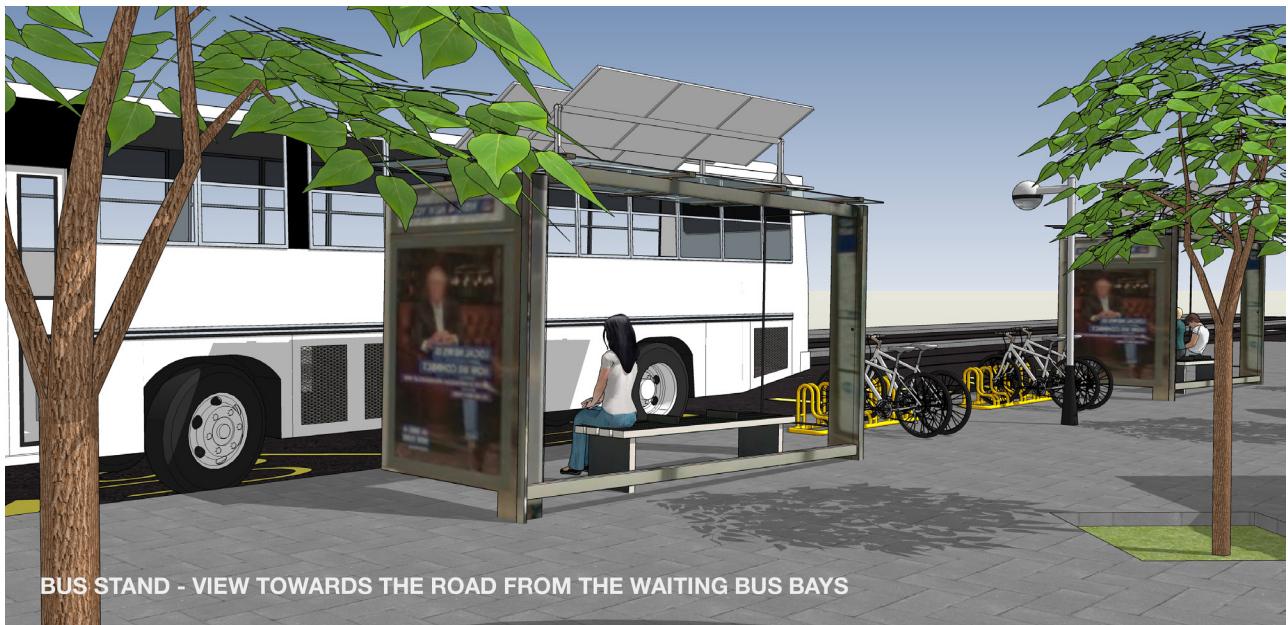
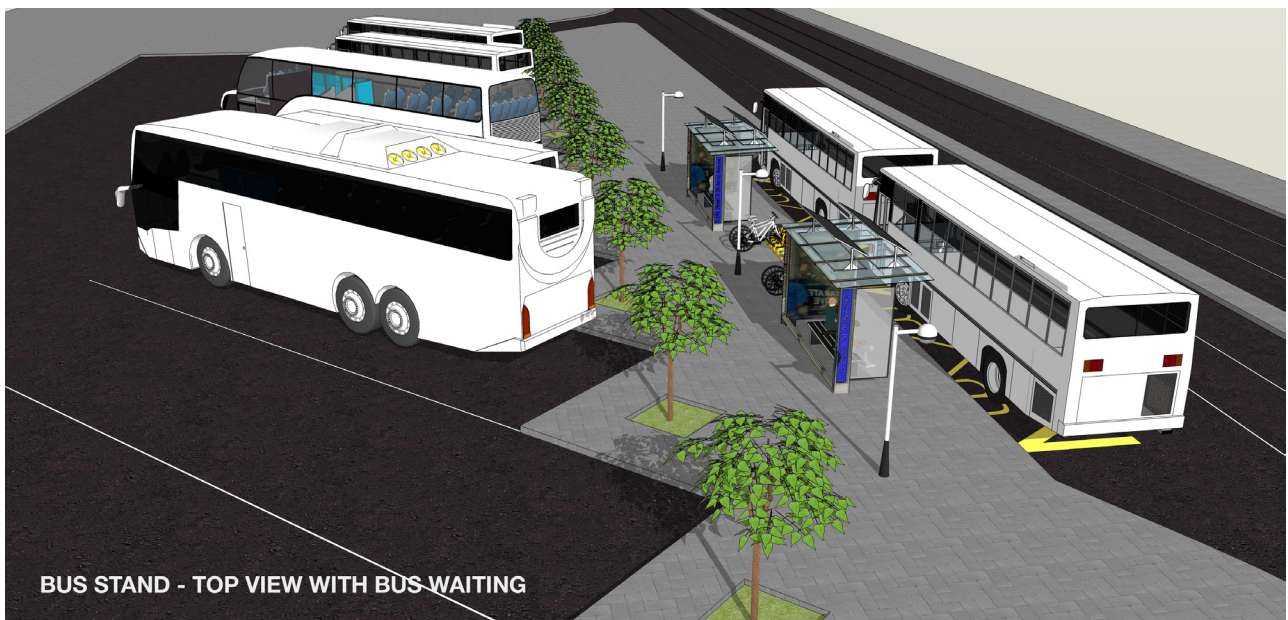
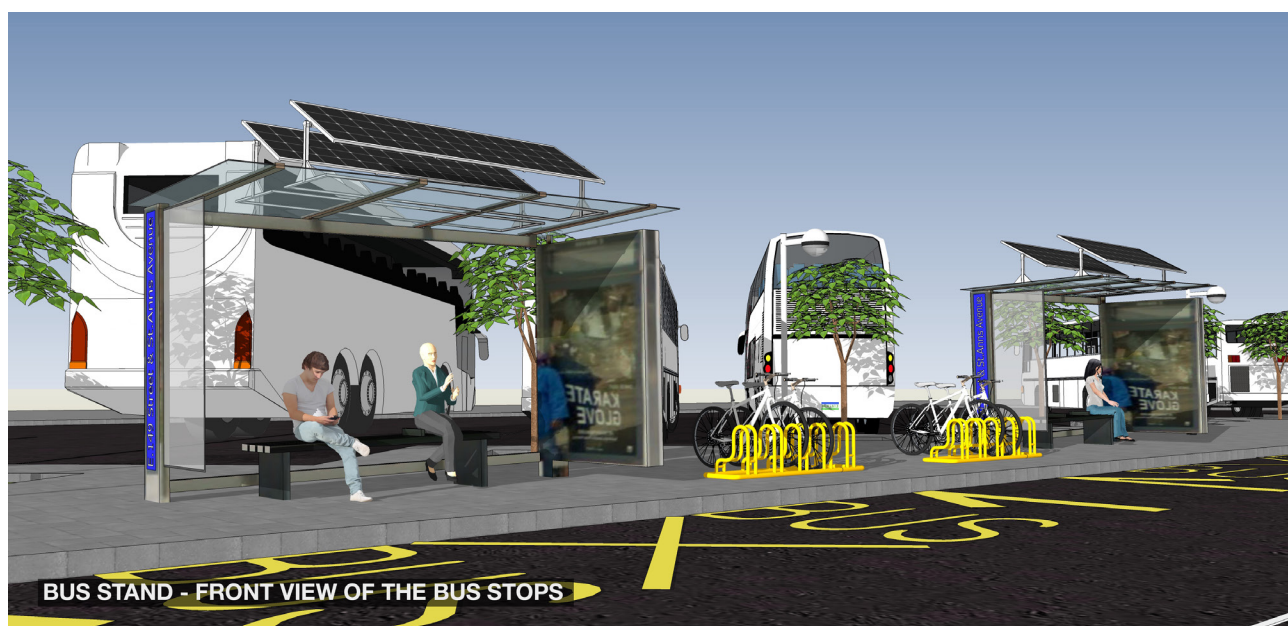
Illustrations for a small Bus Stand which primarily has a bus stop/shelter and some bus waiting/parking bays are shown in Plan, Top and Side view.
