# ENHANCING LAST MILE CONNECTIVITY

a safety analysis of the RK Ashram Marg Metro Station

# RK Ashram Marg

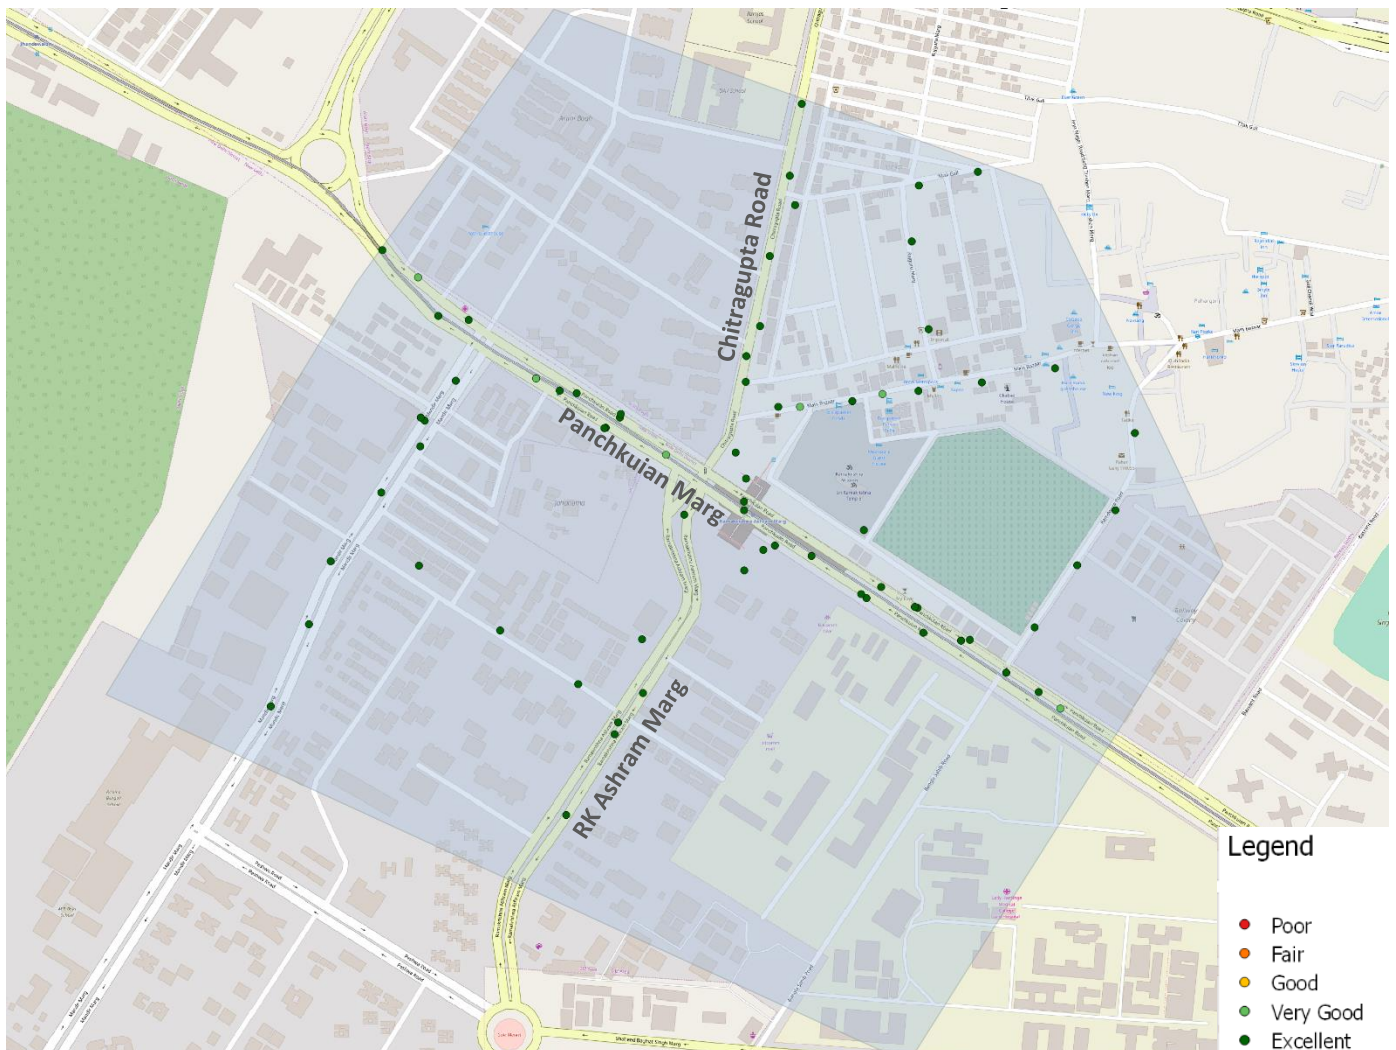
Map indicating Safety Score

Safety Audits indicate that the area around the metro station is safe. Safety score was found to be good throughout the audit area. Lighting parameter has been rated Good i.e. the highest followed by Walkpath and Public Transport (Above Average). The parameter of Security has been rated Below Average.

Visibility has been rated Average owing to popular commercial market surrounding the metro station. The parameter of People and Gender have been rated Average and Below Average respectively. Overall, auditors have rated the Feeling in this area as Average.

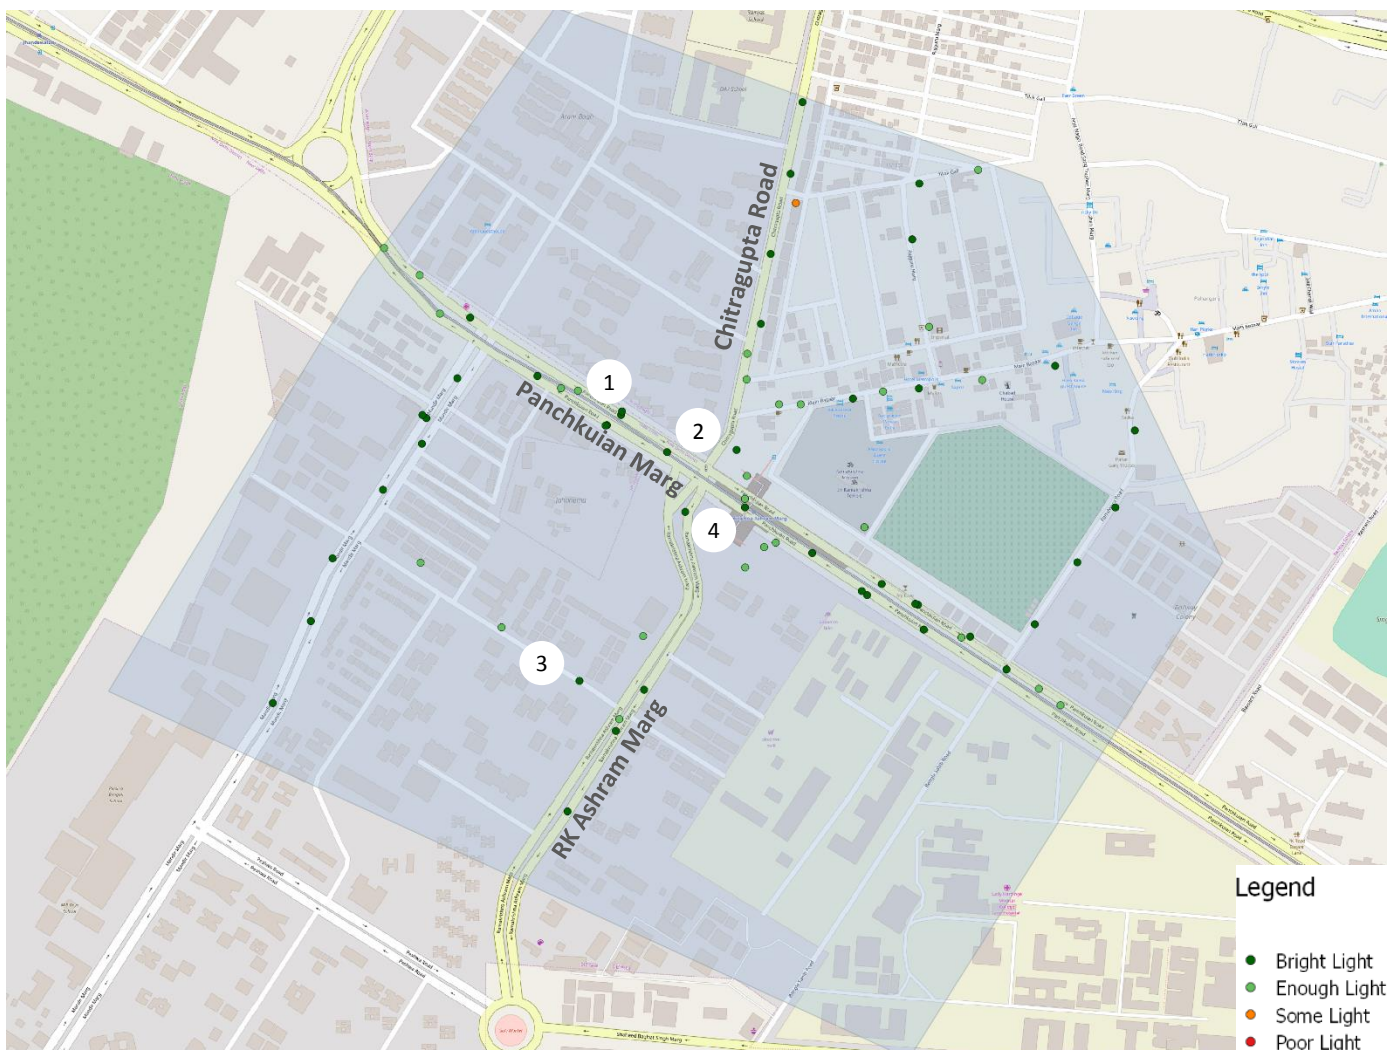
Lighting Rating

Lighting Parameter has been rated 2.6/3 i.e. Good. On Chitragupta Road and RK Ashram Marg, streetlights are installed along the central median. On Panchkuian Marg, streetlights are installed on edge of the footpath on both sides of the road. While streetlights face the main road on one side, on the other side it faces both the road and the footpath. However, this provision is limited to the market area near the metro station.

Rest of the area has streetlights facing only the main road. Pedestrian scale lighting should be installed along the edge of the footpath or boundary wall. Also, at some points overgrown leaves hide the streetlights, thus resulting in low illumination. Tree leaves should be pruned regularly. Regular maintenance checks should be carried out to ensure the same.

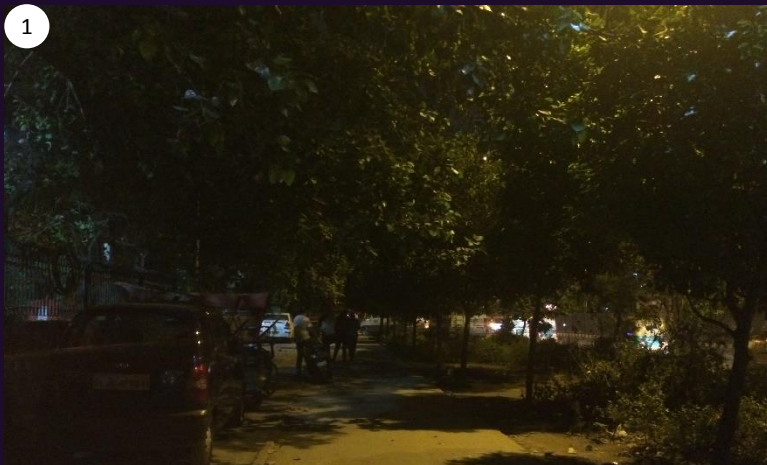
At few points on Panchkuian Marg, trees are lined along the footpath and cycle track. Streetlights installed on the edge of the green belt facing the main road, are not able to provide illumination on the pedestrian path. This lack of lighting can prove risky at the junctions and corners as seen in Pic 2. To avoid this, pedestrian scale lighting should be installed at the edge, clear of the pavement. Also, at points where streetlights are hidden behind tree's foliage, regular pruning of leaves should be carried out.

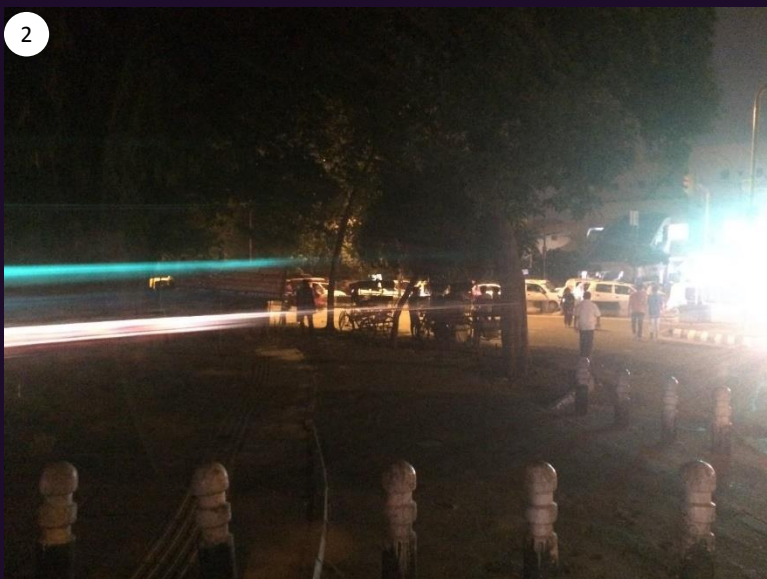
On neighbourhood roads, streetlights are installed on both the sides (Pic 3). However, they are placed too far each other resulting in poor illumination at points between two streetlights. Additional streetlights are needed along this stretch to ensure uniform illumination. At points where there are lights installed along the boundary wall of housing societies, additional streetlights can be installed alternately on both sides of the road.

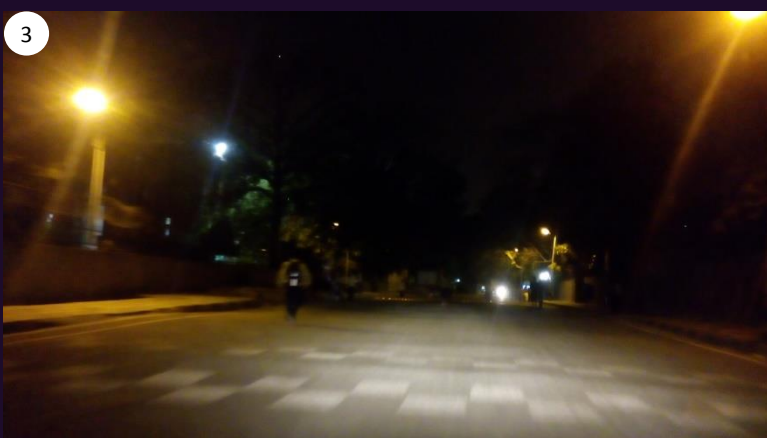
At some points as seen in Pic 4, streetlights were found non – operational. Regular maintenance checks should be done.

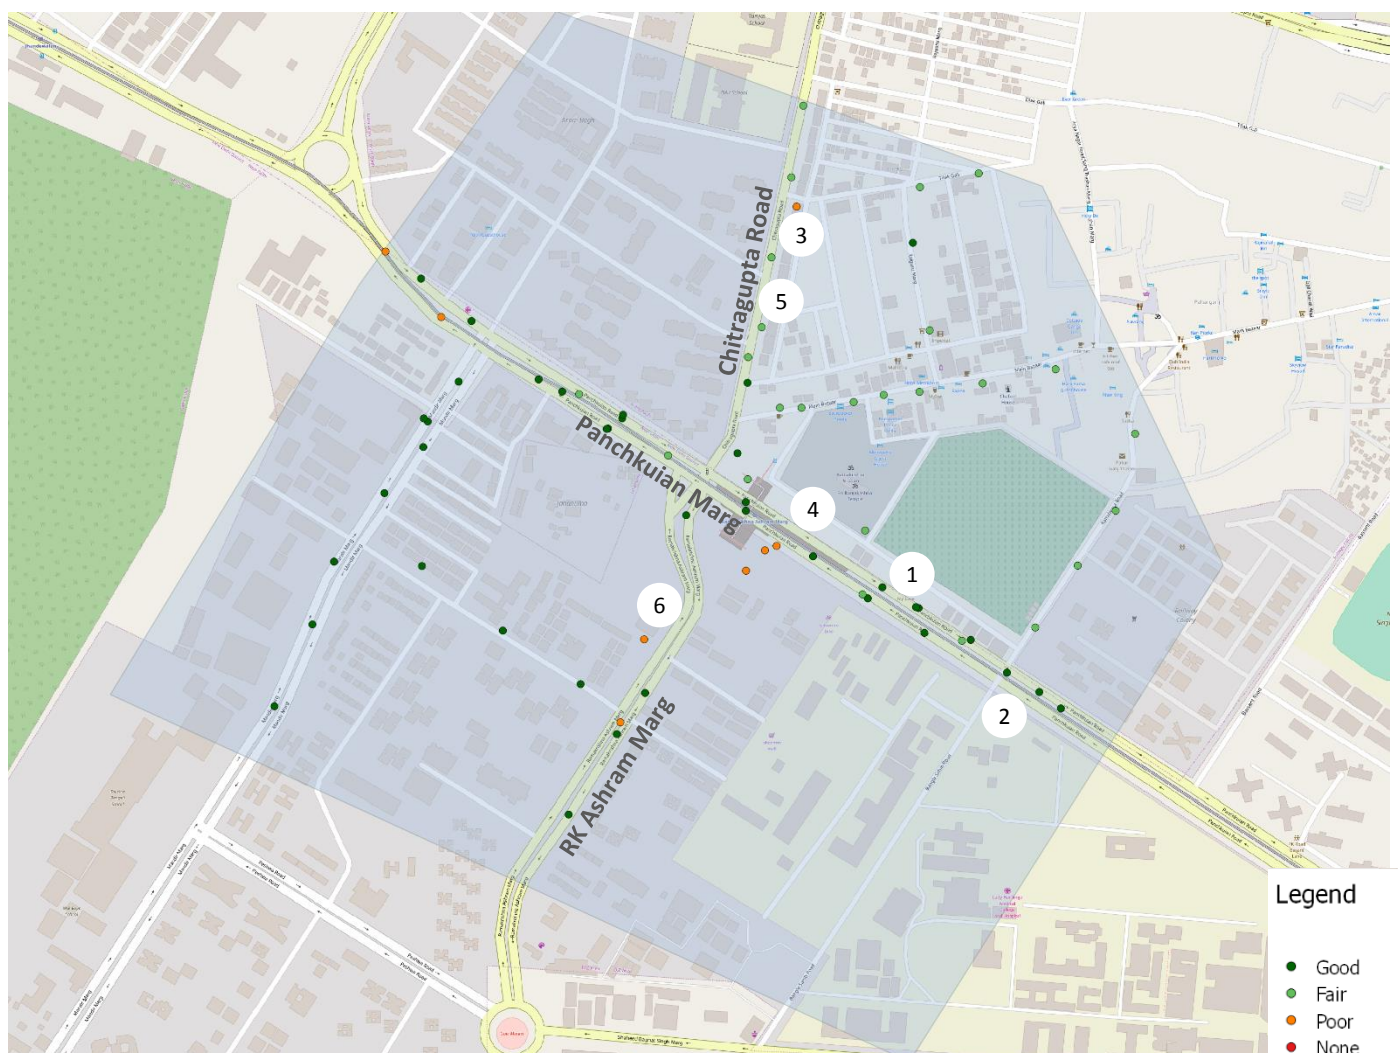
Walkpath Rating

Walkpath Parameter has been rated 2.4/3 i.e. Above Average. Though the footpath exists throughout the audit area, it is not well maintained on Panchkuian Marg and Chitrugupta Road. The footpath along RK Ashram Marg was found to be well maintained but not easily accessible for the physically and visually challenged. At few points, the slope of ramp was too steep and not wide enough for a person on wheelchair.

While there was broken tactile paving on Panchkuian Marg and Chitrugupta Road, there was none on RK Ashram Marg. The broken tactile paving should be repaired and should be linked to the metro station entry/exit and the bus stop. Other issue was vehicular parking on the footpath. It should be disallowed and separate space should be provided for parking.

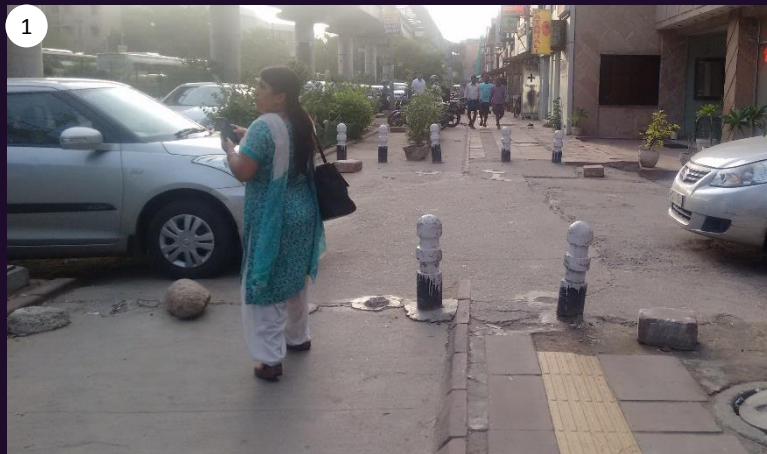
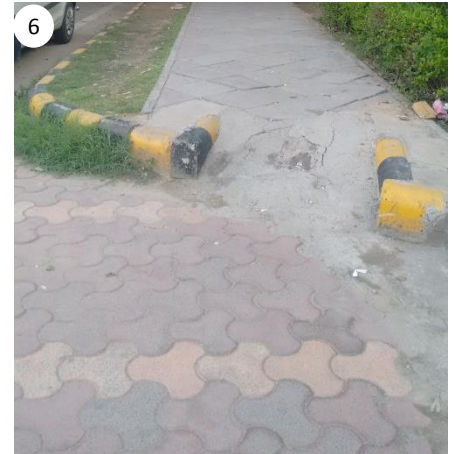
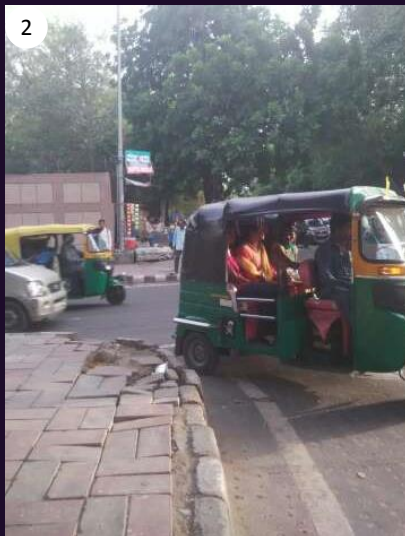
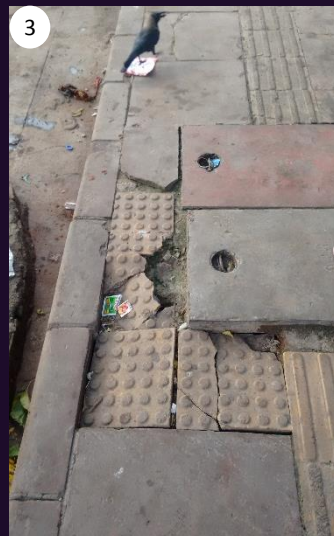
As seen in Pic 1,2 and 3 the footpath is broken at many audit points. Tactile paving and bollards are damaged, and improperly placed. Seen in Pic 6, the slope of the ramp is not suitable for the physically challenged. The footpath should provide smooth and continuous pedestrian movement. The edge of the footpath should be clearly defined. Seen in Pic 2 and 3, the footpath and tactile paving should be repaired. Bollards should be properly placed such that it doesn't obstruct the tactile paving. The ramp should be wide and have a gradual slope to allow people on wheelchair to access the footpath (Pic 6).

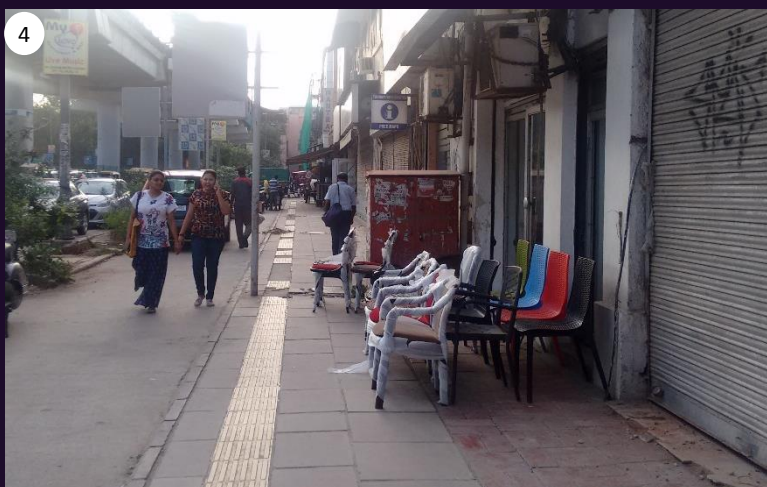
Along Panchkuian Marg, the furniture kept on the footpath forces pedestrians to walk on the cycle track (Pic 4). The cycle track is also obstructed by vehicular parking. Separate parking space should be provided for the vehicles. The footpath and the cycle track should be cleared of all the obstructions.

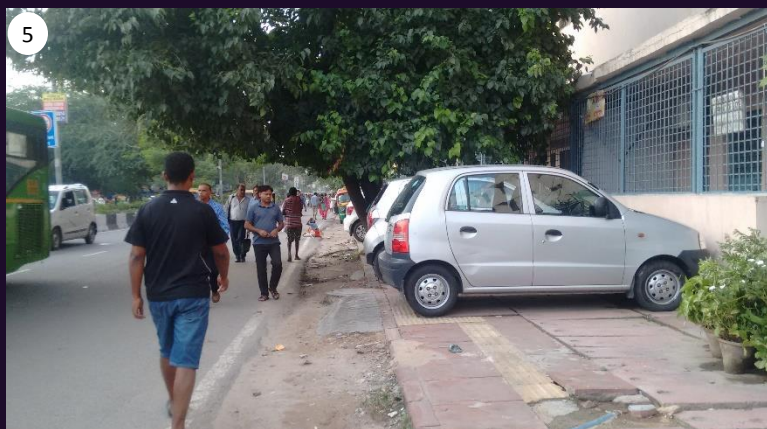
Vehicular parking on the footpath is also seen all along Chitragupta Road (Pic 5). To avoid this, the footpath should be raised to a level from the road and its edges should be well defined. Separate parking space should be provided for the vehicles.

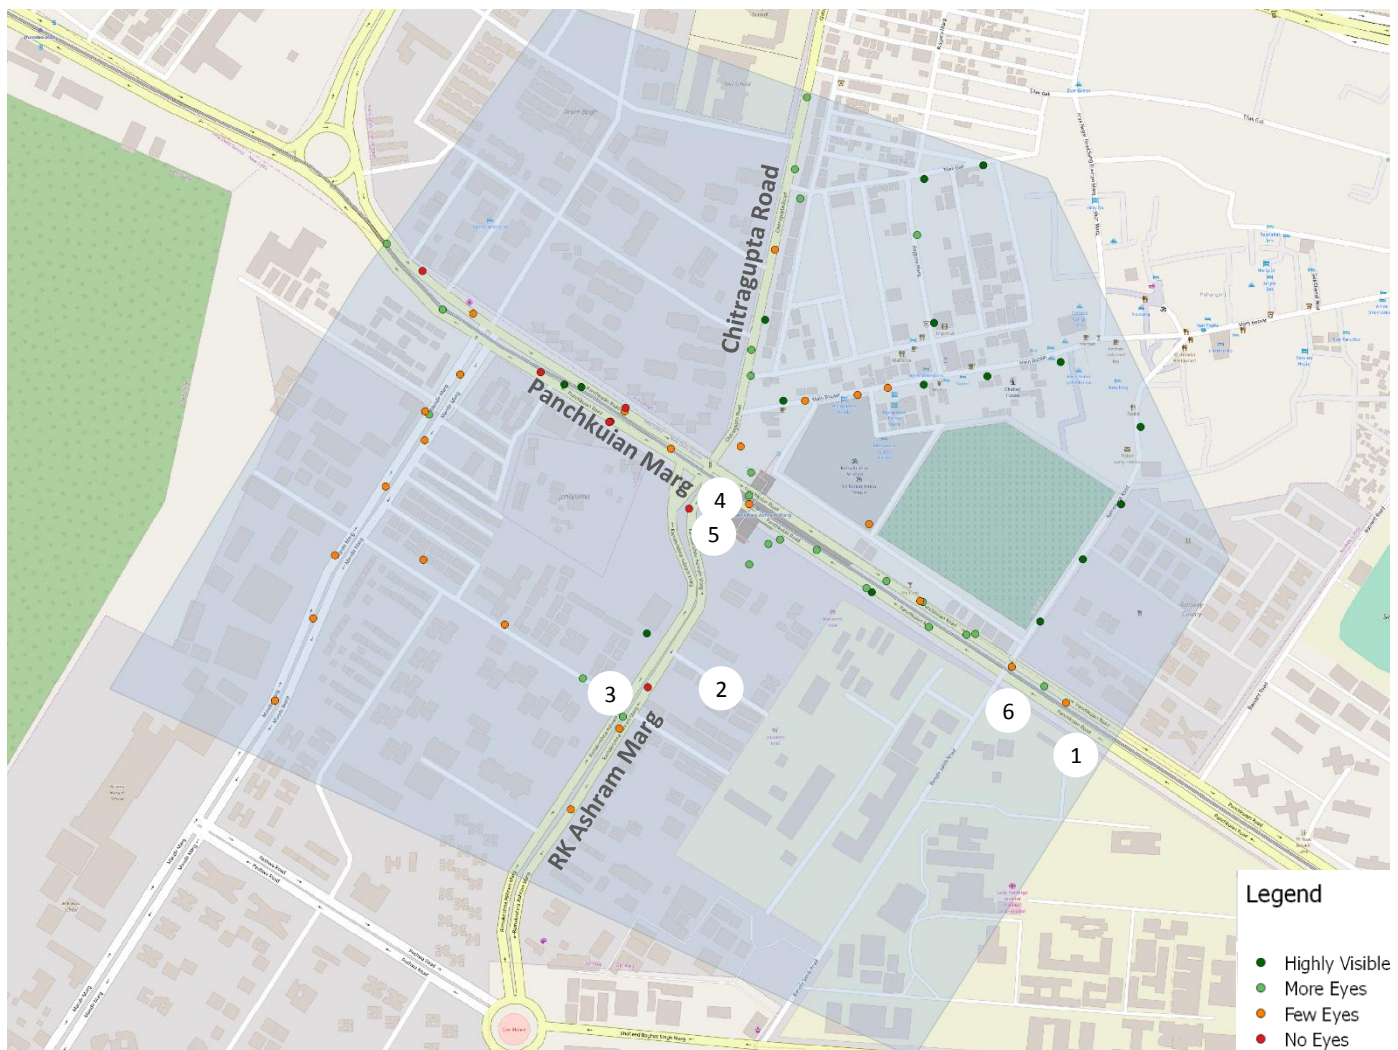
Visibility Rating

Visibility Parameter has been rated 1.7/3 i.e. Average. On one side of Panchkuian Marg towards Chitragupta Road, various shops, houses and street vendors overlooking the street contribute to visibility. The other side towards RK Ashram Marg is largely characterized by high boundary walls of residential society and offices, resulting in low visibility.

There are few kiosks set up clear of the footpath along these boundary walls that provide some visibility. Street vendors were seen occupying the footpath at various audit points. To improve visibility in residential neighbourhoods, the height of the solid part of the boundary wall should be maintained at 1 m. Also, designated hawker zones should be set up within the residential area, clear of the footpath.

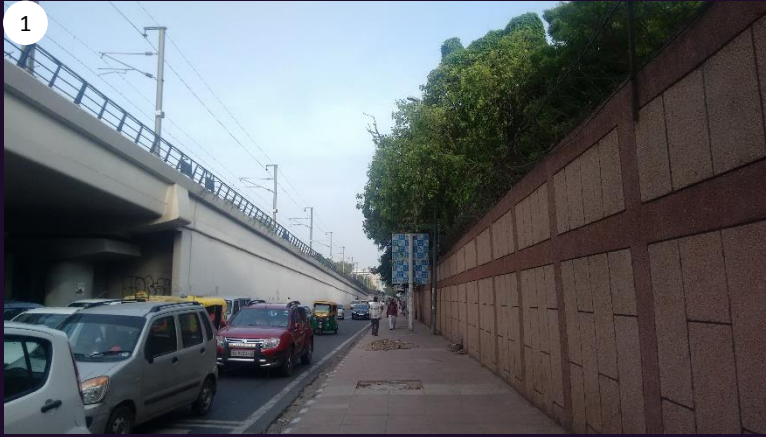
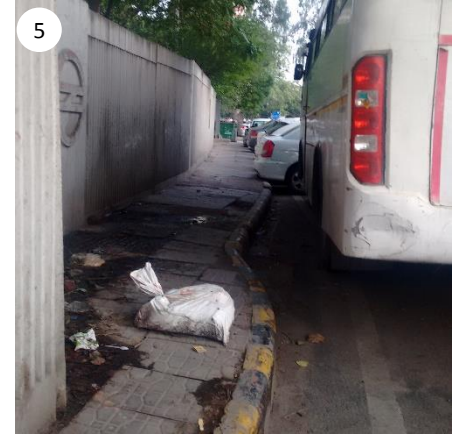
As seen in Pic 1, 2 and 5, high boundary wall results in low visibility. These inactive edges can pose risk to the pedestrians, especially at night. The boundary walls of public buildings, commercial complex and residential society should be kept low to maintain some visual contact with the pedestrians. The solid part should be maintained at 1m and the rest of the wall should have uncovered grill.

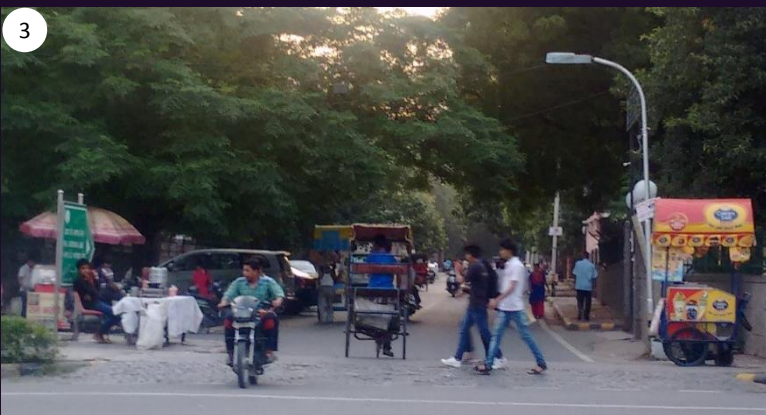
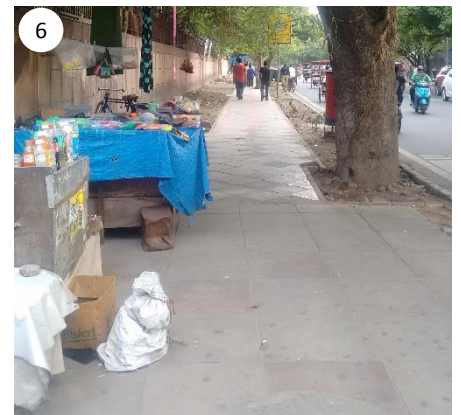
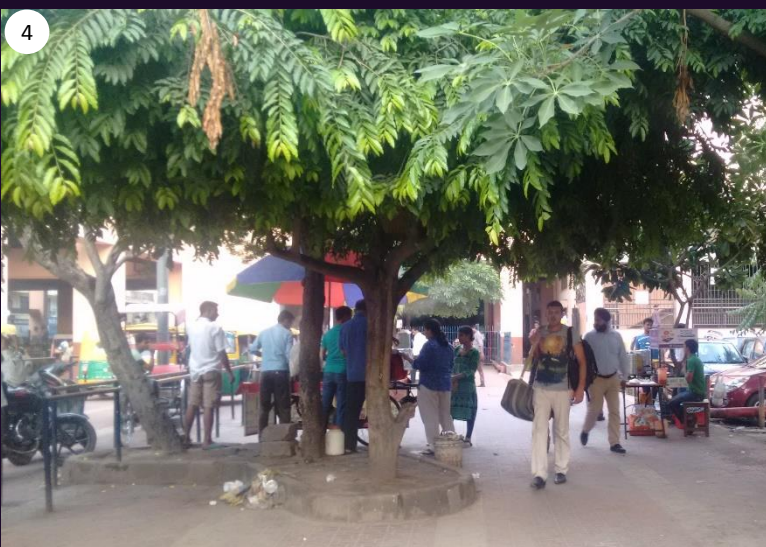
Along these high walls, seen in Pic 3, 6 street vendors occupy the footpath. Niches can be created in the boundary wall to provide space for these hawkers, clear of the footpath. In Pic 4, near metro station entry/exit a designated hawker zone should be set up. This space can be enhanced by adding street furniture and proper lighting.

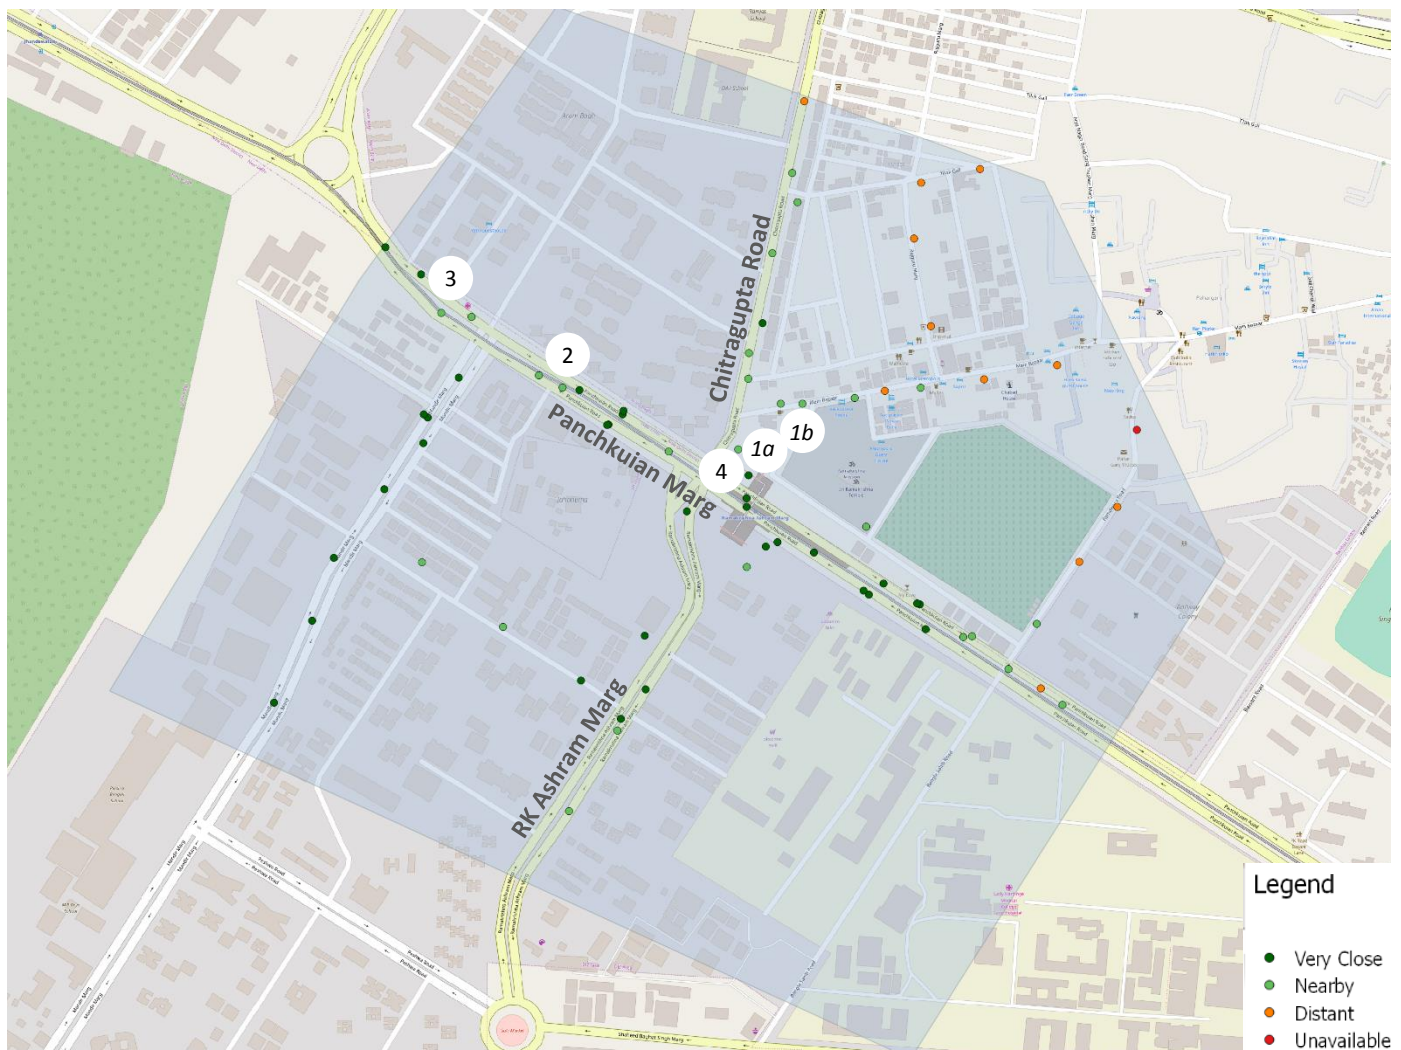
Public Transport Rating

Public Transport Parameter has been rated 2.3/3 i.e. Above Average. Outside the metro station, designated space for autos have been provided at the metro station. However, similar provisions should be made for cycle rickshaw and e- rickshaw. There should be para transit stands at the bus stops, market and within the residential area.

These para transit stands should have proper parking space for rickshaw, public convenience and street furniture. Additionally, the cycle track provided on Panchkuian Marg, should be clear of any obstruction. The track should be well – lit and clearly demarcated. Vehicular parking should be disallowed on cycle tracks.

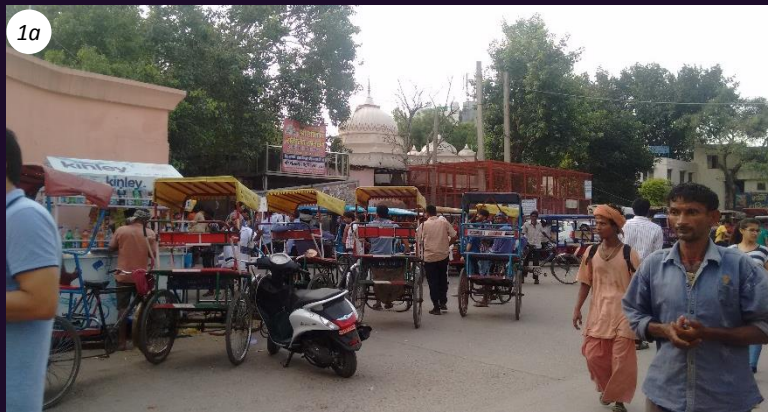
As seen in Pic 1a and 4, a number of cycle rickshaws are present at the entry/exit of the metro station. While there is designated auto stand on the other side of the road, there is none for cycle rickshaw and newly introduced e-rickshaws. Outside RK Mission spiritual centre near Gate no. 2 of the metro station, there is vacant space that can be used to set up a proper para transit stand. Currently, the public space has been restricted using grills (Pic 1b). It should be opened up for public use. Designated space should be provided for the street vendors as well.

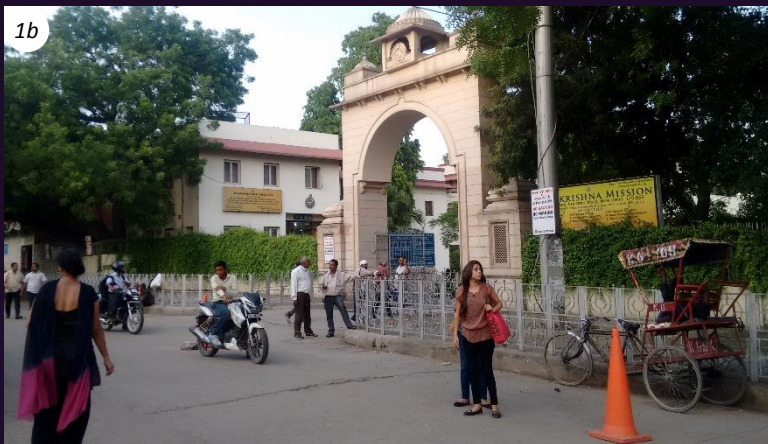
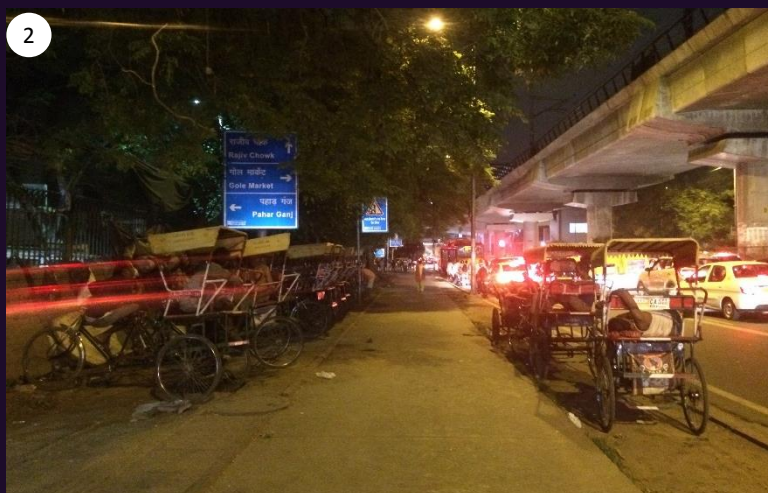
Seen in Pic 2, cycle rickshaws can be found at various points in this area. In the absence of a designated space, they occupy the pavement. People can be seen resting in their rickshaws. Proper para transit stands should be set up at regular distance. They should be equipped with public toilet and street furniture. The para transit stands should be set up at bus stops as well.

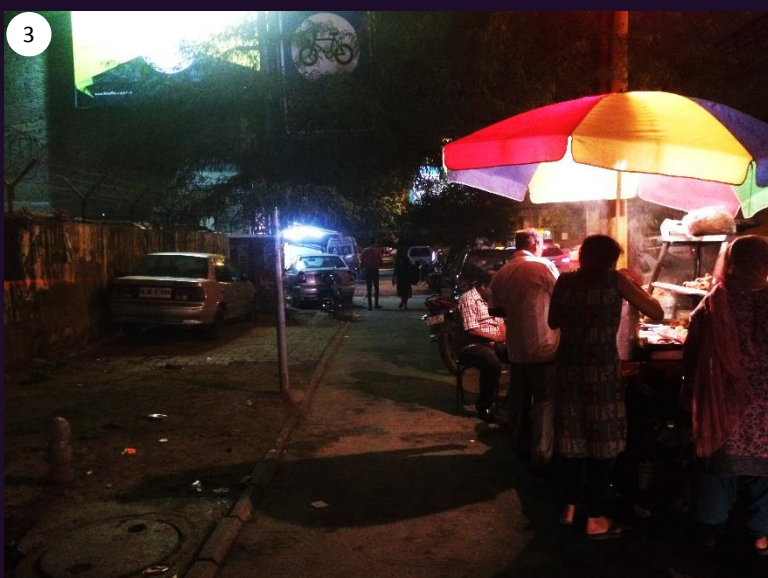
Further along, one can see street vendors occupying the cycle track and vehicles obstructing the footpath. The cycle lane should be clear of any obstruction. Separate space for the vendors should be provided clear of the pedestrians' and cyclists' path. Prune the tree leaves that currently blocks the signage indicating the cycle track.
