BHOPAL

SAFETY ANALYSIS REPORT

2019

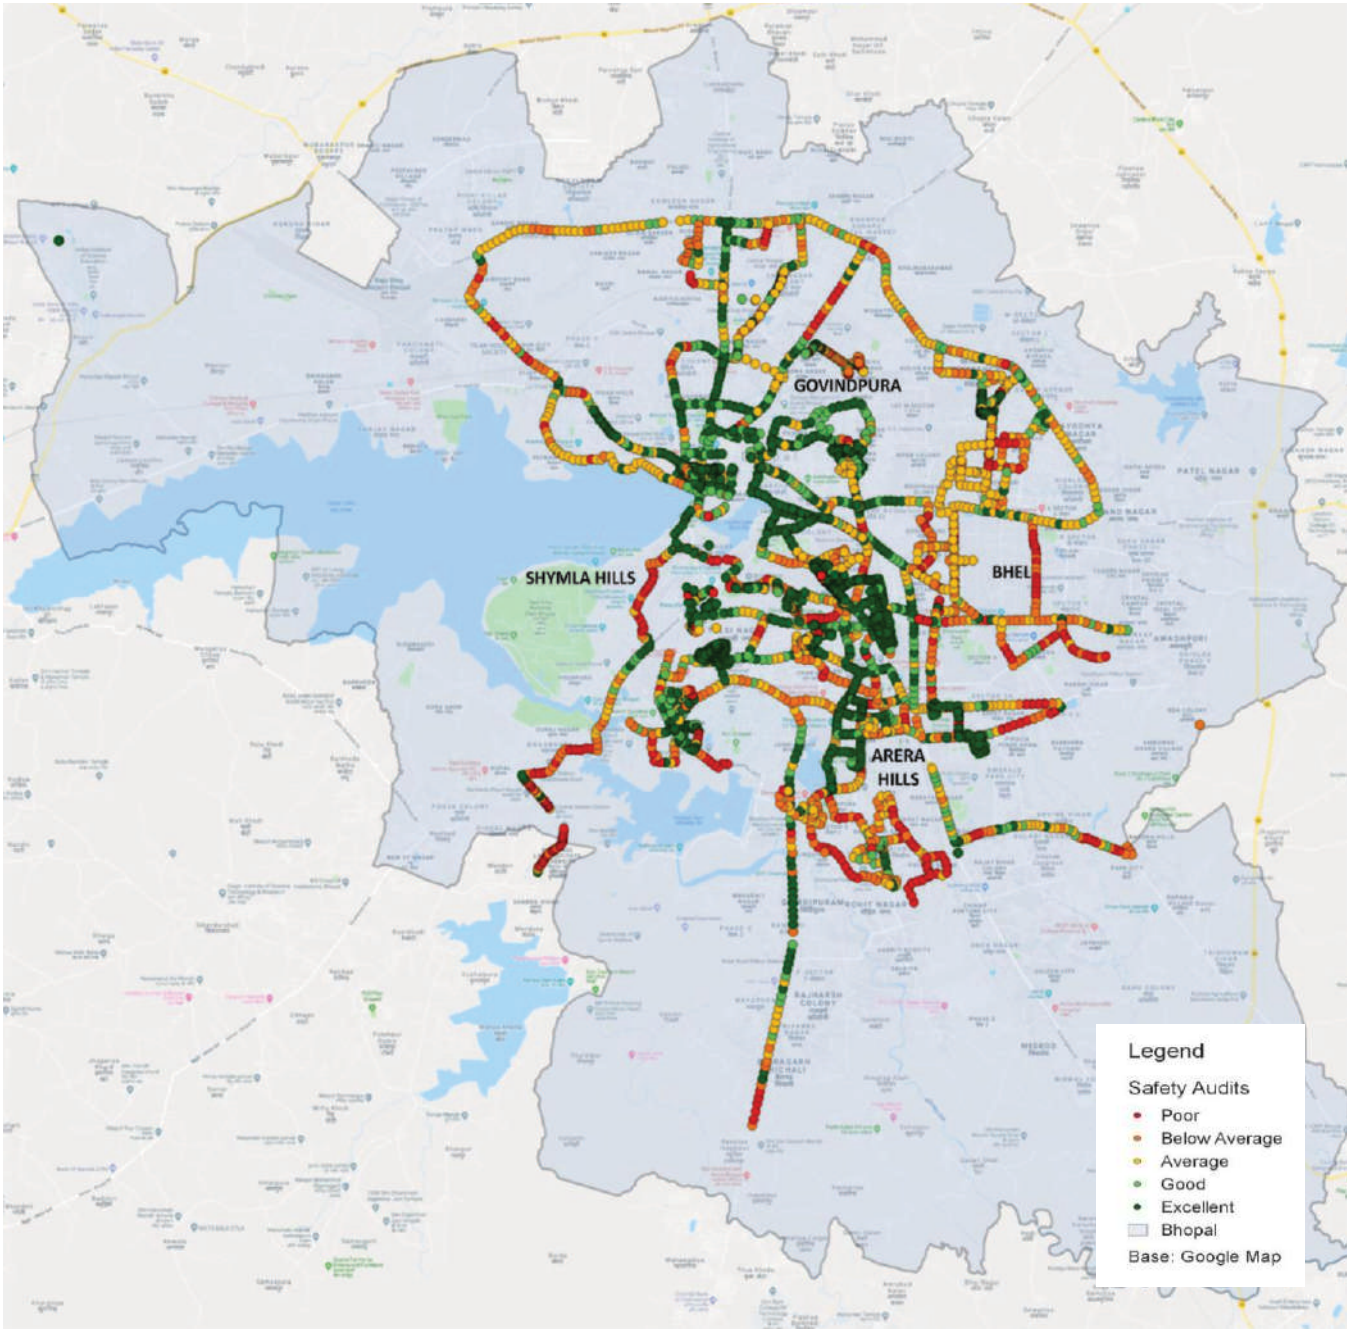
Map 1. Indicating Safety Score ratings

Indicated in the pie chart is the percentage distribution of pins in each range. Over 39% of the audit points were rated poor i.e. safety score less than 2 out of 5, on the other hand 44% were rated excellent or good i.e. safety score above 3. As seen in the Safety Score map, points located around Ibrahimganj, Jahangirpura, Ibrampura, Arera Hills, Indra Press Complex and Kotra Sultanabad were highly rated whereas in BHEL, Govindpura, Gulmohar Colony and Lalghati road safety score was found to be poor.

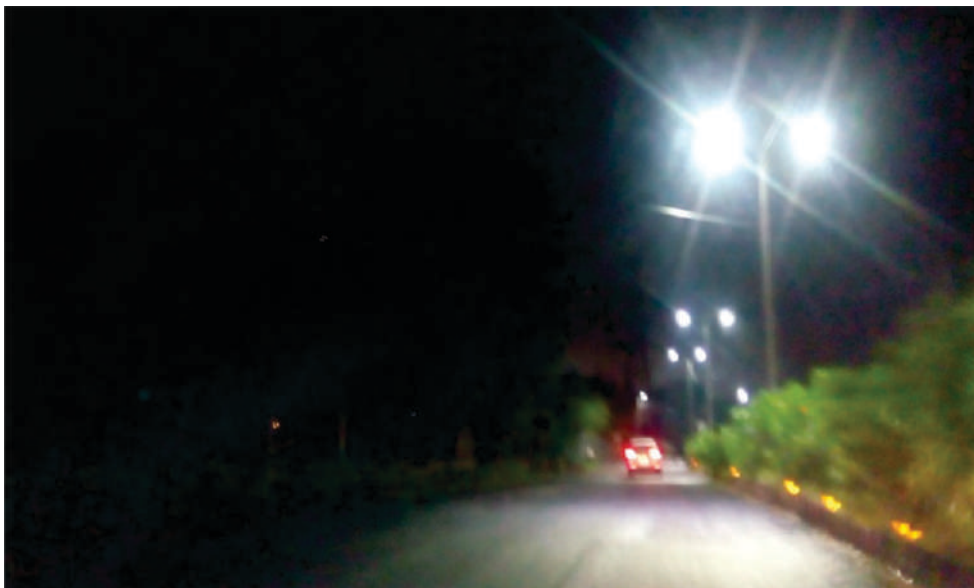
Lighting has been rated 1.9/3 i.e. Average. Streetlights are installed along the central median on most of the roads. While 63% of the audit points have been rated good, 10% of the points have been identified as dark spots. The dark spots indicate no source of lighting and no streetlights installed along the road. Streetlights need to be installed along this points immediately as most of them lie in residential areas including Gulmohar-3, Govindpura and Arera hills.

Image showing streetlights installed along median

Along the main roads having four lanes or more, streetlights are provided along the central median of the road. In such cases, additional streetlights need to be installed along the footpath. Pedestrian scale streetlights should be installed such that the footpaths are also well light.

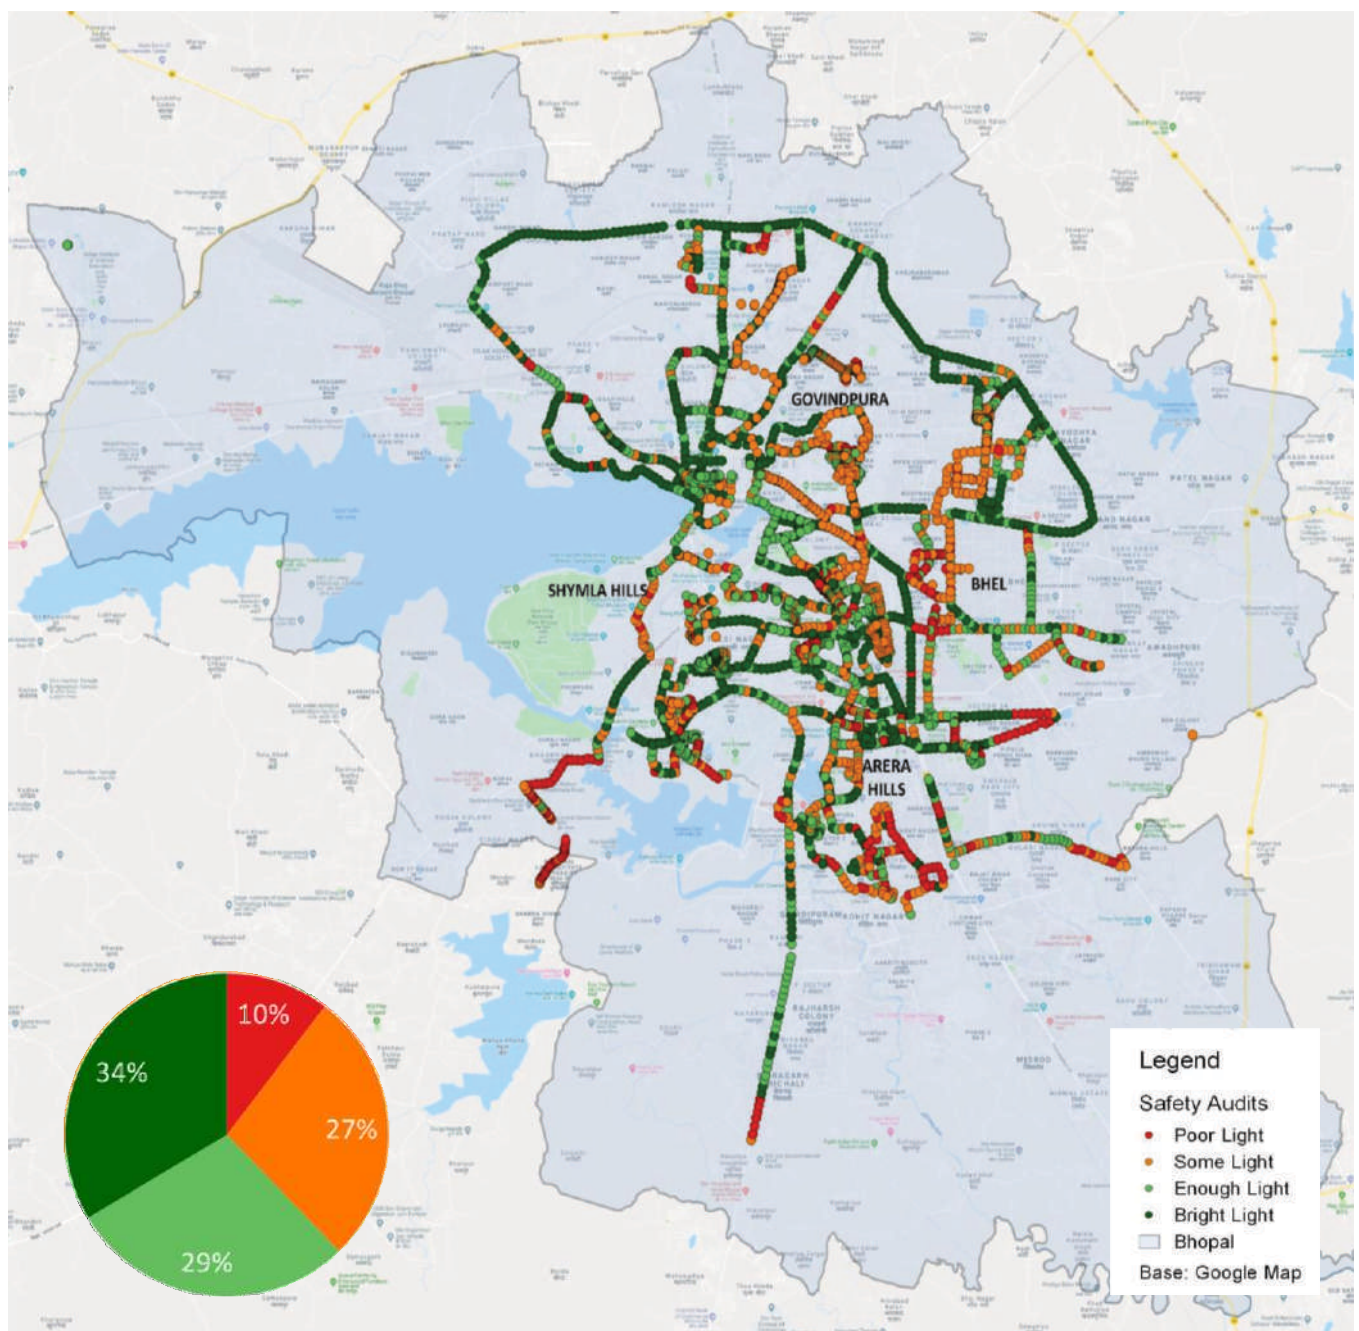
Map 2 Indicating Lighting rating

Additionally, 27% of the points have been rated poor. Majority of these points were found in southern and north western part of BMC area. Karariya Sajdabad, Pushpa nagar, Maharana pratap nagar and Arera hills were found to have streetlights obstructed by leaves resulting to dim illumination.

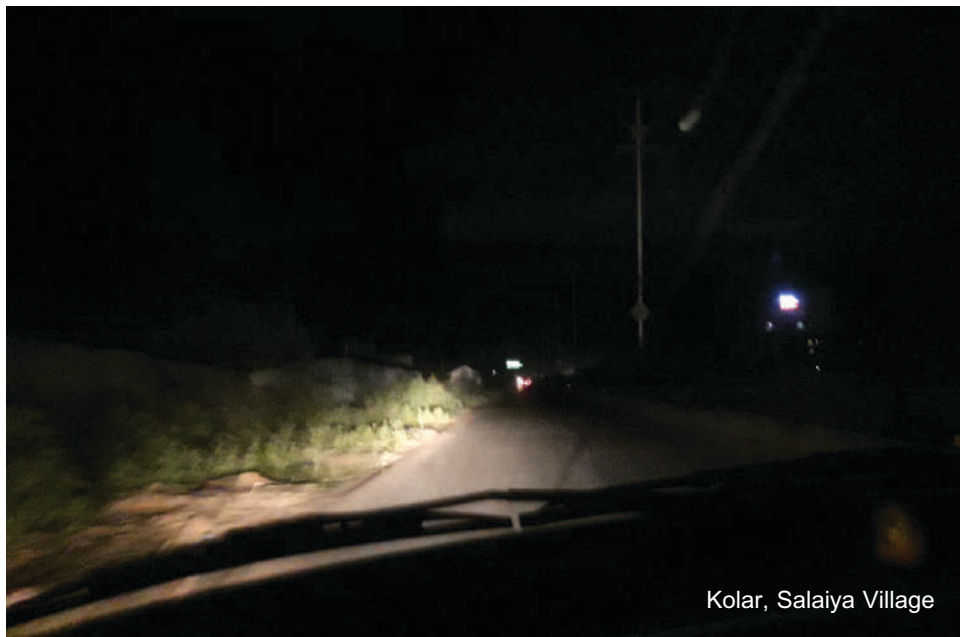
Map 3 indicates points which were found to have streetlights non-functional or no streetlight at all. Majority of these points are located in south east of BMC area. Kalibadi Marg was found with maximum number of non-functional streetlight. Bhadbhada Marg which is the main access to the city from south west had no streetlights on Sakshi Dhaba -Chander Hotel stretch.

Images showing stretches with non-functional streetlights

The existing streetlights that have been found non-operational need to be checked. Regular checks should be carried out to ensure uniform and unobstructed illumination. Streetlights need to be installed along areas, identified as dark spots i.e. at these locations there is no illumination at present.

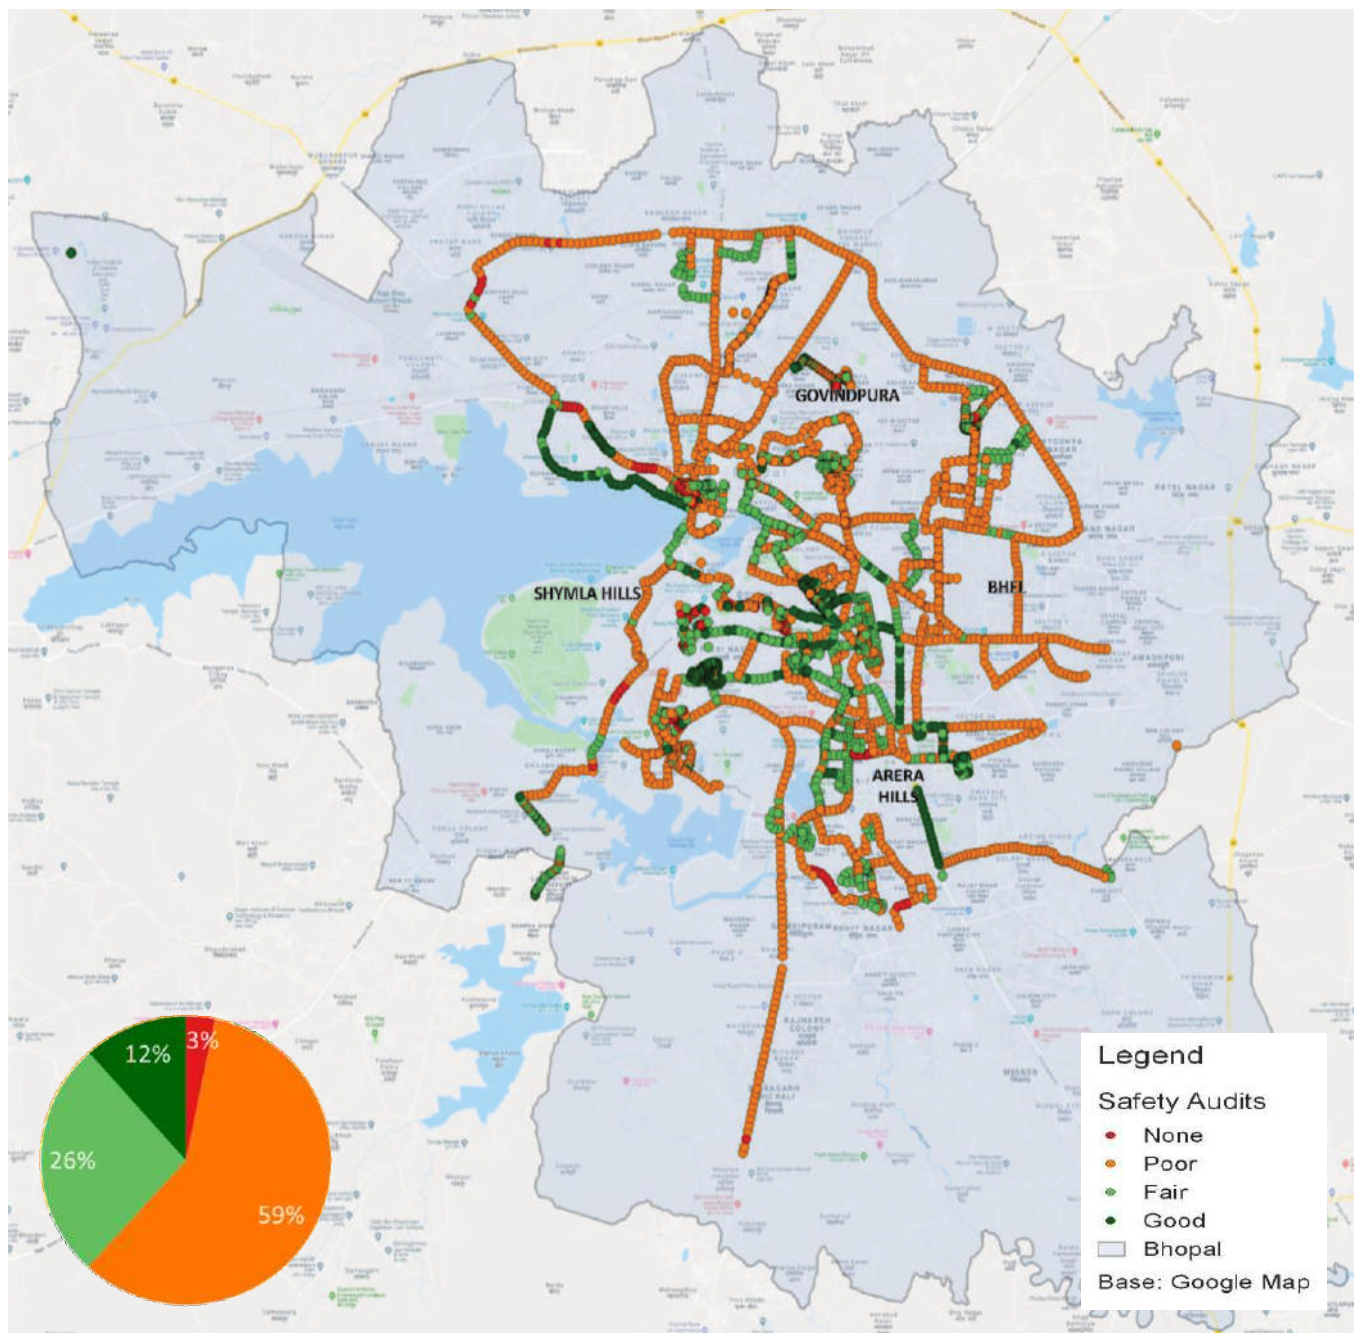
Map 4 indicating Walkpath ratings

Walkpath parameter Walkpath indicates whether a person can comfortably walk at a place. This refers to the quality of walkpath or space left for pedestrians along a road. Walkpath has been rated 1.9/3 i.e. Above Average. The city has only 38% of total streets available with paved footpath, these are audit points which have been rated 2 and above for walkpath parameter. Majority of these streets are in Tulsinagar, Arera Hills, Maharanapratap Nagar and VIP Road. However, at some points the footpath was found to be obstructed by parked cars. On street parking management needs to be improved at majority of market and commercial areas of city.

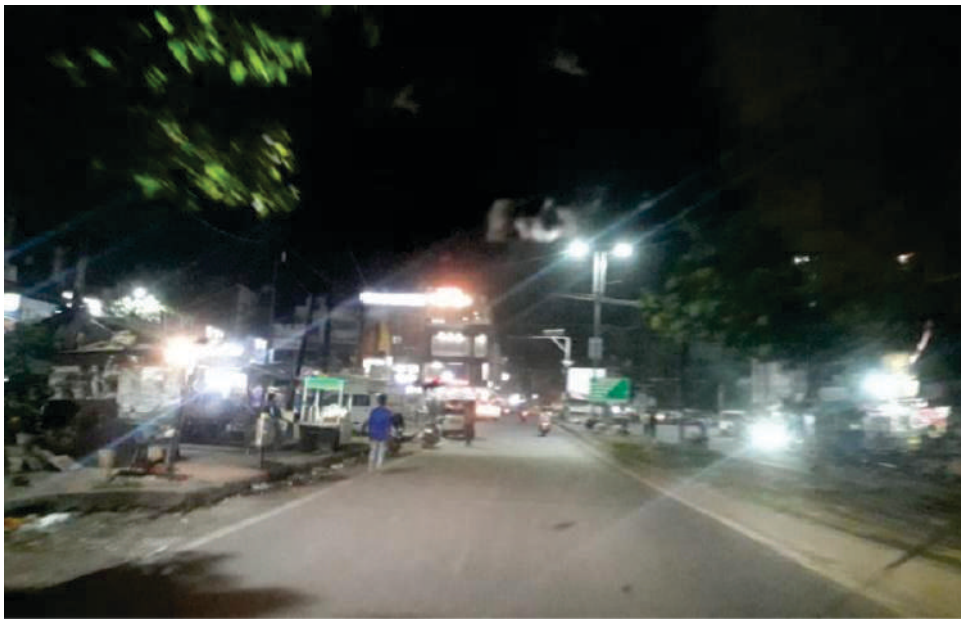
Image showing a stretch with vendors blocking the footpath

Footpath should be kept free from any obstructions. Obstructions due to vehicular parking, construction debris or extended shops should be removed. Designated space to be provided for on-street parking clear of pedestrian path. Space should also be provided for hawkers as they help in making streets active hence safer for women pedestrians.

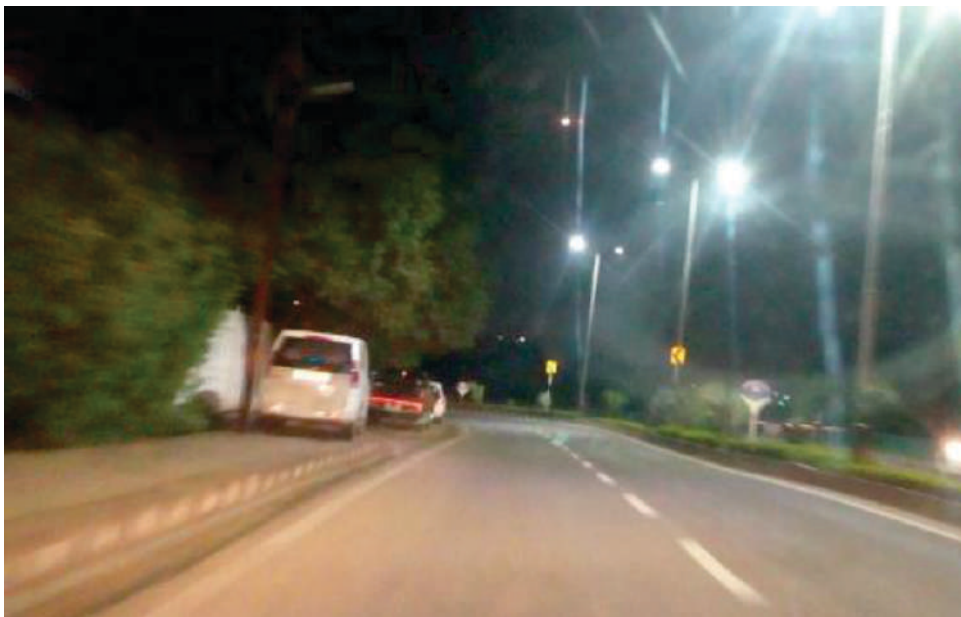
Image showing walkpath being blocked by the cars

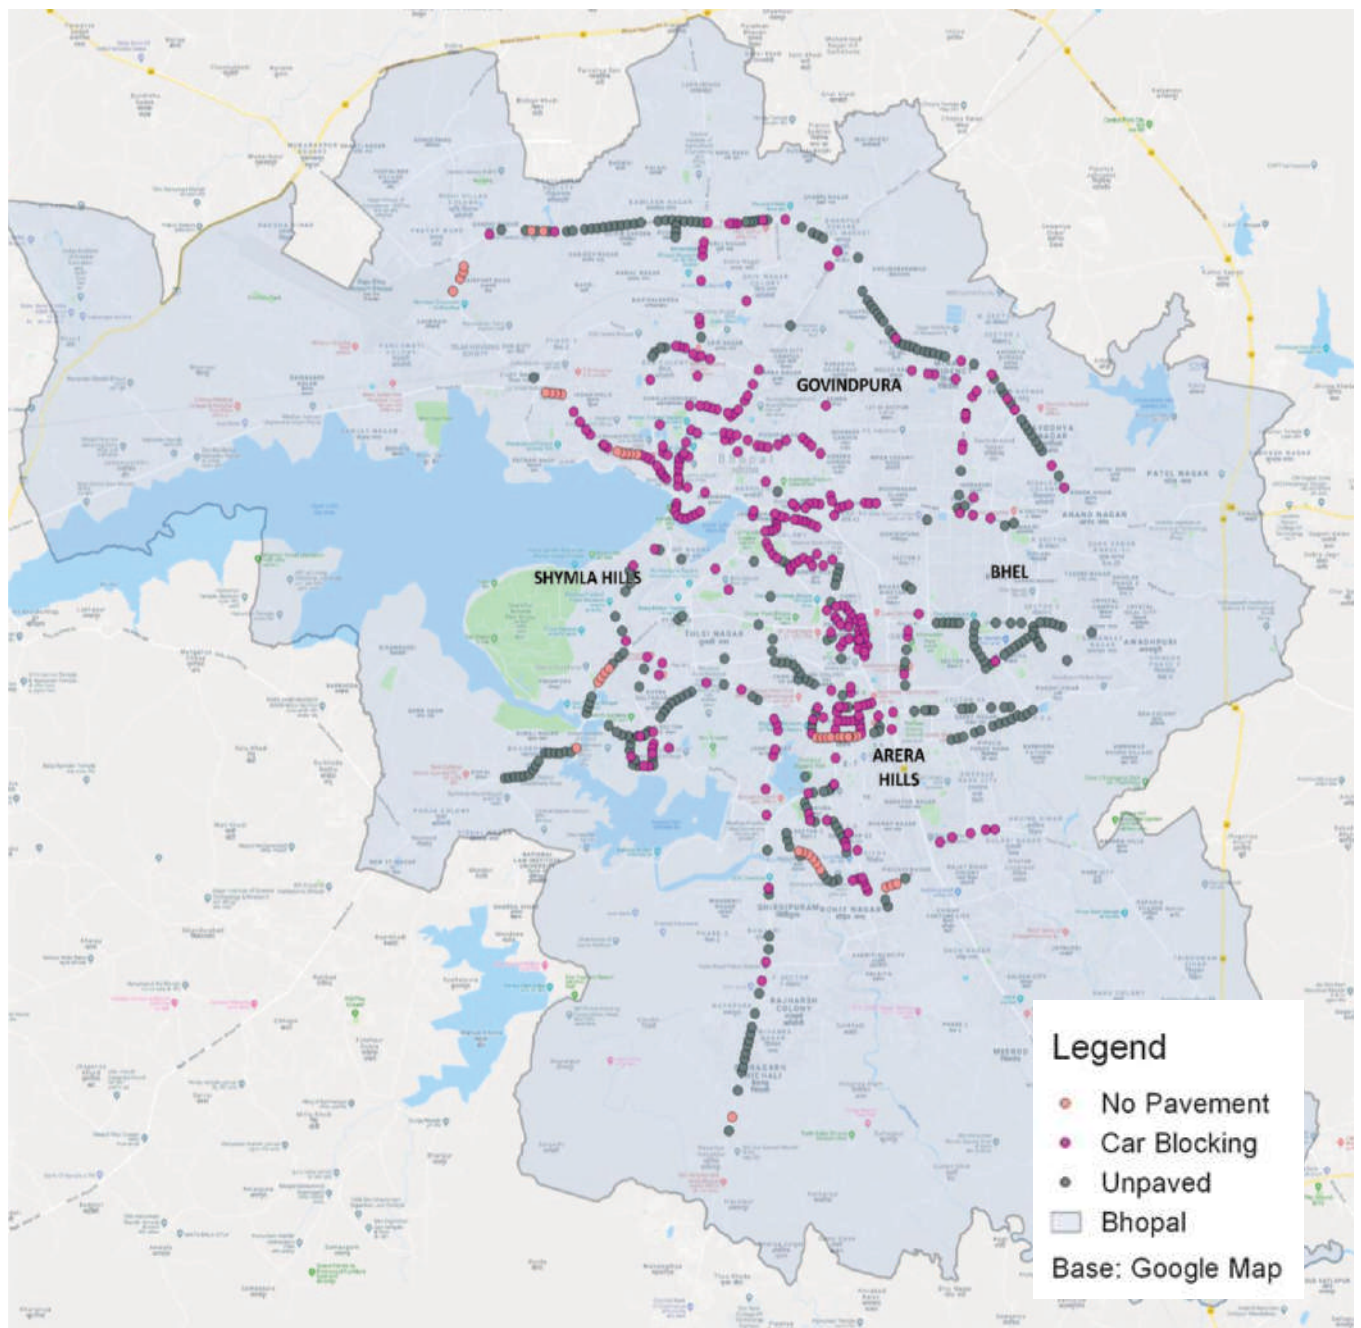
Map 5 indicating points with no, unpaved or blocked walkpath

62% of points were found to be poorly rated. These either don't have pavement or have kaccha/unpaved roads. As seen in the map 5, these points were found in TT Nagar, Moti Masjid area, Kotra Sultanabad and Arera Colony main road. Proper footpath needs to be constructed along these stretches. Signage and streetlights should be installed along the edge of the footpath, clear of the pedestrian path to ensure seamless and accessible walkpath for the pedestrians.

Properly paved footpath should be constructed at points with unpaved or broken walkpath and they should be maintained regularly.

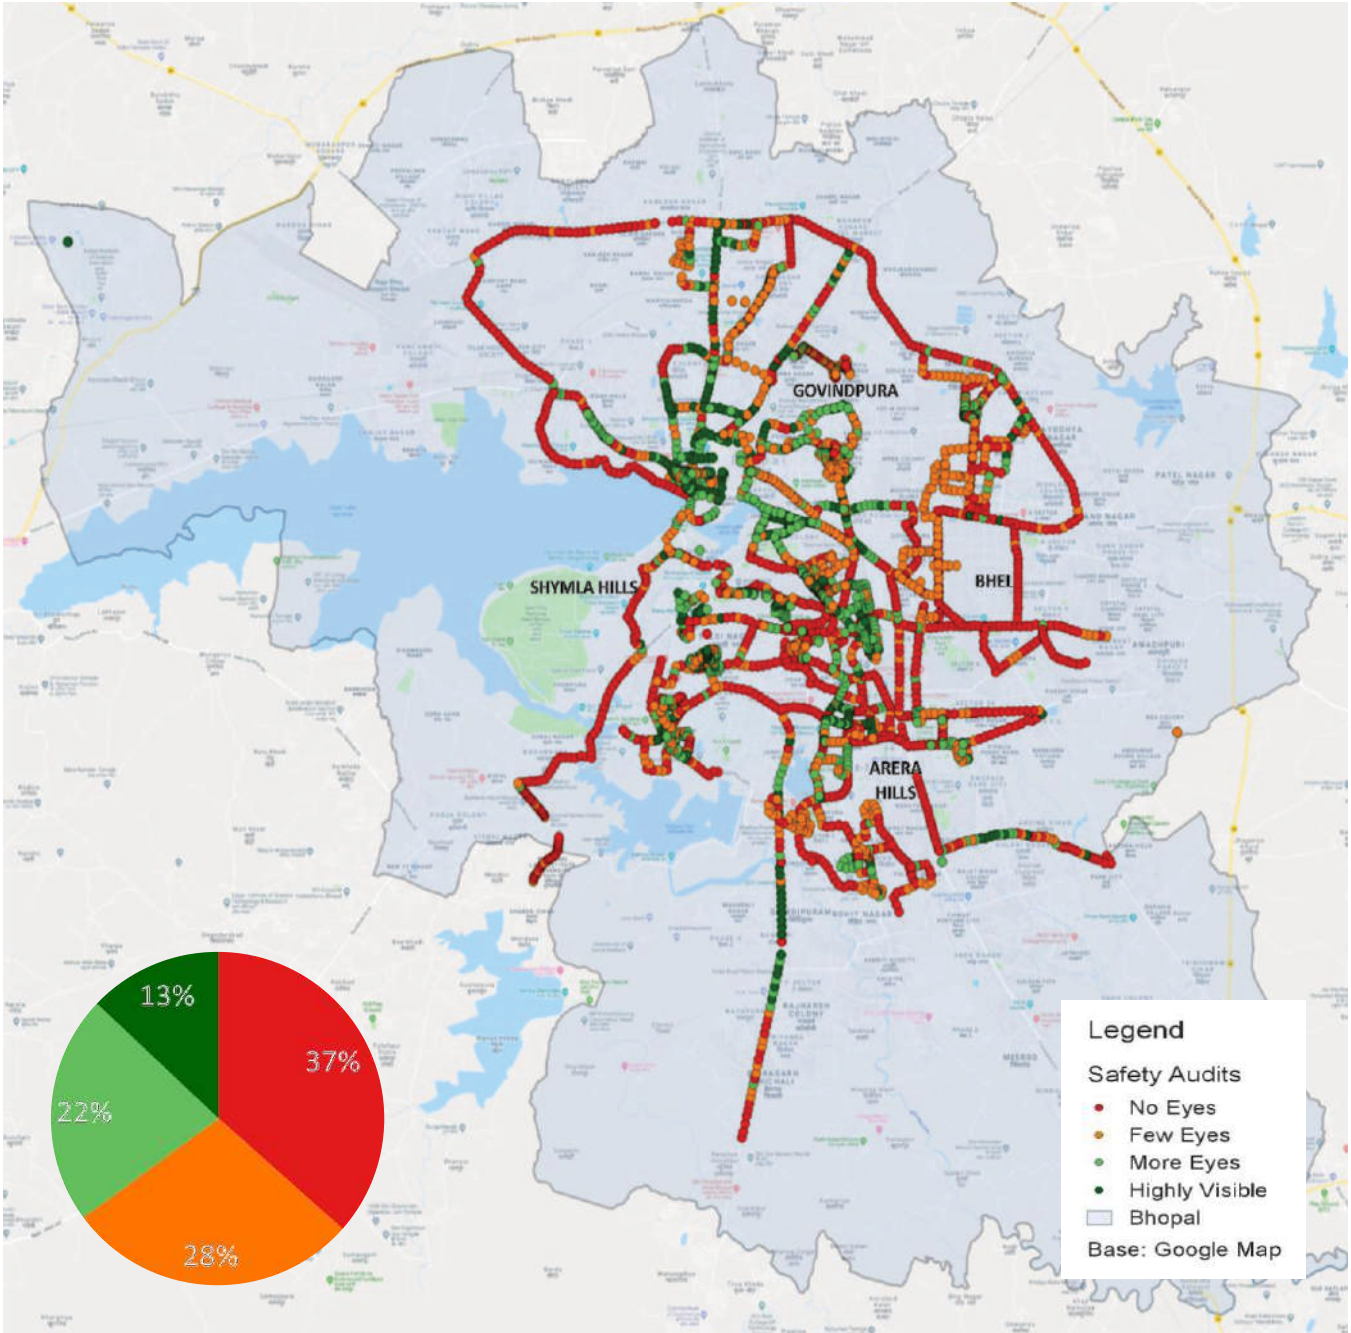
Map 6 Indicating Visibility ratings

Visibility has been rated 1.1 out of 3 i.e. Average. It is the least rated parameter in terms of physical infrastructure. 65 percent of the audit point have been rated poor visibility. The residences and government institutions on major roads have high boundary walls. This results in poor visibility and pedestrians have no visual contact with the inhabitants. To improve visibility, the height of solid part of the boundary wall should be reduced to 1 m and the rest of the height can be attained through grills. This would increase level of transparency between the streets and the buildings.

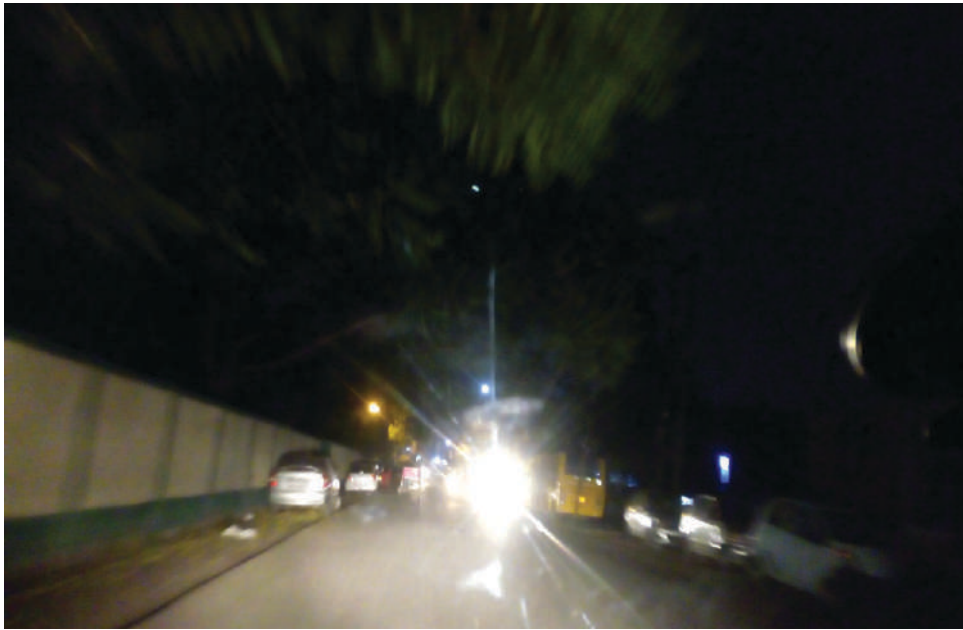
Image showing a stretch with high boundary wall

High boundary walls result in poor visibility along the walkpath. Wherever possible, the height of the solid part of the boundary wall should be maintained at 1m. Above the solid part, grills can be used to achieve the remaining height. Inactive edges along the footpath instill a sense of fear in the pedestrians.

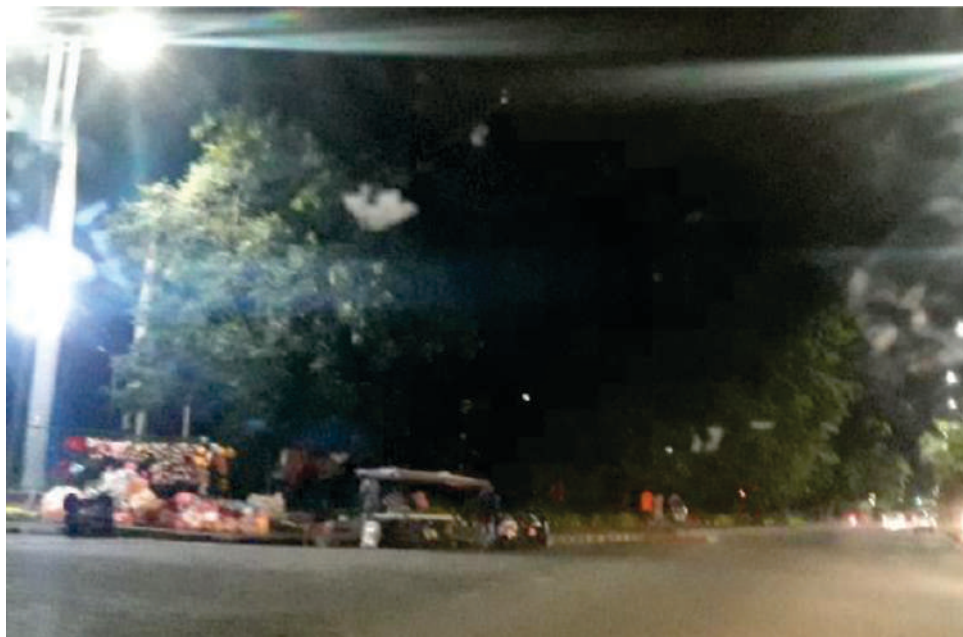
Vendors and hawkers at junctions and road sides were found to be contributing to 'eyes on the street' thus acting as a natural surveillance. Designated spaces i.e. 'hawker zones' should be provided for them along the footpath to clear of the pedestrian path.

Image showing street vendors along a stretch

Edges can be made active by providing space for street furniture and incorporating the street vendors. Hawkers and vendors act as natural surveillance system. Creating such zones throughout the city will help activate the public realm making one feel safer.

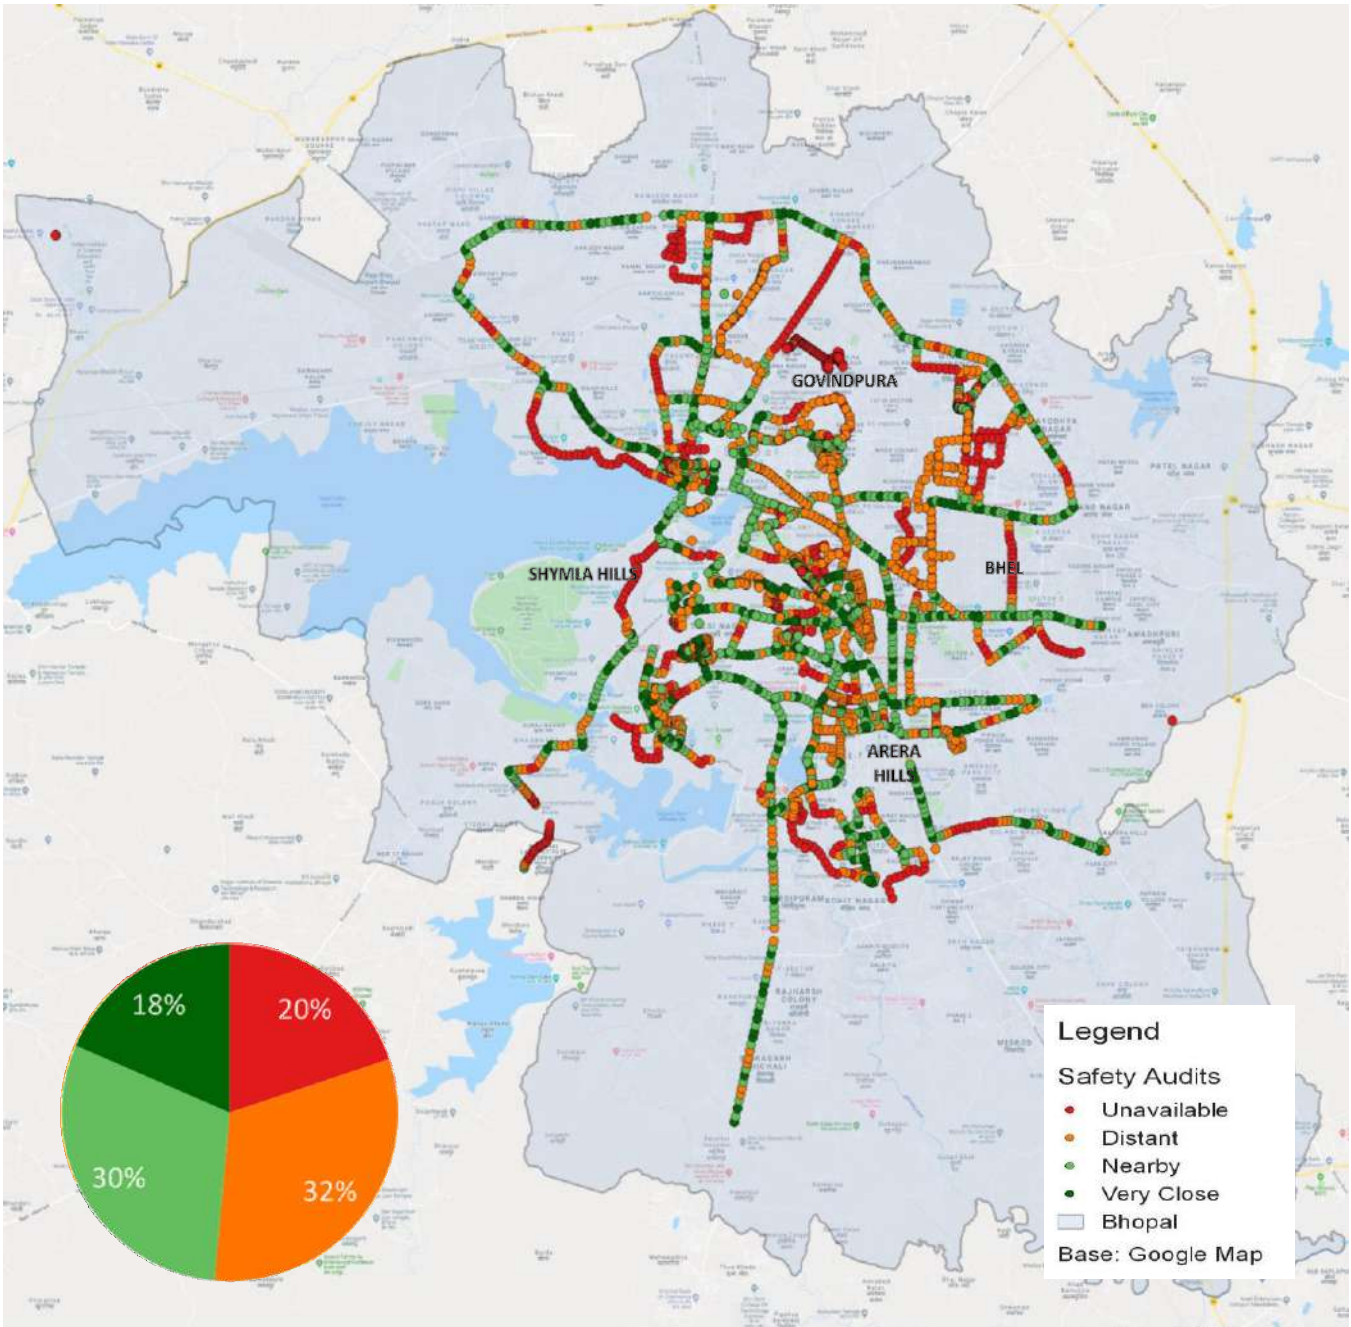
Map 8 Indicating Public Transport ratings

Public Transport has been rated 1.5/3 i.e. Average. The bus public transport in Bhopal is run by government as well as private operators. 48% of the audit area has good connectivity of bus public transport. Modes like auto-rikshaws & Tata Magic provide last mile connectivity as well as run on dedicated routes as shuttle service.

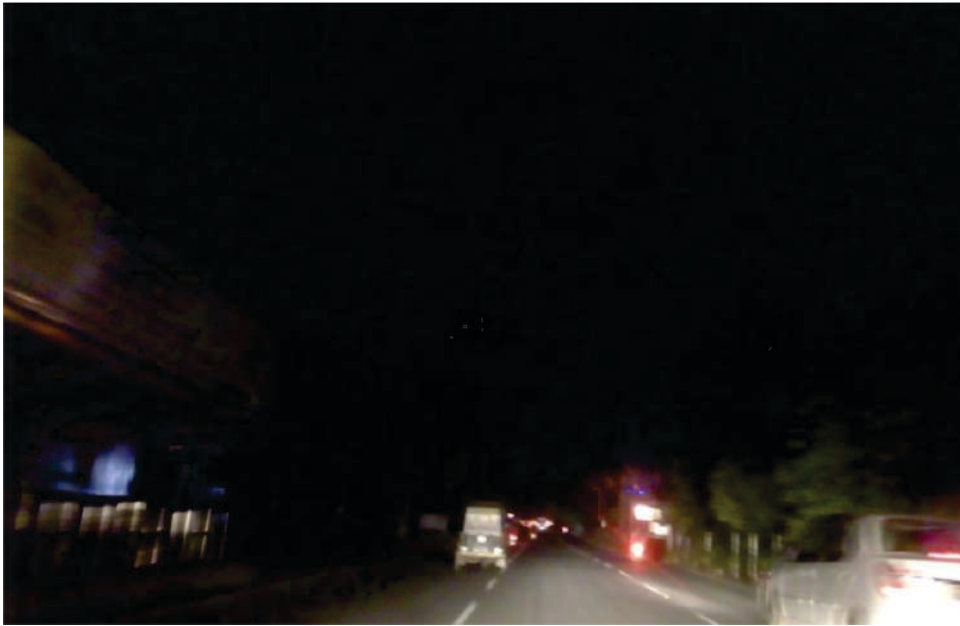
Image showing a deserted dim-lit bus stop

It is important to ensure that people find public transport in their city as safe and convenient. Existing bus shelters should be upgraded. They should be well lit and have adequate seating. Interactive panels indicating routes, emergency helpline numbers and an emergency button for help in distress should be provided at the bus stops.

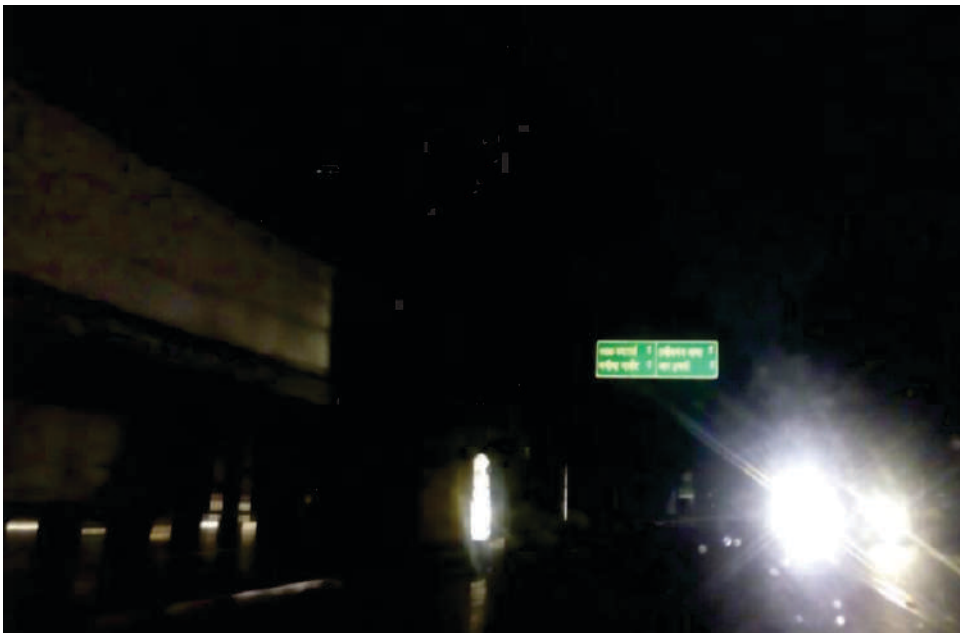
Image showing poorly lit Bus stop in Ibrahimpura

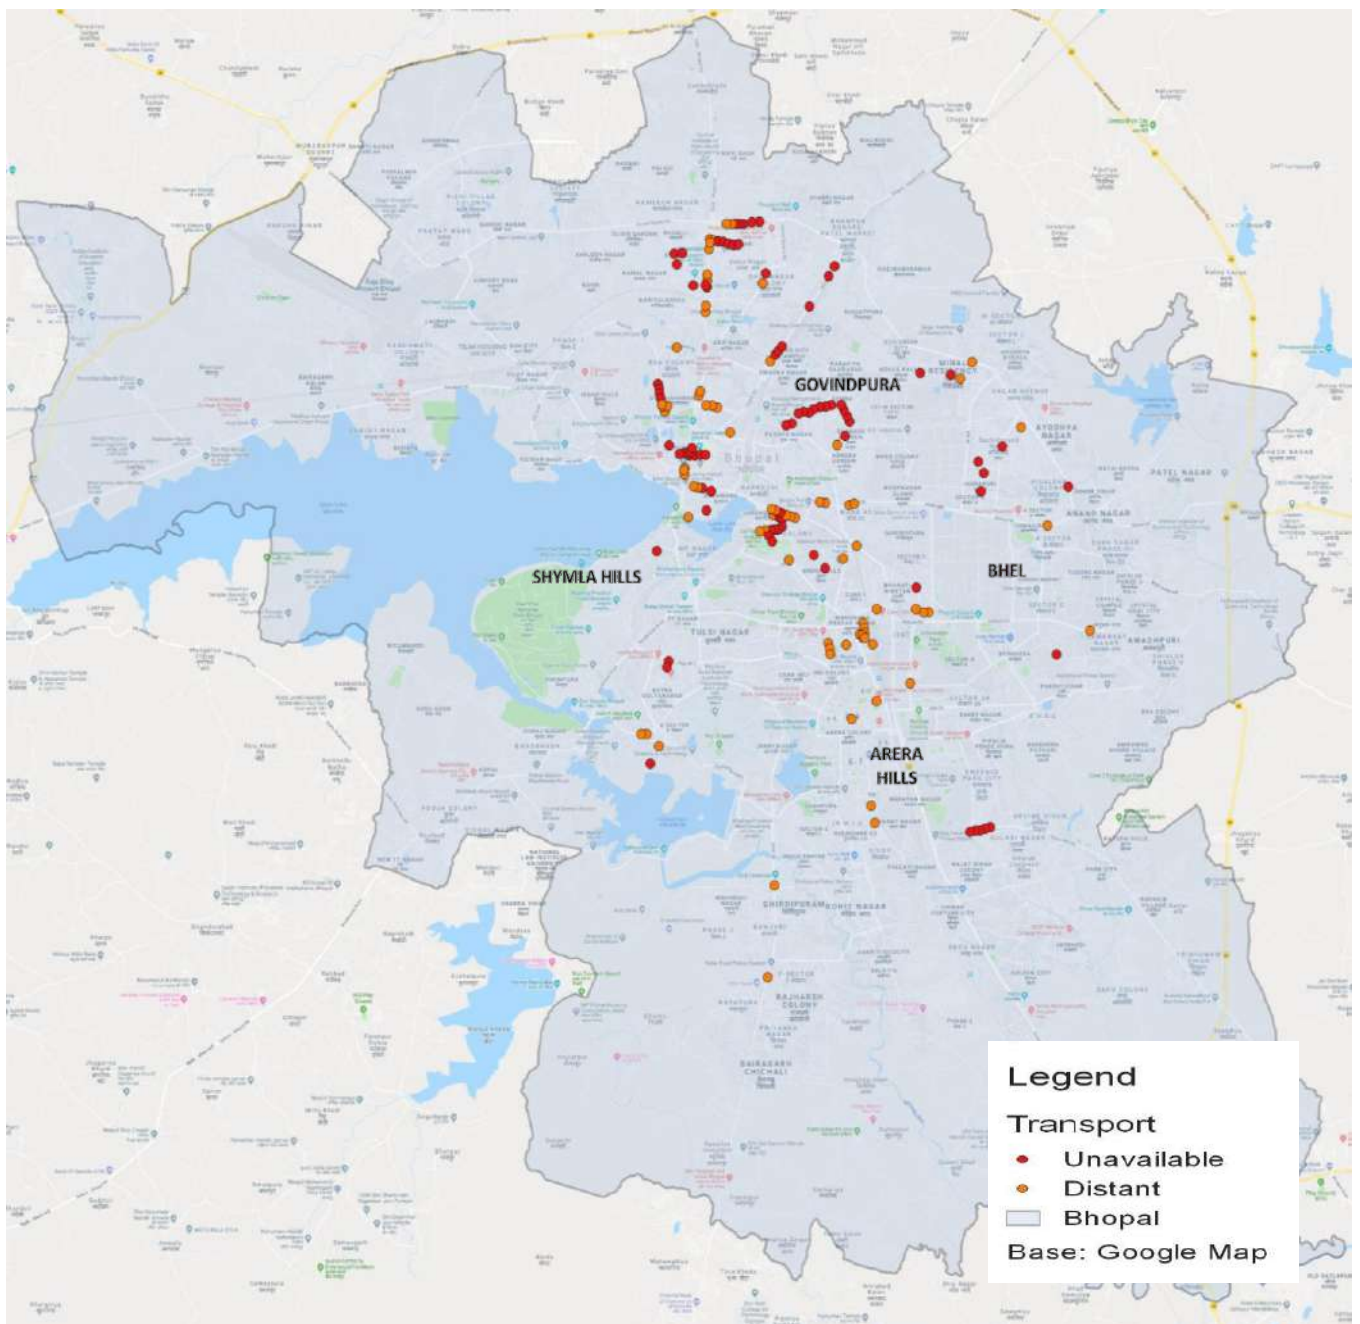
Map 9 Indicating areas which have high Crowd but low Public transport rating.

20% of the audit points have no bus stop within 10 mins walking distance There is a major need for organizing the private bus system and building bus shelters at major roads. Map 9 shows audit points where people parameter has been rated high but are more than 10 minutes walking distance from nearest bus stop. Bus stops and Auto stands lack proper lighting. Designated auto stands should be set up with proper space for parking autos, street furniture and convenience facilities for the commuters and drivers

Designated well lit para transit stands with public convenience facilities needs to be created near bus stops to ensure last mile connectivity. These stands should have designated parking space where autos , e-rickshaws, etc. can be parked and from where they can be hailed.
