# Jakarta City

A Safety Analysis

## Jakarta, Indonesia

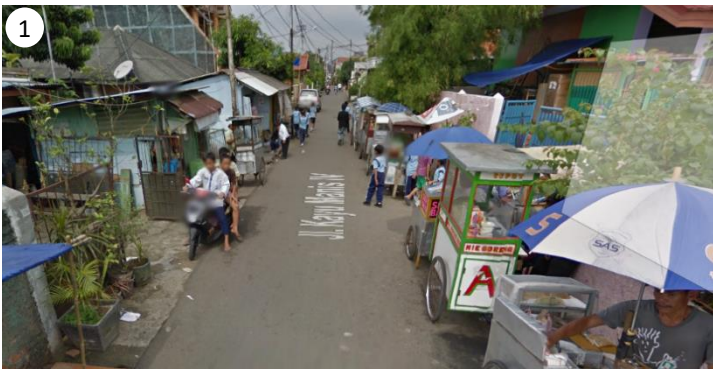
As seen in the pictures below, hawkers provide eyes on the street thus acting as natural surveillance (Pic 1). However, pedestrians are not seen using these stretches at night, therefore Crowd and Gender Usage is rated the lowest (Pic 2 and 3). Overall, Feeling of safety has been rated as Below Average.
