New Delhi Municipal Council

A Safety Analysis Report

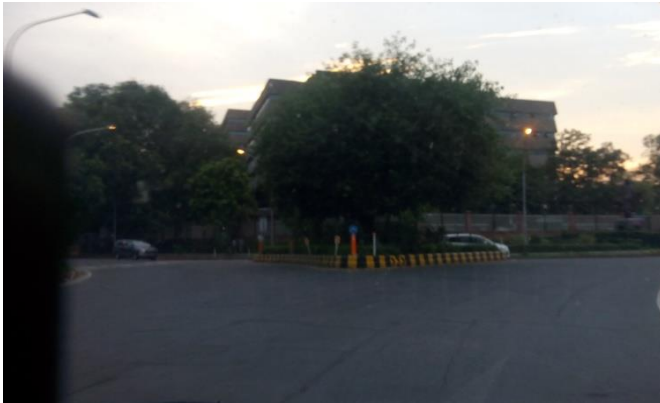
Image 12 showing non-functional streetlights at Prime Chowk

Sr.No.	Lighting Issues Identified	Street Name	Recommendations
I.	Non-functional streetlight	Mother Teresa Crescent, Sri Aurobindo Marg, Shanti Path, Rafi Ahmed Kidwai Marg	Regular maintenance checks needs to be carried .
II.	Tree foliage covering luminaire of the streetlight	Mandir Marg, Mother Teresa Crescent, Talkatora Road, Ashoka Road, Firoz Shah Marg, Dr. Rajendra Prasad Marg, Akbar Road, Maulana Azad Marg, Moti Lal Nehru Marg, Shahjahan Marg, Pandara Road, APJ Abdul Kalam Marg, Teen Murti Marg, Safdarjung Road, Lodhi Road, Kautilya Marg, Panchsheel Marg, Vinay Marg, Sardar Patel Marg, Shri Vinayak Mandir Marg.	Regular pruning of trees along the streetlights is required
III.	Streetlight on only one side of the main roads (more than 4lanes)	Shahjahan Road, Prithvi Raj Marg, Firoz shah Road, Lodhi Road.	Additional pedestrian scale streetlights needs to be installed along the walkpath.

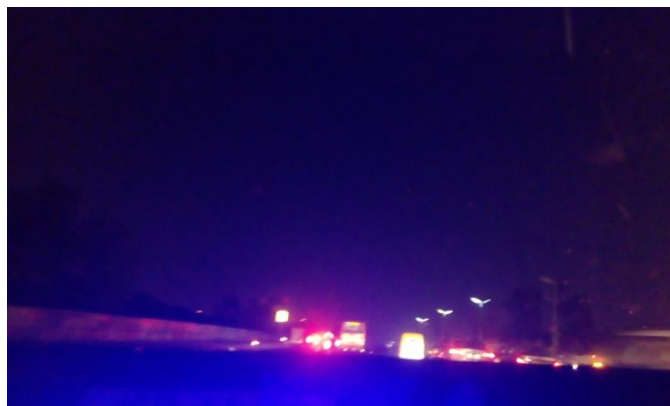
Image 14 showing non-functional streetlights at Sri Aurobindo Marg

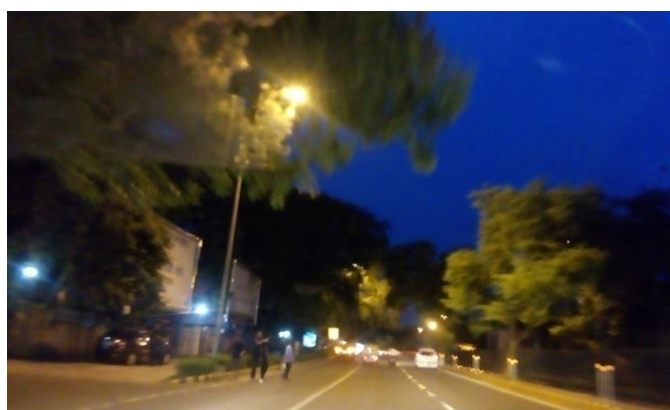
Image 16 showing leaves covering the luminaire of streetlights at Africa Avenue Road

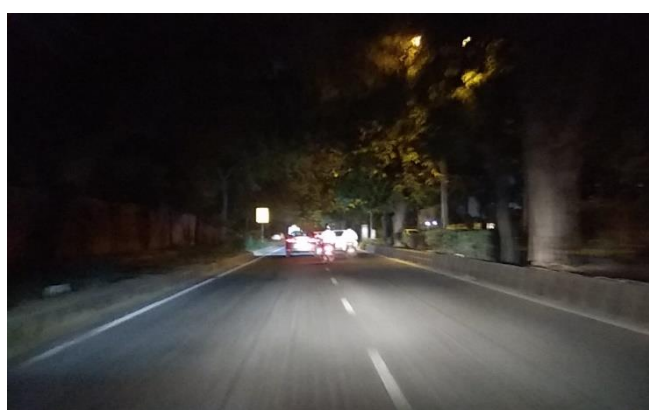
Image 17 showing leaves covering the streetlights at Archbishop Markarios Marg

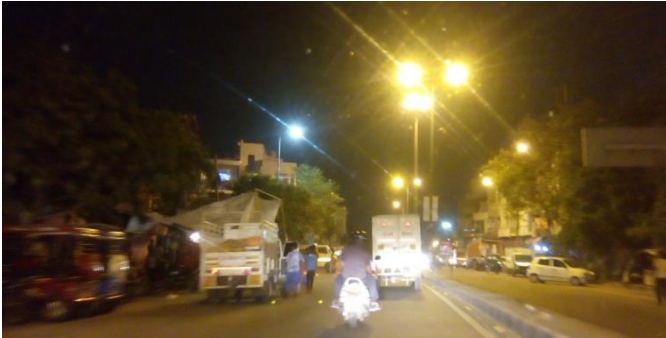
Image 19 showing audit point with vehicular parking on Kanjhawala Link Road

Sr.No.	Walkpath Issues Identified	Street Name	Recommendations
I.	Broken footpath	Shankar Marg, Panchkuian Marg	The walkpath needs to be repaired as required
II.	Obstructions due to vehicular parking	Babar Marg, PVR Cinema Marg, Old Ramakrishna Ashram Marg, Akbar Road, Barda Ukil Marg, Rajmata Vijayraje Scindia Marg, Bengali Market	Vehicular parking on the pavements should be prohibited. Proper level difference needs to be created between footpath and parking space
III.	Other obstructions on footpath	Shankar Road, Shaheed Bhagat Singh Marg, Udyan Marg, Rajpath, Lodhi Road, Barda Ukil Marg, Fourth Avenue Road, Karbala Road, A K Roy Rarg, Shri Vinayak Mandir Marg, Jesus and Mary Marg, Maharani Laxmibai Marg	Walkpath should be kept free from any obstructions. Any obstruction like construction debris or presence of hawkers on the walkpath may cause inconvenience to the pedestrians thus forcing them to walk on the roads

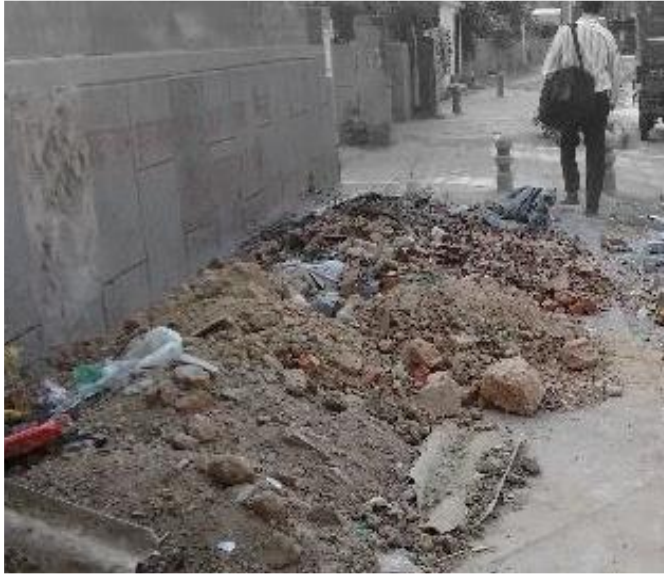
Image 21 showing construction debris on the walkpath near INA metro station

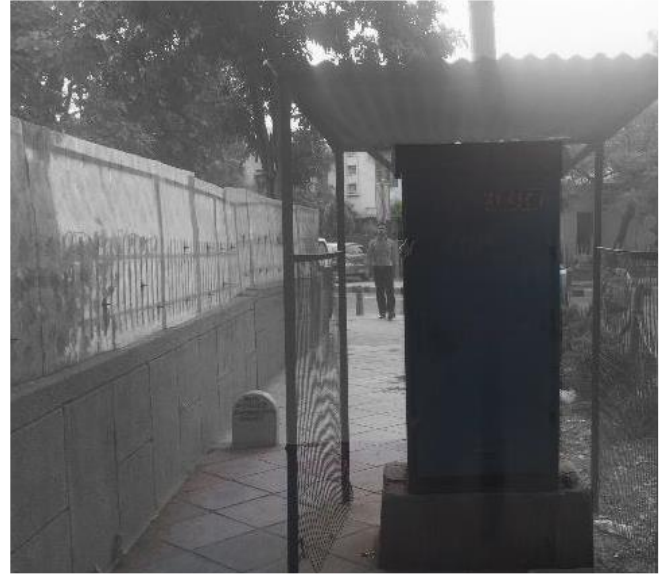
Image 22 showing obstructions on the walkpath near INA metro station

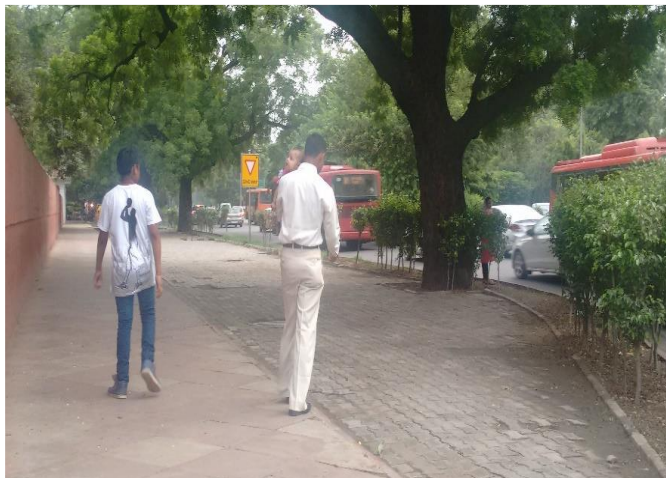
Image 24 showing inactive edges and high boundary wall

The edges along the walkpath can be made active by providing space for street furniture and street vendors. Also, the plantation along the walkpath should be regularly pruned so that the pedestrians can clearly view their surroundings.

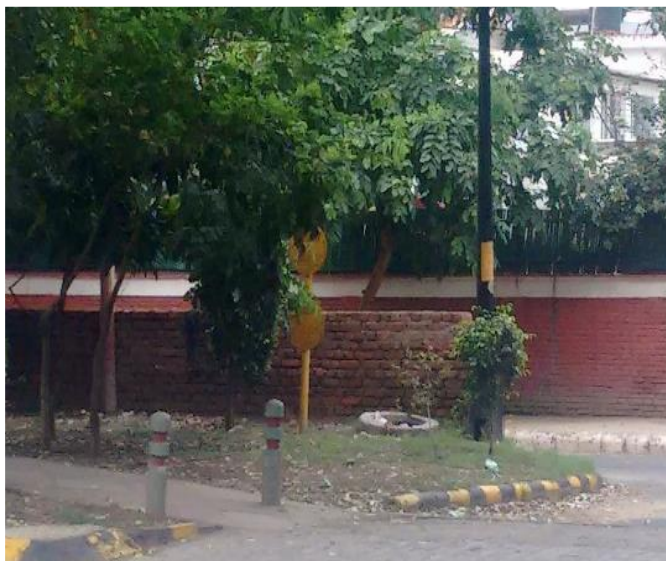
Image 25A showing low height brick wall and opaque wooden fence of boundary wall

1. The green sheet covering the wooden fence or metal grills should be removed. This would result in partial visibility between the building and the streets.
2. In case of two footpaths i.e. one along the road and other along the building, there should not be a wall obstructing or restricting the movement and view of the pedestrians. Thus, the wall in image 25A should be removed to provide some line of sight for pedestrians walking in the service lane.
3. Vehicular parking in the service lane should be prohibited to avoid creating a barrier for pedestrians.

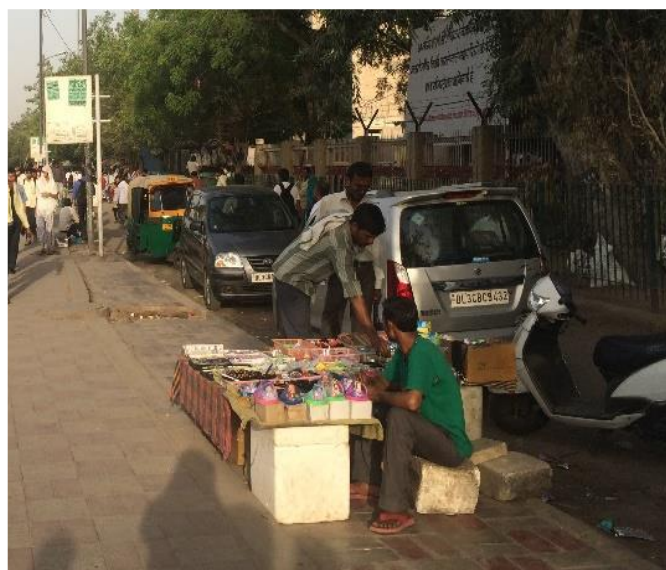
Similarly, as seen in Image 25B, the service lane is obstructed by vehicular parking. In both these cases, the pedestrians feel unsafe walking on the footpath adjoining the building after dark.

Image 25B showing vehicles parked in service lane resulting in low visibility

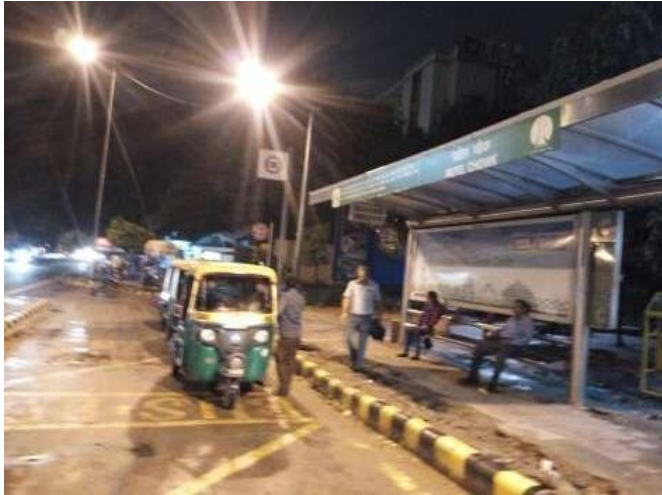
Image 26 showing a bus stop at Patel Chowk

As seen in Image 26, the footpath at Patel Chowk bus stop is broken. Also, autos can be seen waiting on the vehicle carriageway at the bus stop. Footpath should be properly maintained so that people do not shy away from using them. Designated auto stands should be provided preferably near the metro stations or bus stops. These stands should have adequate parking space for autos/ e-rickshaws and should be well lit. Public conveniences should also be located nearby.

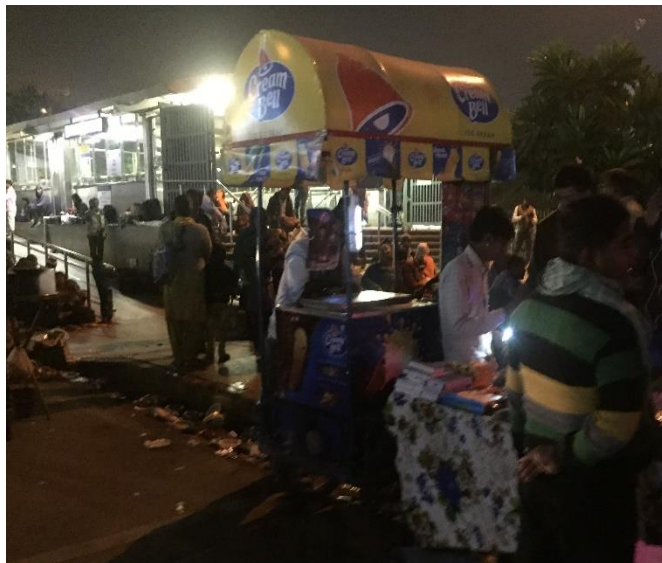
Image 27 showing street hawkers outside AIIMS Metro Station

As seen in Image 27, the footpath outside the AIIMS metro station is obstructed by street hawkers thus forcing the pedestrians to walk on the road instead of the walkpath. Well lit segregated hawkers and vendor zones equipped with adequate street furniture should be provided so as to enable people to use the footpath.

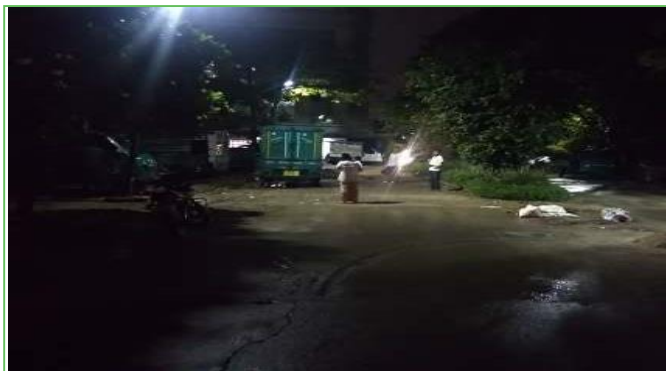
Image 30 showing poor lighting at Panchkula market due to leaves obstructing the luminaire

Parameter	Market	Road Name	Recommendations
1	Lighting	<ul style="list-style-type: none"> Panchkuian Market Sarojini Nagar Market 	<ul style="list-style-type: none"> Bhai Veer Singh Marg A K Roy Marg 	<ul style="list-style-type: none"> Pruning of trees required Additional street lights to be installed
2	Walkpath	<ul style="list-style-type: none"> Mini Market Chanakyapuri 	<ul style="list-style-type: none"> Madhu Limaye Marg 	<ul style="list-style-type: none"> Repair broken walkpath
3	Visibility	<ul style="list-style-type: none"> CSC Market, Panchkuian Market 	<ul style="list-style-type: none"> Tilak Marg, Bhai Veer Singh Marg 	<ul style="list-style-type: none"> Make dedicated vending area/spots for Hawkers
4	Transport	<ul style="list-style-type: none"> Begum Zaidi Market Bengali Market 	<ul style="list-style-type: none"> Within market area 	<ul style="list-style-type: none"> Make dedicated Auto-stands

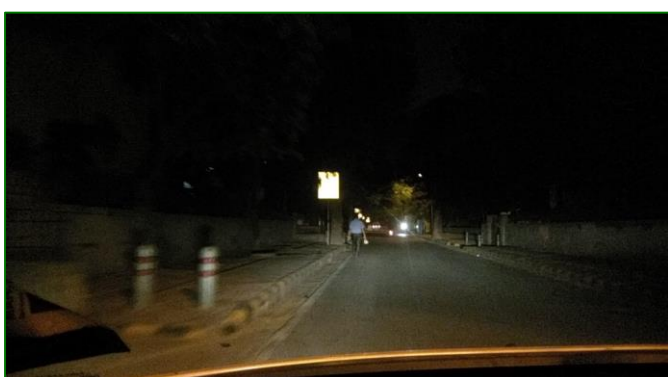
Image 33 showing access roads of Sarojini Nagar Market. These roads have poor lighting. Area needs additional street lights.

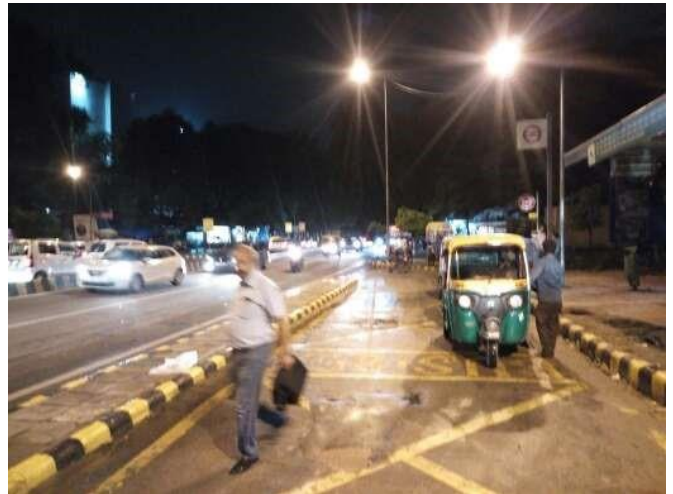
Image 34 showing rikshaws blocking bus lane in front of Patel Chowk bus stop and metro gate

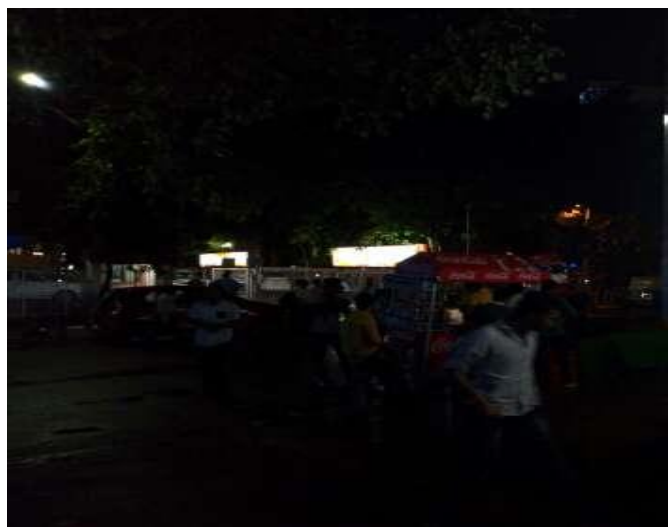
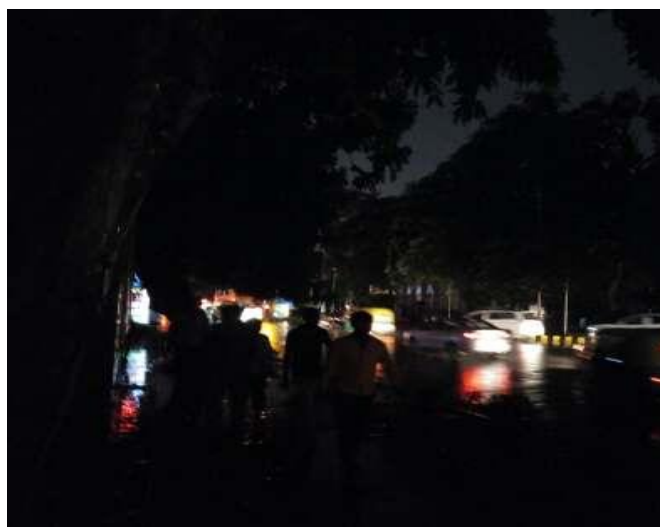
Image 36 and 37 showing lane opposite to Valmiki Mandir where Crowd was rated 2 or 3 but the street lights were off. These areas needs additional street lights to be installed

Sr. No	Metro Station	Lighting	Public Transport
1	Ramakrishna Ashram	Street lights outside Valmiki Mandir are non-functional and needs to be repaired	
2	Janpath	Street light outside NDMC public toilet at Atul Grove Road is non-functional and needs to be repaired	Ashoka Road has no metro/bus transport available within 400 meters. Area remains deserted in night. No need to have designated auto stands, though we recommend frequent police patrolling on this road.
3	Shivaji Stadium	Lane joining Baba Kharak Singh Marg and Hanuman Marg needs to get pruned.	
4	Barakhamba Road	Additional streetlights required near pillar number 13 at Maharaja Ranjeet Singh Marg	
5	Udyog Bhavan	Trees on Motilal Nehru Marg needs to get pruned	
6	Khan Market	Street light covered by leaves near SBM toilet at Khan market and SBI ATM on Dr. Zakir Hussain Marg. Trees needs to get pruned	
7	Mandi House	Trees opposite to SBM Toilet on Safdar Hashmi Marg, Vakil lane needs to get pruned	Bengali Market remains crowded but has no metro/bus stop within 400m distance. It is recommended to have a designated auto stand.

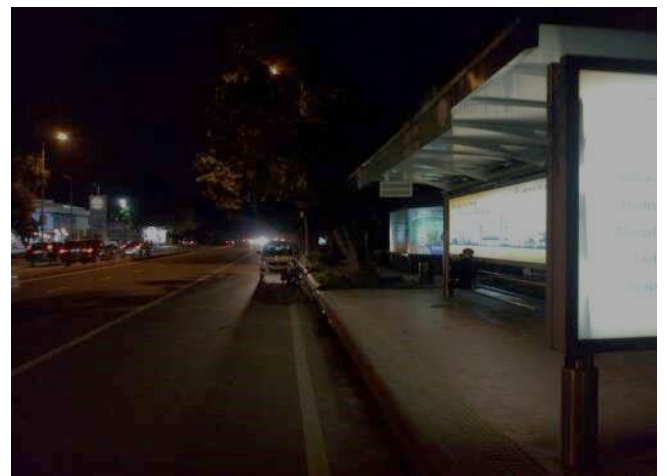
Image 40 showing Golf Club Bus stop at Dr Zakir Hussain Marg. It is only lit by advertisement panels

Sr. No.	PARAMETER	BUS STOP	RECOMMENDATION
1	Lighting	<ul style="list-style-type: none"> Marina Hotel, Chelmsford Road Jaipur House, Dr. Zakir Hussain Marg YMCA, Jai Singh Road Sena Bhawan, K Kamraj Marg Lodhi Garden, Lodhi Road Talkatora Stadium, Park Street M Block, Africa Avenue Laxmi Narayan Mandir 	Installation of additional street lights and Pruning of trees required
2	Walk-path	<ul style="list-style-type: none"> YMCA, Jai Singh Road Pilanji Village, B H S Marg 	Built foot path on one side of the road

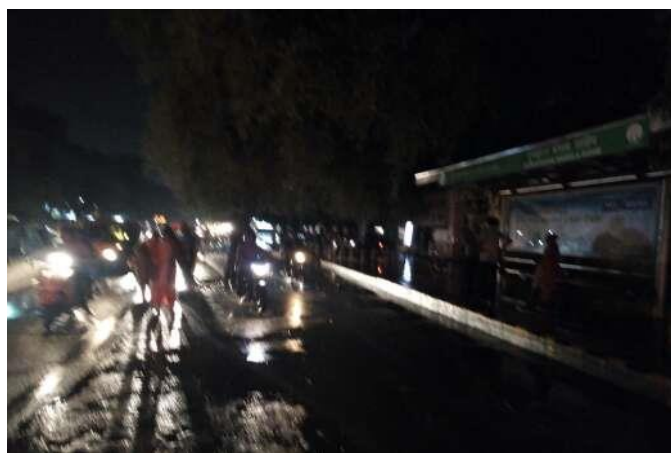
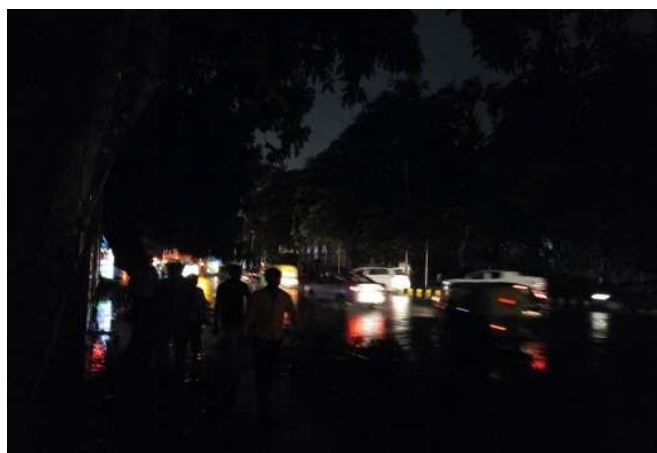
Image 41 and 42 are of Laxmi Narayan Mandir Bus stop remains dark . Street lights need to be repaired along with installation of new streetlights

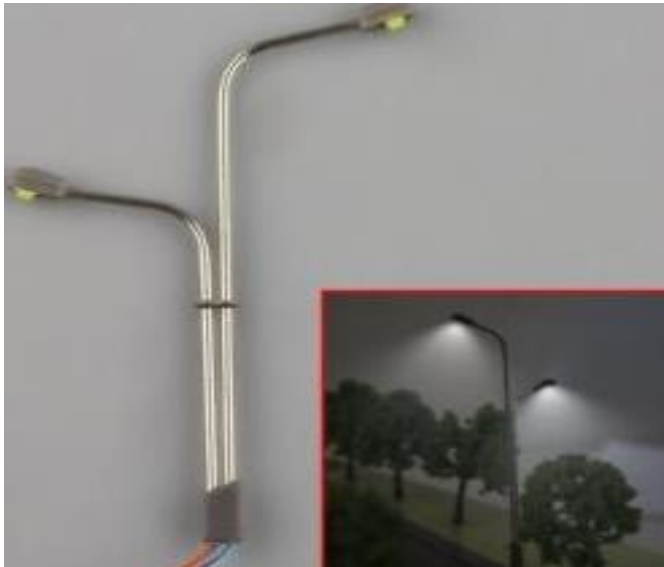
Image 49 showing streetlights with dual luminaire

Pedestrian scale streetlights as shown in Image 49 should be installed along the walkpath of the identified streets (Refer Table no.1). This would ensure that both the vehicular carriageway as well as the walkpath are well lit and the pedestrians feel safe while walking.

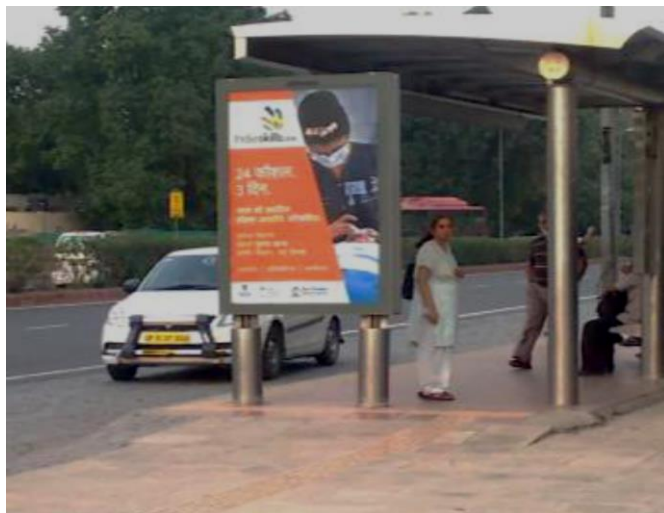
Image 50 showing tactile paving at Mandi House metro station

Footpath should be accessible and convenient to use for all. Tactile paving should be provided from the exit gates of the metro stations to the nearest bus stops to provide assistance to the visually challenged pedestrians. Such facilities are provided at Mandi House metro stations. These facilities should be extended at other metro stations and bus stops as well.

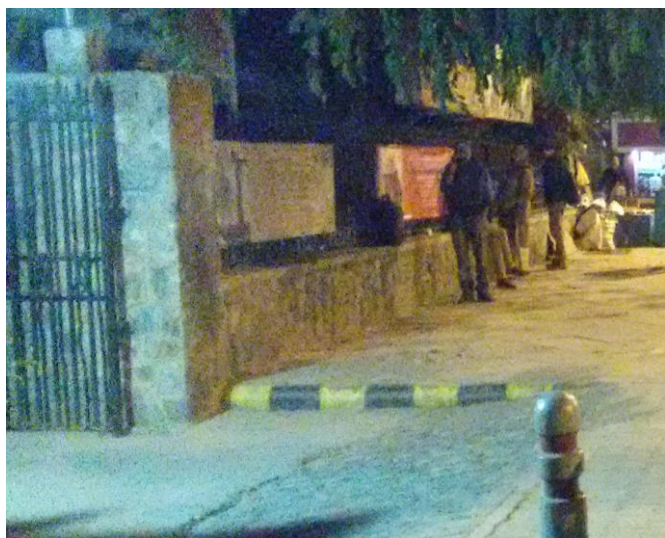
Image 52 showing boundary walls around Mandi House metro station

High boundary walls act as a barrier and restrict visibility between the built environment and the pedestrians. Low height solid boundary walls upto 1m high with grills above it should be provided to increase transparency and enhance visibility. The boundary walls around Mandi House metro station are good examples that can be replicated in other areas in NDMC.

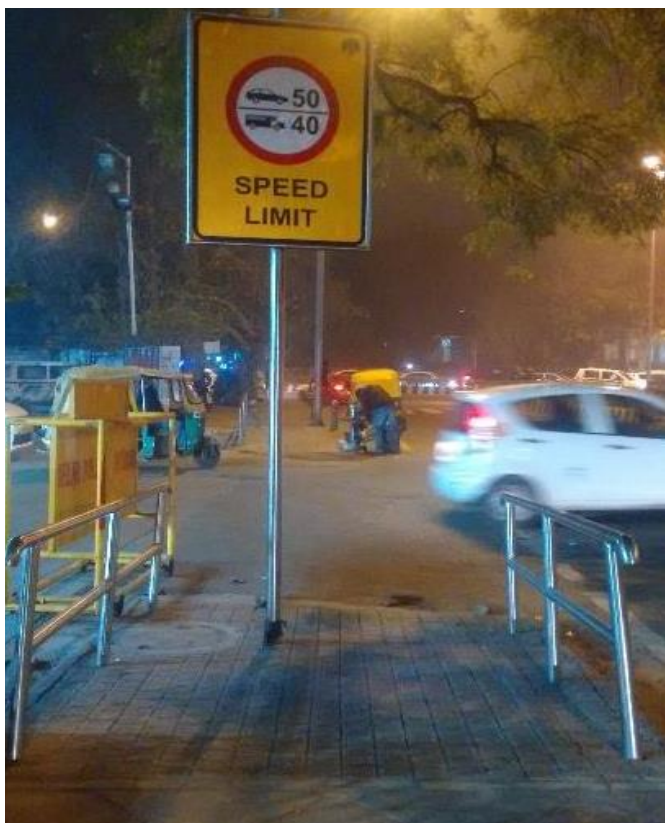
Image 53 showing signage obstructing the ramp near Khan market
