Hyderabad

Safety Audit Report

We are thankful to the Bumble India team for their support in data collection in the city of Hyderabad as a part of their campaign to address women's safety. This Safety Audit report has been prepared by Safetipin team.

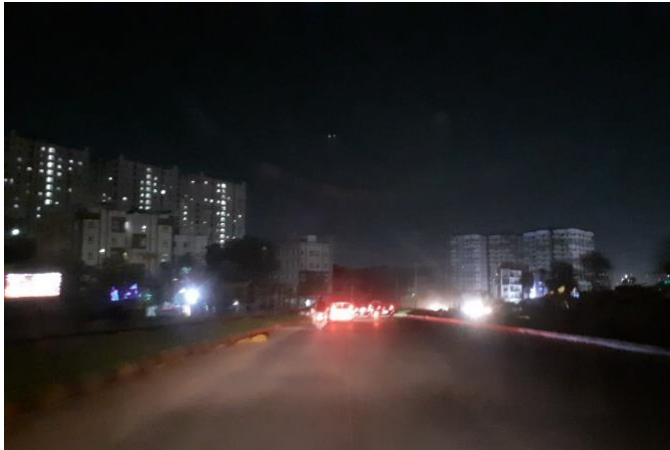
Image showing a stretch on Khajaguda-Nanakramguda Road with no streetlights

The existing streetlights that have been found non-operational need to be checked. Regular checks should be carried out to ensure uniform and unobstructed illumination. Streetlights need to be installed along areas, identified as dark spots i.e. at these locations there is no illumination at present.

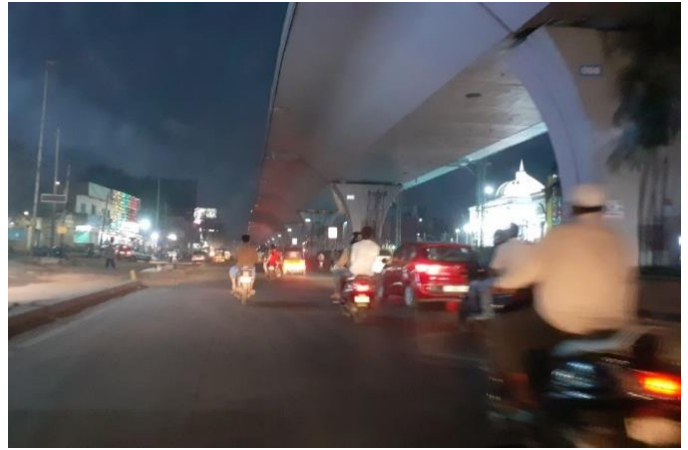
Image showing a stretch on PV Narsimha Rao Expressway with non-operational streetlights

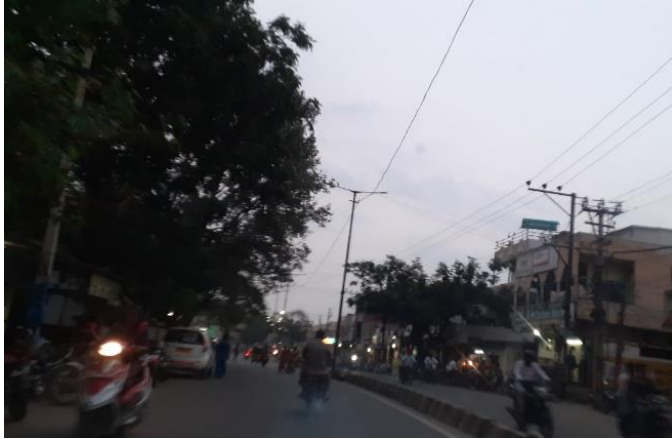
Image showing a stretch on Gajularamaram Road with streetlights along the center of the road

Along the main roads having four lanes or more, streetlights are provided along the central median of the road. In such cases, additional streetlights need to be installed along the footpath. Pedestrian scale streetlights should be installed such that the footpaths are also well light.

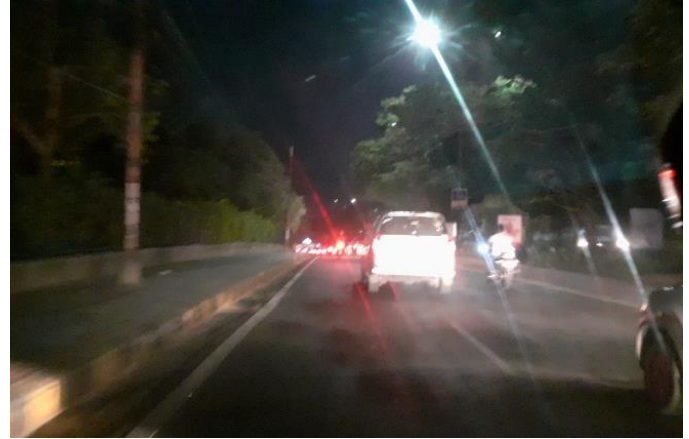
Image showing a stretch on Jubilee Hills Check Post Road with streetlights on only the center of the road

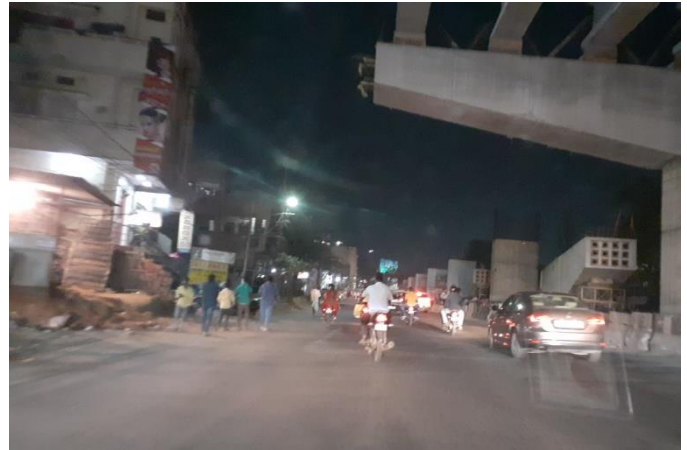
Image showing a stretch on Shaikpet Road with unpaved walkpath

Properly paved footpath should be constructed at points with unpaved or broken walkpath and they should be maintained regularly. Footpath should be kept free from any obstructions. Obstructions due to vehicular parking, construction debris, inappropriate positioning of advertisement boards, etc. should be removed. Designated space should be provided for on-street parking clear of pedestrian path.

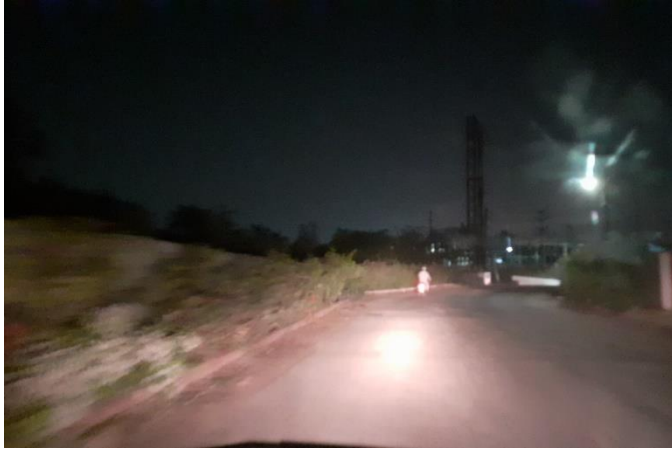
Image showing a stretch on Srinagar Colony Main Road with no pavement

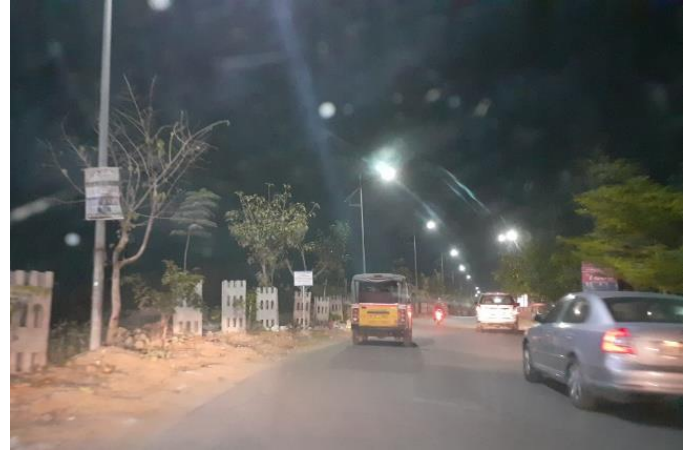
Image showing a stretch on Lanco Hills Road with an unpaved walkpath

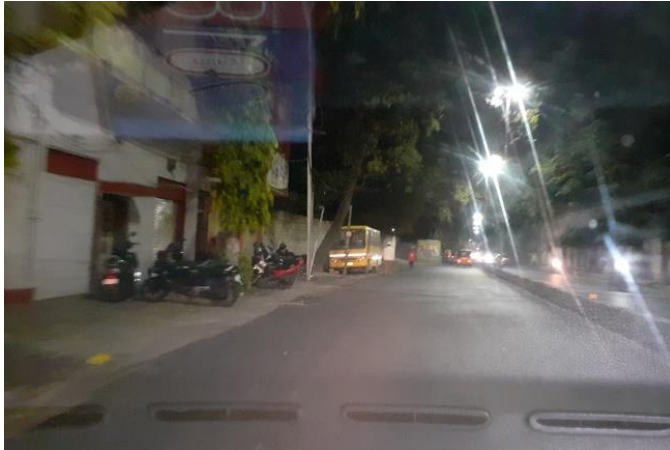
Image showing a stretch on Chilkalaguda Road being blocked by vehicular parking

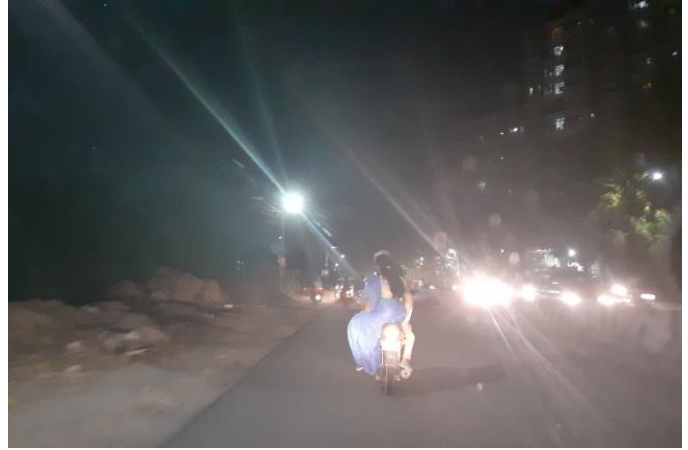
Image showing a stretch on Kukatpally Housing Board Road being blocked by construction debris

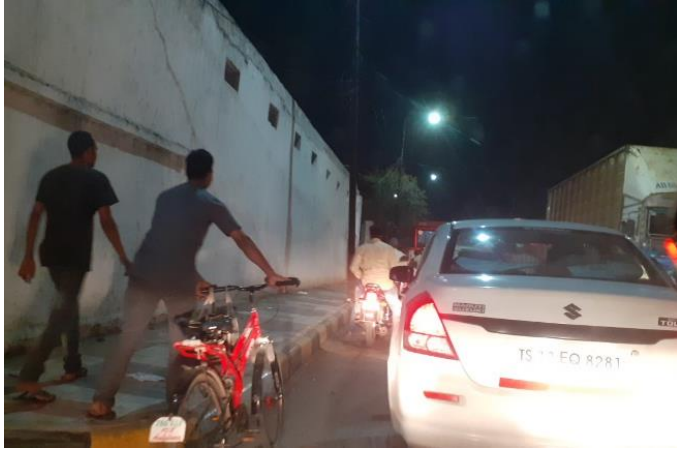
Image showing a stretch near Old Kurnool Road with high boundary wall

High boundary walls result in poor visibility along the walkpath and instill a sense of fear in the pedestrians. Wherever possible, the height of the solid part of the boundary wall should be maintained at 1m. Above the solid part, grills can be used to achieve the remaining height. Inactive edges along the footpath instill a sense of fear in the pedestrians.

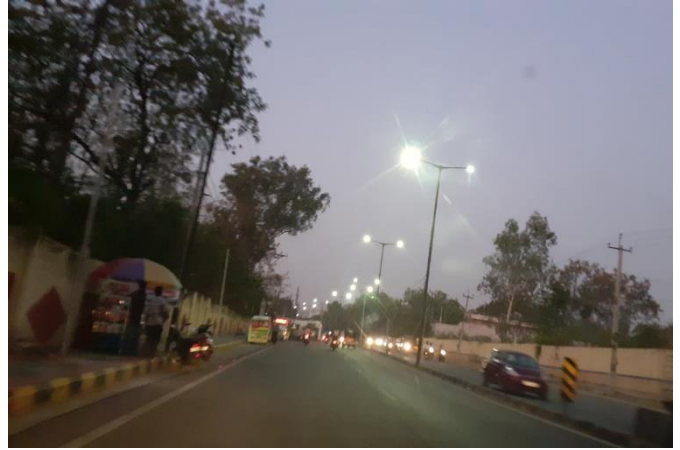
Image showing a stretch on Lalapet-Moula-Ali Road with street vendors and high solid boundary wall

Proper vendor zones/dedicated space for vendors should be demarcated. Provisions of adequate lighting and availability of public conveniences such as drinking water kiosks and public toilets should also be made near the vending zones.

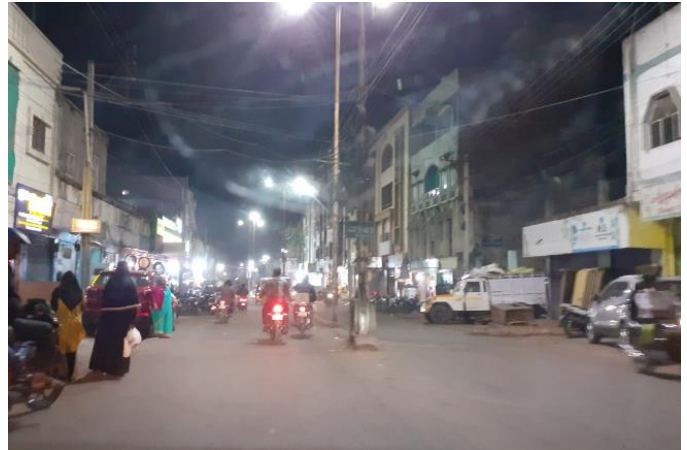
Image showing a stretch on Rein Bazar Road where Gender Usage is rated high (2,3) but Public Transport is low (0,1)

It is important to ensure that people find public transport in their city safe and convenient. Existing public transport stands should be upgraded. They should be well lit and have adequate seating. Interactive panels indicating routes, emergency helpline numbers and an emergency button for help in distress should be provided at the stands.

Last mile connectivity is an important aspect of a city's public transportation system. Strengthening the last mile connectivity by formalizing informal/para-transit modes such as non-motorized modes (e-rickshaws) could be a useful way of ensuring safe travelling. Designated well lit para transit stands with public convenience facilities needs to be created near bus stops to ensure safe and convenient last mile connectivity. These stands should have designated parking space where autos , e-rickshaws, etc. can be parked and from where they can be hailed.

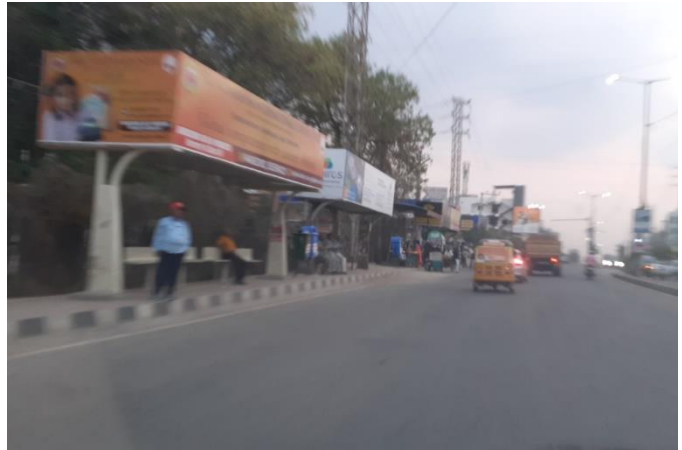
A total of 1023 bus stops were audited using Safetipin Nite application. Map 11 below shows the Gender Usage ratings (in brown color) at the audited points. The audited bus stops are shown in blue color. Our data shows that very few women can be seen around the bus stops during late evening hours. The data also highlights poor public transport connectivity at few audit locations which are commonly used by women.

Image showing a bus stop with only men at Chevella Road

To encourage more women to use the public spaces, ensuring good public transport connectivity (including first and last mile connectivity) is imperative.
