James Long Sarani

A Pilot Design Intervention Report by Safetipin

Design strategies to improve accessibility

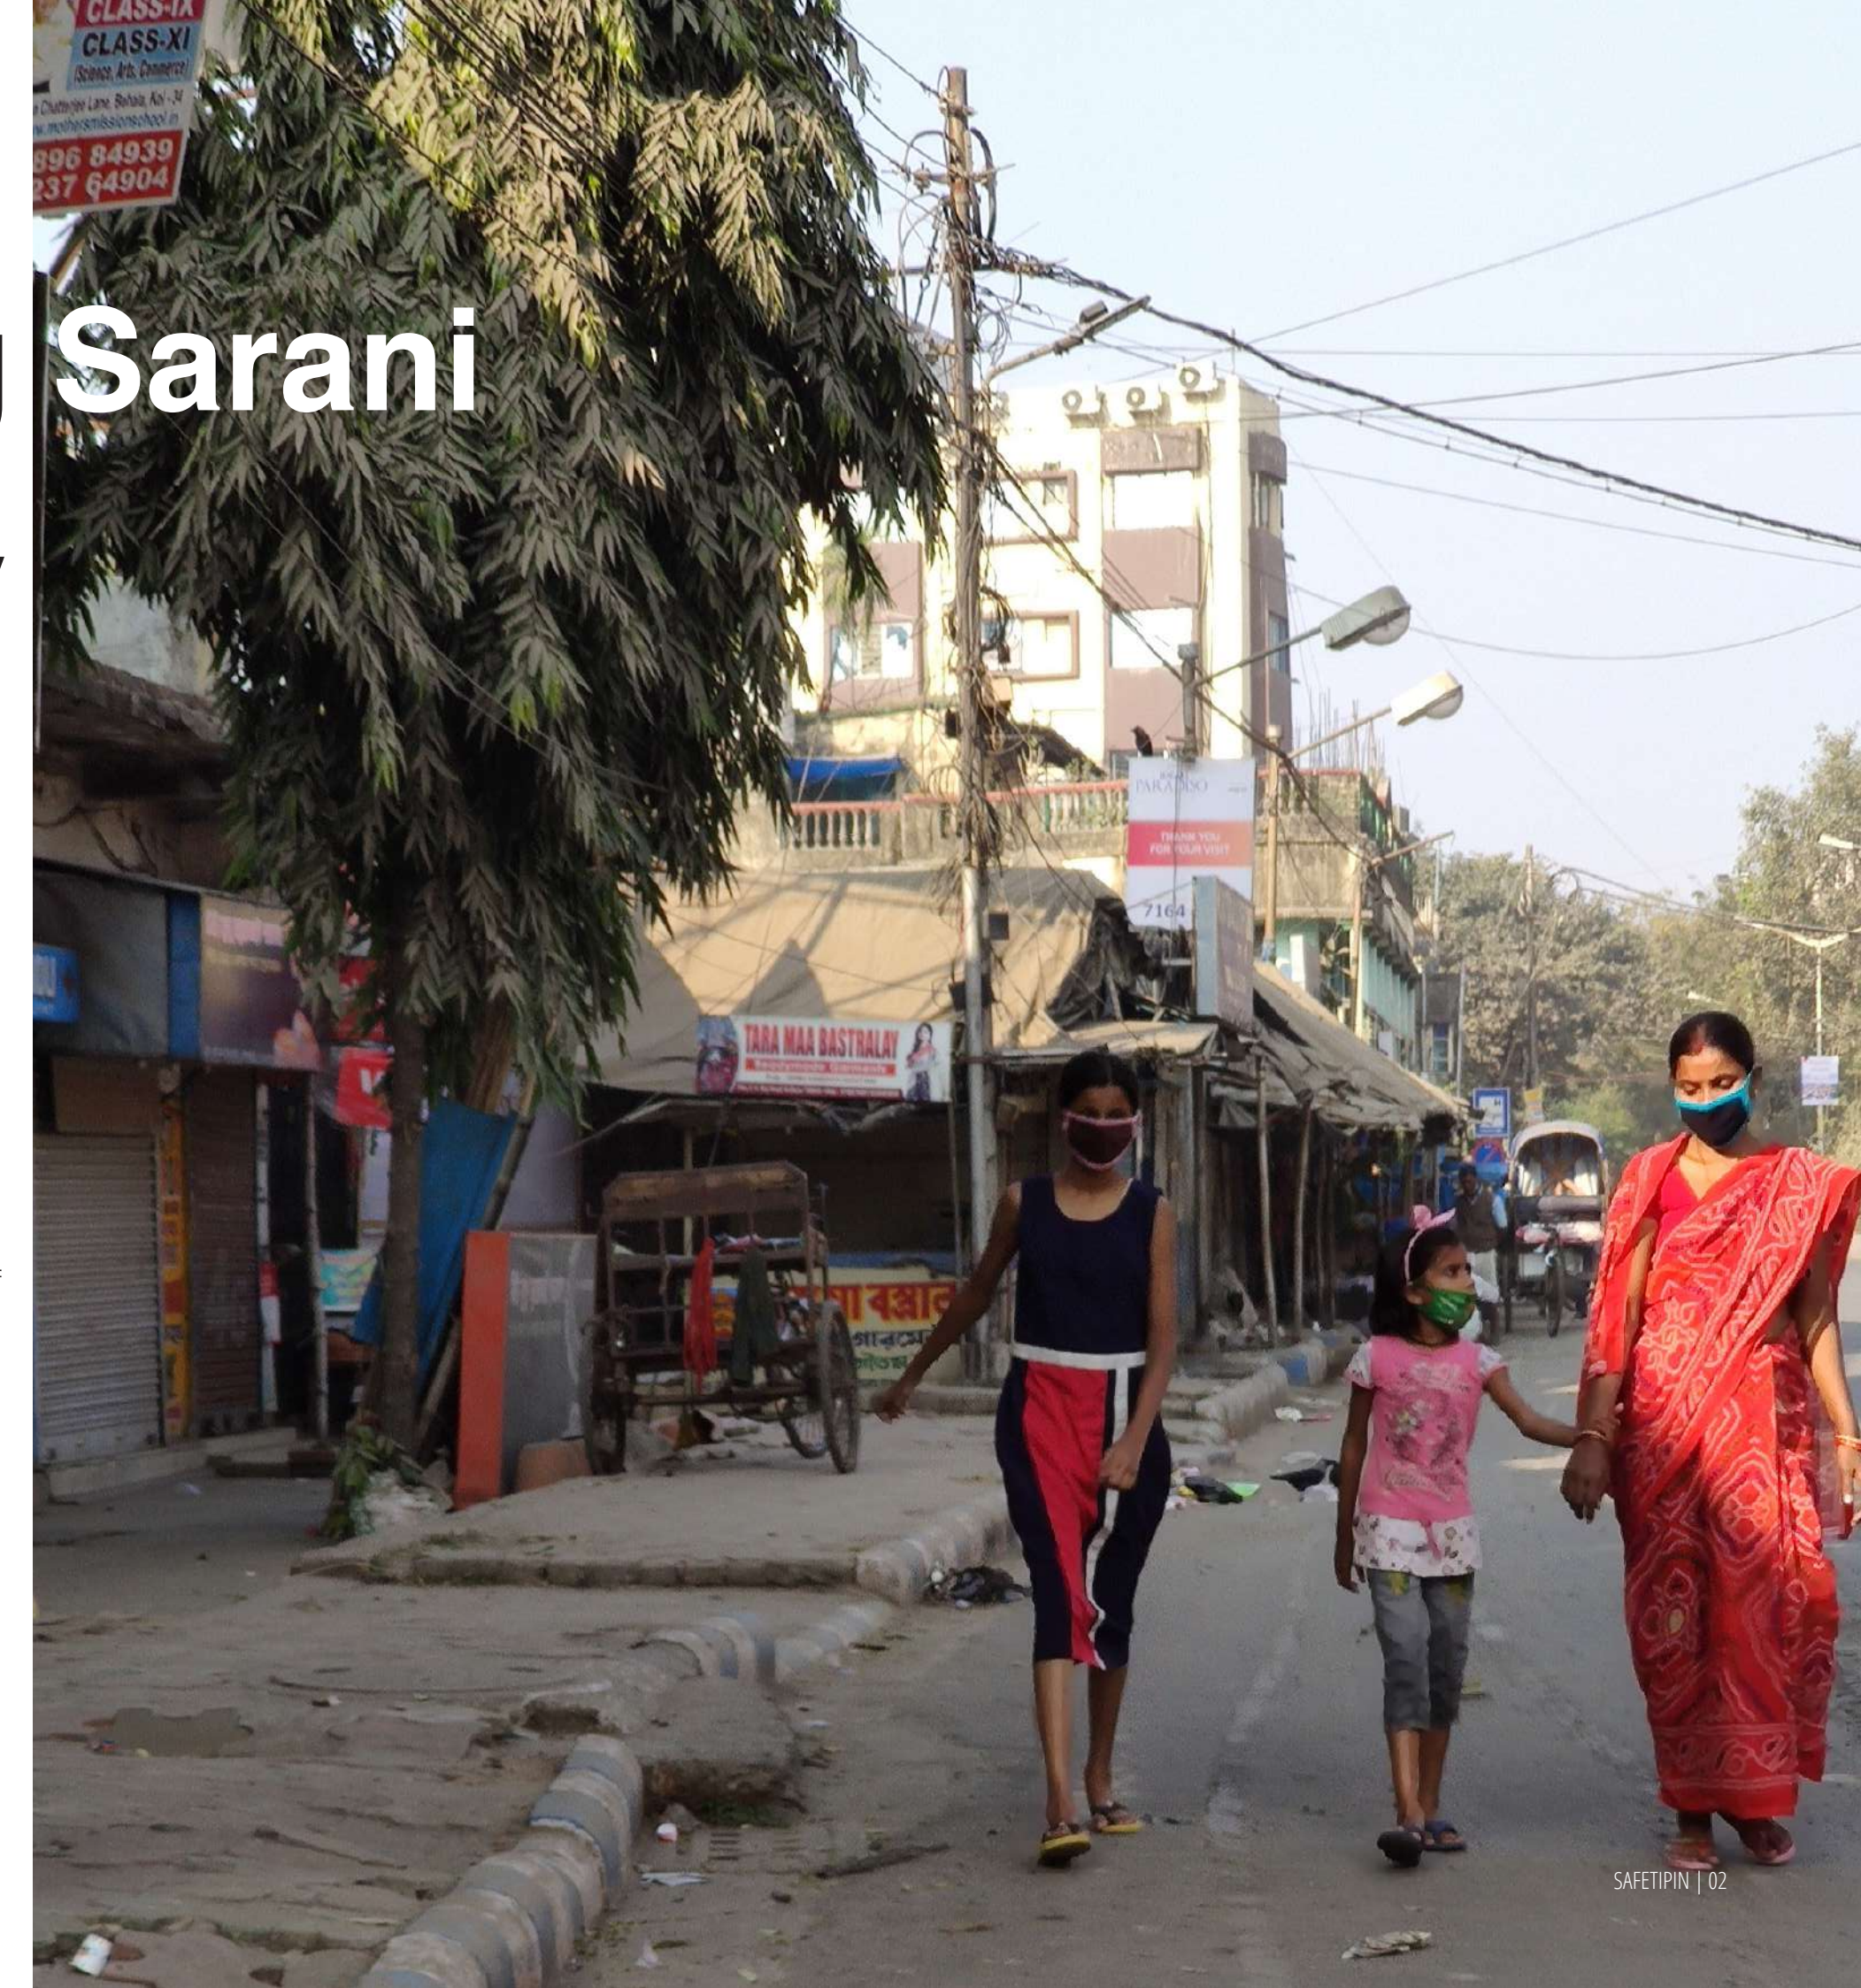
Image 01: Woman with children walking on the vehicular road because of footpath condition being poor

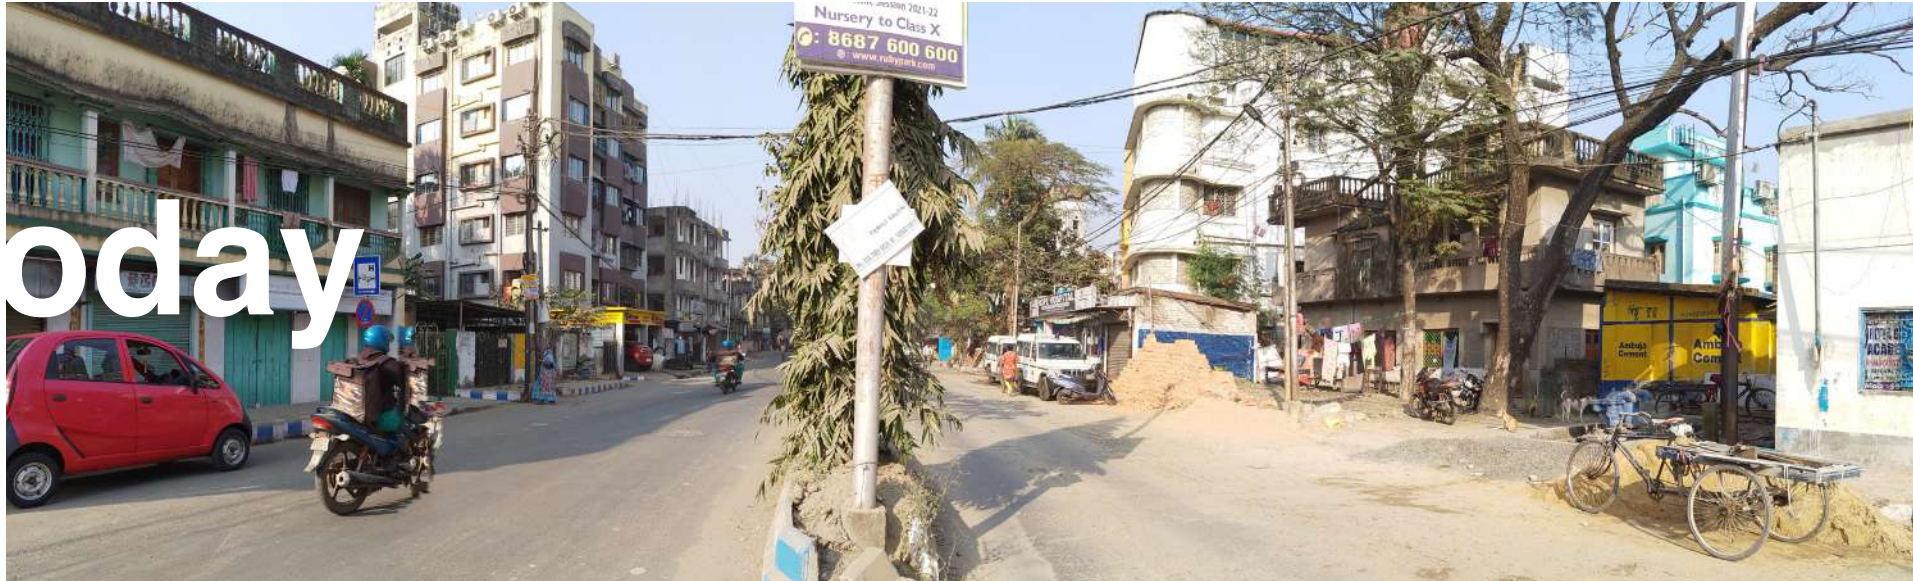
Image 02: J L Sarani - Two-way, four-lane road with median

The entire stretch has three vehicular road condition:
A. Two-way, four-lane road with median (Image 02)
B. Two-way, six-lane road without median (Image 03)
C. Two-way, six-lane road with median (Image 04)

FINDINGS	RECOMMENDATIONS
RECLAIM one vehicular lane on both side for footpath extension	
INSUFFICIENT SPACE AVAILABLE FOR PEDESTRIANS	Images on Page 4 of three typical vehicular road conditions seen on J. L. Sarani
Two-way, four-lane road with median	Reclaim encroached footpath spaces from house and shop extensions and maintain minimum 2 meters of footpath space for pedestrians and street lights. There is no space for any multi-utility or frontage zone on this stretch of the road. For illustration, refer proposed street section 1-1' on page 18
Two-way, six-lane road without median	Given the traffic on the existing road, two lane carriageway on each side of the road are enough. This keeps the vehicular speeds low and enhance both vehicular and pedestrian safety. The third lane on both sides could be reclaimed for widening the footpath which does not have adequate width to allow clear walking space for pedestrians. The 3 meter wide traffic lane on each side will increase the width of the existing footpath on either sides and will provide 1.8 meter of clear access for pedestrians - the minimum width required for two people to move. The remaining 1.2 meter will provide multi-utility space for street utility, vendors and street furniture. For illustration, refer proposed street section 2-2' on page 20.

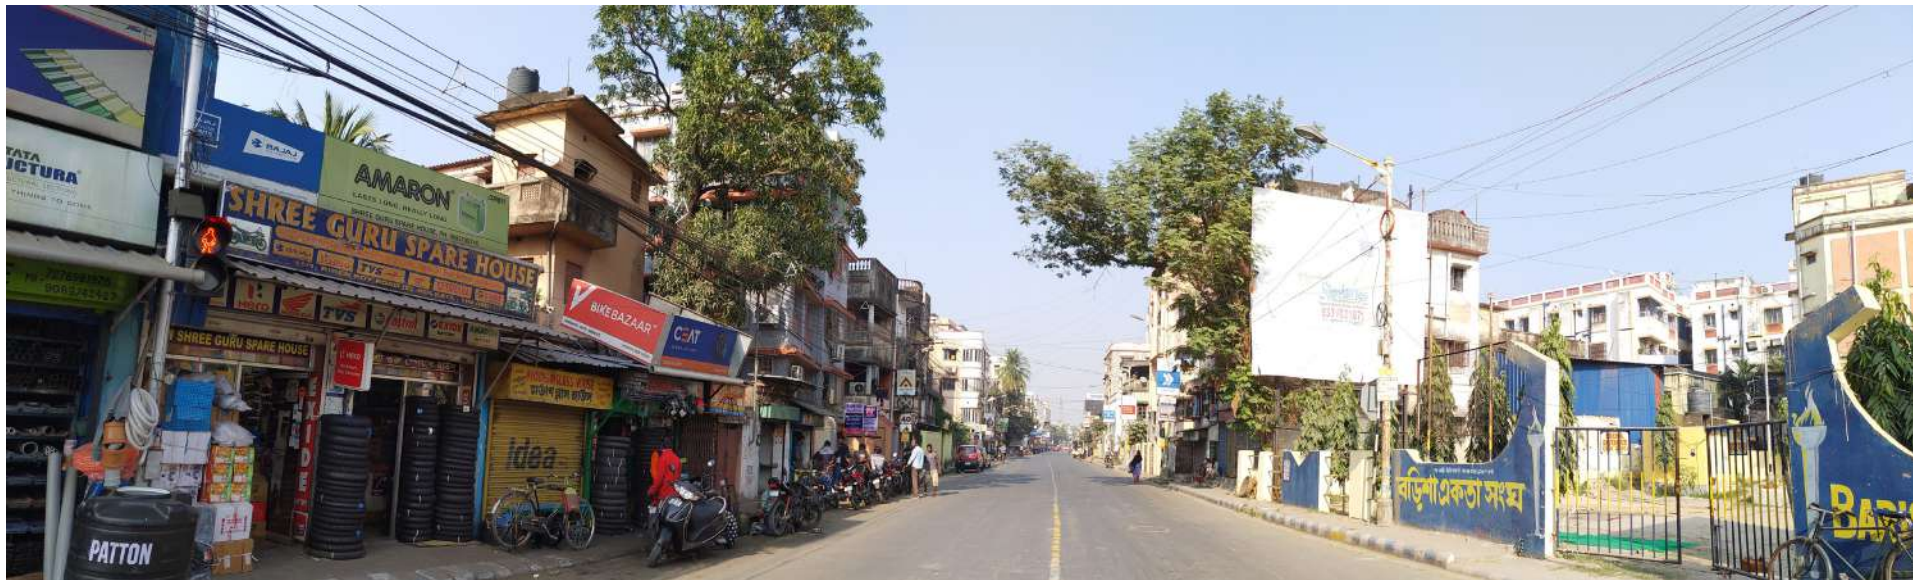
Image 03: J L Sarani - Two-way, six-lane road without median

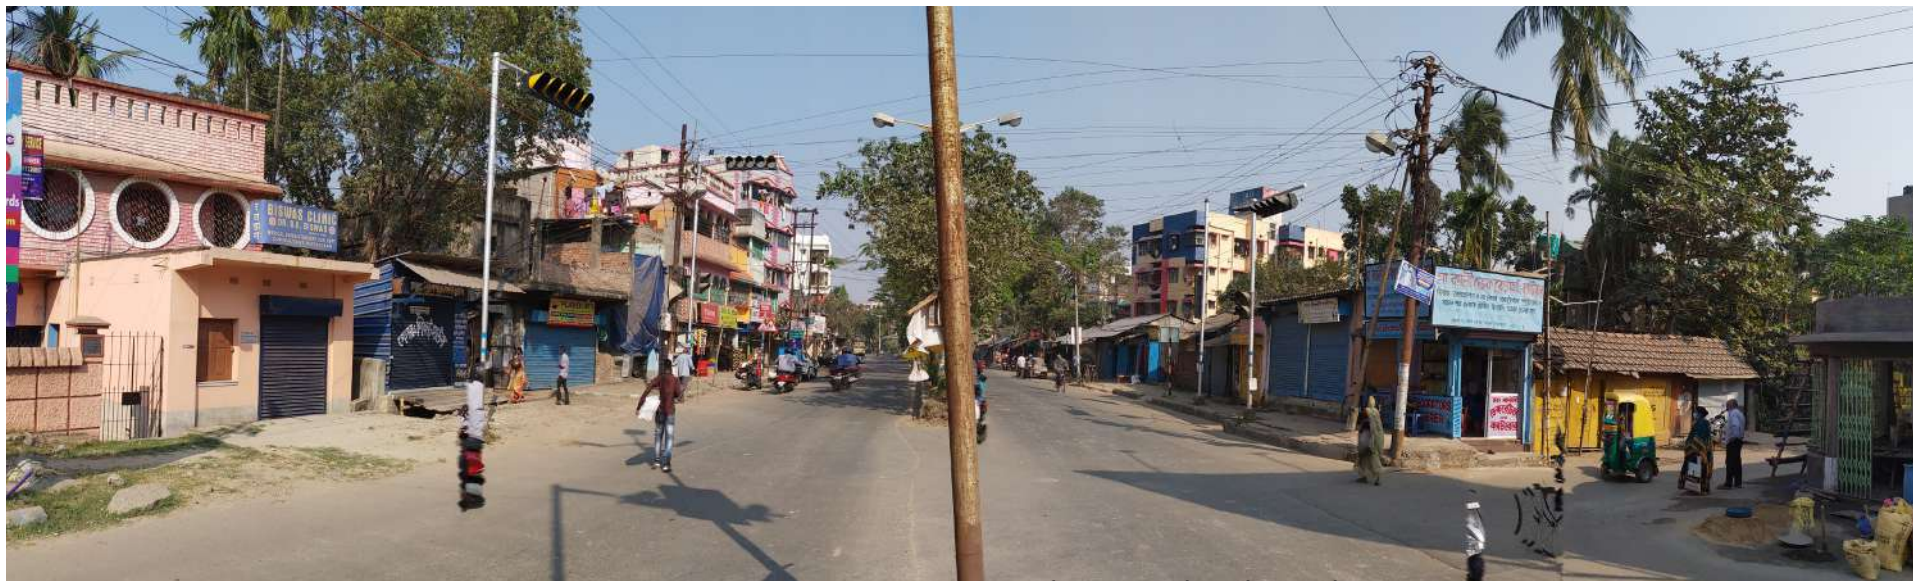
Image 04: J L Sarani - Two-way, six-lane road with median

Two-way, six-lane road with median	Same as above. For illustration, refer proposed street section 3-3' on page 22.

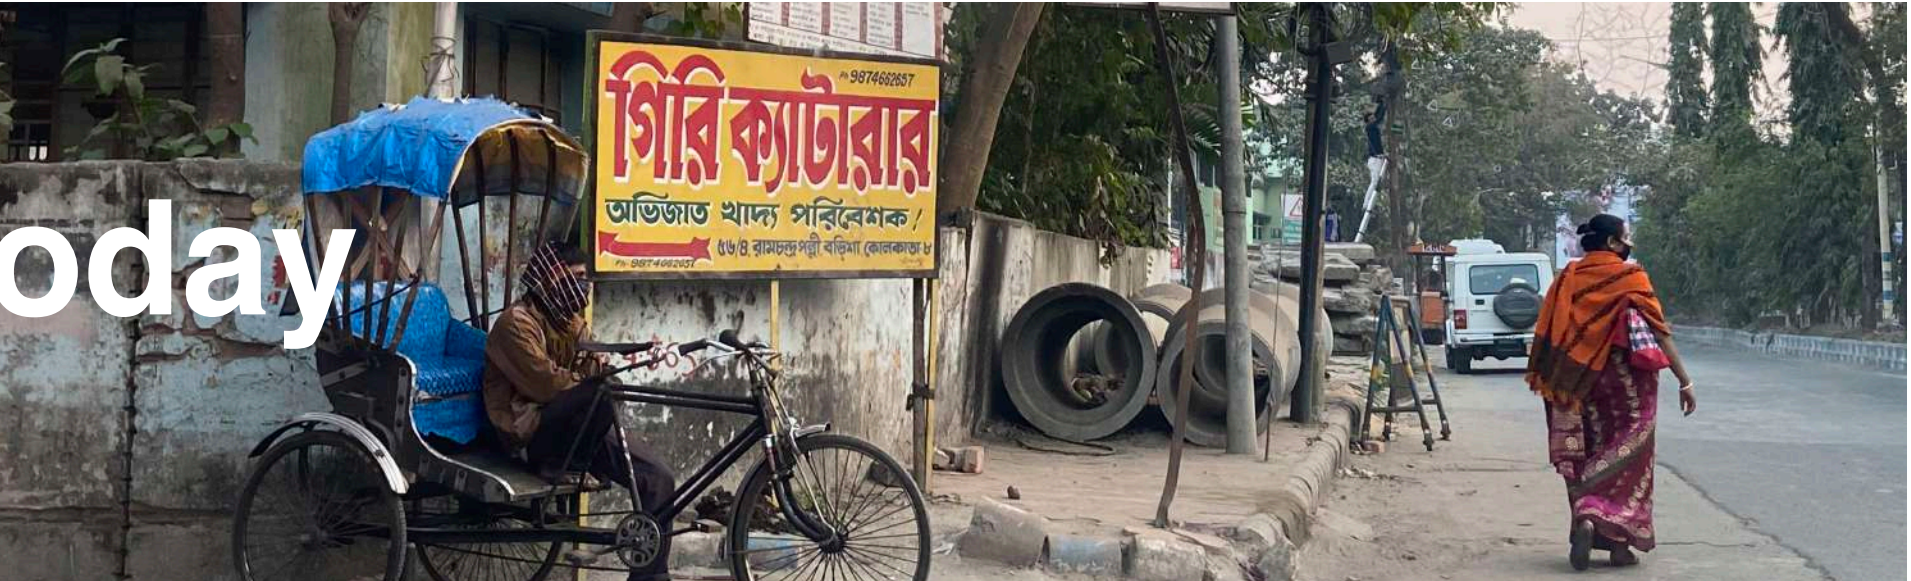
Image 06: J L Sarani - Woman walking on the road as construction material is blocking the footpath

The footpath provided on either side of the road have multiple obstructions, such as, parked vehicles, vegetable vendors, temporary shop extensions, restaurant encroachments, piled construction materials, garbage dumps (as illustrated on page 10). All most all of these could be removed immediately without causing any damage to the buildings or hindering public life on the street. The important components of the streets - parking, vendors and shop/restaurant spill-outs - could be then organised within the pedestrian realm without posing as obstructions on the footpath.

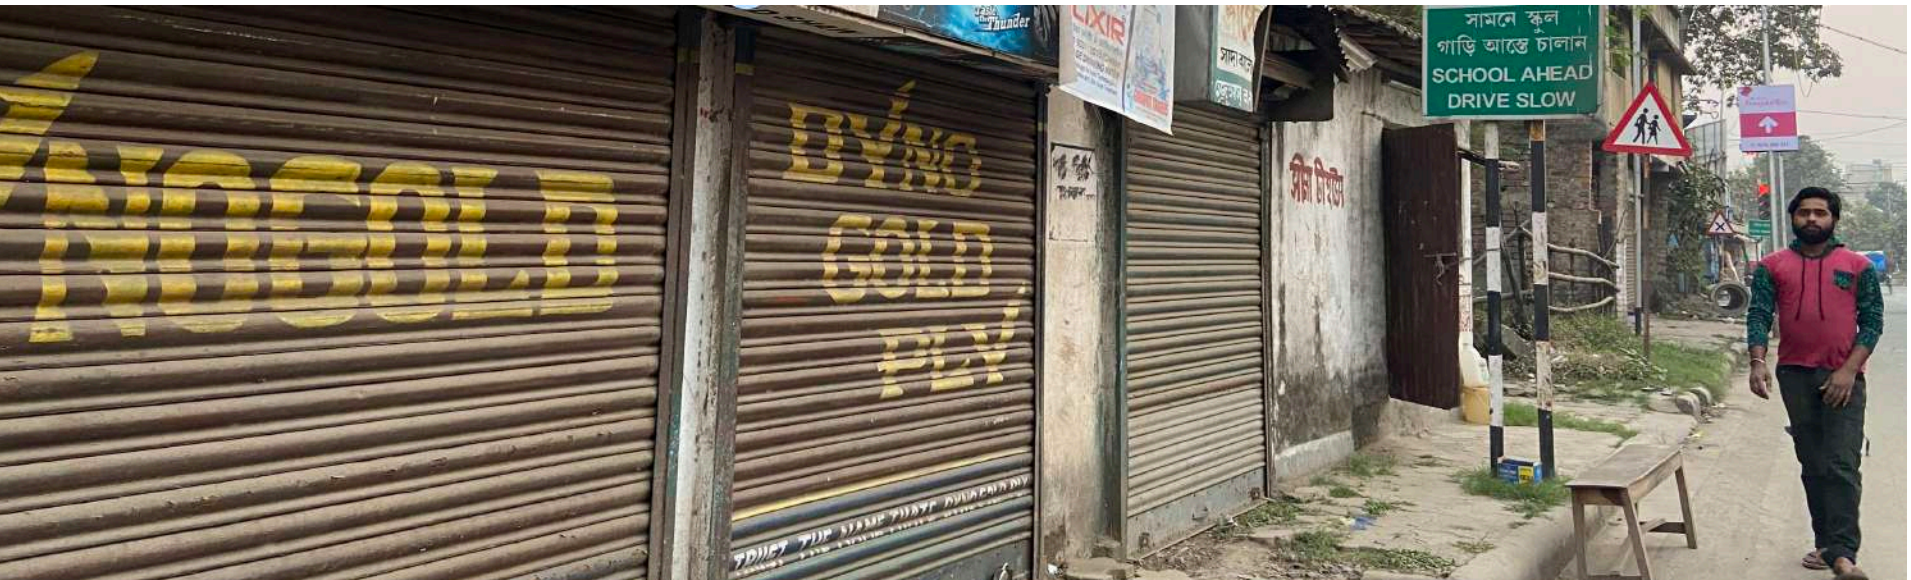
Image 07: J L Sarani - Man walking on the road as signage poles are blocking the narrow footpath

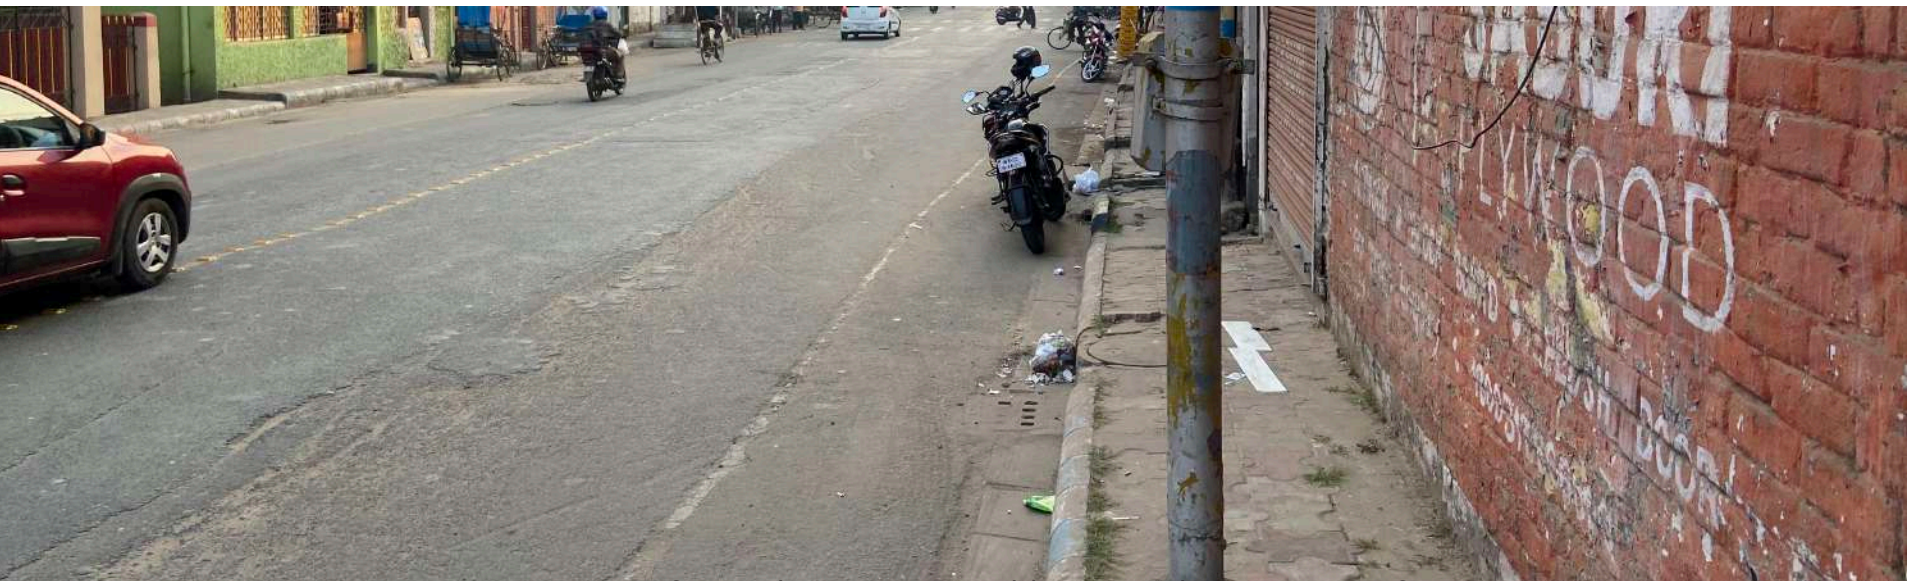
Image 08: J L Sarani - Very narrow footpath, minimum width required is 1.8 metres for two persons to pass

The provided footpath is broken and disjointed at numerous places. It is has sudden drops at vehicular ramps cutting across and protruding manholes covers posing as tripping hazards (as illustrated on page 10). The curb height of footpaths are too high and they are very narrow in some parts. Maximum curb height should be 150 mm and minimum width of pedestrian footpath should be 1.2 meters. To move from point A to point B - people need to move at grade, so a continuous at grade walking surface is critical to improve pedestrian accessibility. Repairing the broken parts, adding curb ramps at every drop and providing pedestrian crossings with median breaks at every intersection will ensure seamless routes.

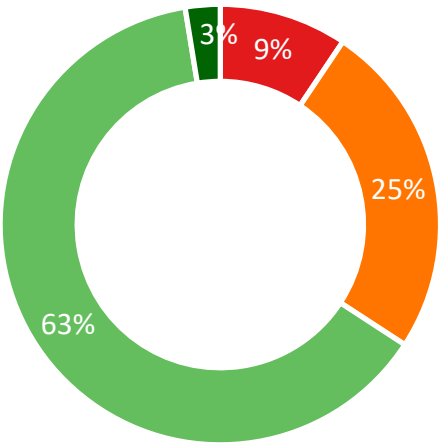
Map 01: Safetipin Parameter Map of People on J L Sarani

66% of the street have
good number of people using it

Safetipin mapped 66% of the street to have good
number of people present during the time of the
audit. 25% of the street were found to have few
people and 9% of the street were quite empty.

When this data is represented geographically (see
Map 01) it is seen that areas with higher ratings on
people are spread all along the street. This means,
people use the street well for performing everyday
activities.

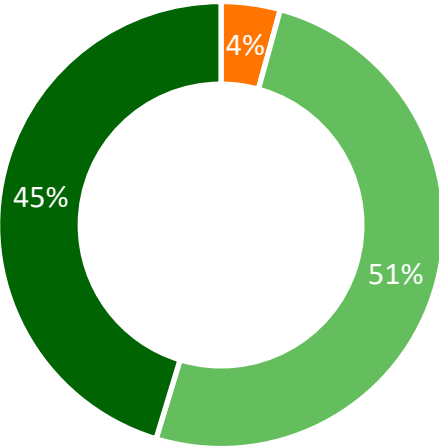
Map 02: Safetipin Parameter Map of Walkpath on J L Sarani

96% of the street have
footpaths built for pedestrians

Safetipin mapped 96% of the street to have
footpaths constructed for pedestrians and only 4%
of the street is rated poorly on the same.

When this data is represented geographically (see
Map 02) it is seen that areas with higher ratings on
footpaths are found all along the street and only in
few areas they are missing or completely broken.
This means, footpaths are built and allocated for
pedestrians on this street. A detailed footpath
analysis follows to understand the built condition of
the footpaths and how accessible they are for all.

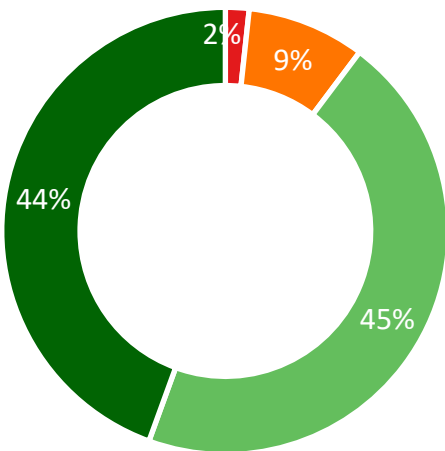
Map 03: Safetipin Parameter Map of Visibility on J L Sarani

89% of the street has active frontage and ‘eyes on the street’

Safetipin mapped 49% of the street to have good visibility or enough eyes on the street to make people feel safer on it. Only 11% were found to have poor visibility.

When this data is represented geographically (see Map 03) it is seen that areas with higher ratings on visibility are spread all along the street and only in few locations visibility is found to be low. This means, the street has less number of high boundary walls or blank facades facing the street and have more people, vendors, shops on the streets to provide active frontage. This also says that there is active engagement of people on this street.

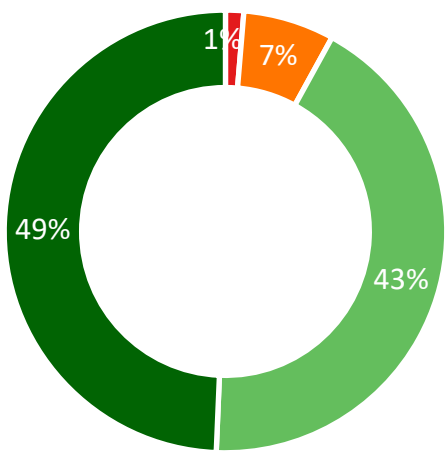
Map 04: Safetipin Parameter Map of Lighting on J L Sarani

92% of the street has adequate street lighting

Safetipin mapped 92% of the street to have adequate street lighting and only 8% of the streets is rated poorly on the same.

When this data is represented geographically (see Map 04) it is seen that areas with higher ratings on street lighting are found all along the street and only in few locations they are non-functional. This means, the street has adequate street lighting for clear visibility and is used by people for daily activities even after dark.

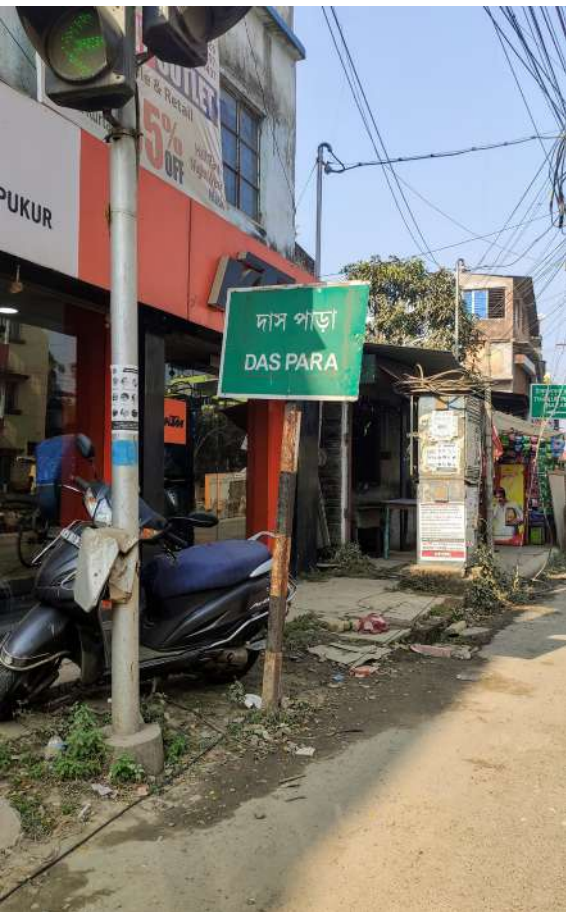
Image 09: Parked two-wheeler

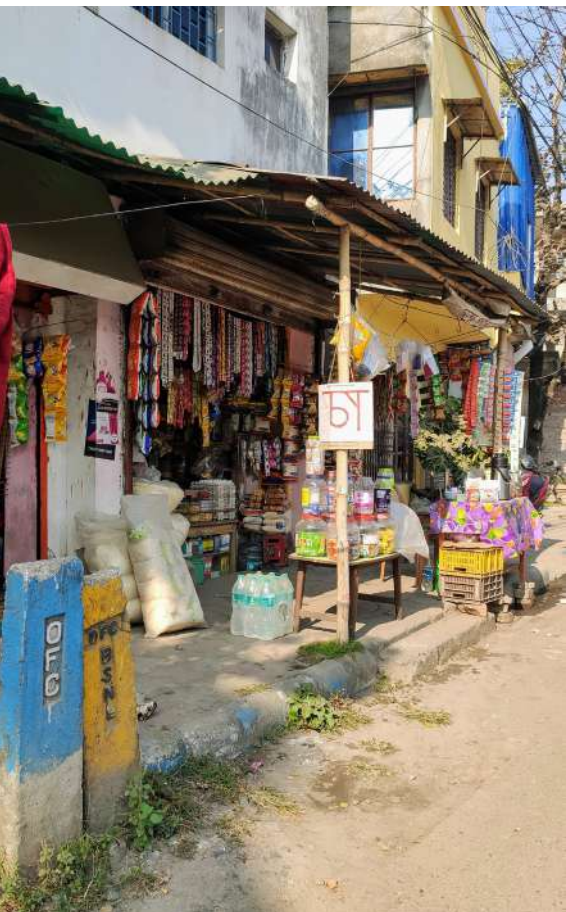
Image 11: Shop extension

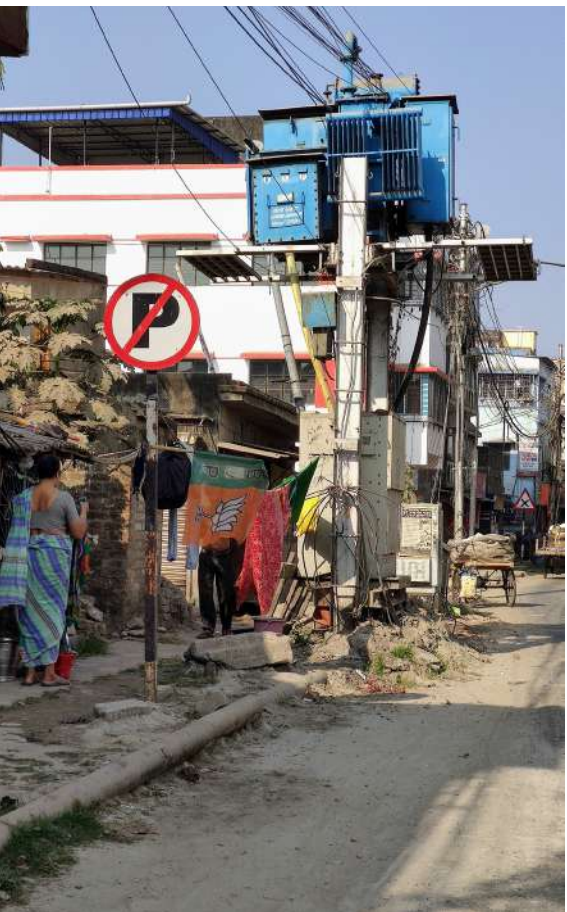
Image 13: Power transformers

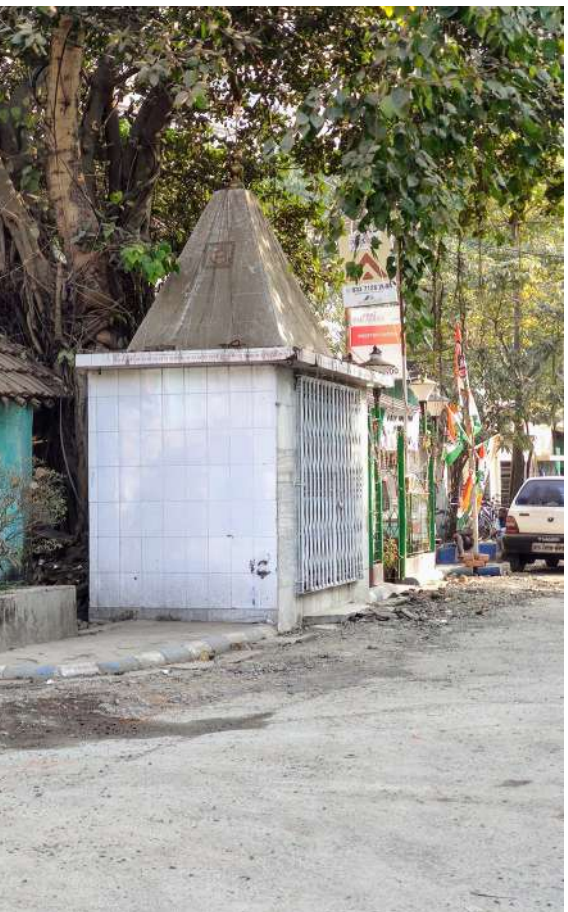
Image 15: Religious place

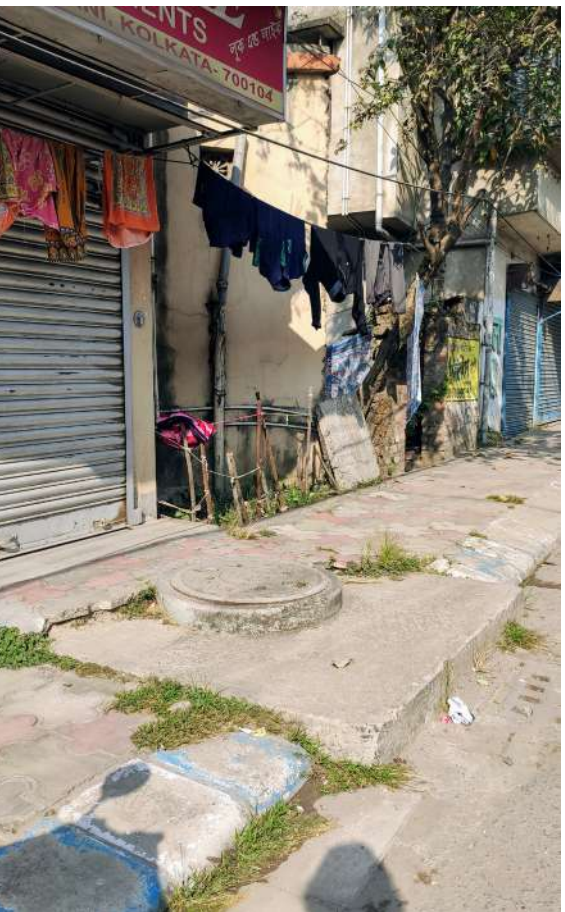
Image 17: Manhole jutting out

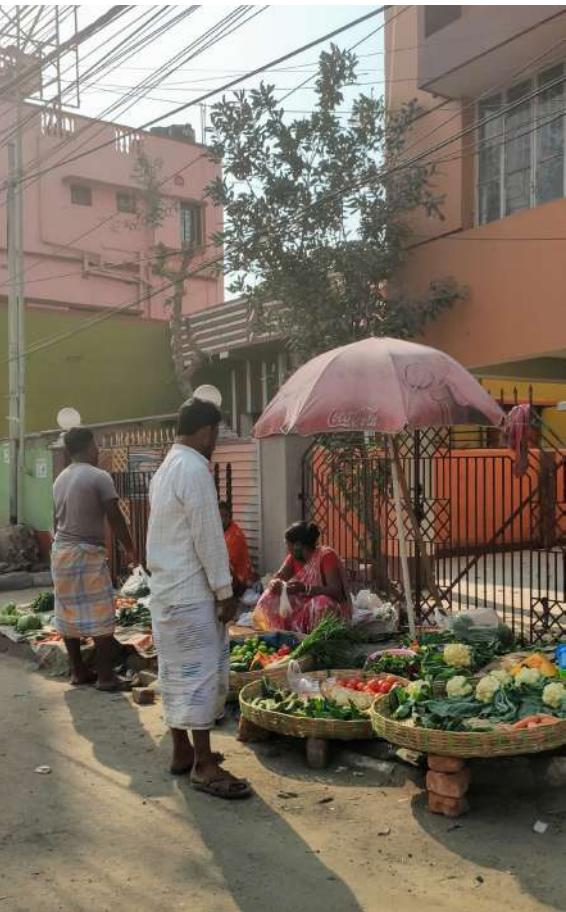
Image 12: Vegetable vendors

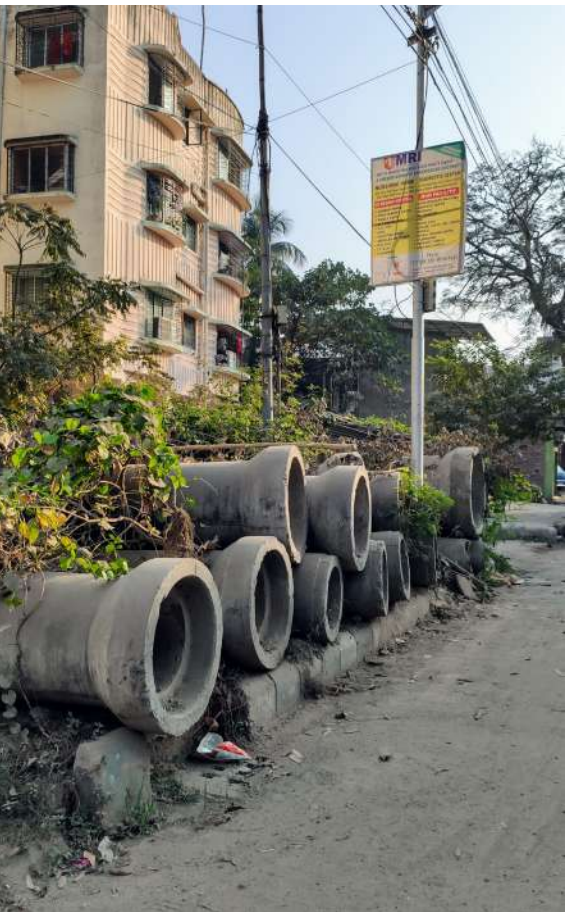
Image 14: Construction material

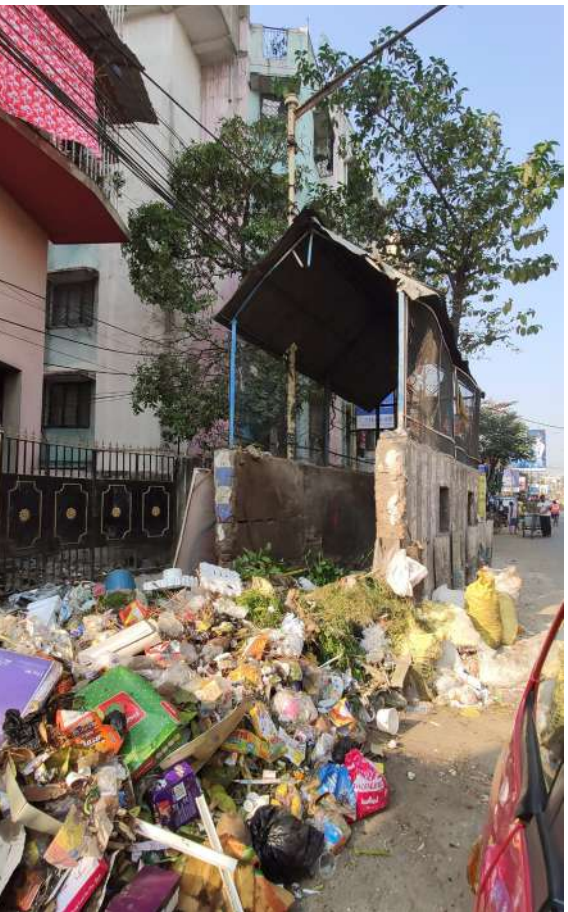
Image 16: Garbage dump

Large garbage containers and loose garbage dumps	Remove large garbage containers and loosely dumped garbage from the existing footpath to provide clear walking space (min 1.8m). Plan and organise garbage collection points on the street at various locations to avoid spilling of garbage on the footpaths
Construction material blocking the footpath	Remove construction materials piled on and blocking the existing footpath to provide clear walking space (min 1.8m)
Vehicle (two, four wheelers, cycle rickshaws) parked	Remove two, four wheelers, autos, cycles and cycle rickshaws parked on existing footpath to provide clear walking space (min 1.8m). Organise parking for two, four wheelers, autos, cycles and cycle rickshaws on shared lane (parking and driving) of the carriageway
Google Map Link: https://www.google.com/maps/d/u/0/viewer?mid=1POdEbN0Q5xnxPqTi6Z6_XUf0FiL6Gef7&ll=22.48445074666058%2C88.31494778499999&z=13	Please use the given map link and the csv files shared for the project to view the collected data supported with images at every point where obstructions are present on the existing footpath.

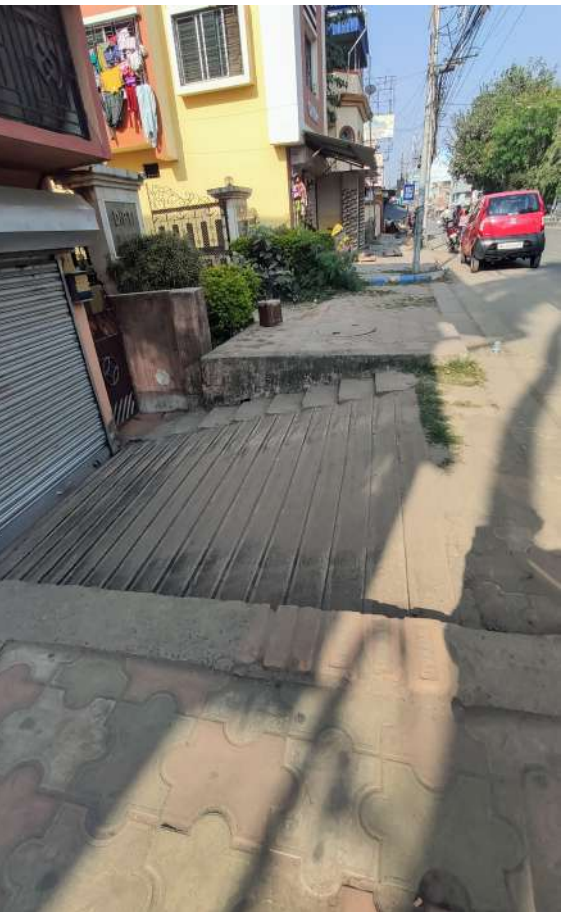
Image 18: Reverse ramp drop

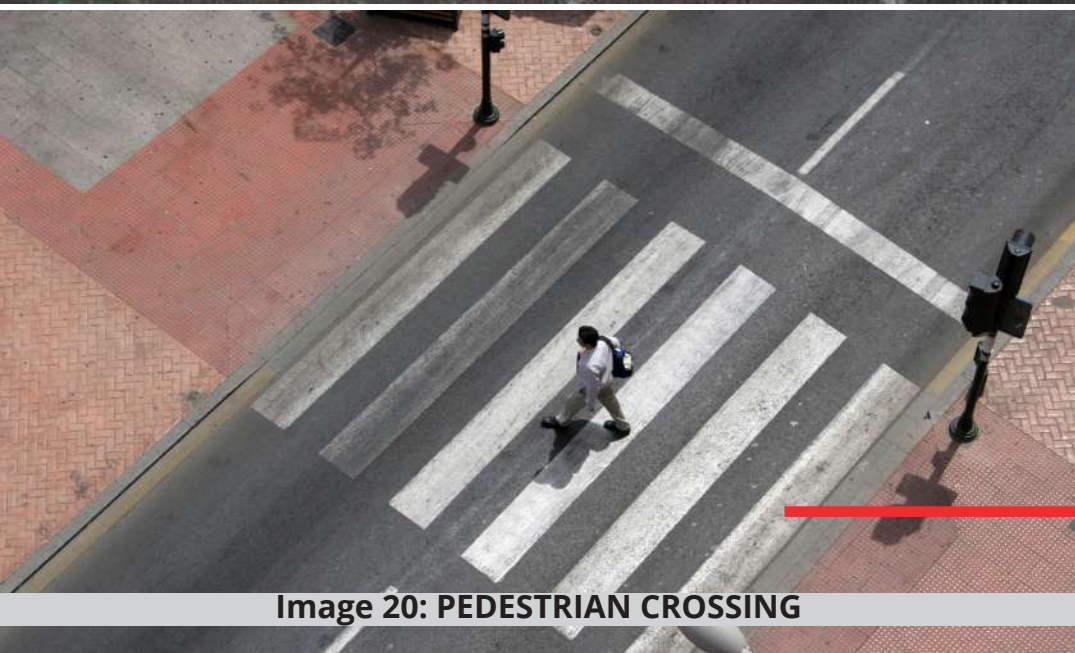
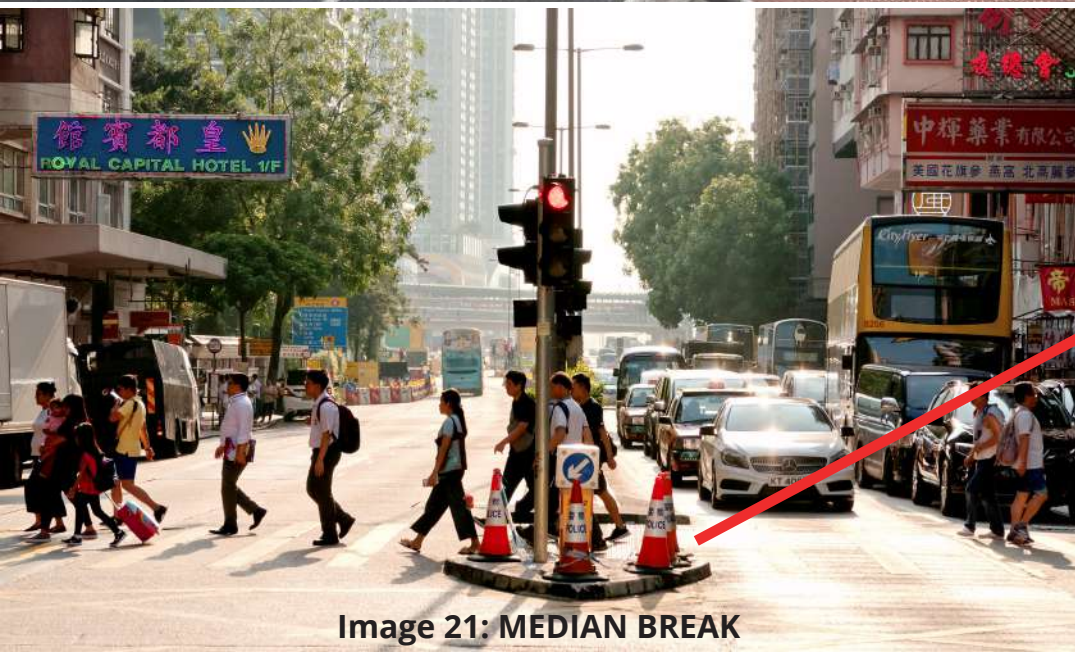
The street intersection drawing (Image 24) on the next page illustrates the principles of intersection planning with footpaths with tactile paving, curb ramps, pedestrian crossings and median breaks to allow at grade pedestrian access. The supporting detail images of each element of the footpath shows how they enable the pedestrian to move at grade easily and effortlessly on the streets.

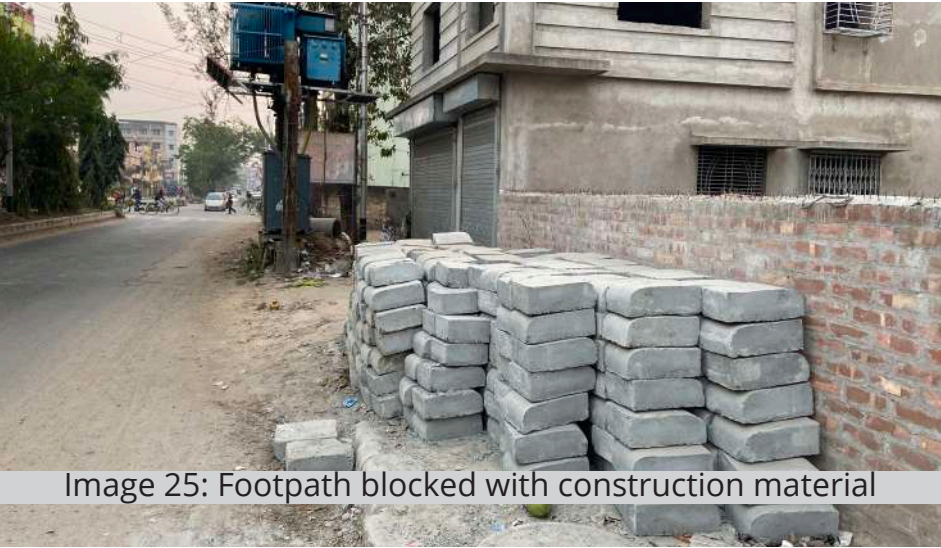
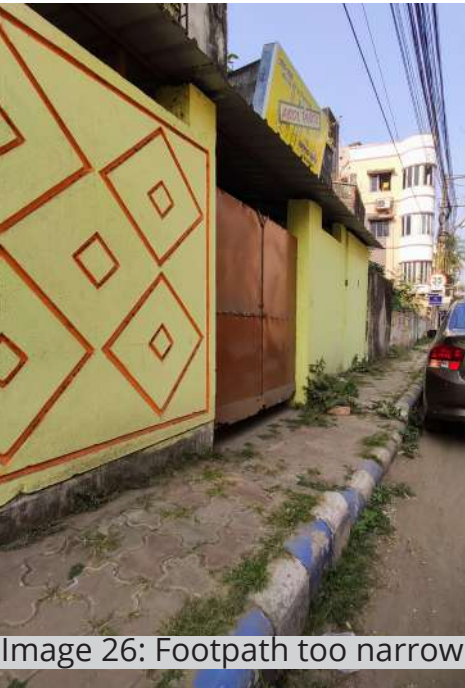
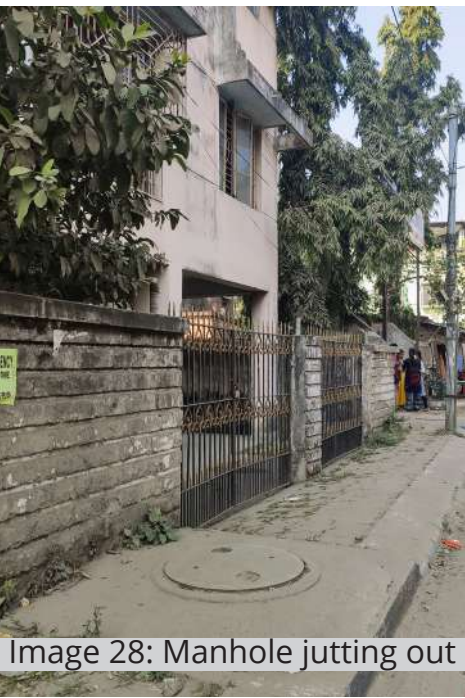
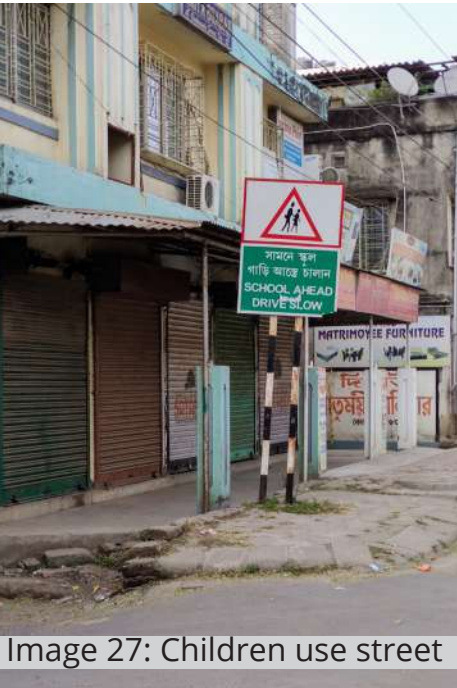
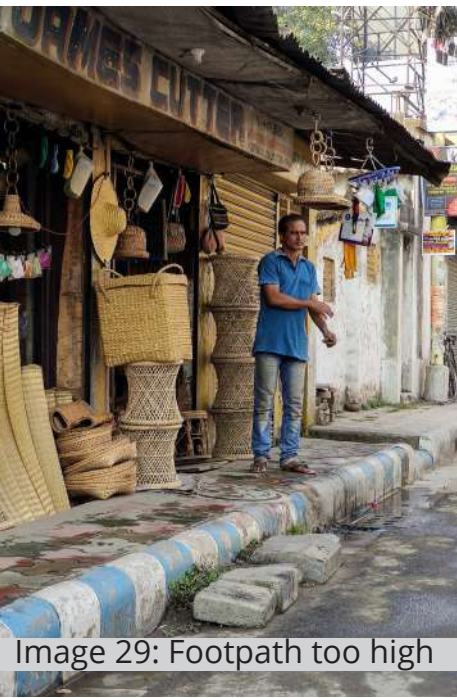
JAMES LONG SARANI - PILOT INTERVENTION STRATEGIES TO IMPROVE ACCESSIBILITY FOR ALL

FINDINGS

RECOMMENDATIONS
