James Long Sarani

A Pilot Design Intervention Report by Safetipin

Design strategies to improve accessibility

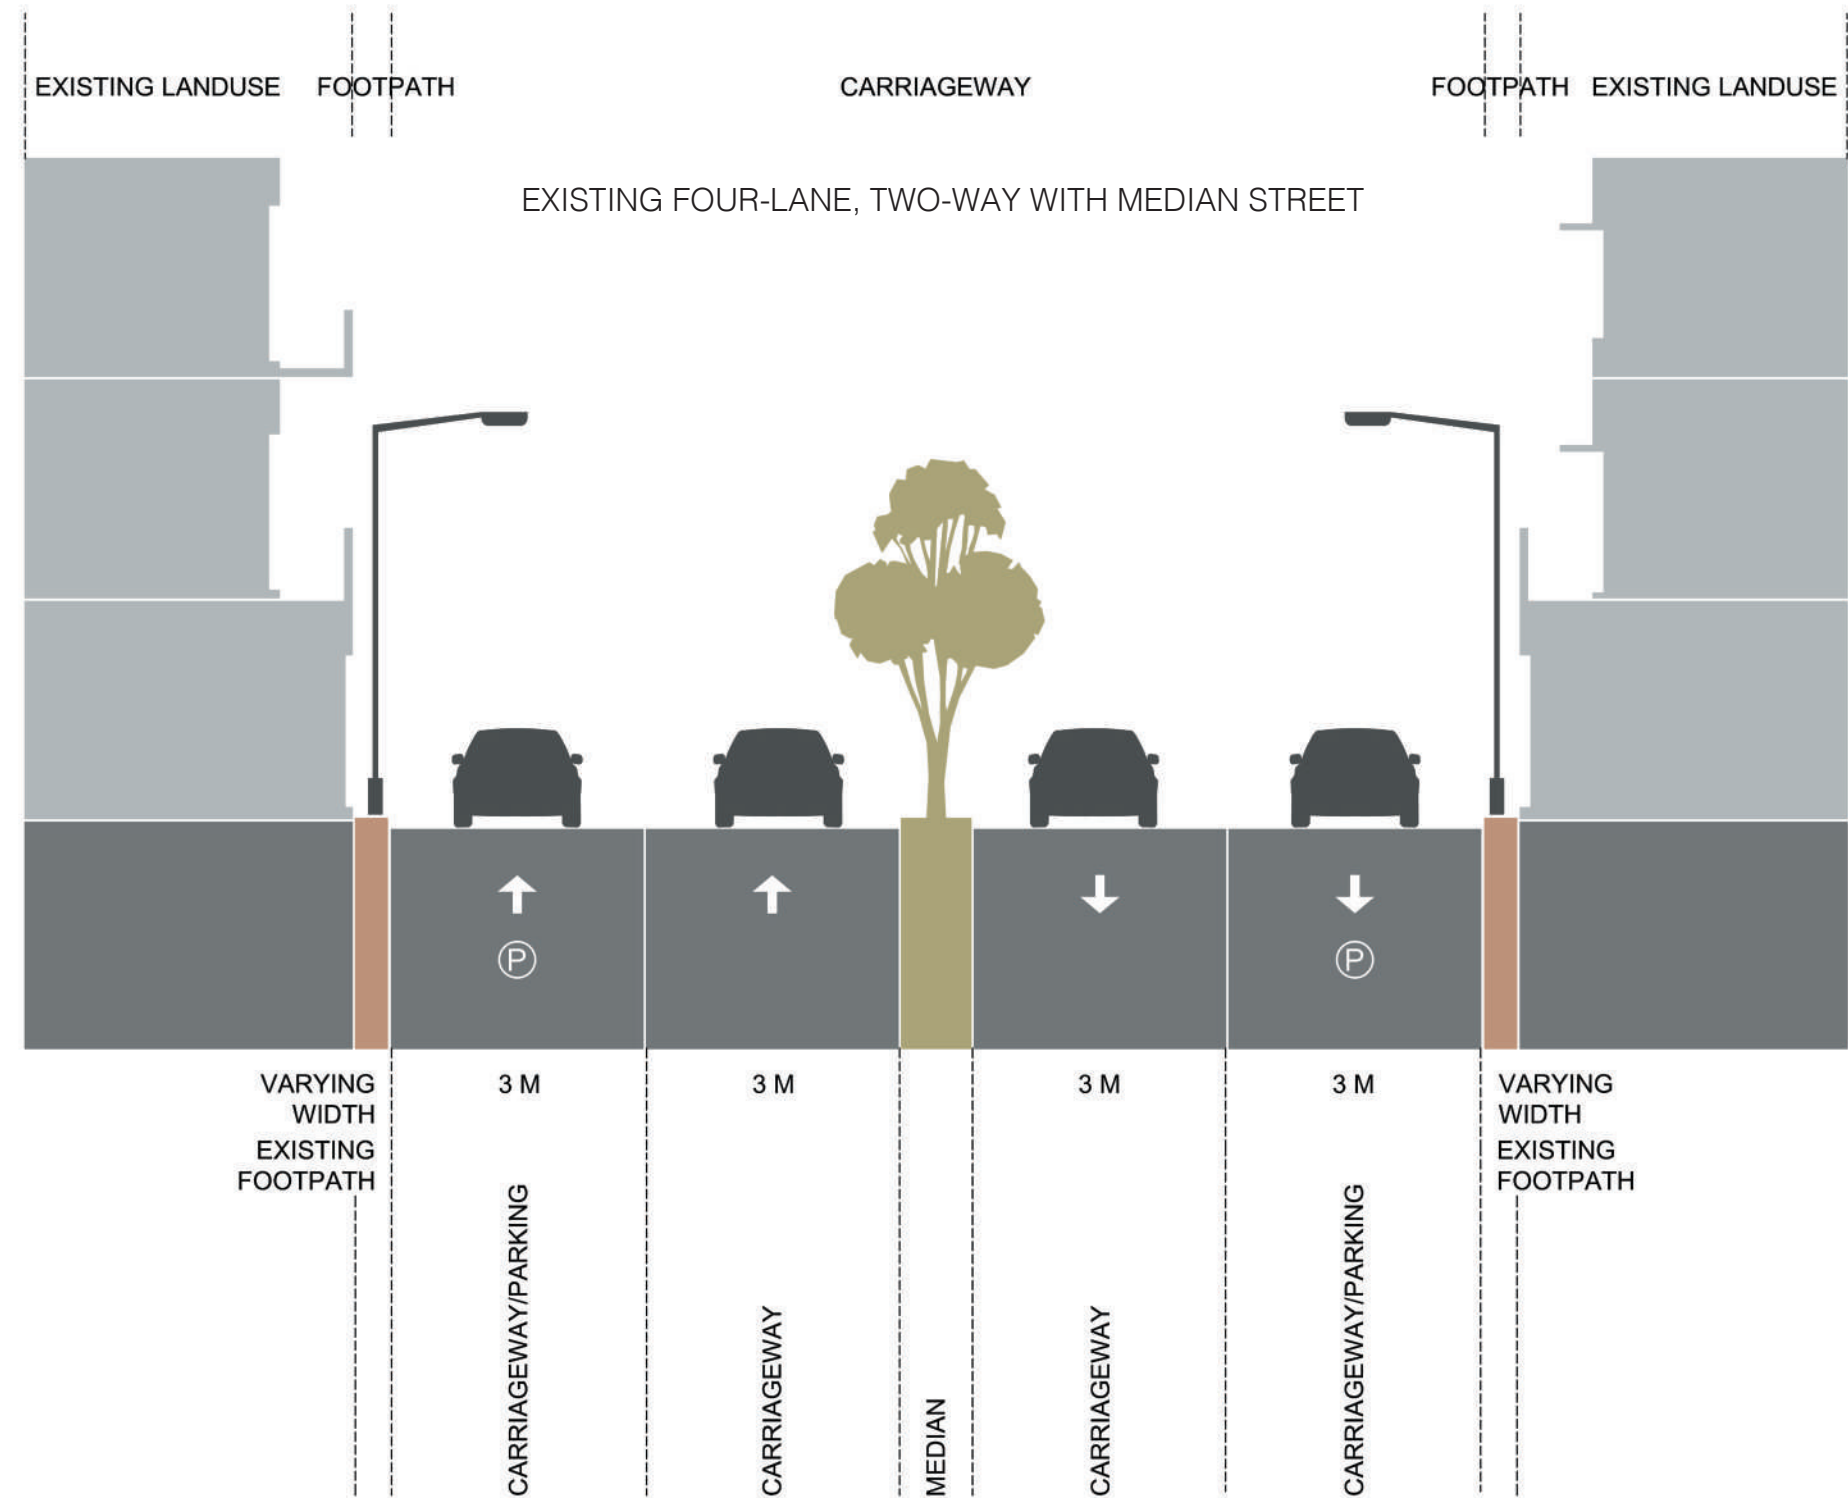
Existing Street Section 1A-1A'

Image 30: **STREET SECTION 1A-1A'**
ACCESS FOR ALL

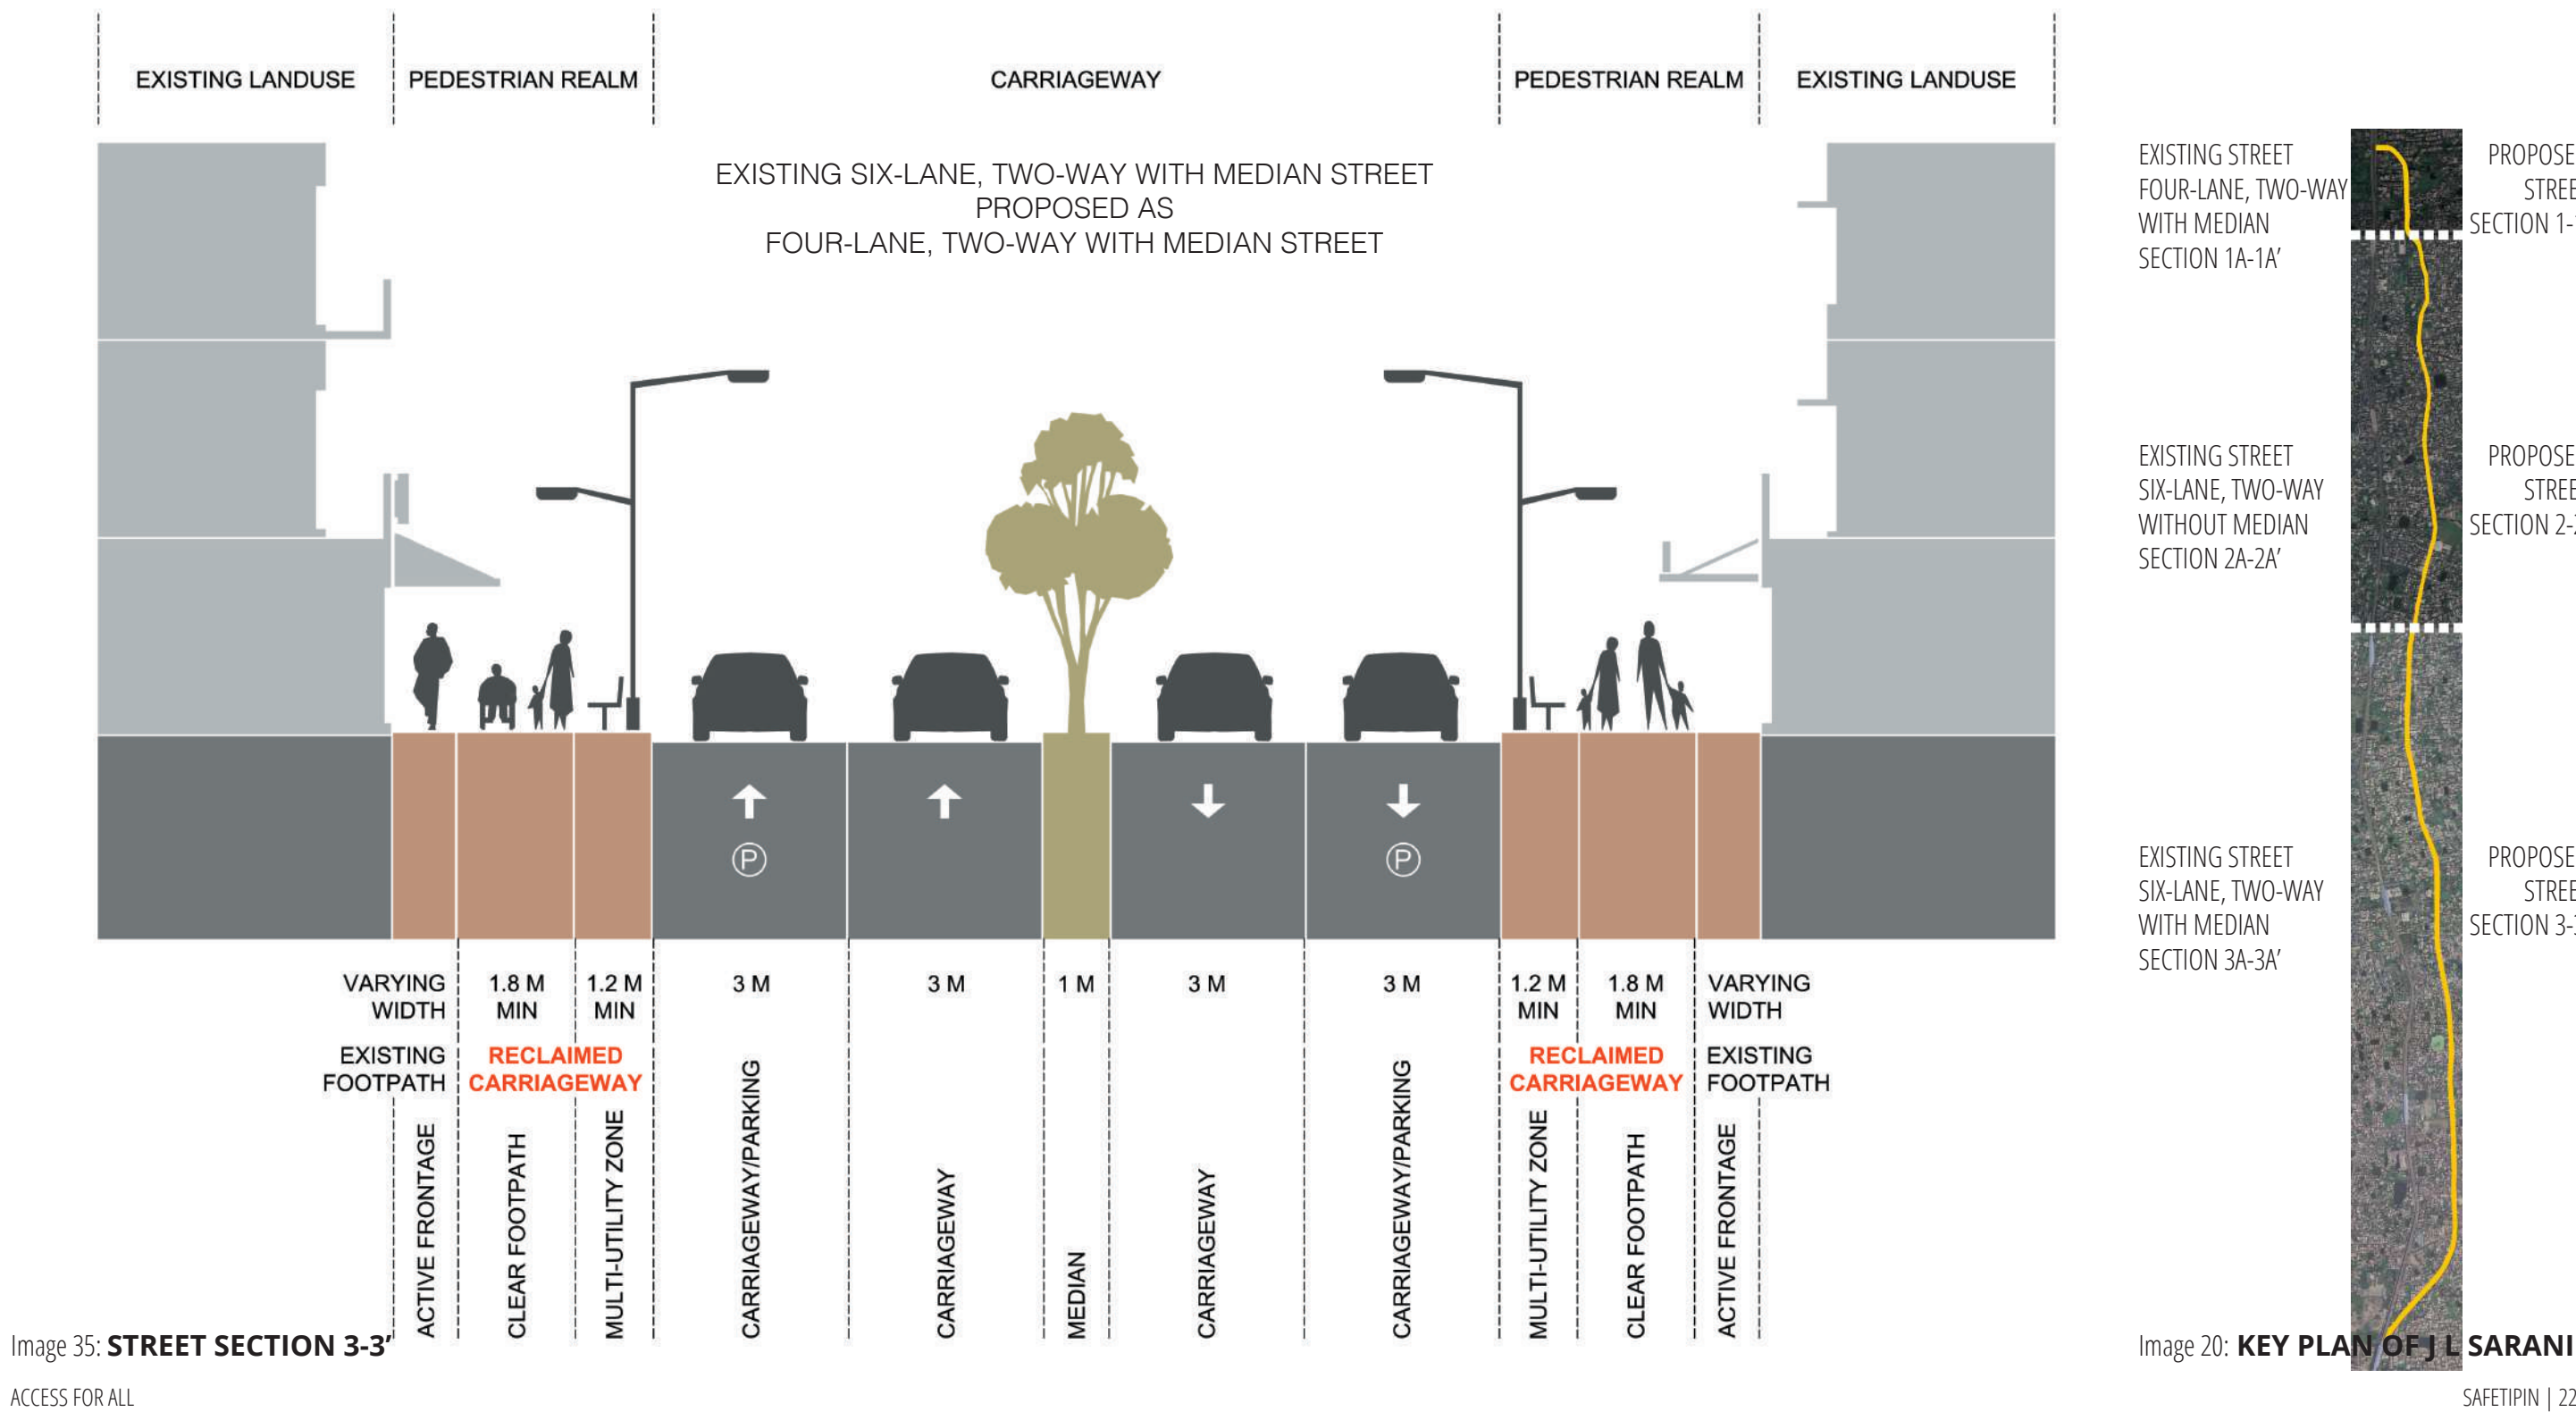
Proposed Street Section 3-3'

Two-way, six-lane road with median	Same as above. For illustration, refer proposed street section 3-3' on page 22.
