# SOCIAL VULNERABILITY AUDIT REPORT OF KOLKATA

# KOLKATA VULNERABILITY AUDIT

The grant fund for TA 9157-IND S24436 Social Vulnerability Audit of Kolkata was received from the Urban Climate Change Resilience Trust Fund financed by the Rockefeller Foundation and the Governments of Switzerland and the United Kingdom. We would like to extend our sincere gratitude for their support.

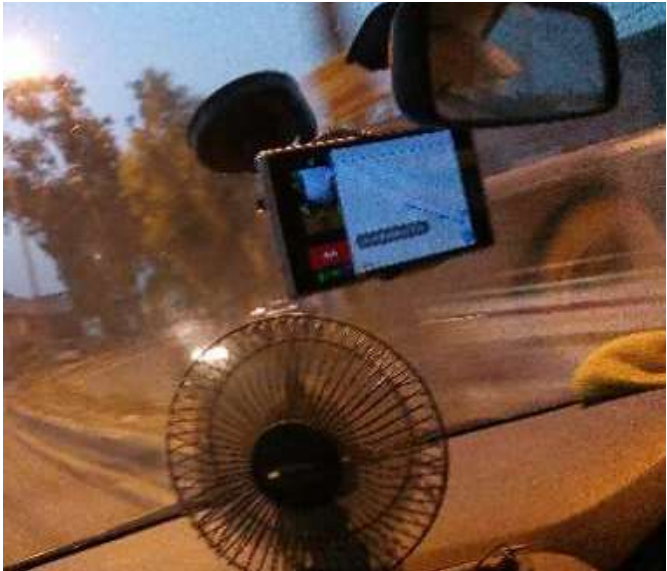
Image on right  
Phone running Safetipin Nite App mounted on the windshield of a car

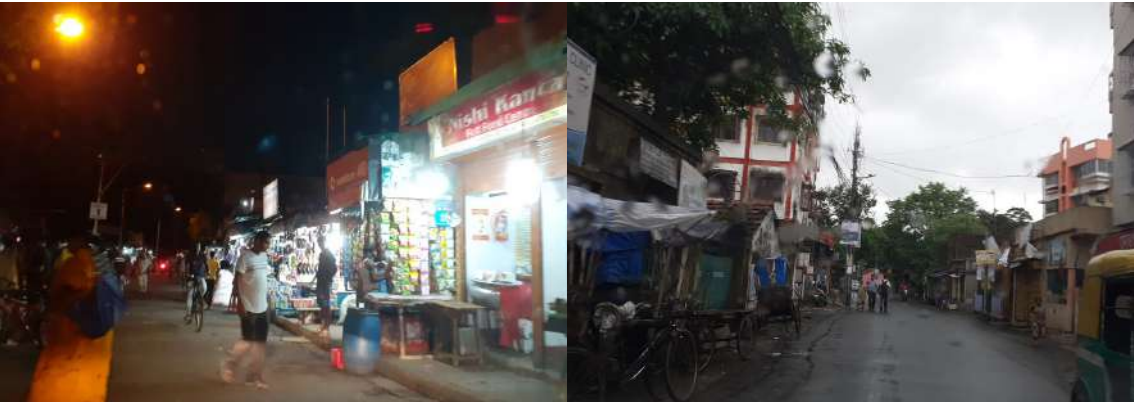
Safetipin identified five type of physical barriers disrupting clear path of access for all pedestrians, especially the vulnerable users. These are namely parked vehicles, house extensions and temporary shops, electricity and advert poles, utility boxes and lastly dumped garbage. We mapped all of the above when found on footpaths during the image mapping and geo-tagged the information with their exact locations on GIS layers. The composite map below represents all the kinds of barriers found on footpaths and highlights the intensity of the issue. Separate maps for each type of barrier identified are discussed as follows.

GEO-LOCATED IMAGES  
*Left to right*  
The geo-tagged photos show barriers on footpaths

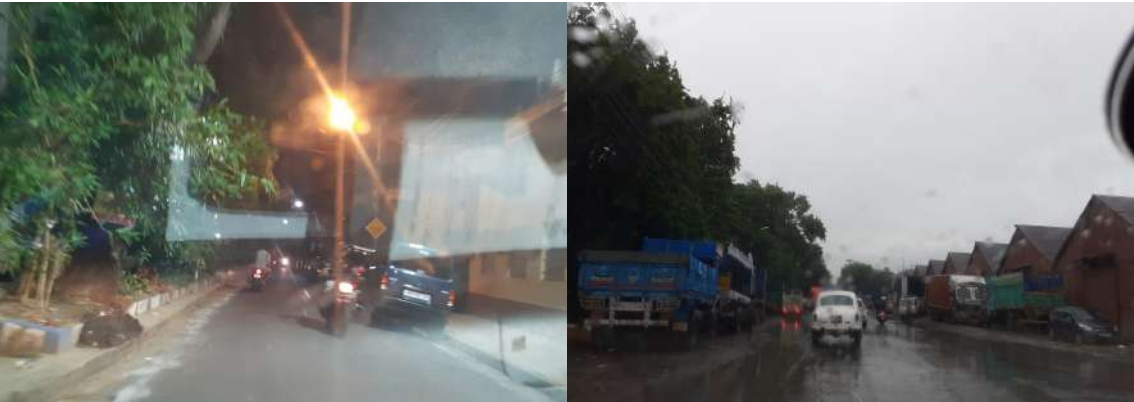
Safetipin identified 'parked vehicle on footpaths' as a type of physical barrier disrupting clear path of access for all pedestrians. We mapped all two and four wheeler vehicles found parked on footpaths during the image mapping and geo-tagged the information with their exact locations on a GIS layer. The map below illustrates the intensity of the issue of having vehicles parked on footpaths. The GIS layer generated could be used for immediate public space intervention to upgrade these areas. The layer is provided as a CSV file and needs to be integrated with the city's existing GIS platform.

GEO-LOCATED IMAGES  
*Left to right*  
The geo-tagged photos show vehicles parked on footpaths.

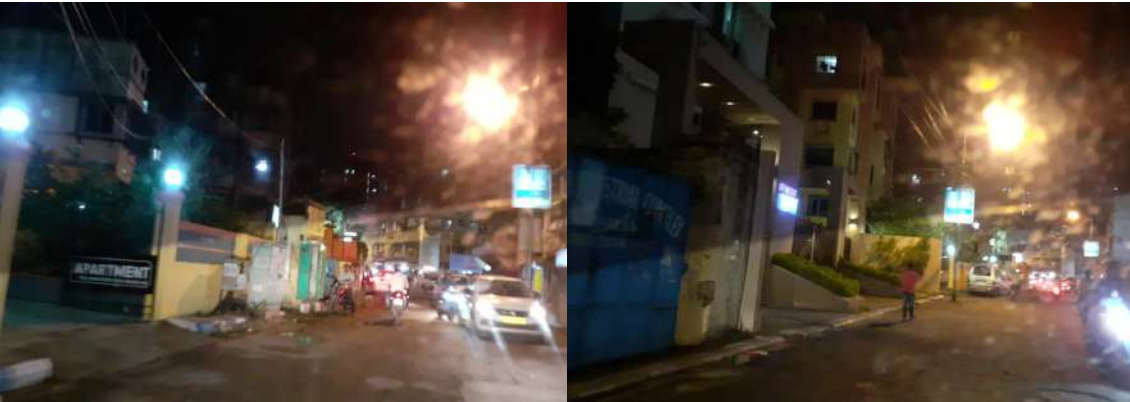
Safetipin identified 'house extensions, temporary shops, vendors on footpaths' as a type of physical barrier disrupting clear path of access for all pedestrians. We mapped all kinds of extensions and temporary establishments found on footpaths during the image mapping and geo-tagged the information with their exact locations on a GIS layer. The map below illustrates the intensity of the issue of having temporary structures onto footpaths. The GIS layer generated could be used for immediate public space intervention to upgrade these areas. The layer is provided as a CSV file and needs to be integrated with the city's existing GIS platform.

GEO-LOCATED IMAGES  
*Left to right*  
The geo-tagged photos show temporary structures on footpaths.

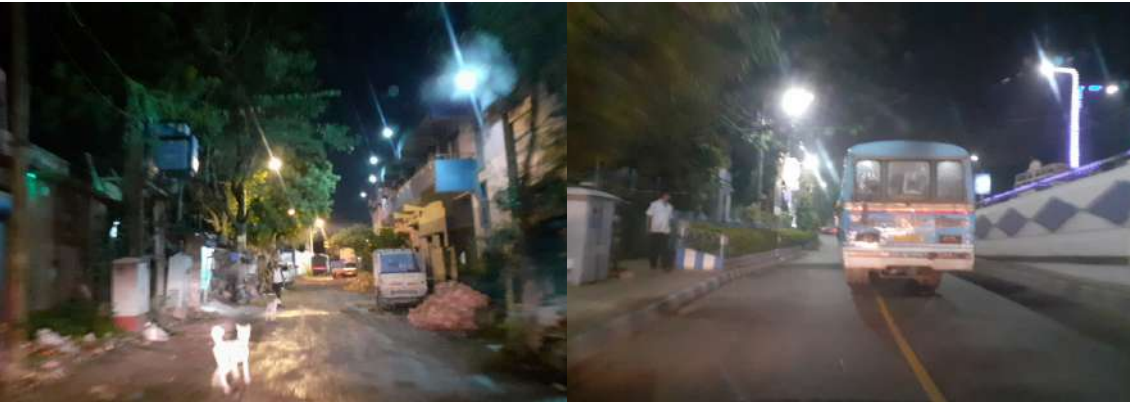
Safetipin identified 'utility boxes for communication and electricity on footpaths' as a type of physical barrier disrupting clear path of access for all pedestrians. We mapped both the kinds of utility boxes found placed incorrectly on footpaths during the image mapping and geo-tagged the information with their exact locations on a GIS layer. The map below illustrates the intensity of the issue of having these boxes wrongly placed on footpaths. The GIS layer generated could be used for immediate public space intervention to upgrade these areas. The layer is provided as a CSV file and needs to be integrated with the city's existing GIS platform.

GEO-LOCATED IMAGES  
Left to right  
The geo-tagged photos show utility boxes on footpaths.

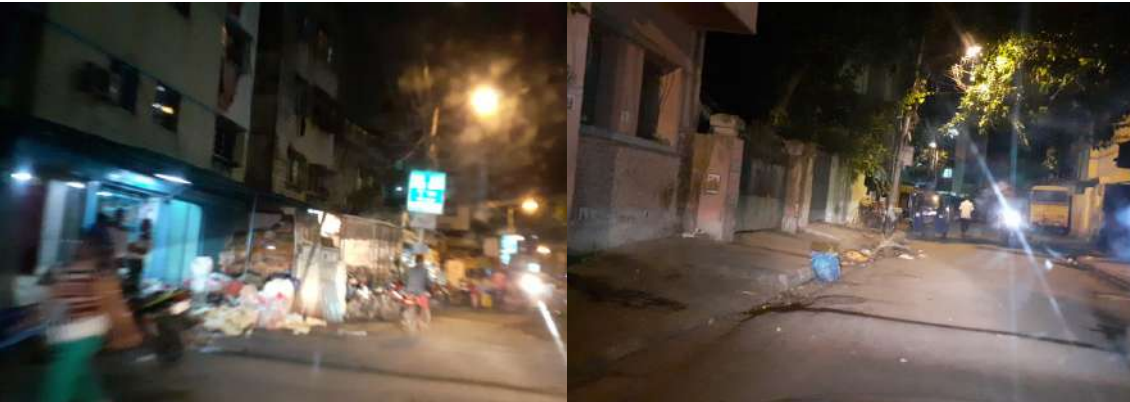
Safetipin identified 'loose garbage dumped on footpaths' as a type of physical barrier disrupting clear path of access for all pedestrians. We mapped all big and small garbage dumps found on or by the footpaths during the image mapping and geo-tagged the information with their exact locations on a GIS layer. The map below illustrates the intensity of the issue of having loose garbage on footpaths. The GIS layer generated could be used for immediate public space intervention to upgrade these areas. The layer is provided as a CSV file and needs to be integrated with the city's existing GIS platform.

GEO-LOCATED IMAGES  
Left to right  
The geo-tagged photos show garbage dumps on footpaths.

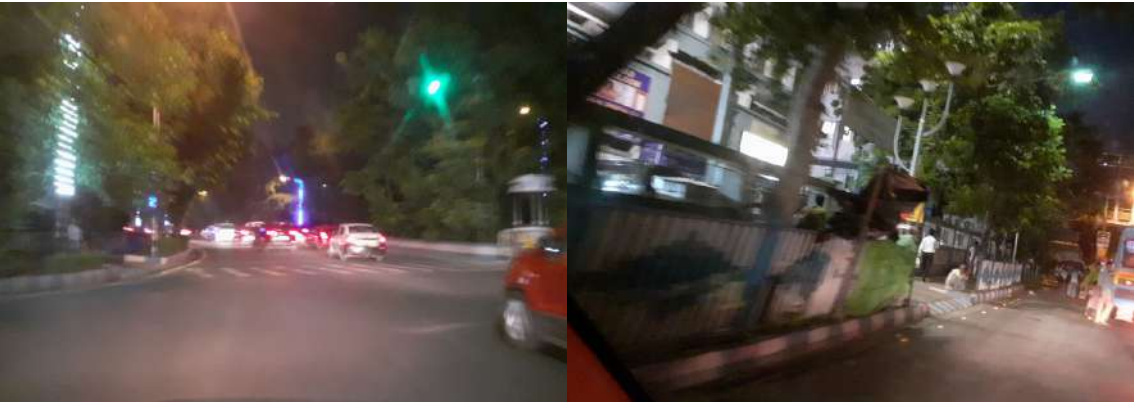
Safetipin identified the presence of 'curb ramps' to be a type of footpath element which assists all pedestrians in having at grade walking experience. We mapped all the locations where curb ramps were present on footpaths during the image mapping and geo-tagged the information with their exact locations on a GIS layer. The map below shows the availability of curb ramps only at 24 locations in the city and illustrates the intensity of the issue of having no or inadequate curb ramps. The said GIS layer is provided as a CSV file and needs to be integrated with the city's existing GIS platform for further analysis.

GEO-LOCATED IMAGES  
Left to right  
The geo-tagged photos show types of curb ramps on footpaths.

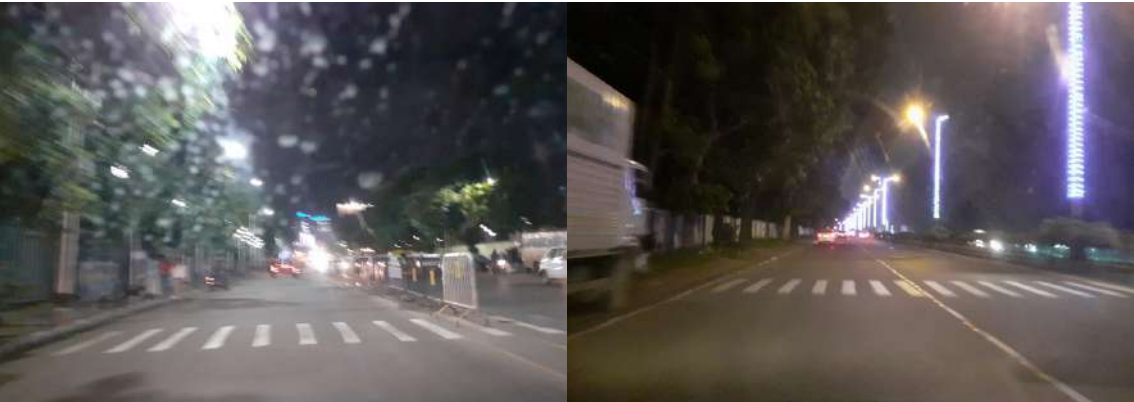
Safetipin identified the presence of 'zebra crossings or pedestrian crossings' to be a type of street element which assists all pedestrians in having at grade walking experience. We mapped all the locations where zebra crossings were present on streets during the image mapping and geo-tagged the information with their exact locations on a GIS layer. The map below shows the availability of zebra crossings only at 87 locations in the city and illustrates the intensity of the issue of having less or inadequate pedestrians crossings. The said GIS layer is provided as a CSV file and needs to be integrated with the city's existing GIS platform for further analysis.

GEO-LOCATED IMAGES  
*Left to right*  
The geo-tagged photos show obstructed zebra crossings on streets.

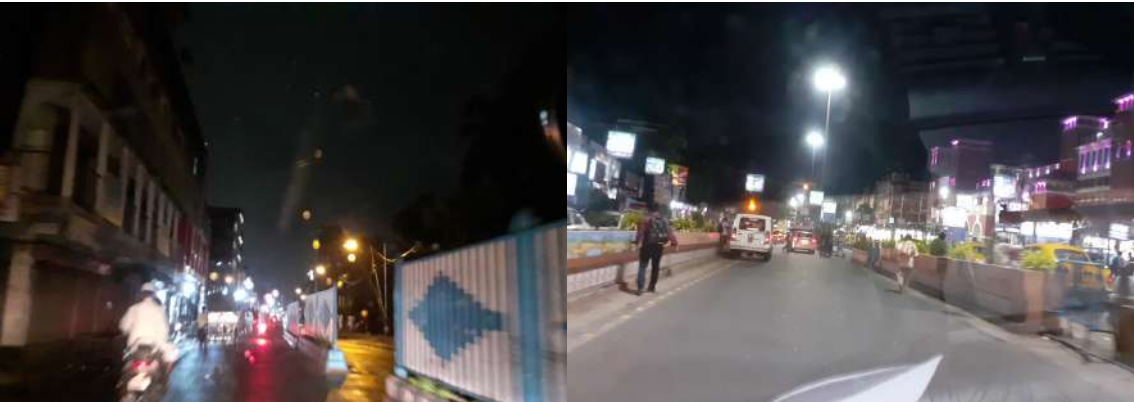
Safetipin identified the presence of 'median cuts or median breaks' to be a type of street element which assists all pedestrians in having at grade walking experience. We mapped all the locations where median cuts on footpaths were present during the image mapping and geo-tagged the information with their exact locations on a GIS layer. The map below shows the availability of curb ramps only at 4 locations in the city and illustrates the intensity of the issue of having no or inadequate median cuts. The said GIS layer is provided as a CSV file and needs to be integrated with the city's existing GIS platform for further analysis.

GEO-LOCATED IMAGES  
*Left to right*  
The geo-tagged photos show types of median cuts on streets.

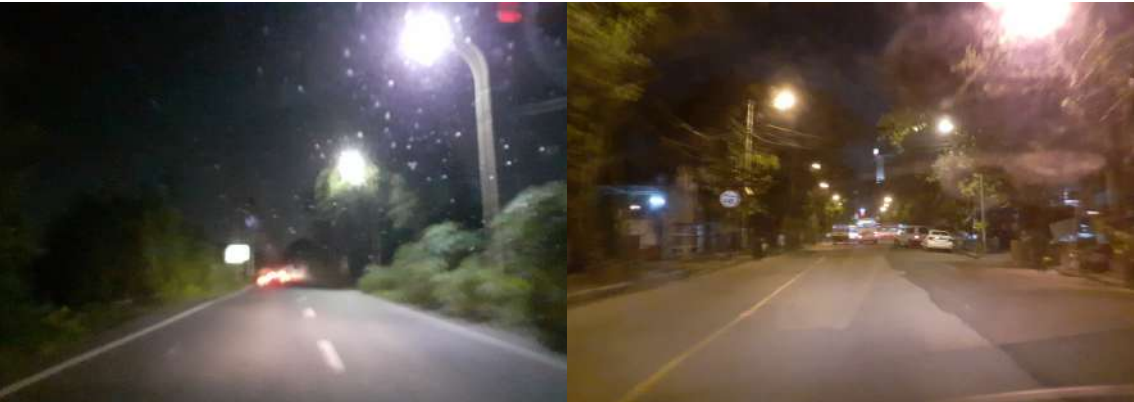
03% of the city has inadequate street lighting and could be fixed immediately to achieve 100% street lighting in Kolkata. Street lighting is crucial for ensuring safe accessibility in public spaces and plays a vital role in people's, particularly vulnerable users' perception of safety in streets and public places after dark. Safetipin's data (geo-located images) can be used to improve street lighting in the city. The map below represents the locations where there are either absolutely no lights, inadequate lights or non-functional street lights. This information can be used for the ease of planning for immediate up-gradation like, adding and fixing street lights.

GEO-LOCATED IMAGES  
Left to right  
The geo-tagged photos show low street lighting.

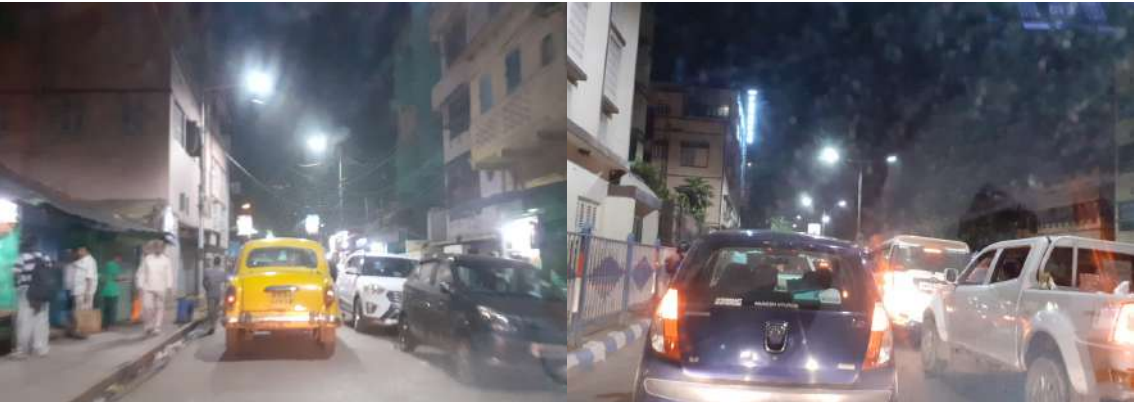
37% of the city has either no or poor footpath condition. Broken, discontinuous and blocked footpaths could be easily fixed to achieve ease of walking in the city which is important for pedestrians, especially vulnerable users to feel safe while accessing the city for various daily activities. Safetipin's data (geo-located images) can be used to improve pedestrian access in the city. The map below represents the locations where there are either no dedicated footpaths, no constructed footpaths or obstructed footpaths. This information can be used for immediate footpath up-gradation like, construction, repairs and removal of all obstructions.

GEO-LOCATED IMAGES  
Left to right  
The geo-tagged photos show very narrow footpath.
