SAFETY AND ACCESSIBILITY ASSESSMENT

COLOMBO, SRI LANKA

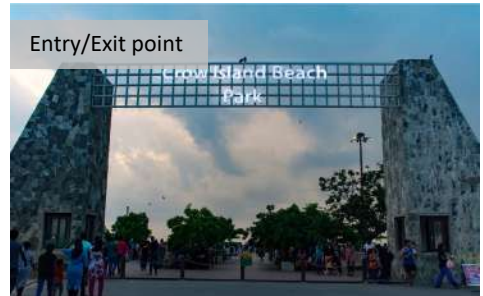
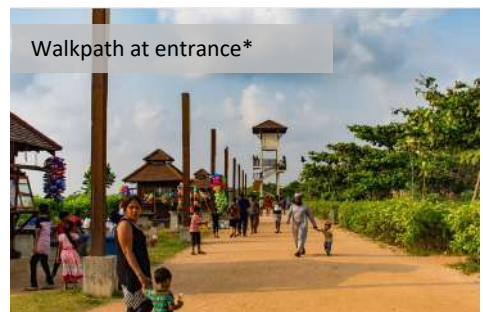
The walkpath near the entrance of the beach is well paved and unobstructed. However, elements of universal accessibility like tactile paving and ramps are not available.

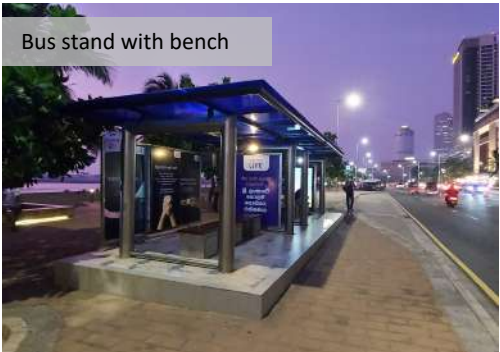
A bus stop and 3-wheeler stands are available within 500m of the Galle Face beach.

Bus stand with bench

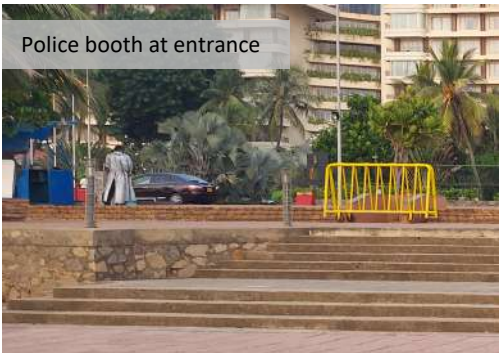
Police officers and police jeeps patrol the entrance, walkpath and waterfront. A police booth, barricades and CCTV cameras are available at regular intervals along the walkpath. However, the cameras face the road instead of the beach.

Police booth at entrance

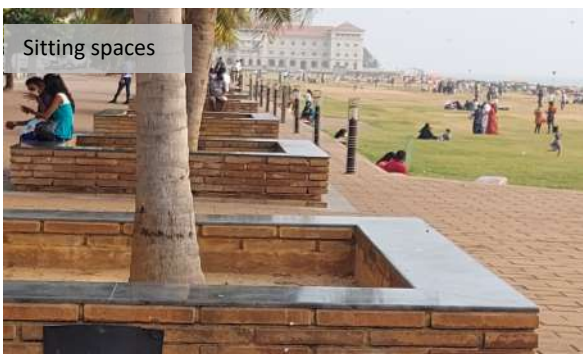
Ample sitting space has been provided. The sitting area is clean and well-maintained. Separate garbage bins are available to dispose waste (for e.g., plastic, paper, food waste, etc.)

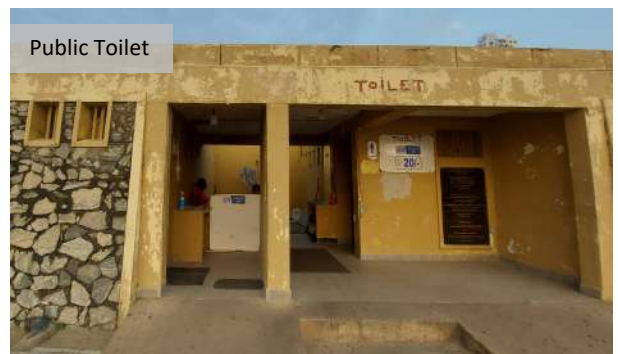
There are two public toilet blocks at the beach. Only one of them is well maintained and can be accessed by a ramp. It is a paid service costing LKR 20 (USD 0.10).

Public toilets were available at only the Crow Island beach and the Galle Face beach. All the other assessed beaches did not have any public toilets. The users use the washroom in the nearby restaurants, but the users must make a purchase from the restaurant to use it. Off the two public toilet blocks at Galle Face beach, only one was well-maintained and in usable condition.

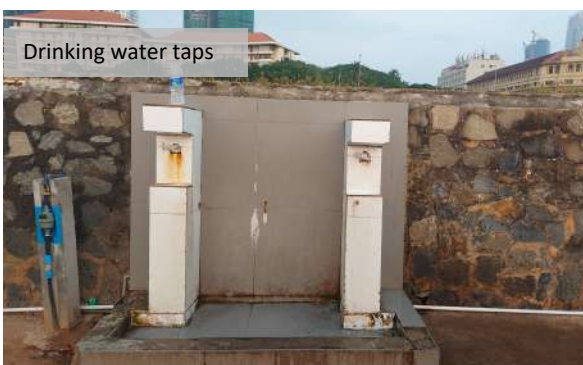
Drinking water taps are available at only one location. The facility is not maintained properly.

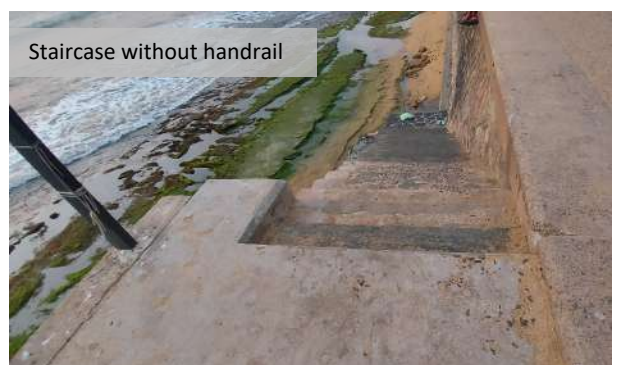
Staircases to reach the waterfront at Galle Face beach waterfront are available. However, handrails have not been provided along the steps.

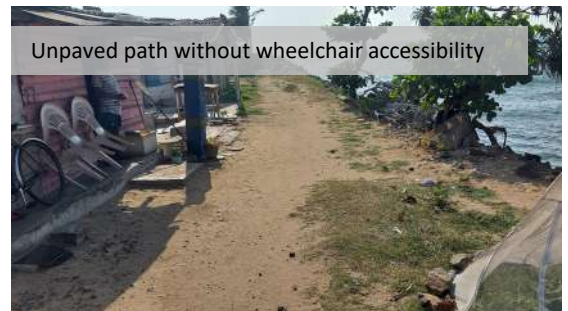
Visitors must cross railway tracks to enter the beach. The path to the beach is unpaved. The path is quite narrow and only one person can walk on it at a time. The walkpath cannot be accessed by a wheelchair user. No tactile paving is provided.

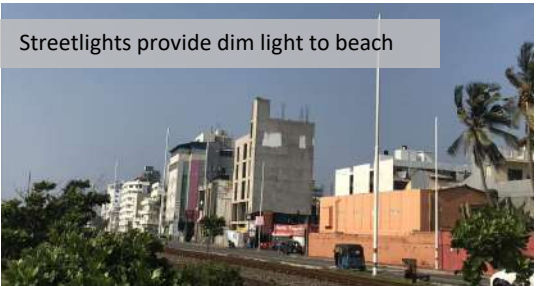
The walkpath at the entrance of the beach is unpaved and broken. Visitors must cross the railway track to reach the beach.

Unpaved pathway

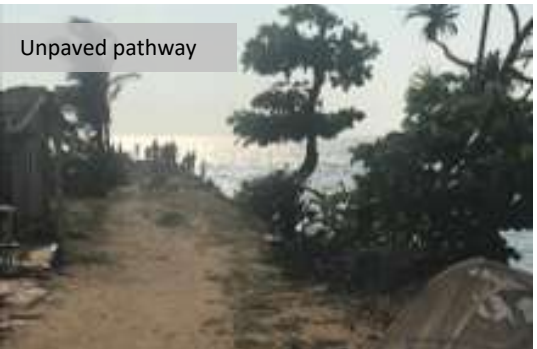
Railway track must be crossed to reach the beach

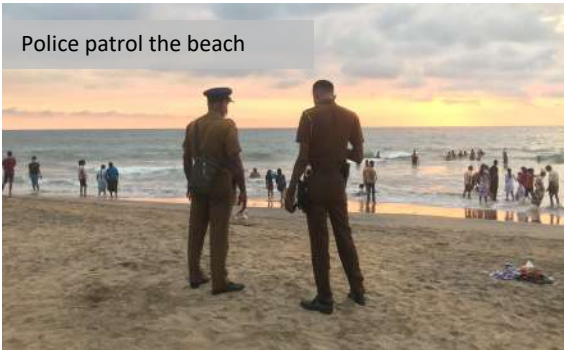
Lifeguards also patrol the beach. They are responsible for protecting visitors from drowning, and from criminal activities such as robberies or harassment. Lifeguards are also responsible for maintaining cleanliness at the beach.

Lifeguards patrolling the beach

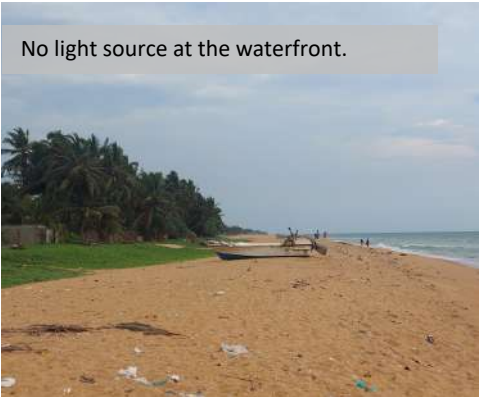
The entrance and walkpath to the beach are poorly lit as very few streetlights are available in this area. The area receives some dim light from the nearby railway station. There are no light sources at the waterfront either, except for a few houses which provide dim light.

No light source at the waterfront.

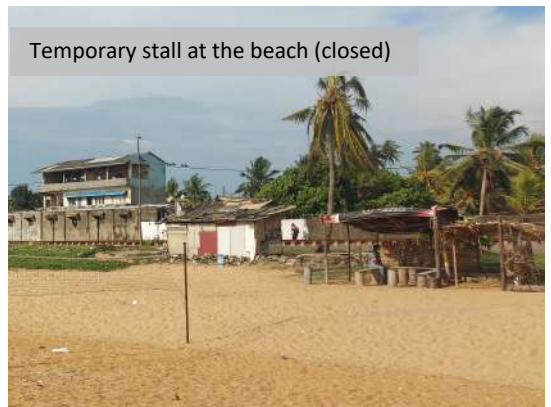
Some small temporary stalls or informal vendors sell betel leaves at the beach occasionally. No large-scale commercial activities are available at the beach.

Temporary stall at the beach (closed)

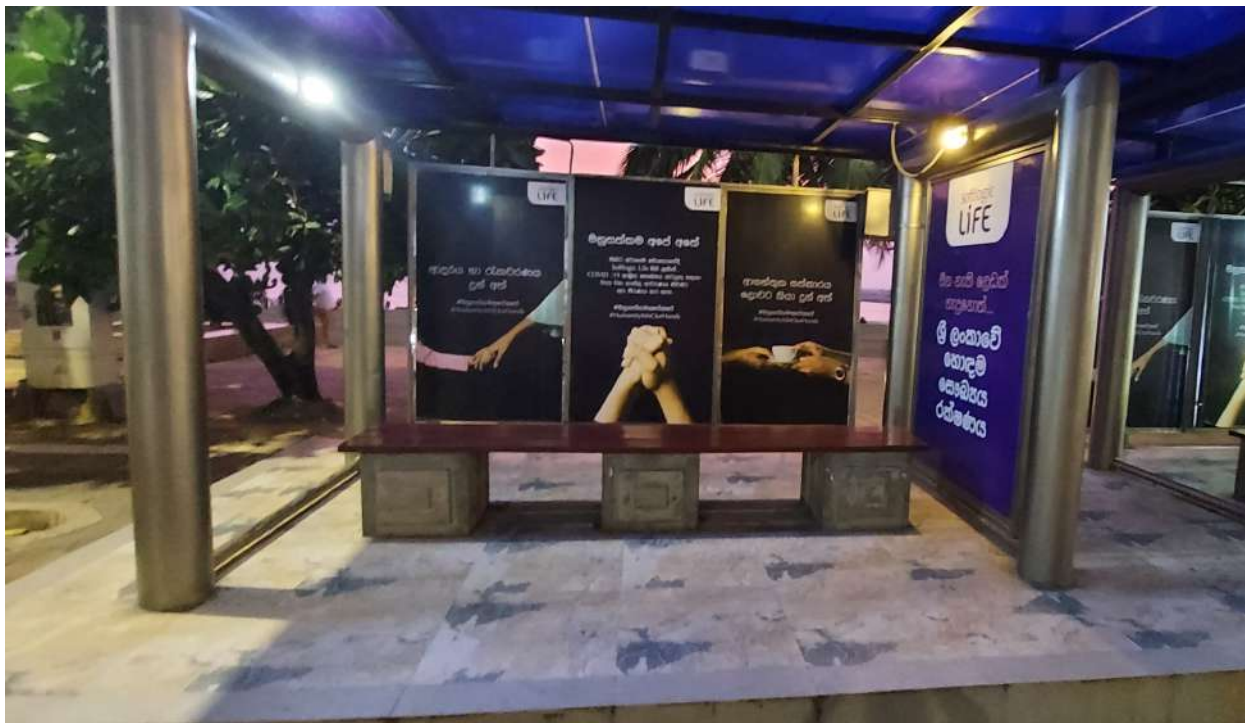
Image showing a well-lit bus stop with shelter and seating space near Galle Face beach.

Availability of adequate lighting at transit stops is an important factor shaping the user’s perception of safety. This is of even higher importance for girls and women who are often more concerned about their safety and image. Common amenities such as shelter should be provided for protection against adverse weather conditions. Seating space should also be provided for the passengers waiting at the stop.

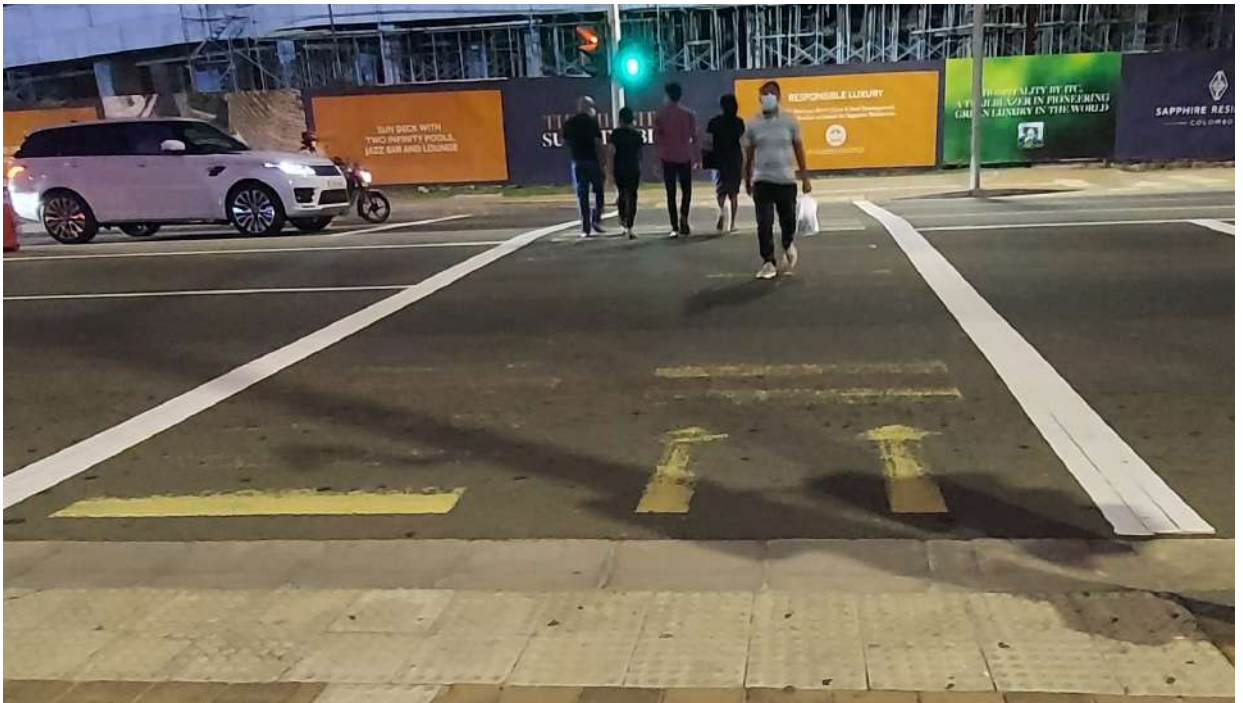
Image showing a pedestrian crossing with pedestrian signal, road marking and tactile pavers near the Galle Face beach bus stop.

Clear markings, signage and/ or traffic calming measures to warn motorists of the crossings and to slow down vehicles should be provided near transit stops. In case of high pedestrian volumes and high speed, pedestrian crossings should be equipped with traffic control signal. Pedestrian traffic lights should be provided with clearly audible signals for the benefit of pedestrians with visual impairments.

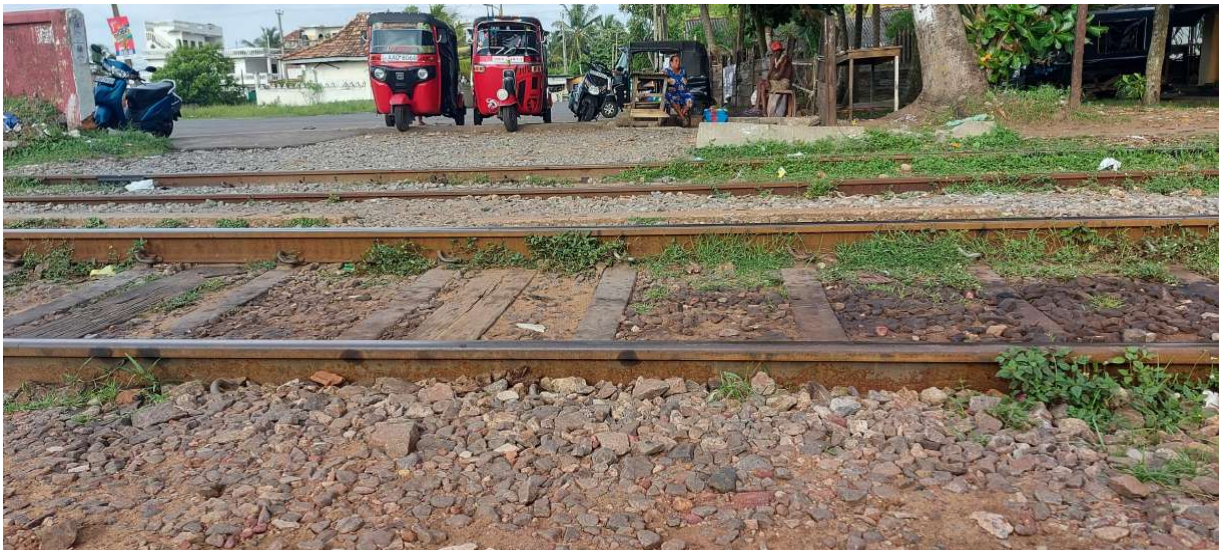
Image showing the existing entrance to the Rathmalana beach through railway tracks

The beach should have a well-defined entrance/exit. The entry and exit to the beach should be through a well-paved and unobstructed path. The path should be safe for pedestrians and should include universally accessible elements such as tactile pavers, ramps and signage. In case the only possible entrance to the beach is through a railway track, signal-controlled table-top crossing could be provided. The path should be wide enough to allow a person to cross alongside a wheelchair user.

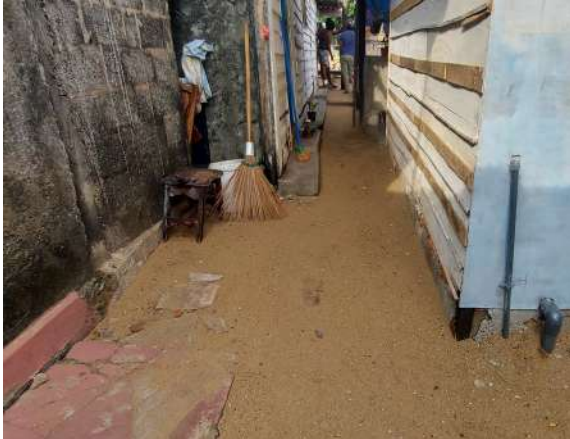
Image showing an unpaved narrow walkpath near the Rathmalana beach.

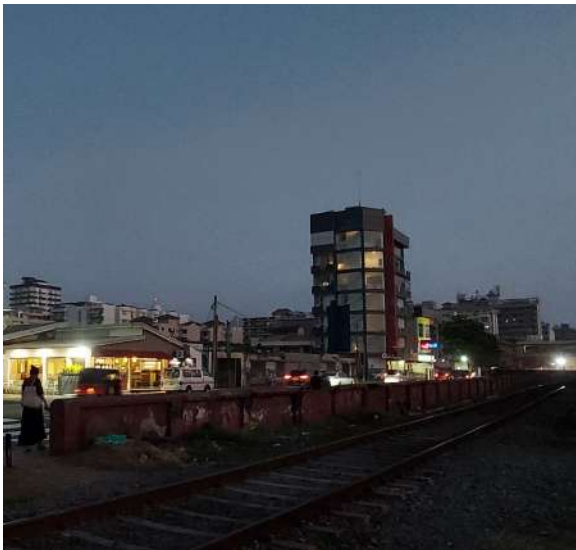
Image showing poor lighting near the entrance to the Wellawatte beach.

The entrance and exit area of the beach should be well-lit at all times of the day. Flood lights, streetlights along with illuminating signage should be used for lighting the beach entrance. Restaurants and shops located near the beach may also provide some additional light to the beach. Well-lit entrances create a sense of security and thus likely to attract more visitors. Regular maintenance checks should be carried out to ensure sufficient illumination near the beach entrance and exit area.

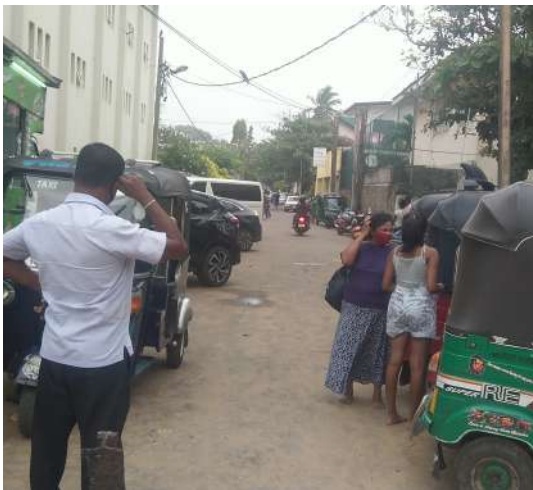
Image showing an informal 3-wheeler stand near Mount Lavinia beach.

Well-lit parking area for private vehicles as well as para transit (3-wheelers) should be provided near the beach entrance. This could lead to an increase in the number of visitors particularly on weekends and holidays as people may come with families from far off distances using their personal vehicles. Designated parking for 3-wheelers will be particularly useful for girls, women and other visitors using public transport. The visitors can stay for longer duration and enjoy activities at the beach without fear of walking to the nearest transit stop after dark.

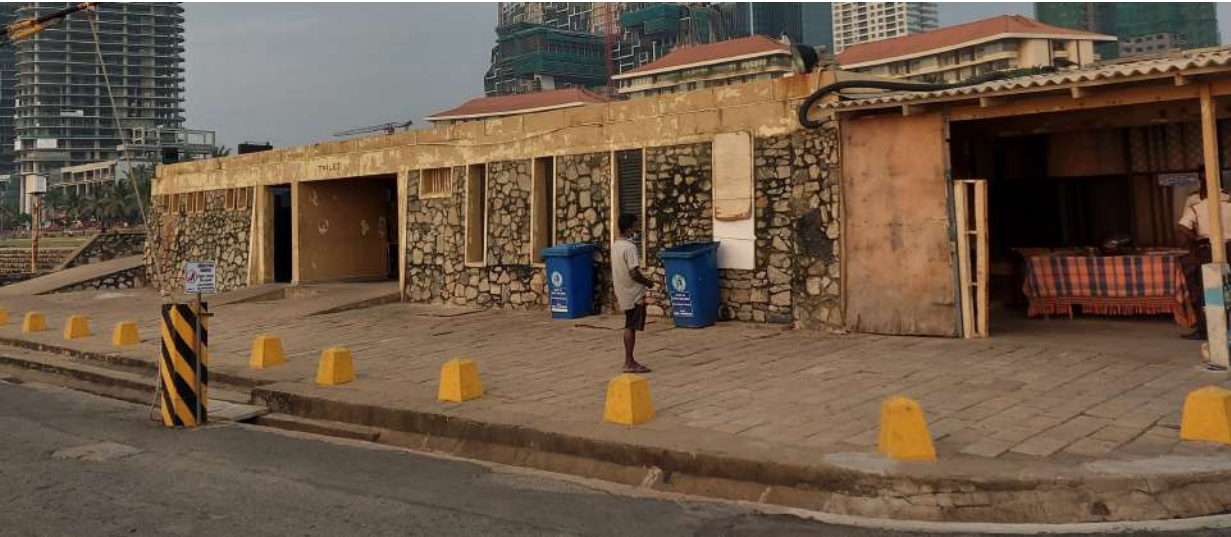
Image showing a public toilet with ramp at Galle Face Beach

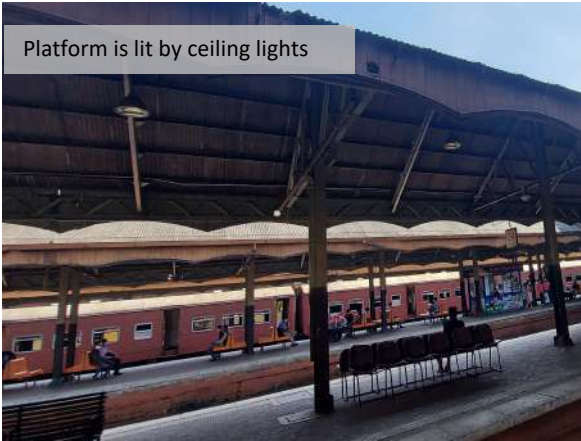
Platform is lit by ceiling lights

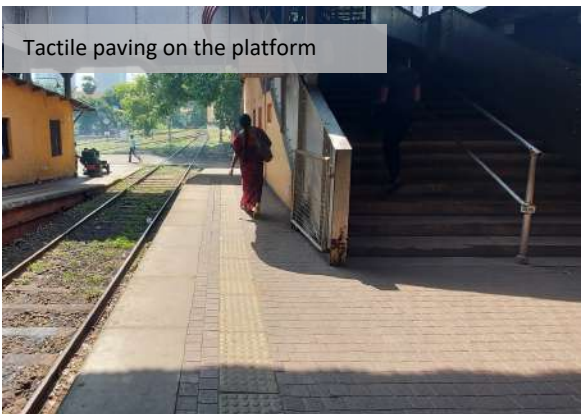
Tactile paving on the platform

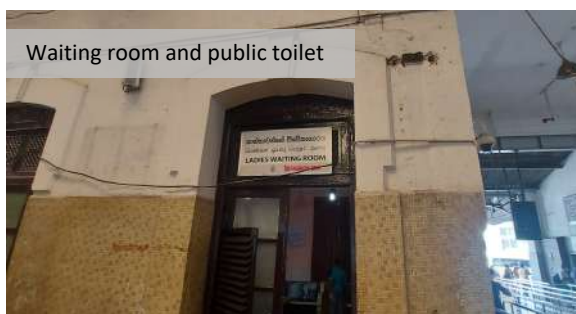
Public washrooms for both men and women are also available. However, due to inadequate door width, these washrooms cannot be used by visitors on wheelchairs. No separate toilet is provided for them either.

Waiting room and public toilet

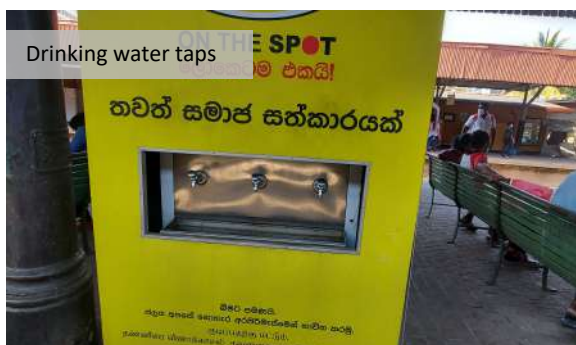
Drinking water taps

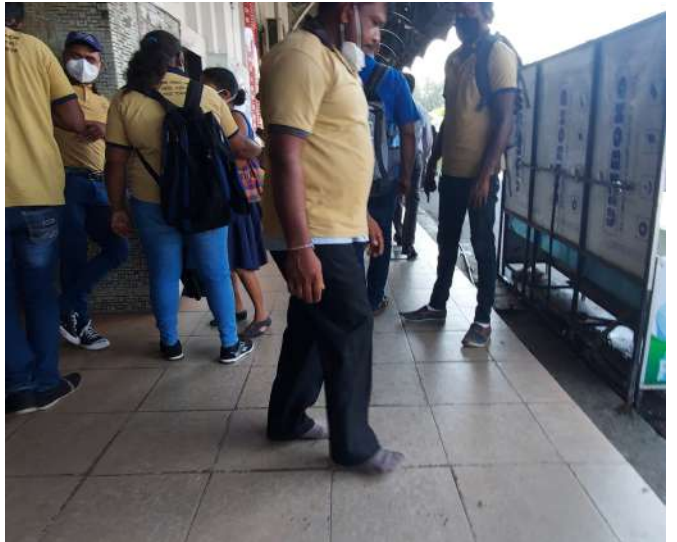
"Someone in a wheelchair cannot access the station through the main entrance as the iron bars are placed too close to each other. They must enter from another entrance. Thus, while the ramp is on one side of the station, the wheelchair can only enter from another side."

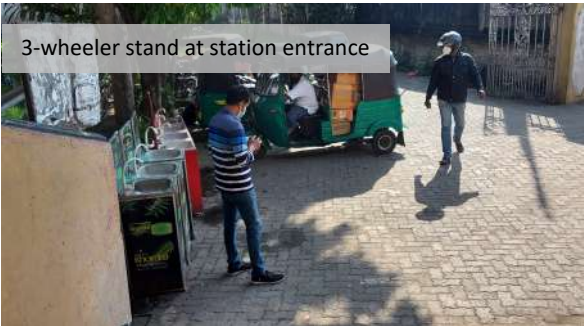
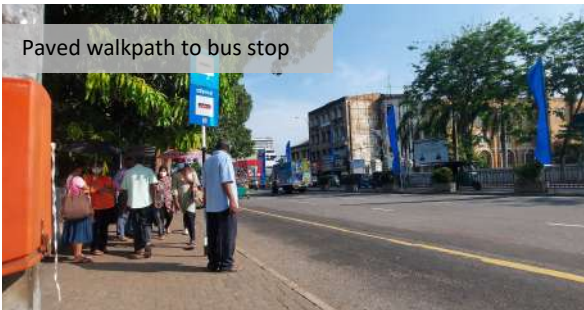
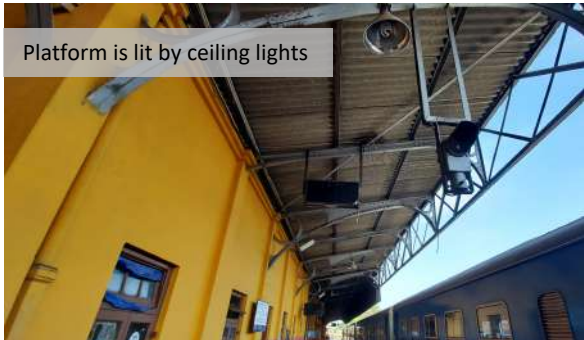
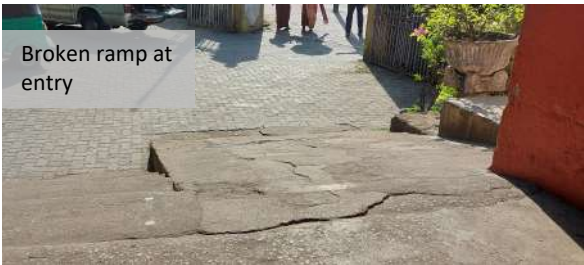
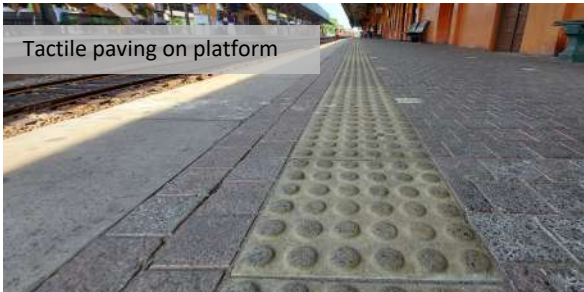
The walkpath at the entrance of the station is paved and free of any obstructions.

Elements for universal access such as ramp and tactile paving are available at the entrance gate and on the platform. However, the ramp at the entrance is broken and poorly maintained.

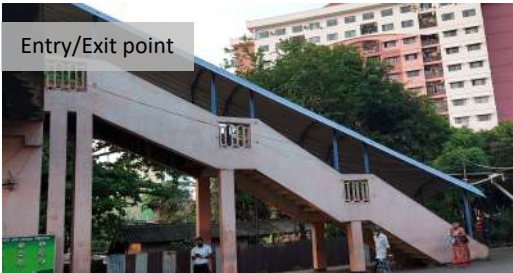
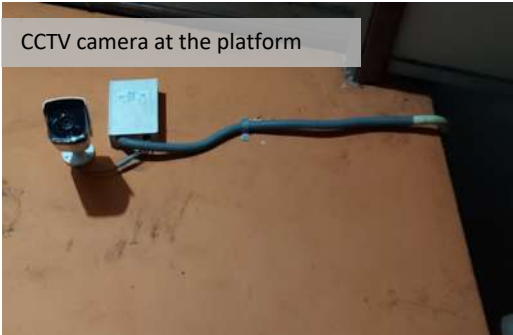
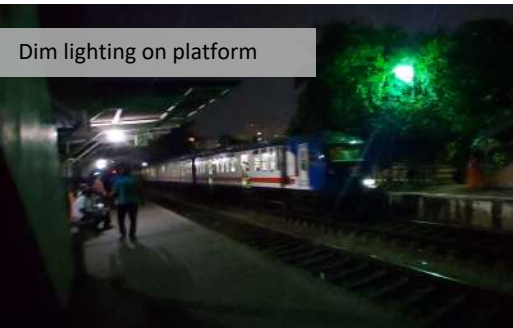
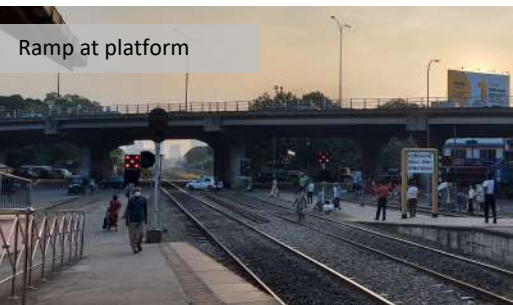
The walkpath at the entrance of the station is paved, however it is broken and obstructed by vehicular parking and garbage.

Elements for universal access such as ramp and tactile paving are available at the entrance gate and on the platform. However, the tactile paving is not continuous.

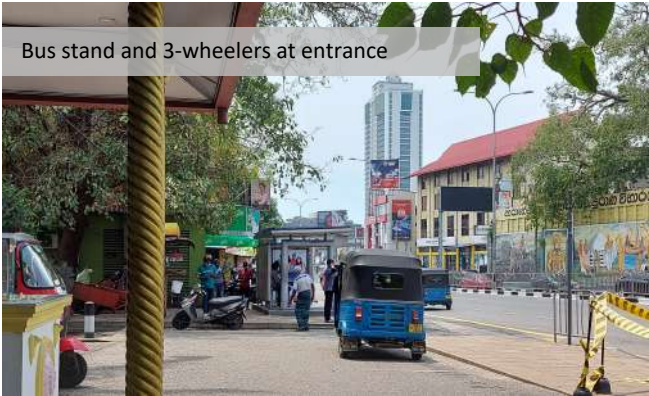
The walkpath at the entrance of the station is broken and obstructed by vehicular parking. No elements for universal access such as ramp and tactile paving have been provided.

Bus stand and 3-wheelers at entrance

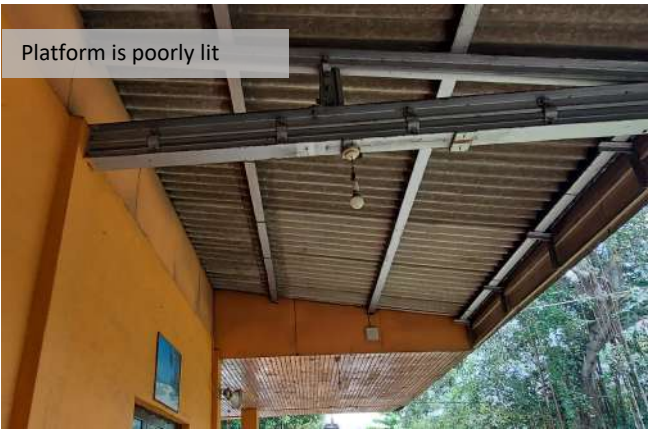
Platform is poorly lit

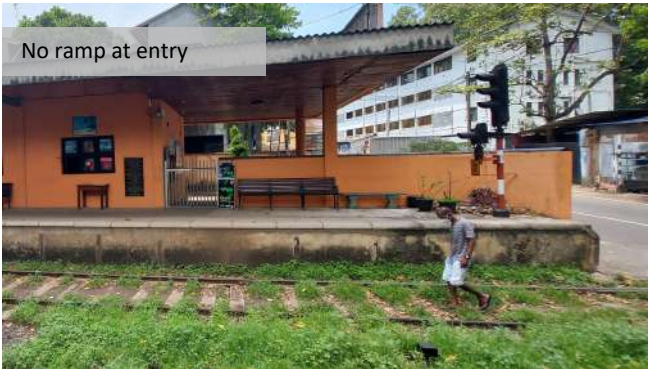
No ramp at entry

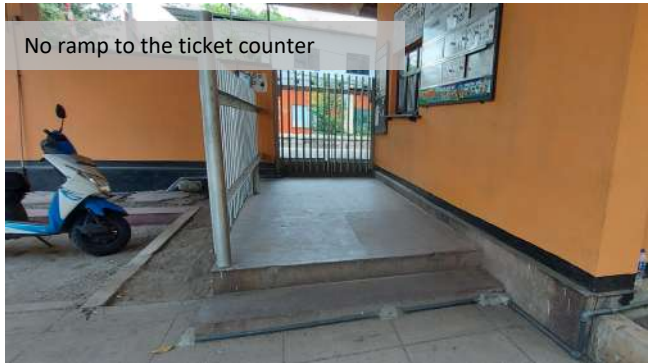
No ramp to the ticket counter

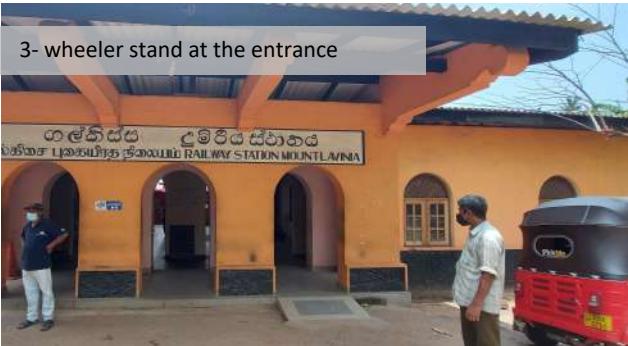
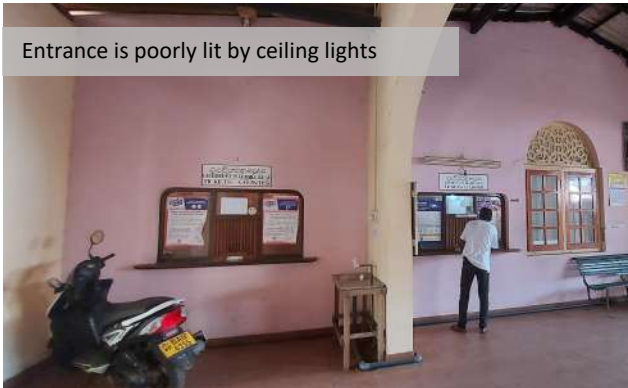
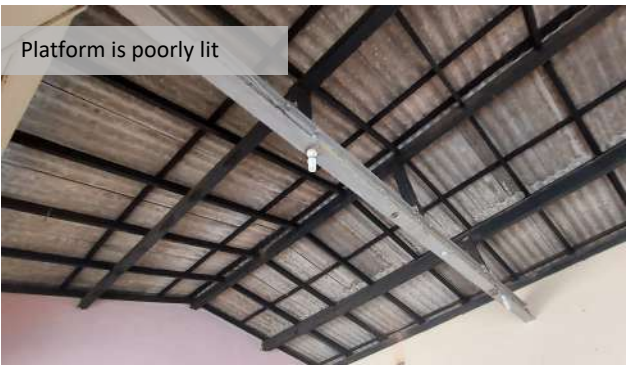
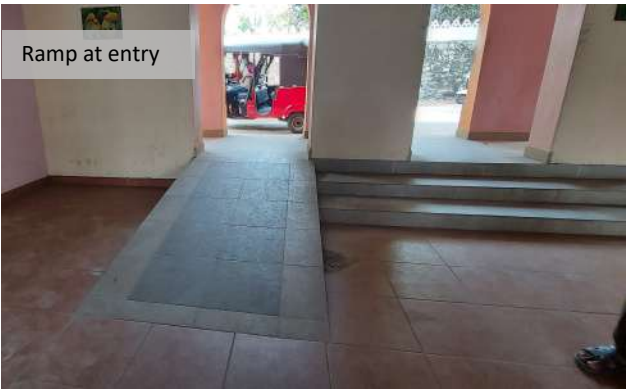
The walkpath at the entrance of the station is paved and free from any obstructions. Elements for universal access such as ramp and tactile paving are provided at the entrance gate and on the platform.

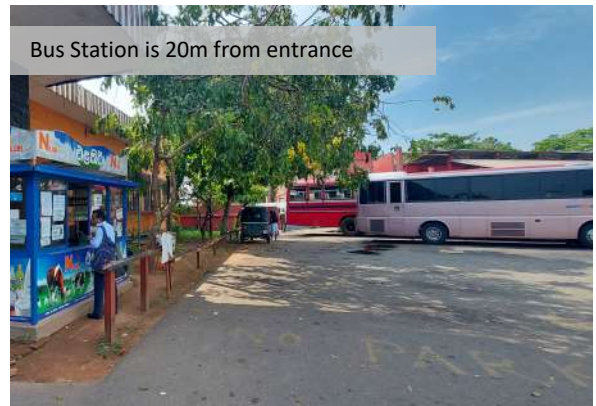
Bus Station is 20m from entrance

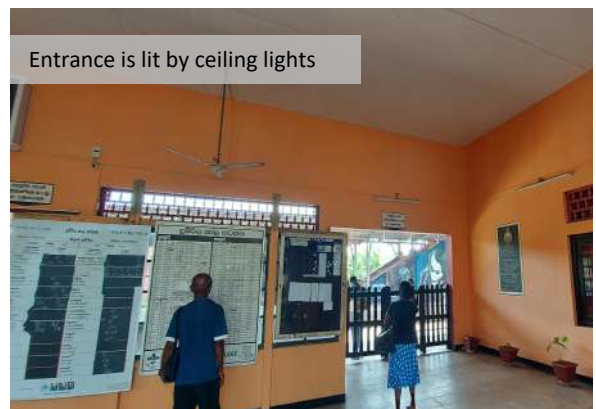
Entrance is lit by ceiling lights

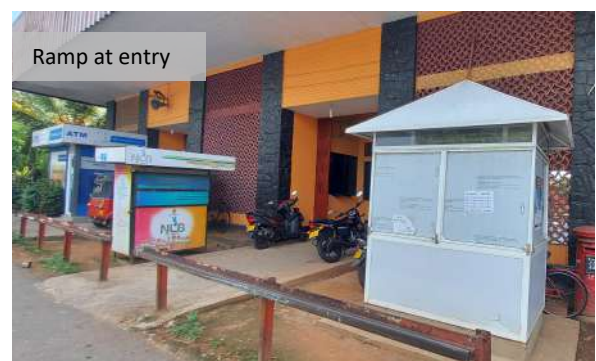
Ramp at entry

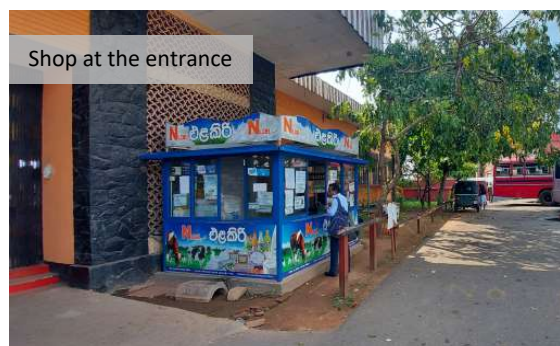
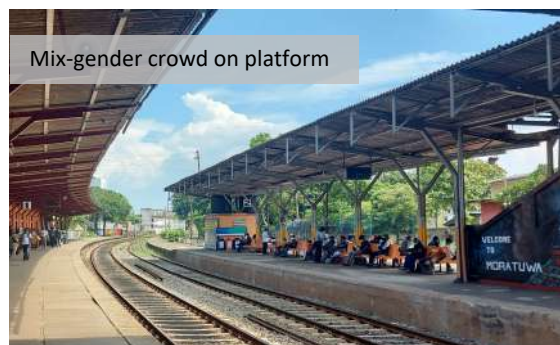
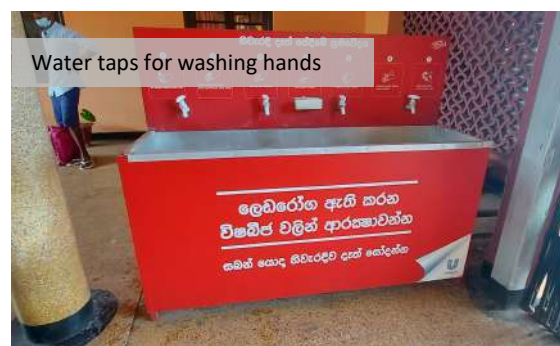
Digital display screen with real-time information about arrival and departure are available on the platforms. Only one was functional at the time.

Waiting area is available for only women and not men. Drinking water taps, benches and dustbins are also provided at the platform. Public washrooms for both men and women are available. A dedicated toilet for differently-abled users is provided.

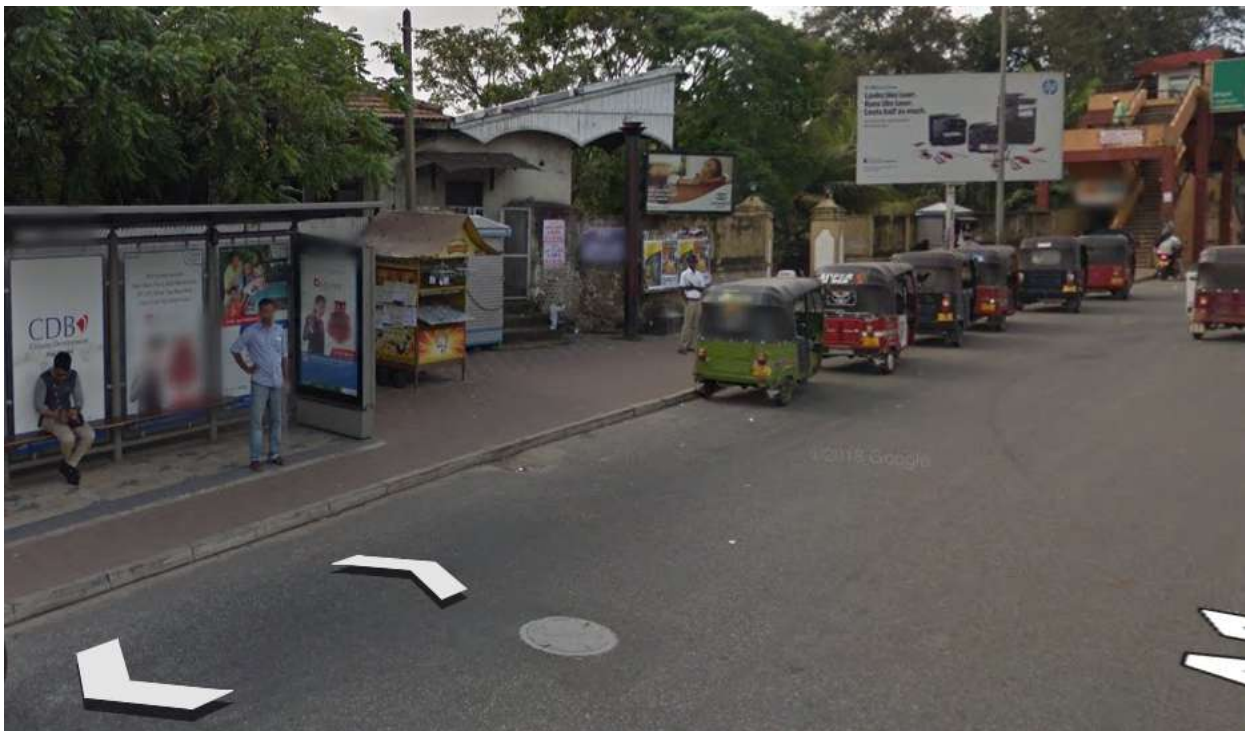
Image showing a bus stop and 3-wheeler stand at the entrance of the Maradana Station (orange overbridge). The bus stop is sheltered and has seating spaces. Source: Google Earth

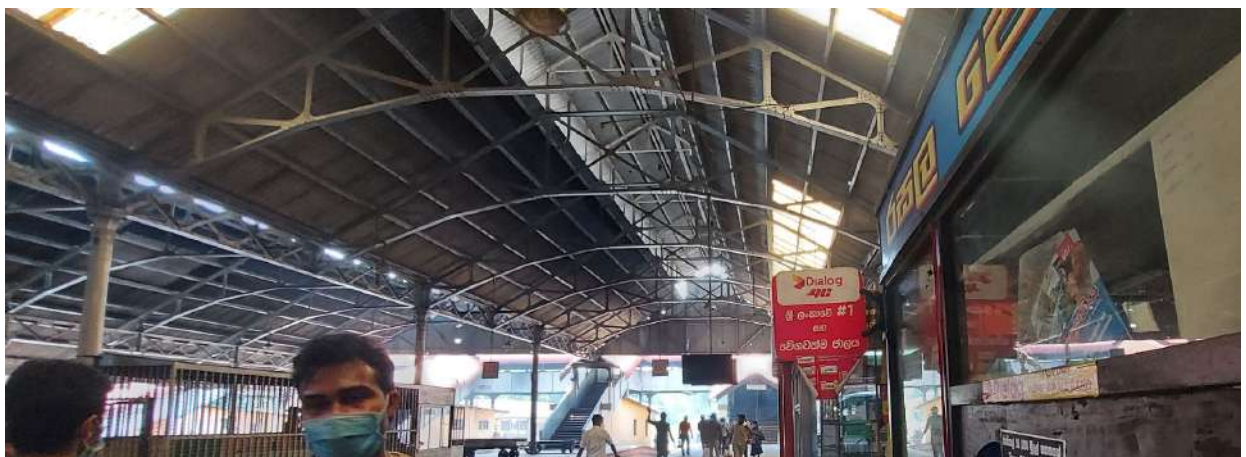
Image showing brightly lit Fort Railway Station.

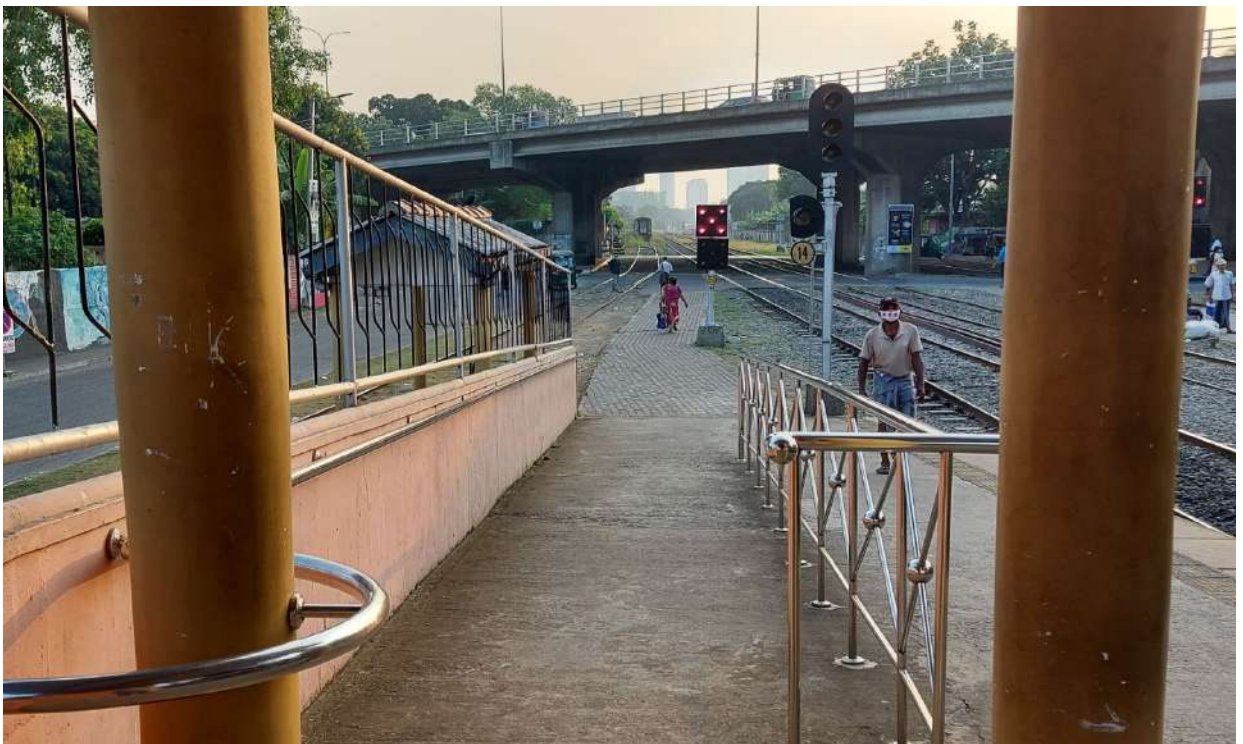
Image showing a ramp at the entrance of the Dematogoda station. There is a continuous railing along it. Tactile paving is available along the platform.

The station entry/exit should be well paved and free from any obstructions. All entry and exit points of the station must be provided with universal accessibility elements such as ramps, handrails and tactile paving to ensure safe mobility for all users, In case a ramp is not available at one entrance, and a detour is required, alternative routes must be clearly identified through signage at the most appropriate decision point to allow timely route selection.

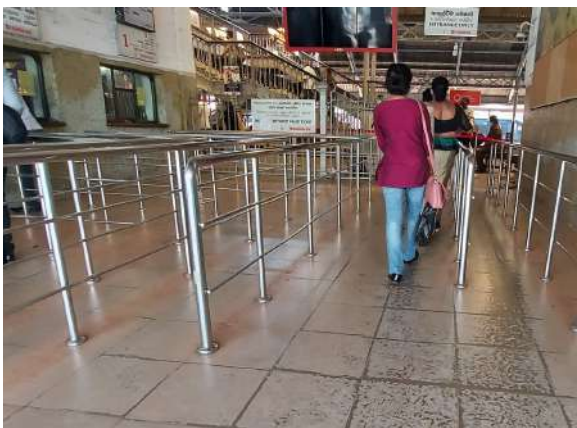
Image showing narrow passage at the ticket counter of Fort railway station. A person on wheelchair cannot use this passage.

The station environment should be designed to be clutter free, such that users can walk in straight lines with long sightlines. Corridors and paths should be wide and unobstructed to accommodate passengers with mobility impairments. Lifts and escalators should be provided for the ease of movement of differently abled persons or those traveling with luggage or dependents. Handrails must be provided along the staircases for safety of the users especially small children, elderly and differently abled persons.

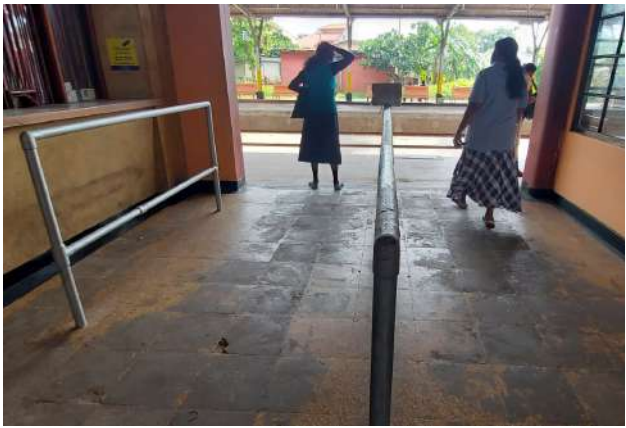
Image showing wide passage at the ticket counter of Moratuwa railway station which can be used by a person on wheelchair.

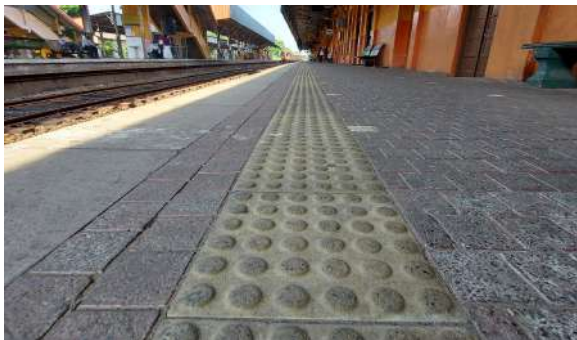
Image showing tactile paving on the platform at Moratuwa station

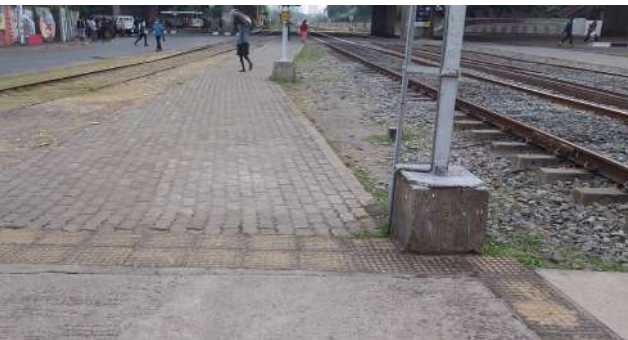
Image showing discontinuous tactile paving on the platform at Dematogoda station

Tactile paving should be provided across the length of the platform to warn and guide visually impaired users. The paving must be continuous across the station and extend till the near by parking and transit stops as well.

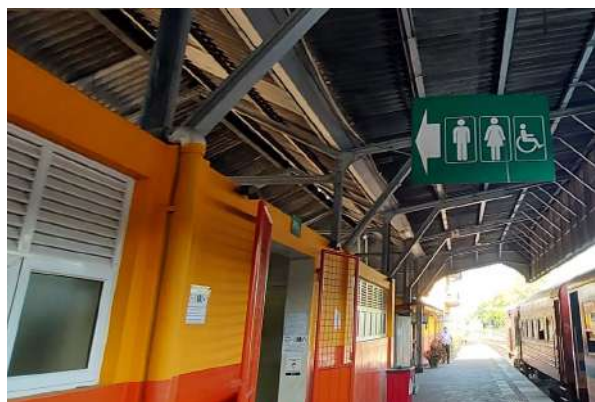
Image showing signage for toilets on the platform At Moratuwa Station.

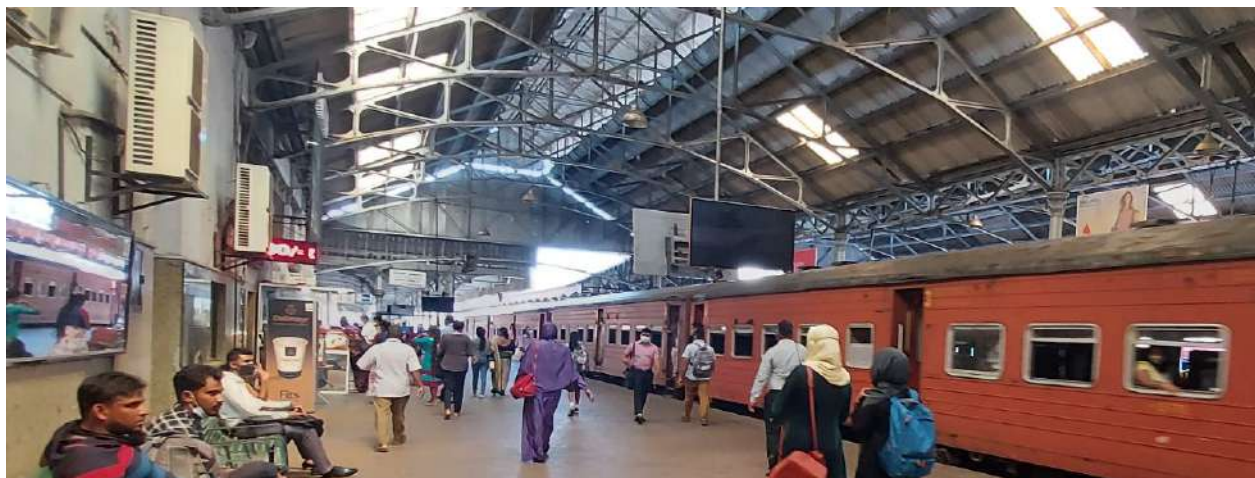
Image showing non-functional digital screens for real time information on the platform at Fort Station.

Digital screens providing real-time information about the train schedule should be provided at the platforms. In Colombo, digital screens have been provided in all large stations, however they were found to be non-functional at the time of the assessment. Information provided on the sign boards was difficult to read. Additionally, audio announcement facilities must also be provided in all relevant languages to cater to local, tourists and people with visual impairments.

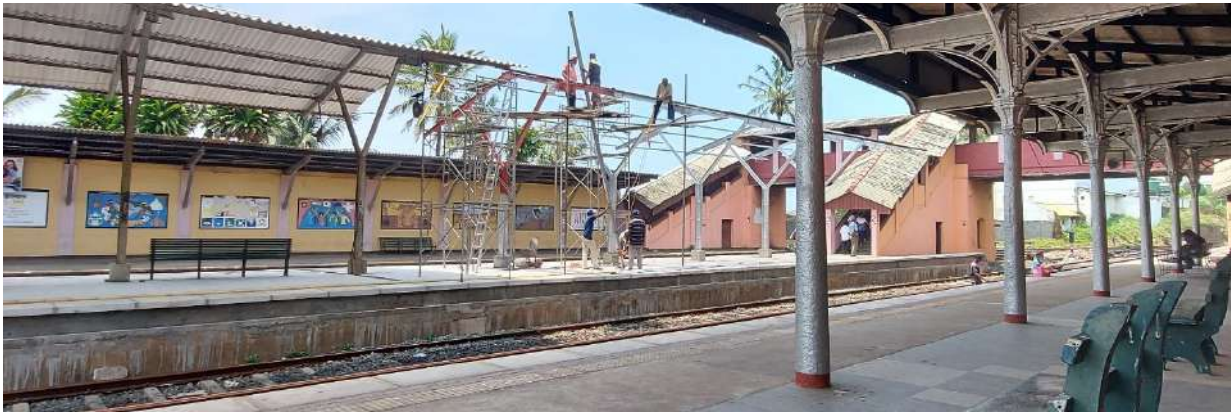
Image showing a broken shelter (roof) at Mount Lavinia Railway Station.

The comfort and experience of a visitor at a railway station is closely related to the type and condition of available amenities at the station. The most common and basic amenities at a station include shelter and sitting spaces. Waiting rooms must be provided for the ease of the passengers. This is particularly important for the elderly who tend to get tired early as well as users who may be travelling with heavy baggage.

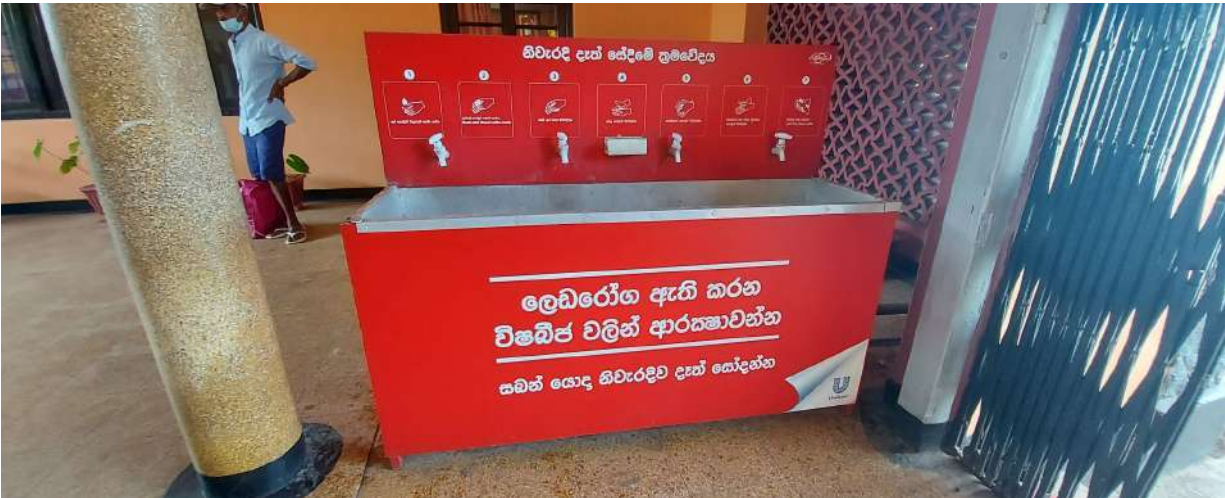
Image showing well maintained water taps at the Moratuwa Station for washing hands with COVID-19 prevention guidelines.

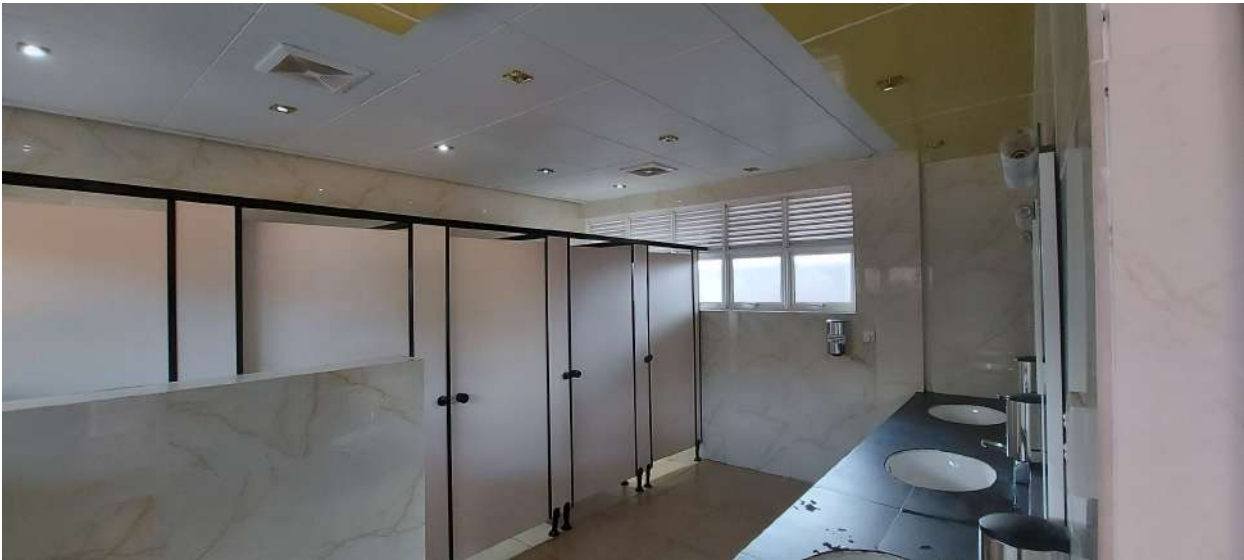
Image showing a well- maintained women’s toilet at Maradana Station.

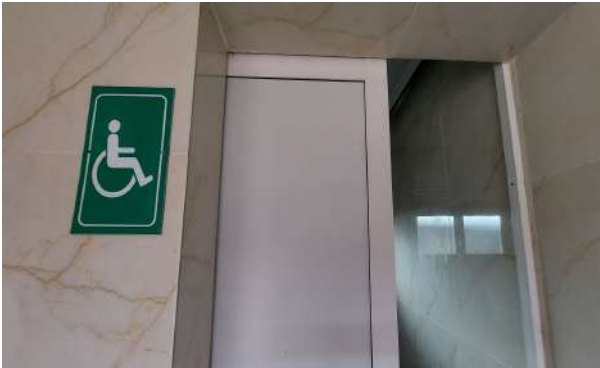
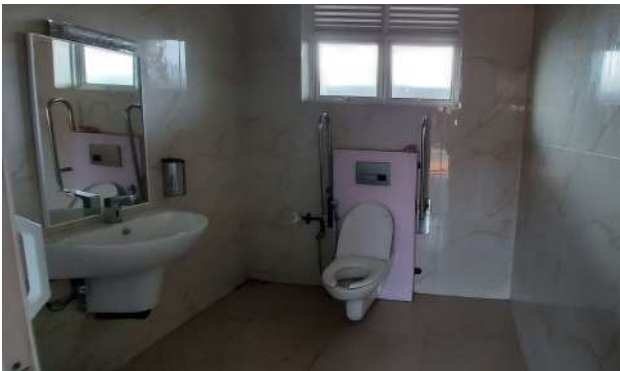
Image showing a toilet for differently-abled users at Maradana Station. Clear and bright signage is provided. The toilet is equipped with handrails, and it is adequately designed to accommodate the needs of a person on a wheelchair.

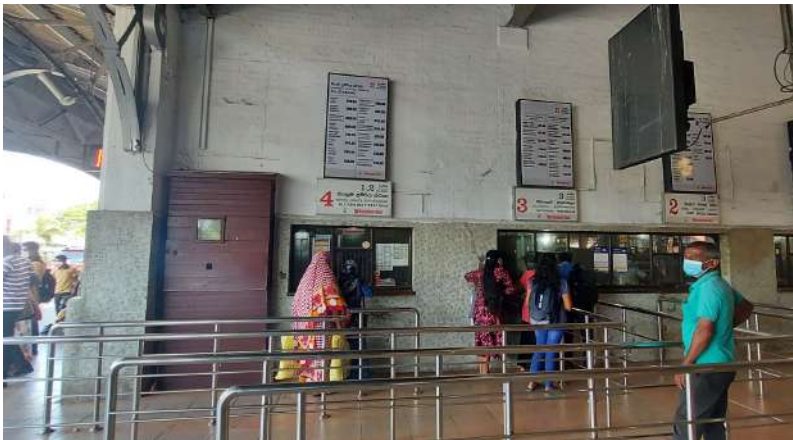
Image showing multiple ticket counters at the Fort station, and they are supported with real-time information. But the handrails are placed too close to each other for a wheelchair to pass through.

There are 24 operating ticket counters at the Fort Railway Station and E-ticketing facilities are also available. This enables users to buy tickets comfortably and safely without chaos. Ticket counters must be designed to quickly and efficiently cater to all users, including those with visual impairments or with mobility impairments.
