SAFETY AND ACCESSIBILITY ASSESSMENT

COLOMBO, SRI LANKA

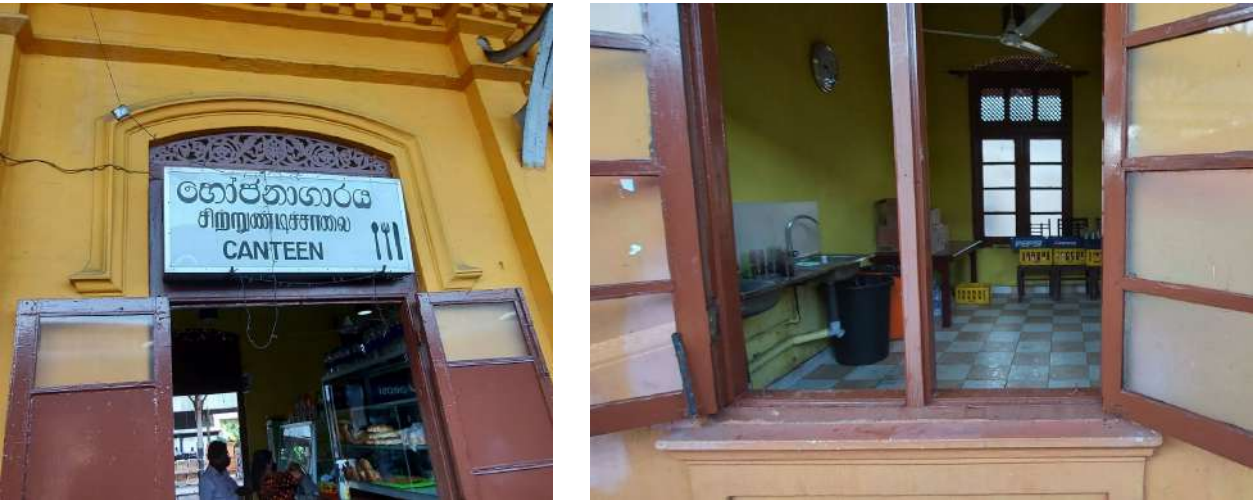
Image showing a functional canteen at the Maradana Station.

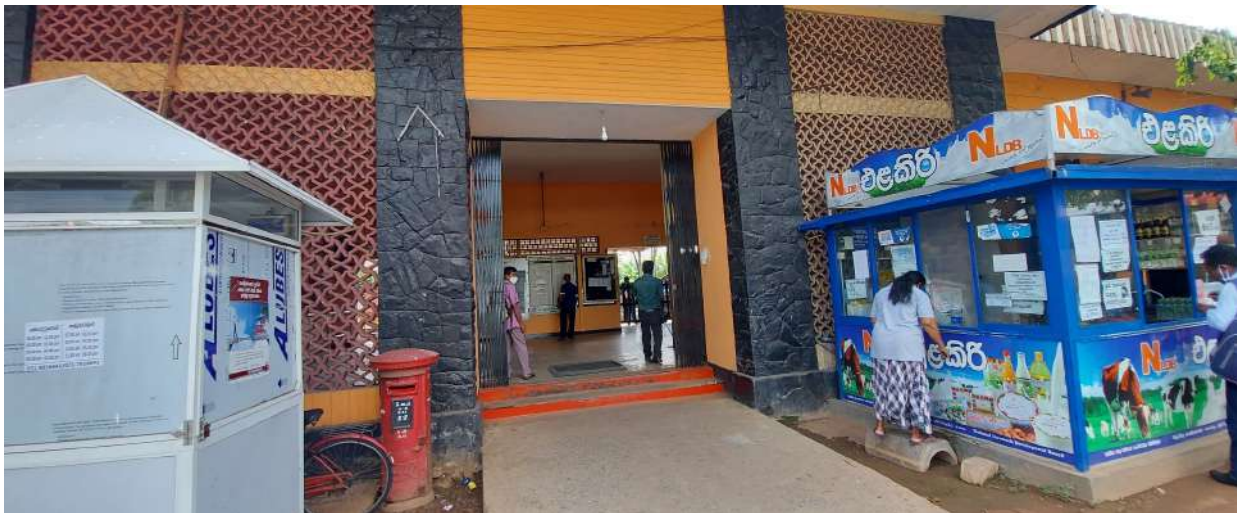
Image showing armed police personnel are available at the entrance to the Moratuwa railway station. Formal vendors also act as natural surveillance and may make users feel safer.

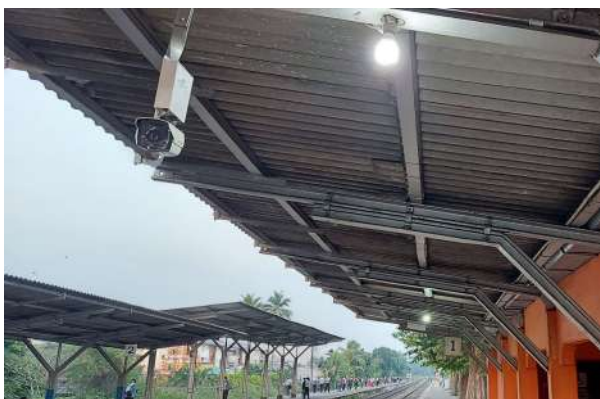
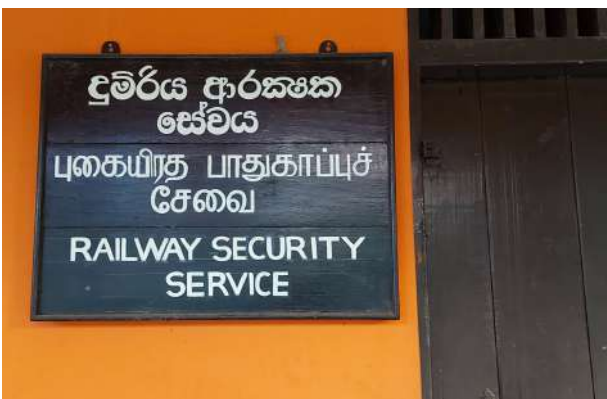
Image showing noticeable placement of CCTV cameras and security services at the Dematogoda station provide the user with a feeling of safety and act as a deterrent to criminal activity.

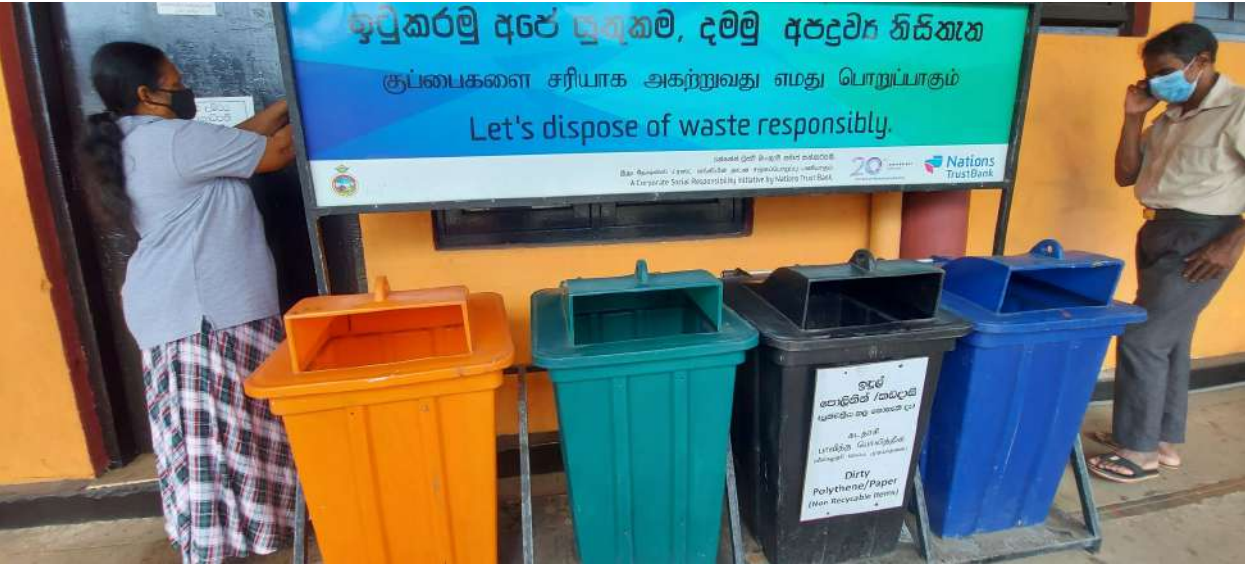
Image showing segregated waste collection at the Moratuwa station with clear and easy to read signage.

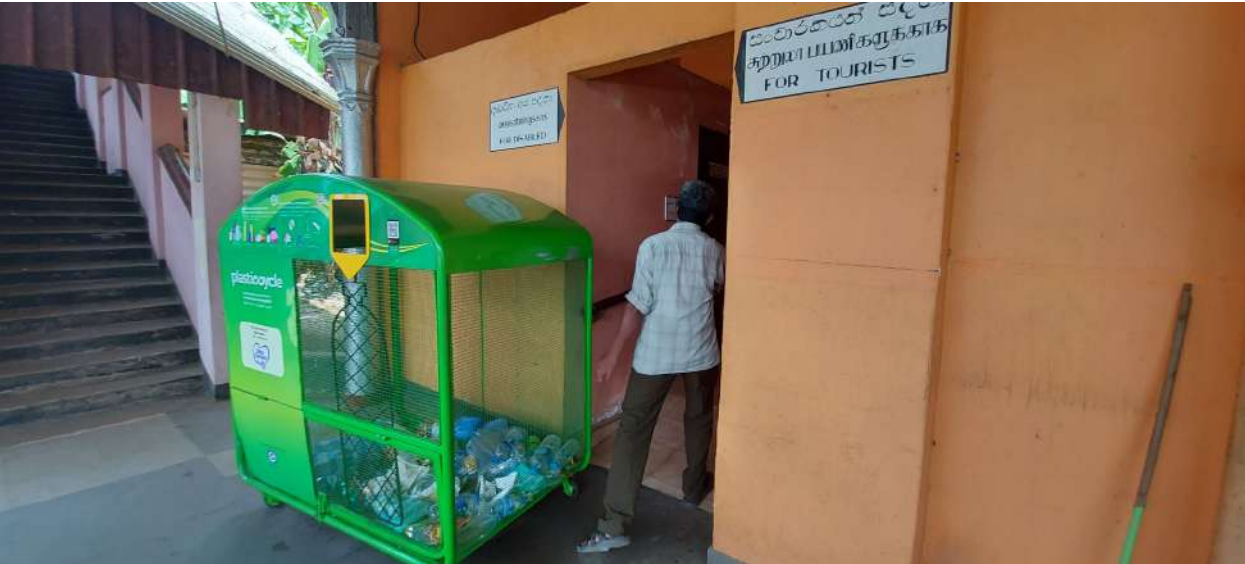
Image showing an innovative waste collection system at the Mount Lavinia station.
