Safety Audits in Alexandra, Johannesburg

Safetipin was engaged by CCI (Centre for Communication Impact) to conduct safety audits in selected communities of the Masiphephe Network Project to understand spatial vulnerabilities that women and girls face in these specified communities and how violence and fear impacts their freedom of access and movement. The aim of the study is to collect data to make public spaces safer and to use technology as an enabling tool for this. For the first phase of this study, the Alexandra township (Region E) of Gauteng province was selected.

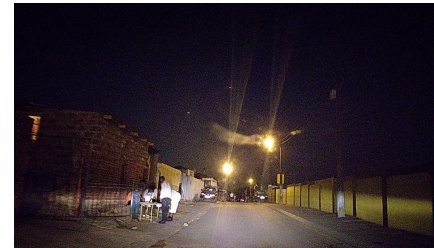
Image 4: Street with high boundary walls

The presence of boundary walls reduces the eyes on the street (example in Image 4). When designing streets with boundary walls, it is suggested to keep the solid height of the boundary wall at a 1 metre height with fencing, wiring or spikes on the top portion. This serves the purpose of an effective boundary wall without hindering the natural surveillance.

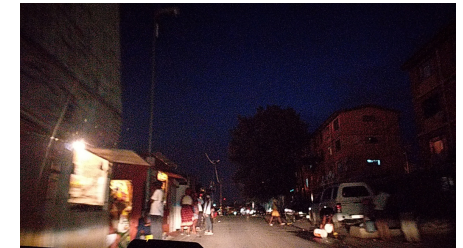
Image 5: People surrounding a vendor

Presence of vendors is likely to encourage more people to use a space thereby increasing the overall activity of the street (Image 5). However, lack of proper vending zones can prove to be a barrier to the walkability of the area (since vendors are generally occupy space on pavements). Places with a high rating for People parameter but low Visibility parameter rating can be prioritized to improve visibility of the area. These can be seen in Map 6.

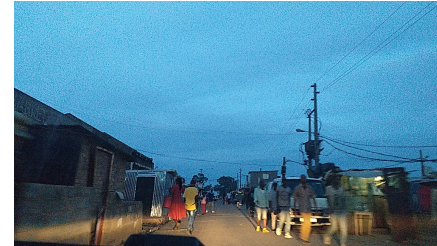
Image 6: Street with people and no pavement

Audit points with a poor rating for the Walkpath parameter have been identified as shared streets. The idea of shared streets is to remove formal distinction between space for multiple users, however, it can lead to car dominant spaces which are impediments for pedestrians (example in Image 6).

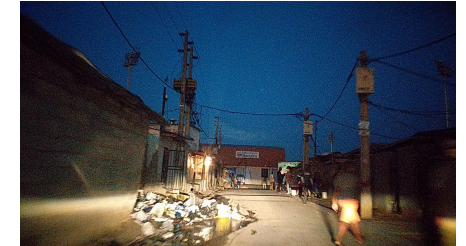
Image 7: Street with garbage blocking the pavement

49 points were identified with unpaved patches on the pavement. Various obstructions on the pavement were identified including cars parked on it, open garbage dumps (example in Image 7) and others. Map 8 shows a heat map of the People parameter with all the points mentioned. Broken patches should be taken up for repair and pavements should be built wherever needed. Designated spaces for parking should be provided clear of a pedestrian's path.

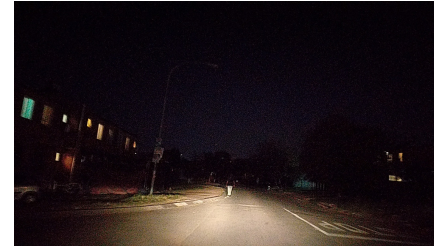
Image 8: Street with non-functional streetlights

The data collected through the Safetipin Nite app has a level of sub-parameter analysis as explained before. Based on our analysis, 134 audit points with non-functional street lights (Image 8) and 9 points with no street lights were identified.

Lighting impacts how clearly one can see around and thus, it has an impact on the perception of safety. It was found that in audited areas where the rating for Lighting was 0 or 1, people were present at 52% (People rating of 2 or 3) of the points (example in Image 9). Map 10 shows the heat map of the People parameter with points with no street lights and non-functioning street lights. These locations should be taken up on priority for street light installation and maintenance, whichever applicable.

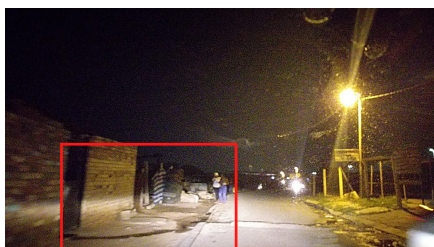
Image 10. Street with broken patch

The overall rating for the Walkpath parameter is average which indicates that majority of the spaces in Alexandra have the presence of pavements. However, through the sub-parameter analysis on the Safetipin portal, it was seen that some stretches on the pavement are broken or unpaved. Maintenance checks should be taken up in these areas and the material used to lay the pavements should be durable in its nature so as to not deteriorate with changing climate conditions or with the regular wear and tear of daily usage.

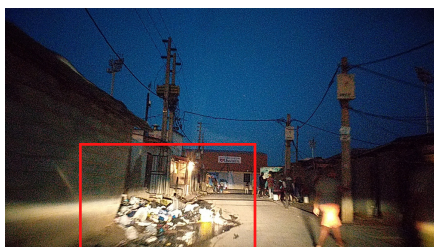
Image 12. Street with garbage obstructing pavement

An ideal safe and inclusive city should be accessible in terms of walkability. Obstructions on the pavement interfere with seamless movement and impact how a pedestrian uses that space. There should be regular maintenance checks for the quality of the pavement. Garbage dumps should be removed and trash cans should be added at regular intervals for use. Dedicated parking areas for vehicles in and around popular market areas and public spaces should be set up so that cars are not parked on the pavement. Vendors who do not have dedicated space to set up, should be given that space so that they and the pedestrians can amicably use the area without disturbances. Images 12 and 13 show the different types of obstructions identified on the pavement hindering the seamless accessibility for pedestrians.

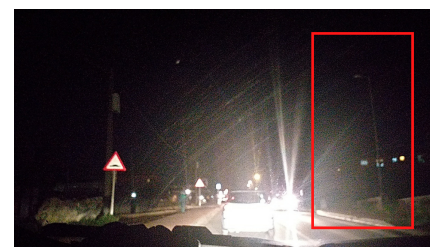
Image 14. Non-functional street lights

Lighting plays a crucial role in the perception of safety in a space. The ability to see your surroundings provides an impalpable feeling of comfort and security. It is for this reason that uniform lighting across the township should be taken up on priority. 134 points were identified having street lights which were not functioning (example in Image 14) at the time of the audit. This could be due to the lack of bulbs in the poles, lack of maintenance in changing the bulbs or poor monitoring the timings of when the street lights are supposed to be functional. The 134 points should be checked by the concerned departments for immediate repair. It was also noticed that 150 points had street lights on only one side of the road. If the roads are more than four-lanes wide, one side of the road gets limited illumination on the pavement. From the collected data, it has been noted that all the points with street lights on only one side were main roads and majority were on roads which are two or three lanes wide. 16 points were found to be on main roads with four lanes (as seen in Image 15), and these points need installation of street lights on both sides of the road.

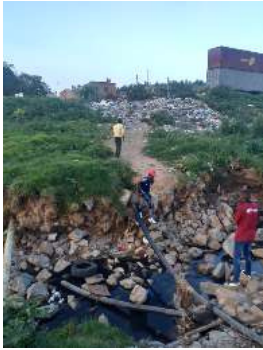
From the safety audits done on the My Safetipin app, users have identified spaces where children are seen playing on the street due to the lack of proper playing spaces for them. Users have also identified parks in the township and highlighted the infrastructure lacuna that has led to creating parks which are unsafe and are used for illegal and criminal activities. This can be seen from the comments by the users.

shortage of street lights the park is dirty and there's a hole used as pass way it's a hub for crime
