PATNA GAYA MUZAFFARPUR SAFETY AUDIT REPORT

By Safetipin

BIHAR SAFETY AUDIT

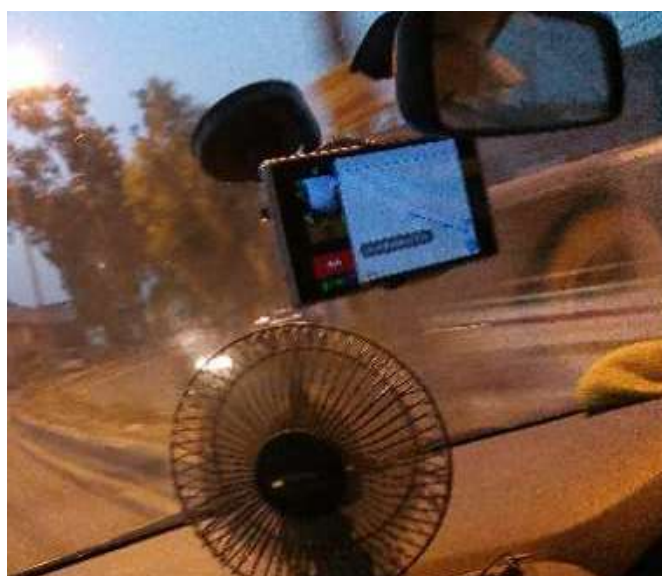
*Image on right
Phone running Safetipin Nite App mounted on the windshield of a car*

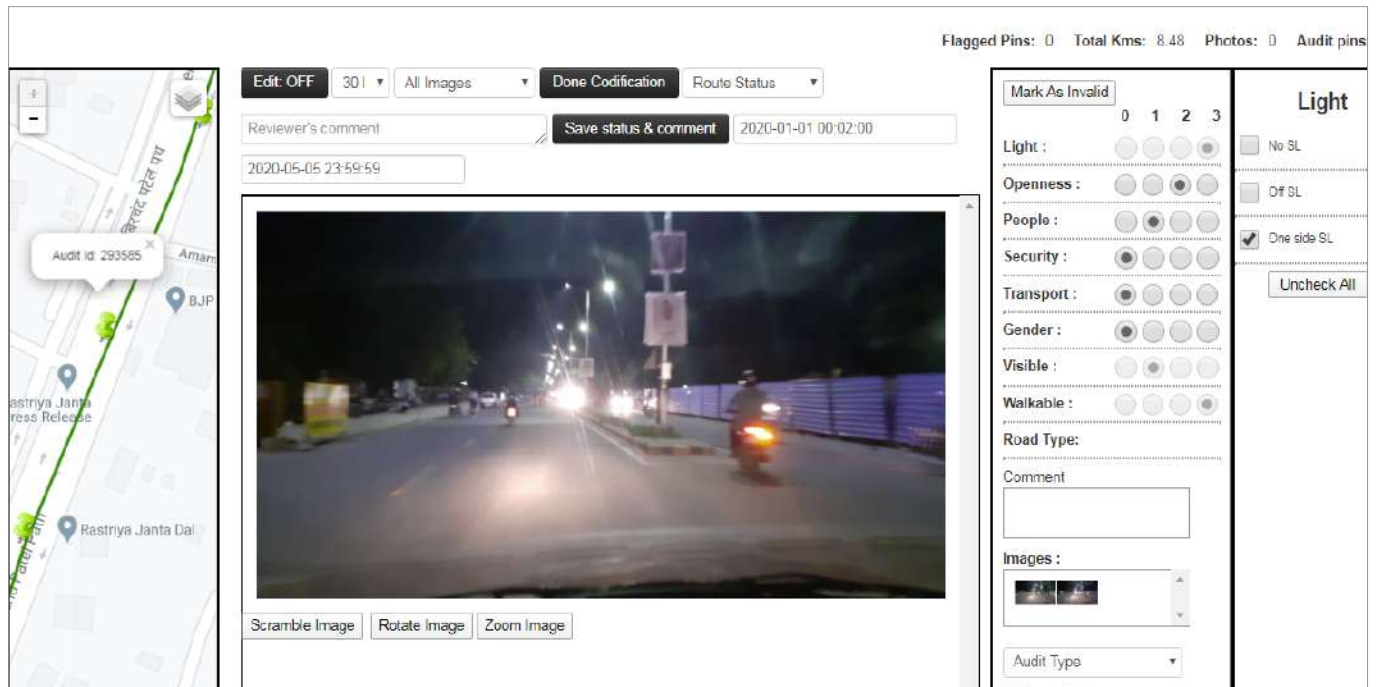
*Image below
Snapshot of the coding screen showing the parameters and sub-parameters*

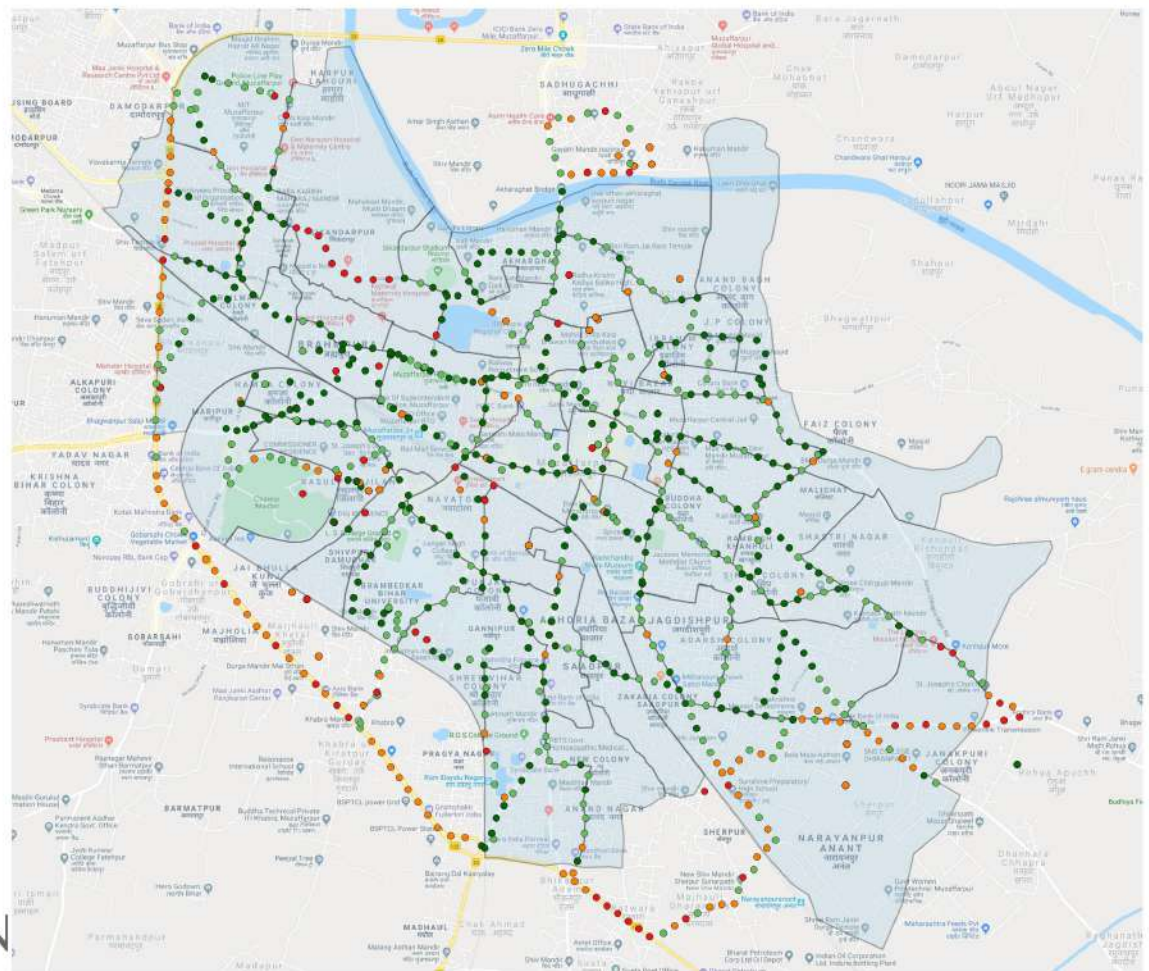
OF THE CITY MAPPED HAS NO OR POOR LIGHT

57% of the city in general has good street lighting but 43% scores poorly on the same. When data is represented geographically (map below) it is seen that most of the lower ratings on street lighting are on the extreme periphery and a few clusters spread across the city too. This means, either there are none or inadequate street lighting in these parts of the city. This geo-located data could be used for city improvement programs to identify the status of street lighting in the city.

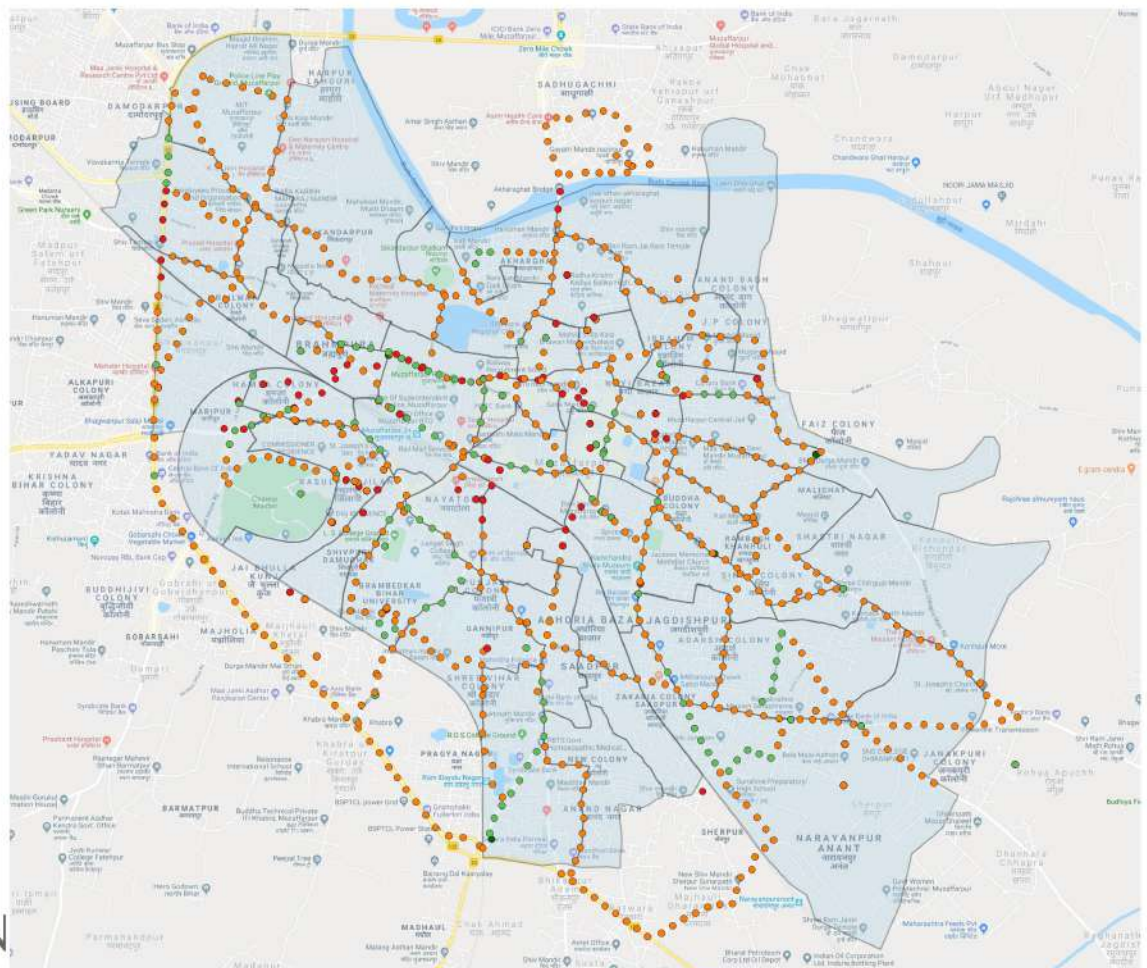
OF THE CITY MAPPED HAS NO OR POOR WALKPATH

Only 21% of the city has walkable footpaths, rest 79% scores poorly on the same. When data is represented geographically (map below) it is seen that most of the lower ratings on footpaths are spread across the city with a few exceptions in some pockets in the core where the ratings are good. This largely means, either there are none or very poor quality footpaths in the city. This geo-located data could be used for upgradation work to identify the condition of walkpath in the city.

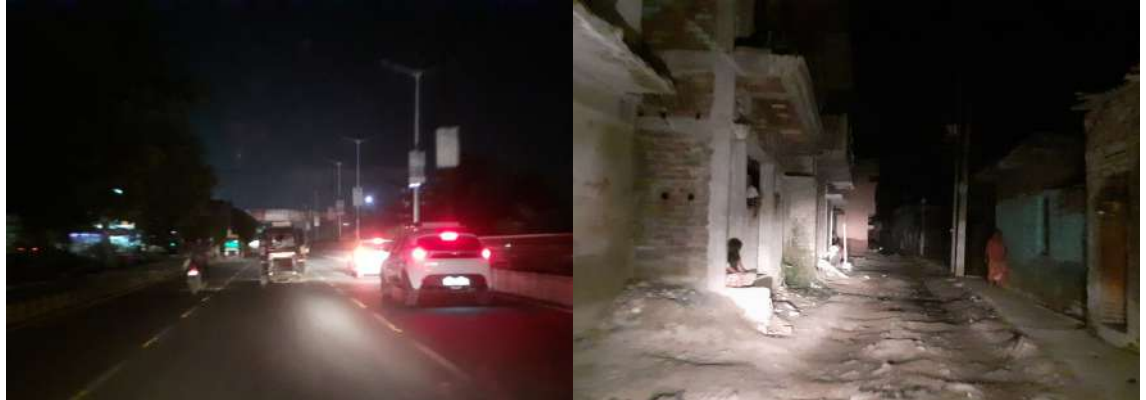
GEO-LOCATED IMAGES

34% of the city has no or poor street lighting. Safetipin's data (geo-located images) can be used to improve street lighting in the city. The map below represents the locations where there are absolutely no lights, very poor or inadequate lights and non-functional street lights. This information is also provided in a csv file which can be intergrated with the city's GIS portal for ease of planning for immidiate upgradation like adding and fixing street lights. Street lighting is crucial for ensuring safety in public spaces and plays a vital role in people's, particularly women's perception of safety in streets and public places after dark.

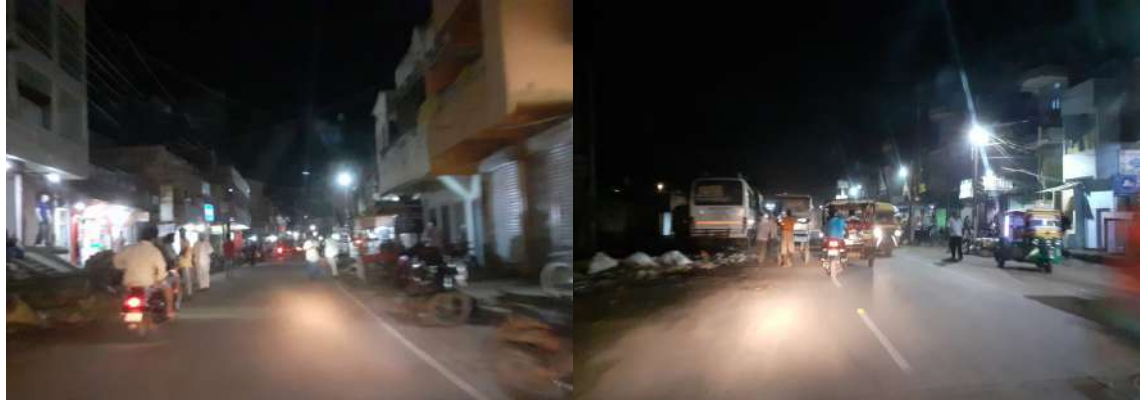
GEO-LOCATED IMAGES

67% of the city has no or poor walkpath condition. Safetipin's data (geo-located images) can be used to improve pedestrian life in the city. The map below represents the locations where there are no dedicated walkpaths, no constructed footpaths and hazardous, encroached or blocked footpaths. This information is also provided in a csv file which can be intergrated with the city's GIS portal for ease of planning for immidiate footpath upgradation like construction, repairs and removal of all forms of obstruction. Ease of walking in the city is important for pedestrians, especially women to feel safe while accessing the city for various daily activities.

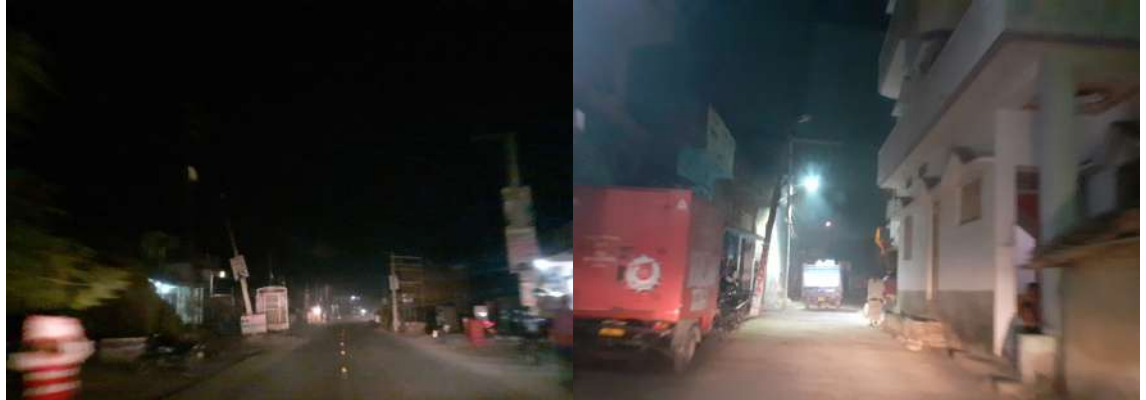
GEO-LOCATED IMAGES

41% of the city has no or poor street lighting. Safetipin's data (geo-located images) can be used to improve street lighting in the city. The map below represents the locations where there are absolutely no lights, very poor or inadequate lights and non-functional street lights. This information is also provided in a csv file which can be intergrated with the city's GIS portal for ease of planning for immidiate upgradation like adding and fixing street lights. Street lighting is crucial for ensuring safety in public spaces and plays a vital role in people's, particularly women's perception of safety in streets and public areas after dark.

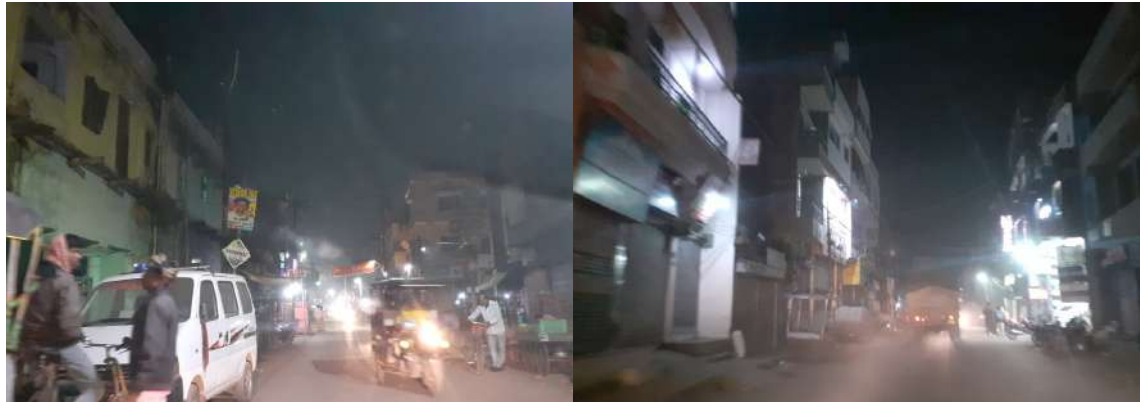
GEO-LOCATED IMAGES

84% of the city has no or poor walkpath condition. Safetipin's data (geo-located images) can be used to improve pedestrian life in the city. The map below represents the locations where there are no dedicated walkpaths, no constructed footpaths and hazardous, encroached or blocked footpaths. This information is also provided in a csv file which can be intergrated with the city's GIS portal for ease of planning for immidiate footpath upgradation like construction, repairs and removal of all forms of obstruction. Ease of walking in the city is important for pedestrians, especially women to feel safe while accessing the city for various daily activities.

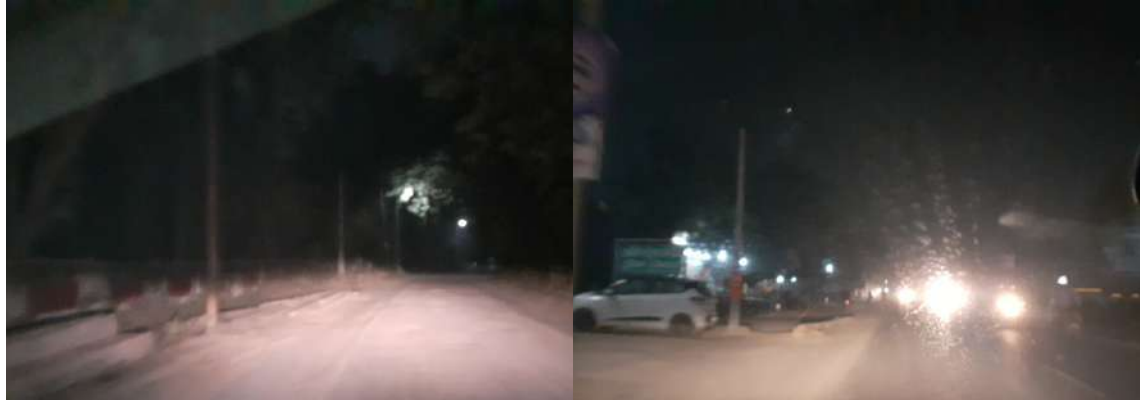
GEO-LOCATED IMAGES

43% of the city has no or poor street lighting. Safetipin's data (geo-located images) can be used to improve street lighting in the city. The map below represents the locations where there are absolutely no lights, very poor or inadequate lights and non-functional street lights. This information is also provided in a csv file which can be intergrated with the city's GIS portal for ease of planning for immidiate upgradation like adding and fixing street lights. Street lighting is crucial for ensuring safety in public spaces and plays a vital role in people's, particularly women's perception of safety in streets and public areas after dark.

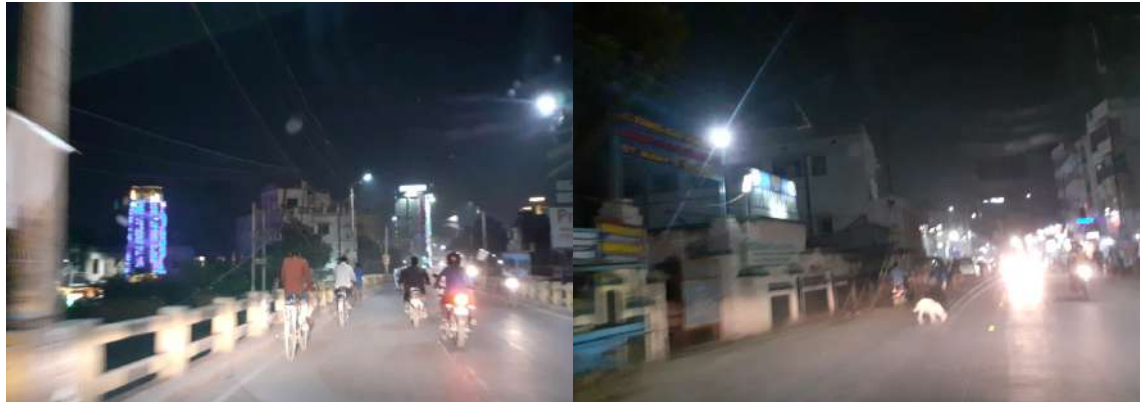
GEO-LOCATED IMAGES

79% of the city has no or poor walkpath condition. Safetipin's data (geo-located images) can be used to improve pedestrian life in the city. The map below represents the locations where there are no dedicated walkpaths, no constructed footpaths and hazardous, encroached or blocked footpaths. This information is also provided in a csv file which can be intergrated with the city's GIS portal for ease of planning for immidiate footpath upgradation like construction, repairs and removal of all forms of obstruction. Ease of walking in the city is important for pedestrians, especially women to feel safe while accessing the city for various daily activities.
