# Safety Audits in Sihanoukville

## A Study on Urban Safety for Women

2020 | 2021

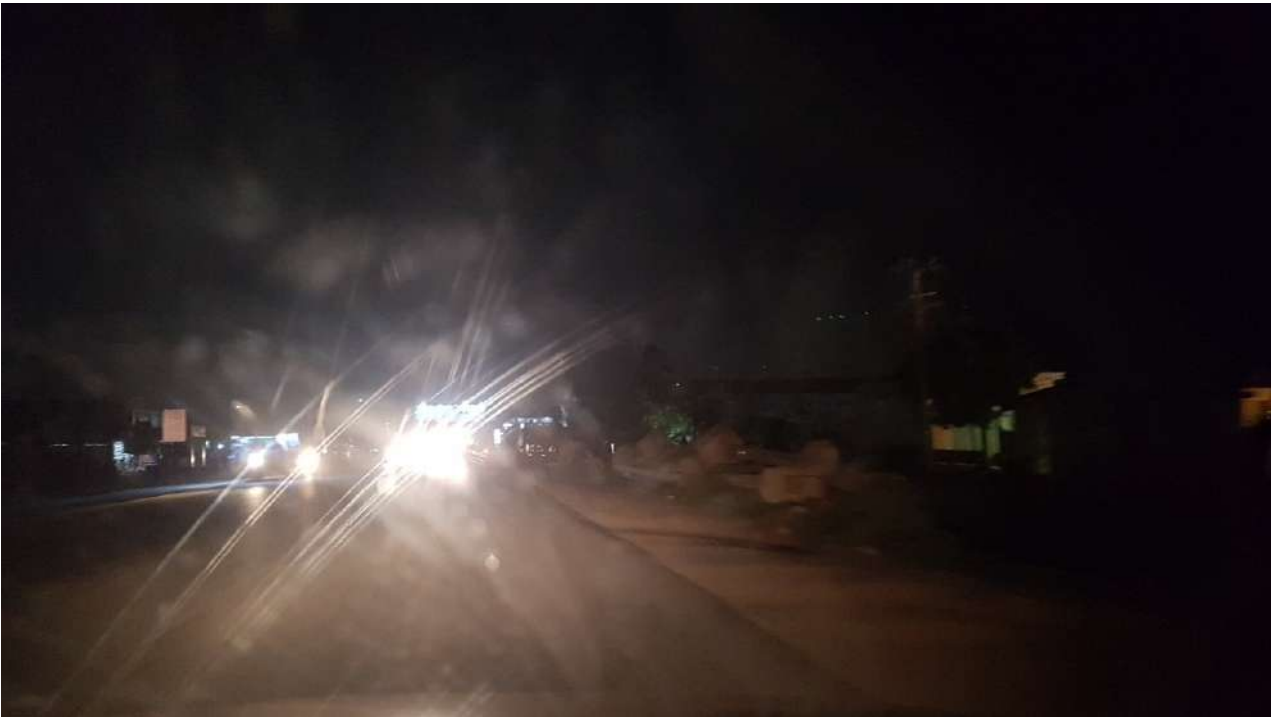
Addition of street lights near Adidas Sihanoukville Factory Outlet, Ekreach Street, Preah Sihanouk

Image 8: No street lights in 2020

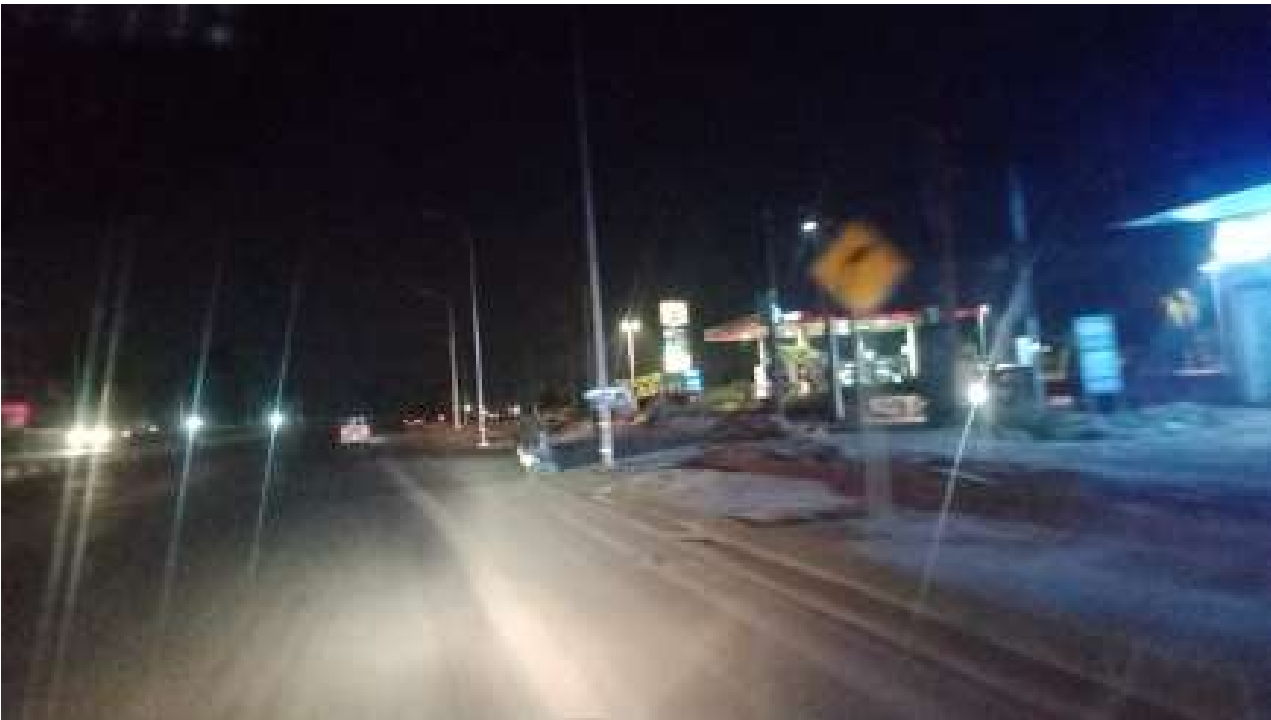
The lighting issues as recorded from the 2020 and 2021 audits are shown in Figure 6. The data indicates that the number of areas with 'No streetlights' reduced by 73%, as more lights have been installed. However, there was a slight increase in the number of streetlights that were found to be non-functional at the time of audits, as seen in images 8 and 9.

Image 9: Non-functional street lights in 2021

| Parameter | Findings 2020 | Findings 2021 | Action to be taken |
|---|---|---|---|
| | 107 points identified with non-functional streetlights | 160 points identified with non-functional streetlights | An example of this is seen in Image 15, where street lights can be seen but there is no illumination. The streetlight fixtures should be checked to see if they have working bulbs and regular maintenance checks should be done. |

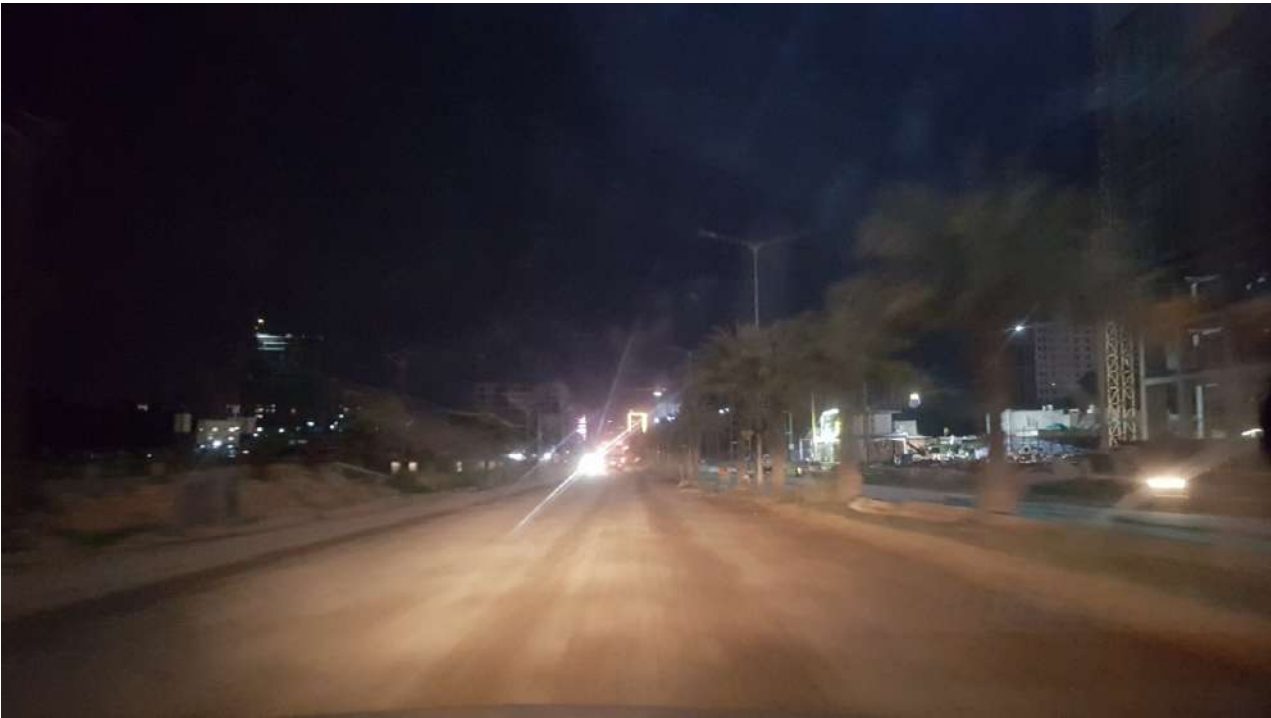
Change in pavement on street near ក្រុម 9, ភូមិ មណ្ឌល 1, Preah Sihanouk, Cambodia

Image 10: No pavement in 2020

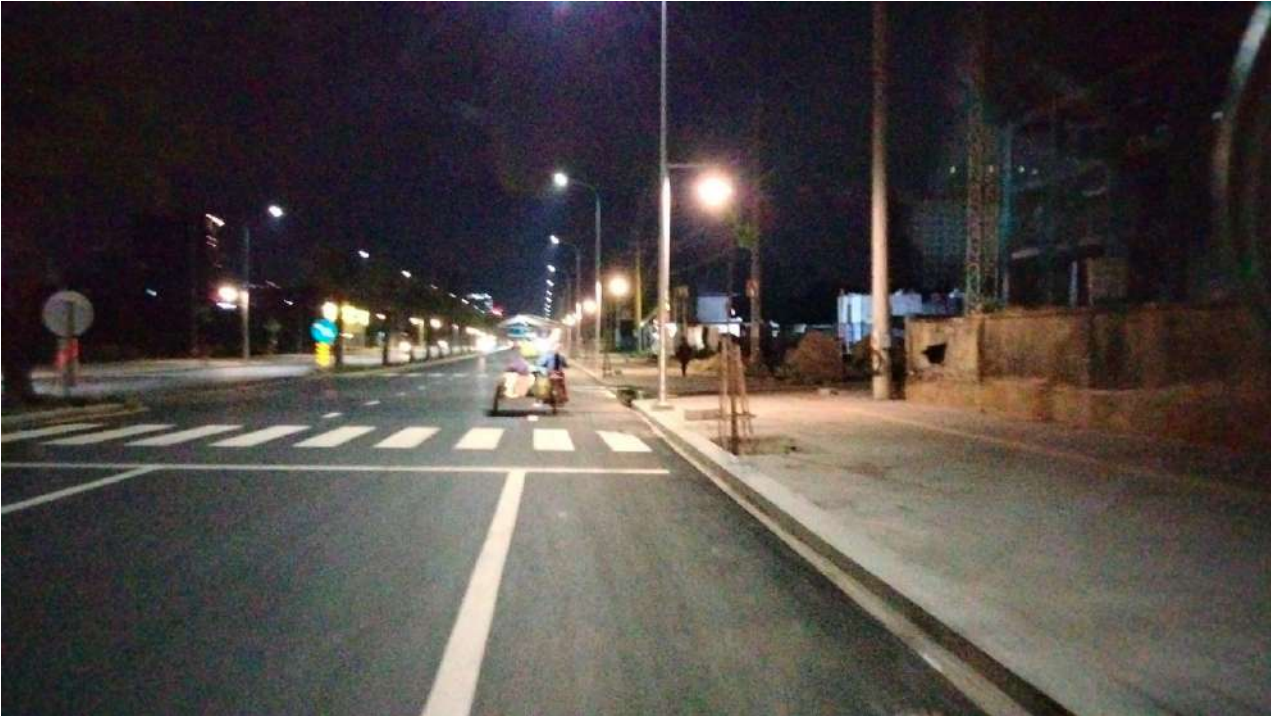
Image 11: Proper pavement in 2021

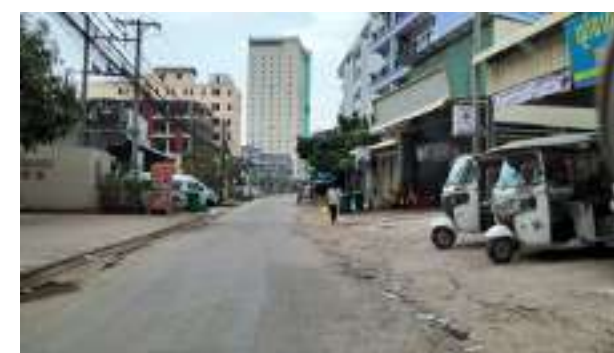
Image 12: Possible tuk-tuk stand

The only mode of transport considered within this parameter was tuk-tuks. As the primary mode of public transportation, they ply all over the city, but their fares are unregulated and there are no designated stands for them. The lack of designated stands affects the transport accessibility for people, especially women, who tend to take shorter and more frequent trips. Tuk-tuk stands were identified as a point with two or more parked tuk-tuks (examples in Image 12 and 13). The distribution of points where tuk-tuk stands were identified over a heat map of the People parameter is shown in Map 14. Designated tuk-tuk stands could be designed for places with a higher presence of people, which will help make the city more accessible.

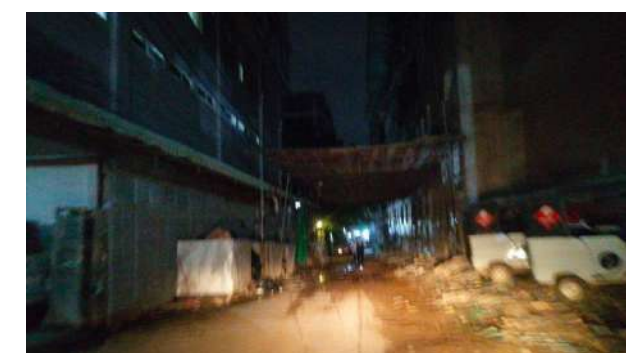
Image 13: Possible tuk-tuk stand

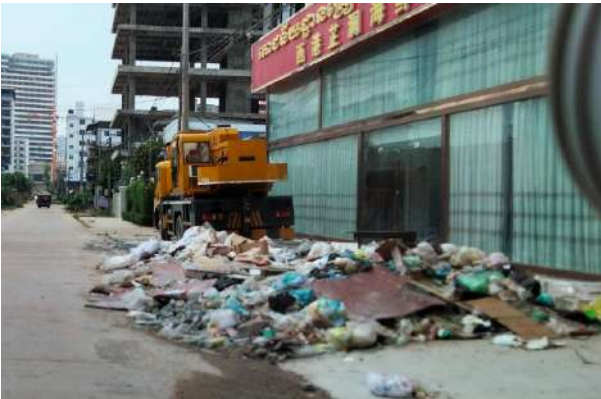
Images 16 and 17 show different types of obstructions on the pavement.

Image 16: Garbage obstructing pavement

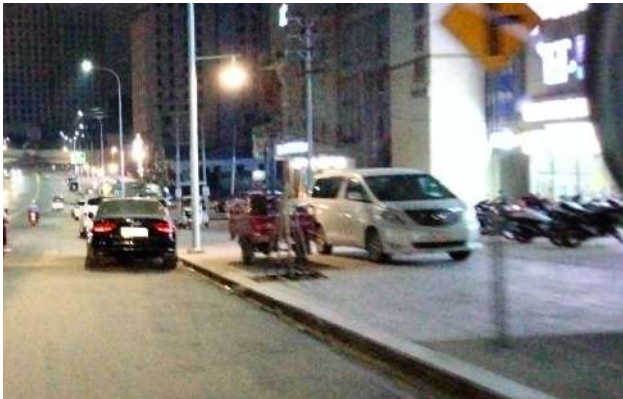
Image 17: Vehicles obstructing pavement

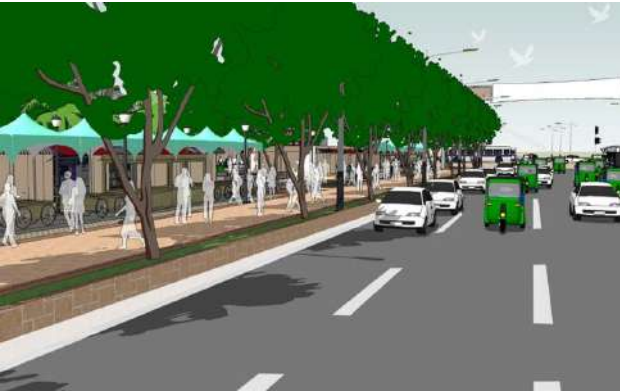
An example of an active street with vending zones is shown in Image 18. An example of proper vending zones is seen on the road along Independence Beach in Sihanoukville. There is ample space for vendors without obstructing or interrupting the pavement for pedestrians. This is seen in Image 19.

Image 18: Ideal street with vending zones

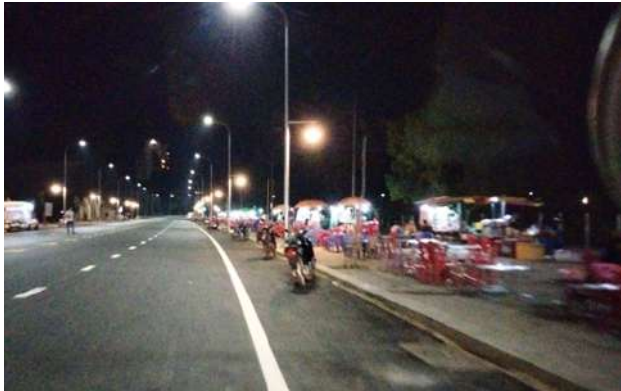
Image 19: Road near Independence Beach with proper space for vendors
