WOMEN'S SAFETY AUDIT OF DHAKA

FINAL REPORT

by Safetipin

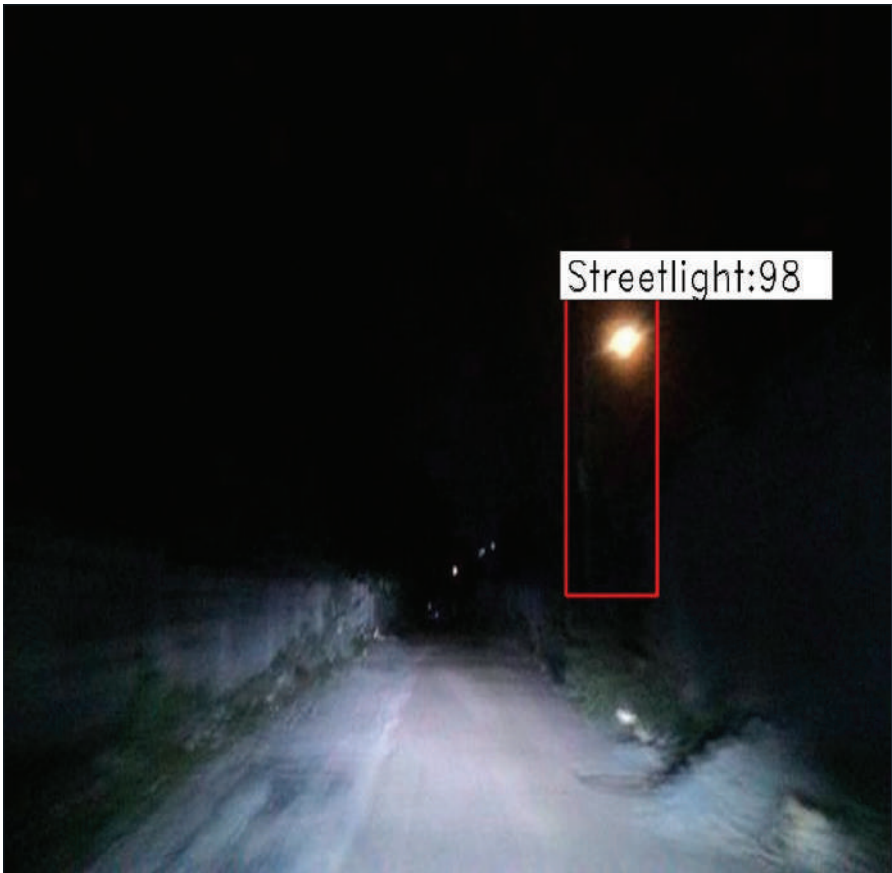
ML MODEL IMAGE

Currently Safetipin uses a hybrid process of data analysis. Analysts receive audits generated by the trained ML model. An algorithm drops markers every 100 meters (red markers as seen in the screenshot below). Each marker is a ML audit having scores (aggregated ratings of parameter and sub-parameters) generated using the trained ML model. For each ML audit, the algorithm automatically analyses all photographs in the vicinity of a marker. To ensure quality and to validate the ML audits, analysts review the entire set of ML generated audits. The final audit points are then prepared as GIS datasets for further analysis and use.

Image on left
Bounding boxes showing the parameters as detected by the machine learning model

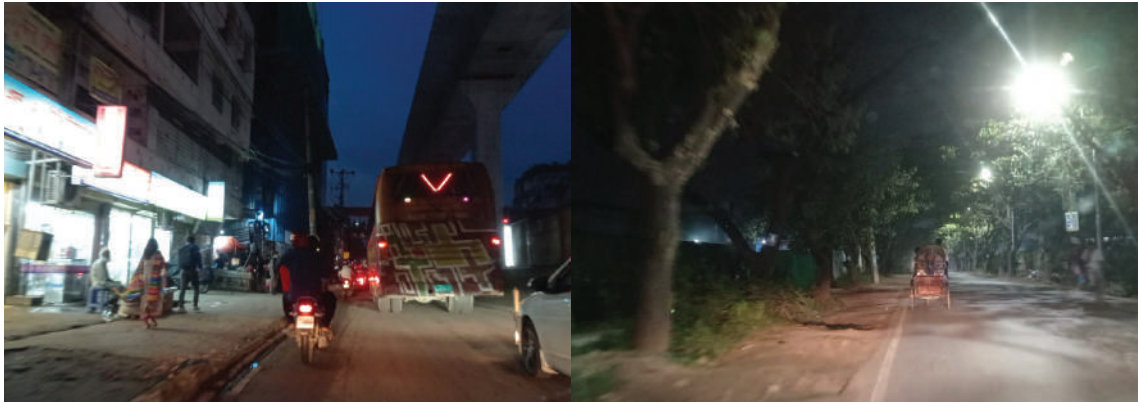
Dhaka North City Corporation: Footpath Conditions

Safetipin identified three types of footpath conditions which mar pedestrian walking experience and cause distress among pedestrians while navigating the streets, especially the vulnerable users. These conditions are namely, one, having no dedicated walking space on the streets, two, having no built footpath, and three, having broken, partly paved, discontinuous walking surface on footpaths. We mapped all of the above conditions wherever found in the area and geo-located the information on GIS layers. The composite map below represents all the non-functional footpaths as found on the streets and highlights the intensity of the issue in Dhaka North City Corporation.

GEO-LOCATED IMAGES
Left to right
The geo-tagged photos show non-functional footpaths

- Legend
- No Space for Footpath (161)
 - No Built Footpath (1031)
 - Broken Footpath (101)
 - DNCC
- Base: Google Map

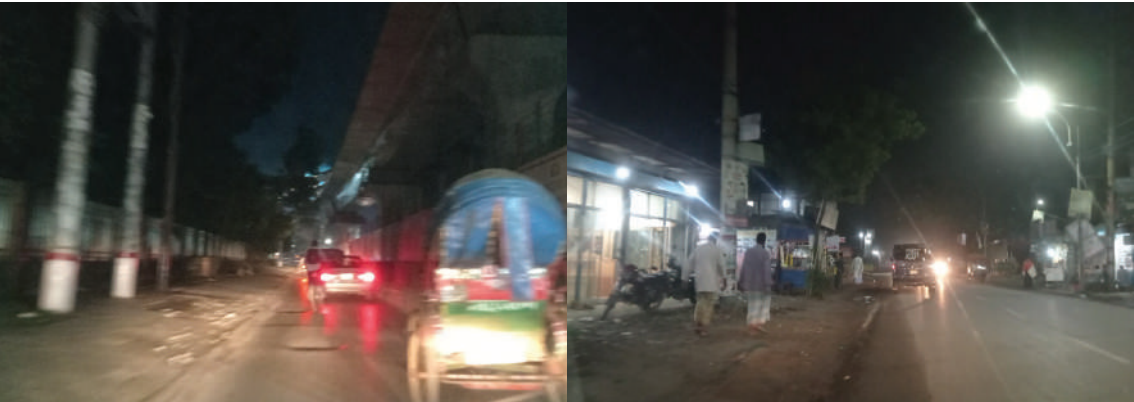
Dhaka South City Corporation: Footpath Conditions

Similarly, the composite map below represents all the non-functional footpaths as found on the streets and highlights the issue of ease of access and mobility in Dhaka South City Corporation. Please follow the legend to see the total number of locations where these conditions were identified. As mentioned, this geo-located data is also provided as a GIS layer and could be used for improving walkability in the area.

GEO-LOCATED IMAGES
Left to right
The geo-tagged photos show non-functional footpaths

- Legend
- No Space for Footpath (187)
 - No Built Footpath (640)
 - Broken Footpath (32)
 - DSCC
- Base: Google Map

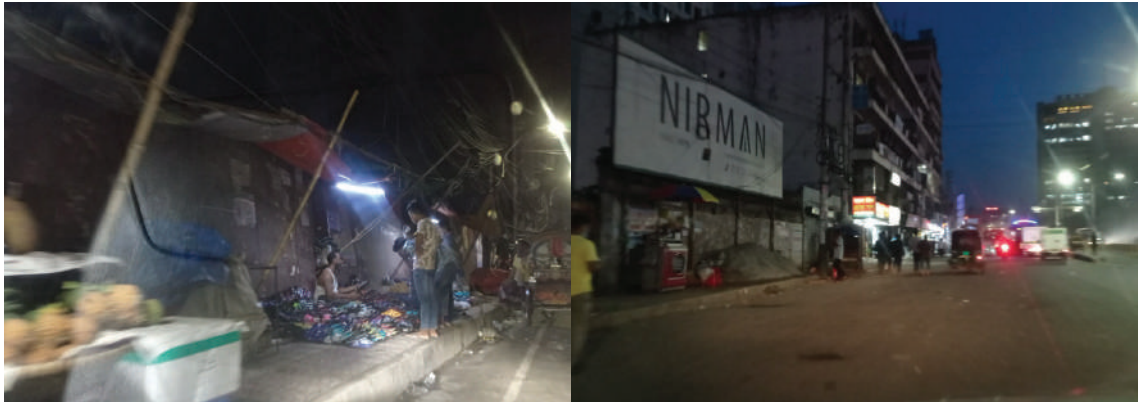
Safetipin identified five types of physical barriers disrupting clear walking space for pedestrians, especially the vulnerable users. These are namely parked vehicles, shop/house extensions, temporary stalls/ vendors, electricity/signage poles, and lastly dumped garbage/construction material. We mapped all of the above when found on footpaths and geo-located the information on GIS layers. The composite map below represents all barrier types found on footpaths and shows the magnitude of the issue. The total number of locations where these obstructions are found are indicated in the legend.

GEO-LOCATED IMAGES
Left to right
The geo-tagged photos show obstructions on footpaths

- Legend
- House Extension (10)
 - Shop Encroachment (96)
 - Light Pole (1)
 - Electric Pole (3)
 - Signage Pole (37)
 - Construction Debris (6)
 - Construction Material (105)
 - Garbage Dump (16)
 - Vendor/Stalls (605)
 - DNCC
- Base: Google Map

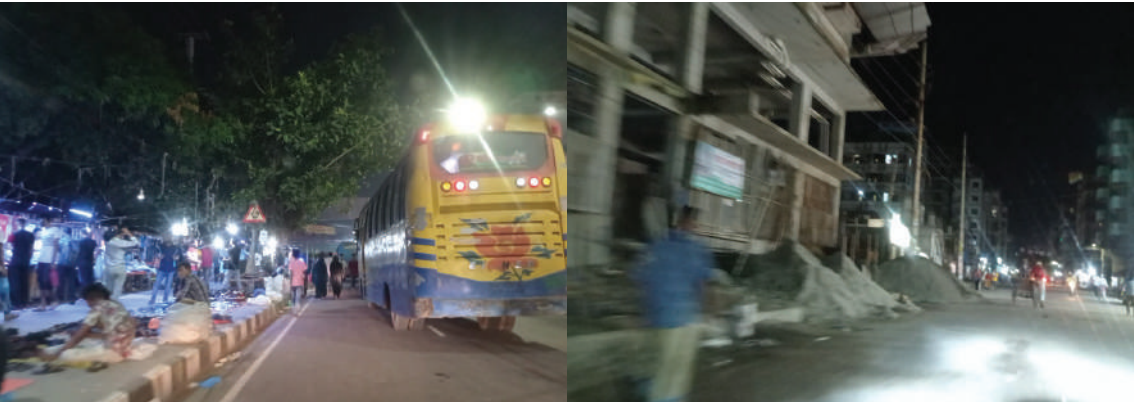
Similarly, the composite map below represents all barrier types found on footpaths and shows the magnitude of the issue of accessibility and mobility in Dhaka South City Corporation. Please follow the legend to see the total number of locations where these obstructions were identified. As seen, the obstructions are present across the entire area and the presence of vendors/temporary stalls posing as obstructions are the highest, in both the corporations. This geo-located data is too provided as a GIS layer and could be used for removing obstructions and improving walkability in the area.

GEO-LOCATED IMAGES
Left to right
The geo-tagged photos show obstructions on footpaths

- Legend
- House Extension (1)
 - Shop Encroachment (75)
 - Light Pole (2)
 - Electric Pole (2)
 - Signage Pole (2)
 - Construction Debris (5)
 - Construction Material (60)
 - Garbage Dump (25)
 - Vendors/Stalls (476)
 - DSCC
- Base: Google Map

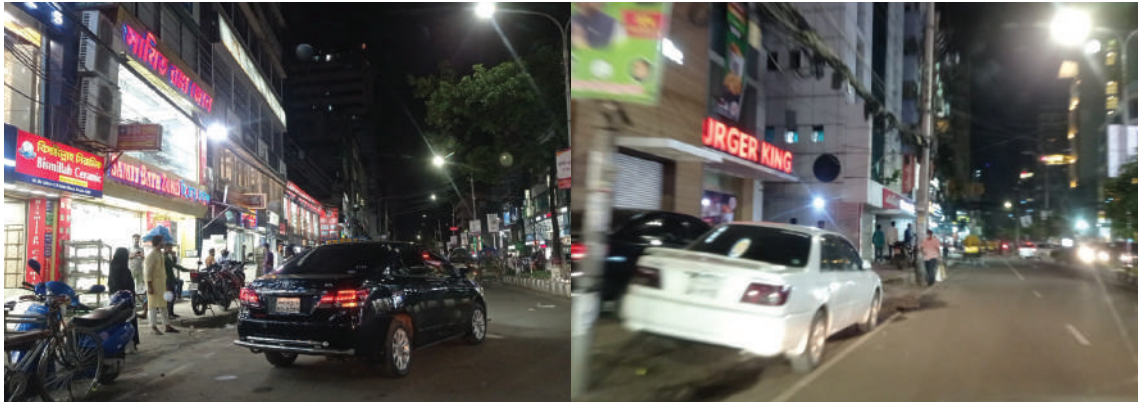
Safetipin identified locations within the corporations where vehicles were parked on footpaths, disrupting clear walking space for pedestrians, especially the vulnerable users. These are mainly two wheelers, four wheelers, small delivery vehicles, rickshaws, carts and cycles. We also mapped clusters of non-motorised vehicles, mainly rickshaws parked on the vehicular roads obstructing access to footpaths and causing traffic congestion. These conditions were mapped and such geo-located information is available as GIS layers. The map below represents all locations in DNCC with parked vehicles on footpaths and beside footpaths to highlight the intensity of the issue. It is found that majority of the footpaths were either occupied by obstructions, were difficult to access or did not have a good, at grade, walking surface.

GEO-LOCATED IMAGES
Left to right
The geo-tagged photos show parked vehicles on footpaths

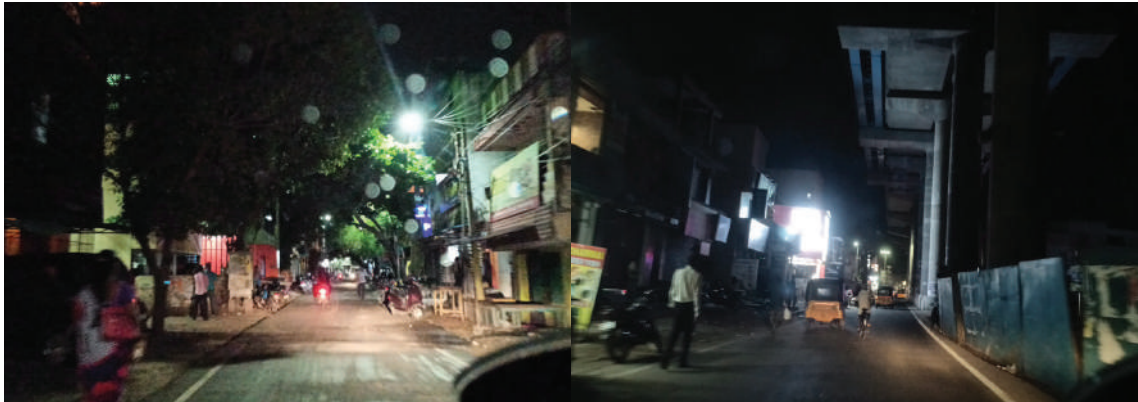
As seen on the walkpath parameter map on page 21 and on the accessibility mapping chapter which includes thorough analysis of the walkpath condition, availability of accessibility elements and types of obstruction present in DNCC - it is noted 40% of the area is either without any footpath or has very poor quality of footpath. Broken, discontinuous and blocked footpath could be easily fixed to achieve ease of walking in the area which is important for pedestrians, especially women to feel safe while accessing the area for various daily activities. Safetipin's data (GIS map with geo-located images) can be used to improve pedestrian access in both the corporations of Dhaka. The map below represents the locations where there are no dedicated walkpaths, no constructed footpaths and footpaths with obstructions.

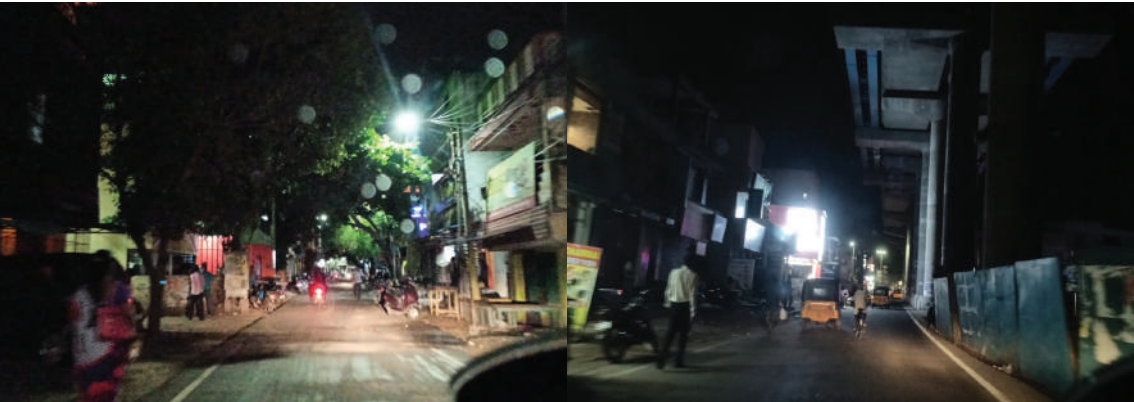
Similarly for DSCC, it is seen on the walkpath parameter map on page 31 and from the analysis given on the accessibility mapping chapter, that 44% of the area is either without any footpath or has very poor quality of footpath. The map below represents the locations where there are no dedicated walkpaths, no constructed footpaths and footpaths with obstructions. This GIS map with supporting geo-located images as evidence, could be used for footpath up-gradation program such as, construction of dedicated footpaths, repair of existing footpaths and removal of obstructions from built footpaths. More detailed recommendations on footpath follows at the end of this chapter.

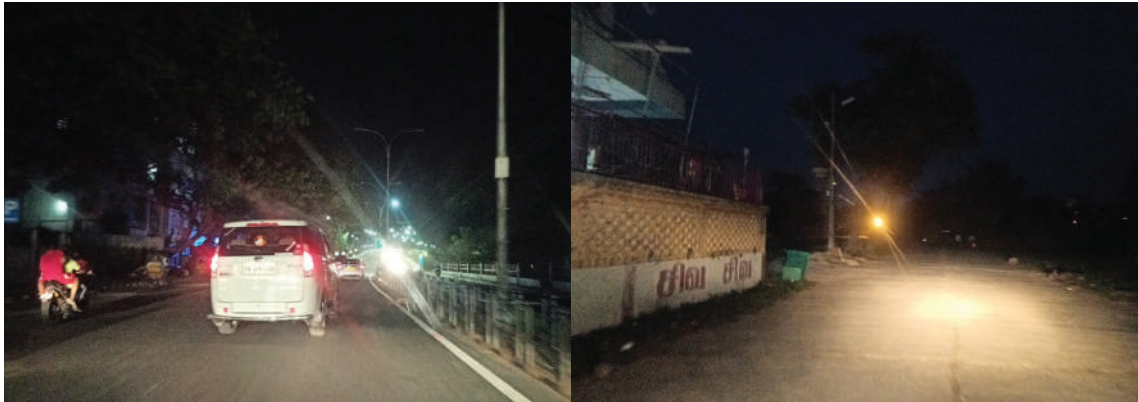
As seen on the lighting parameter map on page 20, only 09% of DNCC, has no street lighting and 20% has inadequate (low light affecting visibility) street lighting. This could be fixed immediately to achieve 100% adequate street lighting. Street lighting is crucial for ensuring safe access to and within public spaces and plays a vital role in people's, particularly women's perception of safety in streets and public places after dark. Safetipin's data (geo-located images) can be used to improve street lighting in the city. The map below represents the locations where there are either absolutely no lights, inadequate lights or non-functional street lights.

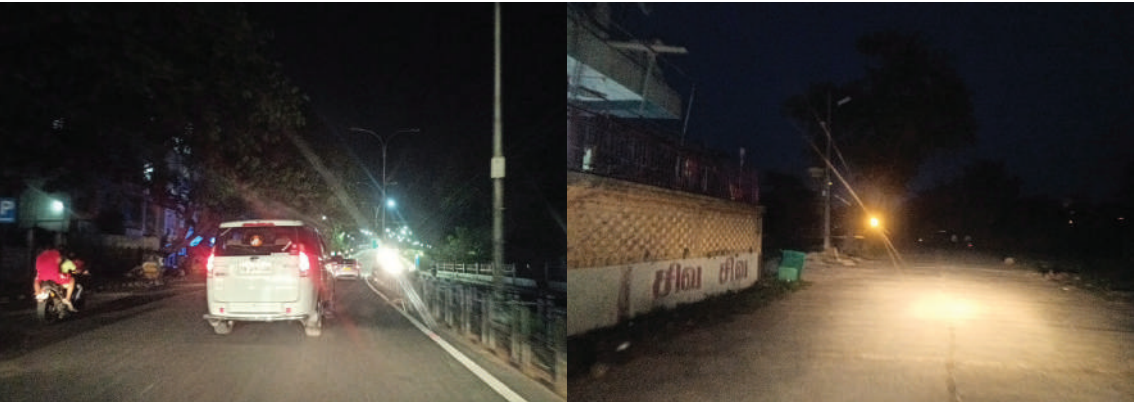
Similarly for DSCC, it is seen on the lighting parameter map on page 30 that only 03% of the area has no street lighting and 14% has inadequate (low light affecting visibility) street lighting. This could be fixed immediately to achieve 100% adequate street lighting. The map below represents the locations where there are either absolutely no lights, inadequate lights or non-functional street lights. This information could be used for the ease of planning for immediate up-gradation such as, adding more street lights and fixing non-functional street lights in order to improve women's perception of safety and actual, physical access to public spaces.
