ENHANCING LAST MILE CONNECTIVITY

a safety analysis of the Barakhamba Road Metro Station

This Report has been prepared as part of the Project being undertaken with NDMC to Enhance the Last Mile Connectivity along the metro stations within it's jurisdiction. The safety audits were conducted by Smt. Nutan, architect from NDMC along with Safetipin team.

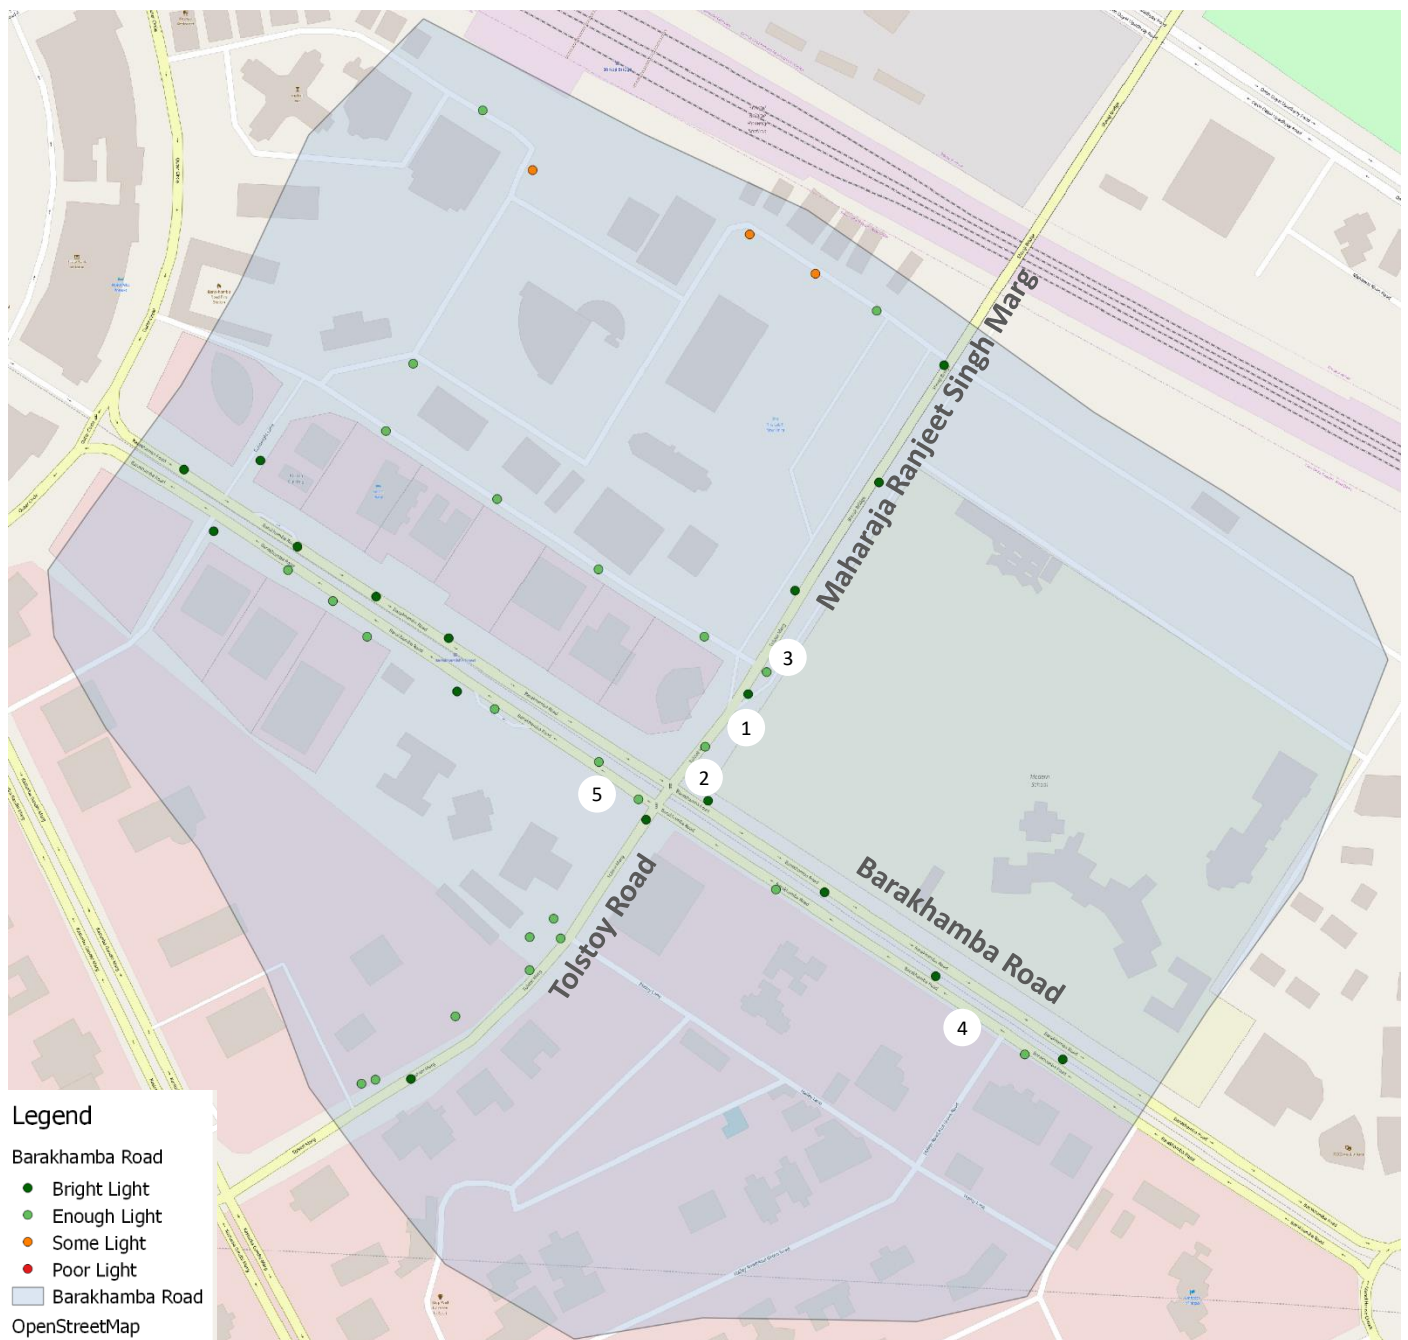
Lighting Rating

Lighting Parameter has been rated 2/3 i.e. Above Average. Along the office stretch, lighting was found to be adequate. The streetlights are located on both sides of the road along the footpath. The footpath along the service lane is not well lit as the light fixture is obstructed by tree leaves. Even along the metro station entry/exits the streetlights are obstructed by trees. In the second stretch too this was a common observation. The tree leaves need to be pruned regularly as they shield the light casting dark shadows on the footpath as well as the road.

Also, at many points while the street pole has been

fixed, it does not have a light fixture. This was seen on the stretch along the Modern School side. Also seen was multiple poles together. This was also seen at the junction. These poles should be properly spaced out such that the entire road is well lit. Additional poles can be re-located along the service lane footpath.

Some poles are very high due to which they get obstructed by leaves. Pedestrian scale streetlights should be provided at such locations.

A few lights were un-operational. Regular maintenance checks should be done to prevent this.

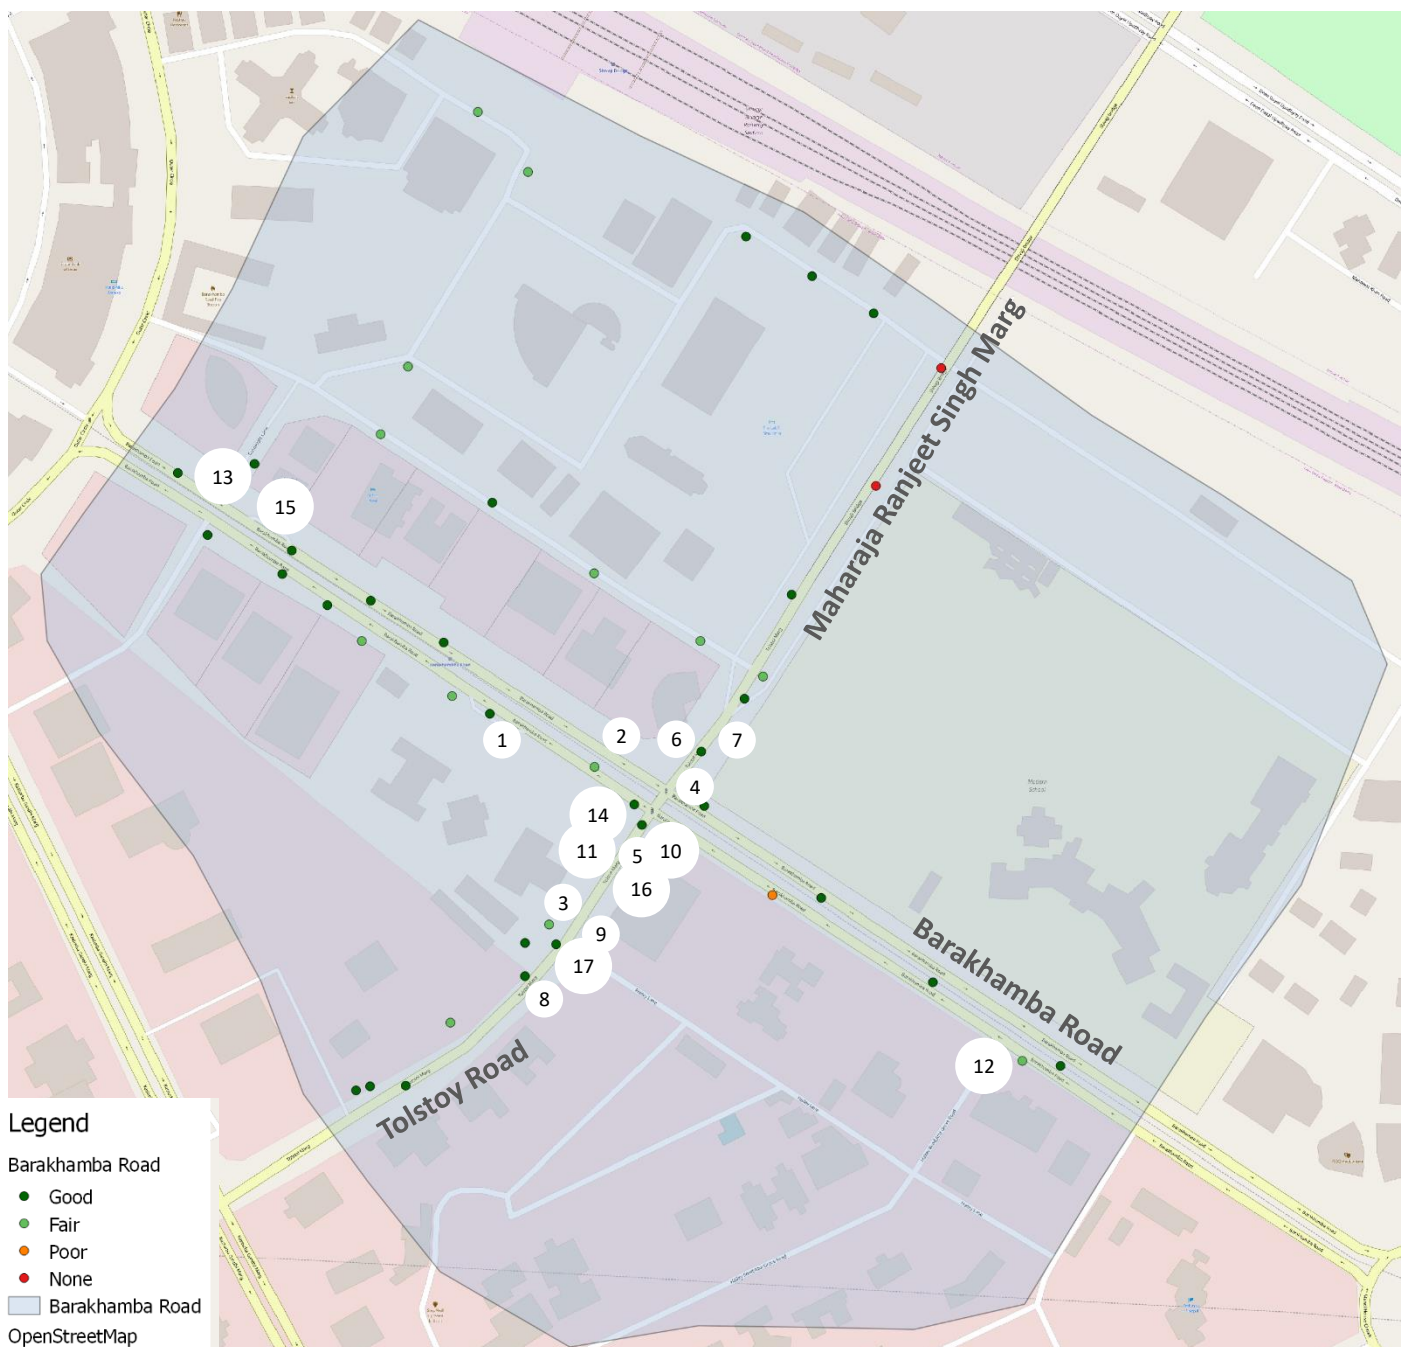
Walkpath Rating

Walkpath Parameter has been rated 2.5/3 i.e. Good. Most of the audit area has footpaths in good condition. The commercial stretch has a footpath along the service lane as well while the second stretch doesn't. Many obstructions were observed which hinder pedestrian movement. Commonly seen obstructions are signages, light poles, electric poles and other units. Manhole covers are not flushed with the surface and protrude out. At many points the surface around the manhole was observed to be broken. The footpath needs to be repaired to have a smooth continuous surface. The obstructions need to

be shifted. At few points especially at the turnings, the footpath was too narrow. This makes walking difficult and prohibits movement of people on a wheelchair.

The footpaths in the audit area do not have provision to enable smooth movement of people with disability. Tactile paving was observed only at the metro station and bus stop and these end abruptly. Even outside the Public Convenience no tactile paving has been provided. The ramps provided for ingress/egress of wheelchair are too steep and the footpath is too narrow.

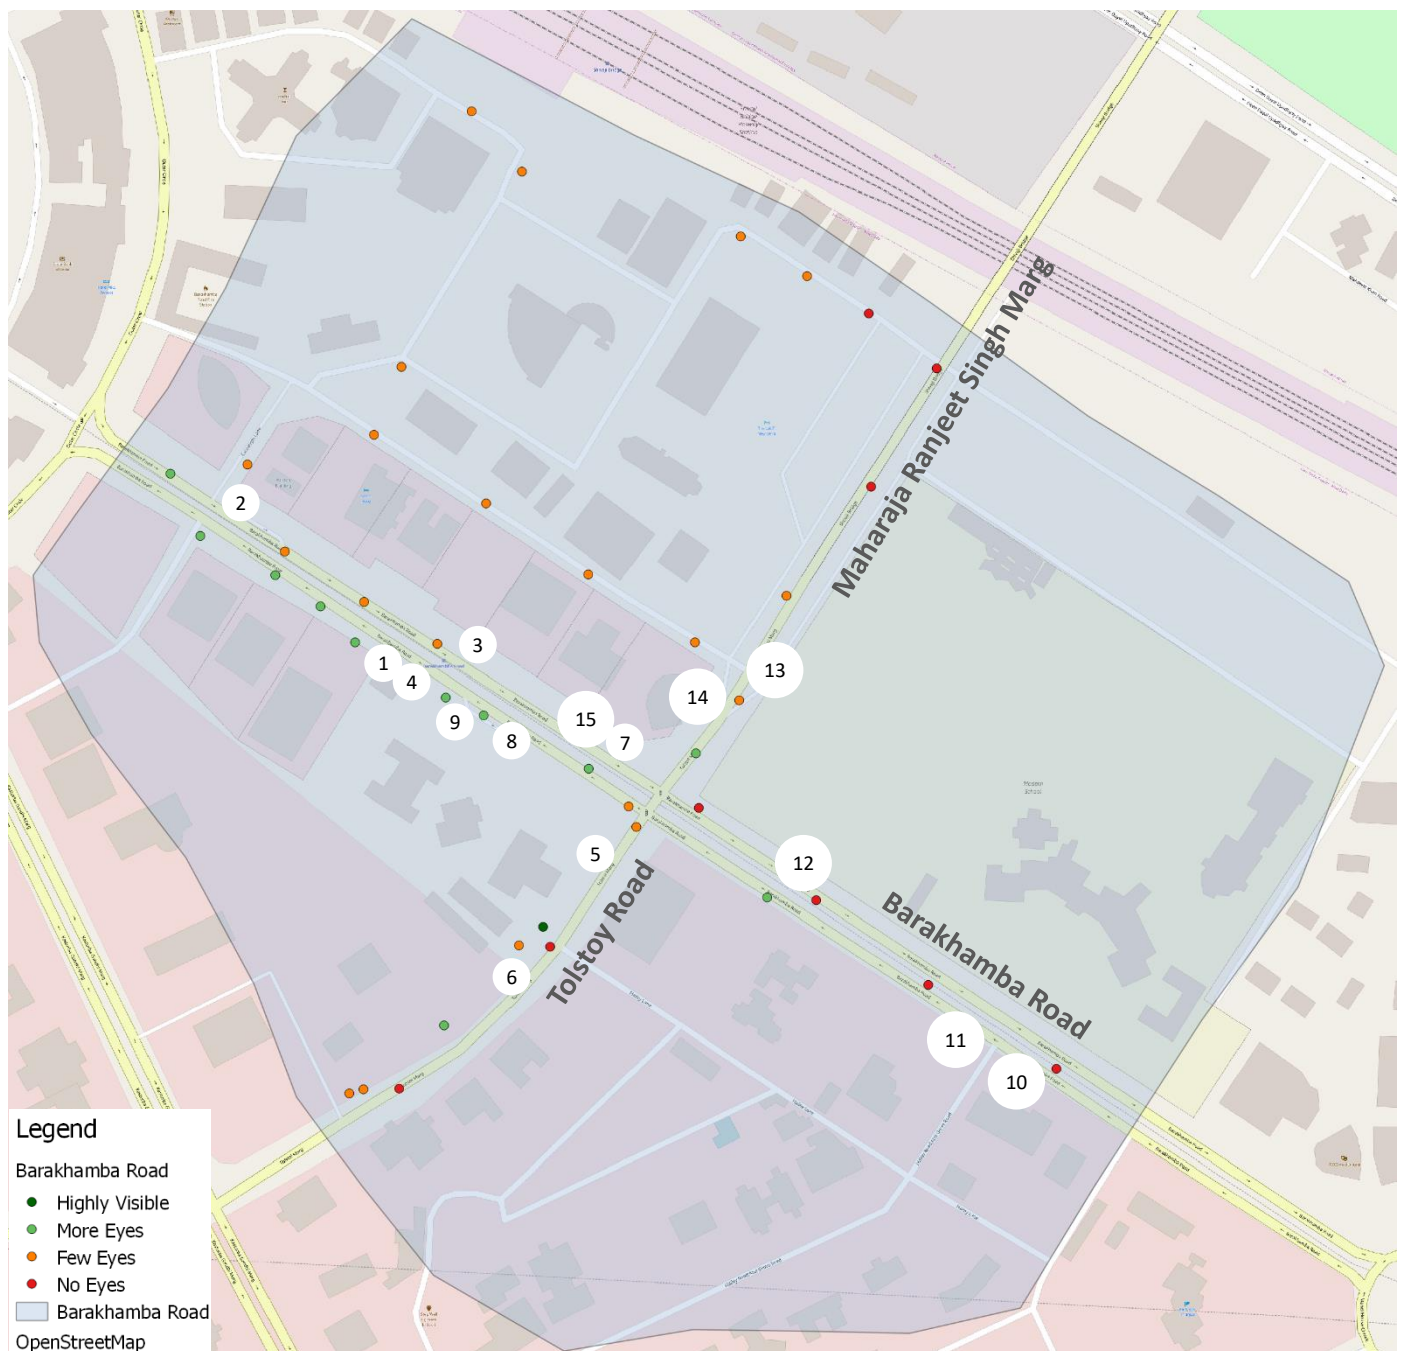
Visibility Rating

Visibility Parameter has been rated 1.1/3 i.e. Below Average. The commercial stretch of Barakhamba Road offers high visibility both due to high-rise office towers as well as the presence of street vendors catering to the office goers. However, the rest of the audit area offers no or very poor visibility.

Along the metro station entry/exits a lot of vendors are present. These cater to the metro commuters as well as the office goers. However, their number starts to dwindle post sunset. Their presence combined with the high rises results in good visibility along this stretch.

Along Tolstoy Road the visibility is low but along the remaining stretch of Barakhamba Road (towards Mandi House) and Maharaja Ranjeet Singh Marg, there is little or no visibility.

The office complexes like Parsvanath and RBS do not have tall opaque boundary walls. Instead the plot edge is defined by a low height transparent wall. This results in better visual connectivity between both sides. Such good practices should be adopted along other office buildings as well. For other built uses, the height of the opaque boundary wall should be reduced.

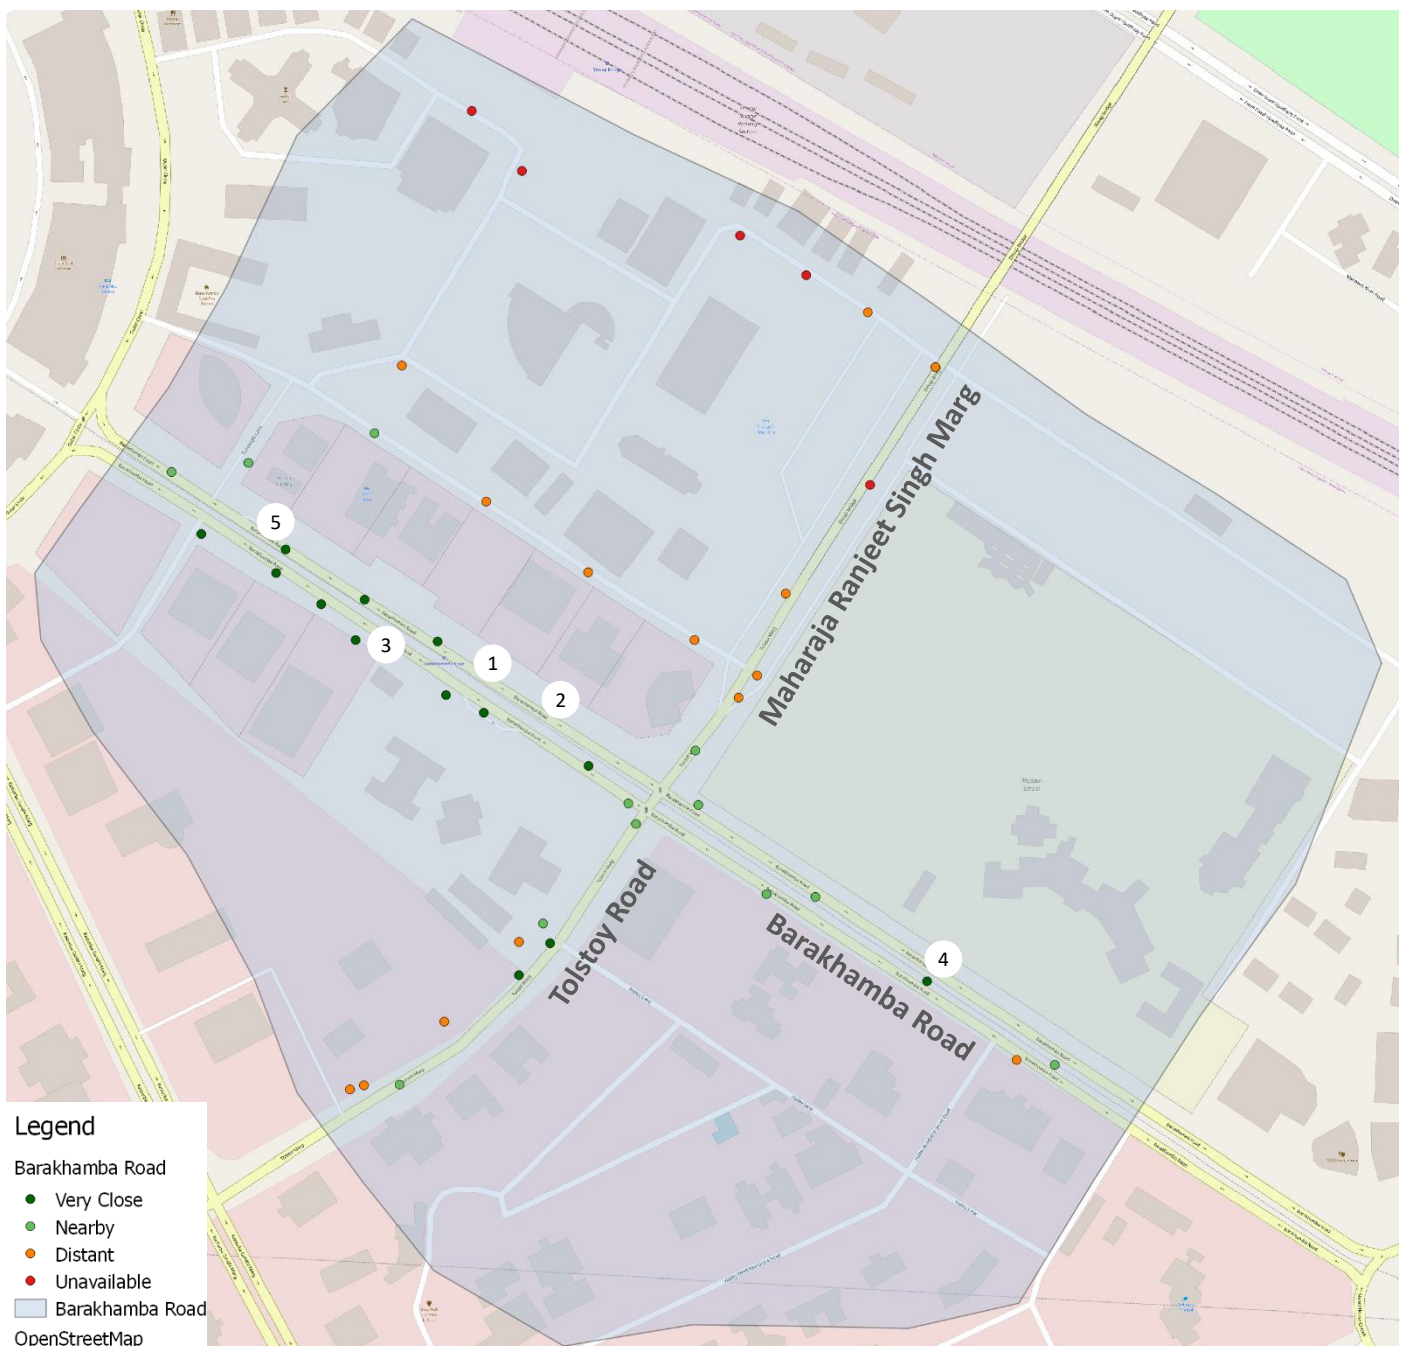
Public Transport parameter has been rated 1.8/3 i.e. Average. The Barakhamba Road has both metro and bus facilities. However the adjacent Tolstoy Road and Maharaja Ranjeet Singh Marg offer poor public transport facilities. Autos are easily available outside the metro station entry/exit. But as we move away from the metro station the para transit facilities are not easily available.

Along Barakhamba Road though bus service is available, proper bus shelters are missing at few points. The bus stop is identified by signage and there is no proper shelter for people to wait. As a result

they end up squatting on the road. Also where the bus shelter is provided, additional street furniture needs to be provided for the passengers. Bus movement needs to be clearly resolved and proper turning radius be provided.

Para transit stands need to be created along the metro station entry/exits. Currently autos queue outside crowding the service lanes. Also since the road is very wide, certain parts of the service lane can easily be designated as a vehicular free zone with space for hawkers and people. the para-transit hub can also be incorporated here.
