ENHANCING LAST MILE CONNECTIVITY

a safety analysis of the Central Secretariat Metro Station

Central Secretariat

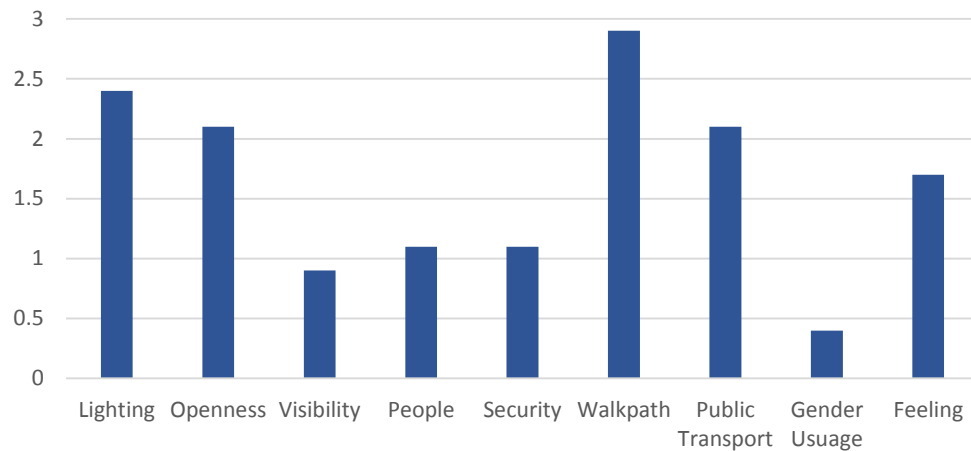
Average Audit Parameters (on a scale of 3)

Safety Audits indicate that the area around the metro station is safe. The parameter of Lighting has been rated Above Average. Being a part of Lutyens' Delhi, this area is well designed and managed. The footpath is present throughout the audit area and is rated Good.

Owing to the availability of interchange stops for metro and bus, the parameter of Public Transport has been rated Above Average.

The parameters of Visibility and Security have been rated Below Average. Being in an administrative zone, the area has continuous Police Patrolling. However, the huge setbacks and high boundary walls offers no visibility on the walkpath. Also, the presence of people and especially women on the streets after office hours is extremely low. Overall, auditors have rated the Feeling in the area as Average.

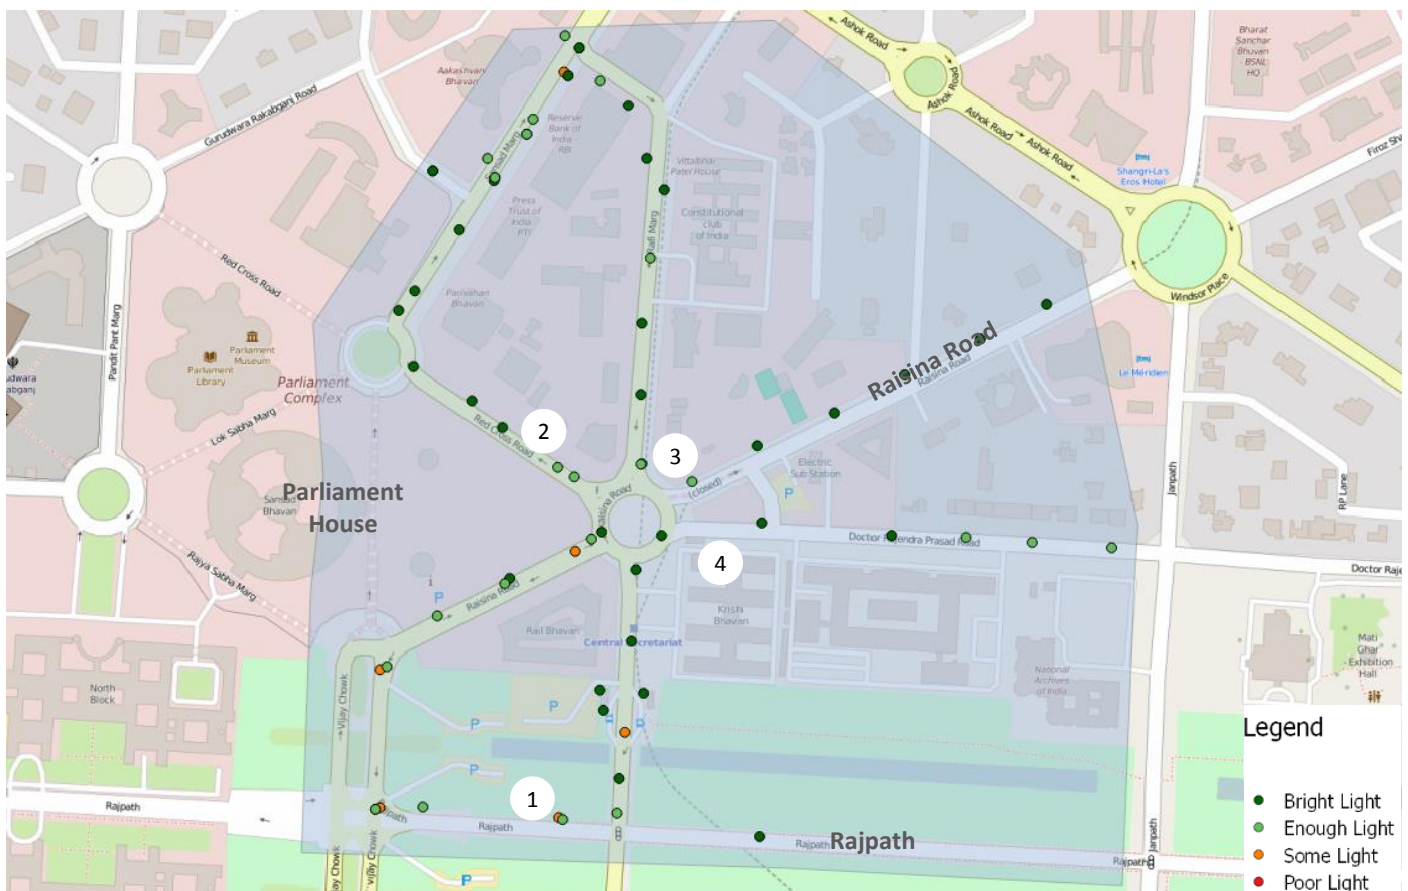
Lighting Rating

Lighting Parameter has been rated 2.4/3 i.e. Above Average. Overall, lighting was found to be enough for clear vision. However in some areas, the streetlights provided focus towards the road resulting in poorly lit footpath.

In an administrative zone, where pedestrian movement is more, the streetlights are provided facing the roads. This results in well lit road but dim lit footpath.

All the radial junctions are brightly lit, however along the inner roads within this area, some streetlights are hidden behind foliage resulting in low levels of lighting in the area.

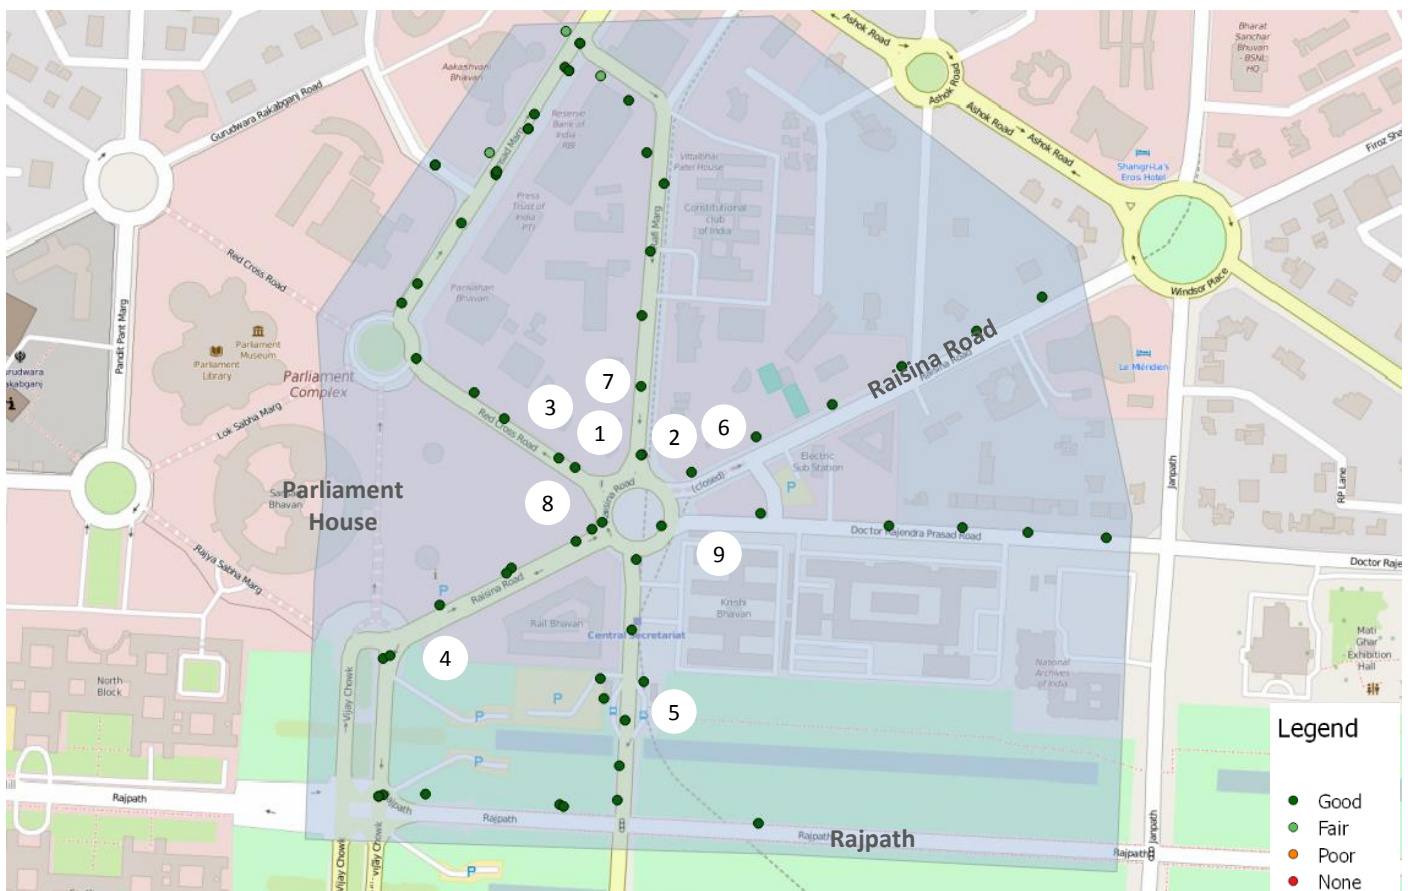
Walkpath Rating

Walkpath Parameter has been rated 2.9/3 i.e. Good. The footpath exists throughout the audit area and is well maintained. However, commonly observed on footpath are various types of obstructions— planters, signage, advertisement boards etc.

In an administrative zone with high footfall, there are street vendors obstructing the walkpath. Some street vendors are provided a designated kiosk. Similar provisions should be provided for other hawkers so that the pavement is clear for pedestrian use.

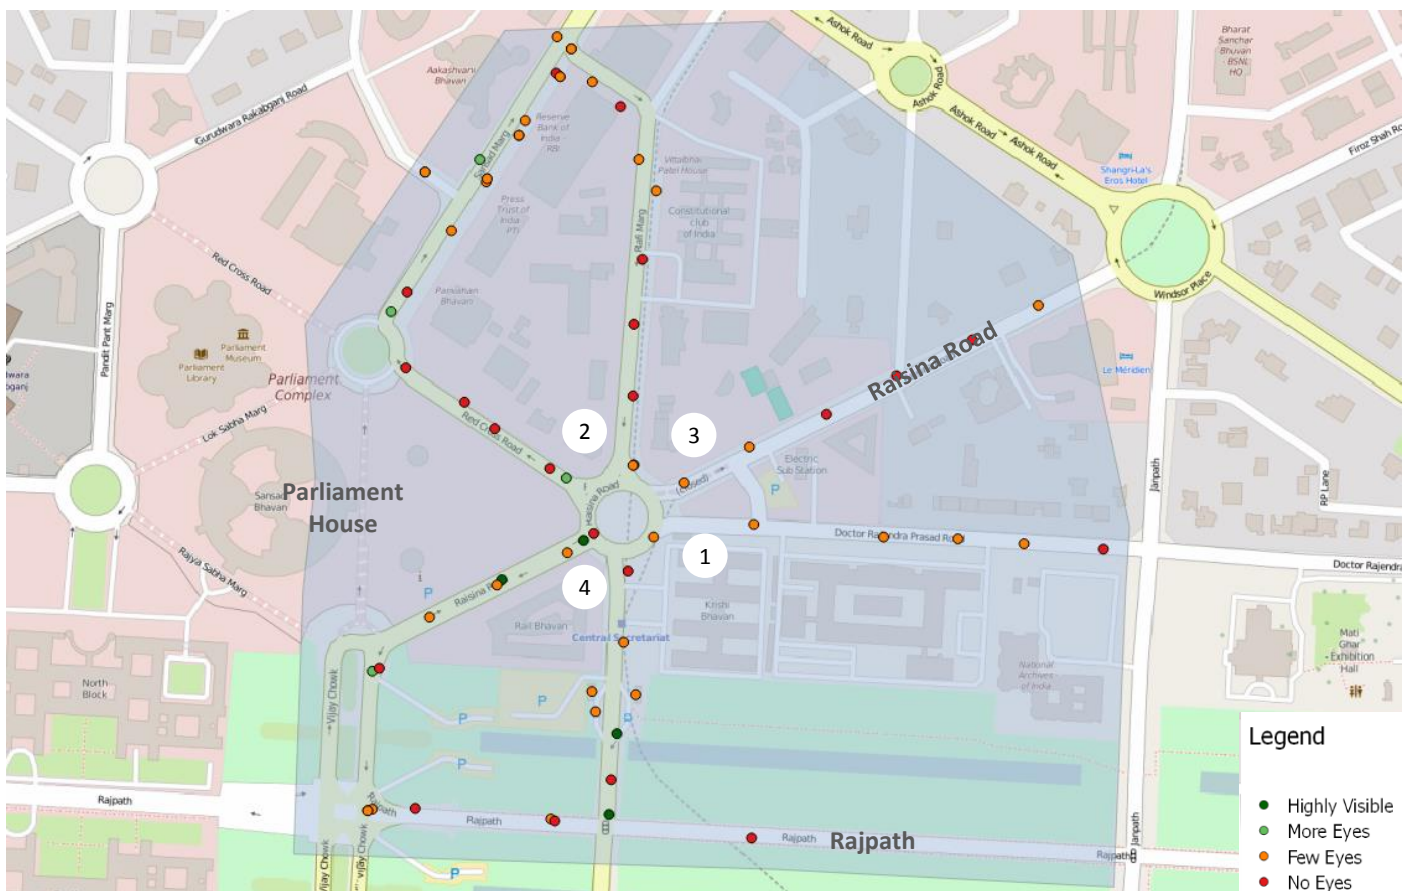
Visibility Rating

Visibility Parameter has been rated 0.9/3 i.e. Below Average. With offices closed at 6 PM, there is hardly any activity on streets at night resulting in “no eyes on the street”. While there is some visibility near the entry/ exit of metro station due to the presence of vendors, largely the stretch offers very poor or no eyes on the street owing to high boundary walls. In such cases, the visibility can be improved by lowering the height of opaque boundary walls

These should be replaced with grills such that a visual connection is maintained between the pedestrian and the building’s premises. This would offer some security and eyes to the pedestrian on the street.

Visibility needs to be further enhanced by creating a designated space for the vendors in a way that, they do not obstruct the path of the pedestrians.

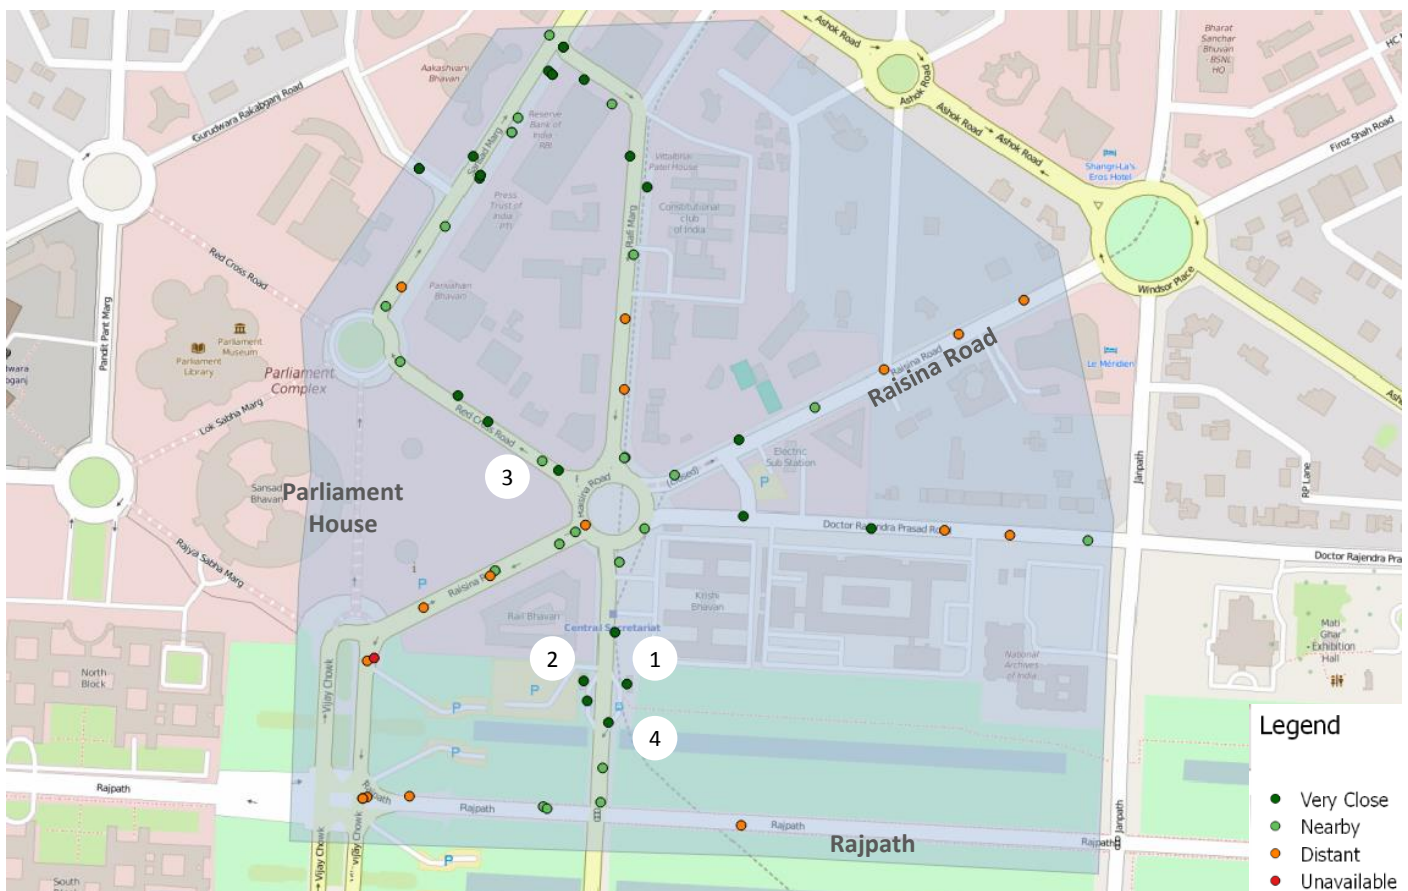
Rating of Public Transport

Public Transport Parameter has been rated 2.1/3 i.e. Above Average. Being an administrative zone, this area is well connected through metro and bus. Autos are available at every entry/ exit gate of the metro station. However, proper stand is not provided for the autos. It results in autos occupying the main road.

Designated Para-Transit hubs for autos need to be created near the metro station and bus stop. These hubs should also be integrated with the existing temporary stalls and vendors. These hubs should be well lit and equipped with street furniture as well as public convenience for the people.
