# ENHANCING LAST MILE CONNECTIVITY

## a safety analysis of the I.N.A. Metro Station

# I.N.A.

**SAFETY SCORE: 3.2/5**

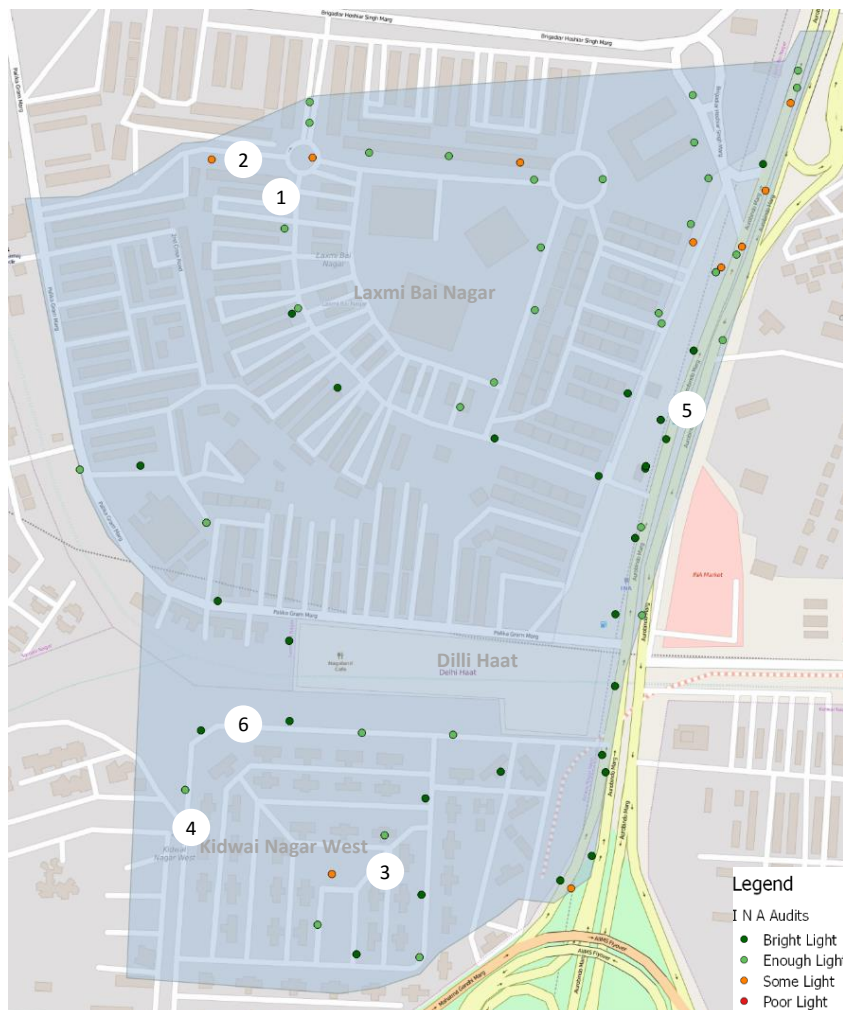
Lighting Rating

Lighting Parameter has been rated 2.3/3 i.e. Good. Along the main Aurobindo Marg lighting is enough for clear visibility. However, currently the streetlights have been provided focusing towards the road and not the footpath. Pedestrian scale streetlights along the footpath will ensure a brightly lit pedestrian path safe for women to walk on at night.

Laxmi Bai Nagar is a residential area and there are women who use the metro to commute. For them ensuring safe last mile connectivity from the metro station to their house at night is important. The area has streetlights provided along the roads. However, a few were found to be un-operational. Also, along the wider main roads within this locality, the streetlights have been provided only on one side of the road. As a result, the footpath on the other side of the road has poor illumination. The high mast light has been provided along roundabouts but as one moves away from them, the roads tend to offer low illumination.

Kidwai Nagar West faces similar issues as Laxmi Bai Nagar. While this area has pedestrian scale lights they are hidden behind foliage resulting in low levels of lighting in the area.

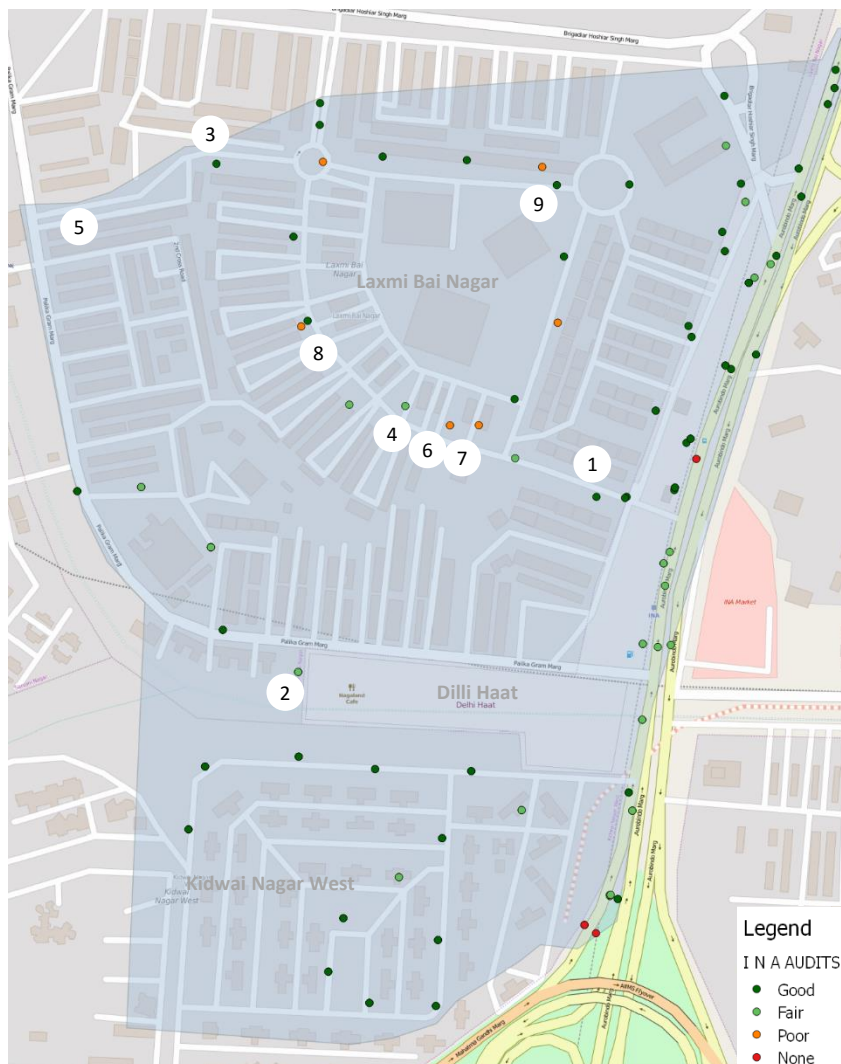
Walkpath Rating

Walkpath Parameter has been rated 2.5/3. While the walkpath exists in most parts of the area, it is in poor condition at some points. Also commonly observed are various types of obstructions along the footpath – parked vehicles, permanent structures like Police Booth, electrical units, concrete footings, signages etc.

The survey with the students from the National Association for Blind reveals that while the footpaths are in a fair condition for people with disability especially the visually impaired women, the footpaths are unsafe to walk on.

In both residential areas, vehicles being parked on the pavement is a persistent problem resulting in people being forced to walk along the vehicular carriageway making them susceptible to accidents. Separate parking areas or lane needs to be created such that the pavement is dedicatedly for pedestrian use. Along many parts the pavement is broken and is covered with construction material and debris. These need to be cleared and repaired. At certain locations the footpath is too narrow and the kerb height is too high. This too needs to be repaired.

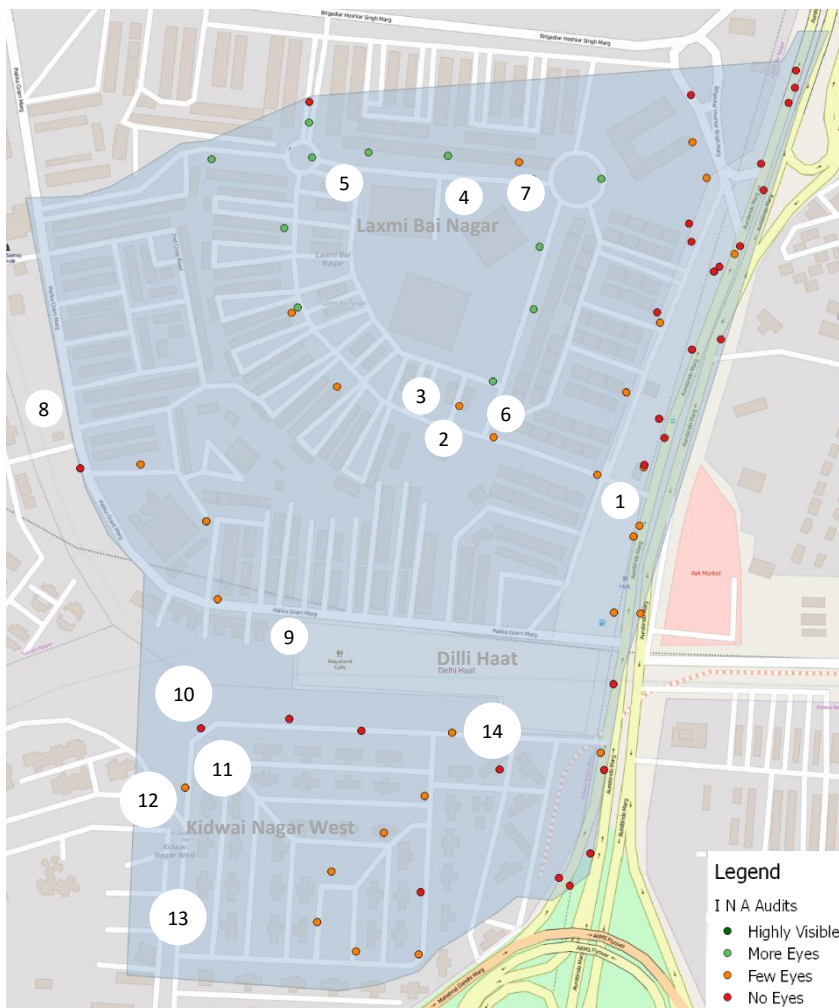
Visibility Rating

Visibility Parameter has been rated 0.7/3 i.e. Below Average. The study area comprises of three sub-zones: the main arterial road Aurobindo Marg, and the residential areas of Laxmi Bai Nagar and Kidwai Nagar West.

Along Aurobindo Marg visibility has been rated the poorest. While there is some visibility outside the metro vomitories due to the presence of vendors, largely the stretch offers very poor or no eyes on the street. Hence, making it seem unsafe for women at night.

Laxmi Bai Nagar offers some eyes on the street on account of the residences and some street vendors. However, this needs to be further enhanced by removing the boundary walls. These should be replaced with grills such that a visual connection is maintained between the pedestrian and the residences. The area also has some government offices and schools. These are setback from the road and have blank boundary walls defining their edge. These need to be reduced and functions like ATM's can be incorporated within the premises to offer some security and eyes to the pedestrian on the street. Kidwai Nagar West too being residential area offers some visibility and faces the same issue.

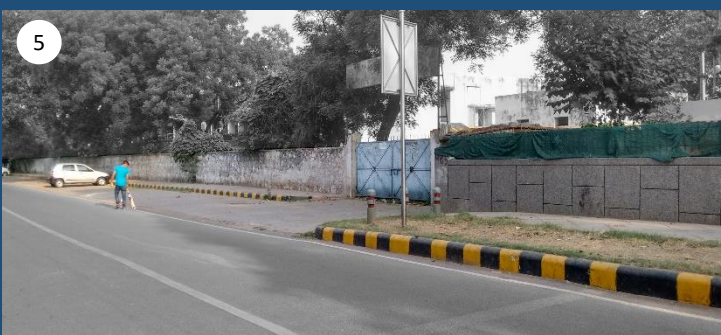
The boundary wall design of these areas needs to be modified. The solid surface of the boundary wall needs to be reduced to atleast 1m and the remaining height be achieved using a grill. It needs to be ensured that the grill is kept open at all times and not covered even for residential complexes.

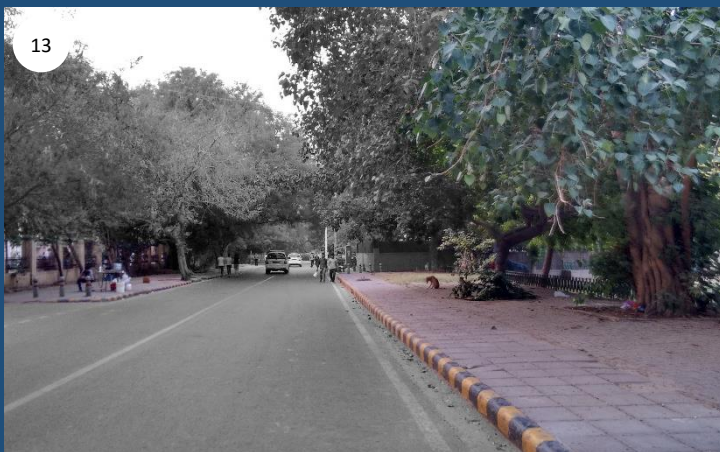
13

The Vardhman Mahavir Medical College & Hostel defines one edge on Kidwai Nagar West. Currently the edge is defined by a boundary wall. This can be replaced by either a small Park. Alternatively, shops (like bread & butter, stationary, photocopy) and cafes and food stalls catering to the needs of the students, faculty and the residents can be provided along the edge of the institute. Both sides of the road have a wide footpath sufficient to cater to the increase in pedestrian footfall. These activities will well connect with the small park on the residential side of the road. Adding street furniture would further ensure activity and presence of people and women.

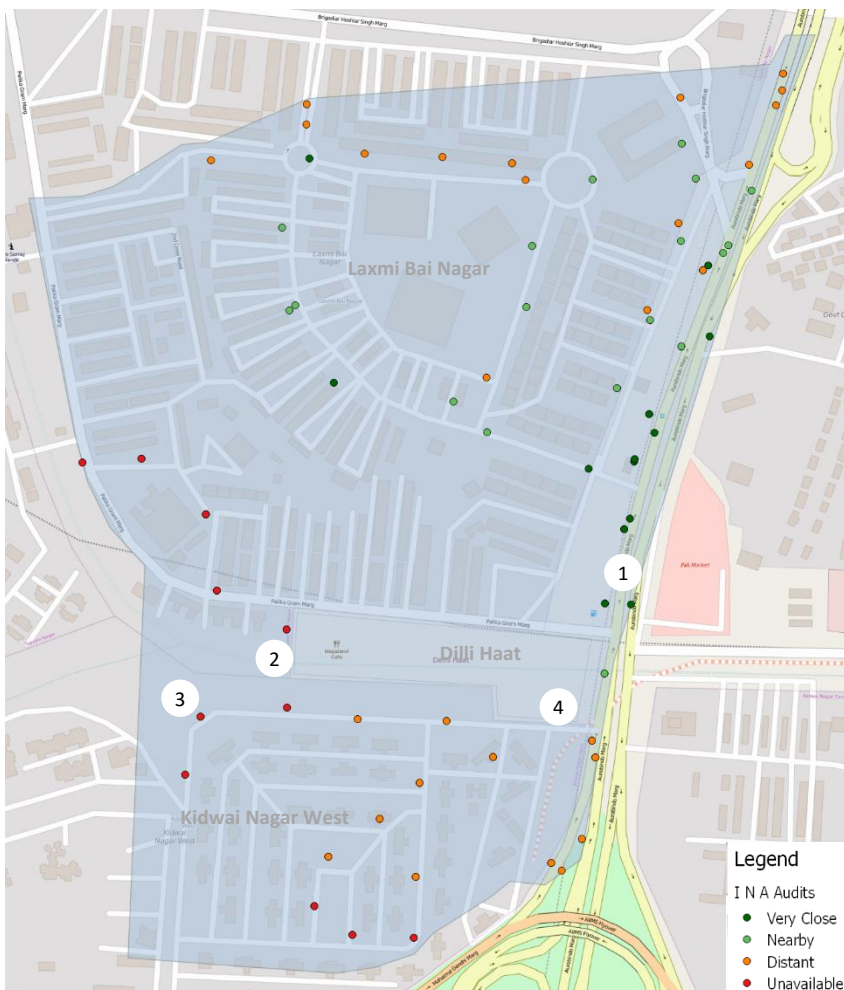
Rating of Public Transport

Public Transport Parameter has been rated 1.3/3 i.e. Average. Along Aurobindo Marg due to availability of the Metro and Bus service, there are autos and shared autos also easily available. However, as one moves away from the main road and into the residential area, there is no Bus connectivity as well. There are no designated auto stands in either of the two residential areas. However, there are few autos known to be standing outside the local markets from where one can hail them. But largely the residential areas do not have access to proper and regular public transportation facilities.

Designated Para-Transit hubs for autos/shared autos/taxis need to be created at regular distances catering to the entire residential neighbourhood. These should also be integrated with the local markets, vehicular parking zones and hawker zones. These should be well lit with waiting areas for passengers as well as proper facilities and toilets for the drivers such that they do not cause inconvenience to the residents.
