ENHANCING LAST MILE CONNECTIVITY

a safety analysis of the Janpath Metro Station

Janpath

SAFETY SCORE: 3.9/5

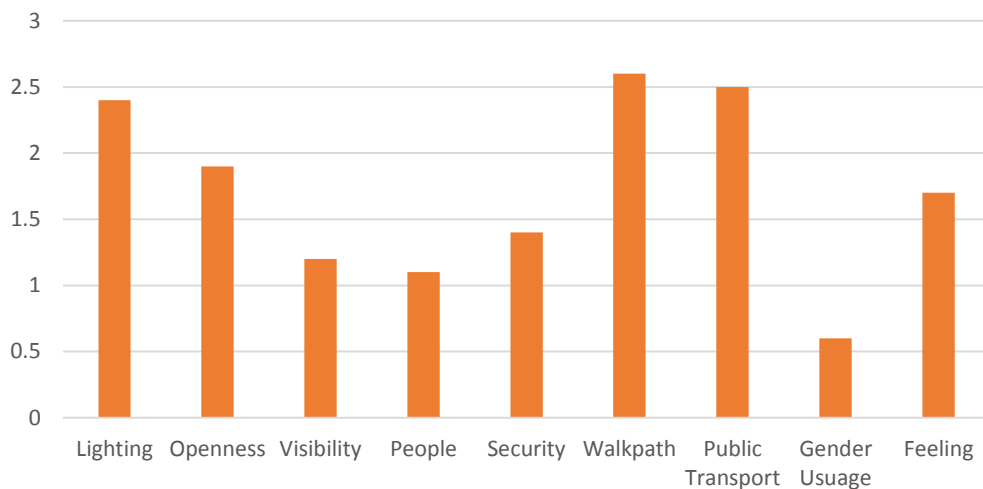
Average Audit Parameters (on a scale of 3)

Safety Audits indicate that the area around the metro station is safe. However, at few spots on Sansad Marg, the safety score is low. The parameter of Lighting and Walkpath has been rated Above Average and Good respectively. Owing to the availability of metro station, and bus stops at regular distance, the parameter of Public Transport in this area has been rated Good. With regular police patrolling in the area, the parameter of Security has been rated Average.

Visibility has been rated Below Average as except Janpath, all the other roads offer low visibility post sunset. With offices getting closed by 7PM, the number of people on streets decreases. As a result, the parameter of People and Gender have been rated Below Average and Poor respectively. Overall, auditors have rated the Feeling in this area as Average.

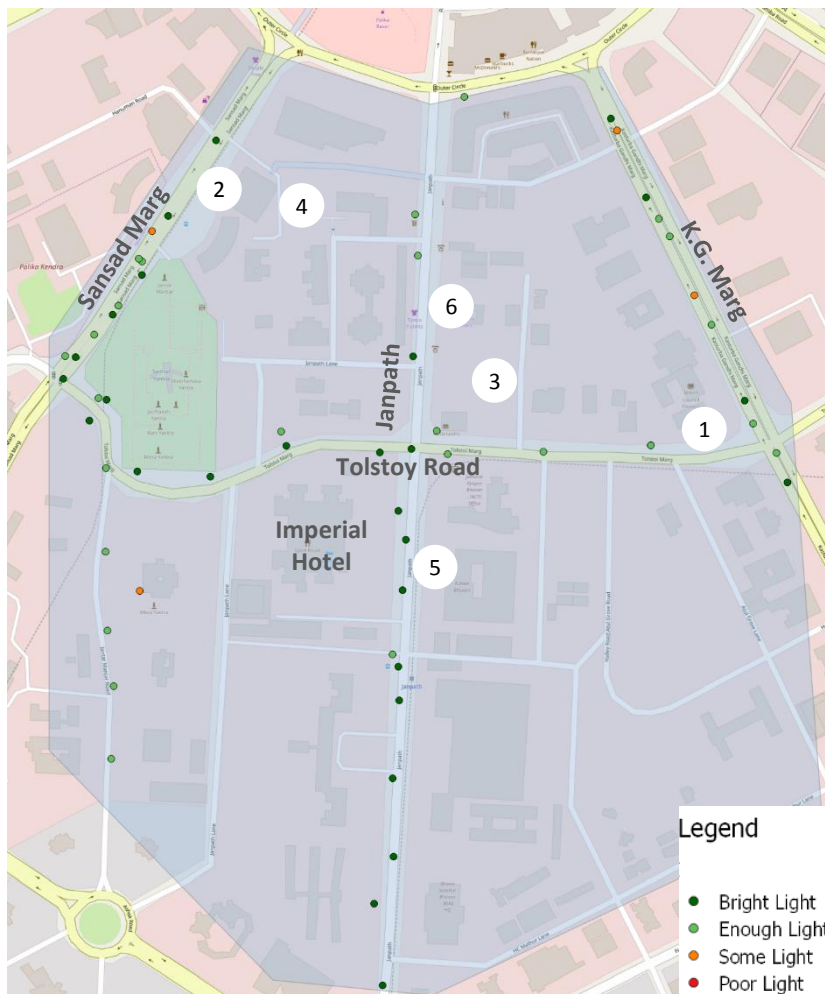
Lighting Rating

Lighting Parameter has been rated 2.4/3 i.e. Above Average. Streetlights are installed on both sides of the main road throughout the audit area.

However, streetlights are installed along the footpath facing the vehicular carriageway resulting in brightly lit road but dim lit footpath. Additional streetlights need to be installed to provide pedestrian scale lighting on the footpath.

Also, at some points streetlights are hidden behind trees' foliage. They need to be pruned regularly.

Another issue found was absence of streetlights in some inner lanes. These lanes used for parking are illuminated by temporary sources i.e. lights from vendors and adjoining building. Streetlights need to be installed in these lanes to provide uniform illumination.

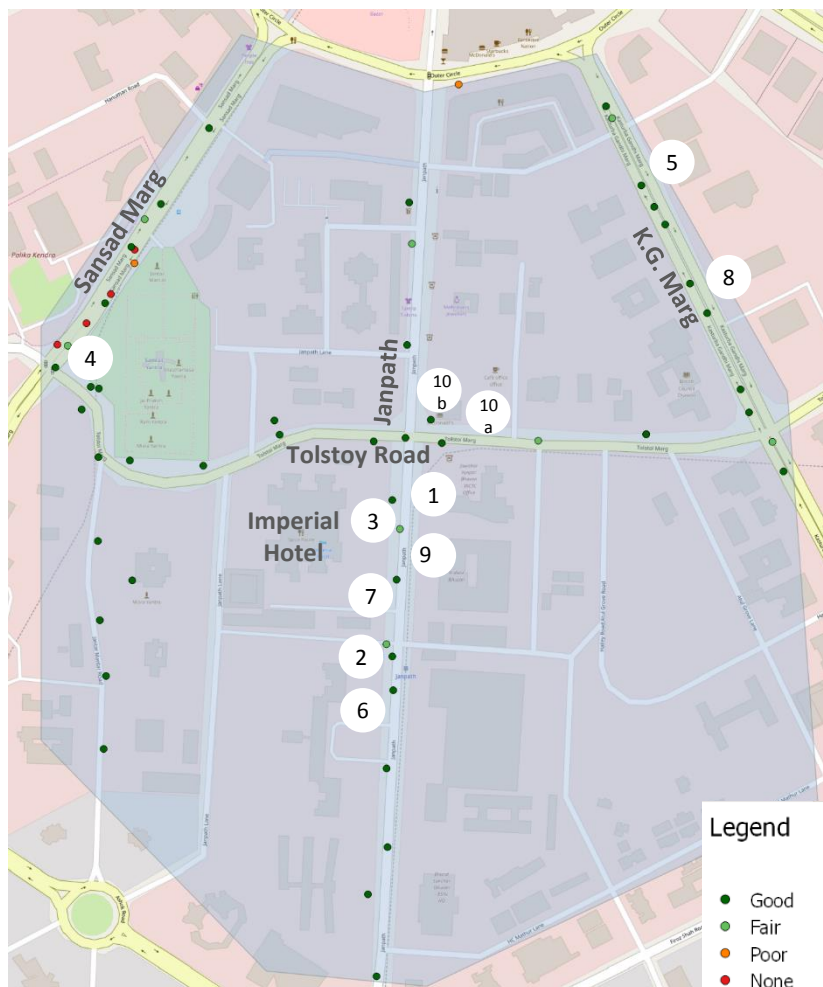
Walkpath Rating

Walkpath Parameter has been rated 2.6/3 i.e. Good. The footpath exists throughout the audit area and is well maintained.

However, commonly observed on footpath are various types of obstructions – vehicles, signage board, advertisement boards, temporary stalls etc. These obstructions should be removed to provide smooth movement for the pedestrians.

On KG Marg, there are street vendors obstructing the walkpath. Some street vendors are provided a designated kiosk, clear of the footpath. Similar provisions should be provided for other hawkers by setting up a hawker zone so that the pavement is clear for pedestrian use.

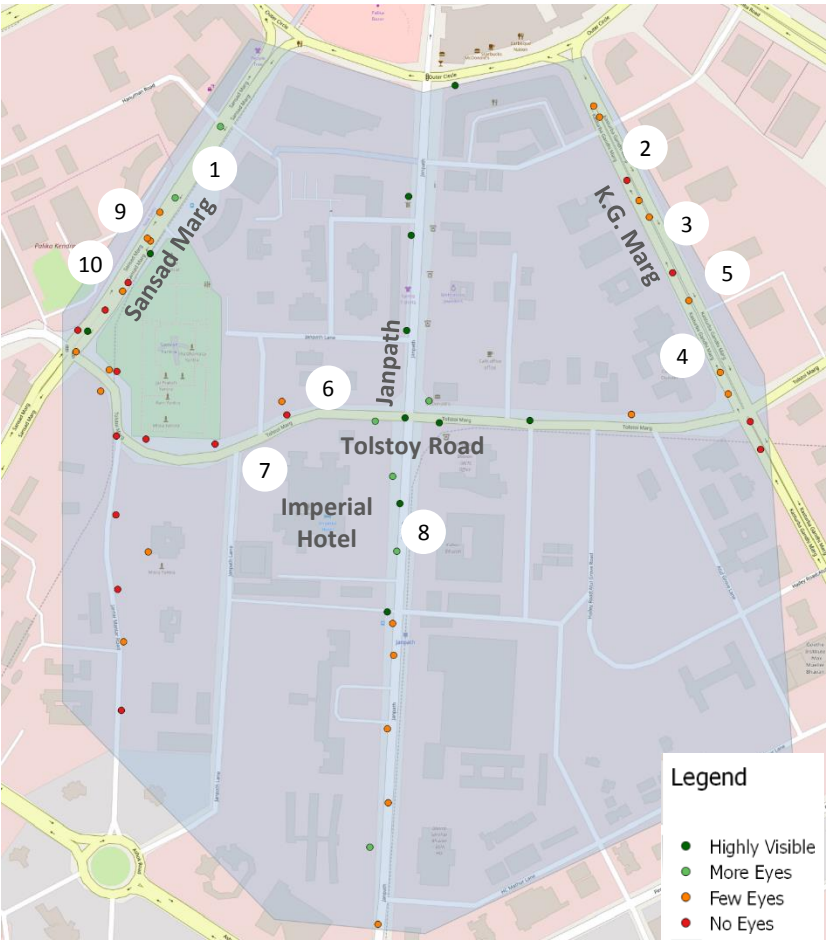
Visibility Rating

Visibility Parameter has been rated 1.2/3 i.e. Below Average. There are few temporary stalls present on Sansad Marg and KG Marg. But with many offices getting closed by 7 PM, it has resulted in low visibility.

Due to the presence of street market, shops and restaurants visibility has been rated high on Janpath. On the other hand, the stretch on Tolstoy Marg towards Sansad Marg offers very poor or no eyes on the street owing to high boundary walls. In such cases, the visibility can be improved by lowering the height of opaque boundary walls and should be replaced with grills.

At points with street vendors, a designated space should be created for them in a way that, they do not obstruct the path of the pedestrians.

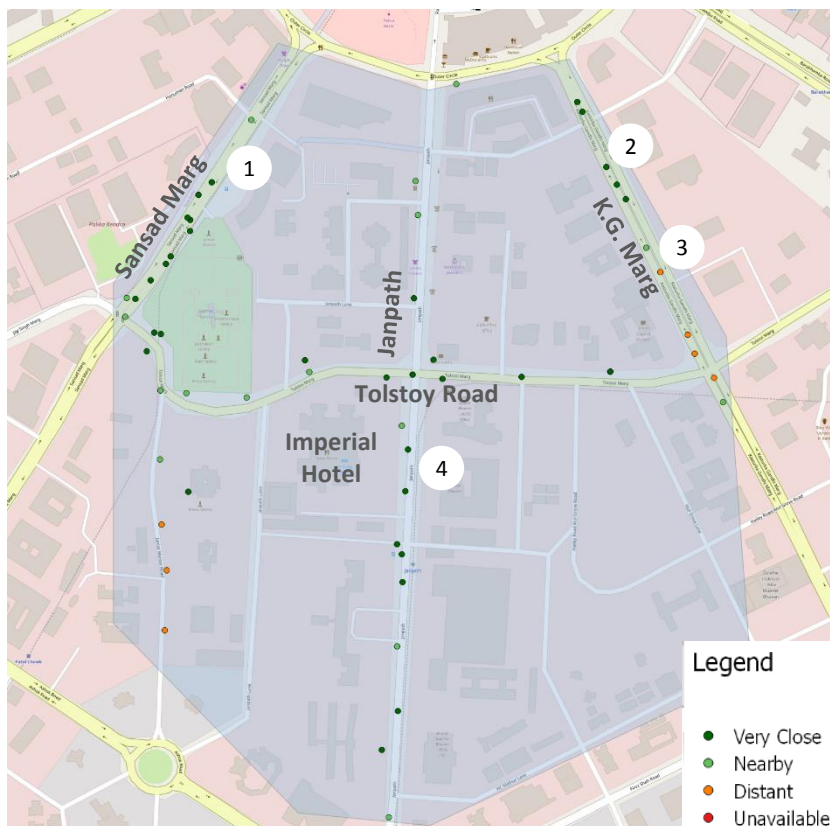
Public Transport Rating

Public Transport Parameter has been rated 2.5/3 i.e. Good. The area is well connected through multiple lines of Delhi Metro, and bus stops located at regular distance. Autos are available at the bus stop and at the entry/exit gate of Janpath market. However, proper stand is not provided for the autos. It results in autos occupying the main road. Additionally, a taxi stand is present near the Imperial Hotel.
