ENHANCING LAST MILE CONNECTIVITY

a safety analysis of the Jhandewalan Metro Station

This Report has been prepared as part of the Project being undertaken with NDMC to Enhance the Last Mile Connectivity along the metro stations within its jurisdiction. The safety audits were conducted by Safetipin team.

Jhandewalan

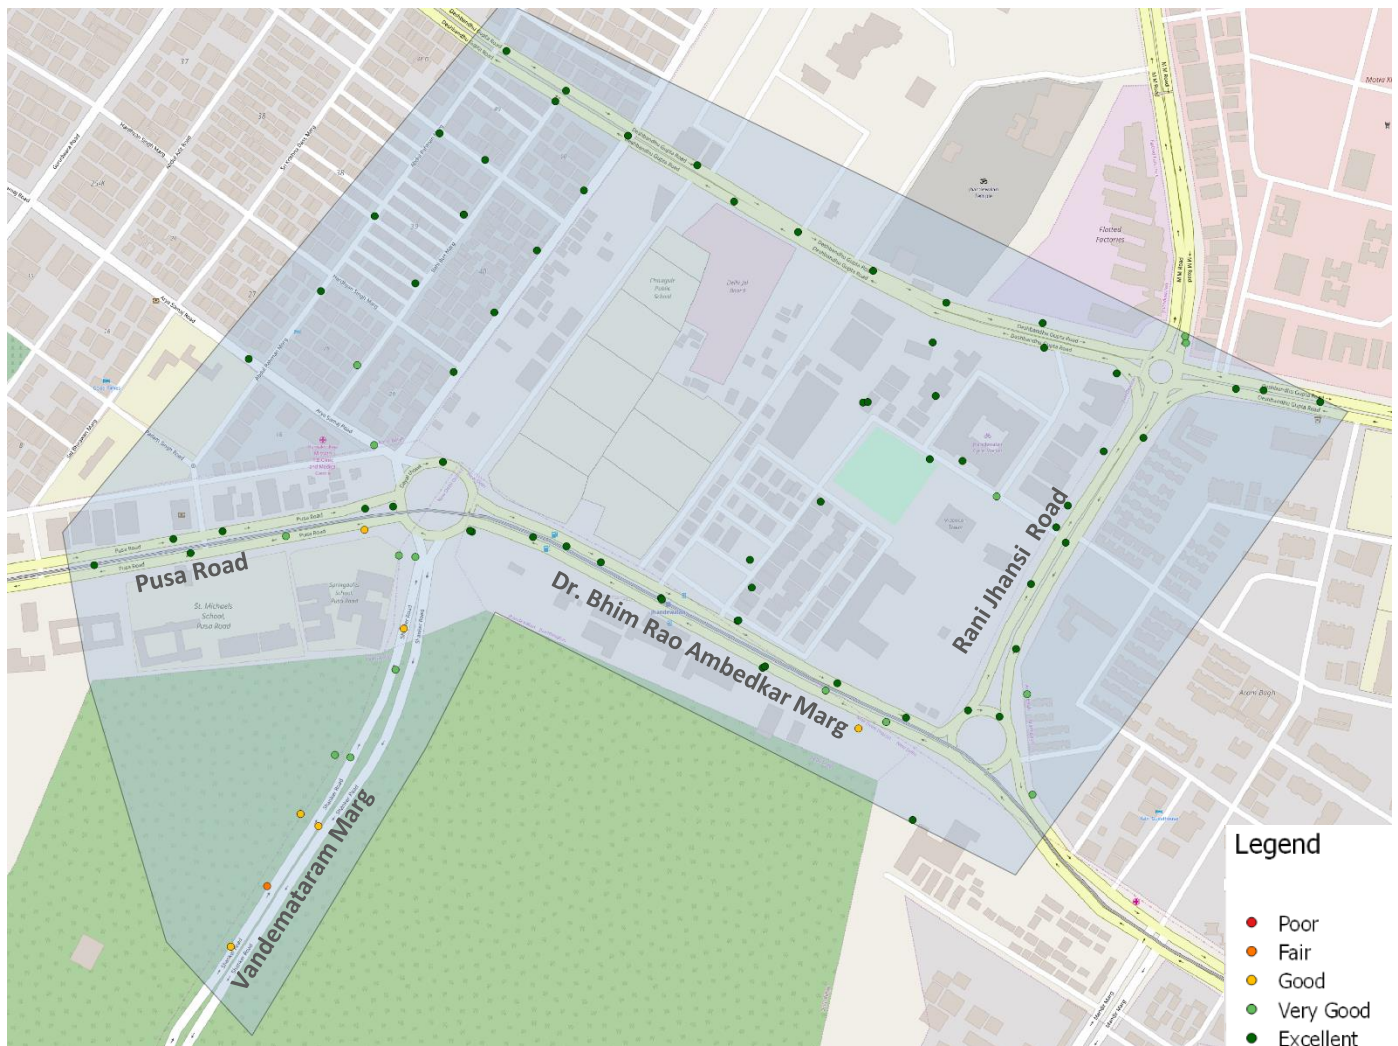
Map indicating Safety Score

Safety Audits indicate that the area around the metro station is safe. The area fares well in terms of safety score. The parameters of Lighting, Walkpath and Public Transport have been rated Above Average. After office hours, Security and Visibility parameters have been rated Below Average.

Though there are people on the streets after dark in this area, women and children are less in number. While the parameter of People has been rated Above Average, Gender Usage has been rated Poor. Overall, auditors have rated the Feeling in this area as Average.

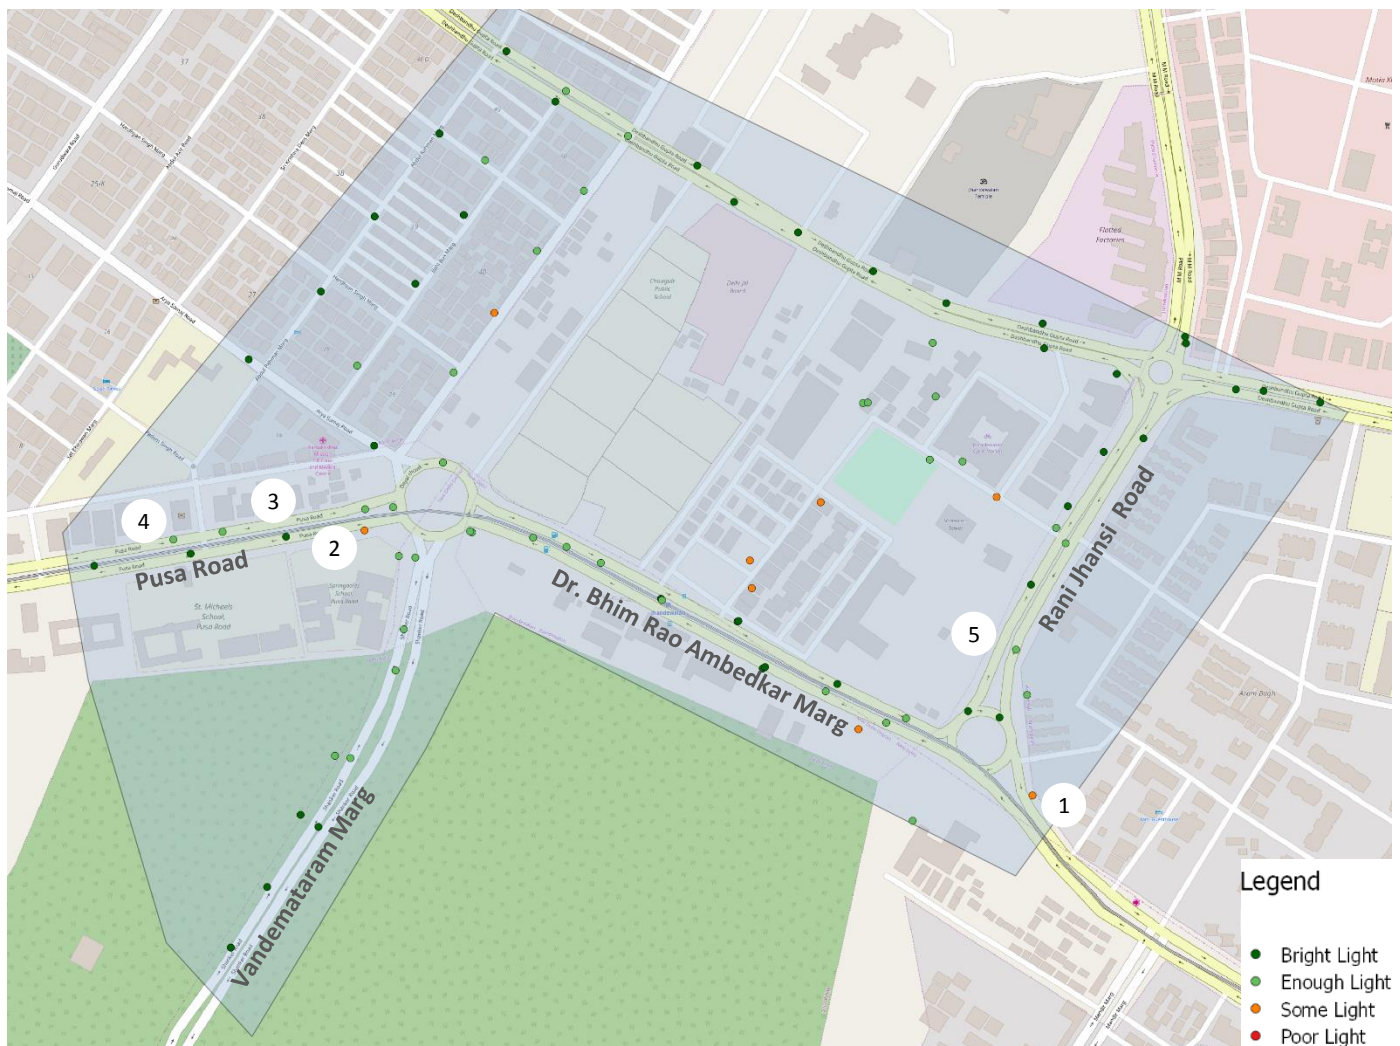
Lighting Rating

Lighting Parameter has been rated 2.4/3 i.e. Above Average. With metro line running along the central median of Dr. Bhim Rao Ambedkar Marg and Pusa Road, streetlights are installed on both sides of the main road. However, at some audit points streetlights were found hidden behind trees' foliage, and some streetlights were found non – operational. Regular maintenance checks should be carried out and tree leaves should be pruned.

At some points, additional streetlights are needed to be installed along the footpath to illuminate pedestrian path. Along the inner lanes at some points, streetlights are installed at a distance from each other, resulting in low illumination in between the streetlights. This should be checked and additional streetlights should be installed wherever required.

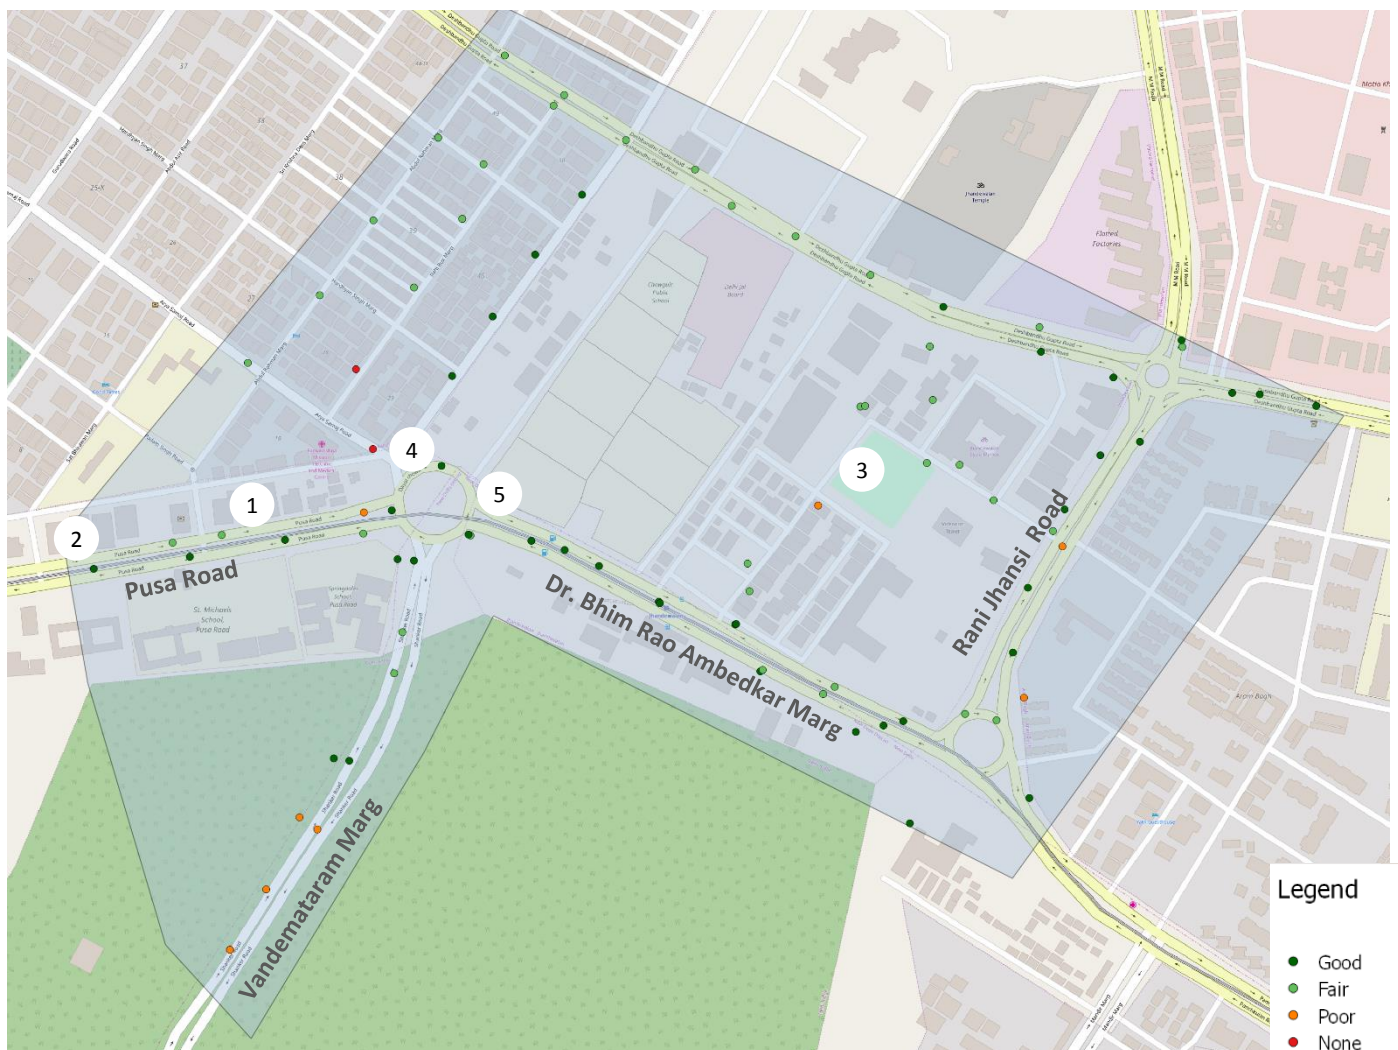
Walkpath Rating

Walkpath Parameter has been rated 2.3/3 i.e. Above Average. The footpath exists throughout the audit path. However, it was found to be broken, non – continuous and obstructed by vehicles at most of the audit points. With no ramps being provided at few points, the level of footpath is not easily accessible. A ramp of gradual slope should be provided for people on wheelchair.

The tactile paving provided on the main road is broken, and obstructed by sign boards, electrical units etc. at many points. The footpath should be continuous and clear of any obstruction. The tactile paving should be provided throughout on the footpath. The bollards should be placed to disallow vehicular parking on the footpath.

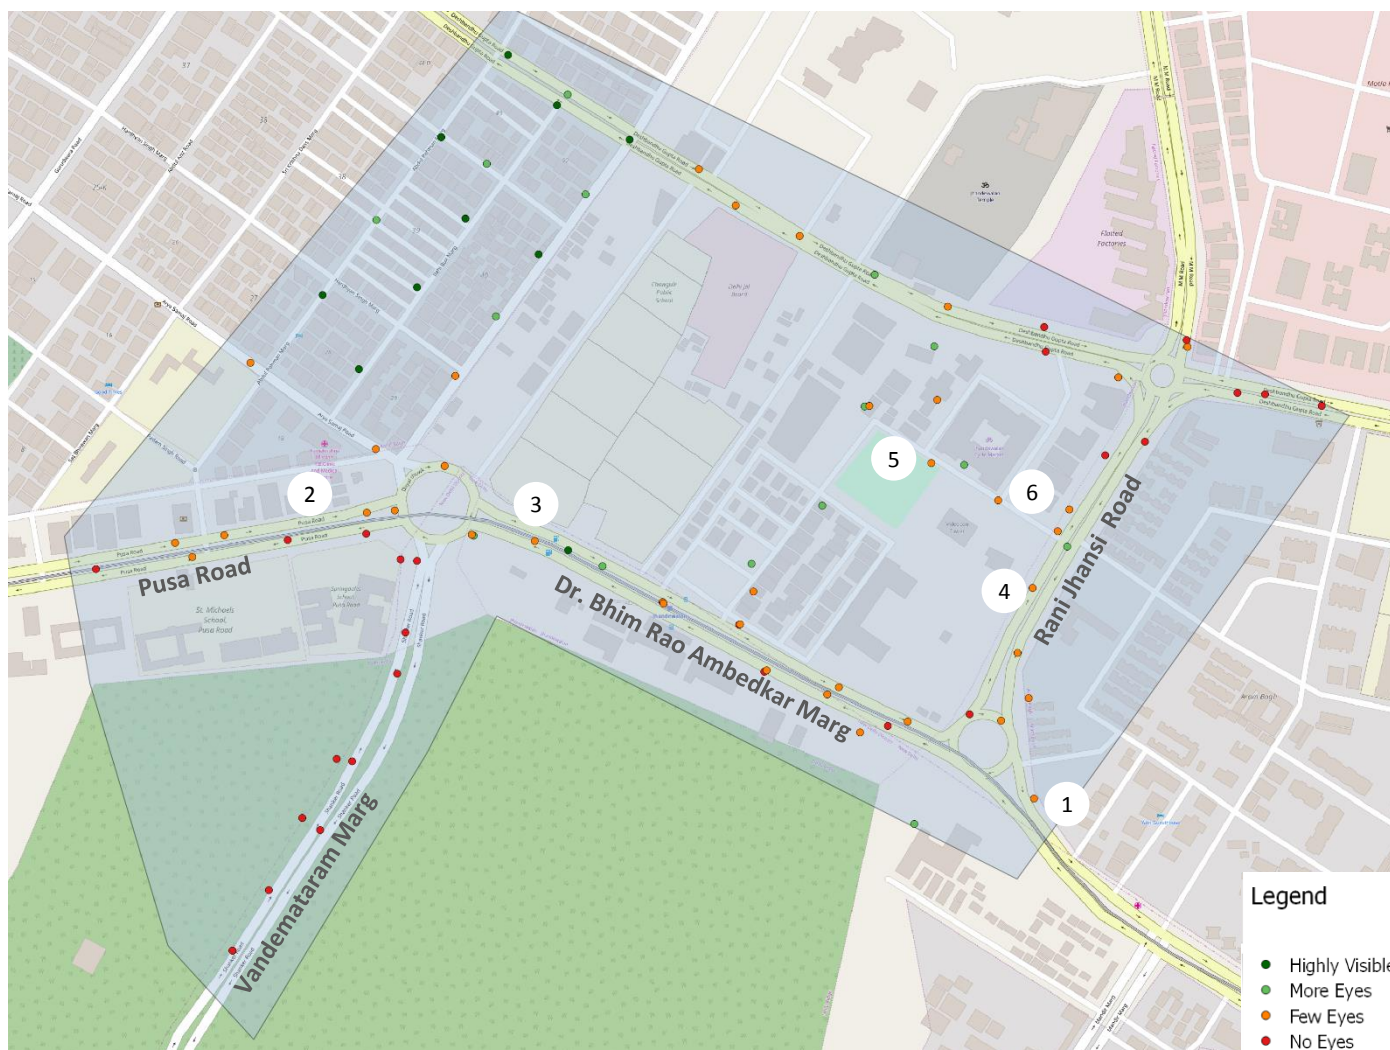
Visibility Rating

Visibility Parameter has been rated 1.1/3 i.e. Below Average. It is due to high boundary walls along the main road. Also, the area around offices become inactive and secluded after dark. The area around temples and mixed use neighbourhood is active till late evening. To improve visibility and maintain some transparency within public space, the boundary walls of the public buildings should be kept low.

Street vendors were seen along the footpath at various audit points. These spaces need to be redesigned, and designated hawker zones should be set up. Niches can also be created in the boundary walls for the hawkers. Adding facilities like street furniture and public convenience can enhance these hawker zones.

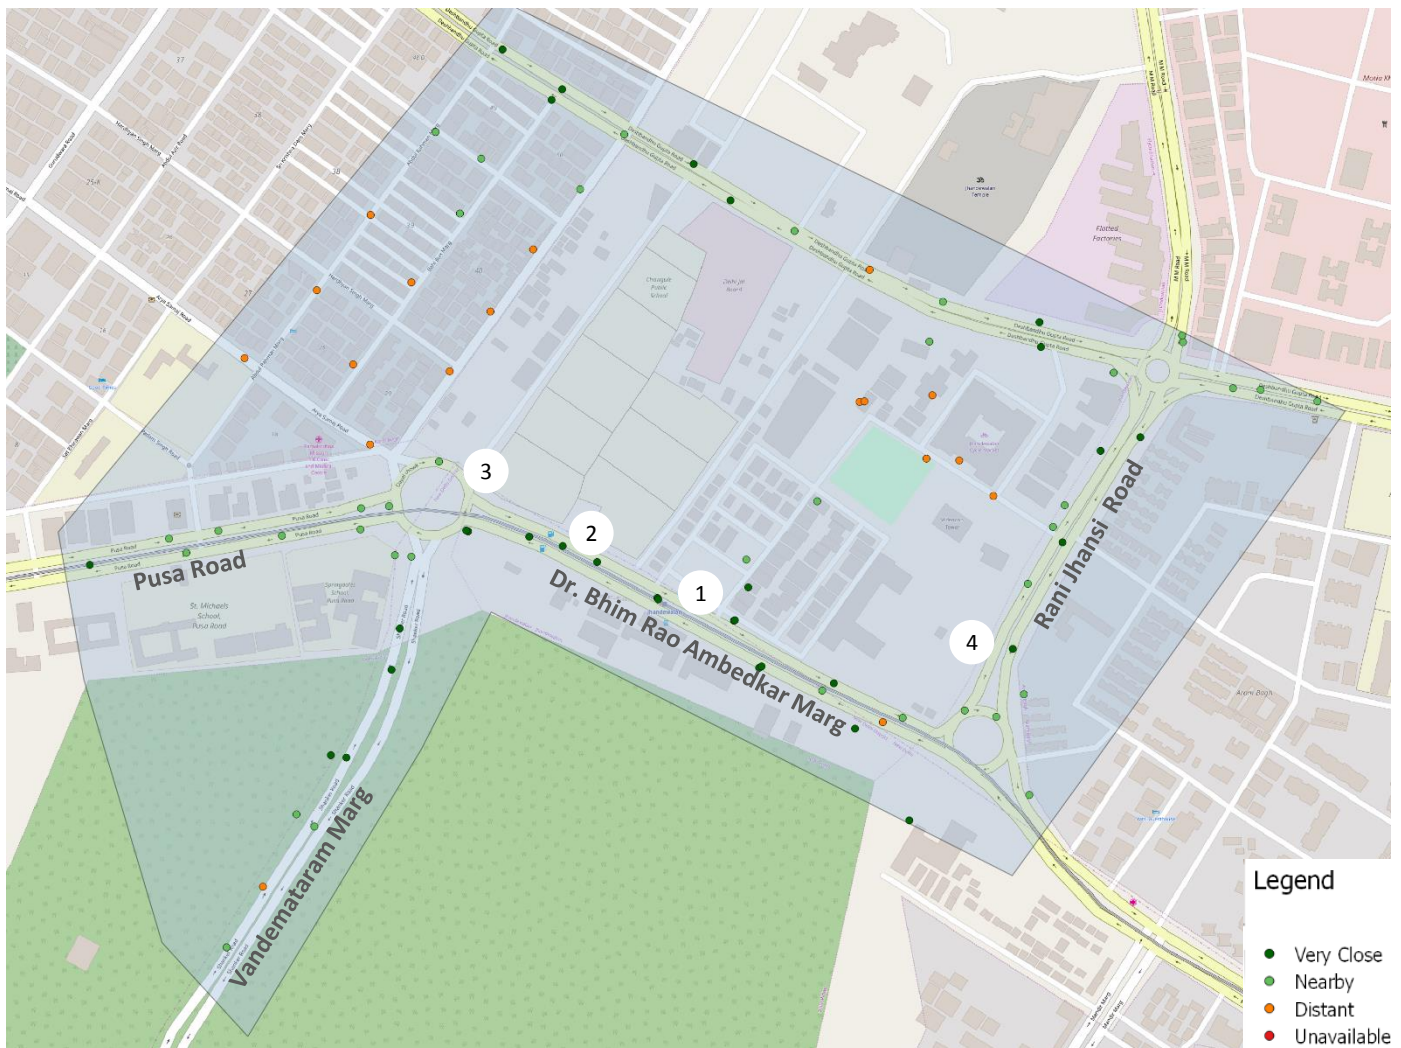
Public Transport Rating

Public Transport Parameter has been rated 2.1/3 i.e. Above Average. At the entry/ exit of the metro station, one can easily hail a cycle rickshaw or auto rickshaw. However, a designated parking space should be created for them. This para transit stand should be equipped with street furniture and a public convenience.

In the inner lanes of the residential neighbourhood, the rating of Public Transport was comparatively lower than the rest of the audit area. To improve last mile connectivity, para transit stands should be set up at regular distance within the neighbourhoods.
