ENHANCING LAST MILE CONNECTIVITY

a safety analysis of the Jor Bagh Metro Station

Jor Bagh

SAFETY SCORE: 3.5/5

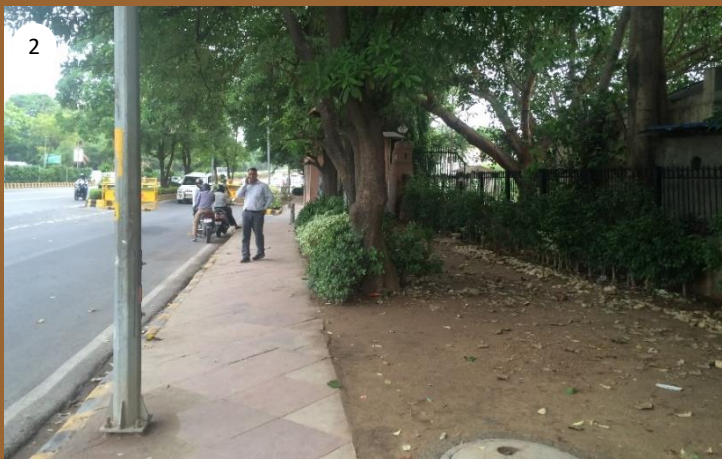
Aurobindo Marg

High Boundary wall along Aurobindo Marg. The opaque surface needs to be limited to 1m height. The remaining needed height can be achieved by a grill with barbed wire on the top. Another option is puncturing the wall to make it porous. Currently it creates an extremely blank edge to walk on. Reducing the opacity by either method would result in better visual connectivity between the private and public realm.

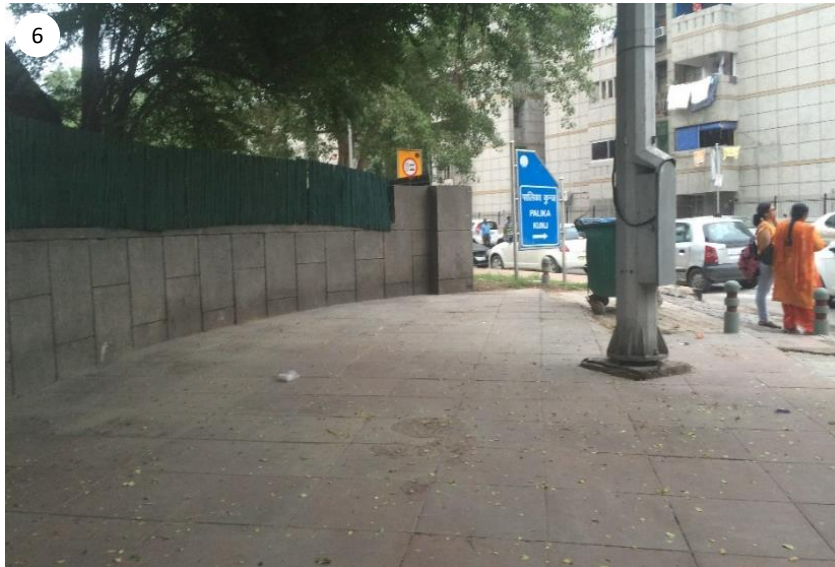
Shown in pics6 and 7 is the junction of the Data Ram Bhutani Marg and Najaf Khan Road. There is a wide paved open space on both sides of the road. There is also a green belt along the footpath. This intersection can be developed as a lively public space equipped with street furniture, a para-transit facility and Public Convenience. Weekly informal markets or haats can also take place here. These would cater to the domestic needs of the residents along with having various food stalls. This would not only activate an otherwise dead intersection but also give identity to it helping people orient themselves.
