# ENHANCING LAST MILE CONNECTIVITY

a safety analysis of the Mandi House Metro Station

# Mandi House

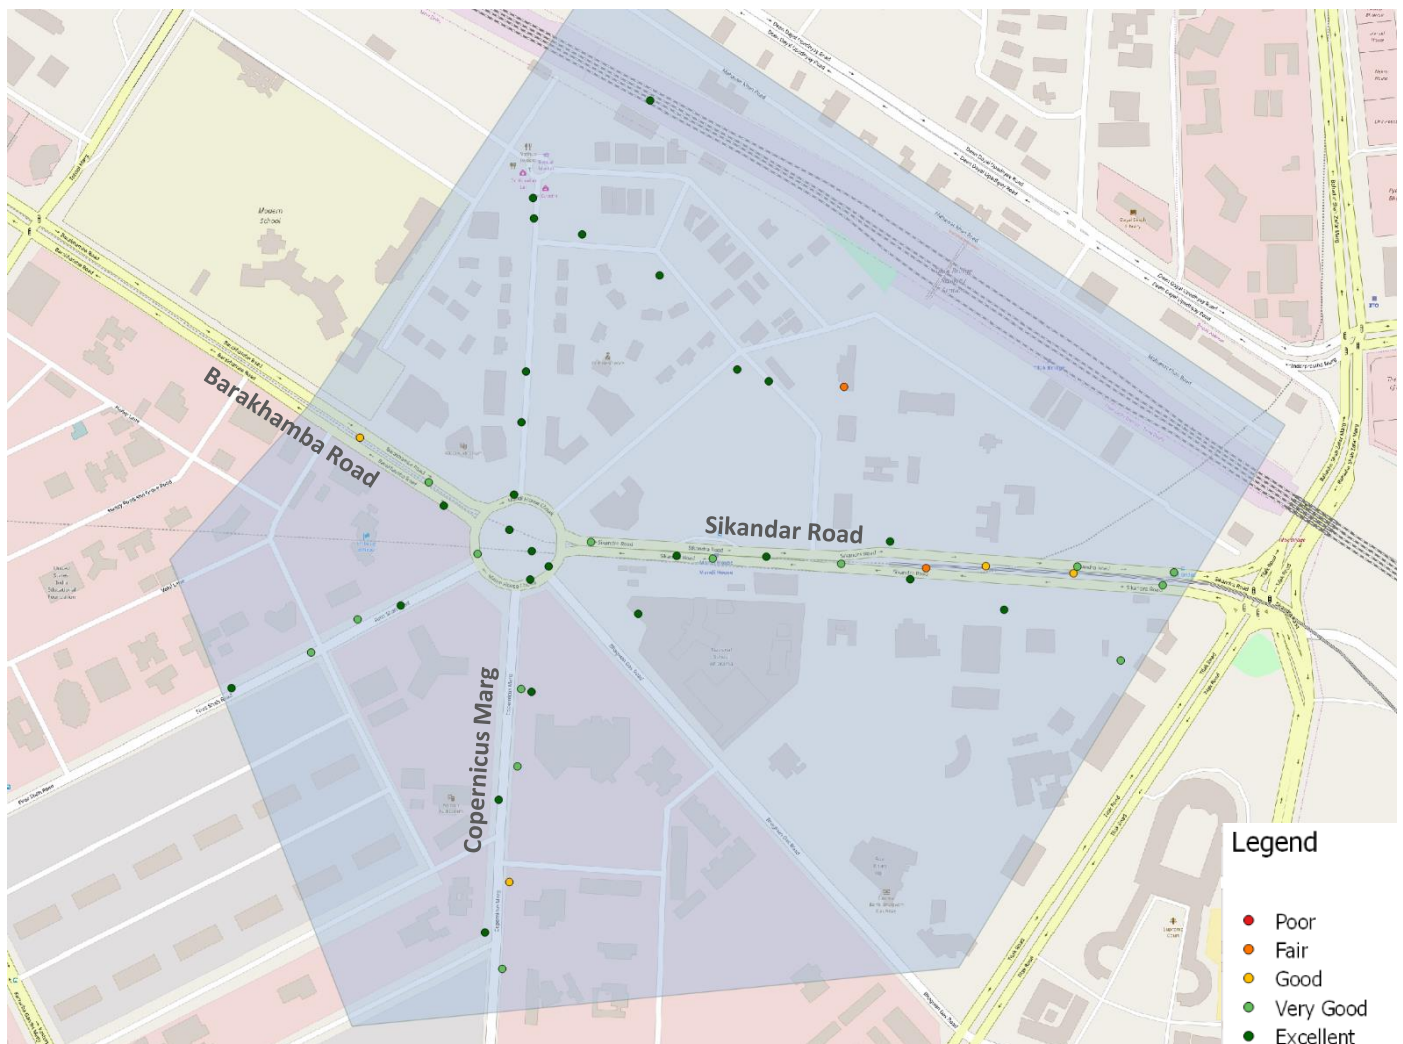
Map indicating Safety Score

Safety Audits indicate that the area around the metro station is safe. The safety score is rated lower at a few spots near the flyover on Sikandar Road. Walkpath parameter has been rated the highest i.e. Good. The parameter of Lighting and Public Transport has been rated Above Average.

Visibility has been rated Below Average due to high boundary walls of buildings. The parameters of Security, People and Gender Usage have been rated Below Average. Overall, auditors have rated the Feeling in this area as Average.

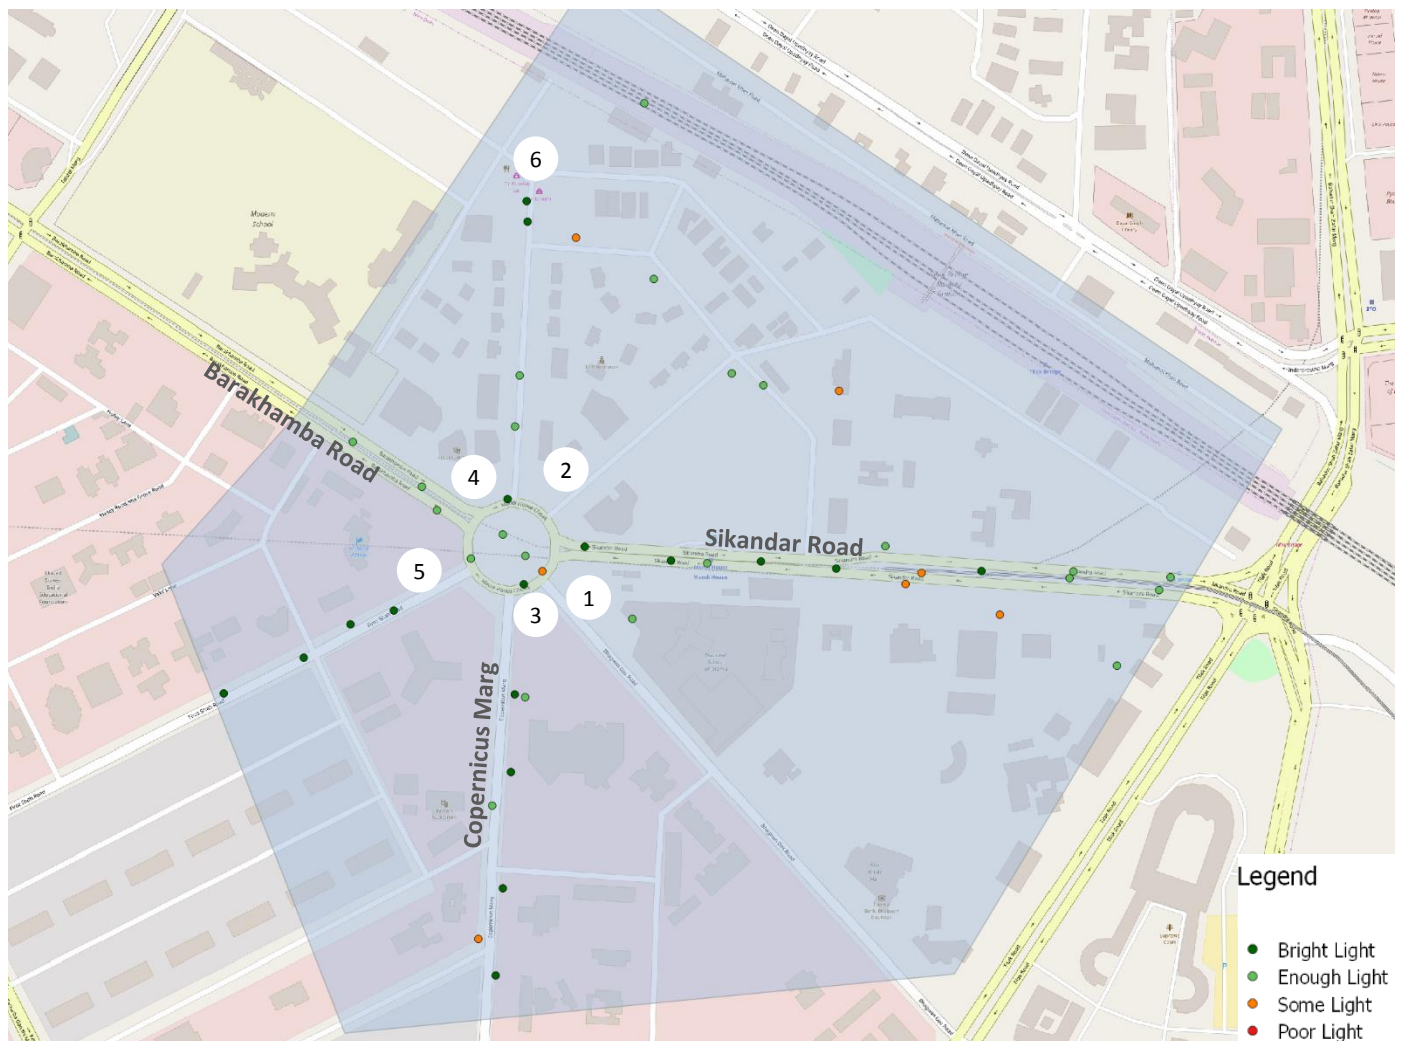
Lighting Rating

Lighting Parameter has been rated 2.2/3 i.e. Above Average. On main road except for Barakhamba and Sikandar Road, streetlights are installed on the edge of the footpath facing the vehicular carriageway resulting in the brightly lit road but dim lit footpath. On Barakhamba and Sikandar Road, streetlights face both the main road and service road, thus providing illumination on the footpath as well. Pedestrian scale streetlights should be installed on all the other roads.

Another issue found was the absence of streetlights on the pedestrian pathway at the junction. The pavement is illuminated by temporary sources, i.e. lights from adjoining building or kiosks. Streetlights need to be installed along these junctions to provide uniform illumination. At some points, streetlights are hidden behind trees' foliage. Tree leaves need to be pruned regularly.

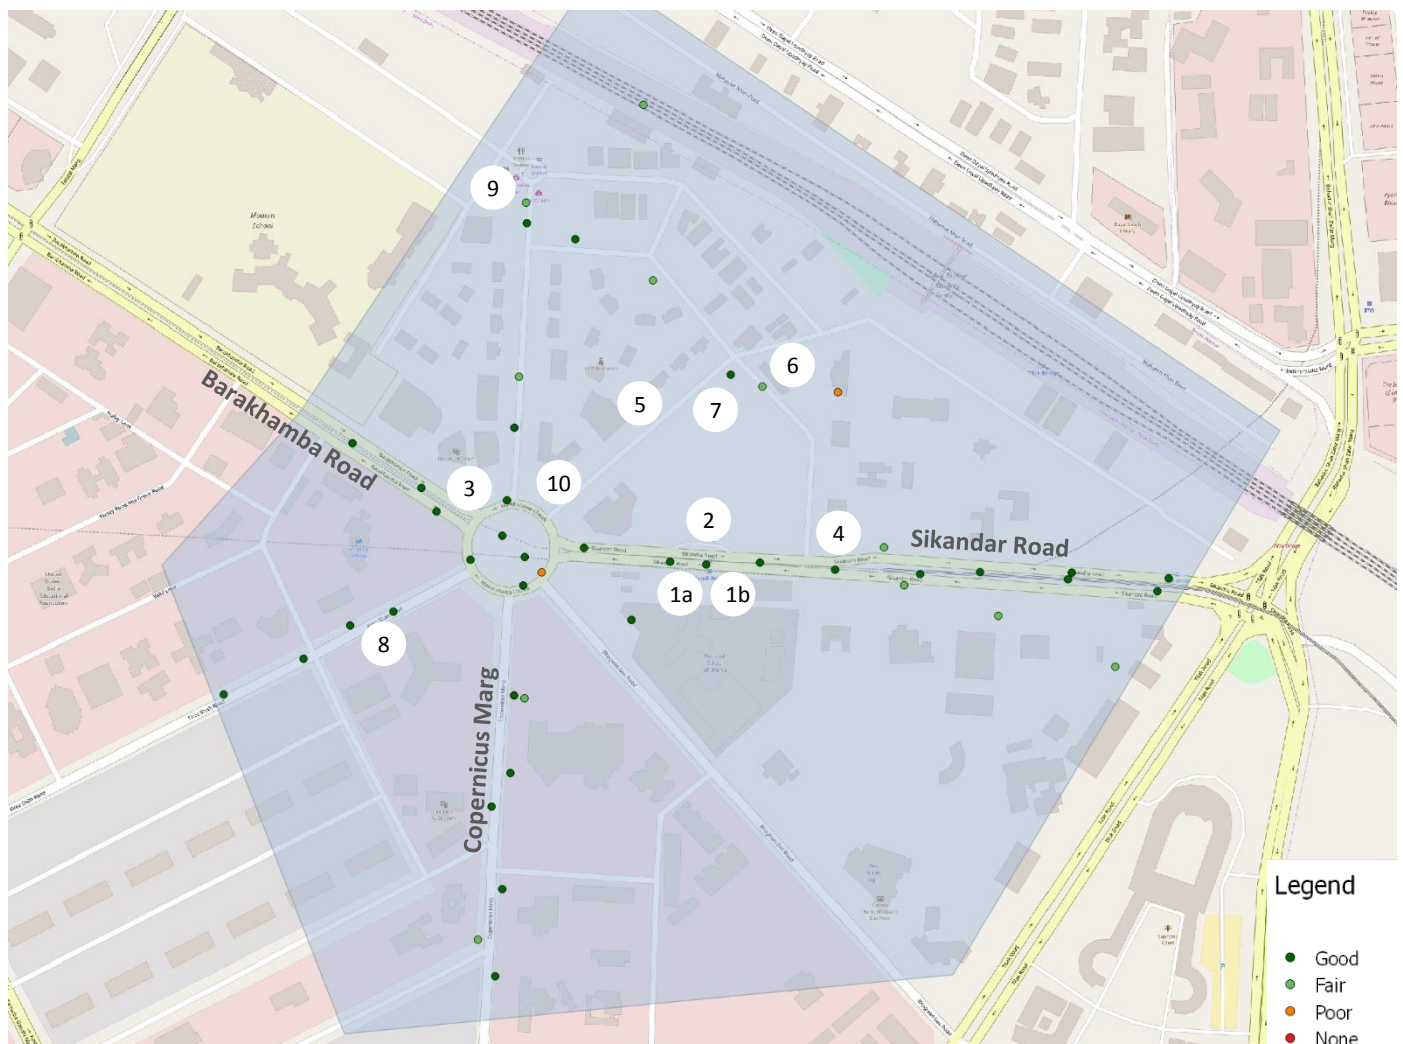
Walkpath Rating

Walkpath Parameter has been rated 2.7/3 i.e. Good. The footpath was found to be well maintained in areas around cultural institutions. However, in residential and market area, footpath is obstructed by streetlights, vehicles, sign boards etc. The street furniture should be placed along the edge of the footpath. Vehicular parking should be disallowed on the footpath.

Also, seen at the metro station (Gate no. 3, 4) was tactile paving being provided all the way from the lift to the bus stop. However, on the other side of the road near Gate no. 1,2 the tactile paving provided is obstructed by an advertisement board and ends abruptly. The tactile paving should be provided throughout the footpath, clear of any obstruction.

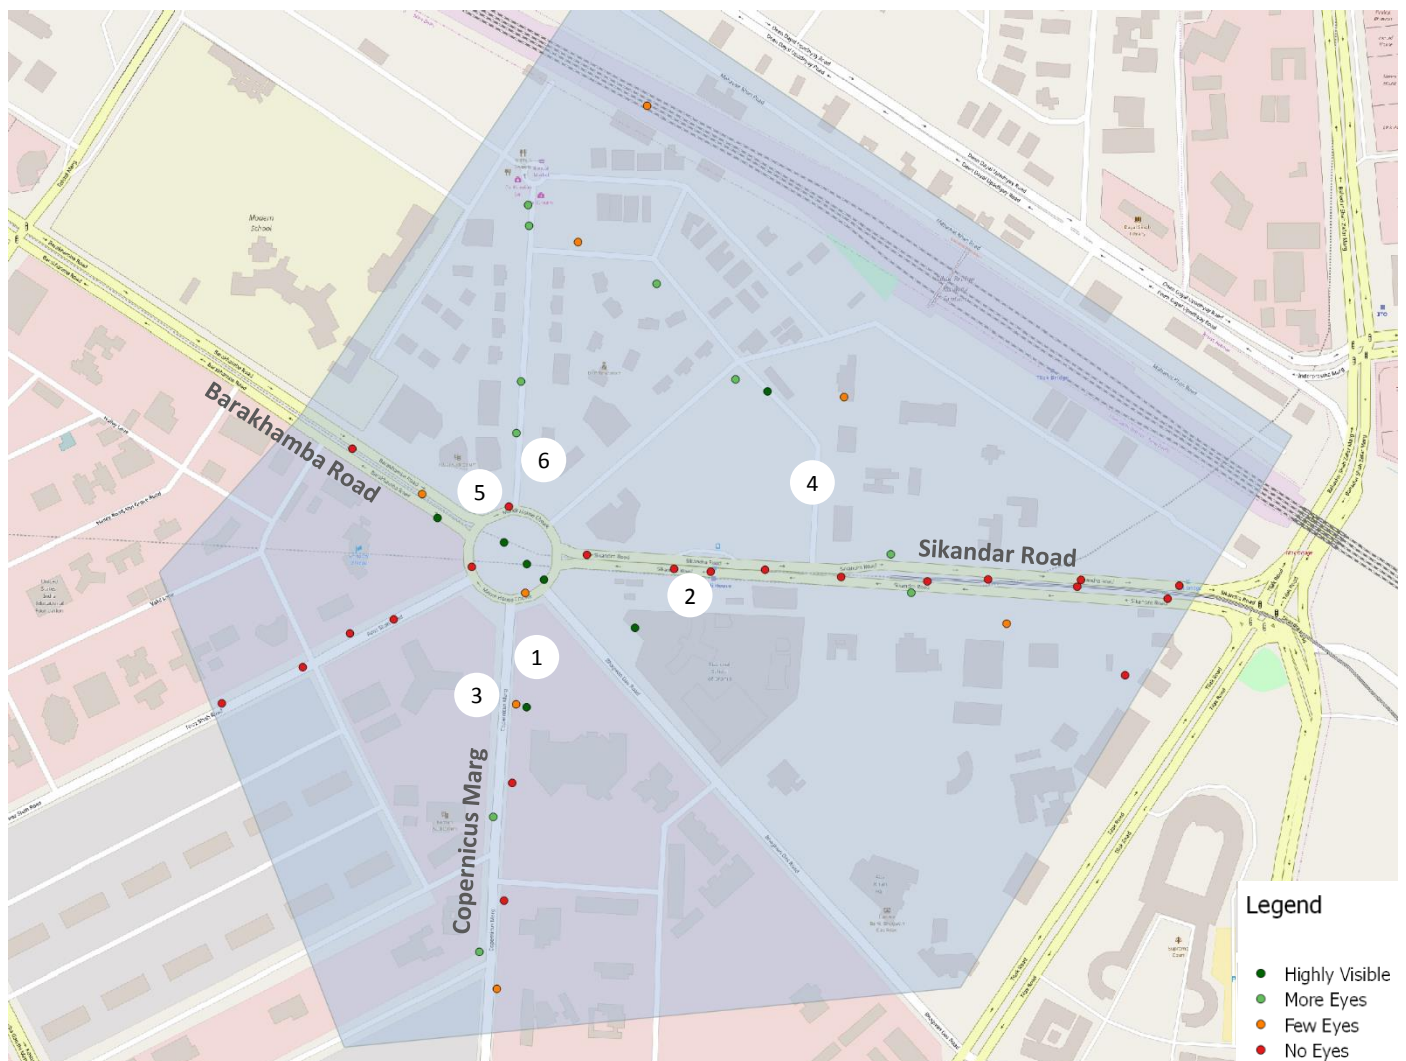
Visibility Rating

Visibility Parameter has been rated 1.1/3 i.e. Below Average. There are few kiosks and street vendors present at various audit points, that provide some visibility. But at most of the points, due to high boundary walls there is low visibility. The exception is around cultural institutions, where the boundary is defined by low height solid wall with grills, that brings some transparency.

The street vendors present near the metro station and the bus stops occupy the footpath and bicycle lane. At metro stations and bus stops, a designated space should be created for them in a way that, they do not obstruct the path of the pedestrians and cyclists. This space should be brightly lit and equipped with street furniture.

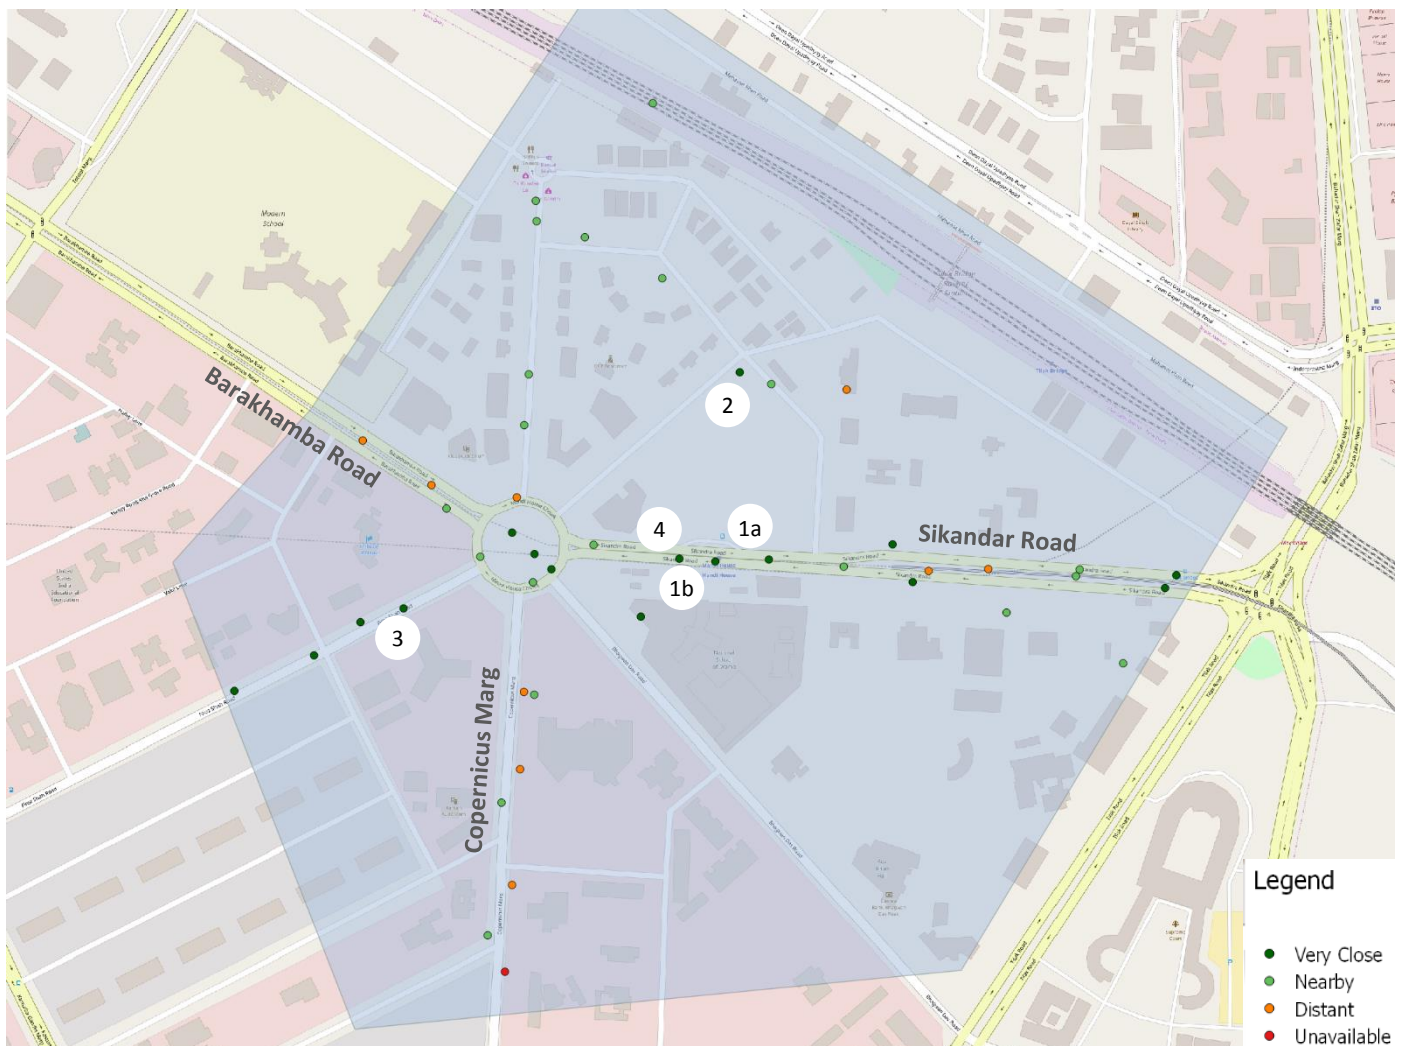
Public Transport Rating

Public Transport Parameter has been rated 2.1/3 i.e. Above Average. Autos are available at the entry/exit gate of metro station and bus stops. However, in the absence of proper auto stand, it results in autos occupying the bus lane. Designated stands for autos should be set up near the bus stops.

Auto stands should also be set up in the residential neighbourhood at regular distance. These stands can be set up near Bengali Market and institutions, where several autos were seen waiting. Additionally, para-transit stands should have public convenience for the drivers.
