ENHANCING LAST MILE CONNECTIVITY

a safety analysis of the Patel Chowk Metro Station

Patel Chowk

SAFETY SCORE: 3.9/5

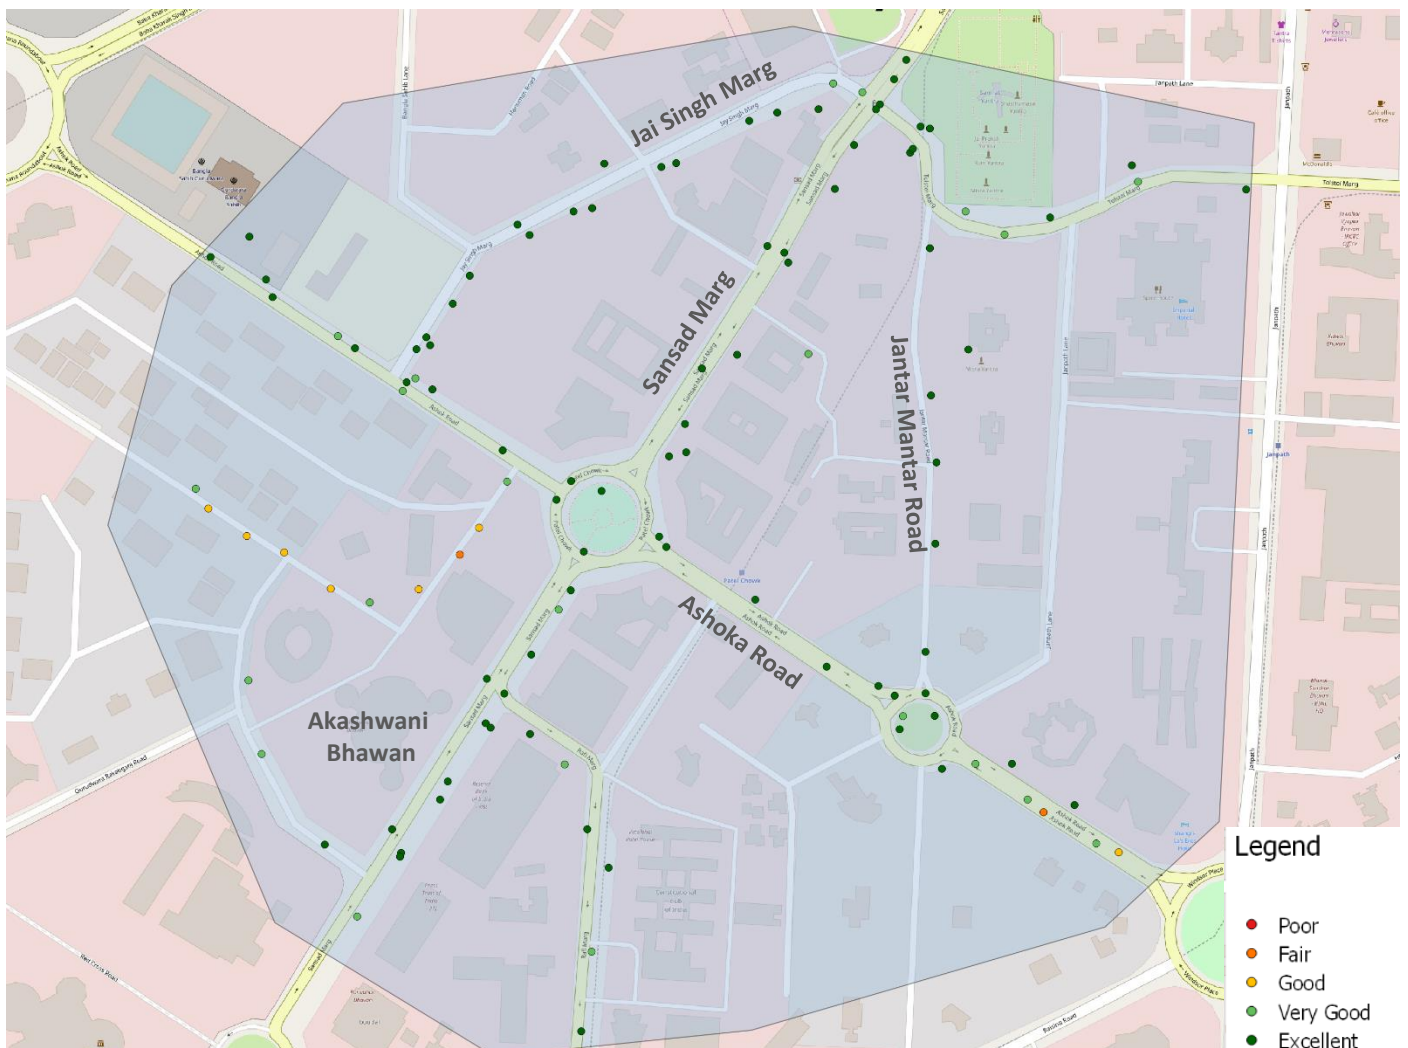
Map indicating Safety Score

Safety Audits indicate that the area around the metro station is safe. Due to lack of activity and pedestrians, the lane behind Akashwani Bhawan has been rated lower in terms of safety. The parameters of Lighting and Walkpath have been rated Good. Public Transport parameter is rated Above Average.

The number of pedestrians decreases after office hours. Therefore, People and Gender Usage parameters have been rated Below Average and Poor respectively. Visibility and Security parameters have been rated Below Average as well. Overall, auditors have rated the Feeling in this area as Average.

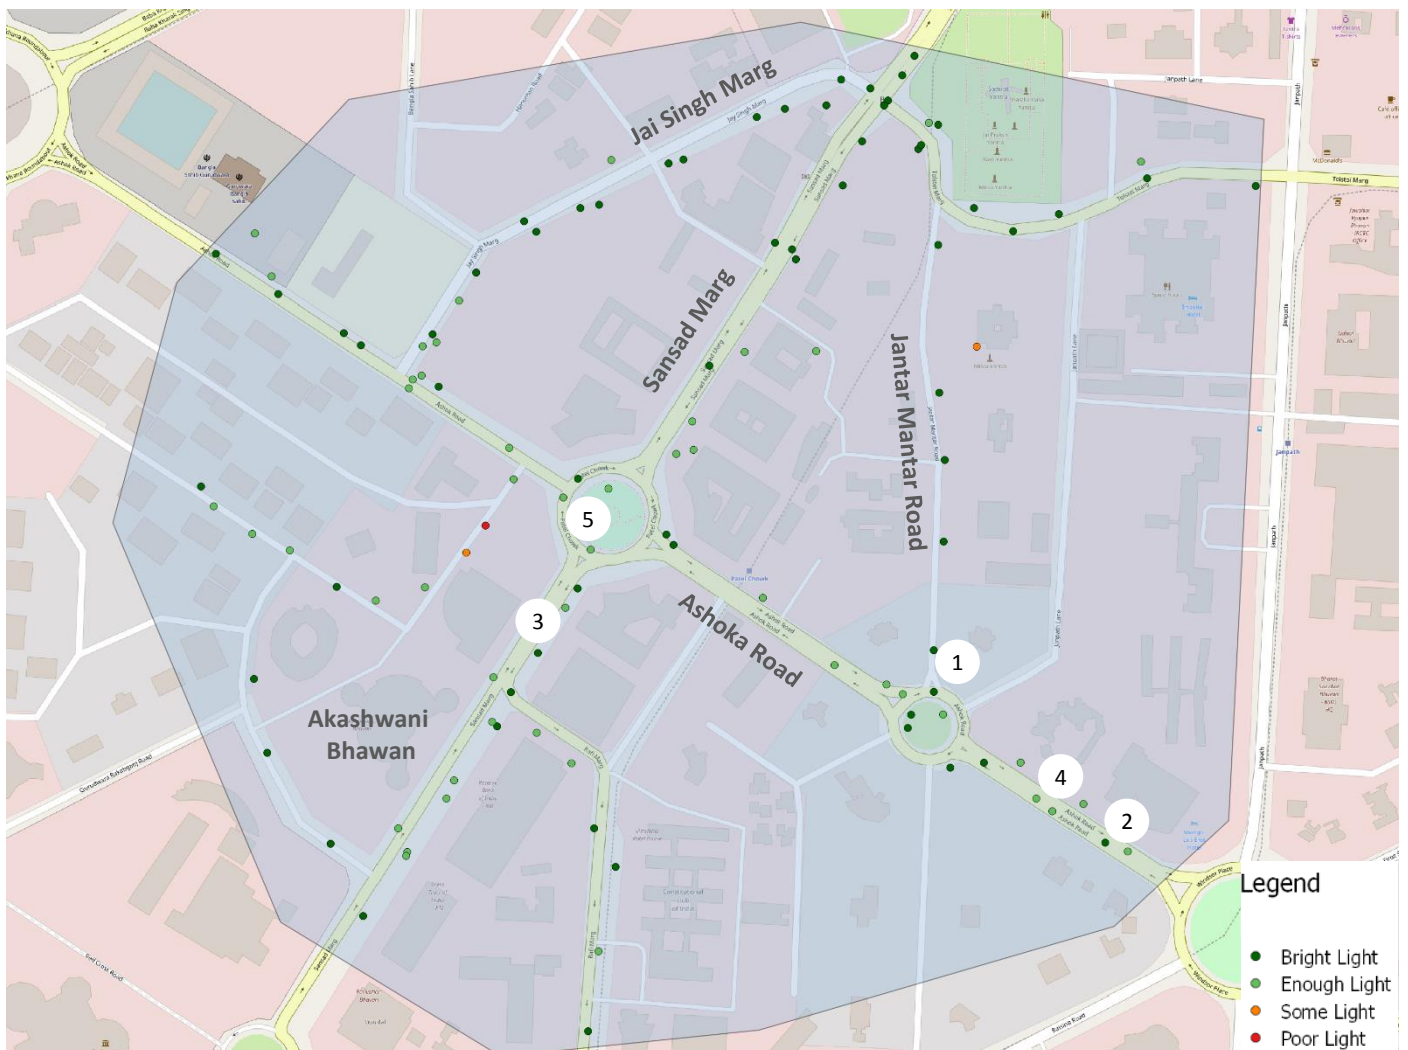
Lighting Rating

Lighting Parameter has been rated 2.5/3 i.e. Good. Throughout this audit area, streetlights are installed along the edge of footpath facing the road. The illumination is bright on the vehicular carriageway but low on pedestrians path. Additional streetlights are needed along the footpath to ensure uniform illumination.

Care should be taken while installing streetlights in midst of trees along footpath. Some streetlights were found to be hidden behind trees' foliage, resulting in low illumination. Regular maintenance checks should be carried out to prune tree leaves in this area. The height of streetlights should be lower than that of trees to avoid disrupted and partial illumination.

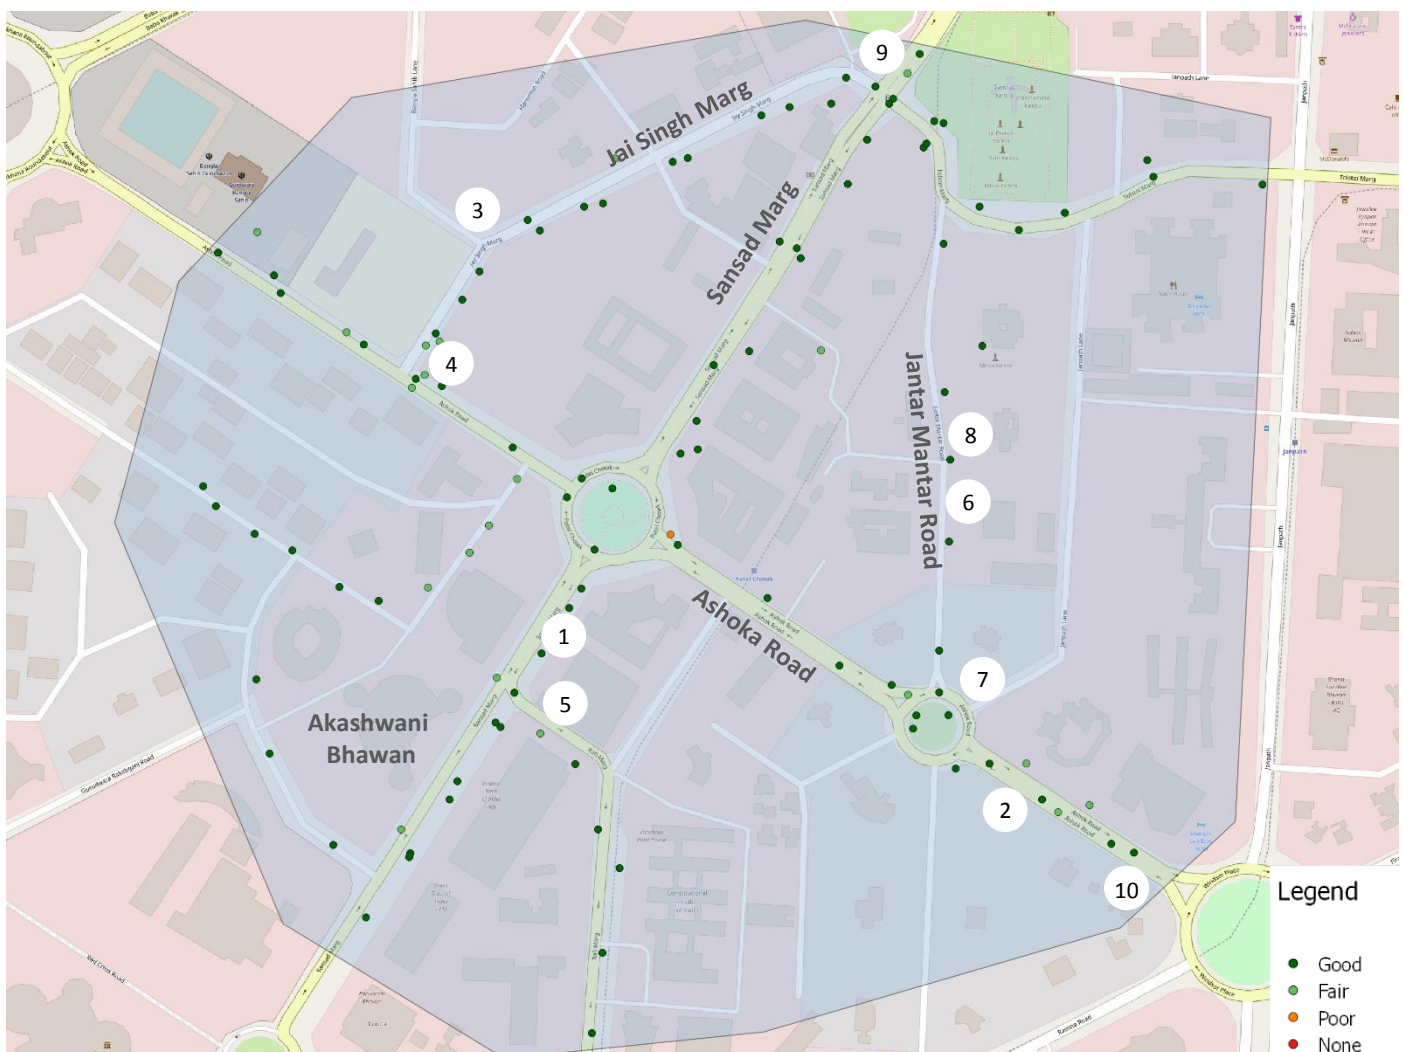
Walkpath Rating

Walkpath Parameter has been rated 2.8/3 i.e. Good. The footpath exists in good condition throughout the audit path. Maintenance is needed for broken paving at some points. Also at various points, footpath is not easily accessible by physically challenged people. Tactile paving was limited to bus stops and within the premises of metro station.

At some points, footpath was found to be obstructed by vehicles, boards, barricades etc. Separate space should be provided for vehicular parking, and barricades when not in use. Signage/ advertisement board should be installed along the edge of the footpath. Table top crossing with proper ramps should be provided at the junctions.

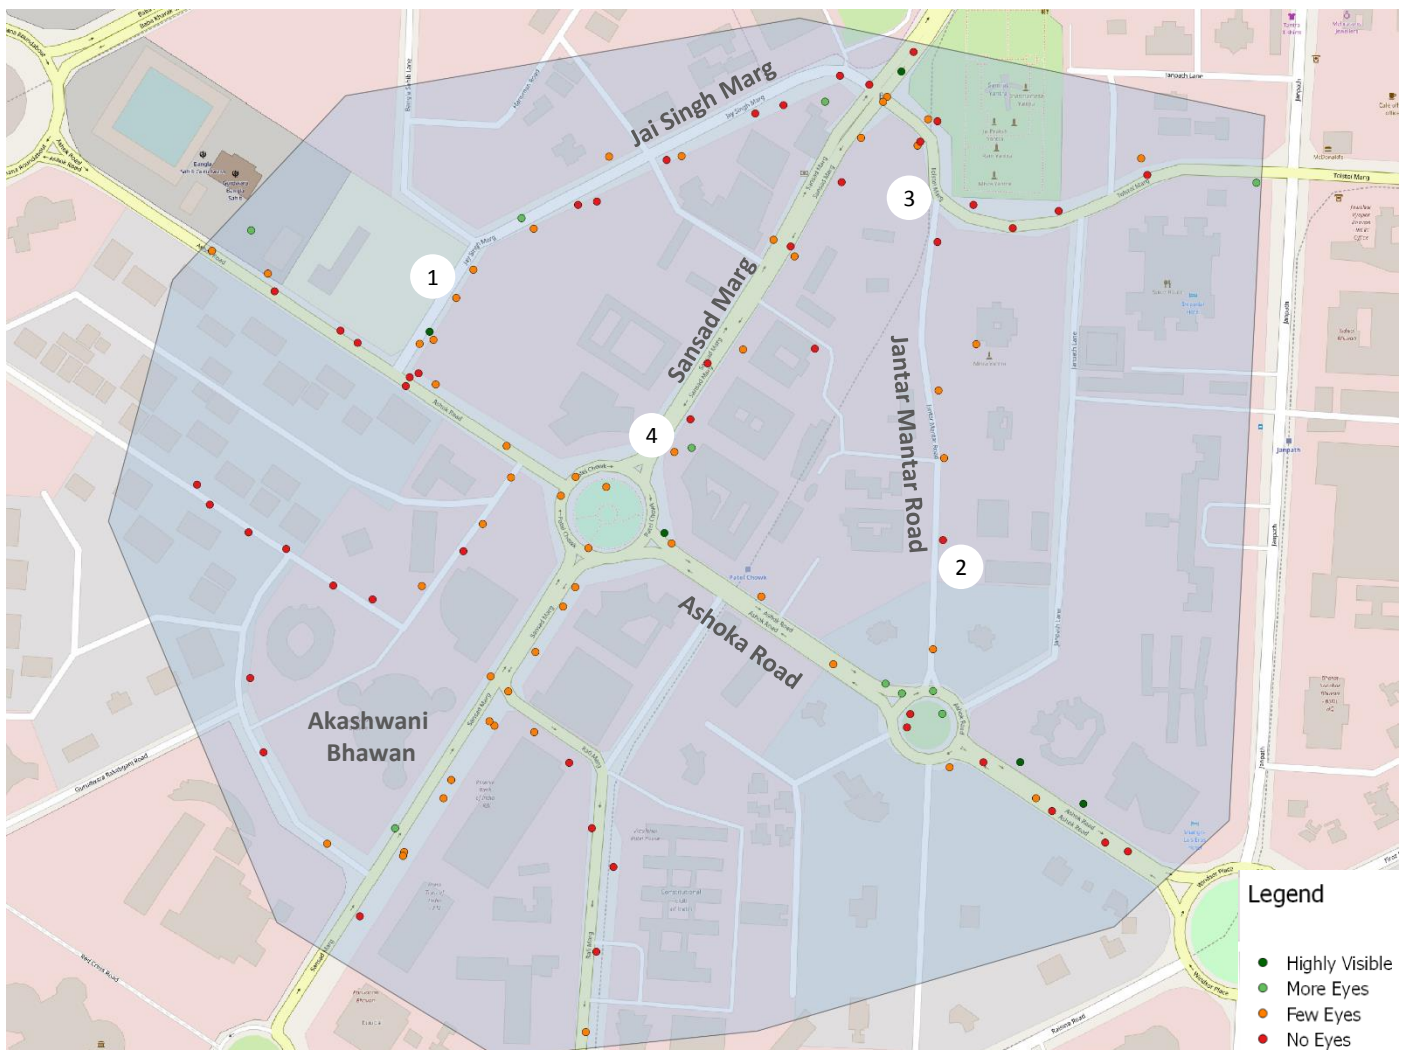
Visibility Rating

Visibility Parameter has been rated 0.8/3 i.e. Below Average. This is due to high boundary walls and large setback area within a public building. Though most of the government buildings in this area have low height boundary walls, their large setback area results in low visibility on the streets.

Few kiosks and street vendors present at various audit points provide some visibility. The area surrounding them should be developed as a designated hawker zone. They should be equipped with street furniture, street lights and a public convenience.

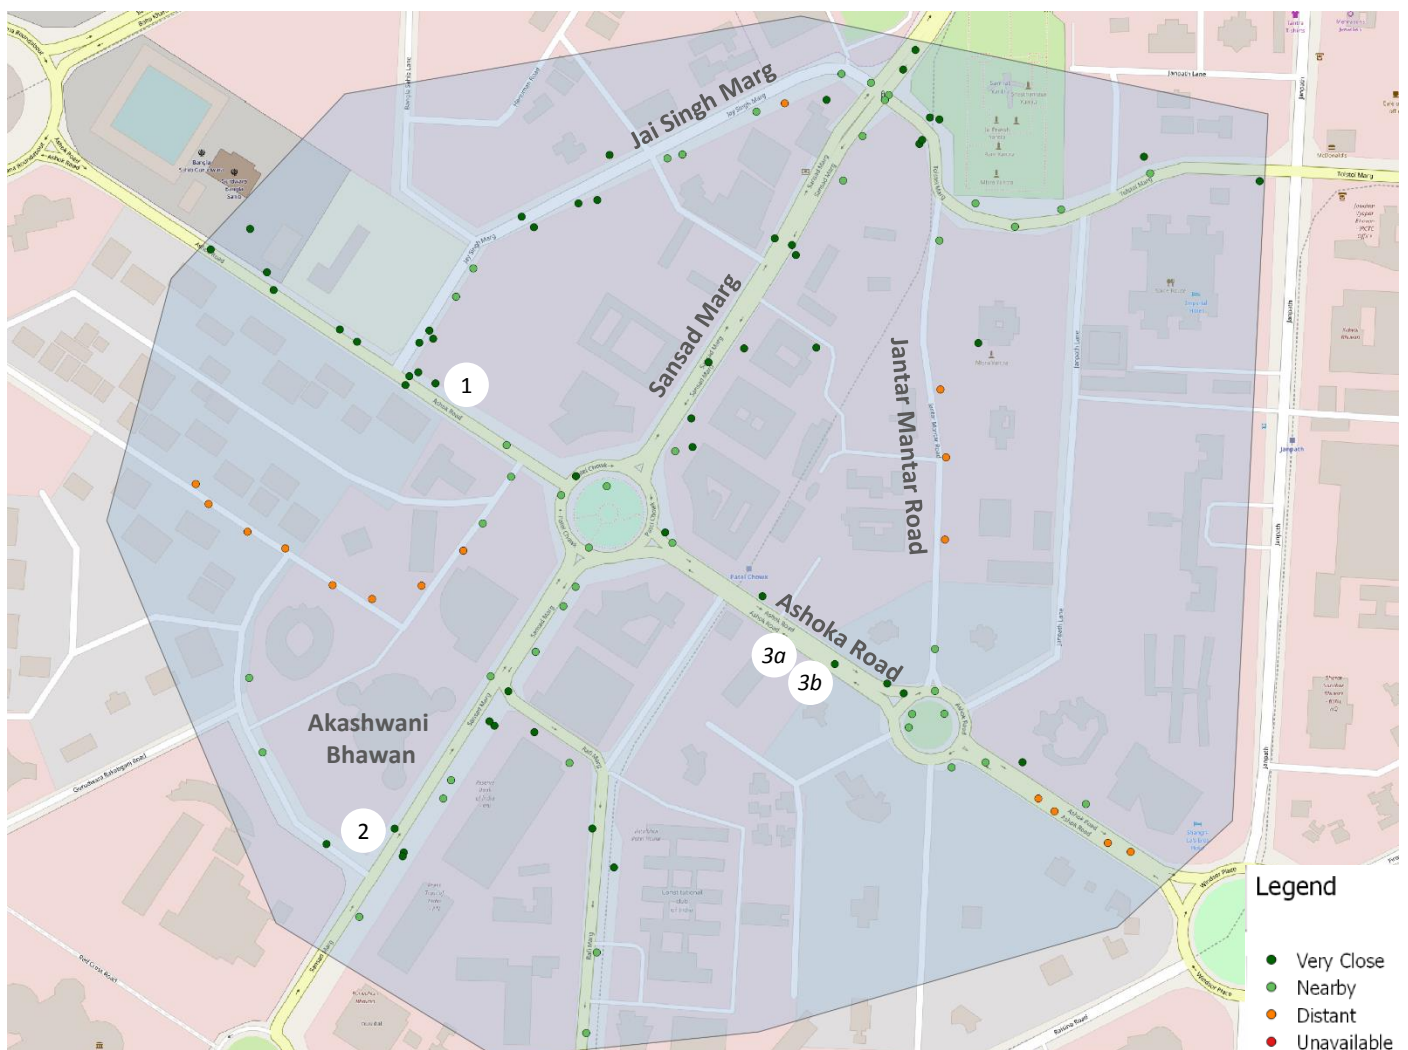
Public Transport Rating

Public Transport Parameter has been rated 2.3/3 i.e. Above Average. Being an administrative zone, auto rickshaws are easily available near the entry/exit of the metro station. Similar provision should be provided near bus stops along Sansad Marg and Ashoka Road.

Para – transit stands should be set up near bus stops, which has designated parking space for autos/ taxi. Additionally, these stands should have street furniture, vending kiosks and public toilet for drivers and commuters.
