# **ENHANCING LAST MILE CONNECTIVITY**

a safety analysis of the Rajiv Chowk Metro Station

This Report has been prepared as part of the Project being undertaken with NDMC to Enhance the Last Mile Connectivity along the metro stations within it's jurisdiction. The safety audits were conducted by Smt. Anshu Gupta and Smt. Veena, architects from NDMC along with Safetipin team.

# Rajiv Chowk

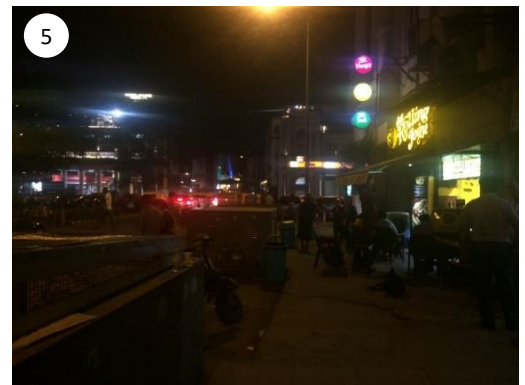
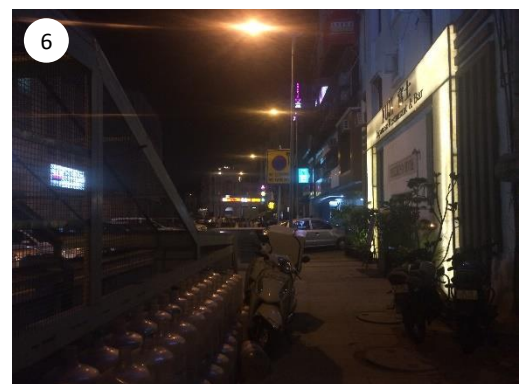
The Middle Circle has mixed ratings for visibility owing to different building uses. Many cafes and restaurants are operational in this circle with some even having outdoor seating. The area outside these should be properly developed to have outdoor seating such that it does not disturb the pedestrian movement.

Certain parts like the plaza connecting the Middle and Outer Circle should be pedestrianized with space for hawkers. No vehicle should be allowed to enter or park in this space. Separate parking zones exist already.

The area along the Service structures like the staircase to the Utility Tunnel should be properly paved and have street furniture. Currently, the space is used for vehicular parking while it has the potential to be a more usable space. Alternatively, this space can also be used as a Hawking Zone.
