ENHANCING LAST MILE CONNECTIVITY

a safety analysis of the Udyog Bhawan Metro Station

This Report has been prepared as part of the Project being undertaken with NDMC to Enhance the Last Mile Connectivity along the metro stations within it's jurisdiction. The safety audits were conducted by Smt. Nutan, architect from NDMC along with Safetipin team.

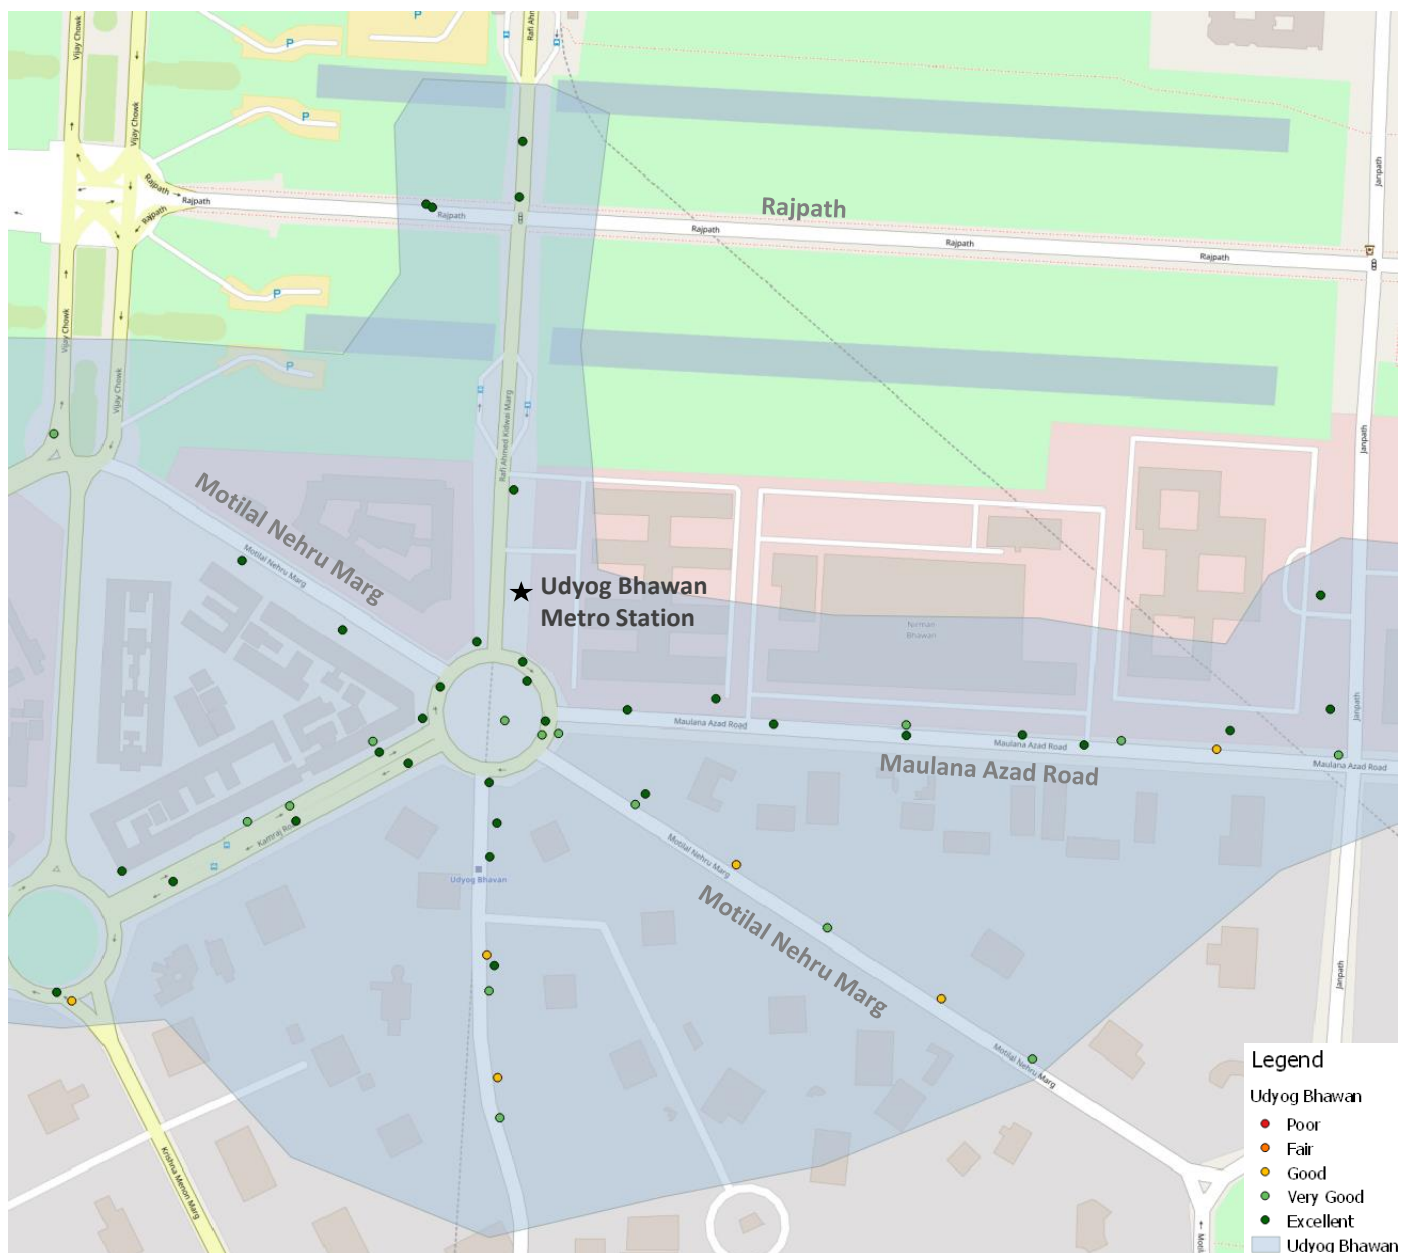
Map indicating Safety Score

Safety Audits indicate that the area around the metro station is safe. Lighting and Walkpath parameters have been rated Good overall. Openness and Public Transport parameters have been rated Above Average. The overall Feeling in this area has been rated Average. This is because the area becomes secluded once the offices close resulting in low ratings for Crowd and Gender Diversity. The Gender Diversity was found to have lowest rating in this area as very few women are present here after the offices close. Security and Visibility parameters have been rated Below Average. While certain areas saw Police presence, the area largely fares low on Security. The Visibility parameter fares low on account on very few eyes-on-the-street and high boundary walls in most parts of the audit area.

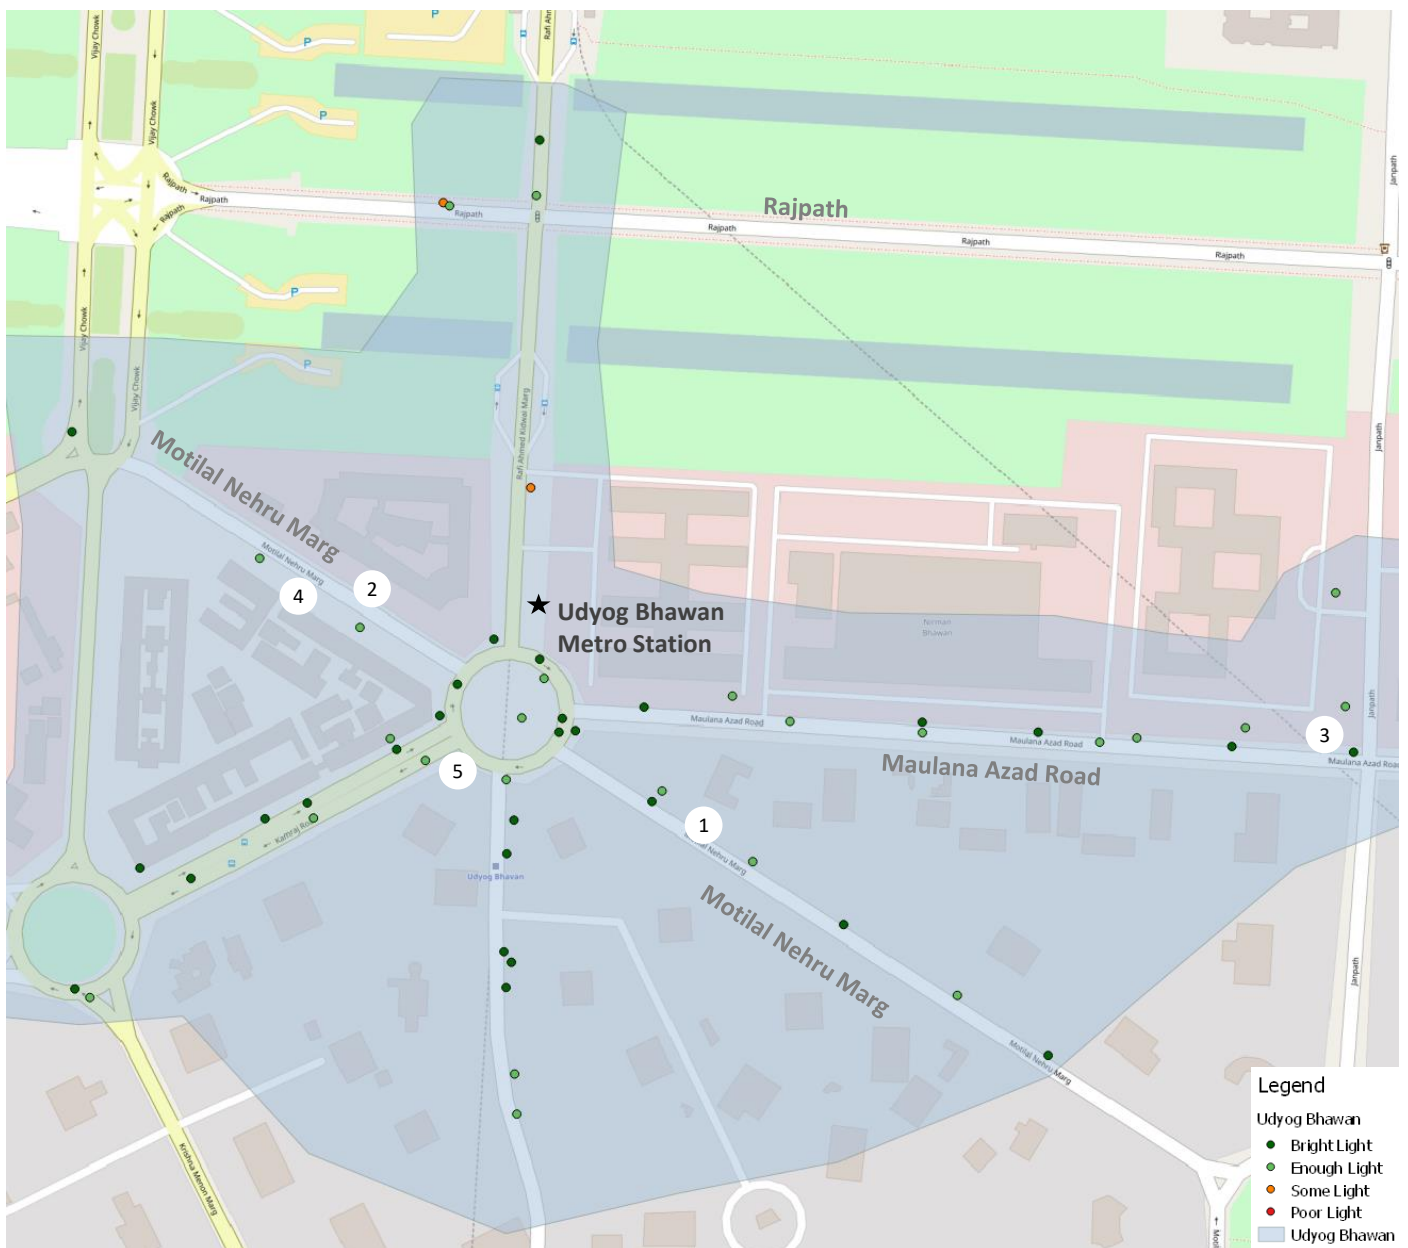
Lighting Rating

Lighting Parameter has been rated 2.5/3 i.e. Good. The audit area has streetlight installed along the entire road length and on both sides along most of the roads. While this ensures that the area is well illuminated, at certain points the illumination was low due to various reasons.

The streetlights have been provided along the road edge focused towards the vehicular carriageway. Also the dense foliage along these stretches casts dark shadows along the footpath. Reducing the height of the streetlight to a pedestrian scale and regular pruning of tree leaves will help ensure that the

footpath is better illuminated.

At certain points the illumination from the buildings/entry gates was stronger than that from the streetlights creating dark patches at certain points and glare at other. Uniform bright illumination from streetlights will prevent this from happening.

At locations having a bus lane, no streetlights have been provided along the footpath resulting in poor illumination. Streetlights should be added along this stretch. Also additional streetlights are needed in the parking areas outside the offices.

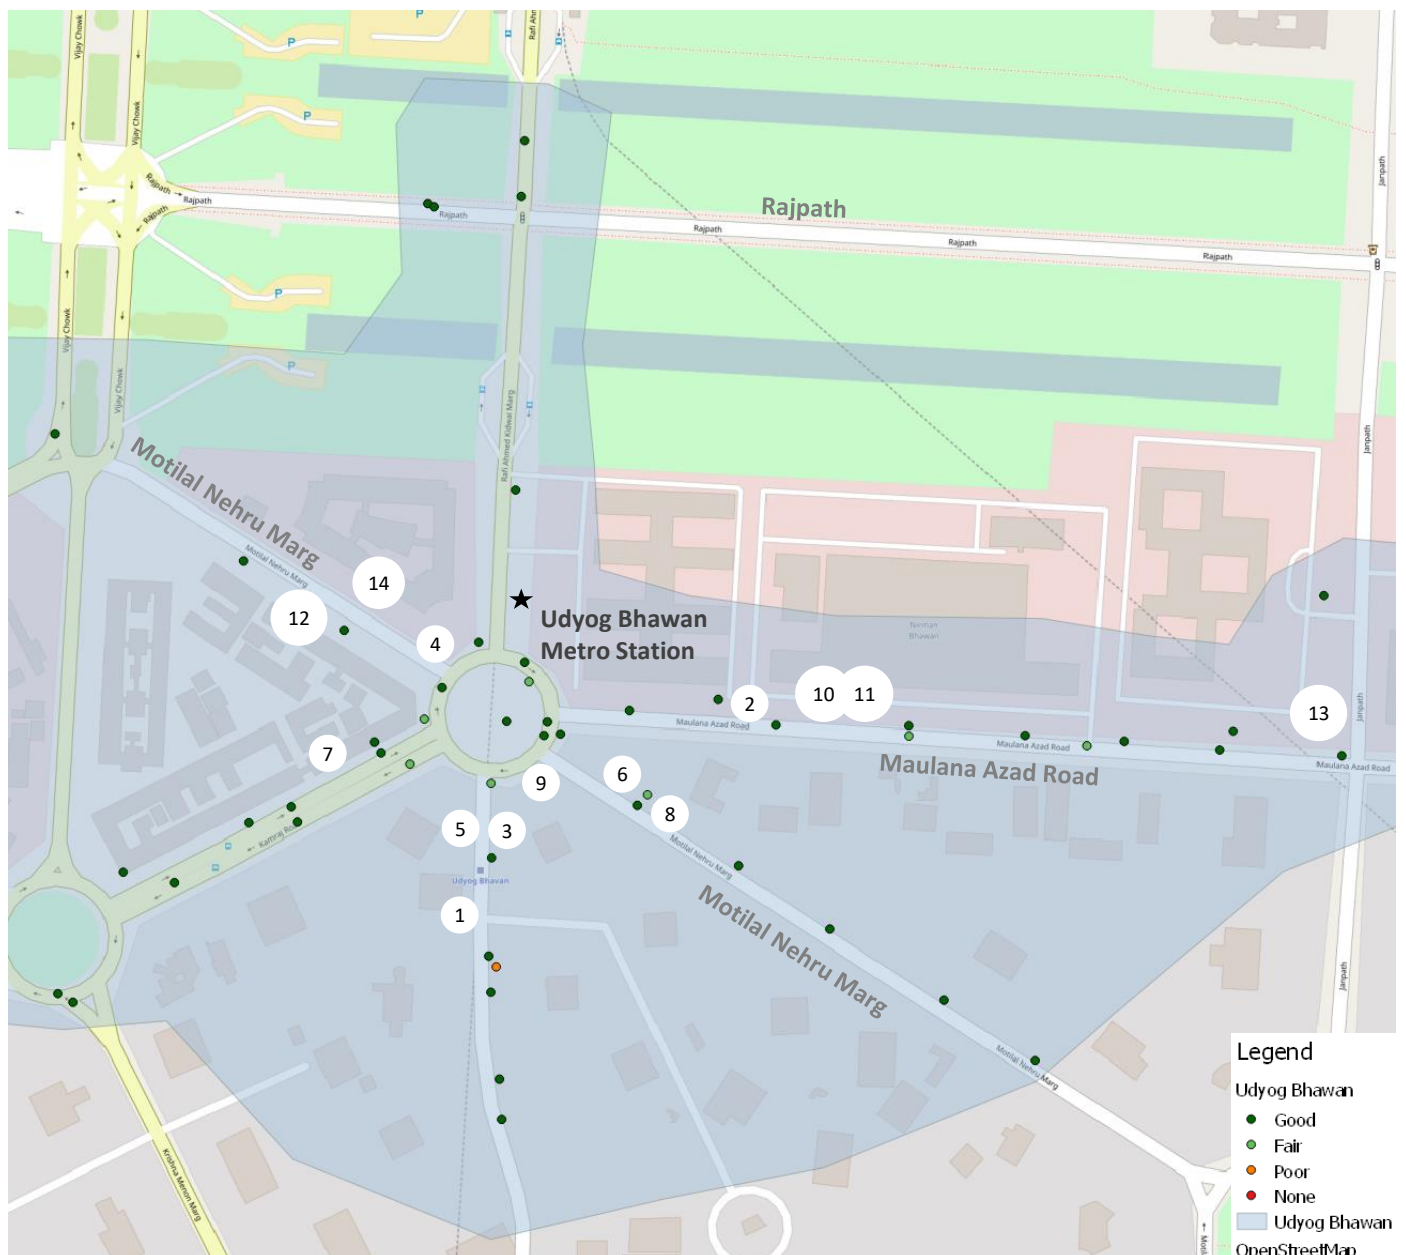
Walkpath Rating

Walkpath Parameter has been rated 2.9/3 i.e. Good. The entire area along the metro station was found to have a footpath and it was in a good condition along most of the audit area.

Outside the offices the footpath was found to be occupied by various hawkers and obstructed at other points due to other factors. Since the footpath and the green belt along it is very wide, a hawker zone can be easily created. This would ensure a continuous unobstructed footpath for all pedestrians.

At few points, the footpath was found to be broken. This was mostly along the manhole covers. Repair

works should be carried out at regular intervals. The location of bollards needs to be changed such that their location doesn't hinder movement of people on wheelchair. The footpath should also have a ramp for ingress/egress. Tactile paving for the visually impaired also needs to be incorporated throughout the area. While the paving is there inside the metro station, outside there is no tactile paving along the footpath.

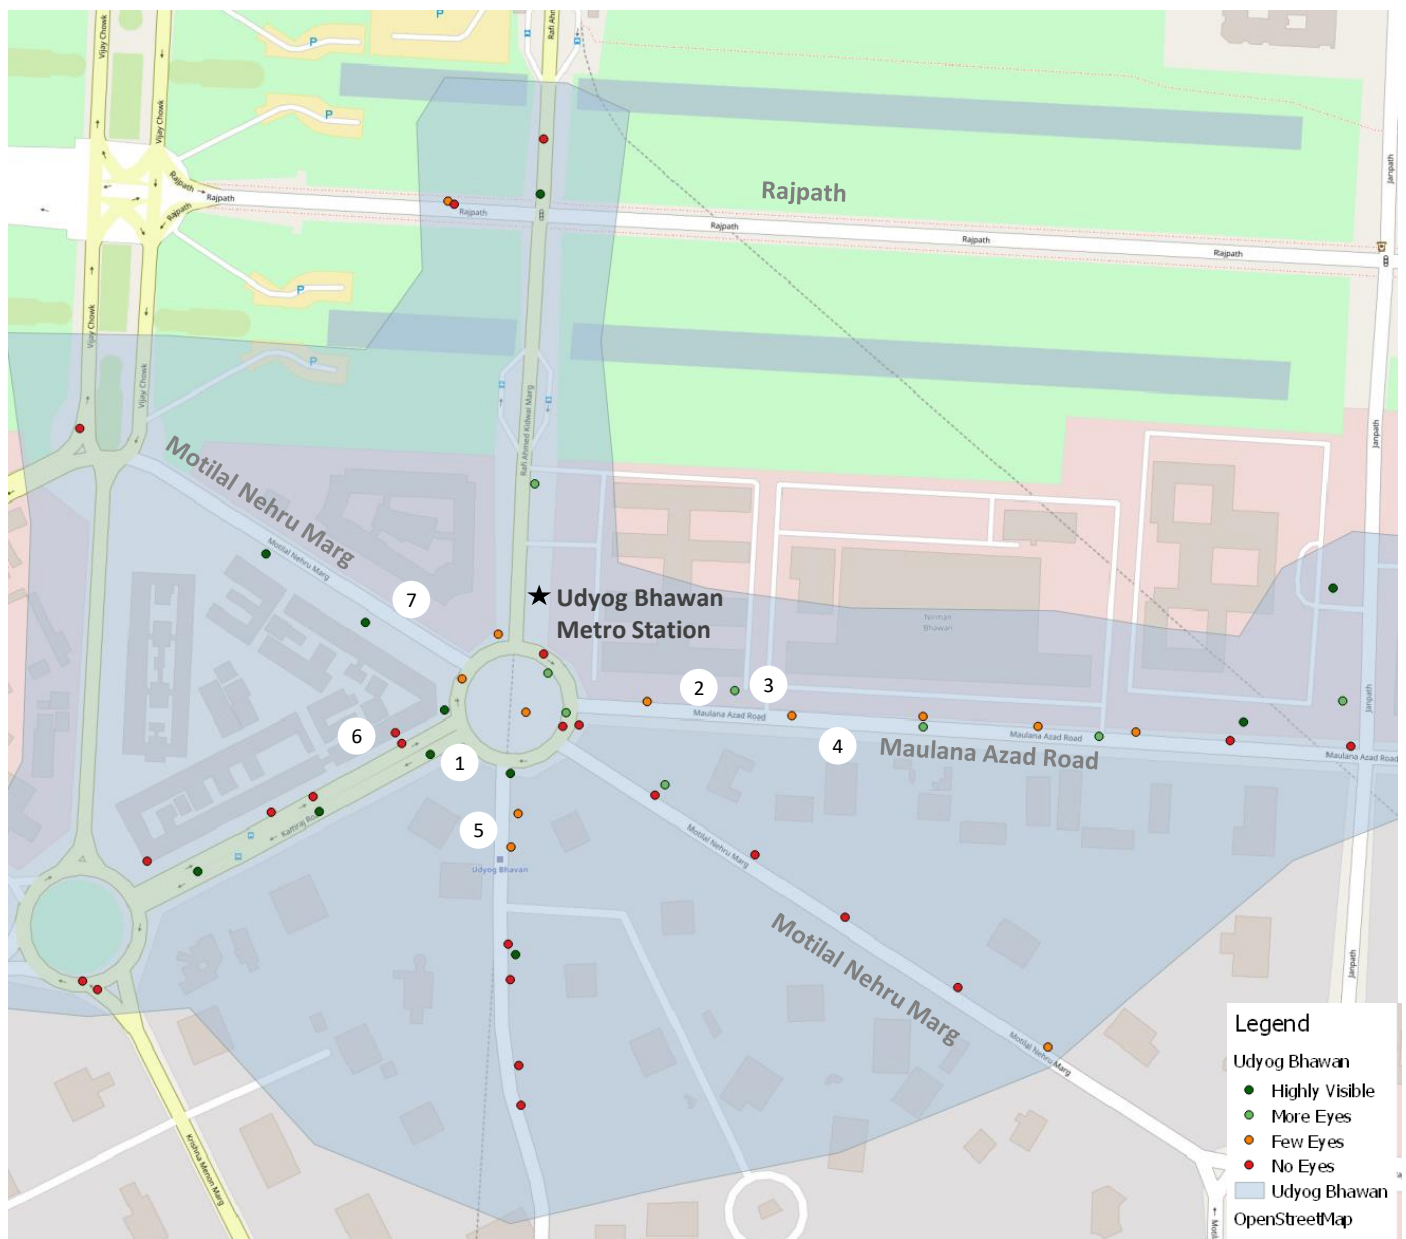
Visibility Rating

Visibility Parameter has been rated 1.0/3 i.e. Below Average. In most parts of the audit area the visibility was found to be low. In some areas like the metro station entry/exits, bus stops and outside the Udyog Bhawan office the visibility was high due to the presence of various food stalls. However, overall the rating has been poor.

One of the main reasons for the poor rating is the inactive edge of the offices with the road(/footpath). Most of these offices have a high boundary wall, others have a low wall with a grill but the porous part has been covered by vegetation or by fiber glass

sheet. As a result, the edge remains dead and inactive with no visual connection between the office complex and the footpath. The high front setbacks of the buildings from the plot edge further reduce the possibility of a connection.

The porous part of the grill should be retained and not blocked. In areas with high boundary wall the height of the wall should be reduced. This area has a wide green belt between the footpath and the plot edge, this should be landscaped properly with street furniture and space for hawkers to create an active edge.

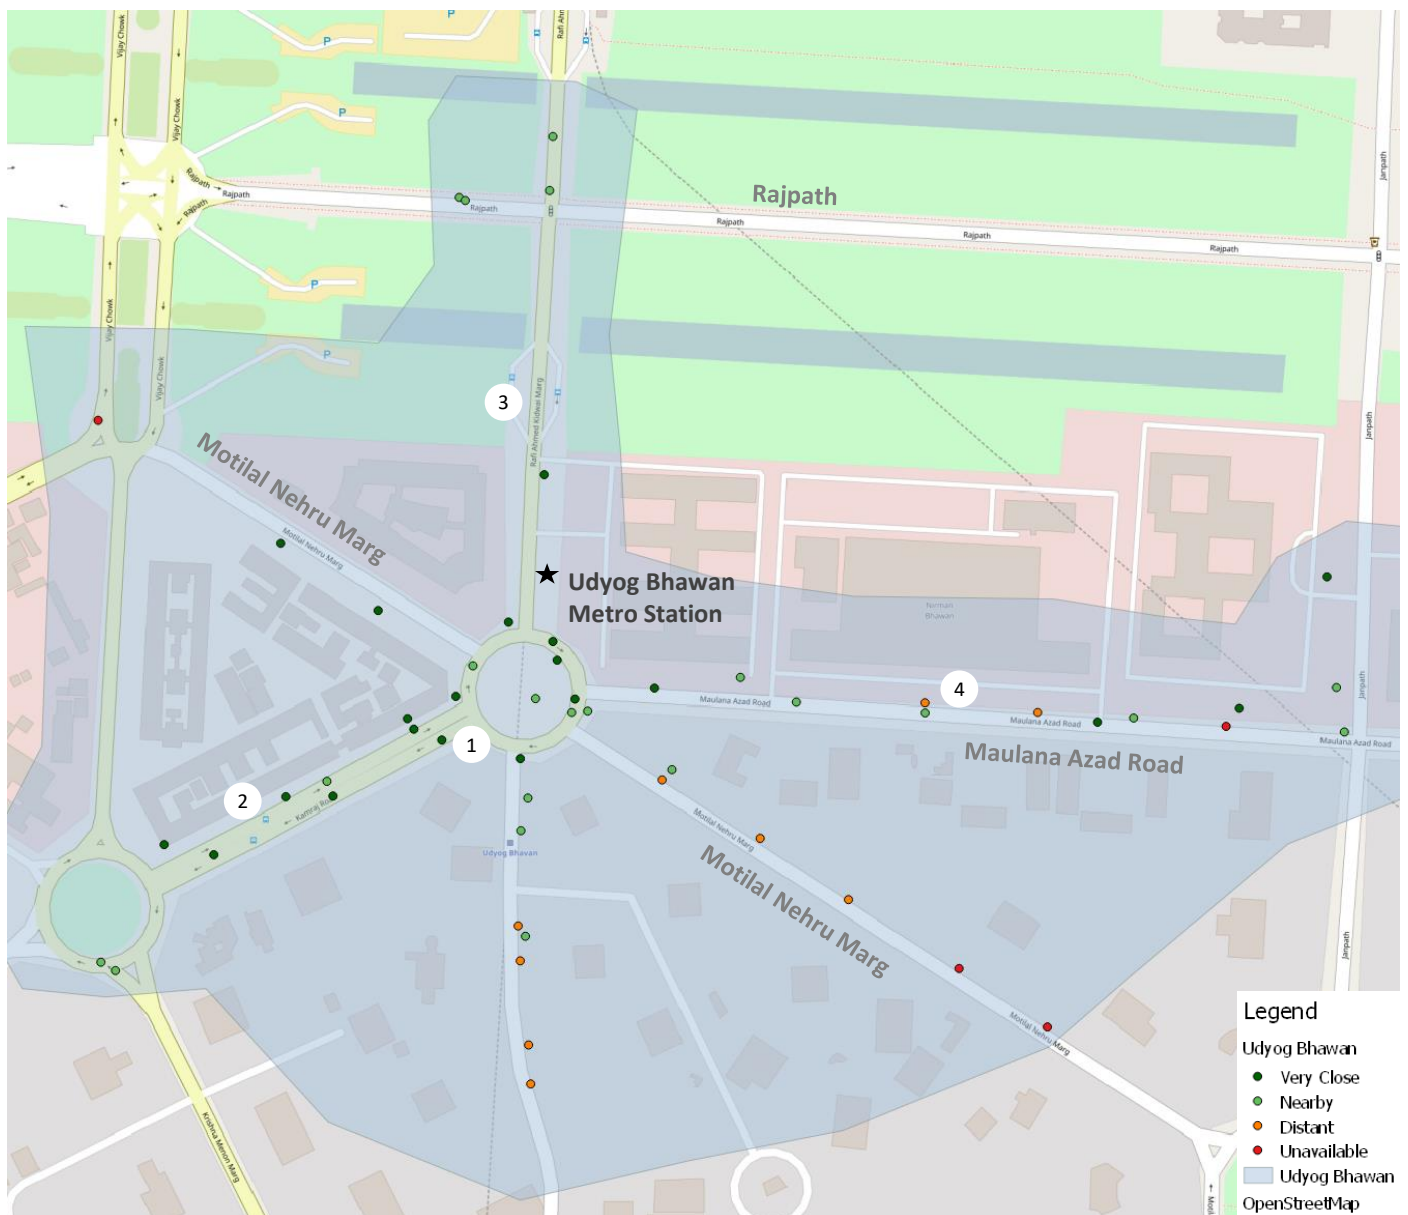
Rating of Public Transport

The metro stations have a lift and ramp for the comfortable movement of the differently abled but there is no tactile paving. Continuous tactile paving should be provided from all metro station exits to the bus stops and well connected to the footpaths leading to the various destinations.

Proper street furniture needs to be added outside the metro entry/exits and along the bus stops. In the absence of required seating people are seen either standing or squatting. These additions will make using public transport comfortable for people.
