ENHANCING LAST MILE CONNECTIVITY

a safety analysis of the Lok Kalyan Metro Station

Lok Kalyan

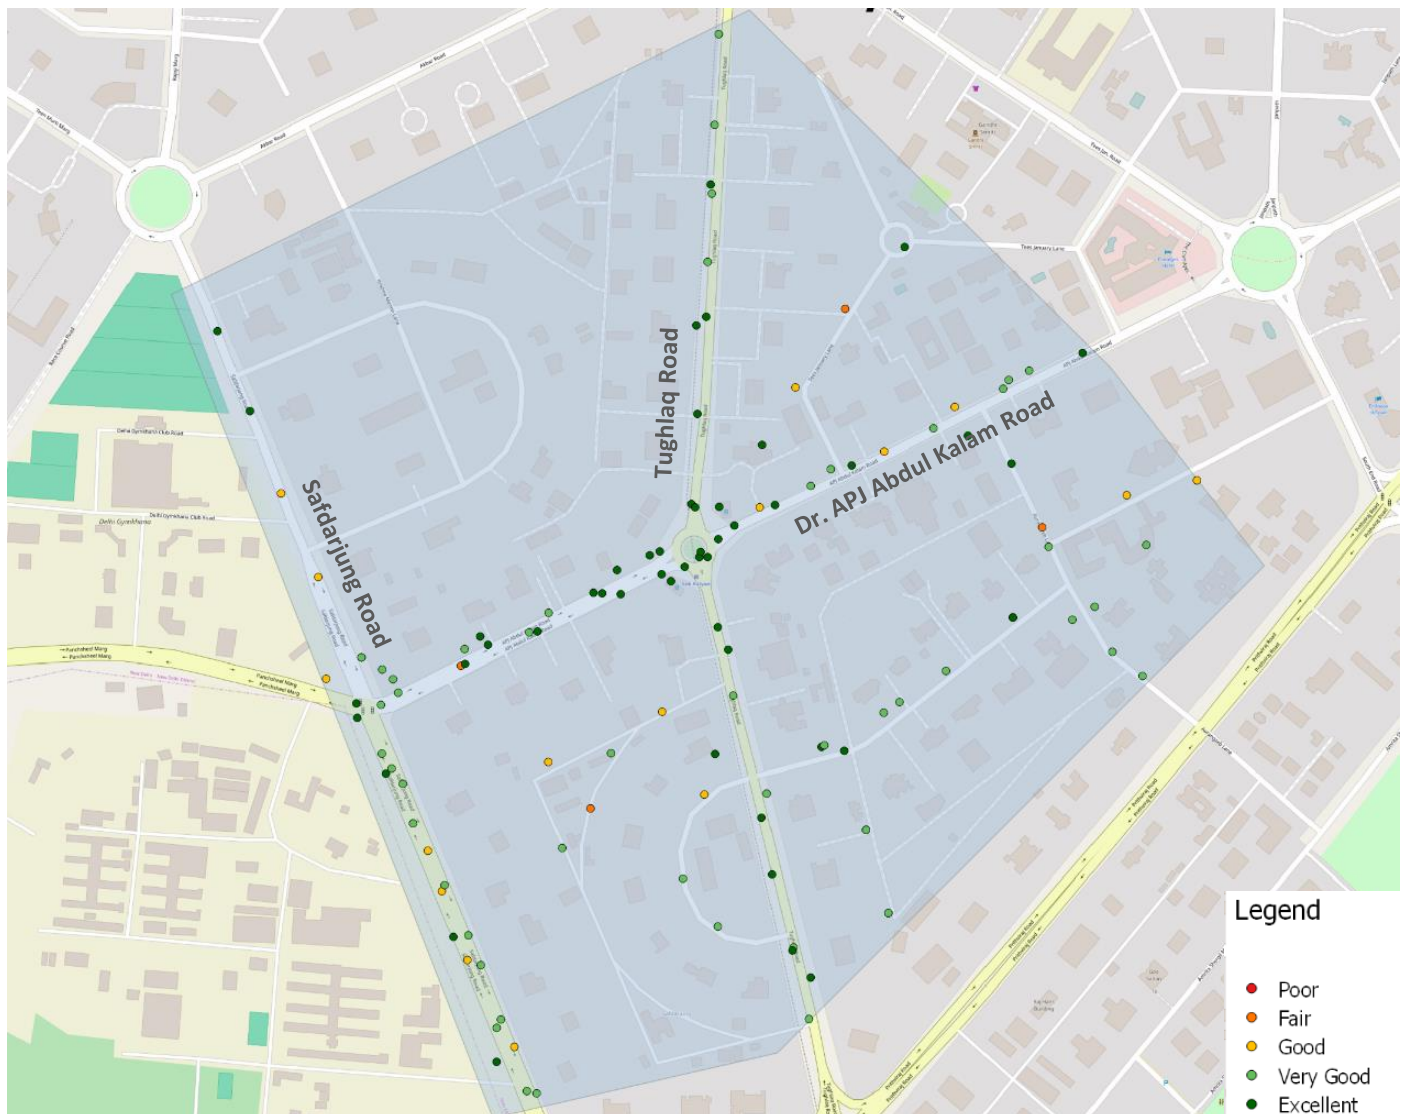
Map indicating Safety Score

Safety Audits indicate that the area around the metro station is safe. When compared to main roads, audit points within the neighbourhood have been rated lower in terms of safety score. Due to the absence of para transit facility at the neighbourhood level, Public Transport has been rated Average. Due to regular patrolling, Security is rated Average as well.

The parameter of Lighting and Walkpath has been rated Good. With high boundary walls and few street vendors, Visibility has been rated Poor. The parameter of People and Gender Usage is rated Below Average and Poor respectively. Overall, auditors have rated the Feeling in this area as Average.

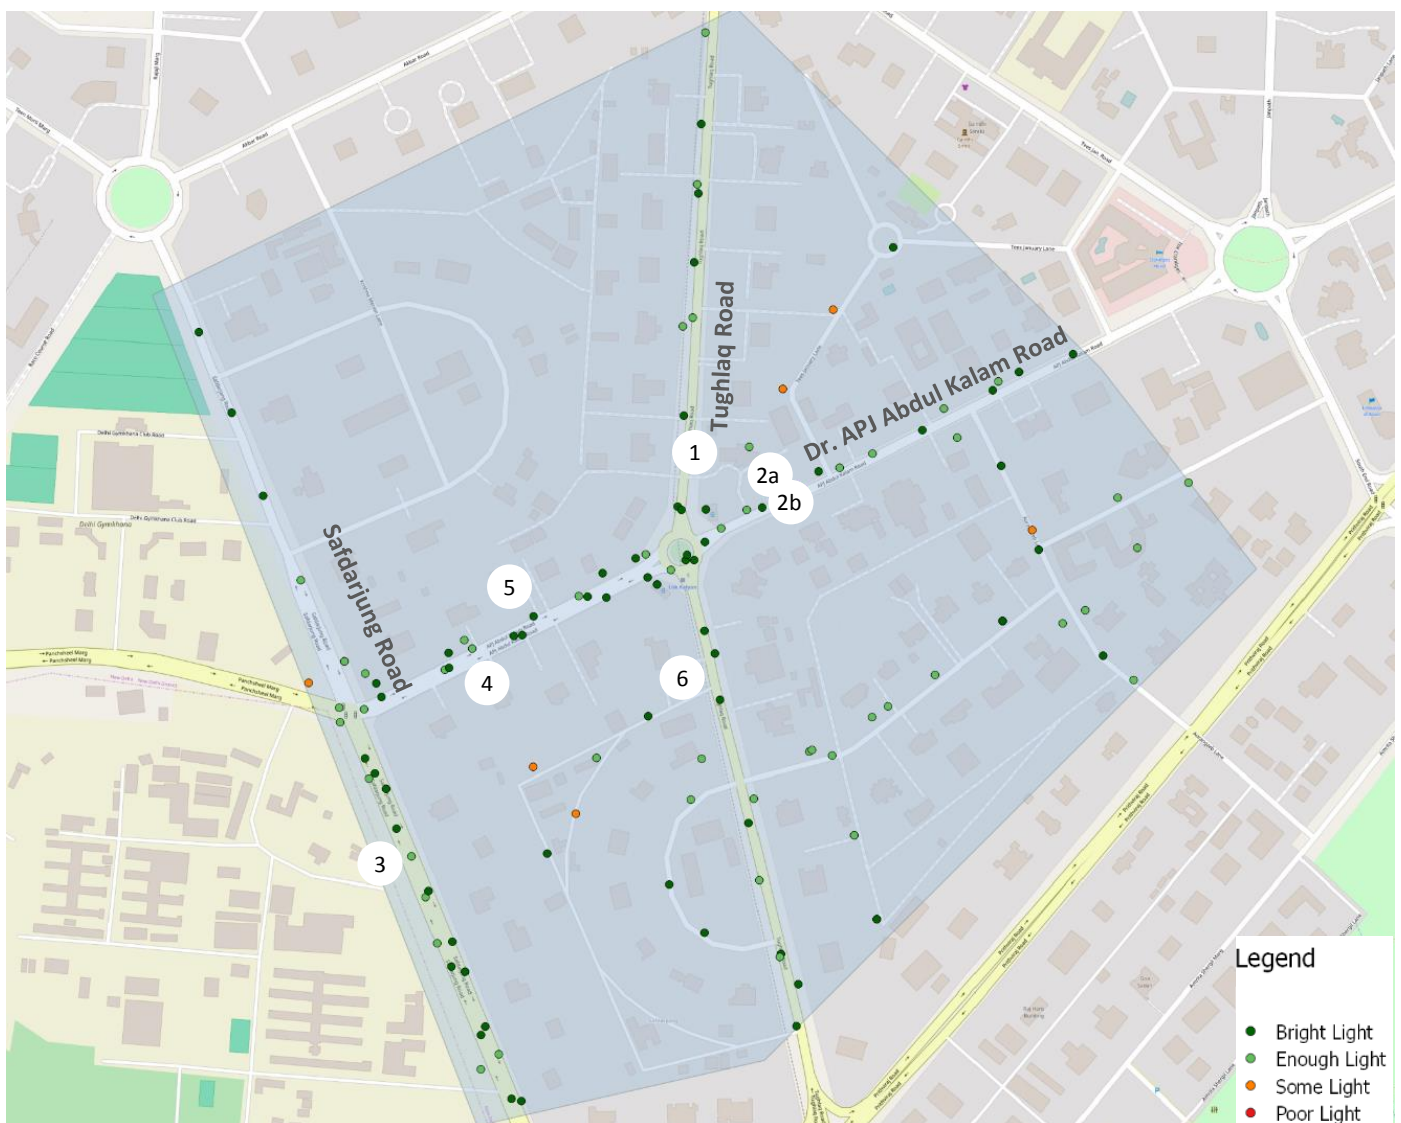
Lighting Rating

Lighting Parameter has been rated 2.5/3 i.e. Good. In this audit area, streetlights were found operational throughout. But the streetlights are installed facing only vehicular carriageway on both sides of the main road. Therefore, the footpath flanked by trees and shrubs is poorly lit. Pedestrian scale streetlights should be installed on the footpath.

Additionally, streetlights need to be installed in some inner lanes. At present, they are illuminated by lights from adjoining building i.e. temporary source. Regular pruning of trees should be carried out at points where streetlights are hidden behind trees' foliage.

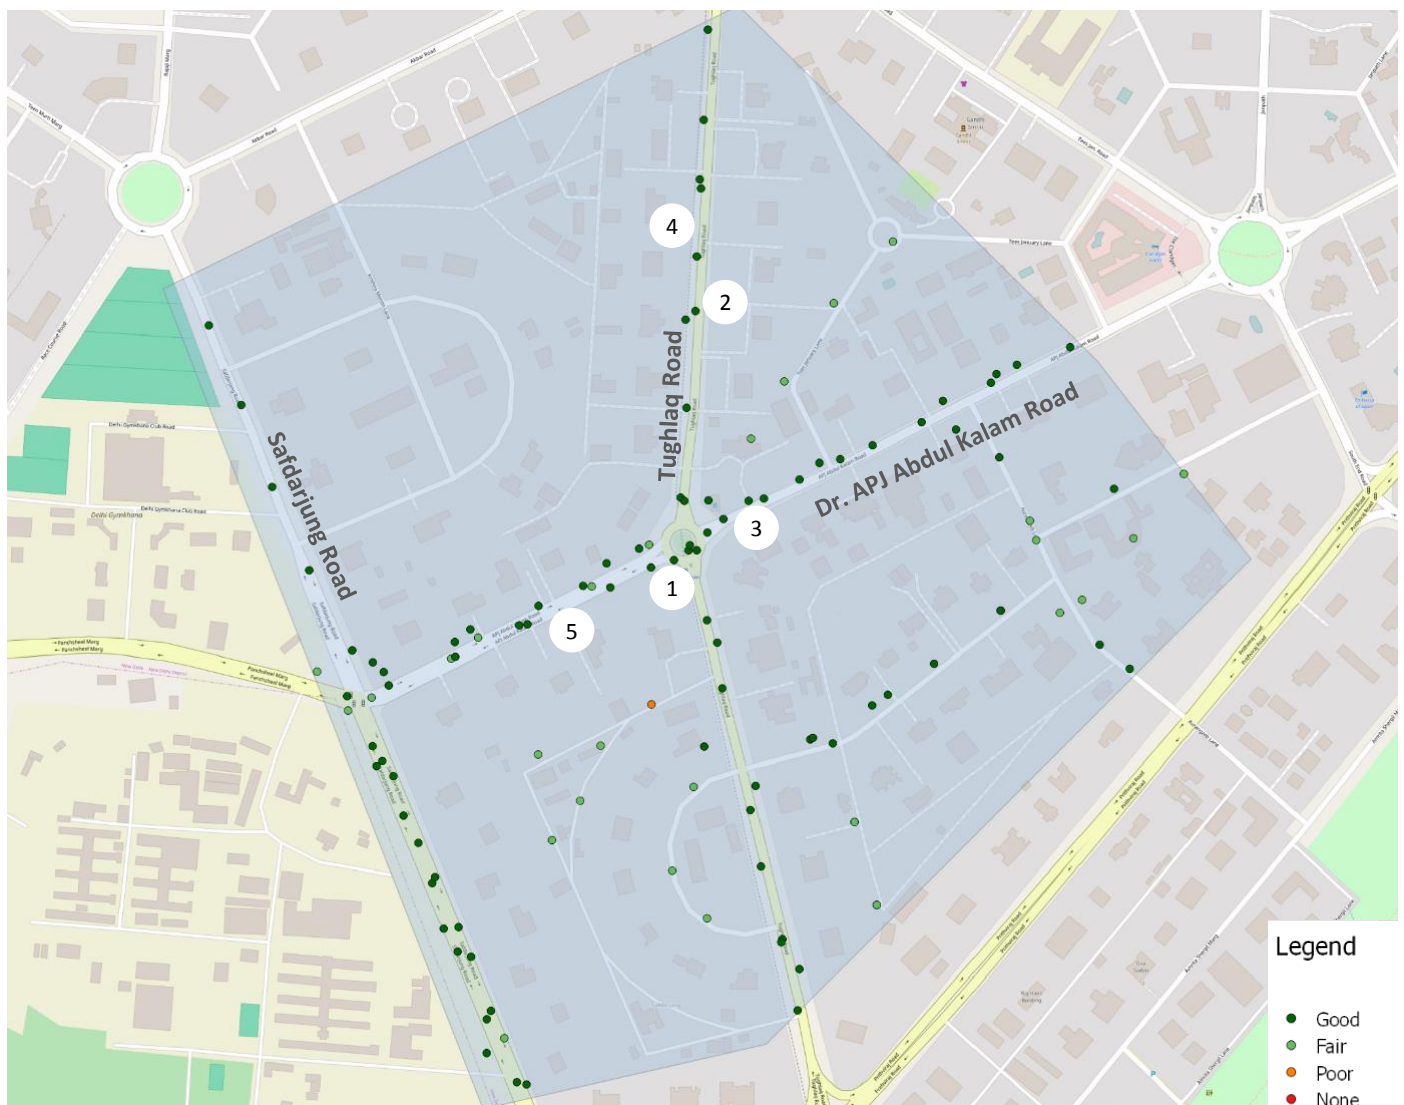
Walkpath Rating

Walkpath Parameter has been rated 2.7/3 i.e. Good. Existing footpath was found to be well maintained throughout the audit area. Table top crossing and ramps are provided throughout for the physically challenged. However, with the bollards placed inconveniently, the footpath is not conveniently accessible.

Additionally, tactile paving for visually challenged is provided only at the bus stops and it is obstructed by an advertisement board. These shortcomings should be looked at and rectified. Other obstructions found were vehicles, barricades etc. Vehicular parking on the pavement should be disallowed.

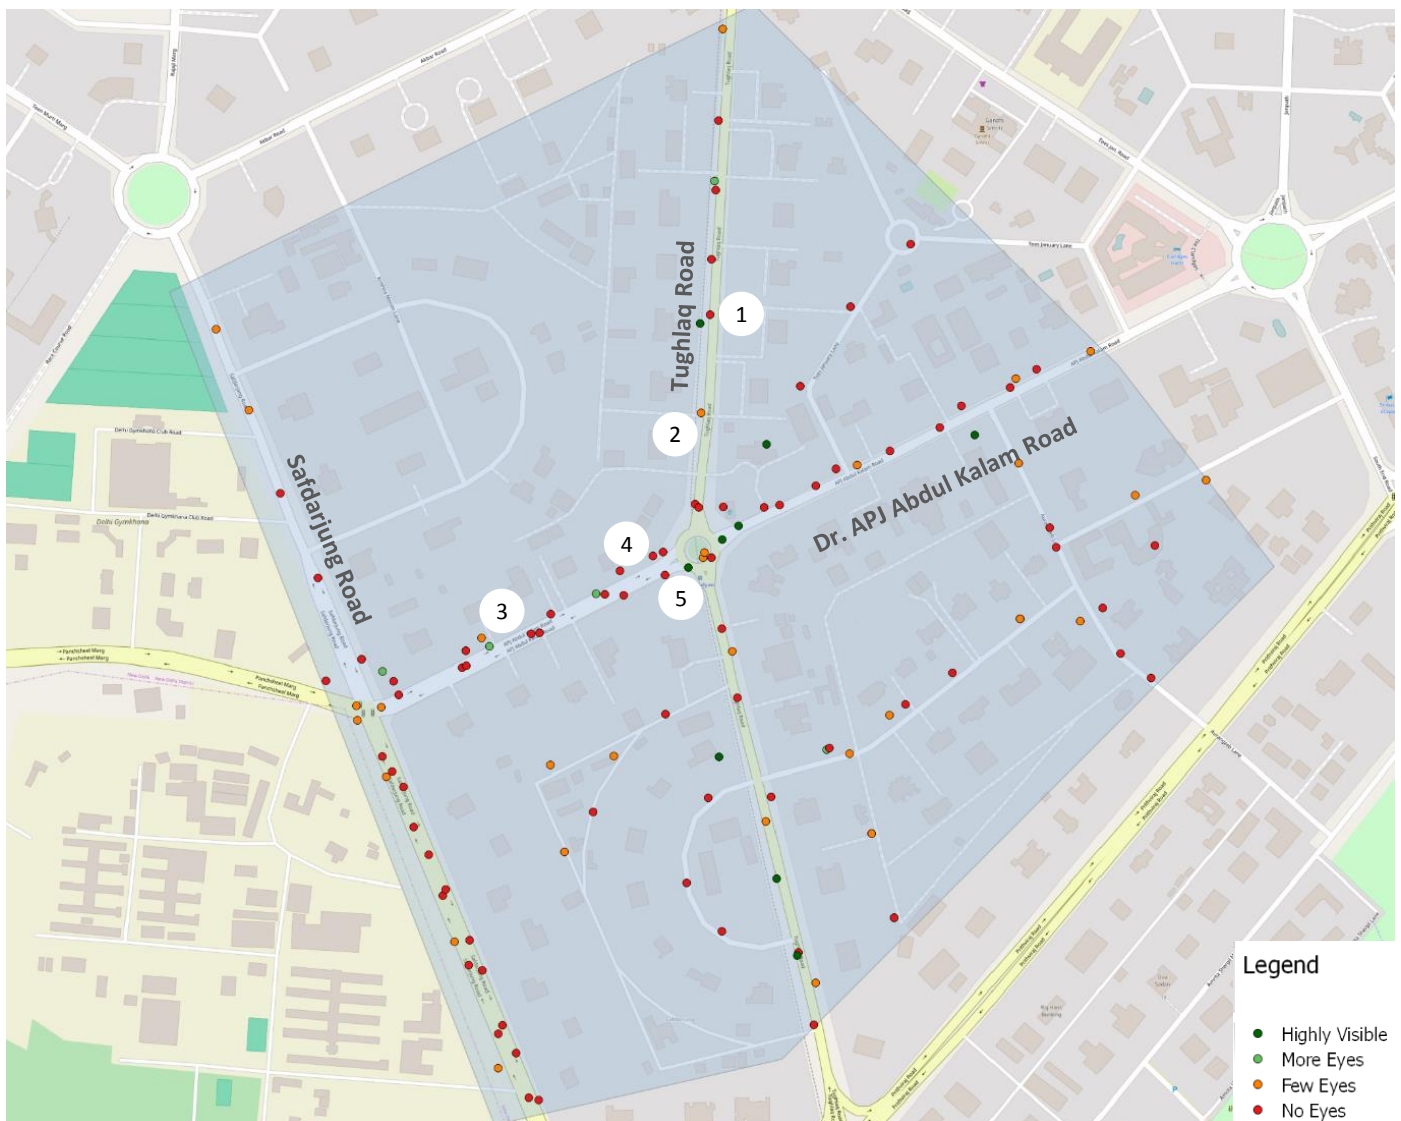
Visibility Rating

Visibility Parameter has been rated 0.6/3 i.e. Poor. Largely, the audit area offers very poor or no eyes on the street owing to high boundary walls. Though the solid part of the wall is low, the height attained using wooden fence and grills restrict the visual contact. In such cases, the opaque part of the boundary walls should be taken down.

There are few kiosks present on APJ Abdul Kalam road and Tughlaq road. Street Vendors are present near the metro station and the bus stops. The wide footpath and green belt around the metro station and bus stops can be redesigned to accommodate street vendors and street furniture. This can help in improving visibility for the pedestrians.

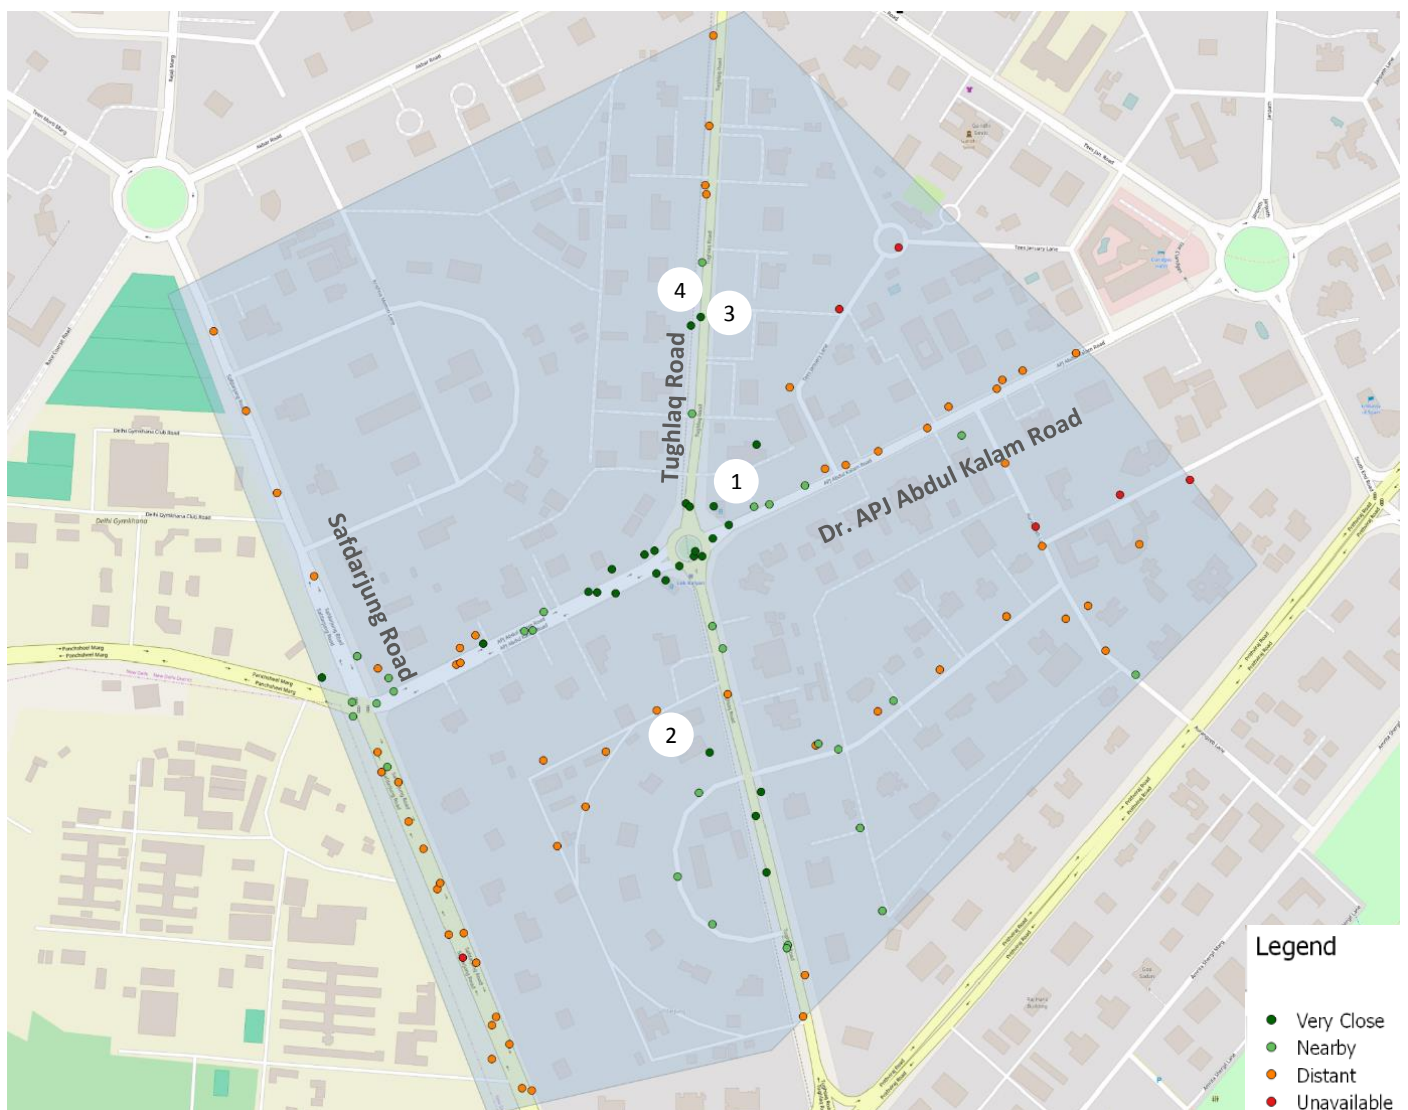
Public Transport Rating

Public Transport Parameter has been rated 1.6/3 i.e. Average. This is because the bus stops are located at large distances from each other. At some points, bus shelter was found only on one side of the road. Bus shelters should be provided on both sides of the road.

Also, there is no designated parking space for the auto at the entry/exit gate of metro station. It results in autos occupying the main road. Designated stands for auto are needed to be created near the metro station and bus stops.
