USING DATA TO CREATE SAFER PUBLIC SPACES IN DURBAN

In 2018, Safetipin and Soul City Institute for Social Justice (SCI) won the third Womanity Award that focussed on programs that are creating safer urban environments for women and girls. On receiving the award, Safetipin and SCI worked on processes to adapt Safetipin methodology in Durban, South Africa. This report is an output of the partnership between Safetipin, India and SCI, South Africa supported by The Womanity Foundation.

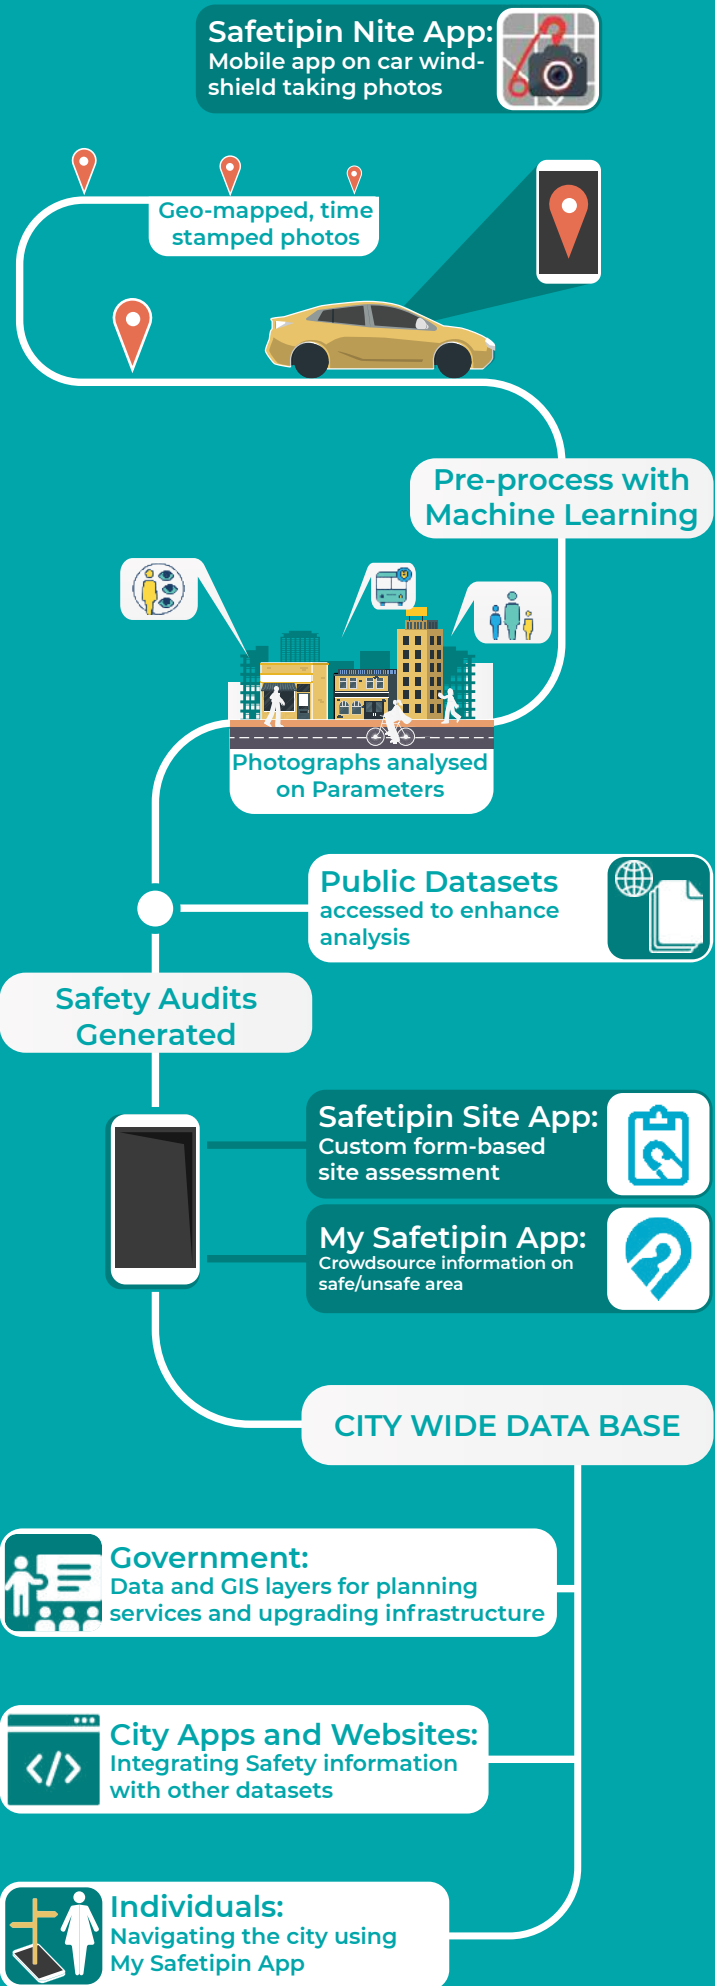
Fig. 1: Safetipin Methodology

For this project, all the three applications have been used to provide a comprehensive dataset on safety parameters for the city of Durban. Figure 1 showcases the assessment tools, analysis process and data outputs.

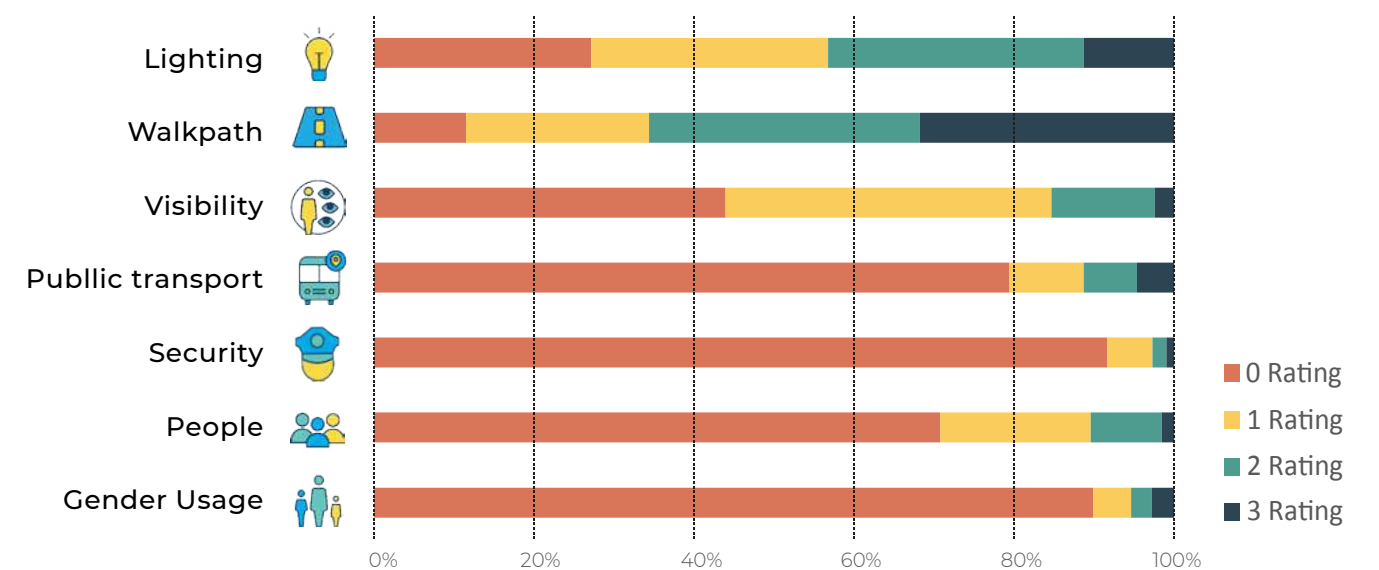
Fig. 4: showing the % distribution of parameter ratings

Figure 4 indicates the audit points distribution of parameters' ratings on a scale of poor and good. The bars show the rating on the scale of 0 to 3 where 0 is poor and 3 is good. Through the comparative representation, the graph shows that Walkpath and Lighting parameters have been rated the highest, and Security, People and Gender Usage have been rated the lowest among all parameters in the audited area of Durban. A thorough analysis of the individual parameters follows to further understand where there is a need for intervention to improve the safety in the city.

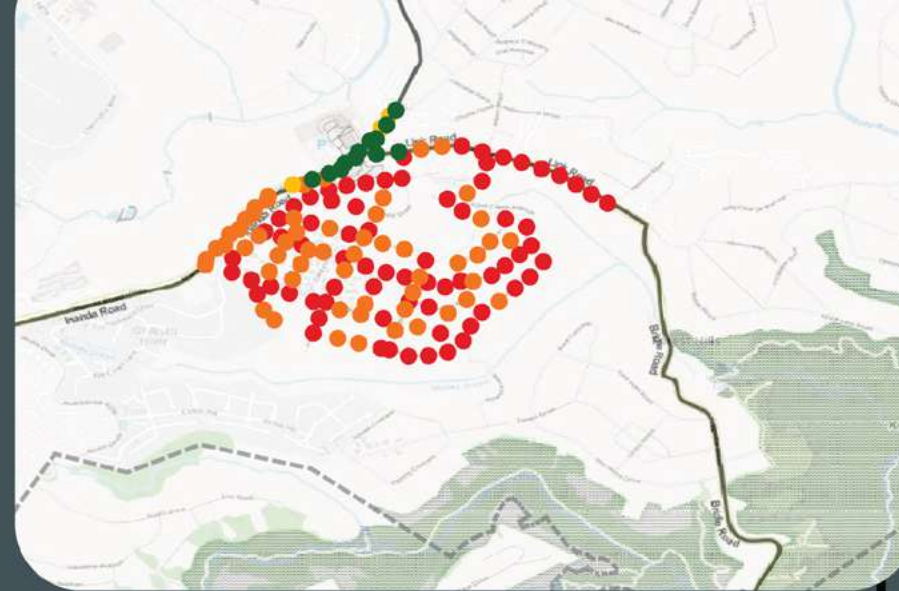
Map 8: Areas audited
using My Safetipin App

Map 8 on page60 shows all the community areas that were audited using My Safetipin App. More than 1000 audits were done by women volunteers. Each parameter is rated on the scale of 0 to 3 (refer Annex 1 for rubric) where 0 is poor and 3 is good rating. The bar graph shows the average ratings of the parameter for each area as compared with the average ratings of the parameter at the city level (as shown by line graph). Through the comparative representation, it is highlighted that most of the parameters are rated below average. Walkpath and Lighting parameters have the highest ratings in most of the areas, followed by the Visibility parameter. The lowest ratings were recorded for the Security and Gender Usage parameters.

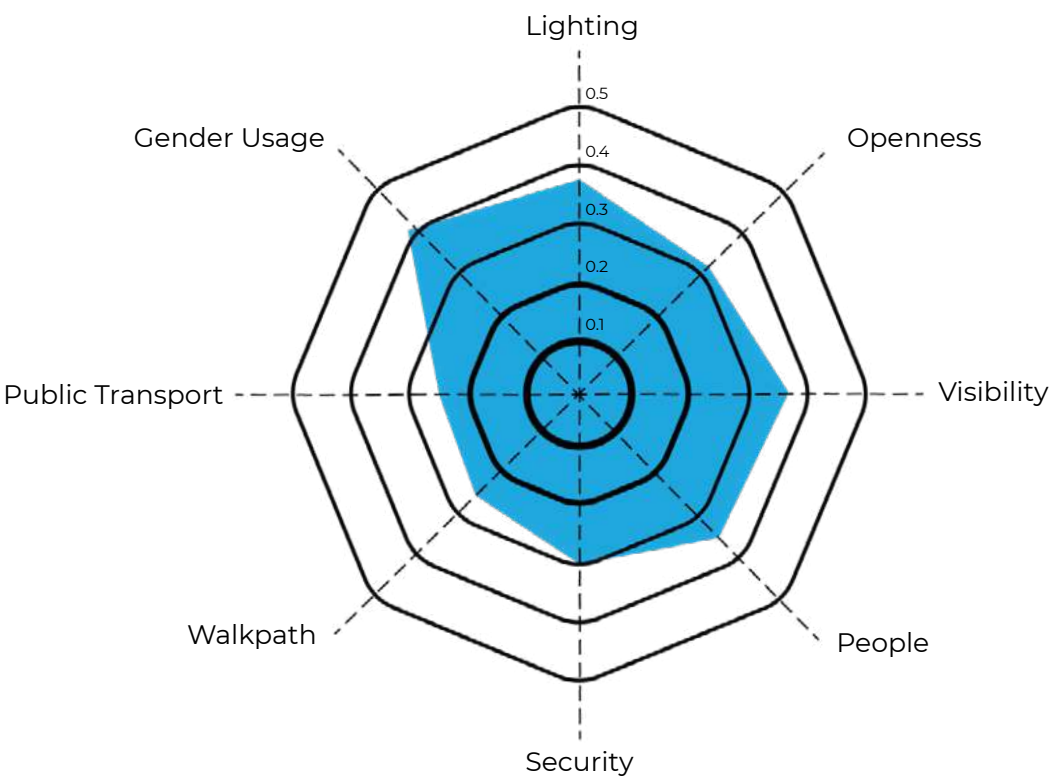
Feeling parameter reflects the perception of safety at a place. As all parameters do not have an equal impact on the perception of safety, it's useful to know how an improvement in each parameter will impact the overall feeling at a place. The radial graph shows the correlation of the Feeling parameter with all the other parameters based on the audits done by the volunteers. It could be seen that Gender Usage (presence of women and children), Lighting and Visibility (active streets) parameters have the maximum impact on the feeling of safety. Improvements on actionable parameters like Lighting, Visibility and Walkpath could encourage more women to use the public space, thereby improving Gender Usage and People parameters. This indicates the inter-dependency of the parameters in improving the overall safety score of a place.
