PUBLIC SPACE AUDITS IN JOHOR BAHRU, MALAYSIA

Executive Summary

Safetipin uses apps and a technology platform to collect data to measure safety and inclusivity of public spaces in cities. Safetipin in collaboration with the Think City, a social purpose organisation, undertook a pilot project on using data to make cities resilient, liveable and inclusive. Greater Johor Bahru was selected as a pilot city. For this project, two Safetipin applications i.e., Safetipin Nite and Safetipin Site have been used to map the streets and key public spaces. At the core of the Safetipin apps is the safety audit, based on physical infrastructure and social environment related parameters. The parameters are Lighting, Walkpath, Openness, Visibility, Access to Public Transport, Security, People and Gender Usage. In October 2020, over 9,000 images were collected using Safetipin Nite followed by visual analysis on the range of parameters to generate 974 safety audits. The analysed data has been represented in the form of maps in this report showing the existing status of physical infrastructure in the audited area. Most of the audited area has been rated high on the Lighting and Walkpath parameters. Th

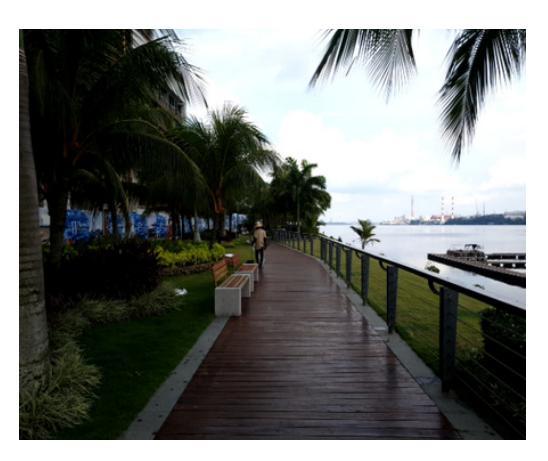
The vehicular path leading to the Opera House has a continuous pavement along it and the promenade along the Opera House is newly constructed, hence wellmaintained. It is surrounded by vegetation beds as well as fences along the Johor Strait. The path has benches and trash cans, clear from the pedestrian path.

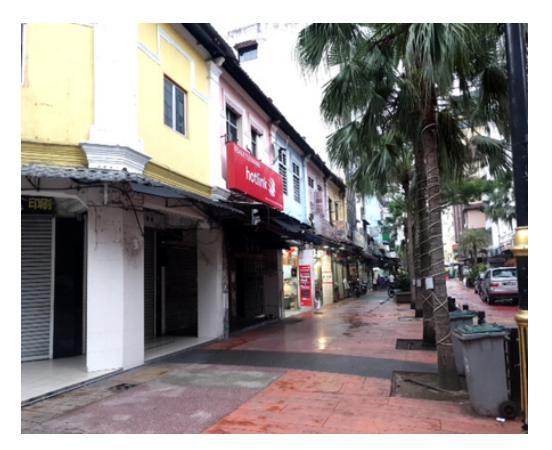
The walkpath is paved and elevated from the main road, as a means of divider for pedestrians. Bollards and fences are fitted at some stretches, to avoid vehicular parking on the pedestrian path. The pavement is wide enough for wheelchair users but doesn't have curb ramps at the corner for smooth transition. At few points, the path was found broken. Additionally, no pedestrian crossings were identified.

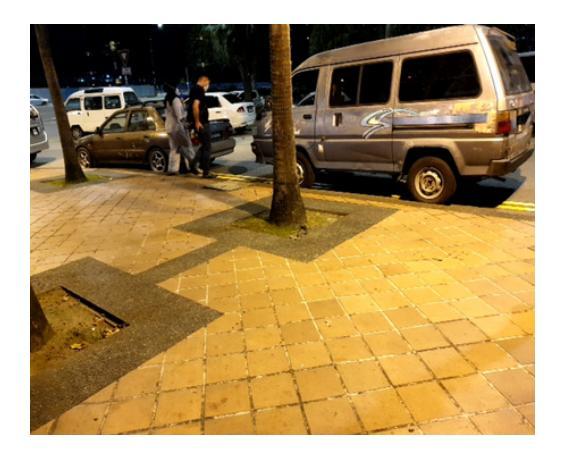
The is a properly constructed pavement in and around the bazaar area. The pavement is elevated which acts as a divider from the main road. There are no obstructions on the footpath, however, some patches are broken and require regular maintenance.

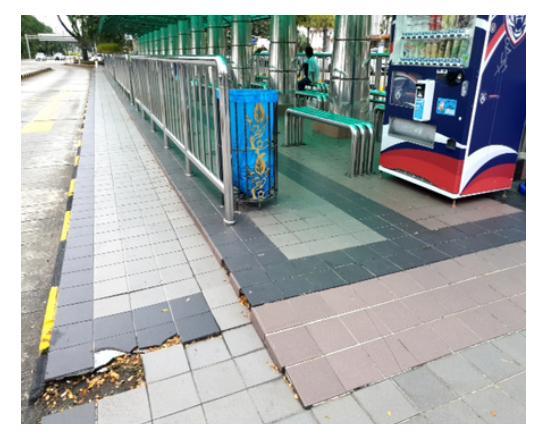
The pavement leading to the bus stop is elevated from the road, and is provided a ramp. A fence is provided to demarcate the waiting area of this stop. As seen in the image, while there is a trash can and vending machine, it leaves minimal clearing space in between for wheelchair users.

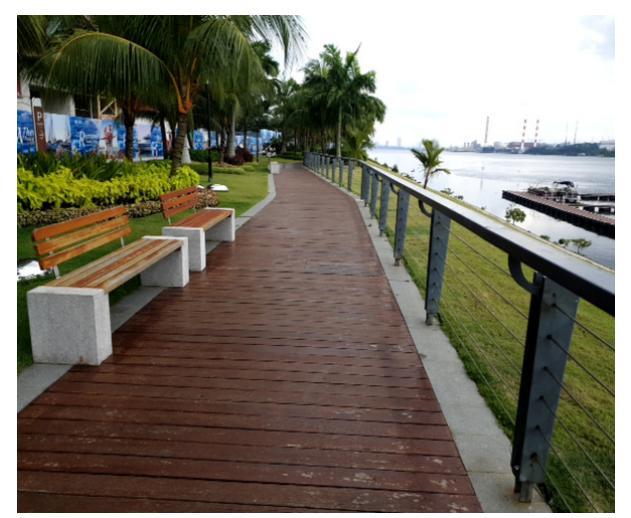
Image 13: The promenade at Permaisuri Zarith Sofiah Opera House

Owing to its location, Permaisuri Zarith Sofiah House isn't well-accessible for public transport users or pedestrians. While the promenade is well-developed along the Johor Strait, it is poorly lit and not active, hence seems unsafe after dark. A cycle path could be developed around this area which would help the visitors avoid private transport and also increase the activity along the promenade.

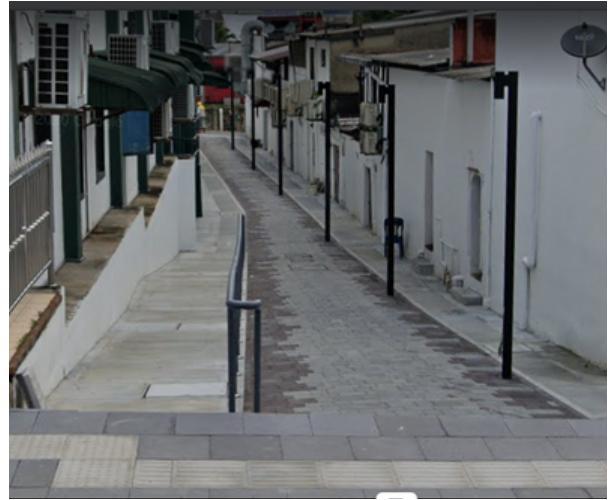
Image 14: Streetview of the Masjid India back lane

The first pedestrian walkway audited was a backlane of Masjid India that can be accessed through stairs or a ramp as seen in image 14. Despite being a back lane, it was well-lit and maintained, providing an obstruction-free space for the pedestrians. The second pedestrian walkway is a crucial link bridge built over Jalan Jim Quee highway, connecting R&F mall to JB Sentral. The major source of lighting over the bridge was from advertisement boards. When placed on both side of the bridge, the boards act as a barrier between the pedestrians and surroundings below. At times when the lighting fixtures are not functional or poorly lit as seen during the audit, the space becomes unsafe with no clear line of sight. Therefore, space should be uniformly lit using ceiling lights and advertisement boards should be kept in a staggered manner so that there is some visual connection with the built environment.

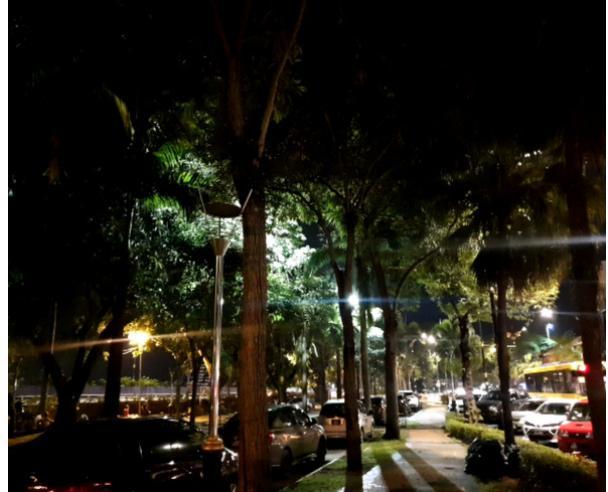
Image 19: Non-uniform illumination at the park

A good park attracts a wide range of people, thus enhancing the livability of a city. The park is brightly lit at most of the audited points, but at a few locations, the lighting was not uniform, leading to poorly lit spaces. The park audited was rated *good* in terms of lighting and walkpath for an able-bodied person. To ensure that the park is accessible to all, it needs to provide tactile paving, curb ramps and an at-grade pedestrian crossing. The crossing will have to be developed with proper signage and traffic signal with timer as the park is situated at a junction with high-speed traffic. There is a need to provide public convenience facilities (including public toilets) that are universally accessible.
